**NEW CAR ASSESSMENT PROGRAM  
FRONTAL BARRIER IMPACT TEST**

**GENERAL MOTORS CORPORATION  
2007 CADILLAC STS  
4-DOOR SEDAN**

**NHTSA NUMBER: G70109**

**FINAL REPORT**

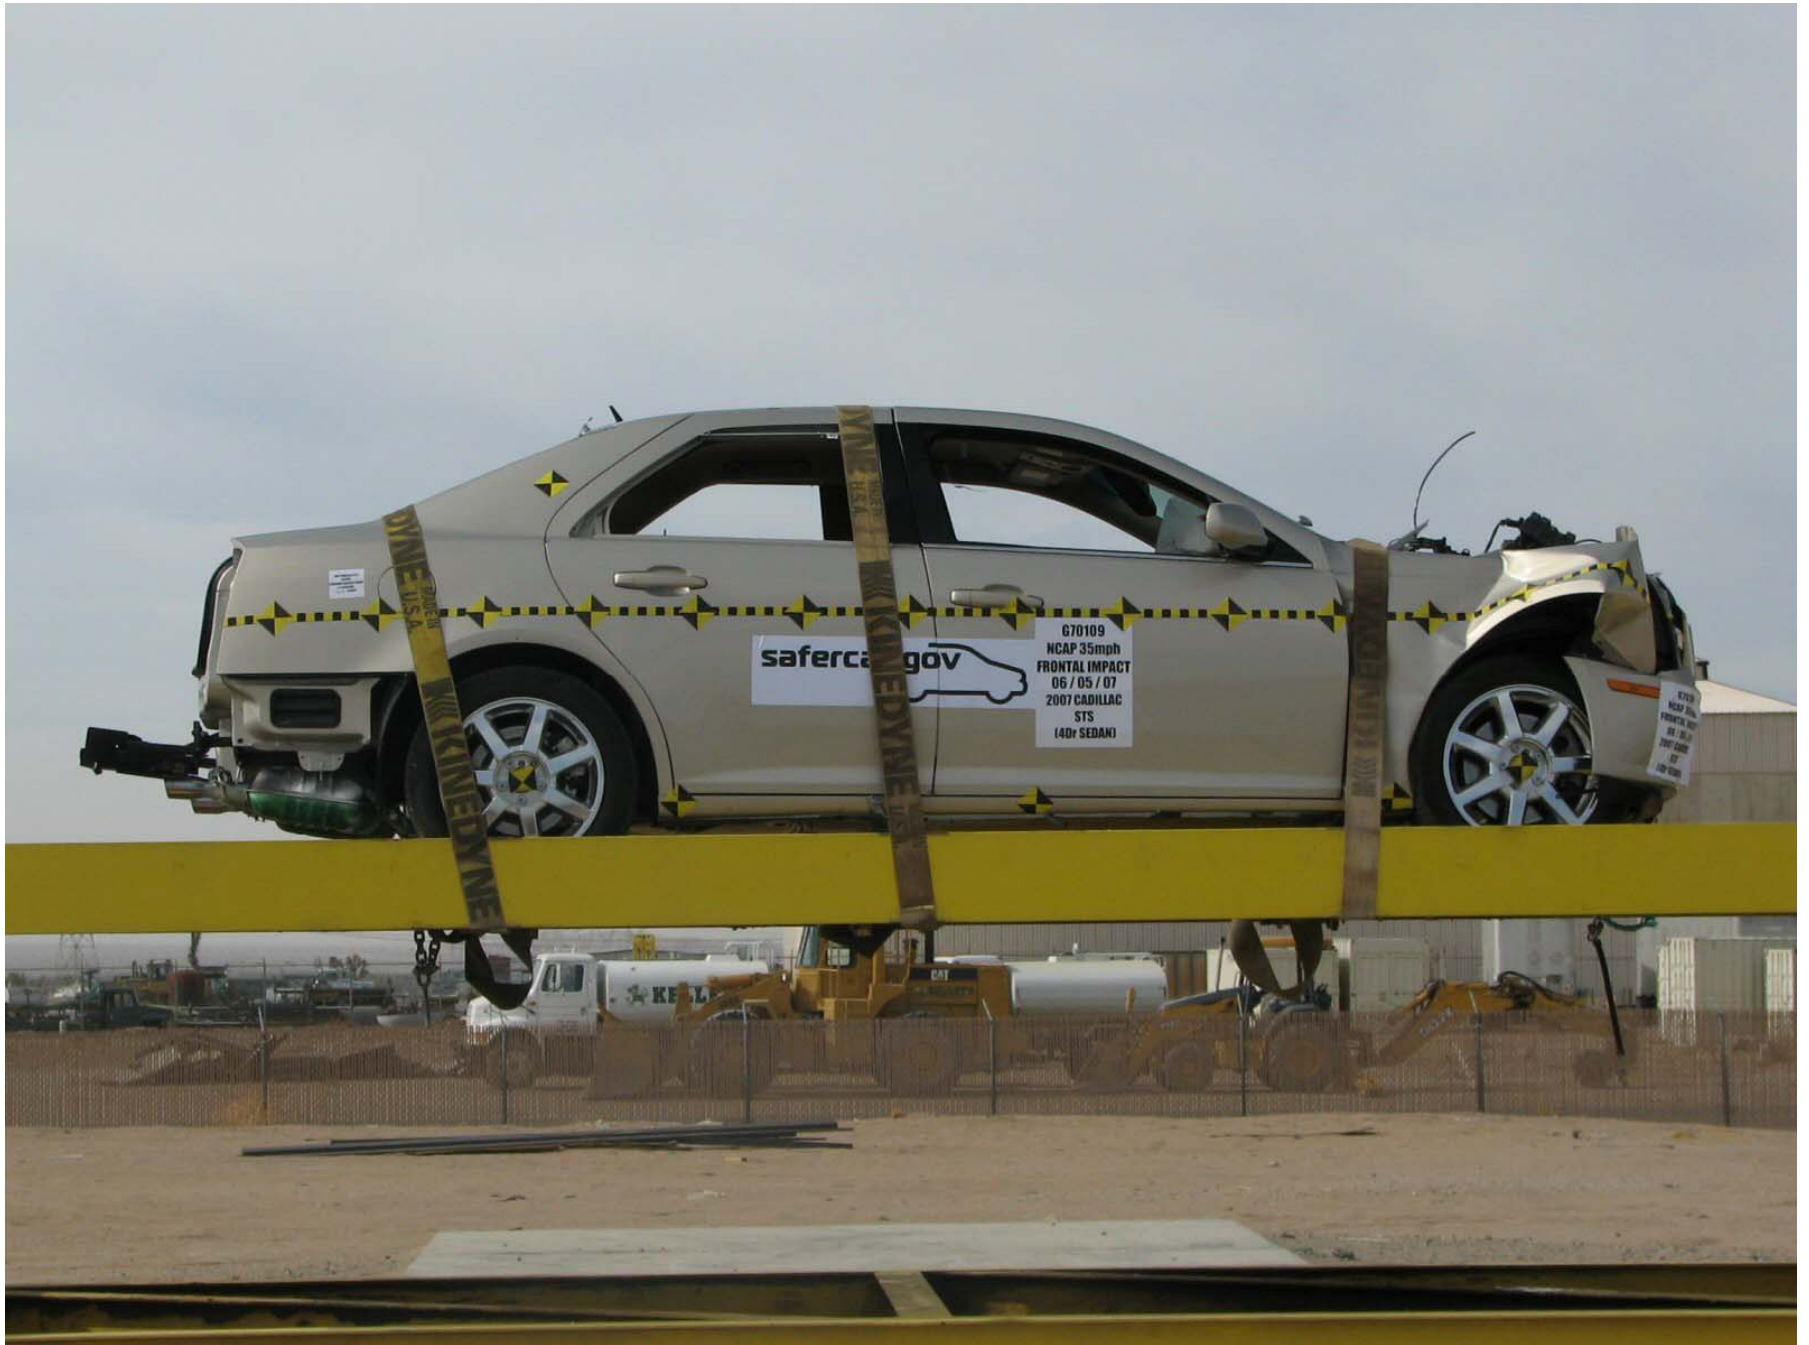
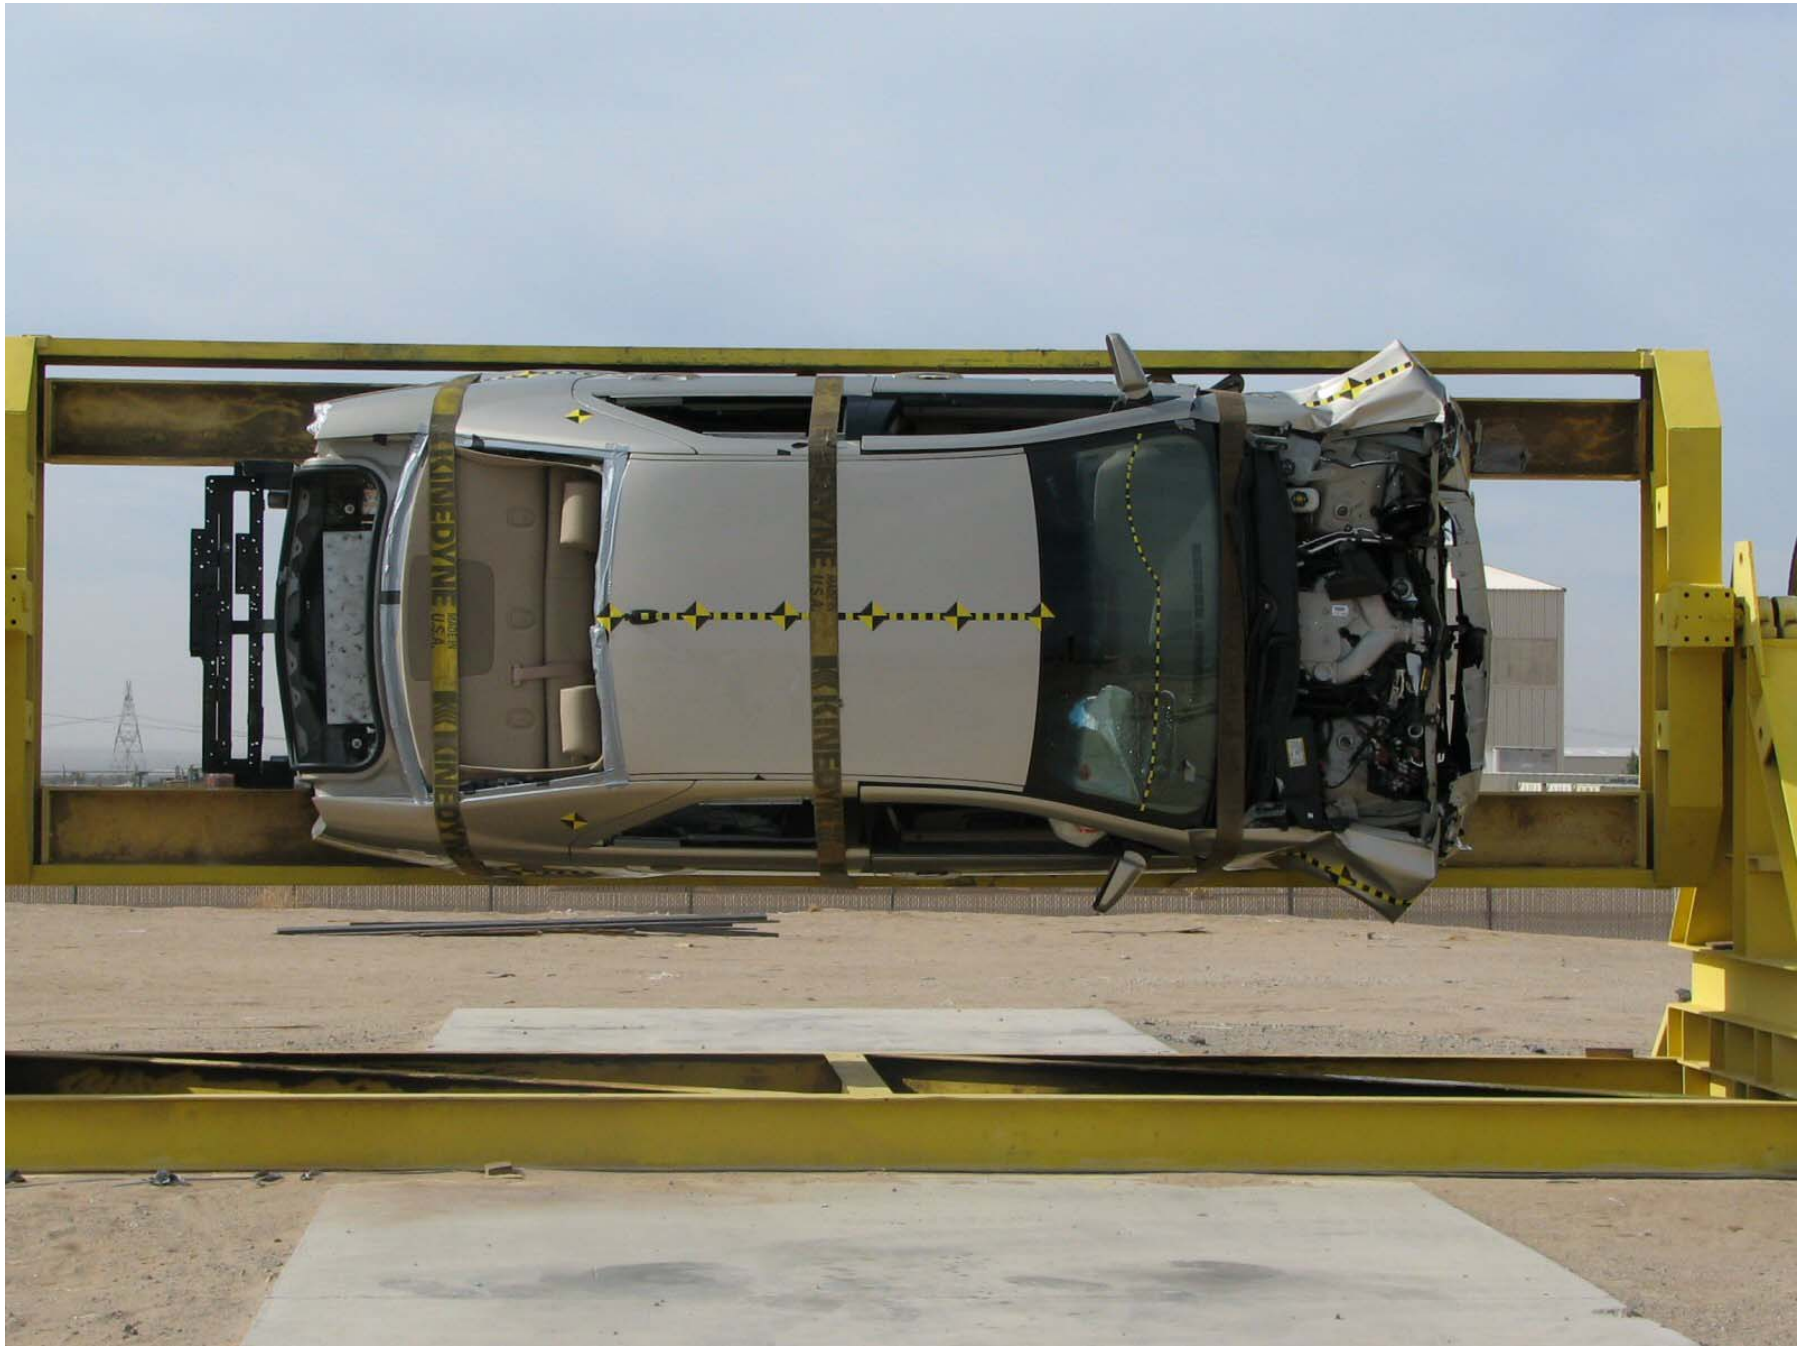
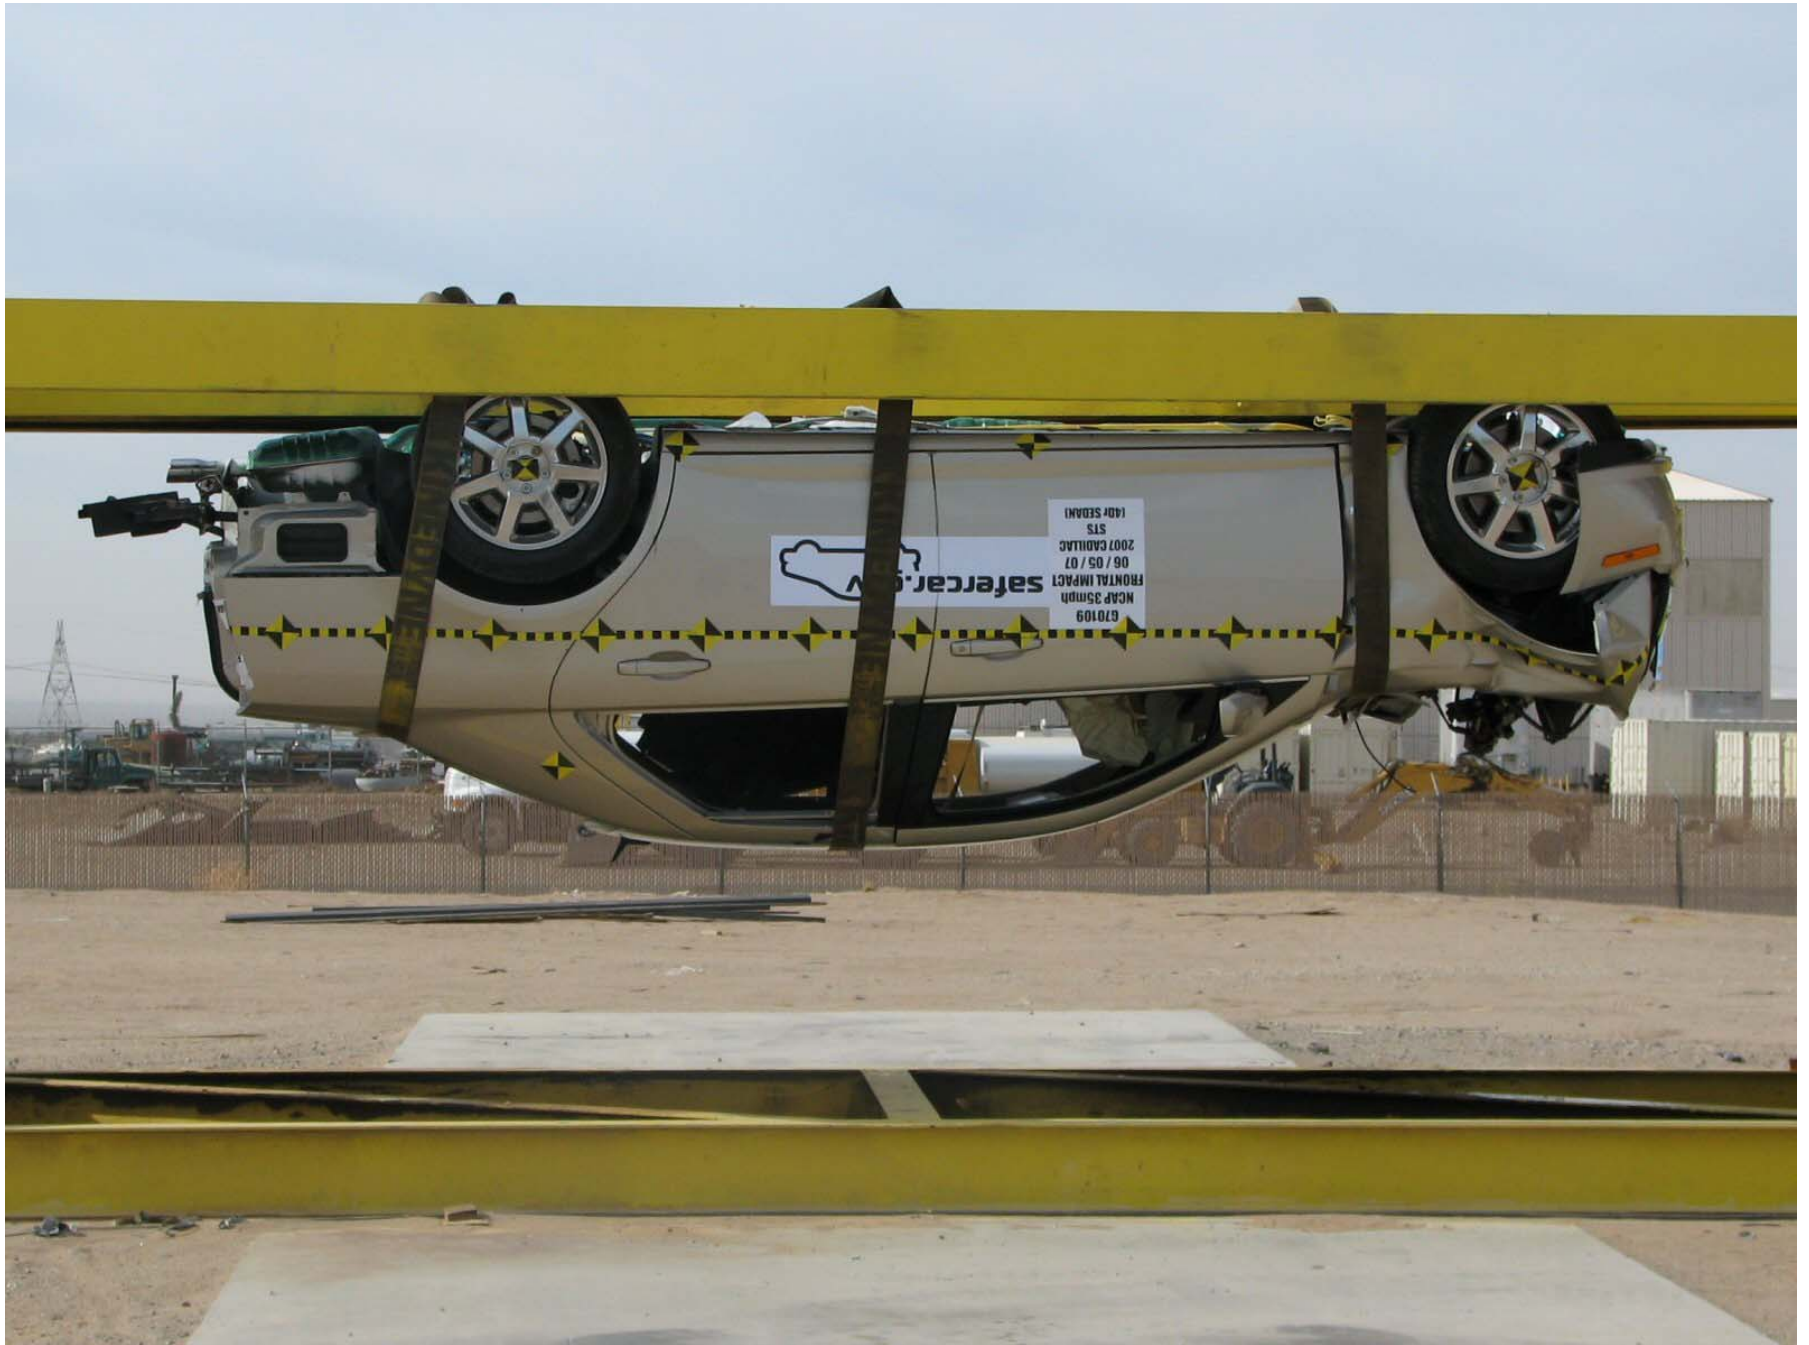
Figure A-58: Vehicle on Rollover Device (0°)

Figure A-59: Vehicle on Rollover Device (90°)

Figure A-60: Vehicle on Rollover Device (180°)

Figure A-61: Vehicle on Rollover Device (270°)

1. The specified fixture rollover rate for each 90° of rotation is 60 to 120 seconds.
2. The position hold time at each position is 300 seconds (minimum).
3. No solvent leakage occurred during rollover.
