REPORT NUMBER TR-P27148-01-NC

**NEW CAR ASSESSMENT PROGRAM
SIDE IMPACT TEST**

**FORD MOTOR COMPANY
2007 FORD EXPLORER XLT
5-DOOR MPV**

NHTSA NUMBER: F80200

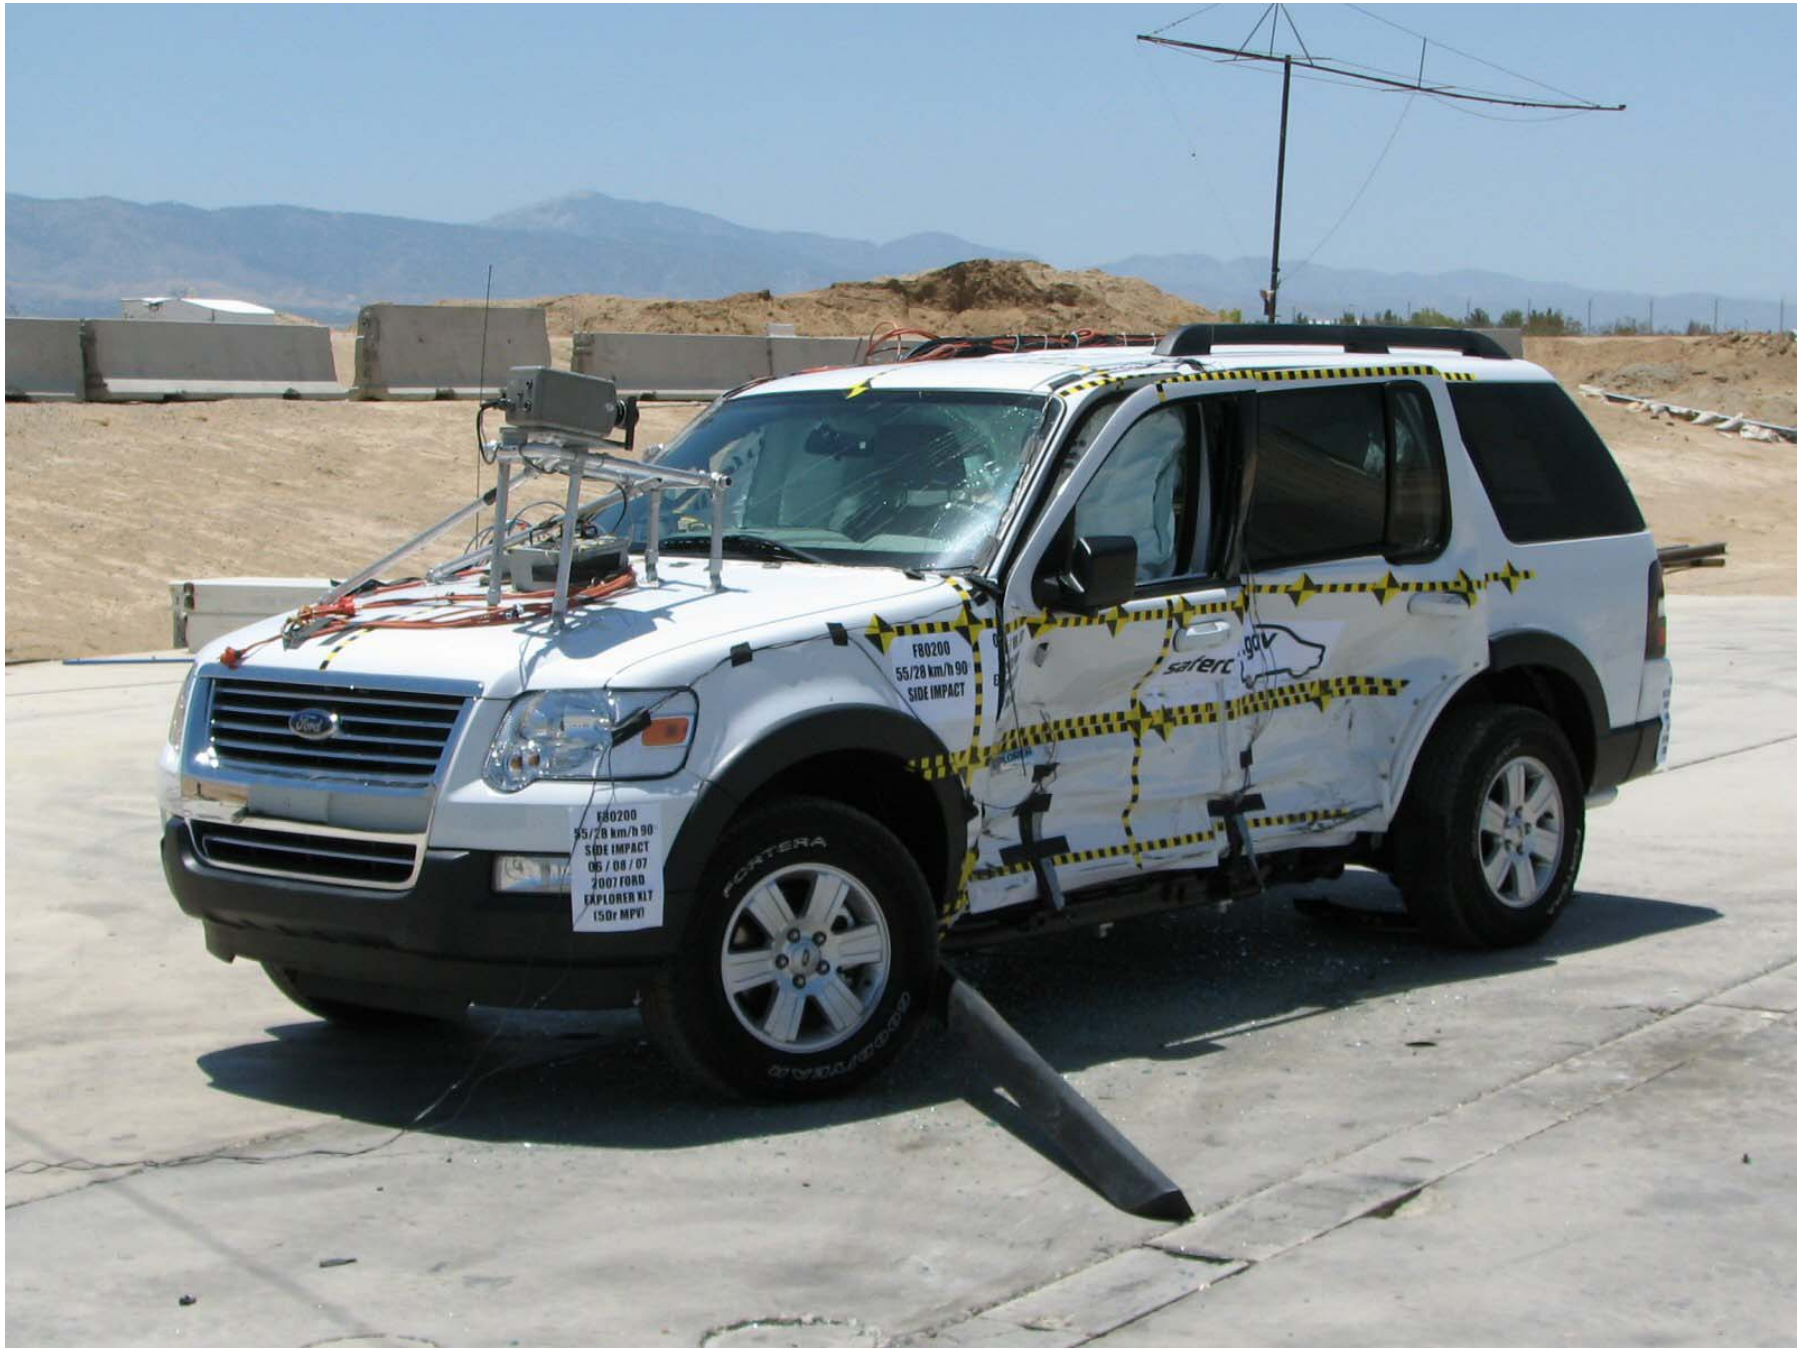
Figure A-8: Post-Test Left Front $\frac{3}{4}$ View

The driver and passenger doors remained closed during impact. The test vehicle sustained a maximum static crush of 256 mm at level 3, 1650 mm rearward of the left vertical impact point. The driver SID/Hybrid III, Serial No. 274 and the passenger SID/Hybrid III, Serial No. 275 were calibrated prior to this test. The SID/Hybrid III injury criteria is summarized as follows:

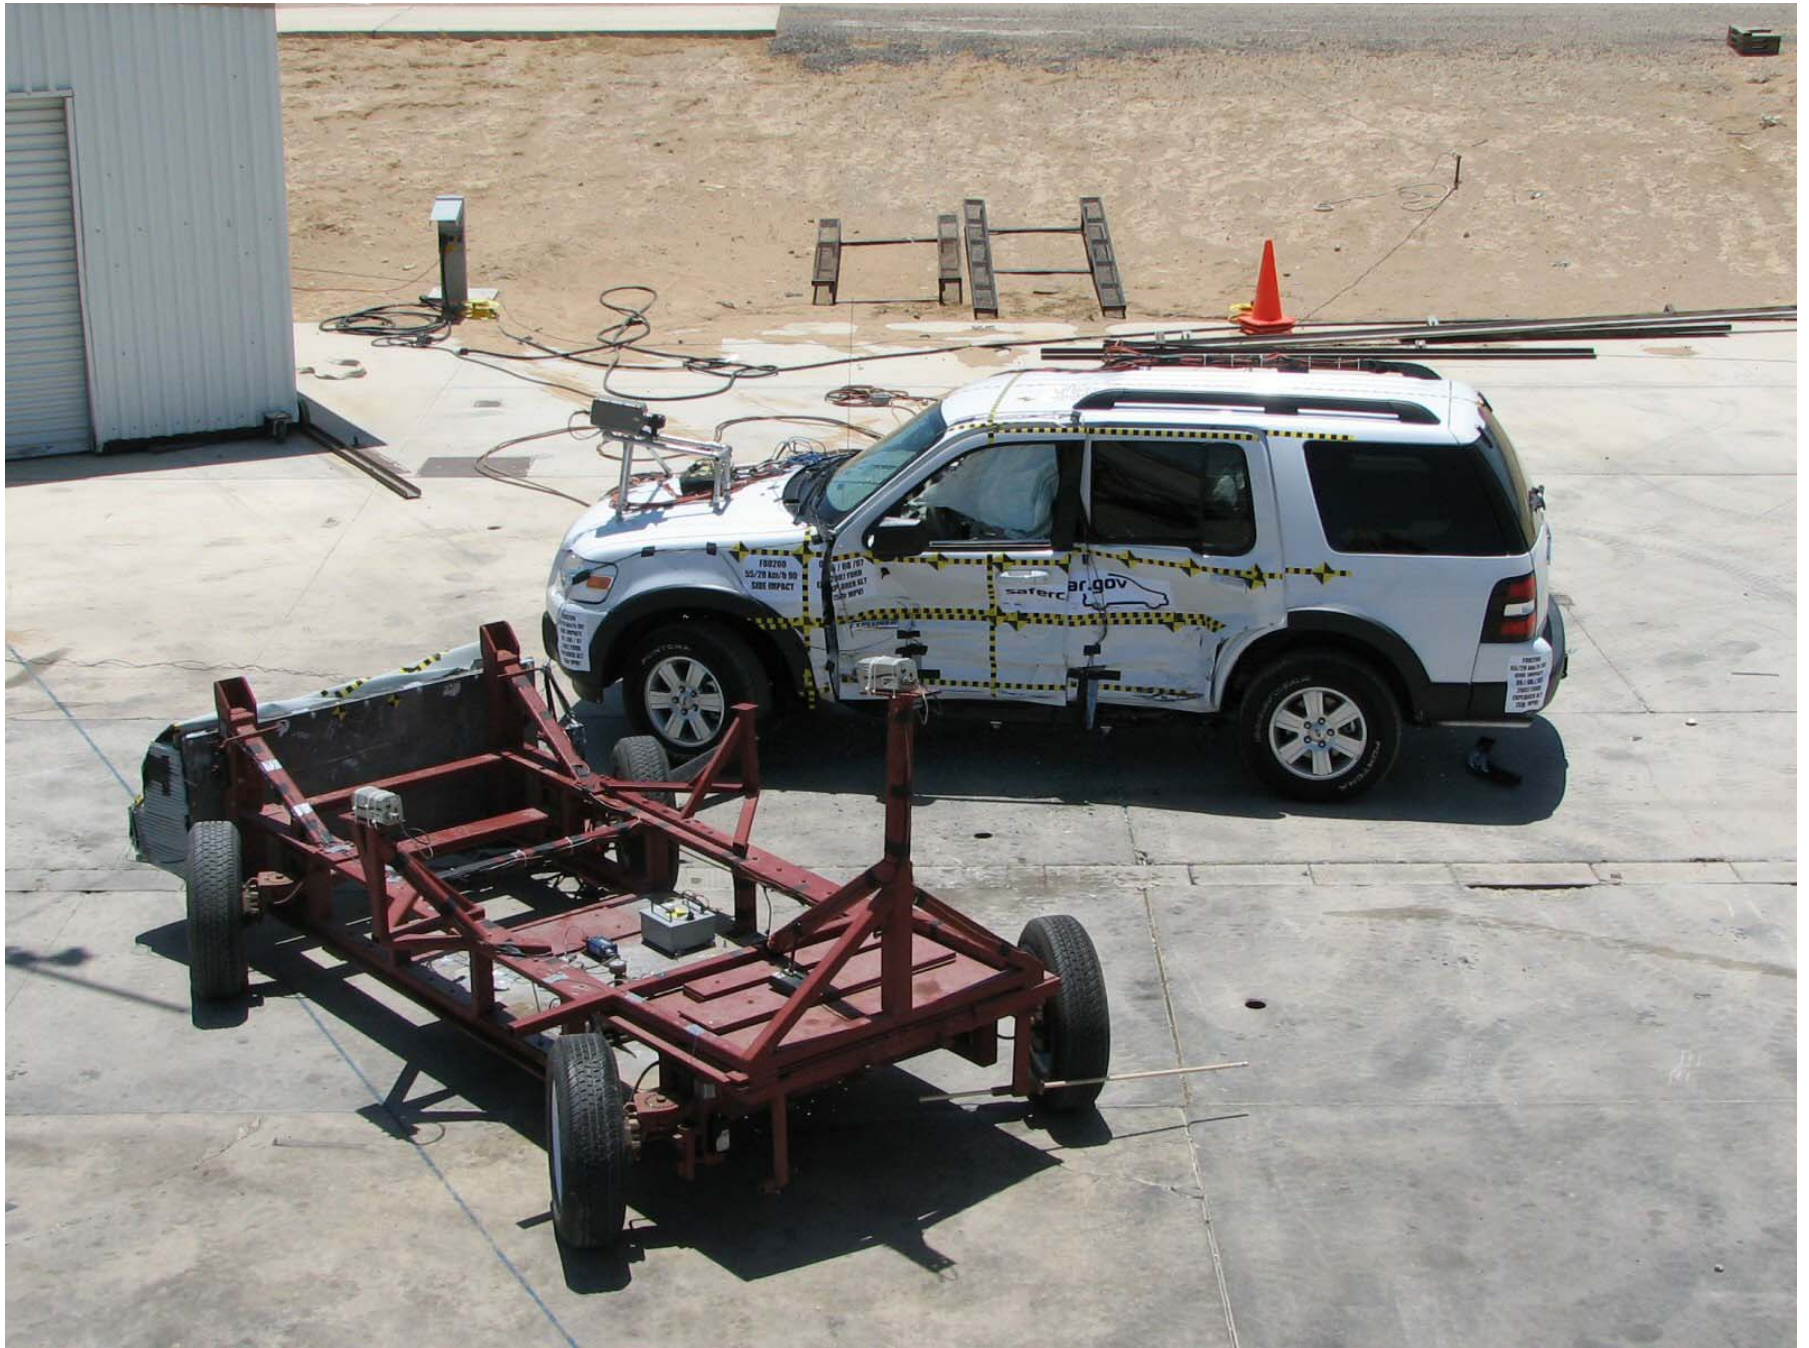
Figure A-22: Post-Test Overhead View

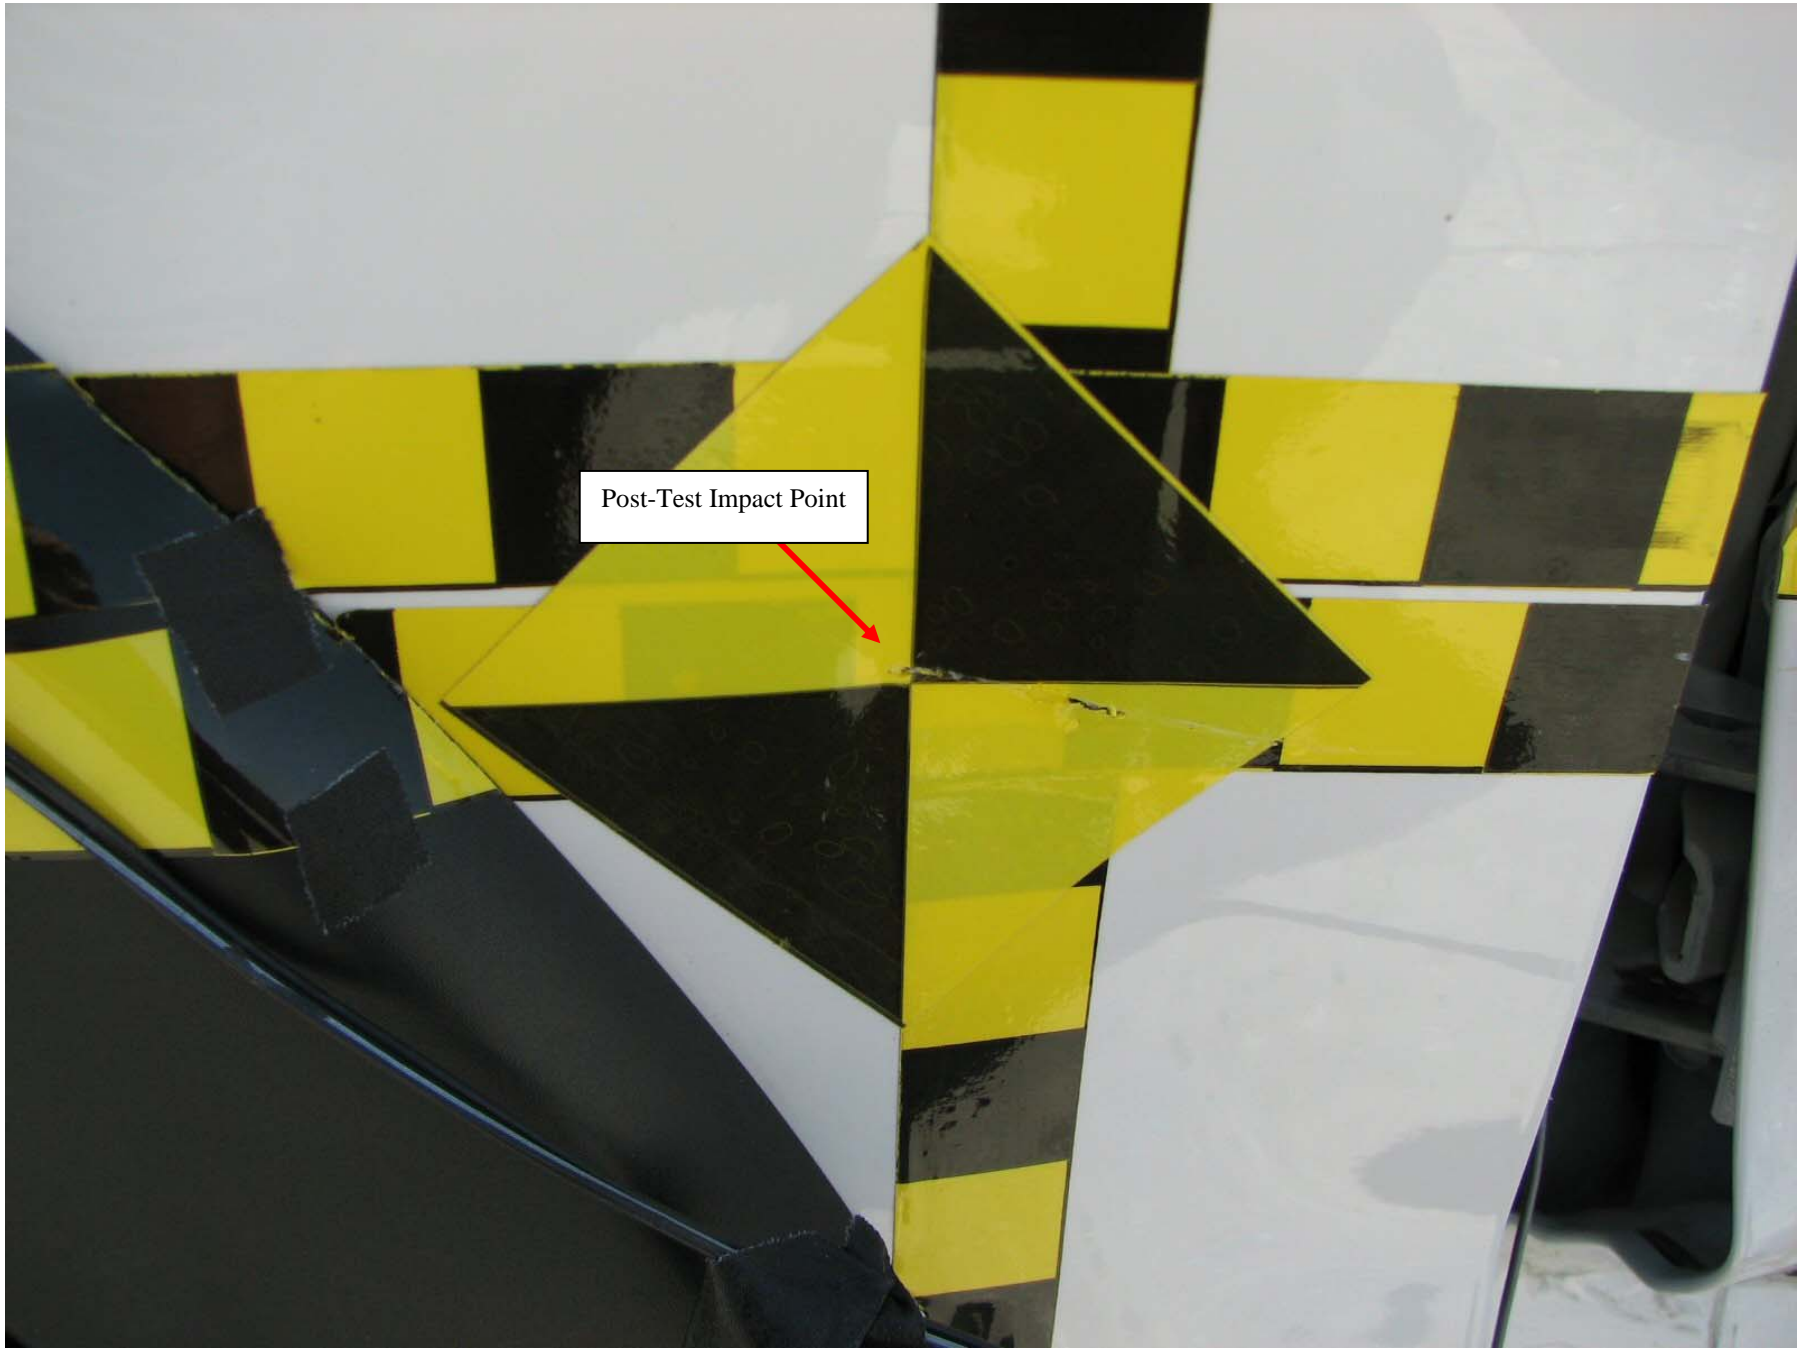
Figure A-26: Post-Test Left Impact Point

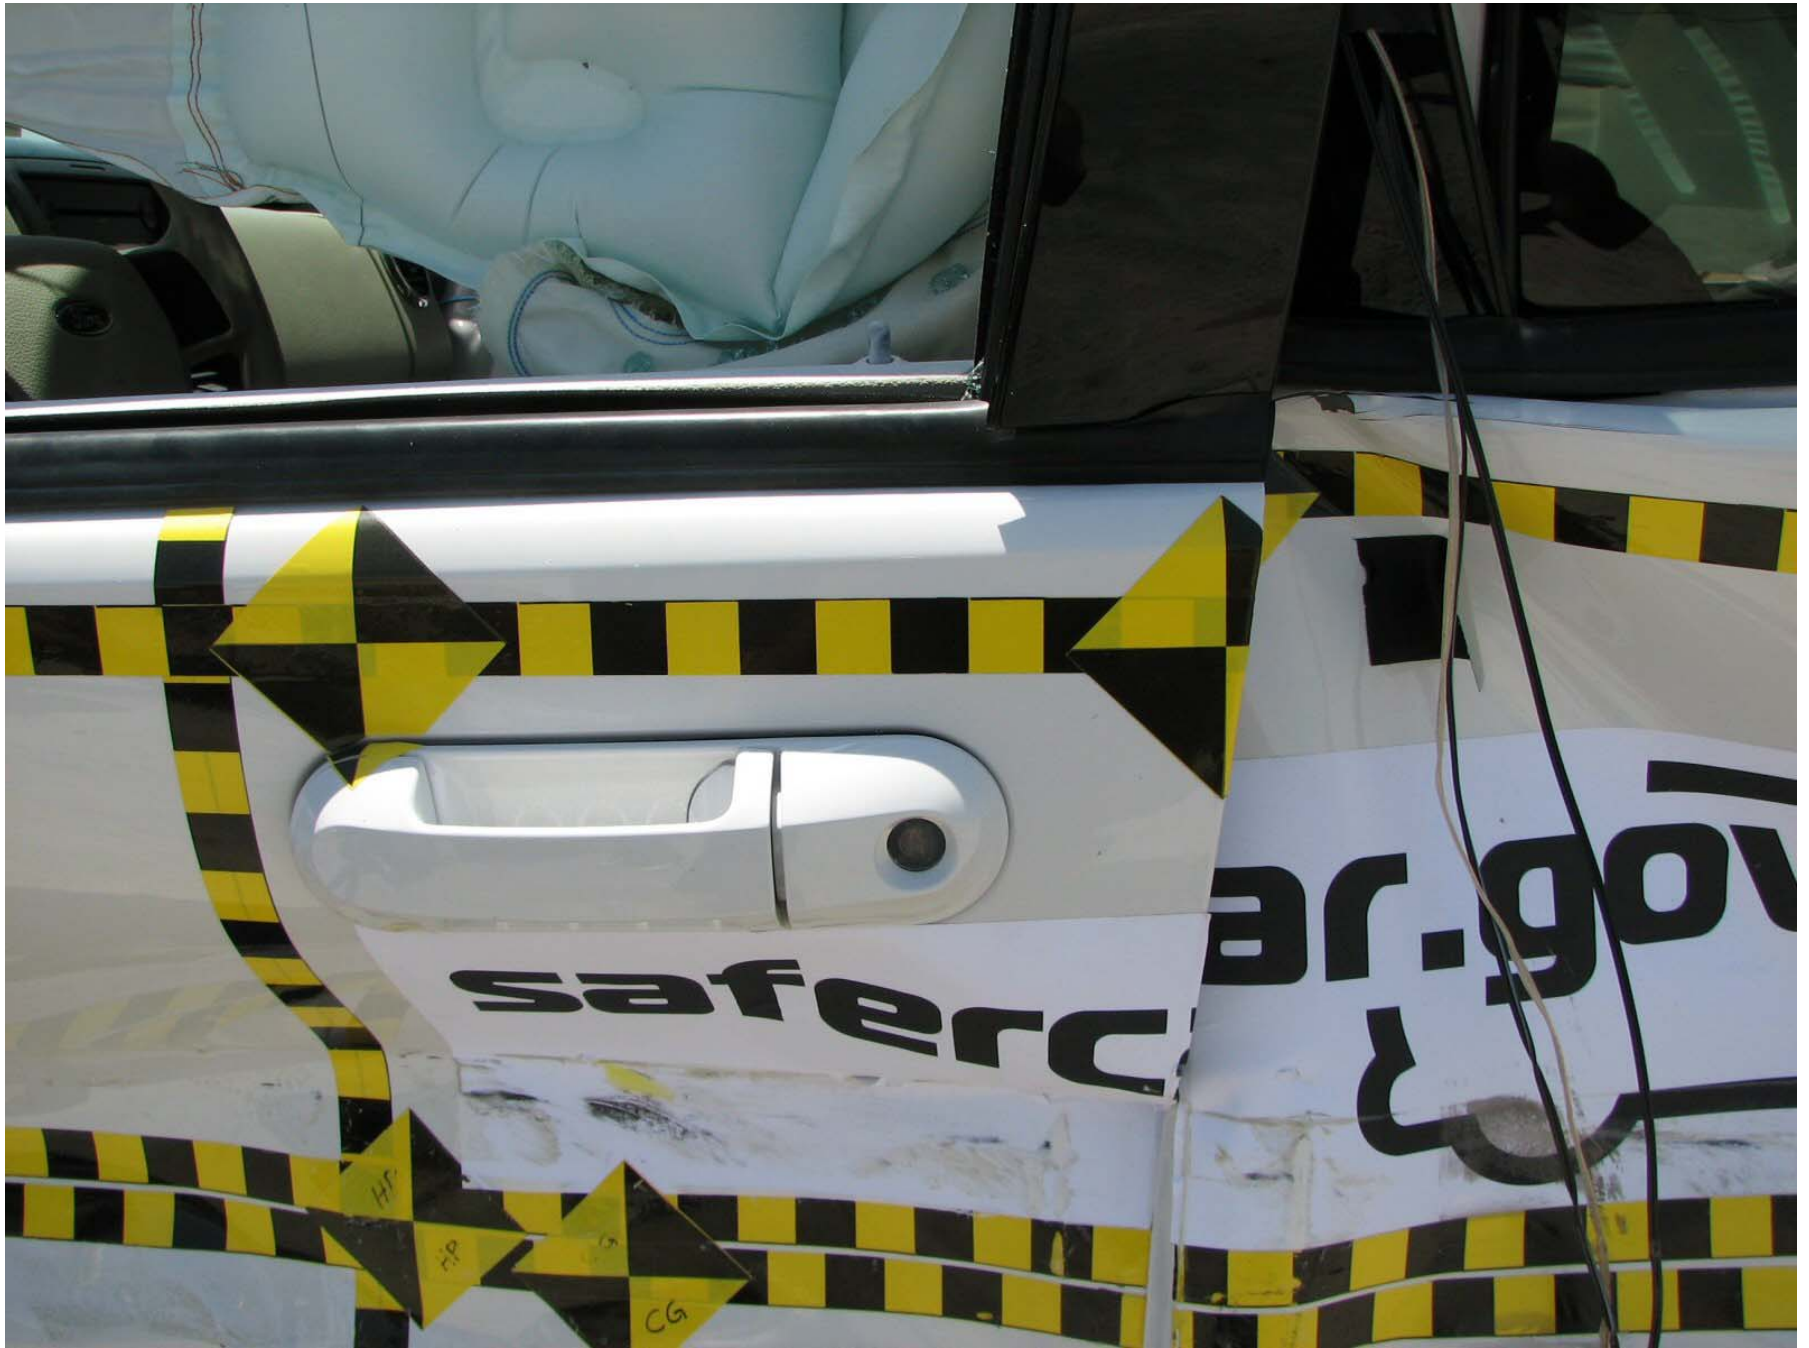
Figure A-32: Post-Test Left Front Door

Description	Front	Rear
Left Side Door Opening	Door remained closed and latched, jammed	Door remained closed and latched, jammed
Right Side Door Opening	Remained closed and latched, operational	Remained closed and latched, operational
Seat Movement	None	None
Seat Back Failure	None	None

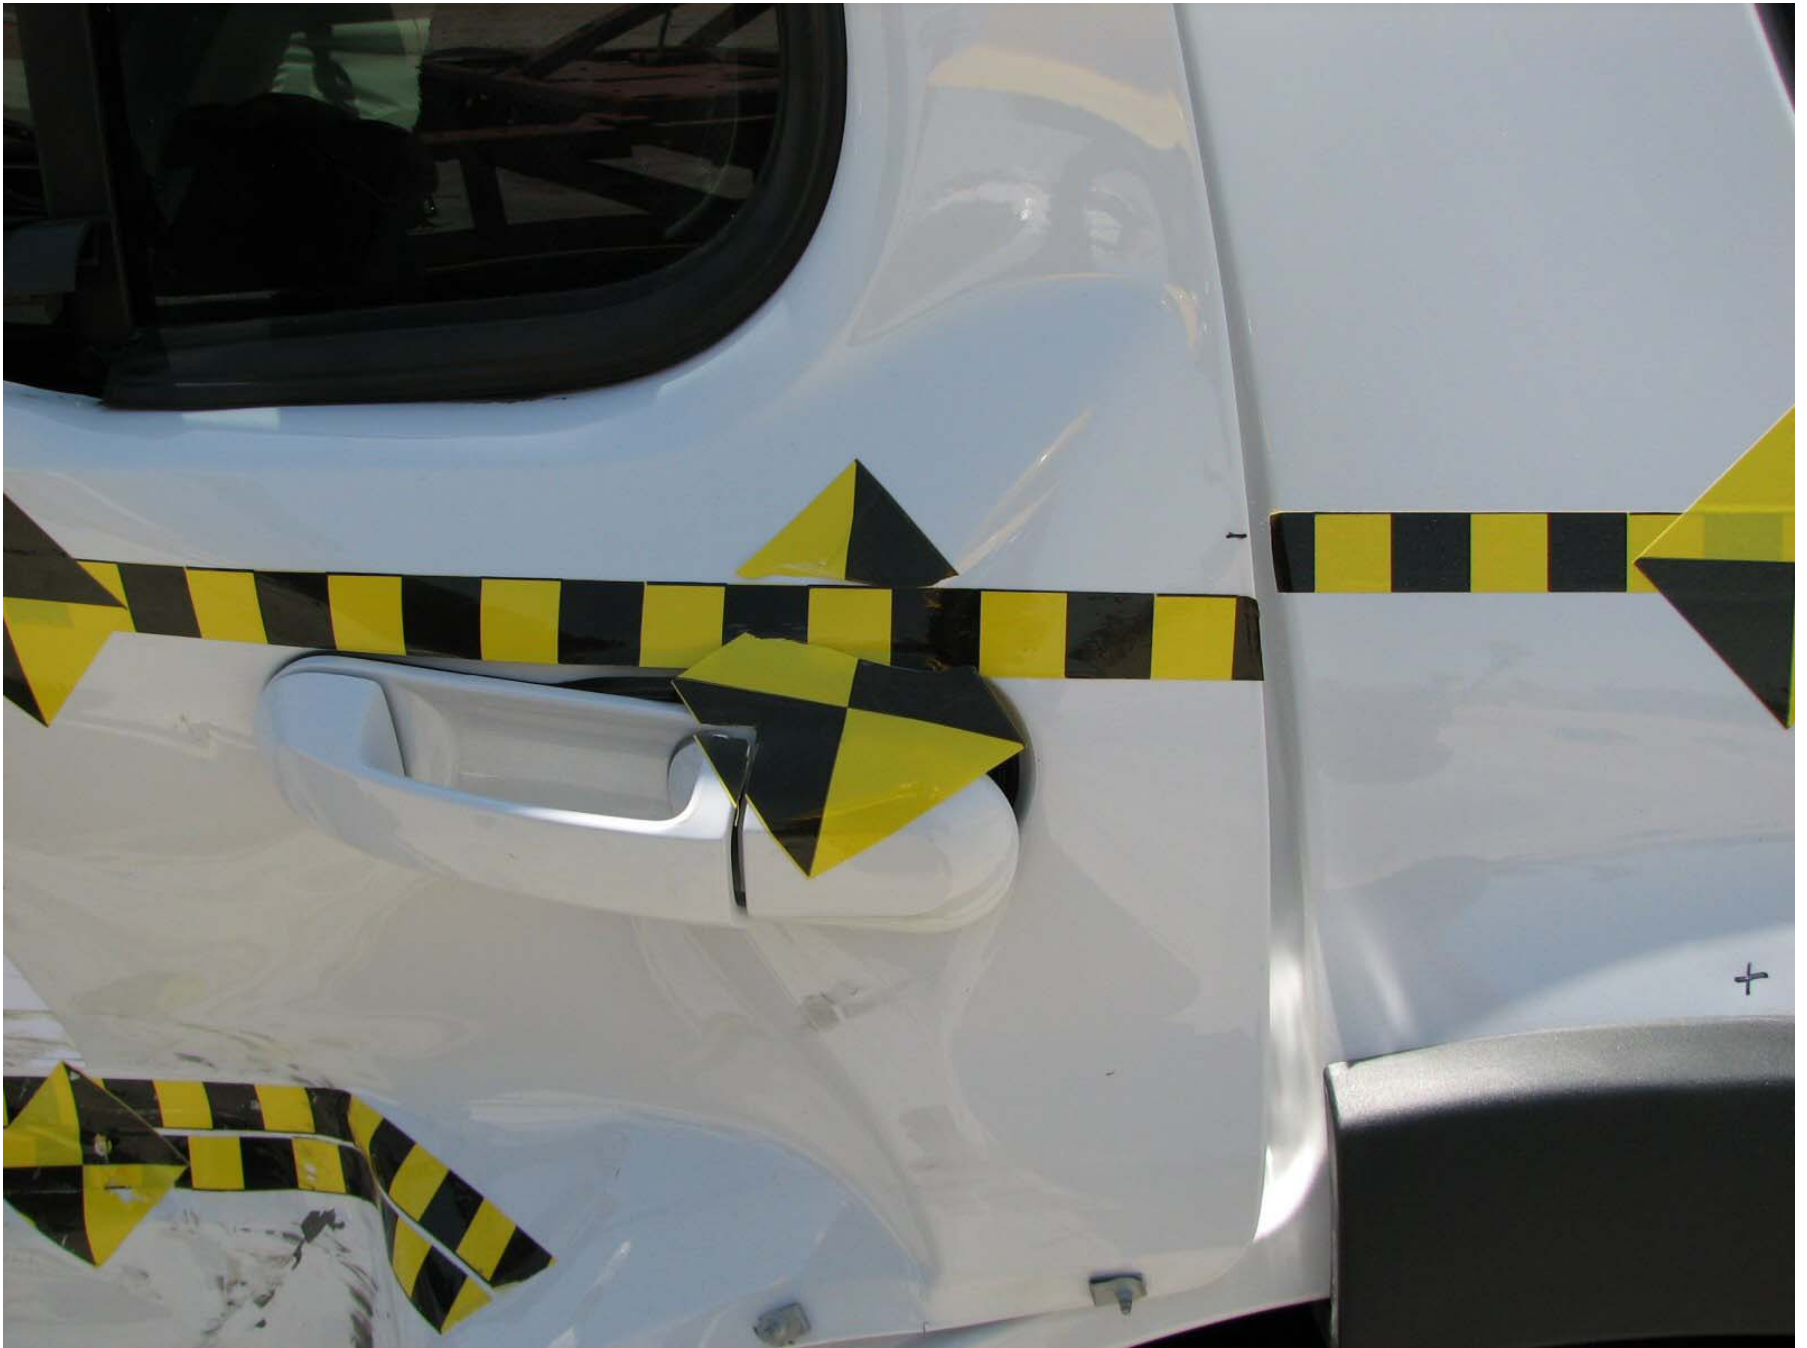
Figure A-34: Post-Test Left Rear Door

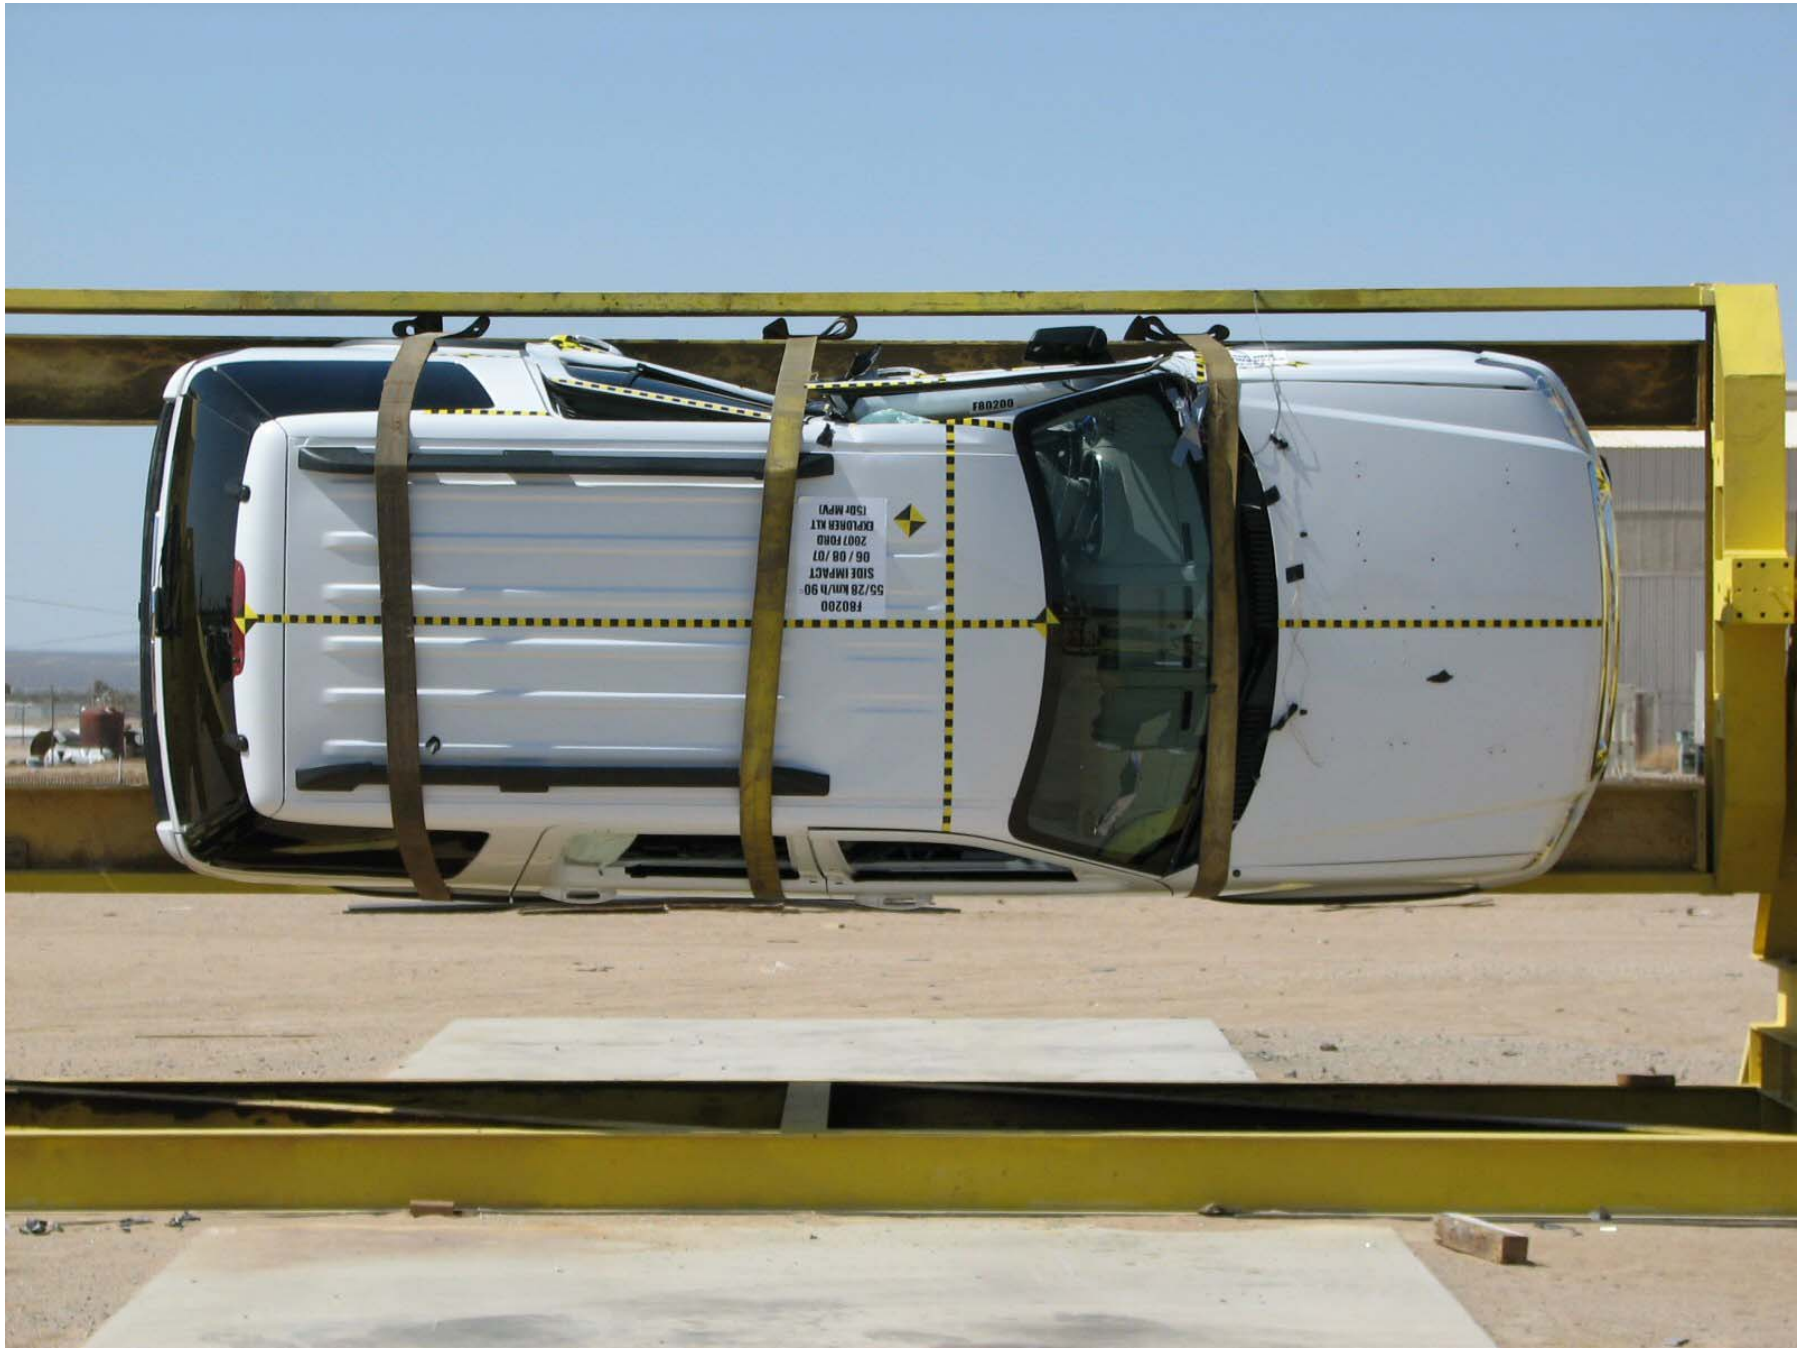
Figure A-62: Vehicle on Rollover Device (90°)

1. The specified fixture rollover rate for each 90° of rotation is 60 to 120 seconds.
2. The position hold time at each position is 300 seconds (minimum).
3. Details of Stoddard Solvent spillage locations.
No solvent leakage occurred during static rollover testing.

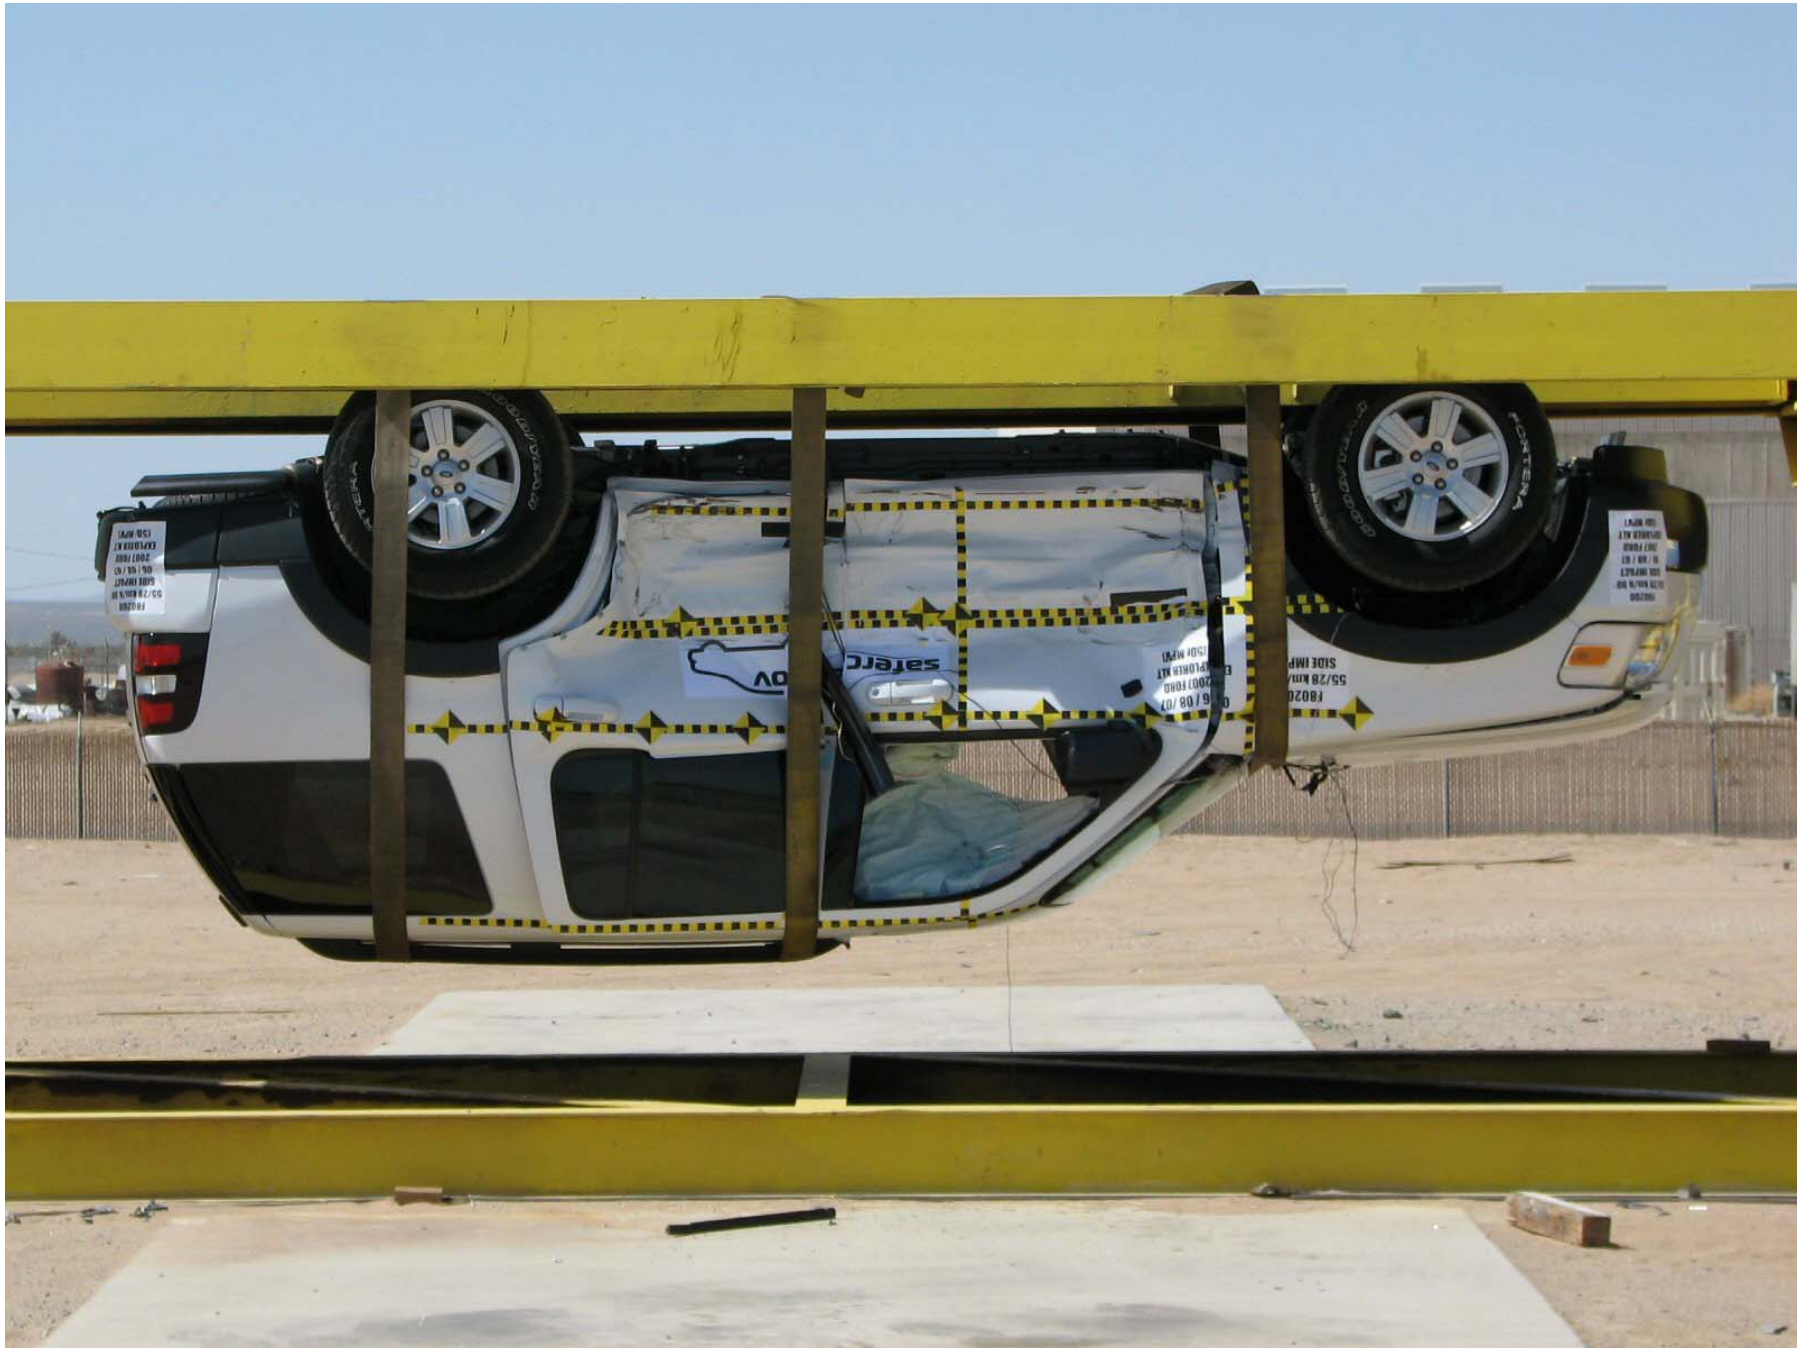
Figure A-63: Vehicle on Rollover Device (180°)

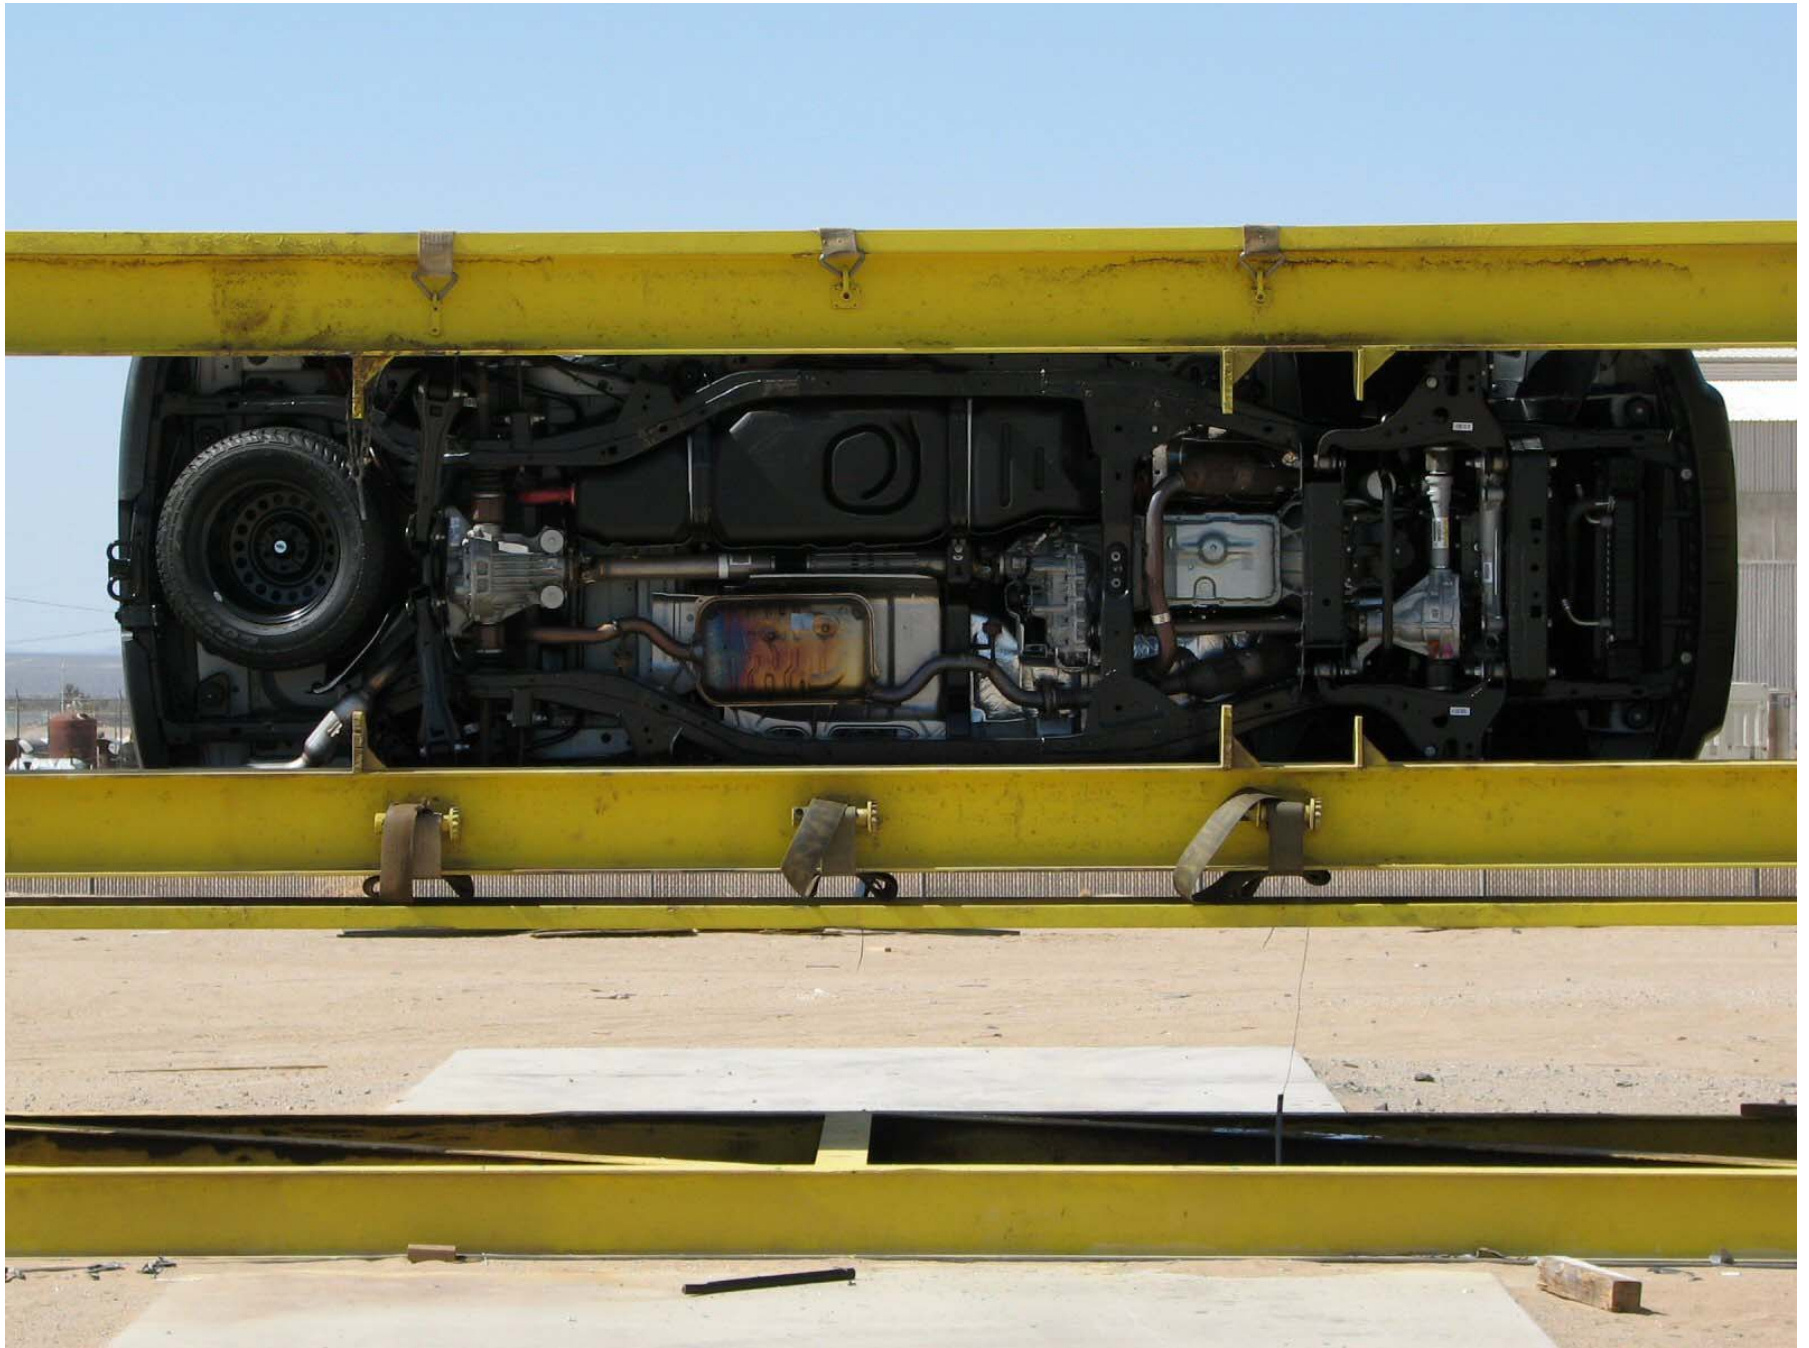
Figure A-64: Vehicle on Rollover Device (270°)

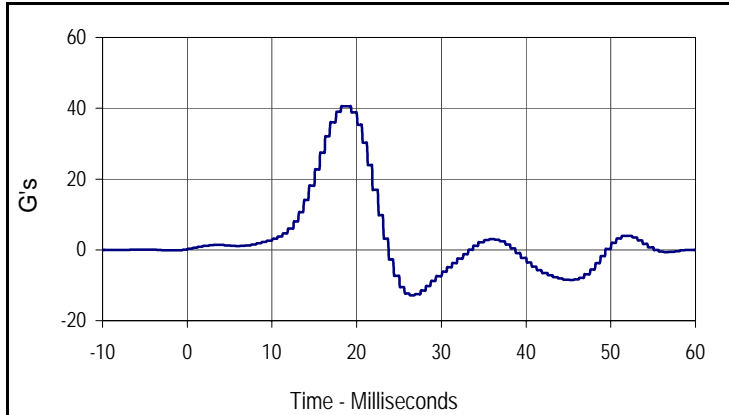
Tested Parameter	Units	Specification	Result	Pass/Fail
Laboratory Temperature	°C	18.9 to 25.6	21.1	Pass
Laboratory Relative Humidity	%	10 to 70	30	Pass
Probe Velocity	m/s	4.21 to 4.33	4.26	Pass
Upper Rib Acceleration	G's	37.0 to 46.0	40.6	Pass
Lower Rib Acceleration	G's	37.0 to 46.0	39.8	Pass
Thoracic Spine Acceleration	G's	15.0 to 22.0	19.3	Pass
Overall Test Results			Pass

Curve Description			
Upper Rib Y Primary			
CURNO	Type	SAE Class	Units
001	FIL	FIR100	G's
Max	Time	Min	Time
40.6	18.2	-12.8	26.3

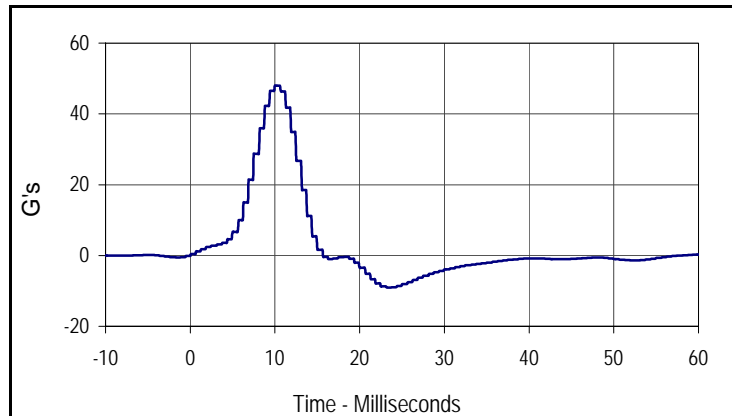
Tested Parameter	Units	Specification	Result	Pass/Fail
Laboratory Temperature	°C	18.9 to 25.6	21.1	Pass
Laboratory Relative Humidity	%	10 to 70	30	Pass
Probe Velocity	m/s	4.21 to 4.33	4.32	Pass
Peak Pelvis Acceleration	G's	40.0 to 60.0	48.0	Pass
Acceleration Time Above 20 G's	Msec.	3.0 to 7.0	4.90	Pass
Overall Test Results				Pass

Curve Description			
Pelvis Y Primary			
CURNO	Type	SAE Class	Units
001	FIL	FIR100	G's
Max	Time	Min	Time
48.0	10.0	-9.0	23.2

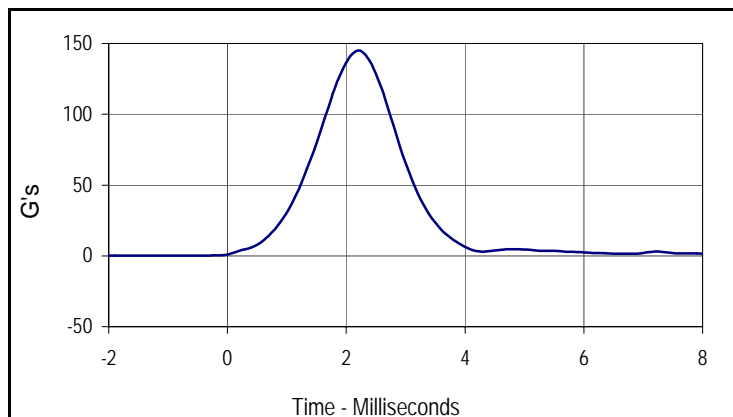
Tested Parameter	Units	Specification	Result	Pass/Fail
Laboratory Temperature	°C	18.9 to 25.6	21.7	Pass
Laboratory Relative Humidity	%	10 to 70	30	Pass
Peak Resultant Acceleration	G's	120.0 to 150.0	145.0	Pass
Peak Longitudinal Acceleration	G's	≤15.0	6.3	Pass
Is Acceleration Unimodal?	Yes/No	Yes	Yes	Pass
Oscillations After Main Pulse	%	<15	3.1	Pass
Overall Test Results			Pass

Curve Description			
Head Resultant			
CURNO	Type	SAE Class	Units
001	RES	1000	G's
Max	Time	Min	Time
145.0	2.2	0.1	-1.9

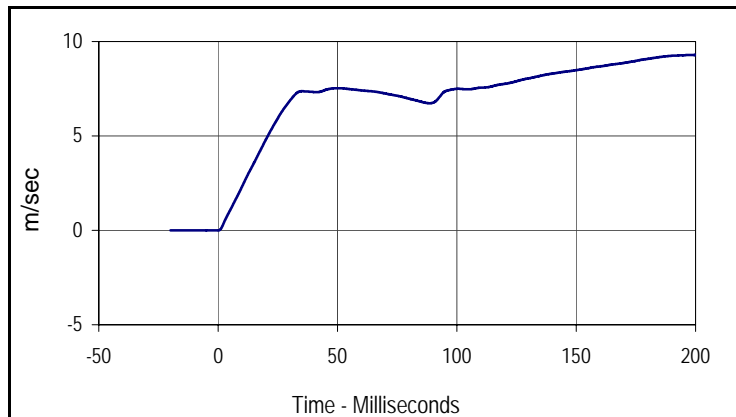
Tested Parameter	Units	Specification	Result	Pass/Fail	
Laboratory Temperature	°C	20.6 to 22.2	21.1	Pass	
Laboratory Relative Humidity	%	10 to 70	30	Pass	
Pendulum Velocity	m/sec	6.89 to 7.13	7.10	Pass	
Pendulum Deceleration	10 Msec.	m/sec	1.96 to 2.55	2.32	Pass
	20 Msec.	m/sec	4.12 to 5.10	4.81	Pass
	30 Msec.	m/sec	5.73 to 7.01	6.86	Pass
	40 to 70	m/sec	6.27 to 7.64	7.53	Pass
"D" Plane Rotation	Max	Degrees	66.0 to 82.0	73.3	Pass
Max Rotation Time After Peak Moment	Msec.	2.0 to 16.0	9.7	Pass	
Rotation Time From Peak to Zero Angle	Msec.	58.0 to 67.0	60.3	Pass	
Moment About Occipital Condyle	Nm	73.0 to 88.0	85.1	Pass	
Positive Moment Decay, Time To 0 Nm	Msec.	49.0 to 64.0	49.7	Pass	
Overall Test Results				Pass

Curve Description			
Pendulum Velocity			
CURNO	Type	SAE Class	Units
001	FIL	180	m/sec
Max	Time	Min	Time
9.3	198.6	0.0	-0.1
