**NEW CAR ASSESSMENT PROGRAM  
FRONTAL BARRIER IMPACT TEST**

**TOYOTA MOTOR CORPORATION  
2008 TOYOTA SCION XB  
5-DOOR MPV**

**NHTSA NUMBER: M85100**

**FINAL REPORT**

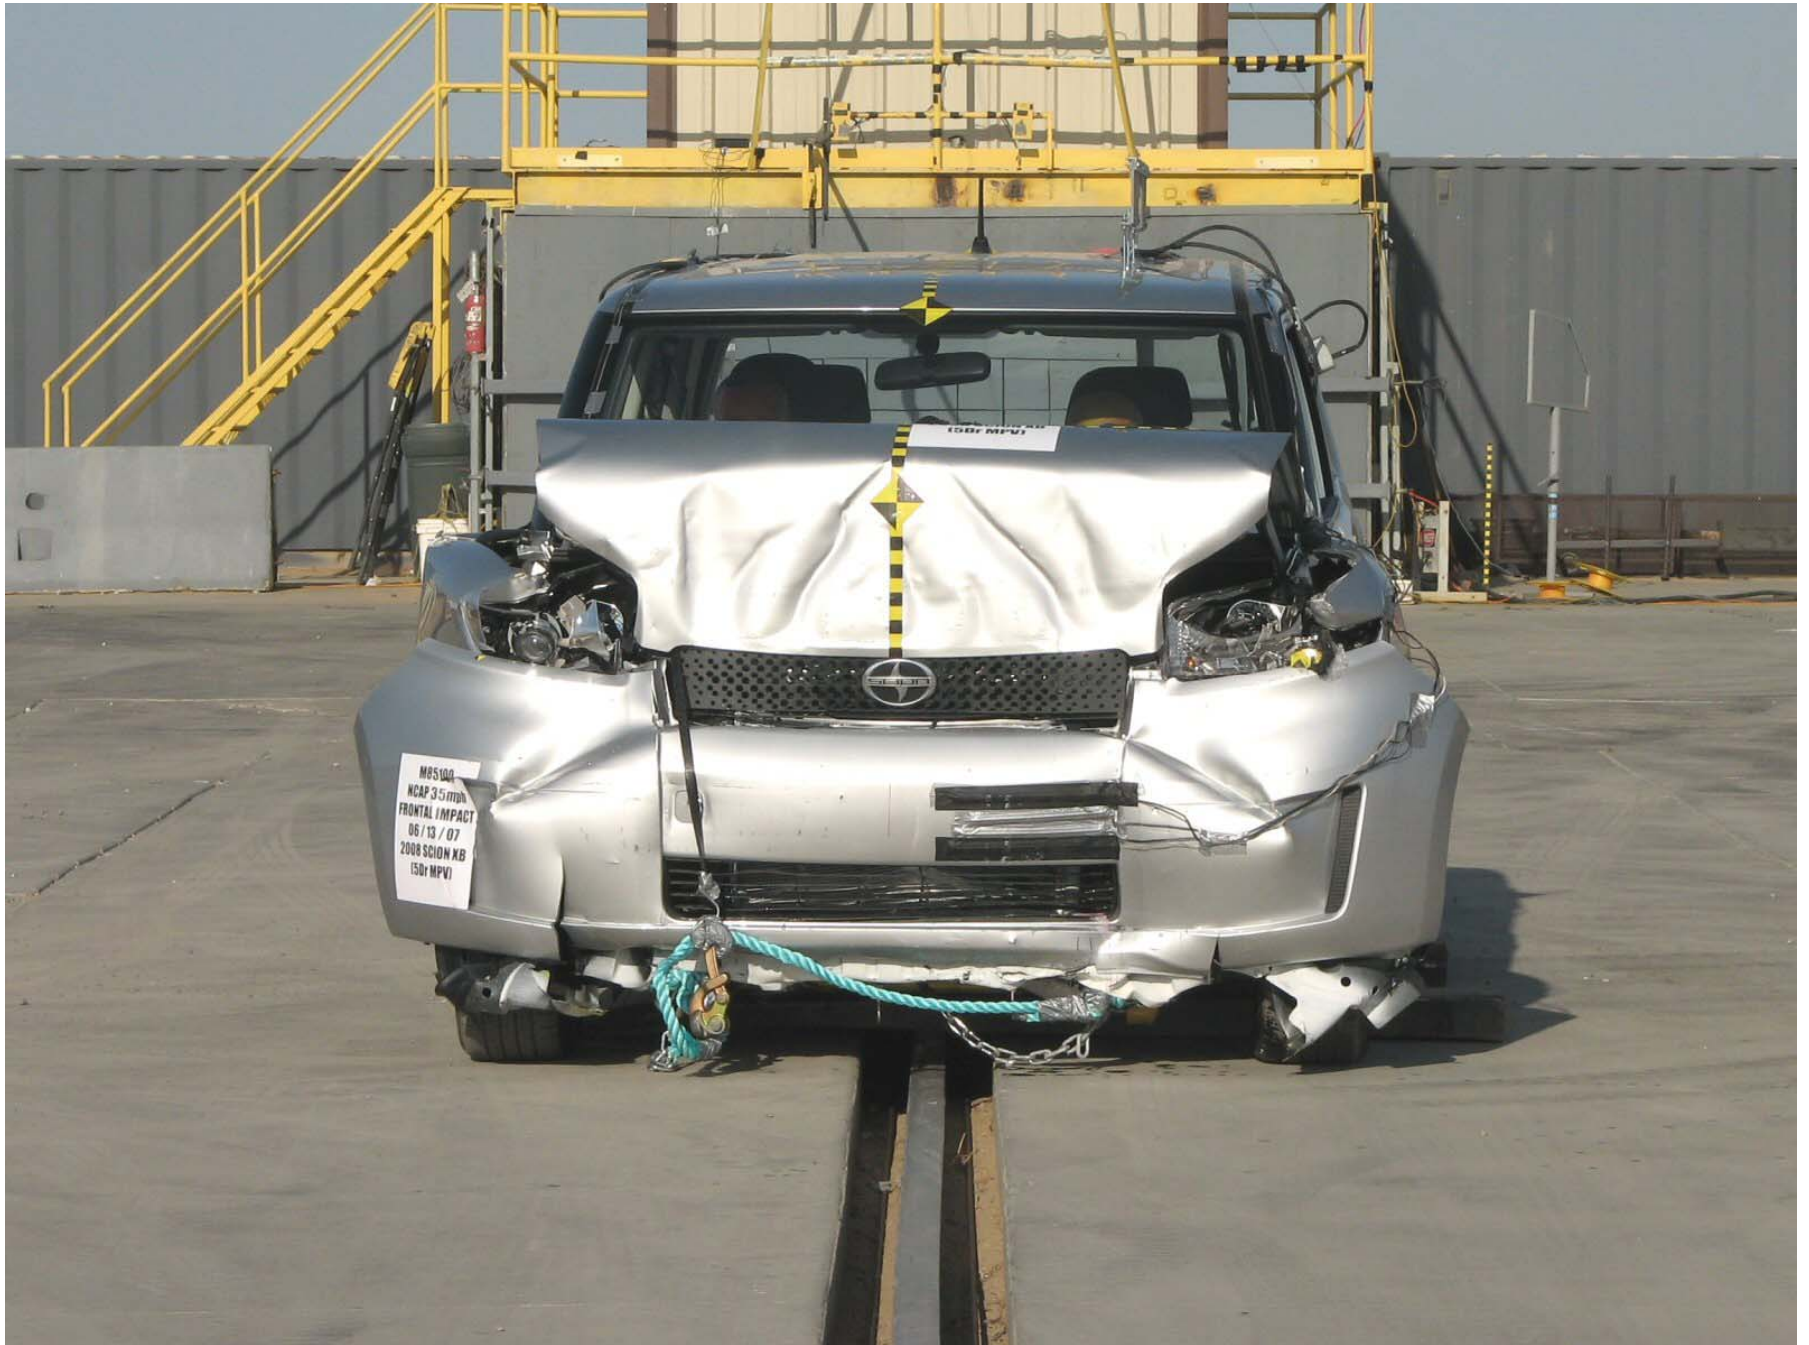
Figure A-7: Post-Test Front View (Vehicle Moved)

The maximum static crush of the vehicle was 349 mm at the vehicle's centerline and both the driver and the passenger side doors remained closed and latched during the impact event and were operable after the impact.

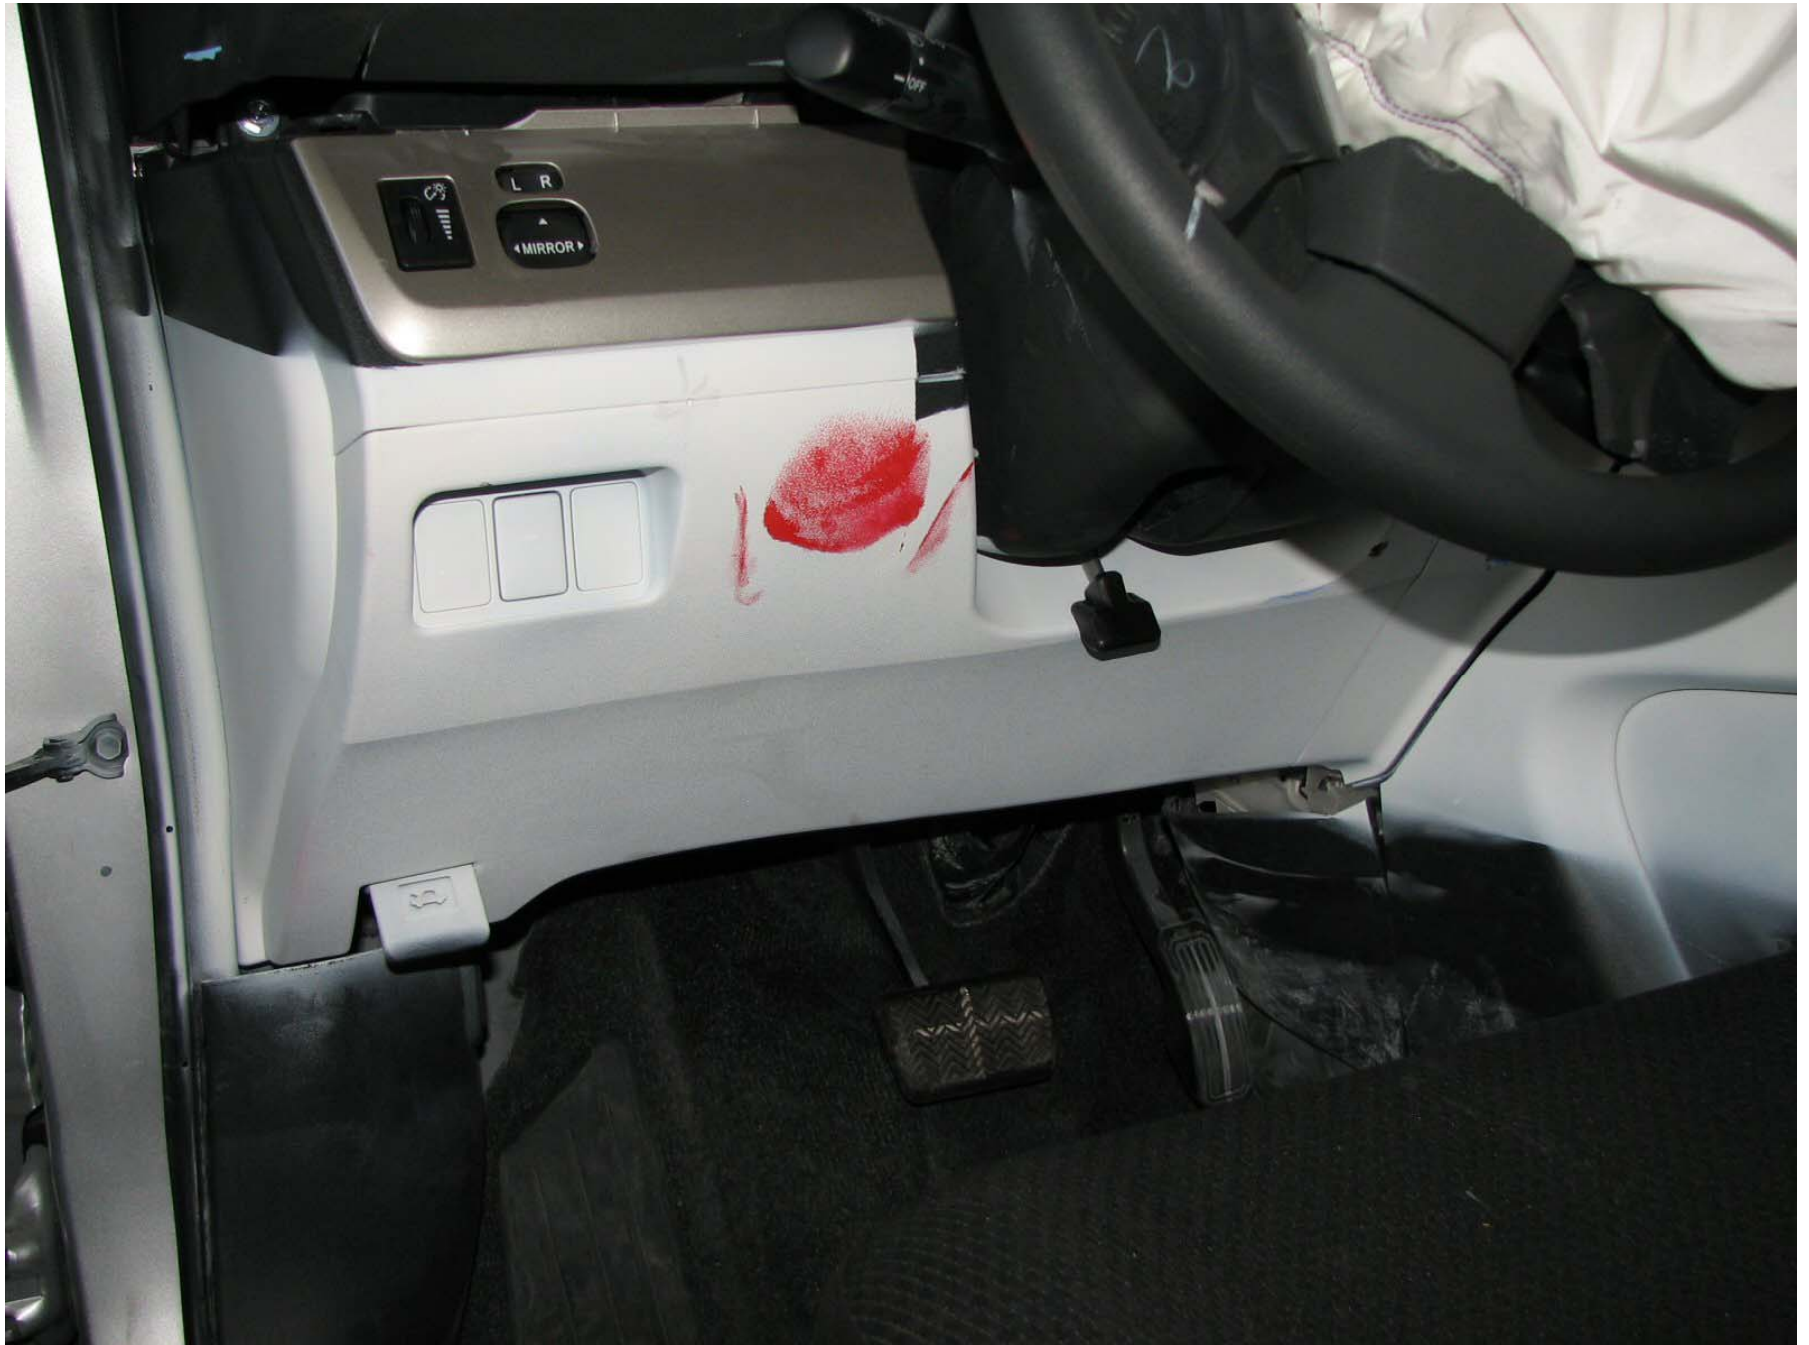
Figure A-39: Post-Test Driver Side Knee Bolster

The driver's visible contact points were as follows: The driver ATD's head and chest contacted the airbag and the abdomen had no contact. Both knees contacted the knee bolster.

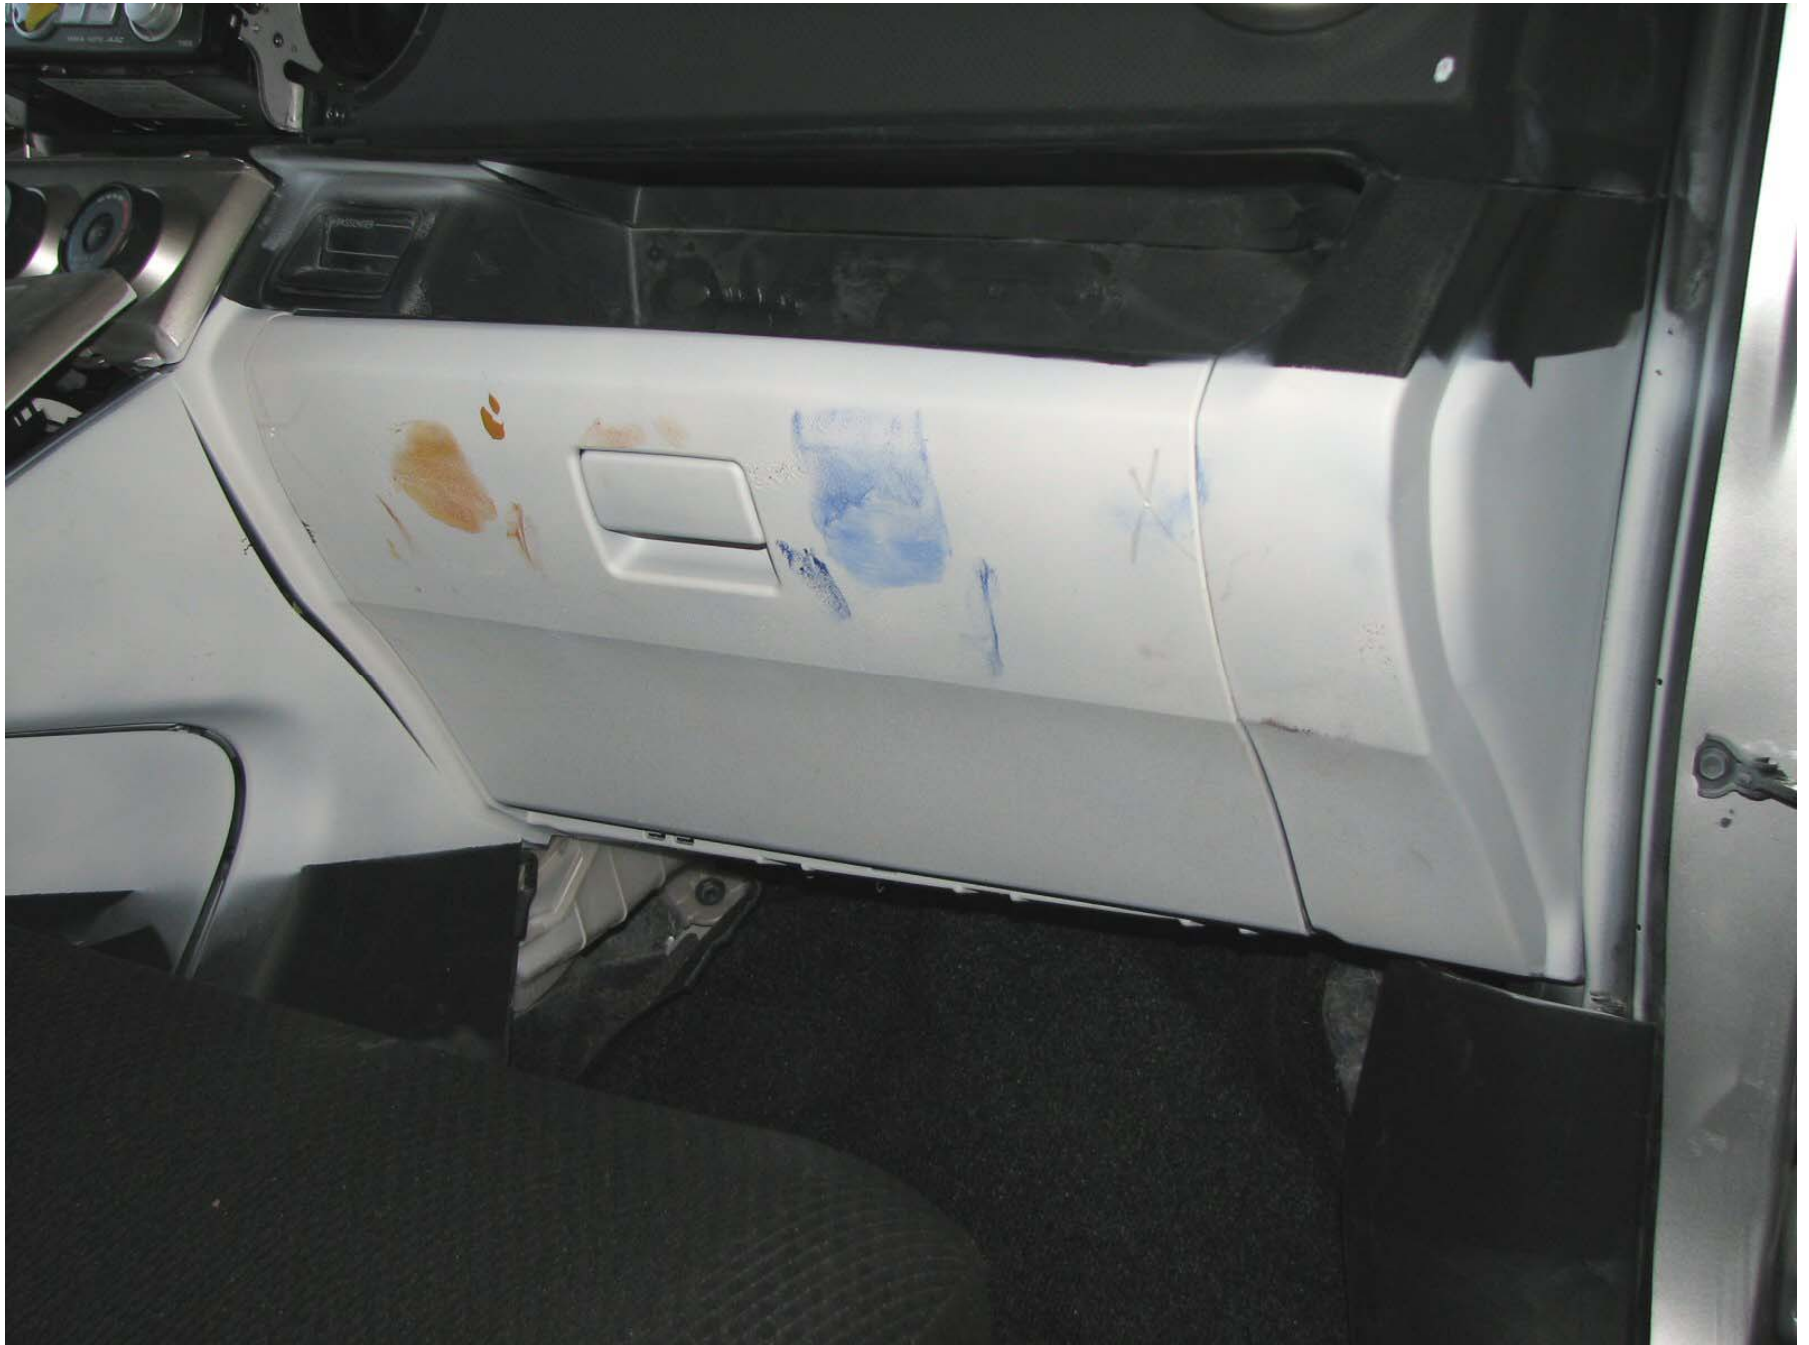
Figure A-53: Post-Test Passenger Side Glove Box

The passenger's visible contact points were as follows: The passenger ATD's head and chest contacted the airbag. Both knees contacted the glove box.
