REPORT NUMBER: CAL-07-13

**NEW CAR ASSESSMENT PROGRAM (NCAP)
FRONTAL BARRIER IMPACT TEST**

FORD MOTOR COMPANY
2008 FORD ESCAPE
MPV

NHTSA NUMBER: F80201

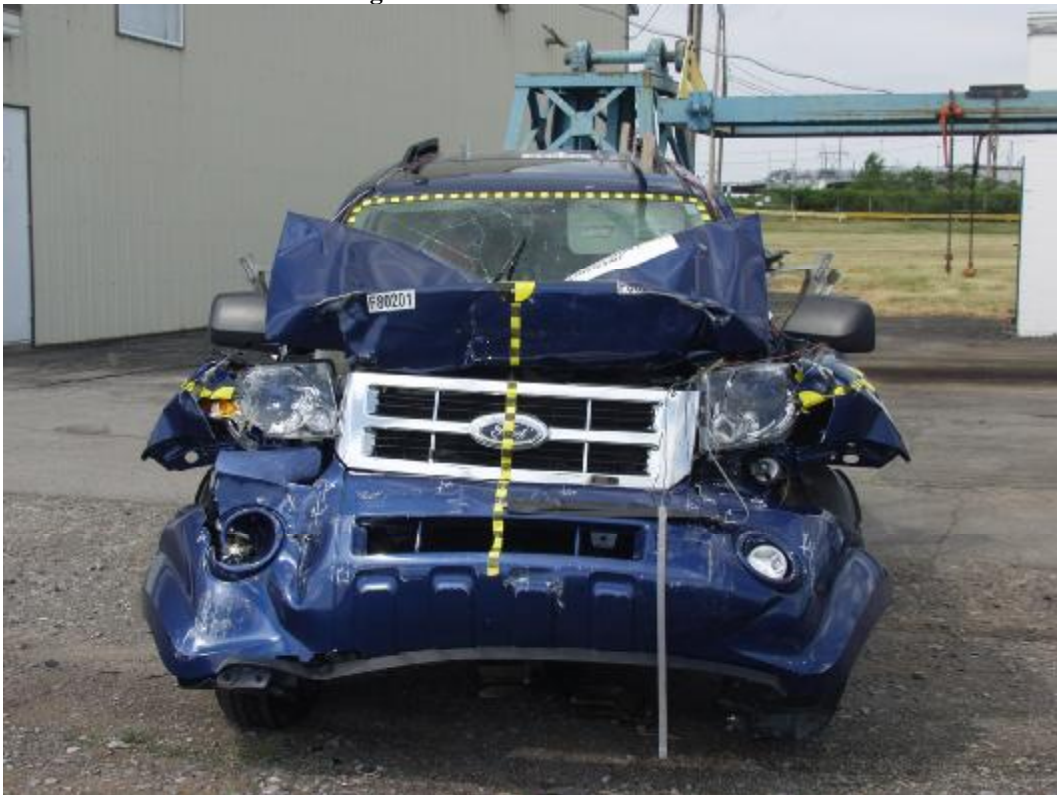
Figure A-7: Post-Test Front View

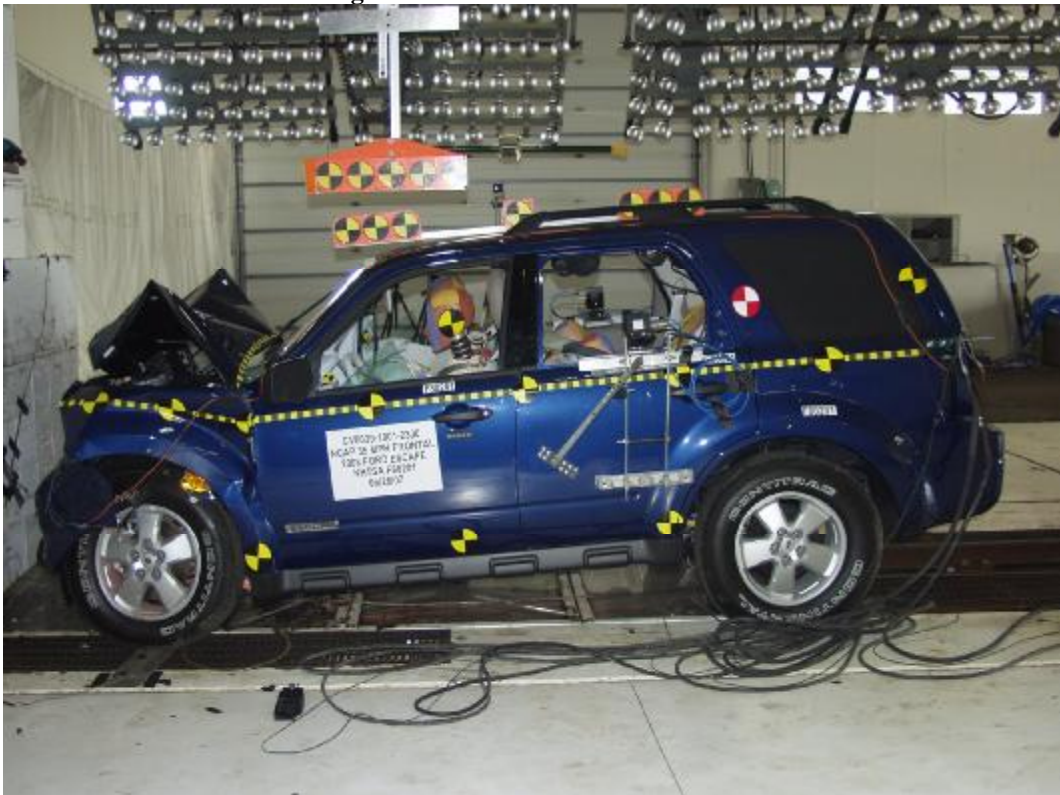
Figure A-9: Post-Test Left Side View

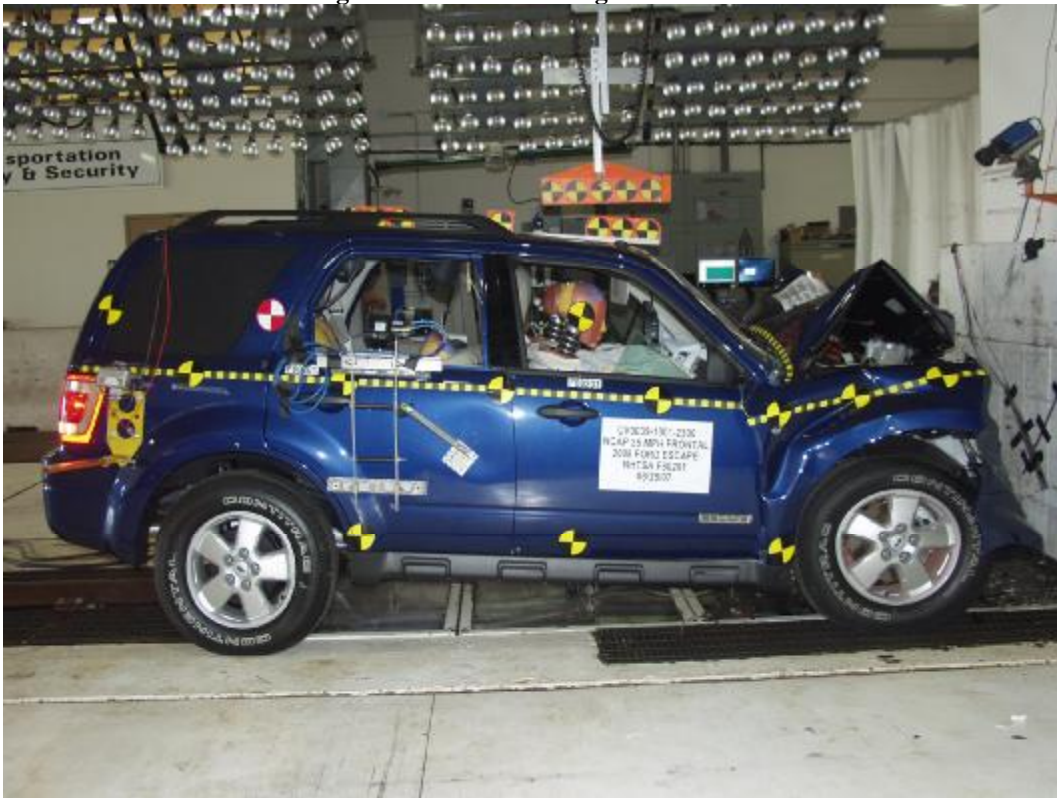
Figure A-11: Post-Test Right Side View

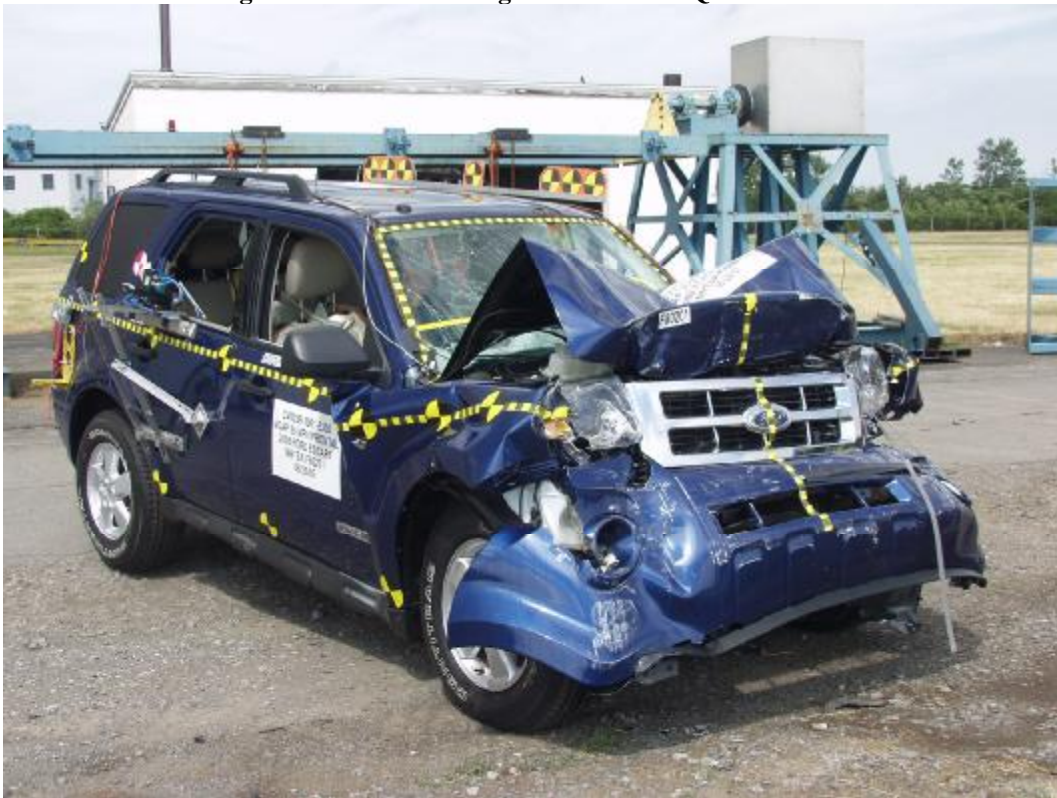
Figure A-13: Post-Test Right Front Three-Quarter View

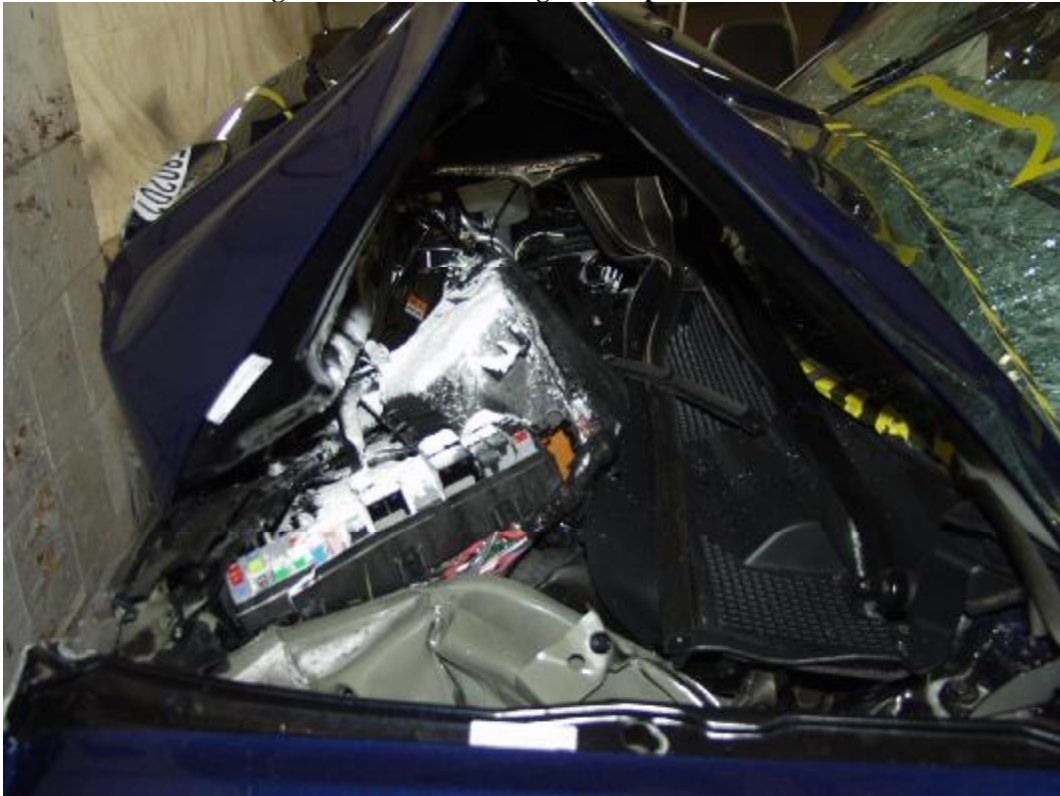
Figure A-21: Post-Test Engine Compartment View

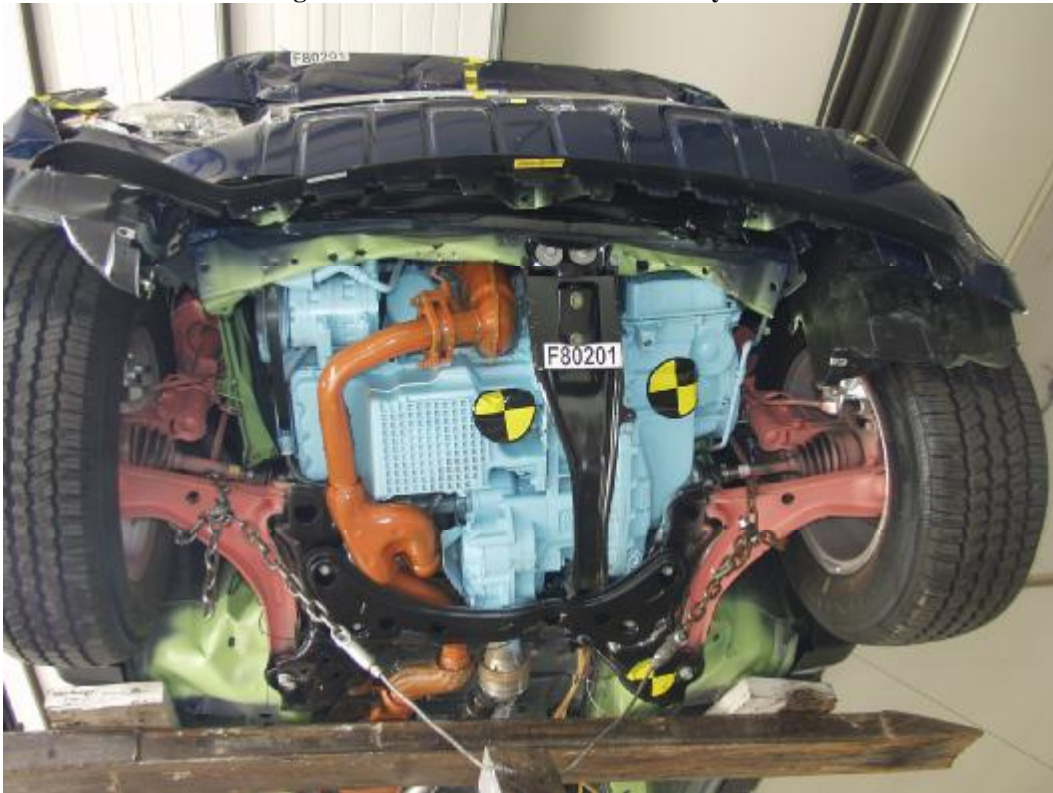
Figure A-25: Post-Test Front Underbody View

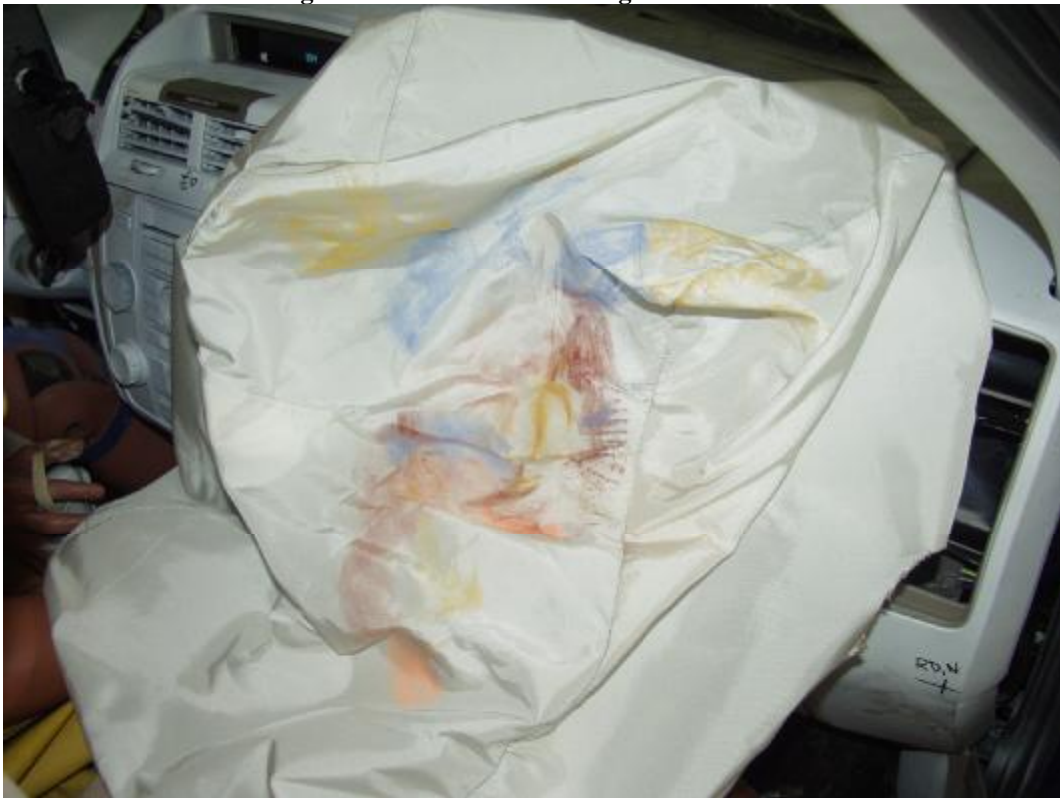
Figure A-57: Post-Test Passenger Contact to Airbag
