REPORT NUMBER TR-P27143-01-NC

**NEW CAR ASSESSMENT PROGRAM
SIDE IMPACT TEST**

**MITSUBISHI MOTORS CORPORATION
2008 MITSUBISHI LANCER
4-DOOR SEDAN**

NHTSA NUMBER: B85600

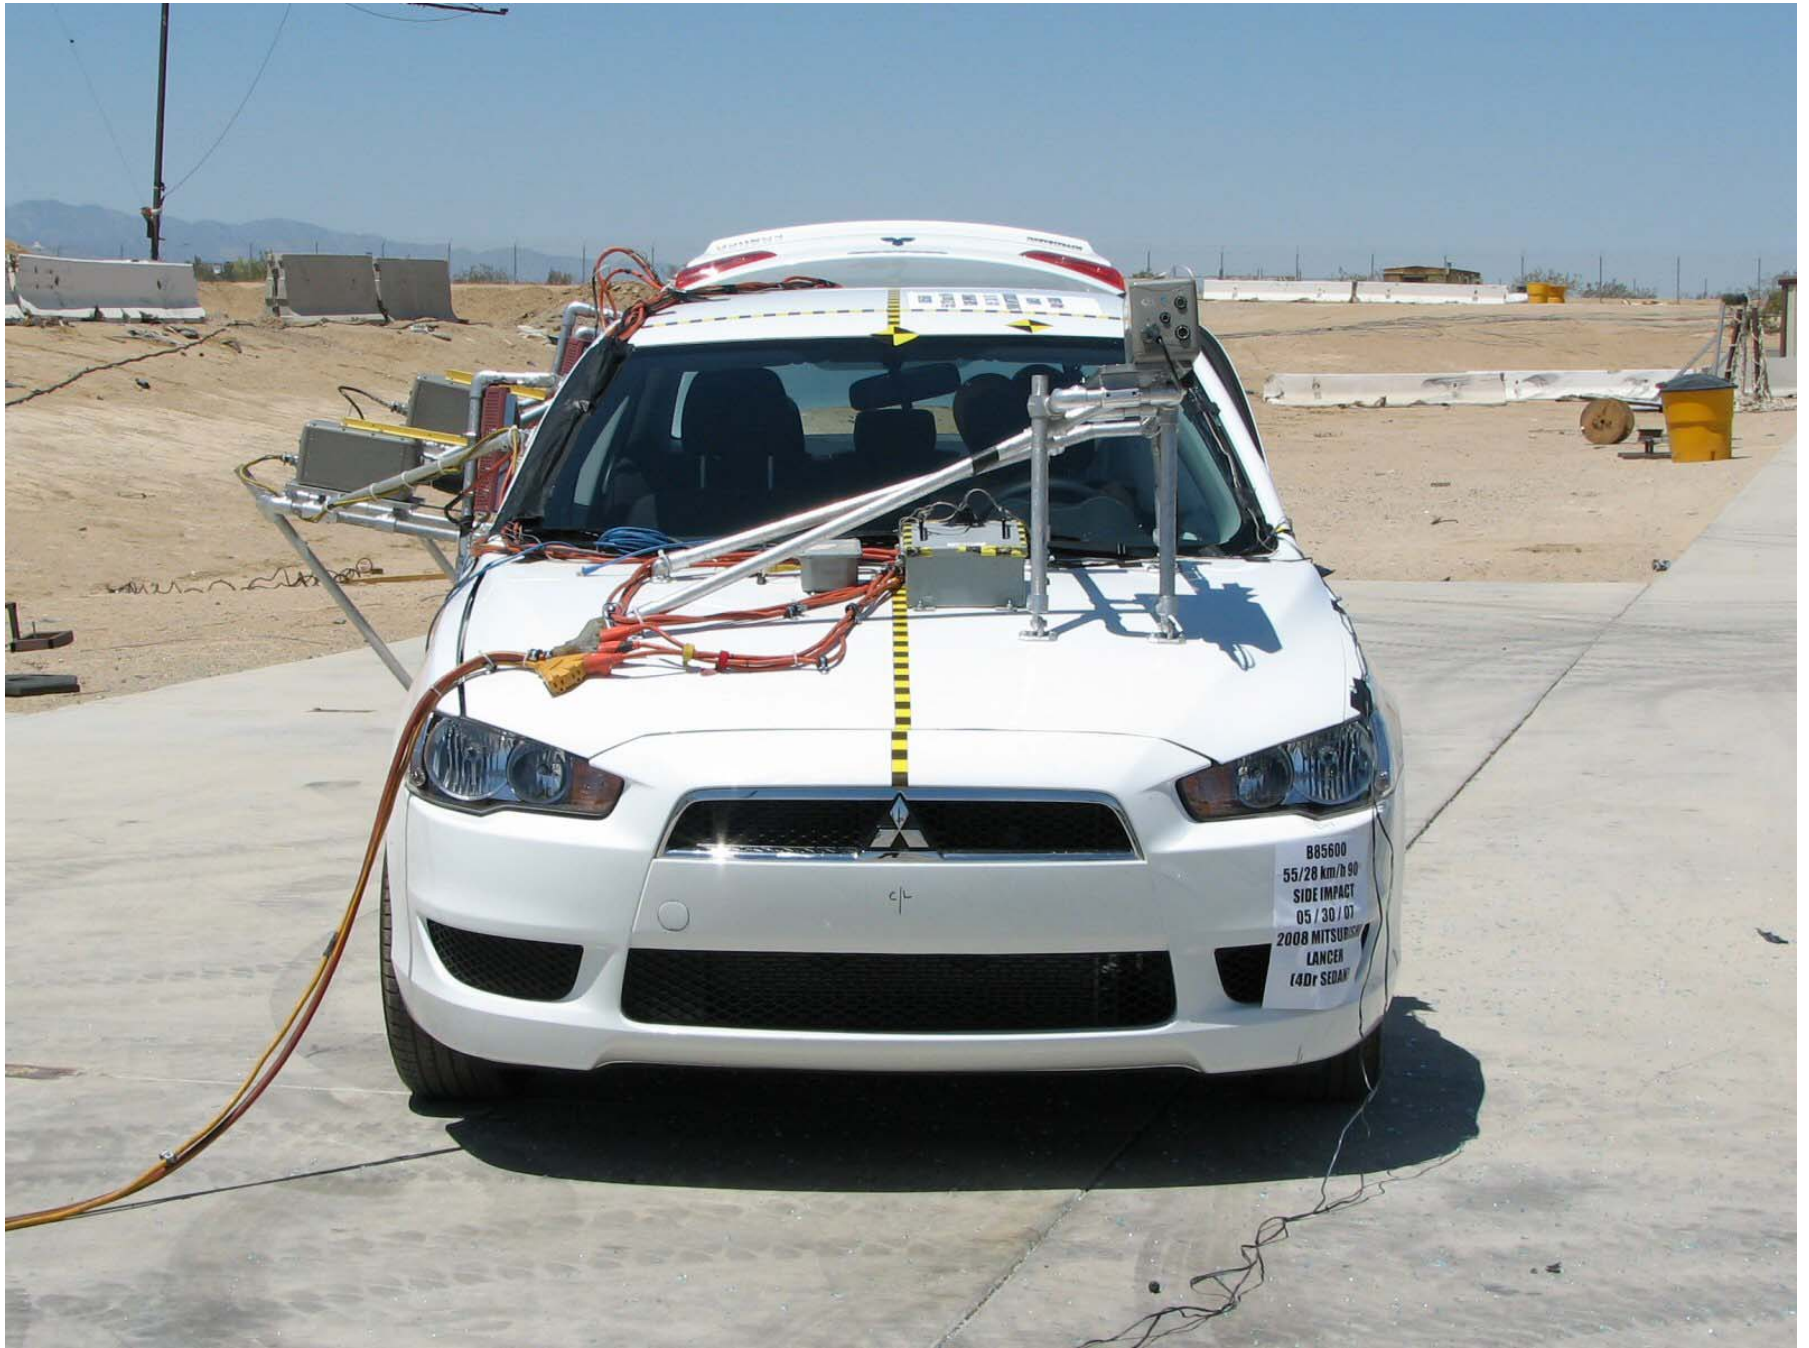
Figure A-6: Post-Test Front View

The driver and passenger doors remained closed during impact. The test vehicle sustained a maximum static crush of 237 mm at level 2, 750 mm rearward of the left vertical impact point. The driver SID/Hybrid III, Serial No. 274 and the passenger SID/Hybrid III, Serial No. 275 were calibrated prior to this test. The SID/Hybrid III injury criteria is summarized as follows:

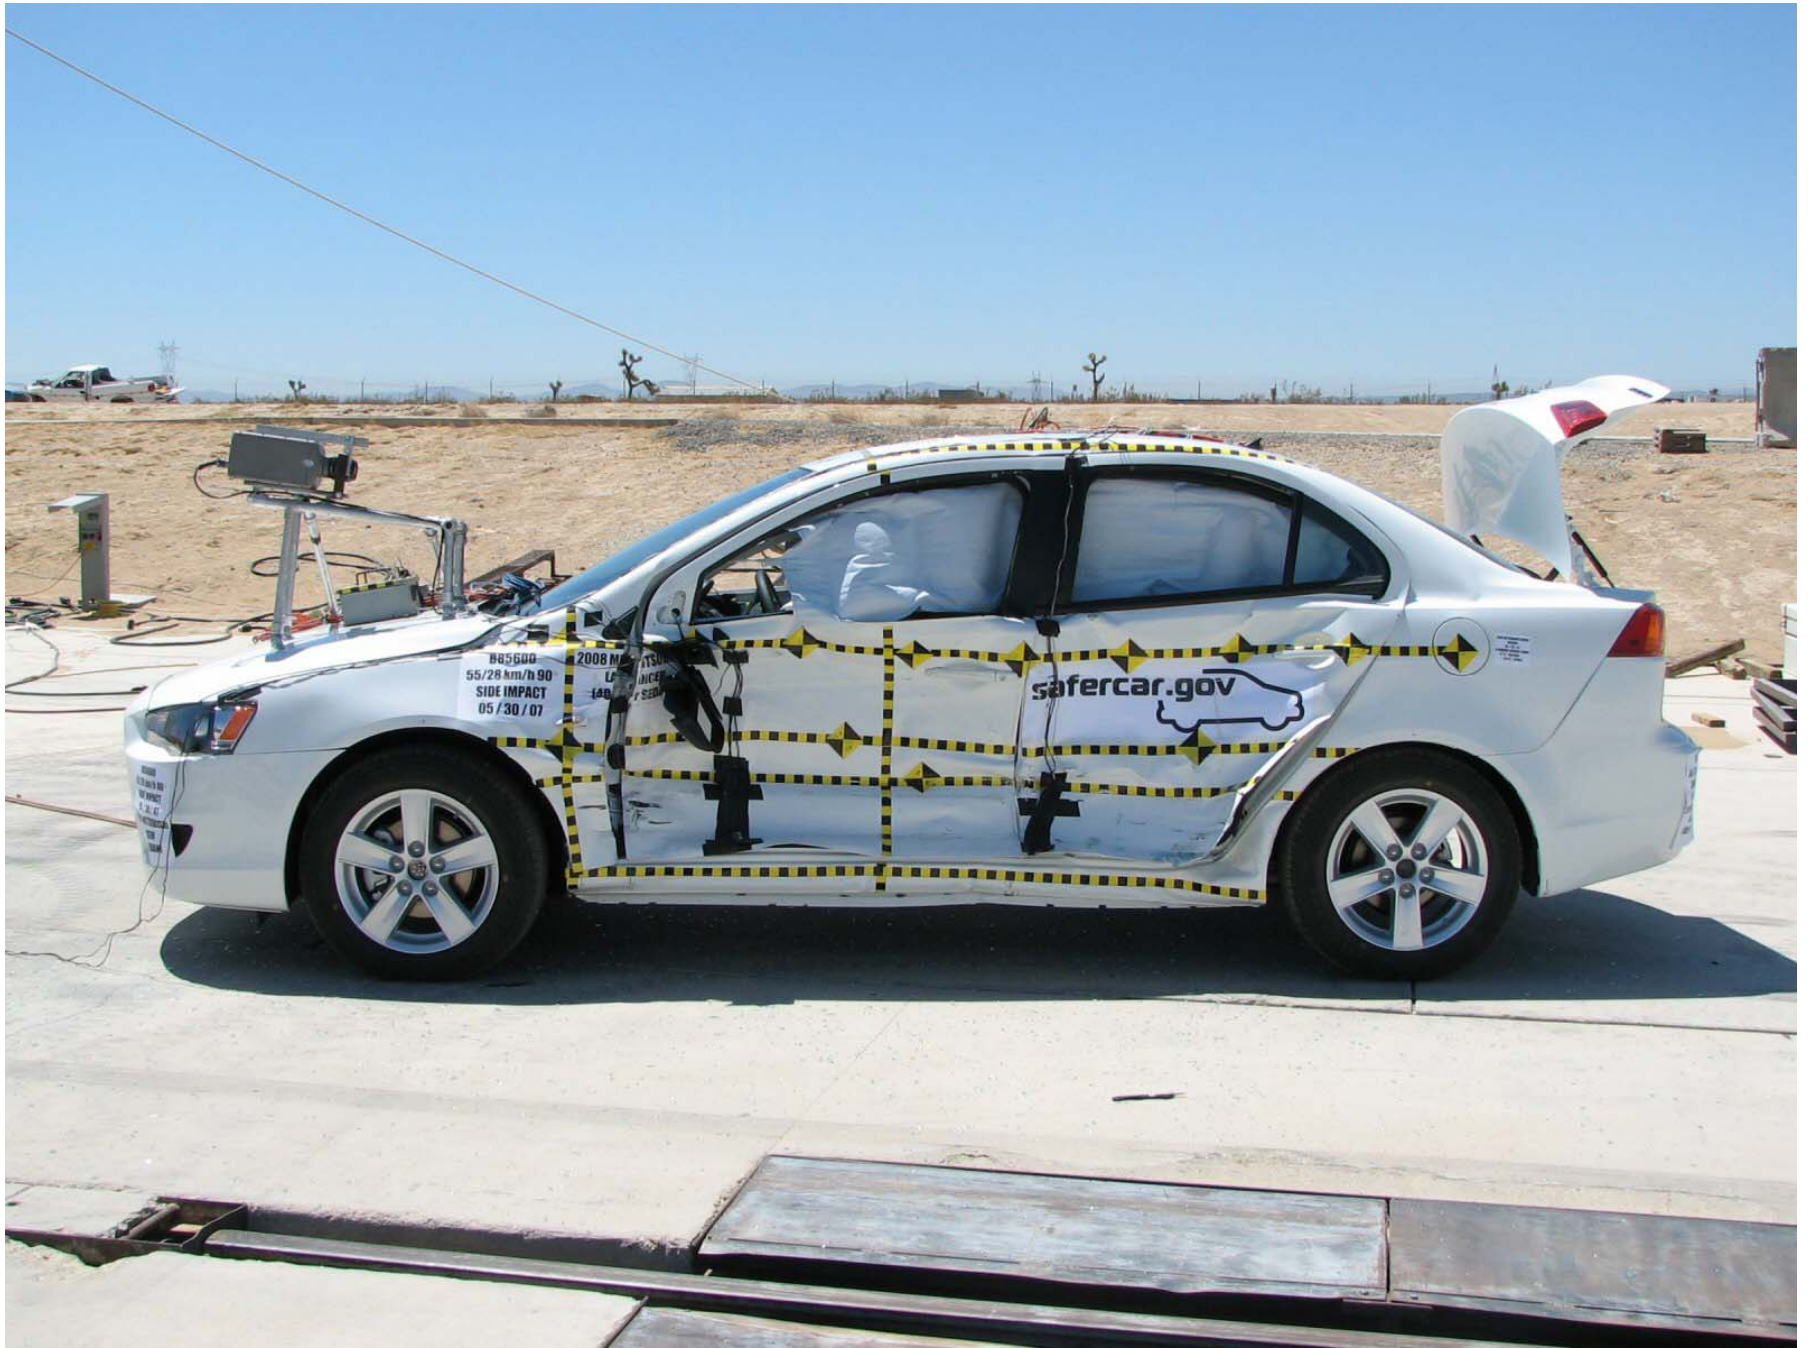
Figure A-10: Post-Test Left Side View

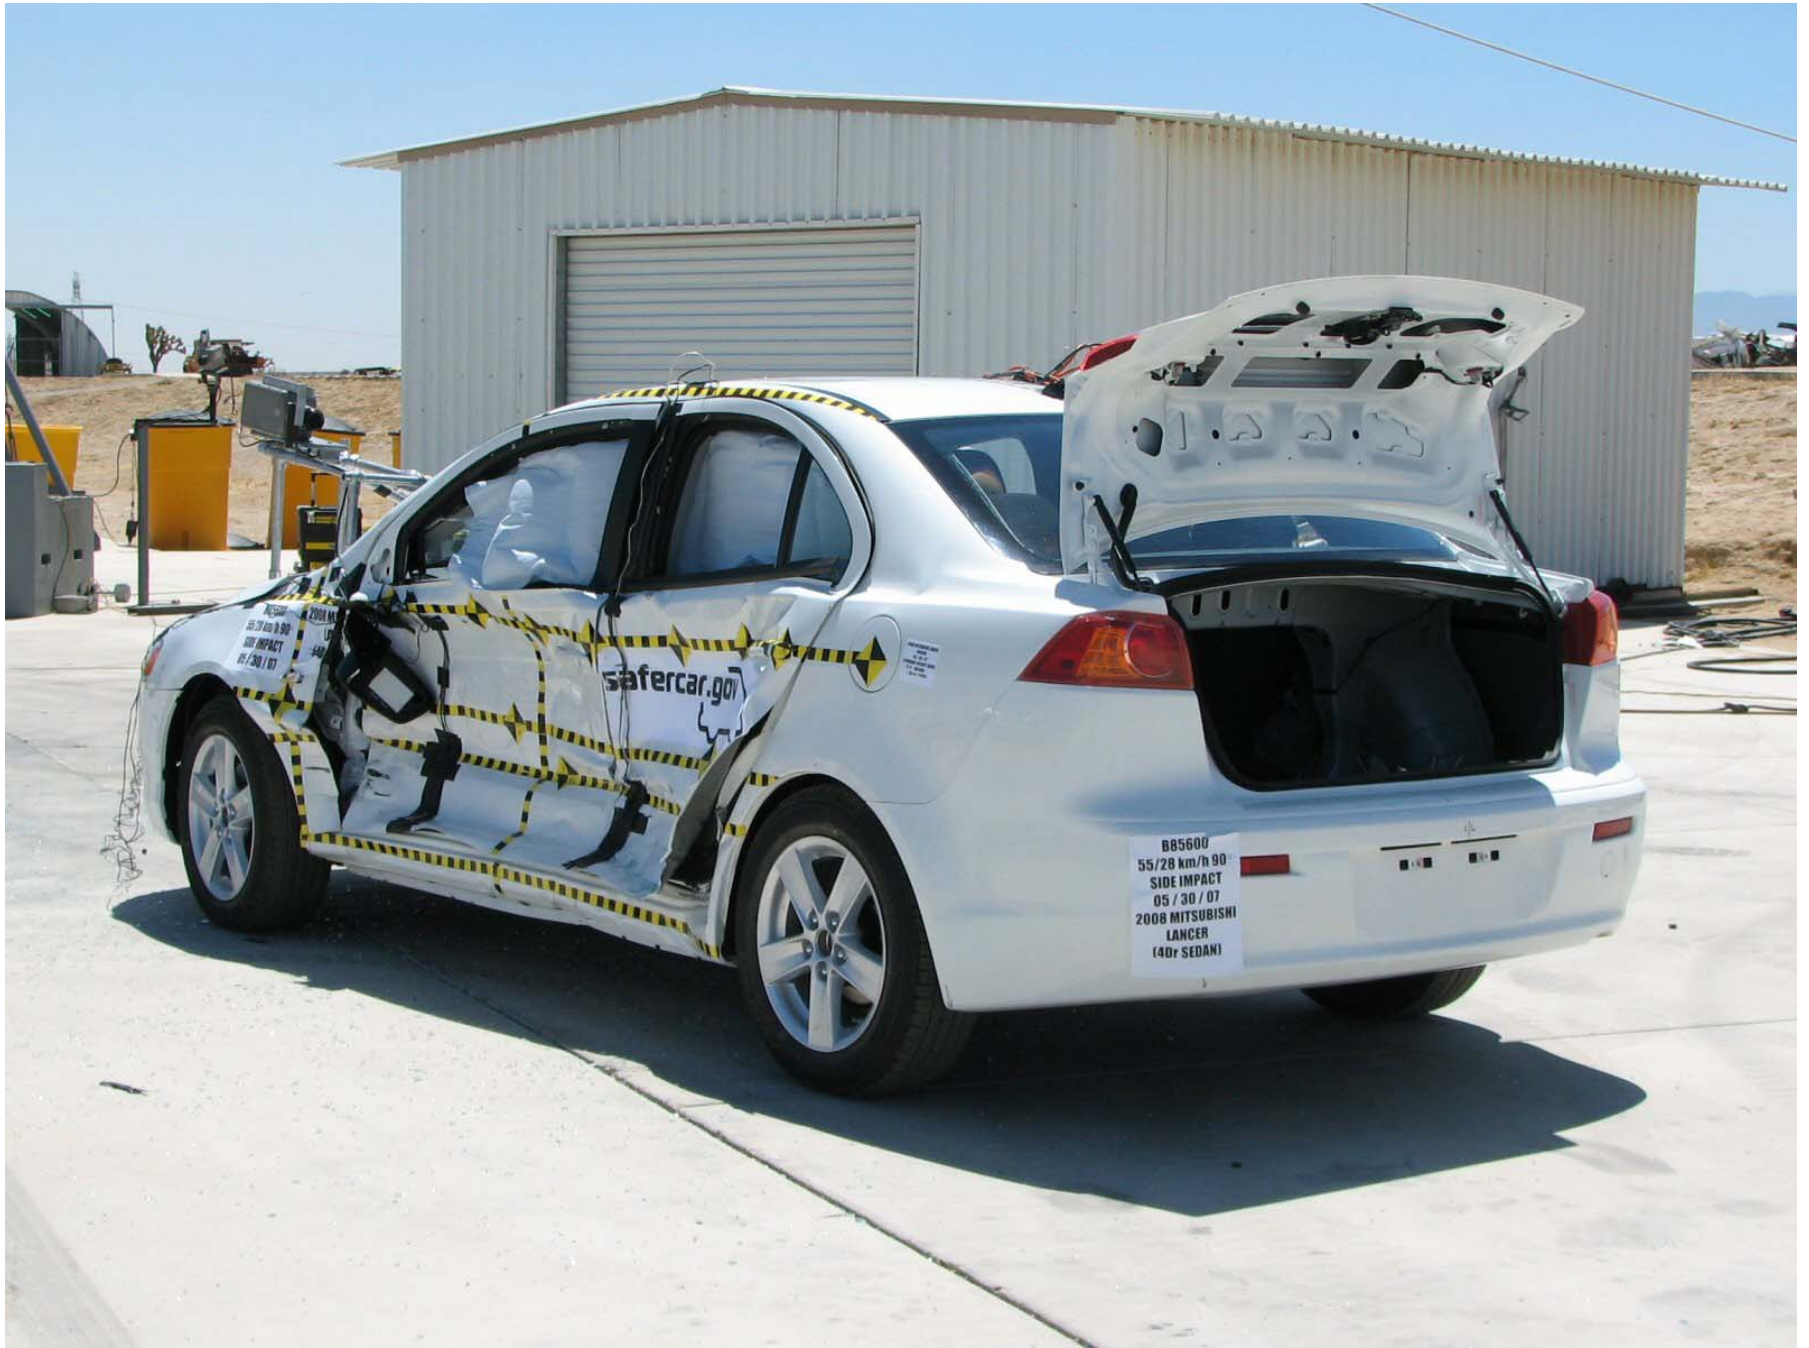
Figure A-12: Post-Test Left Rear $\frac{3}{4}$ View

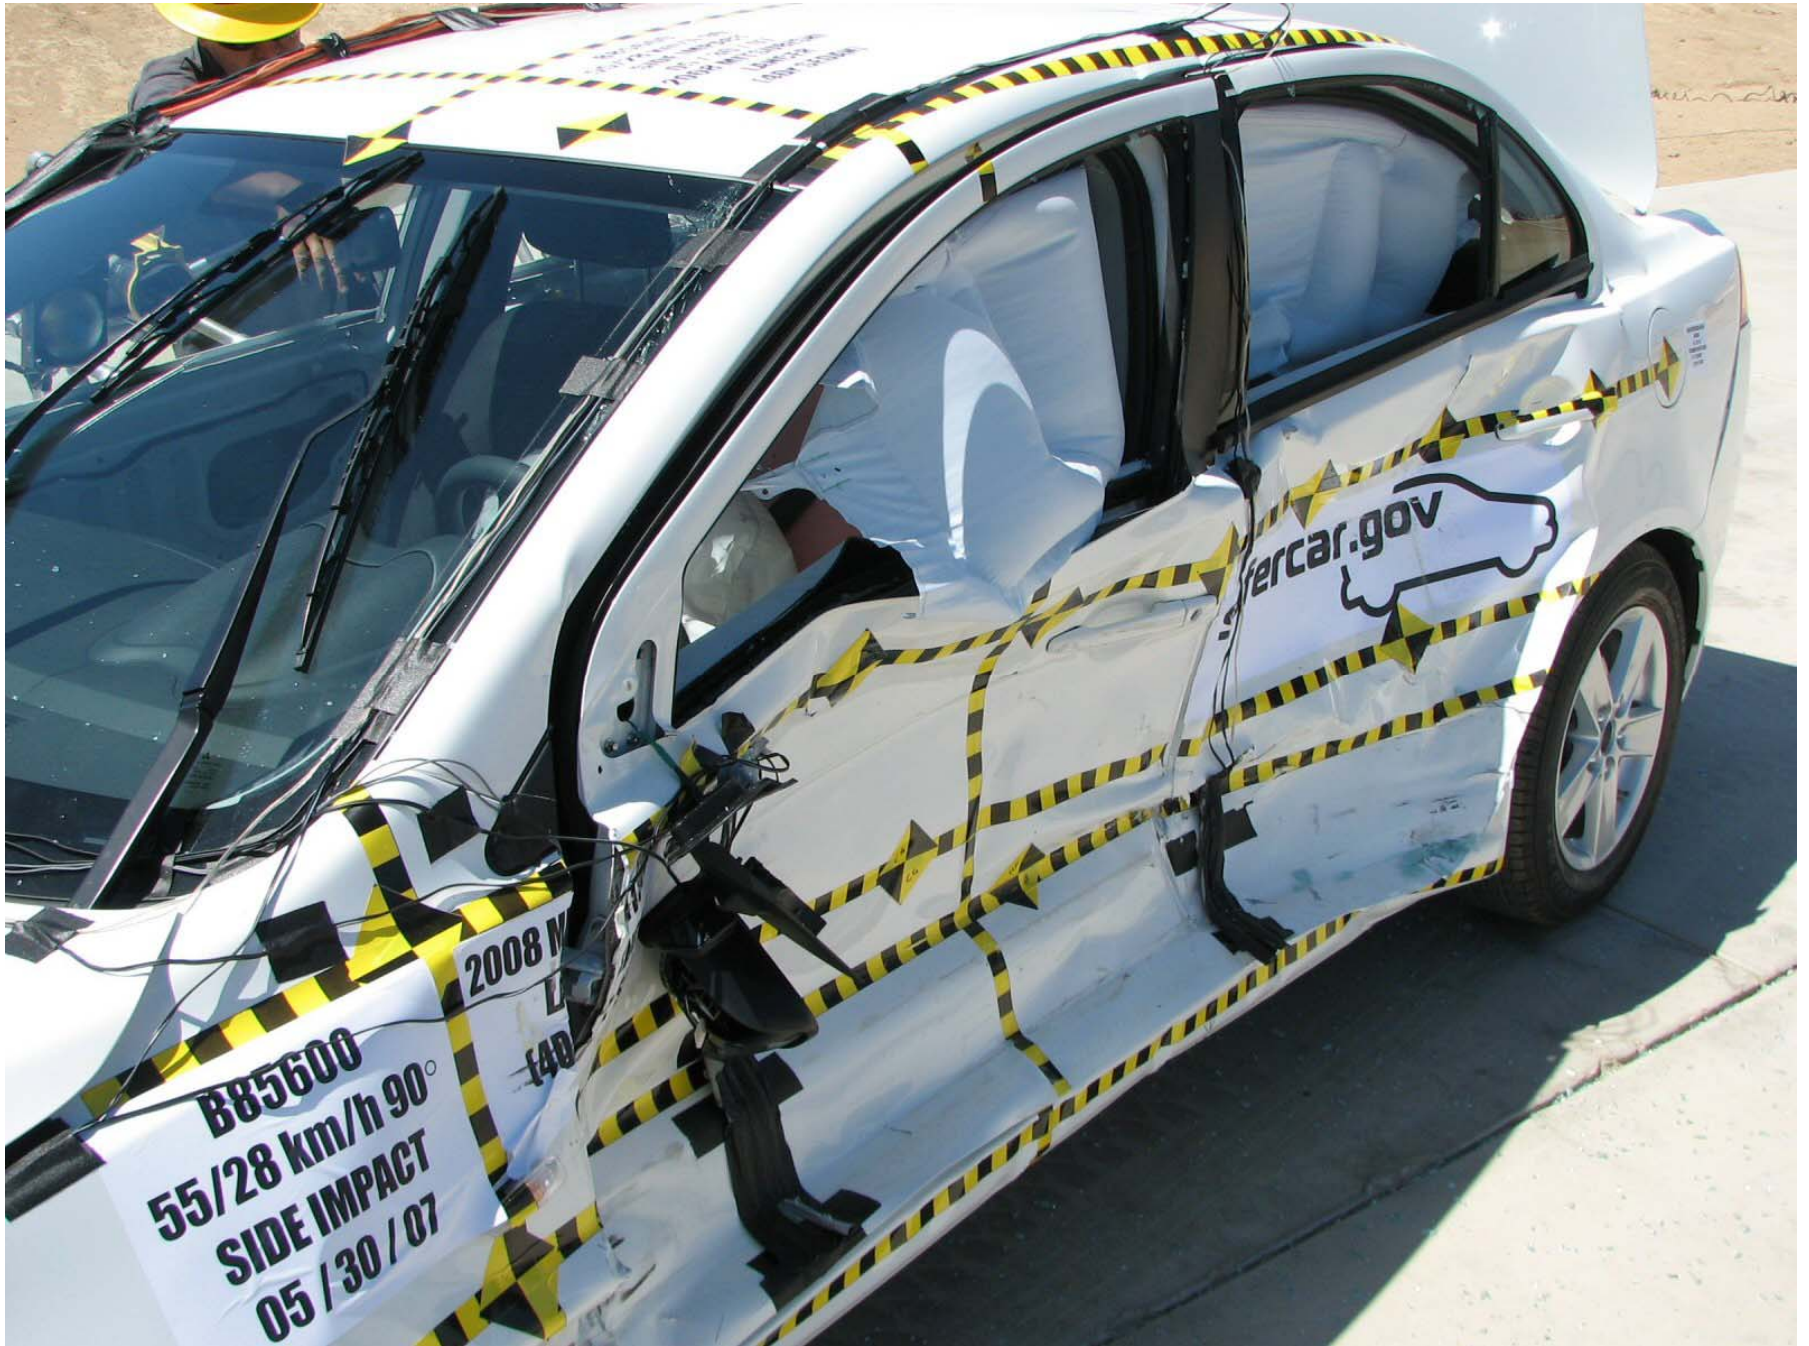
Figure A-28: Post-Test Front $\frac{3}{4}$ View of Left Side Door

Description	Front	Rear
Left Side Door Opening	Door remained closed and latched, jammed	Door remained closed and latched, jammed
Right Side Door Opening	Remained closed and latched, operational	Remained closed and latched, operational
Seat Movement	None	None
Seat Back Failure	None	None

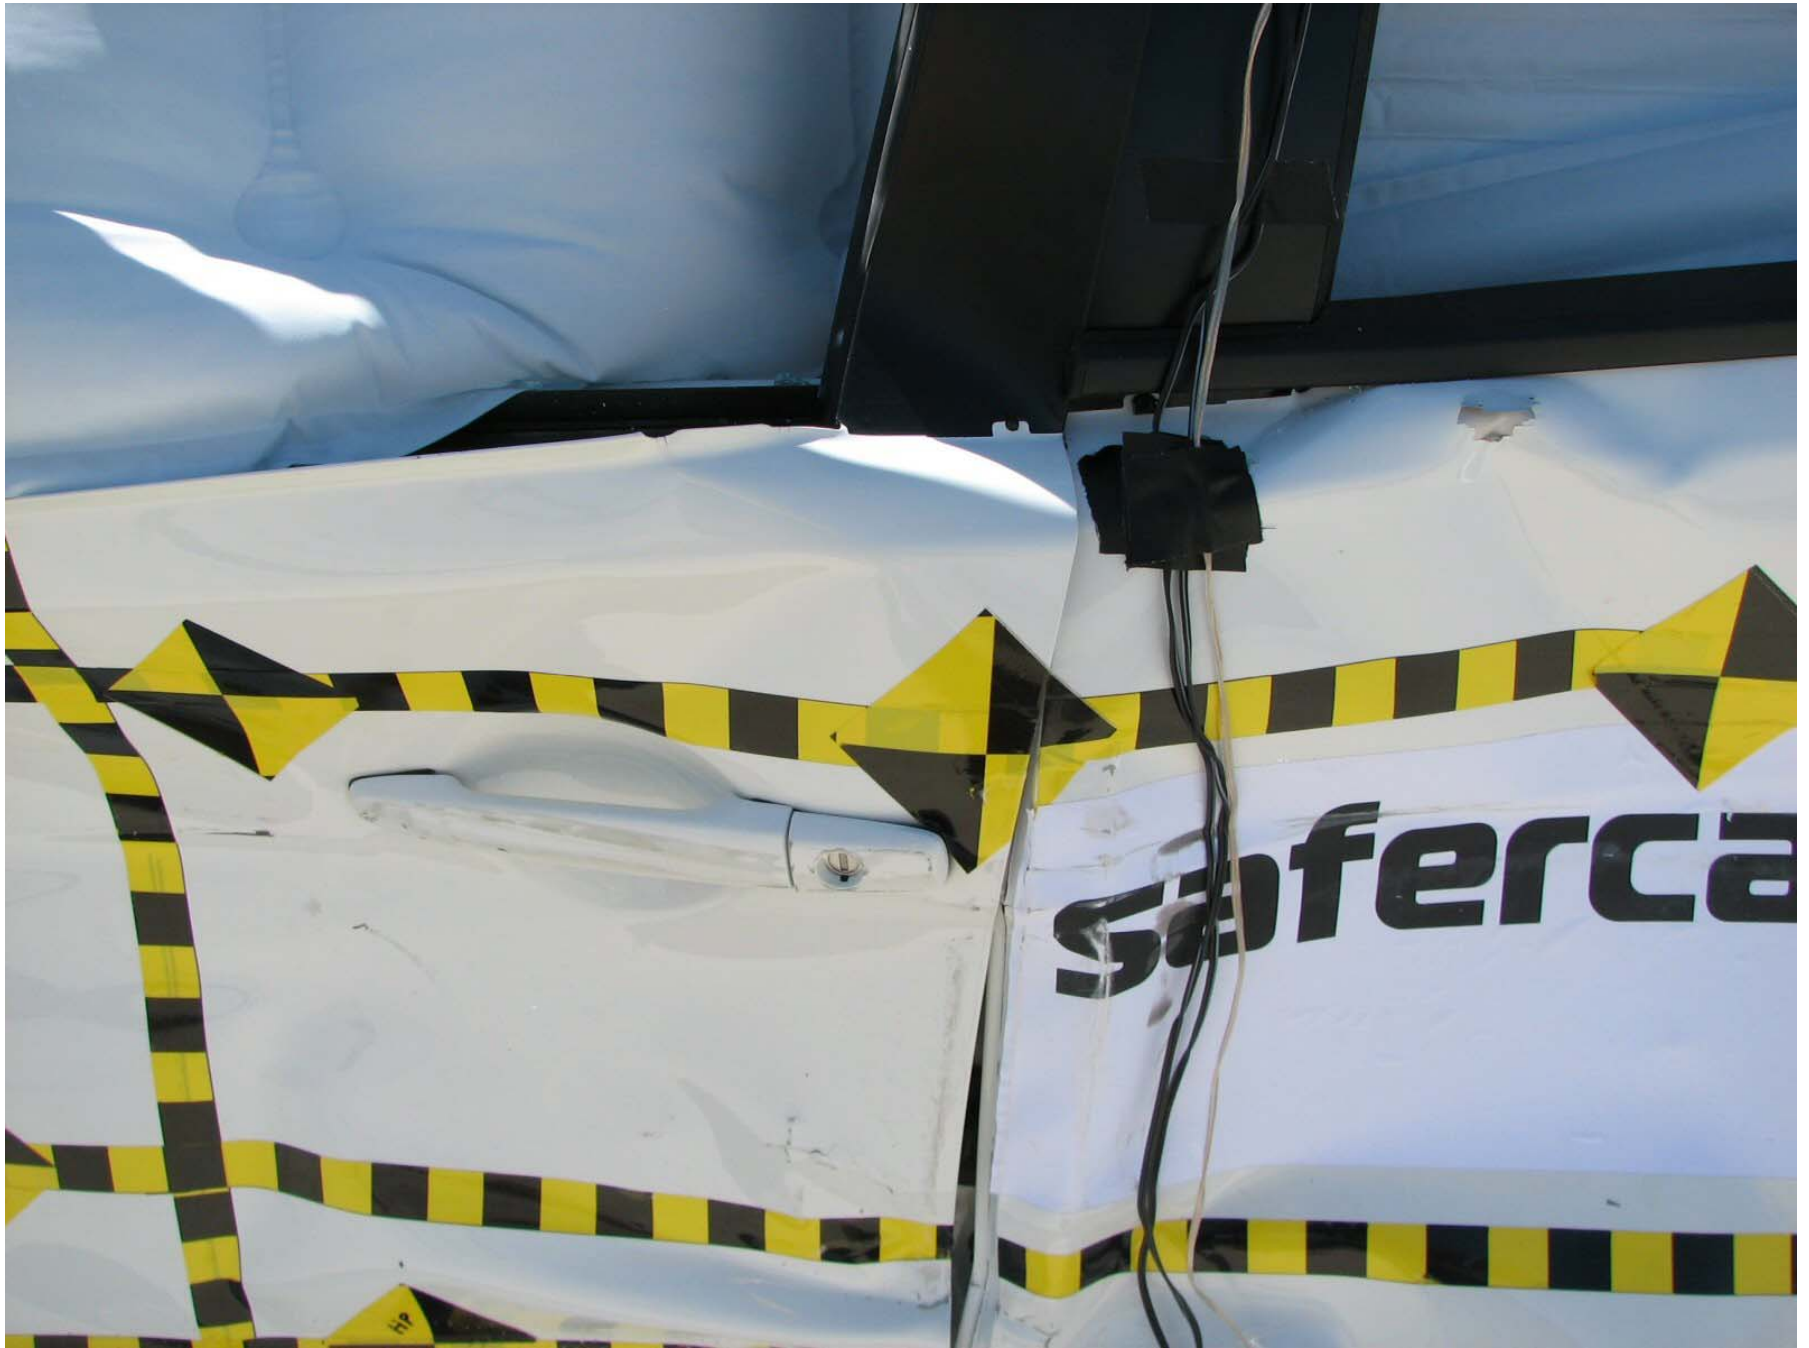
Figure A-32: Post-Test Left Front Door

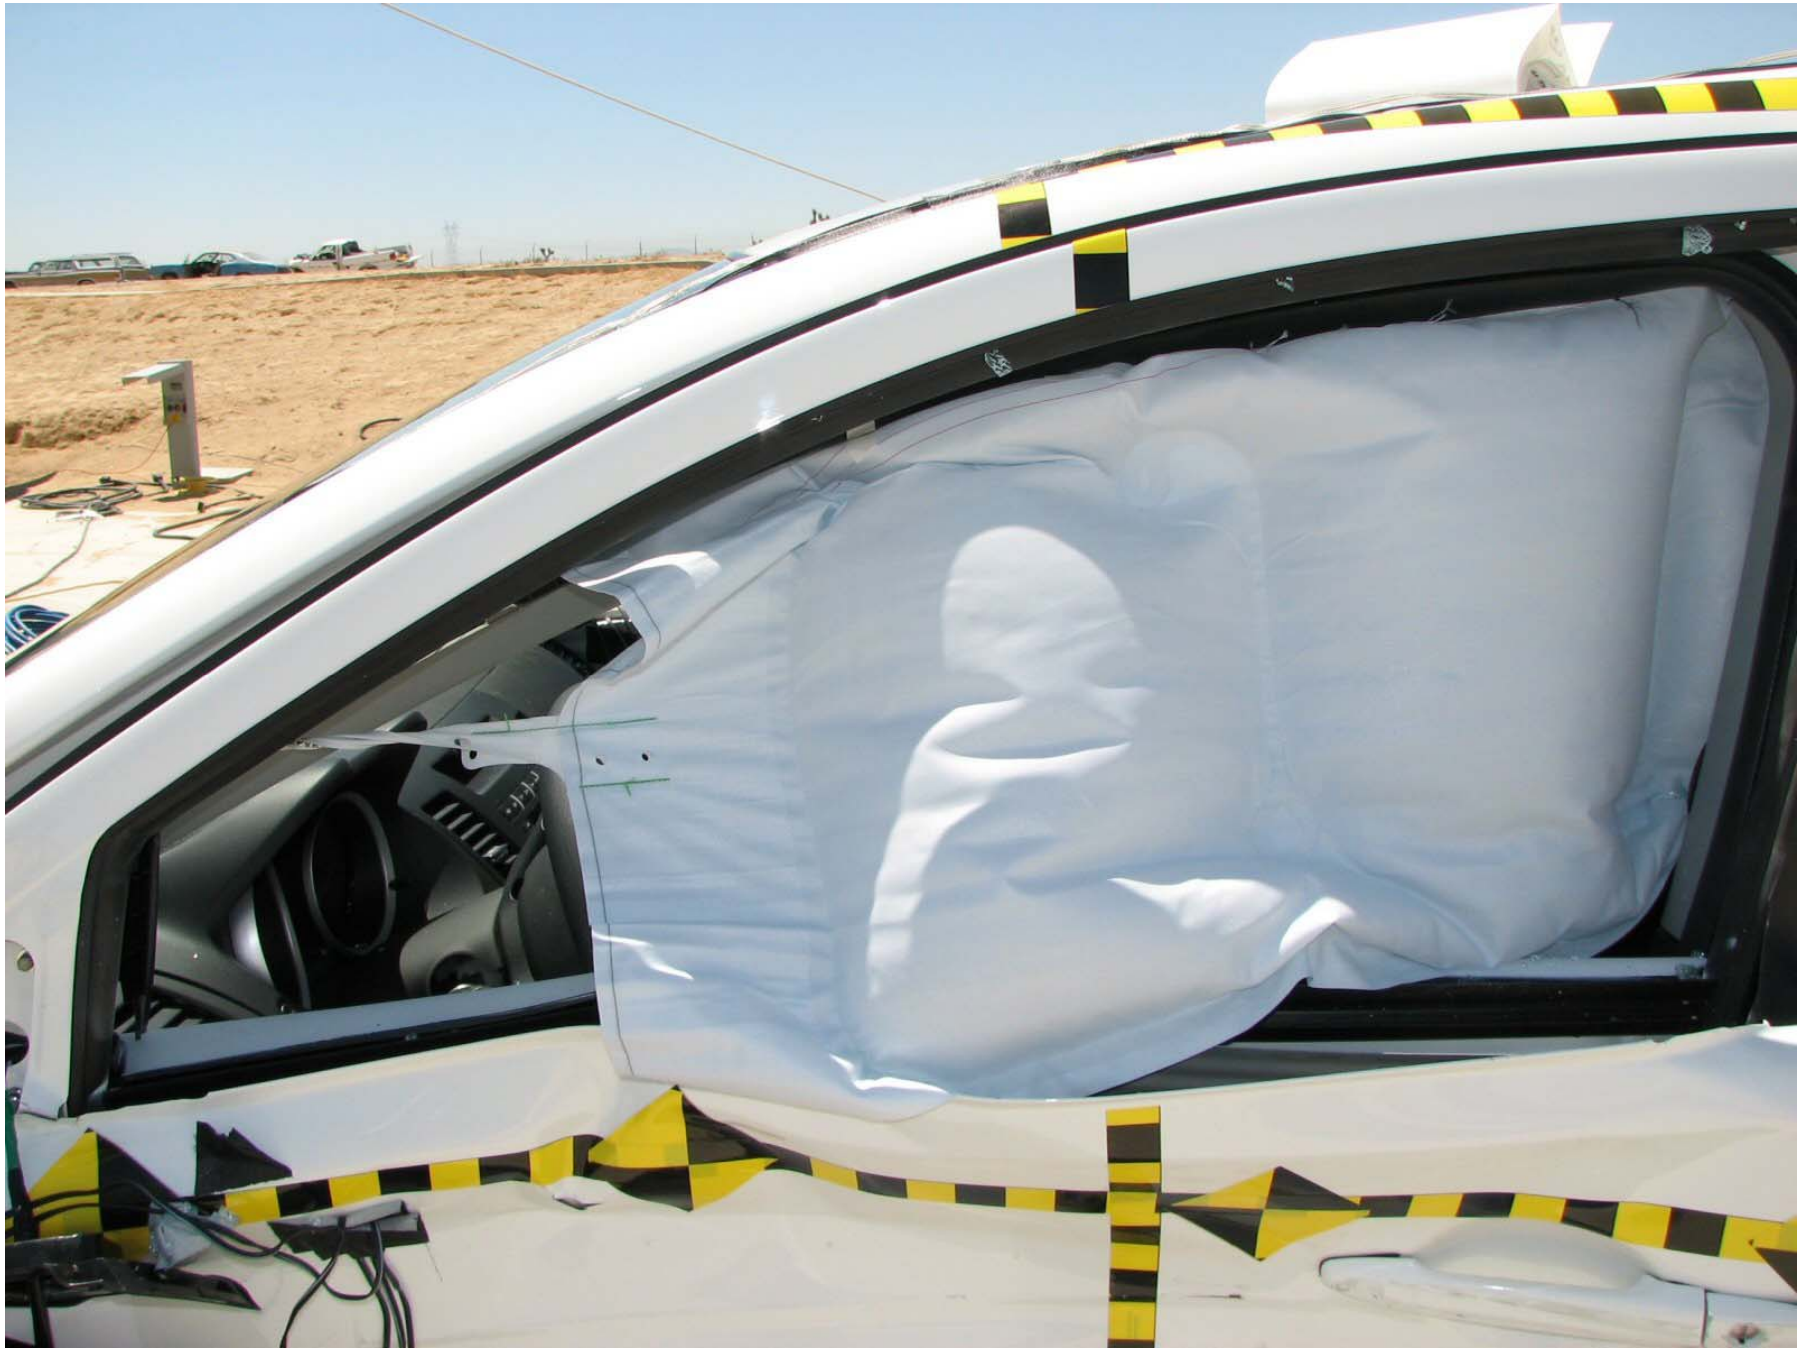
Figure A-37: Post-Test Driver Dummy (Through Window)

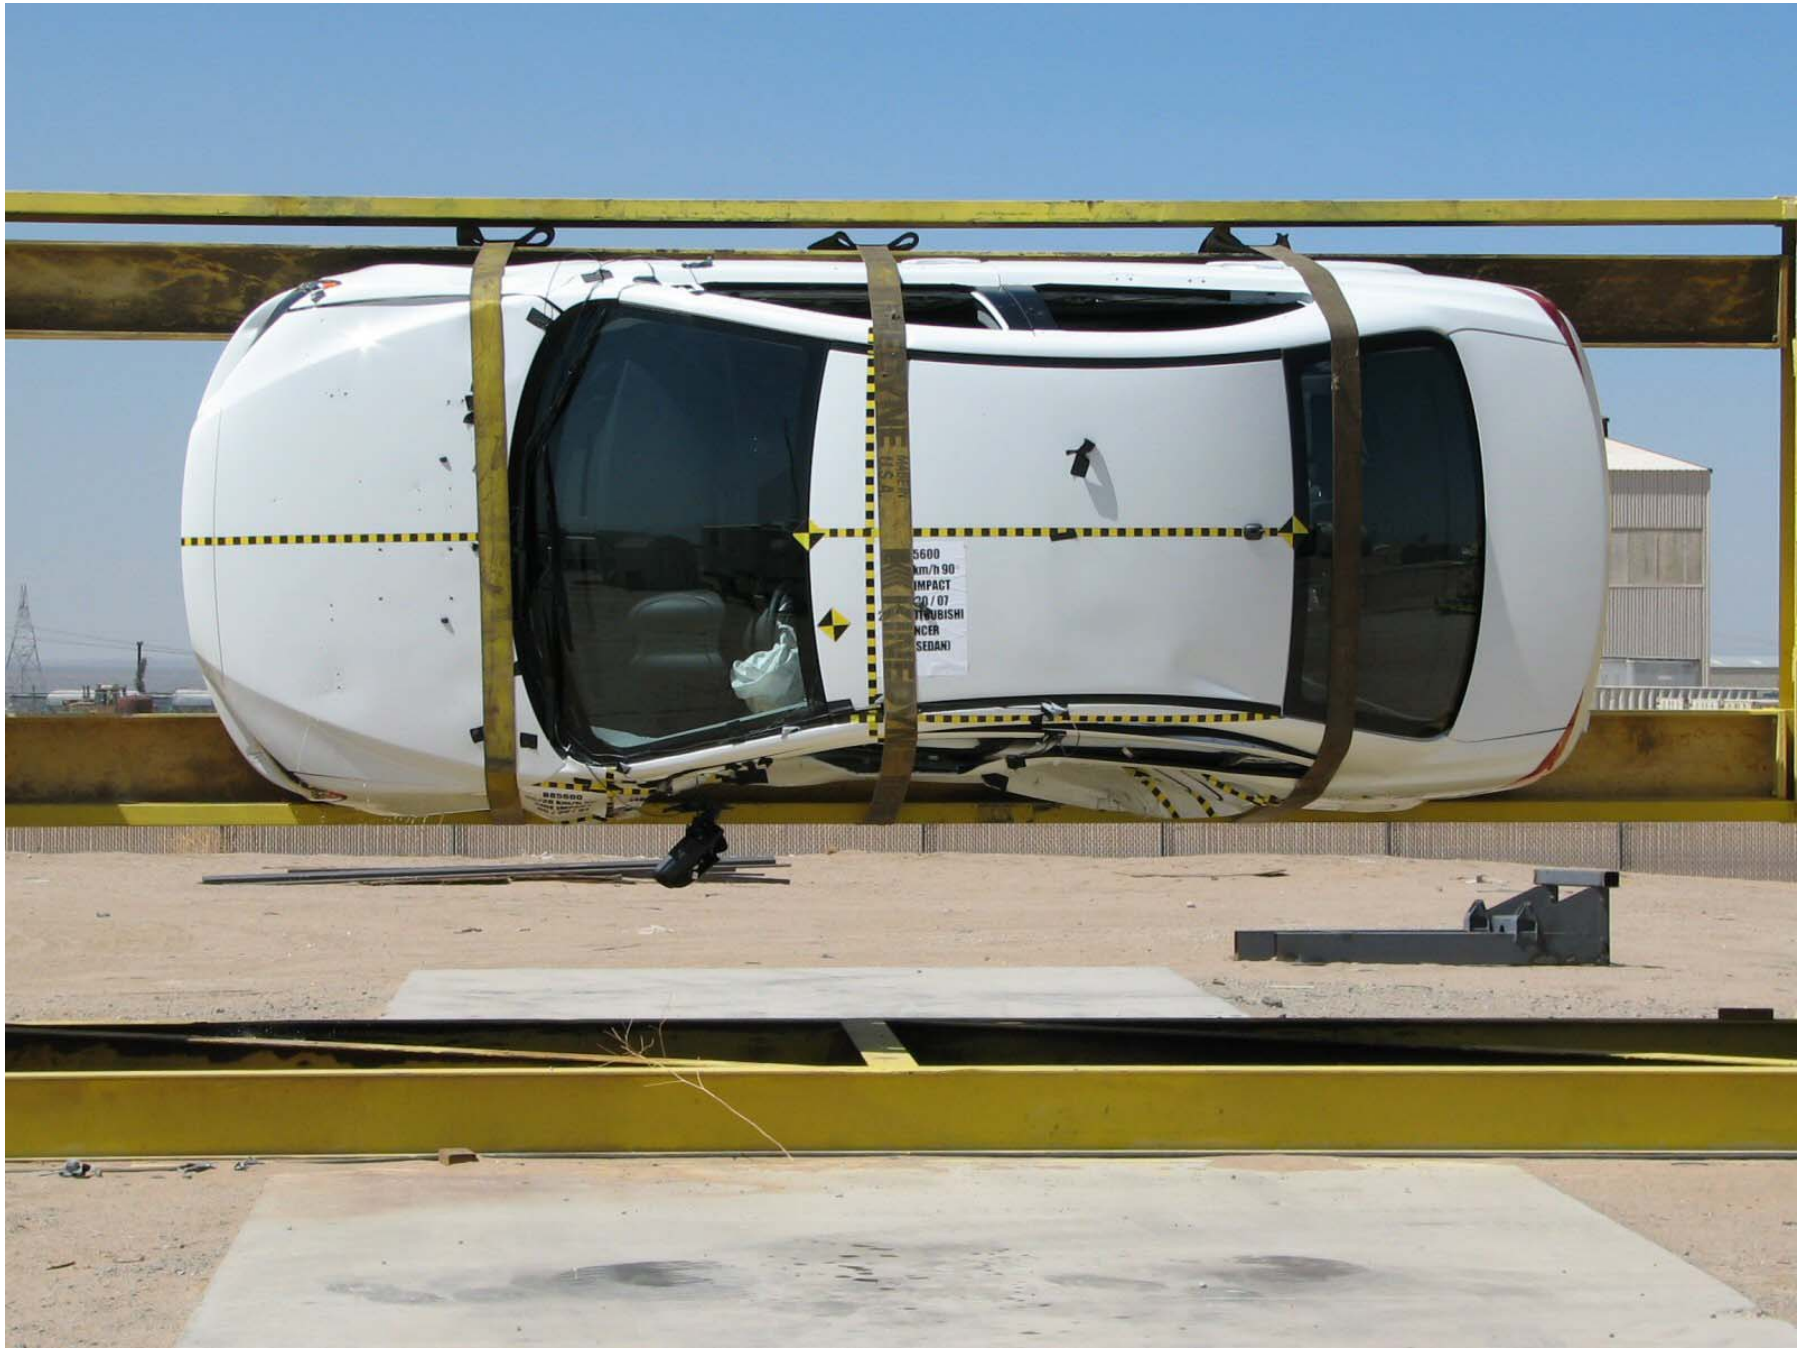
Figure A-62: Vehicle on Rollover Device (90°)

- A. From impact until vehicle motion ceases: 0.0 oz.
(Maximum Allowable = 1 ounce)
- B. For the 5 minute period after motion ceases: 0.0 oz.
(Maximum Allowable = 5 ounces)
- C. For the following 25 minutes: 0.0 oz.
(Maximum Allowable = 1 oz./minute)
- D. Spillage Details: No leakage occurred
