**REPORT NUMBER TR-P27082-04-NC**

**SIDE AIRBAG OCCUPANT RISK PROGRAM  
OCCUPANT OUT-OF-POSITION TESTS**

**MITSUBISHI MOTORS CORPORATION  
2008 MITSUBISHI LANCER  
4-DOOR SEDAN**

**NHTSA NUMBER: M85600TWG2**

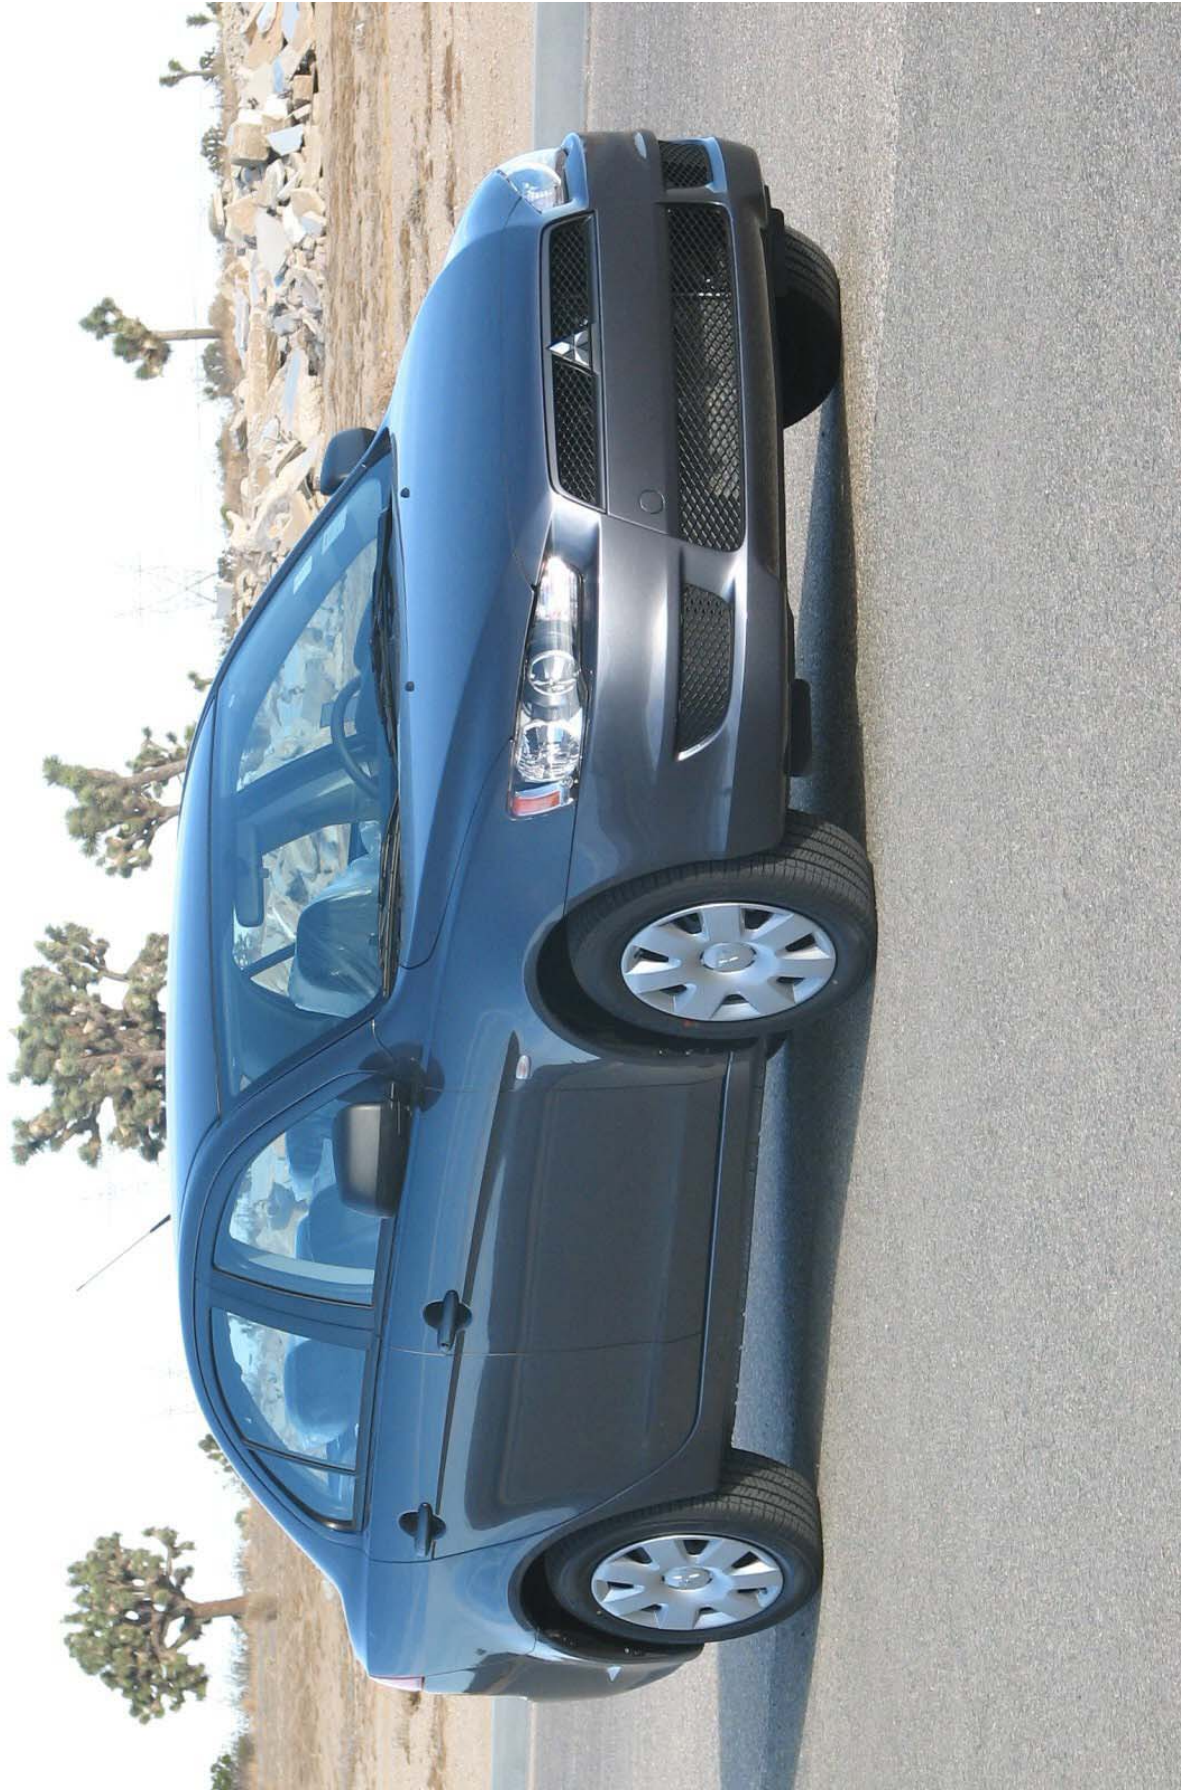
Figure A-1: Right Front  $\frac{3}{4}$  View, As Received

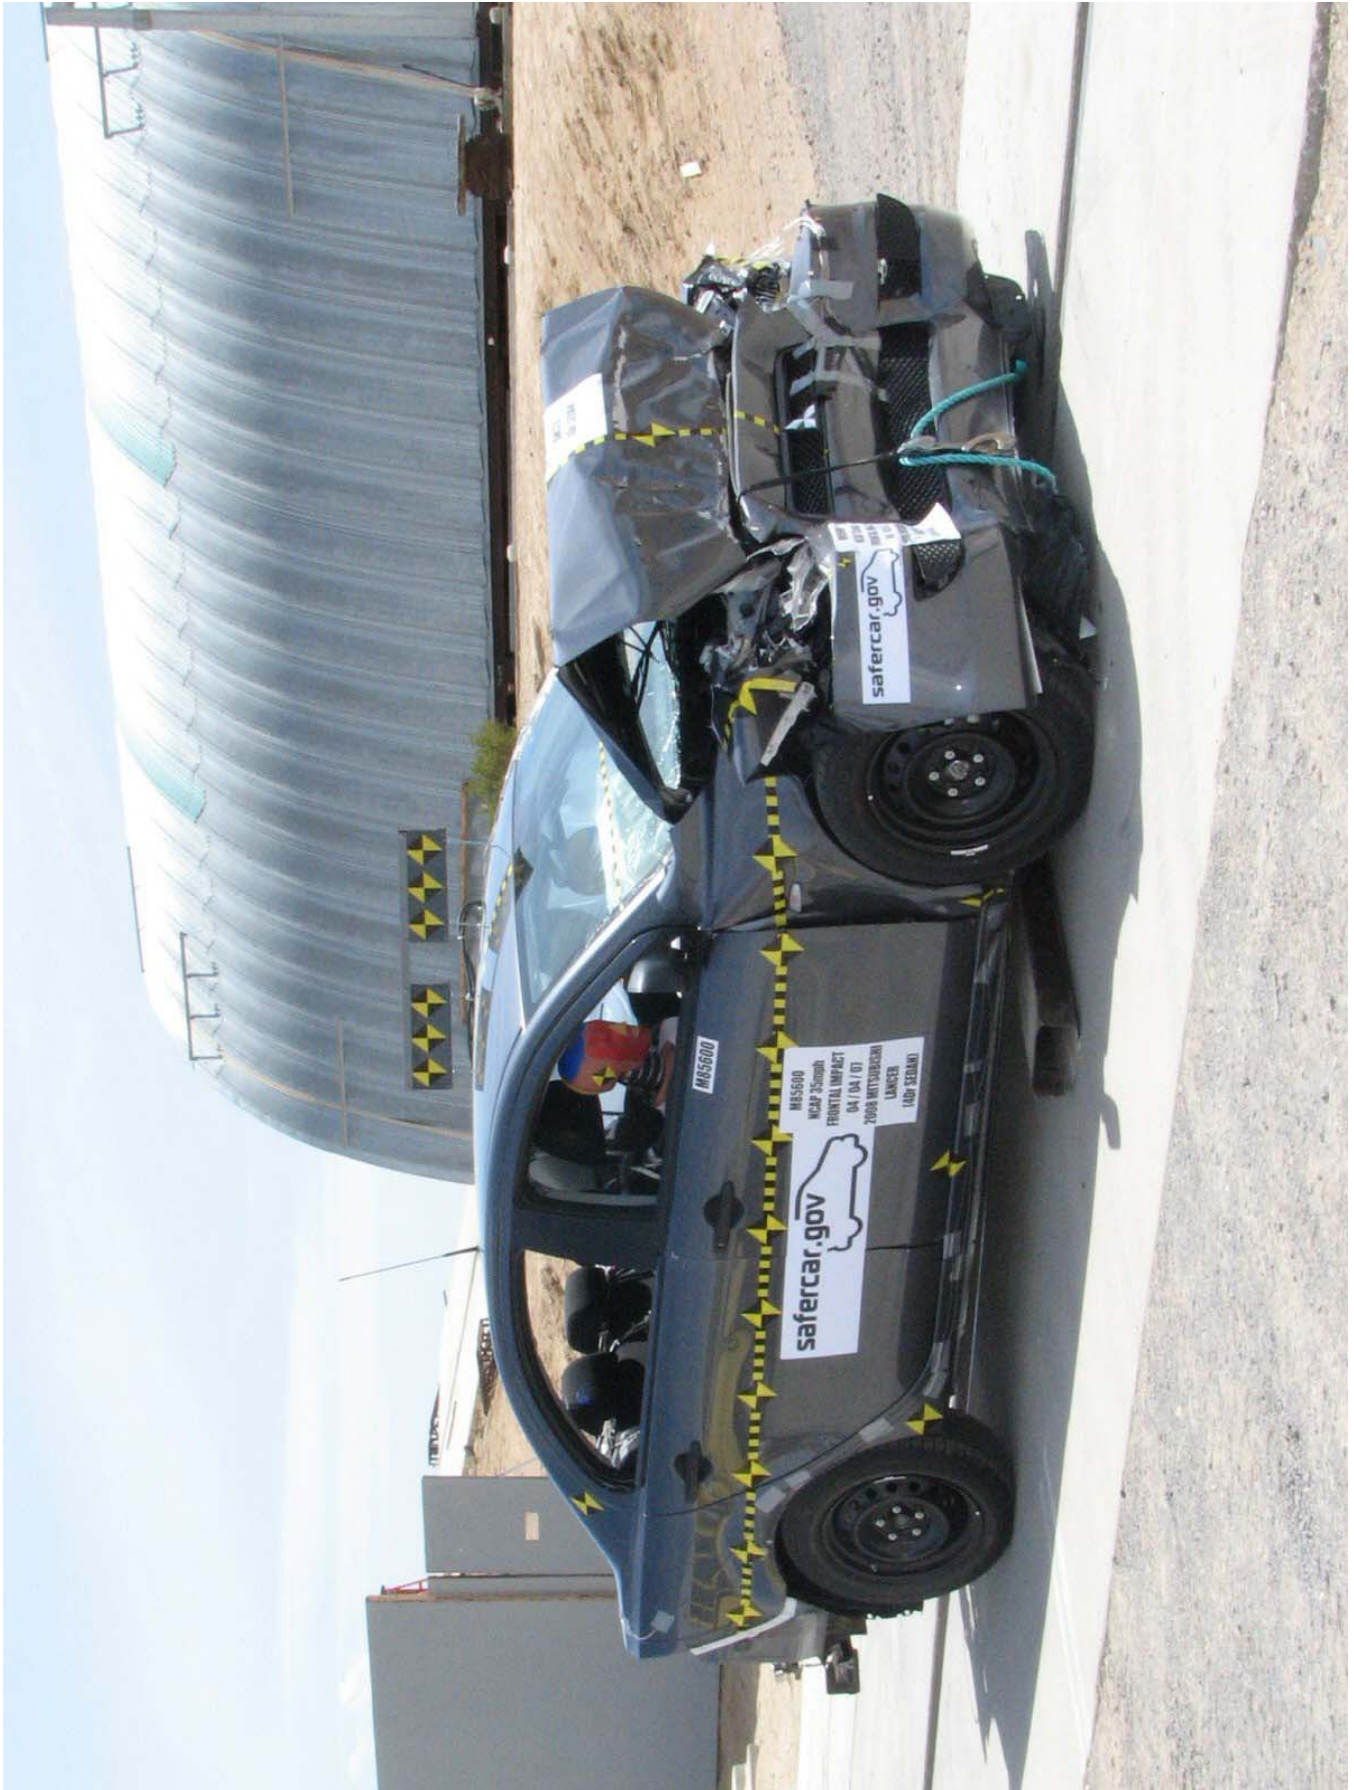
Figure A-3: Post-Test Right Front  $\frac{3}{4}$  View of Frontal NCAP Test

\* Vehicle had undergone New Car Assessment Program Frontal Impact Testing on April 4, 2007

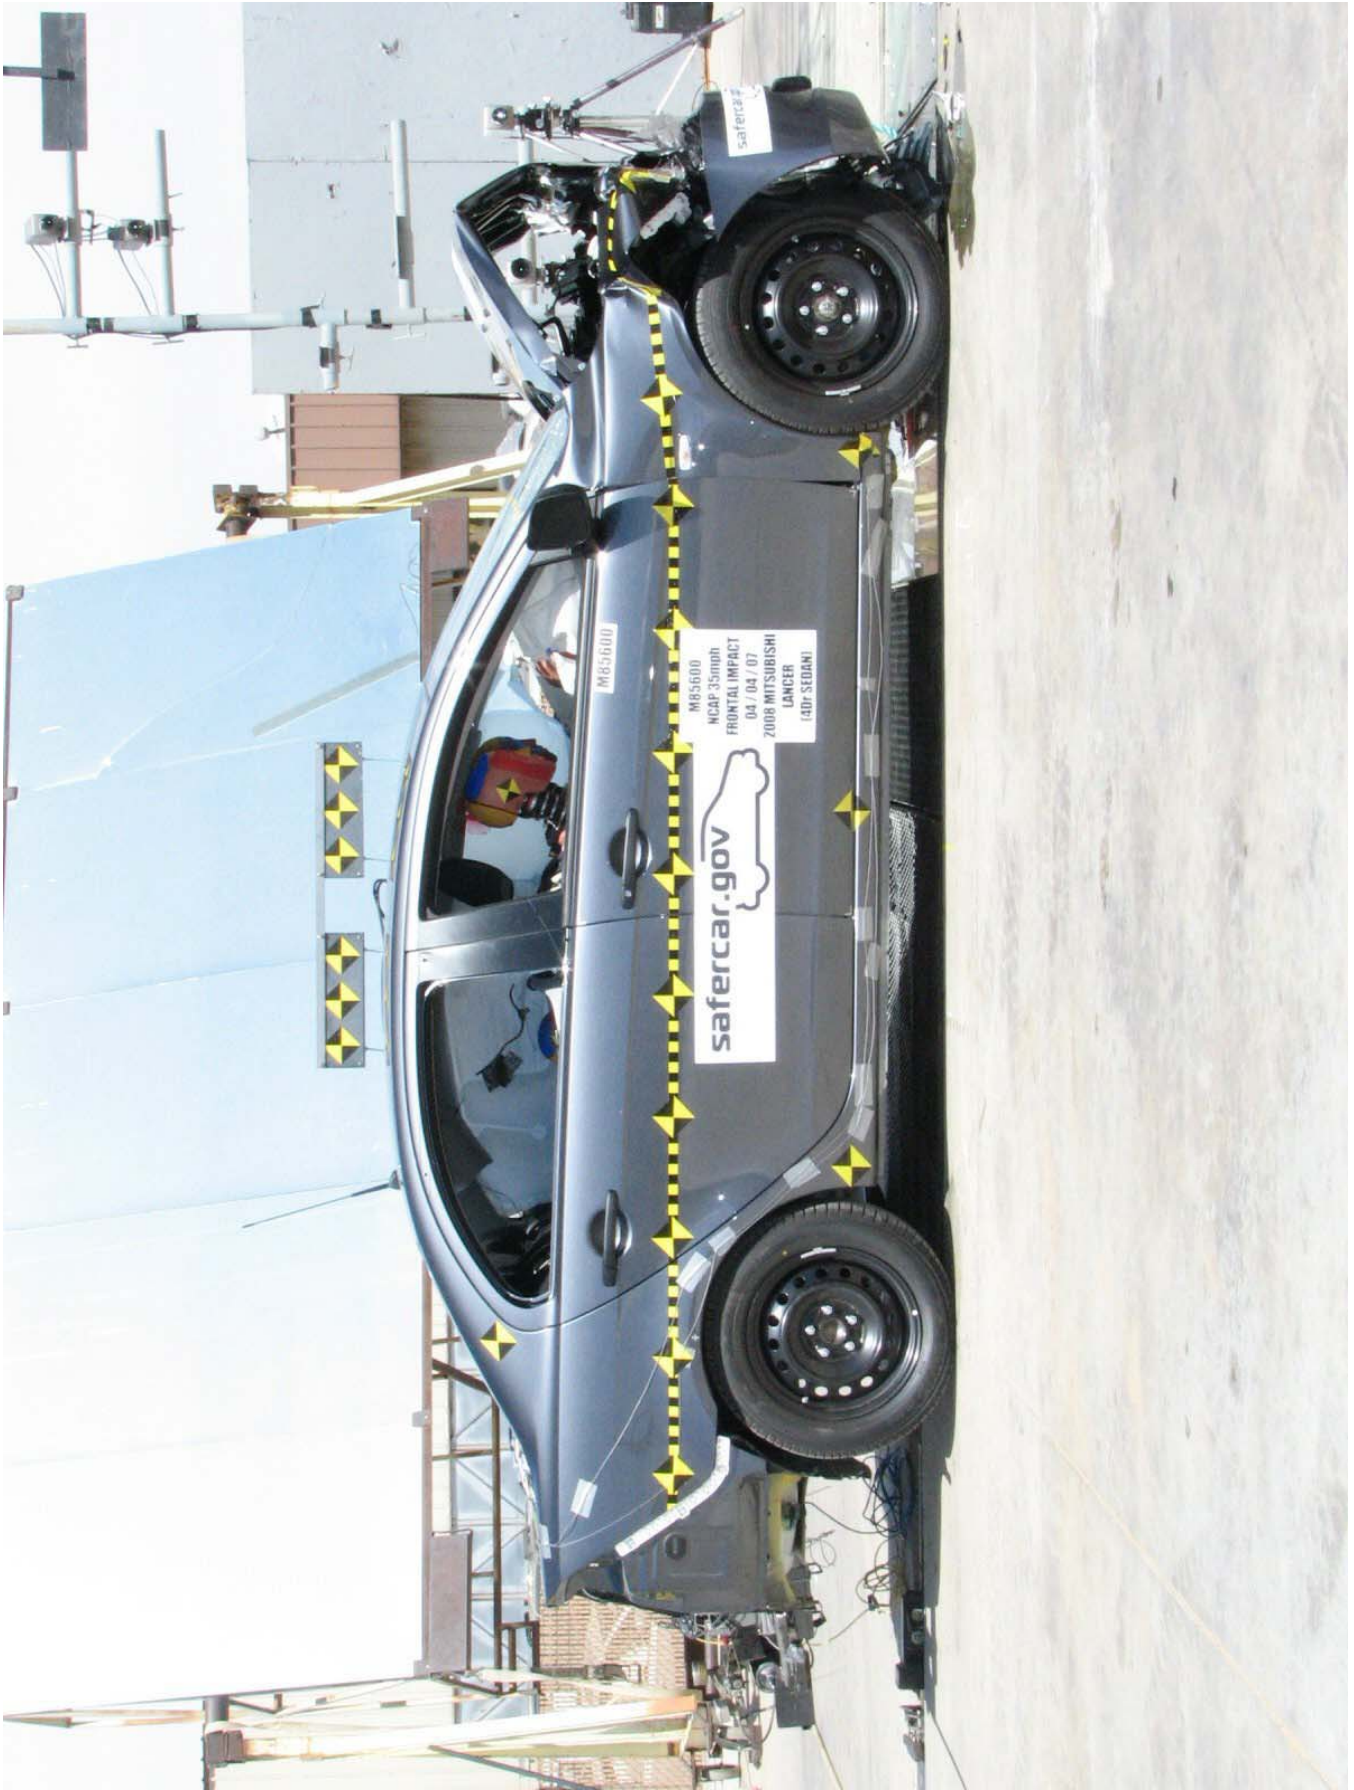
Figure A-4: Post-Test Right Side View of Frontal NCAP Test

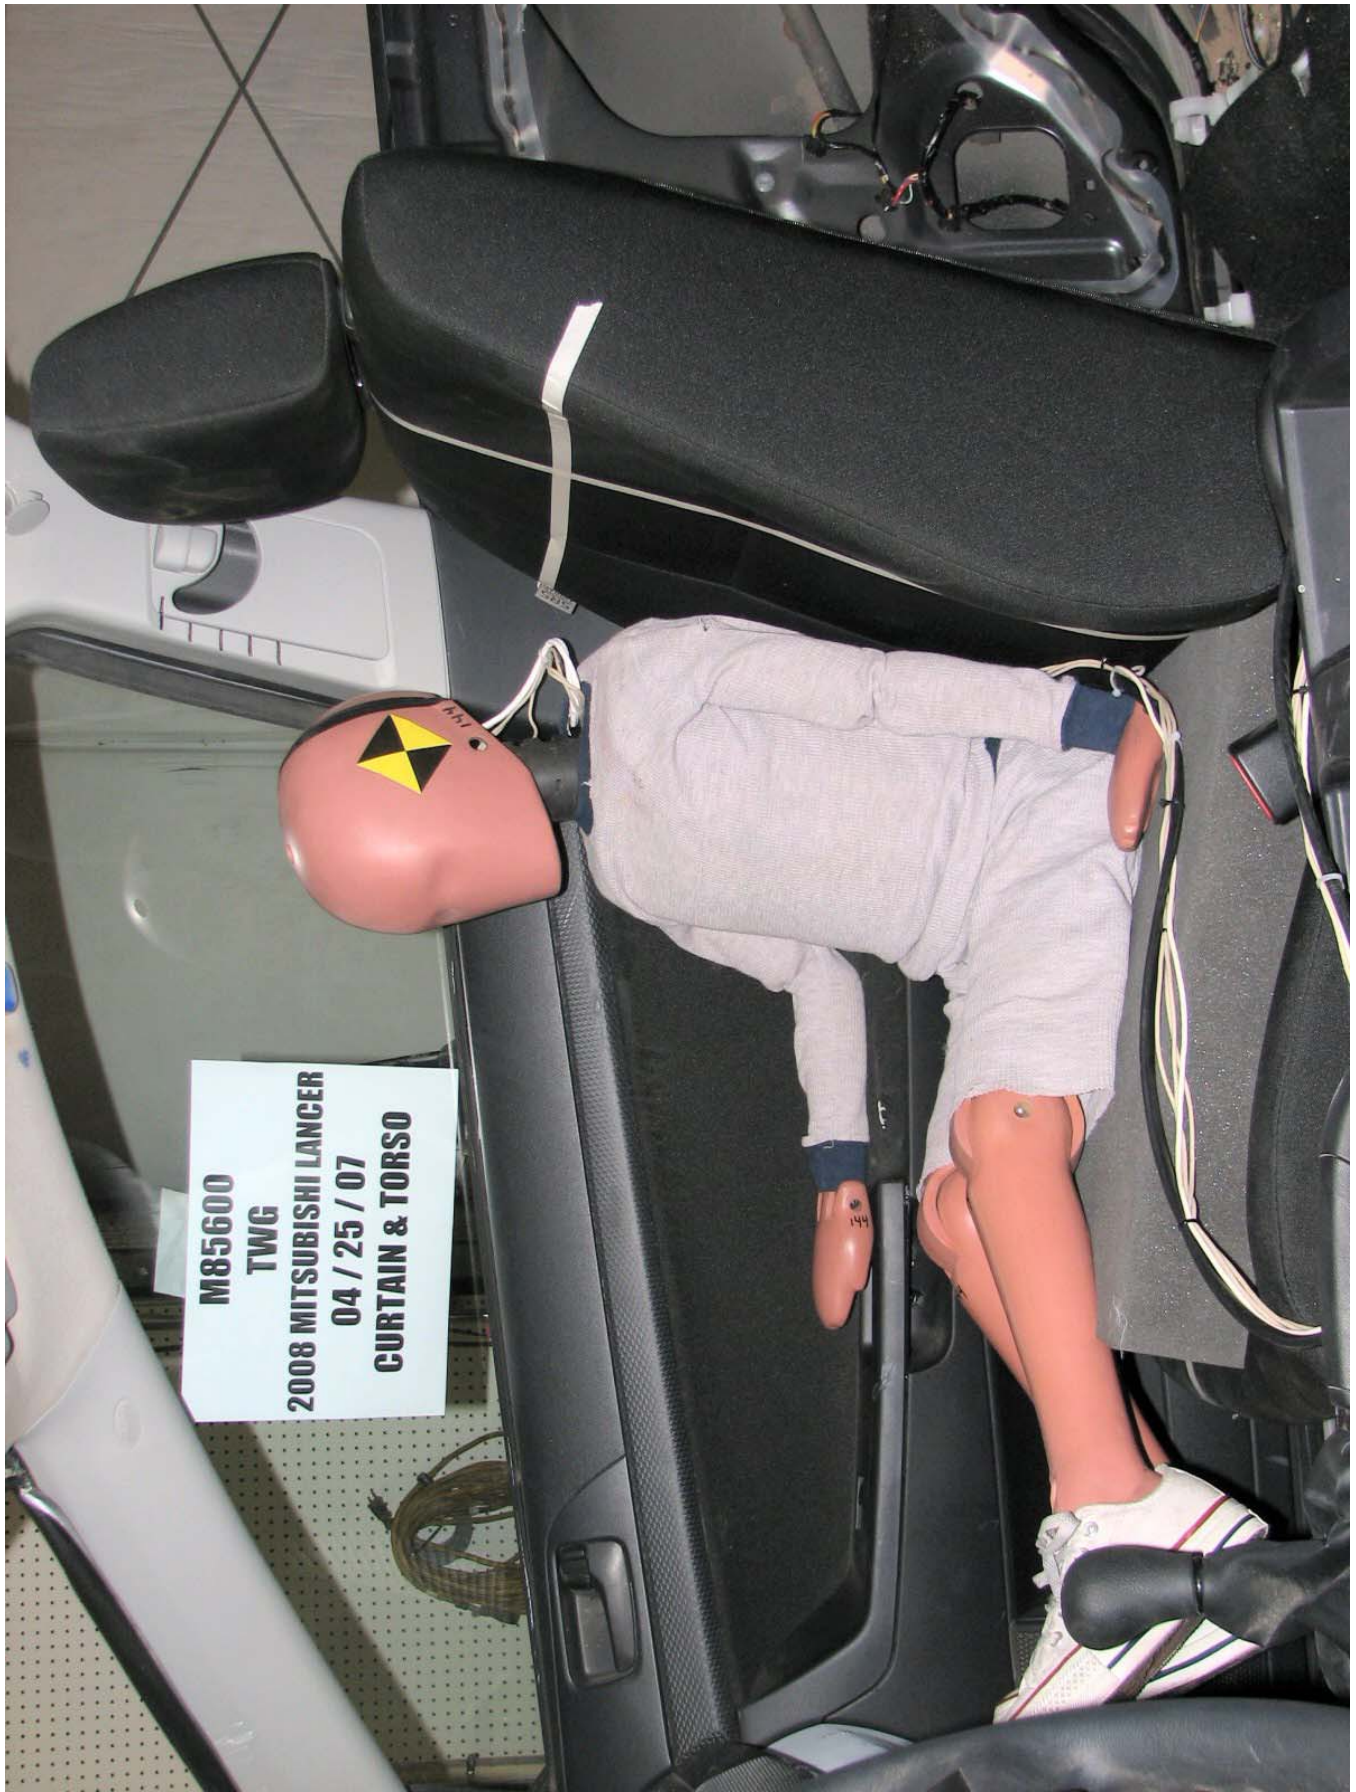
Figure A-5: Pre-Test Dummy Position, Left Side View

Orientation of the Hybrid III 6 Year-old Child Dummy was in the inboard facing position leaning against the front passenger door. The dummy's spine was aligned with the deploying trajectory of the torso airbag. The lower legs were extended. Synthetic foam was used to raise the dummy. This orientation complies with section 3.3.3.5 of the Technical Working Group (TWG) recommendation in the Recommended Procedures for Evaluating Occupant Injury Risk from Deploying Side Airbags.

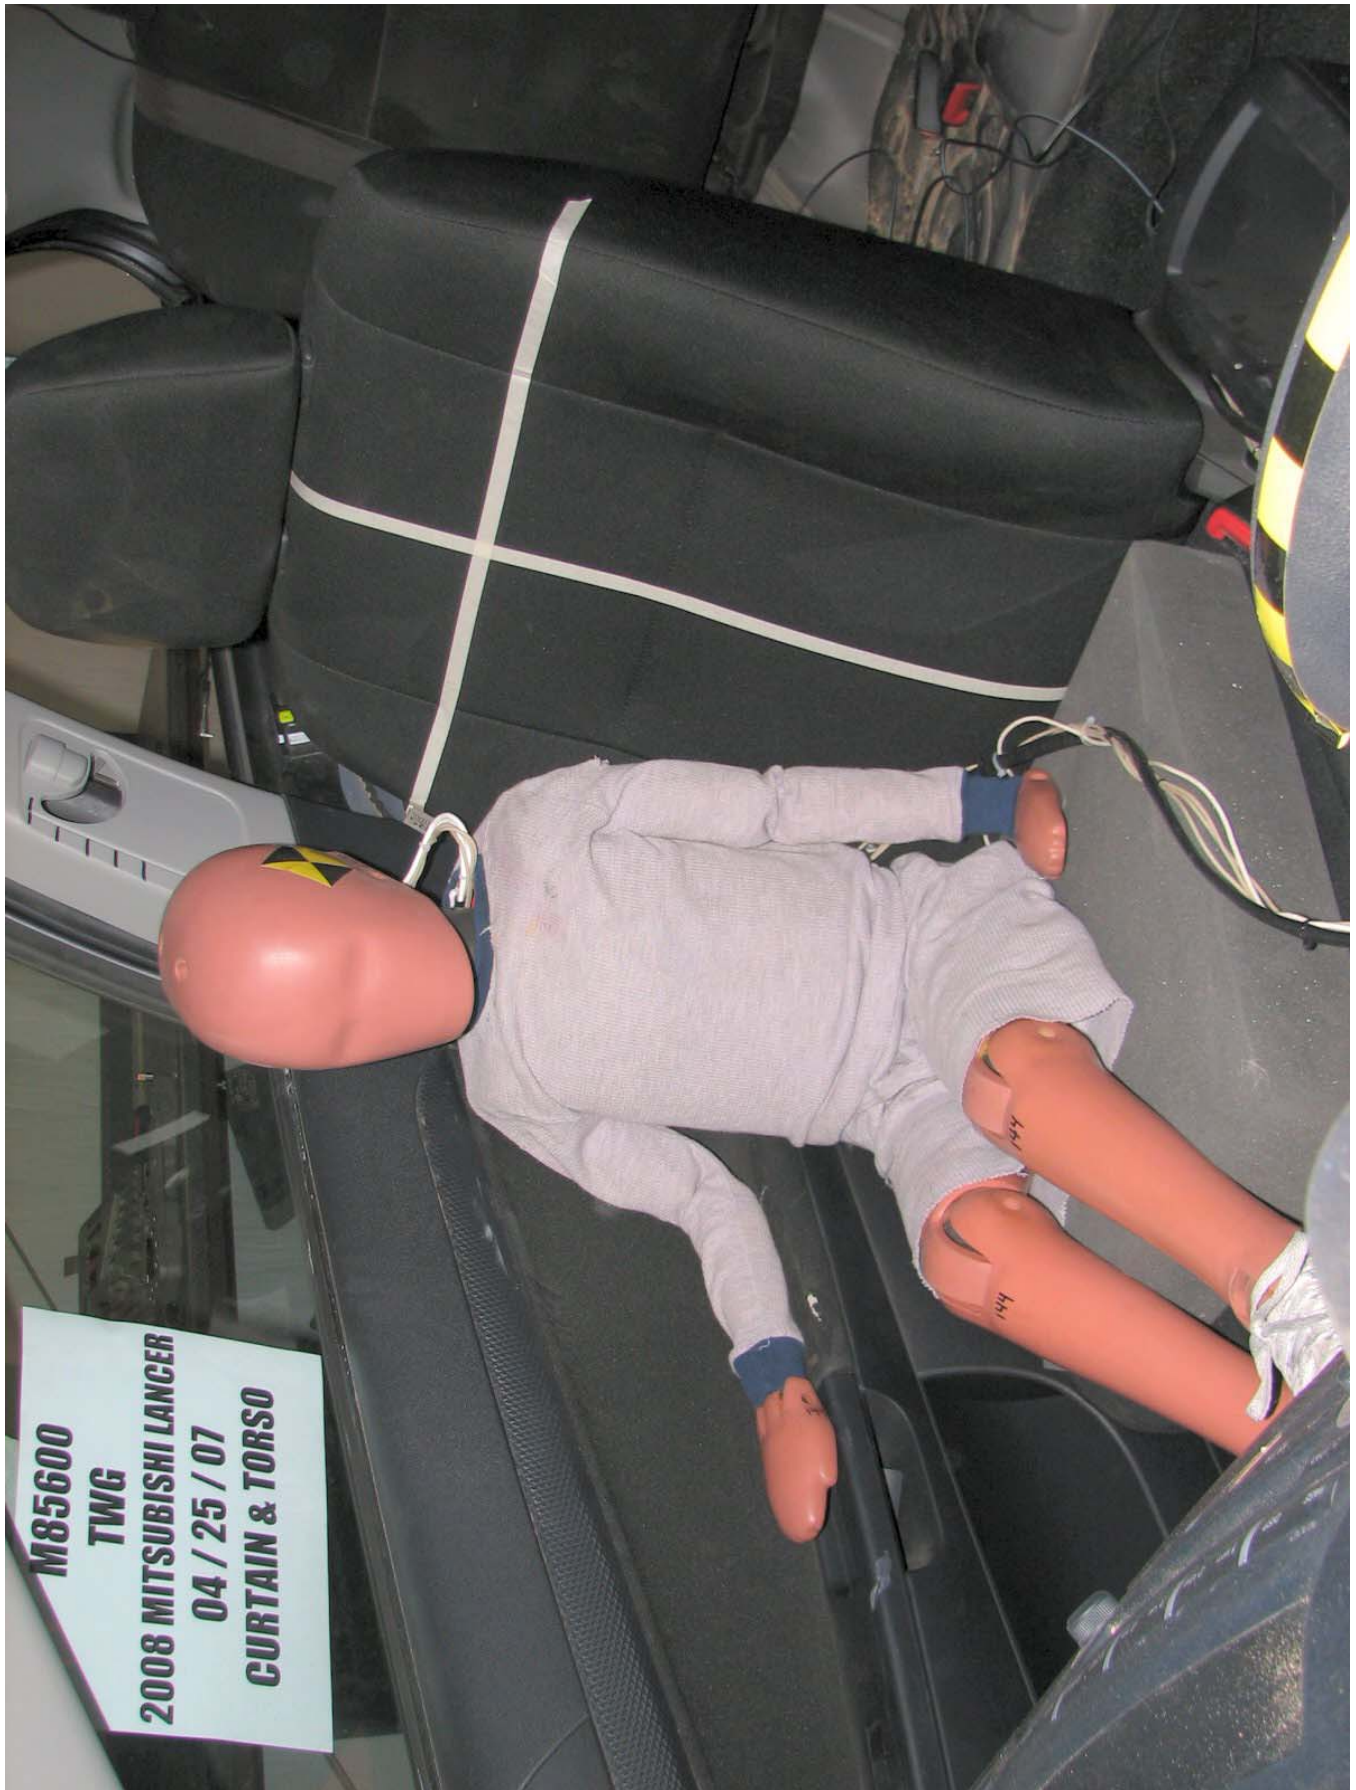
Figure A-6: Pre-Test Dummy Position,  $\frac{3}{4}$  View

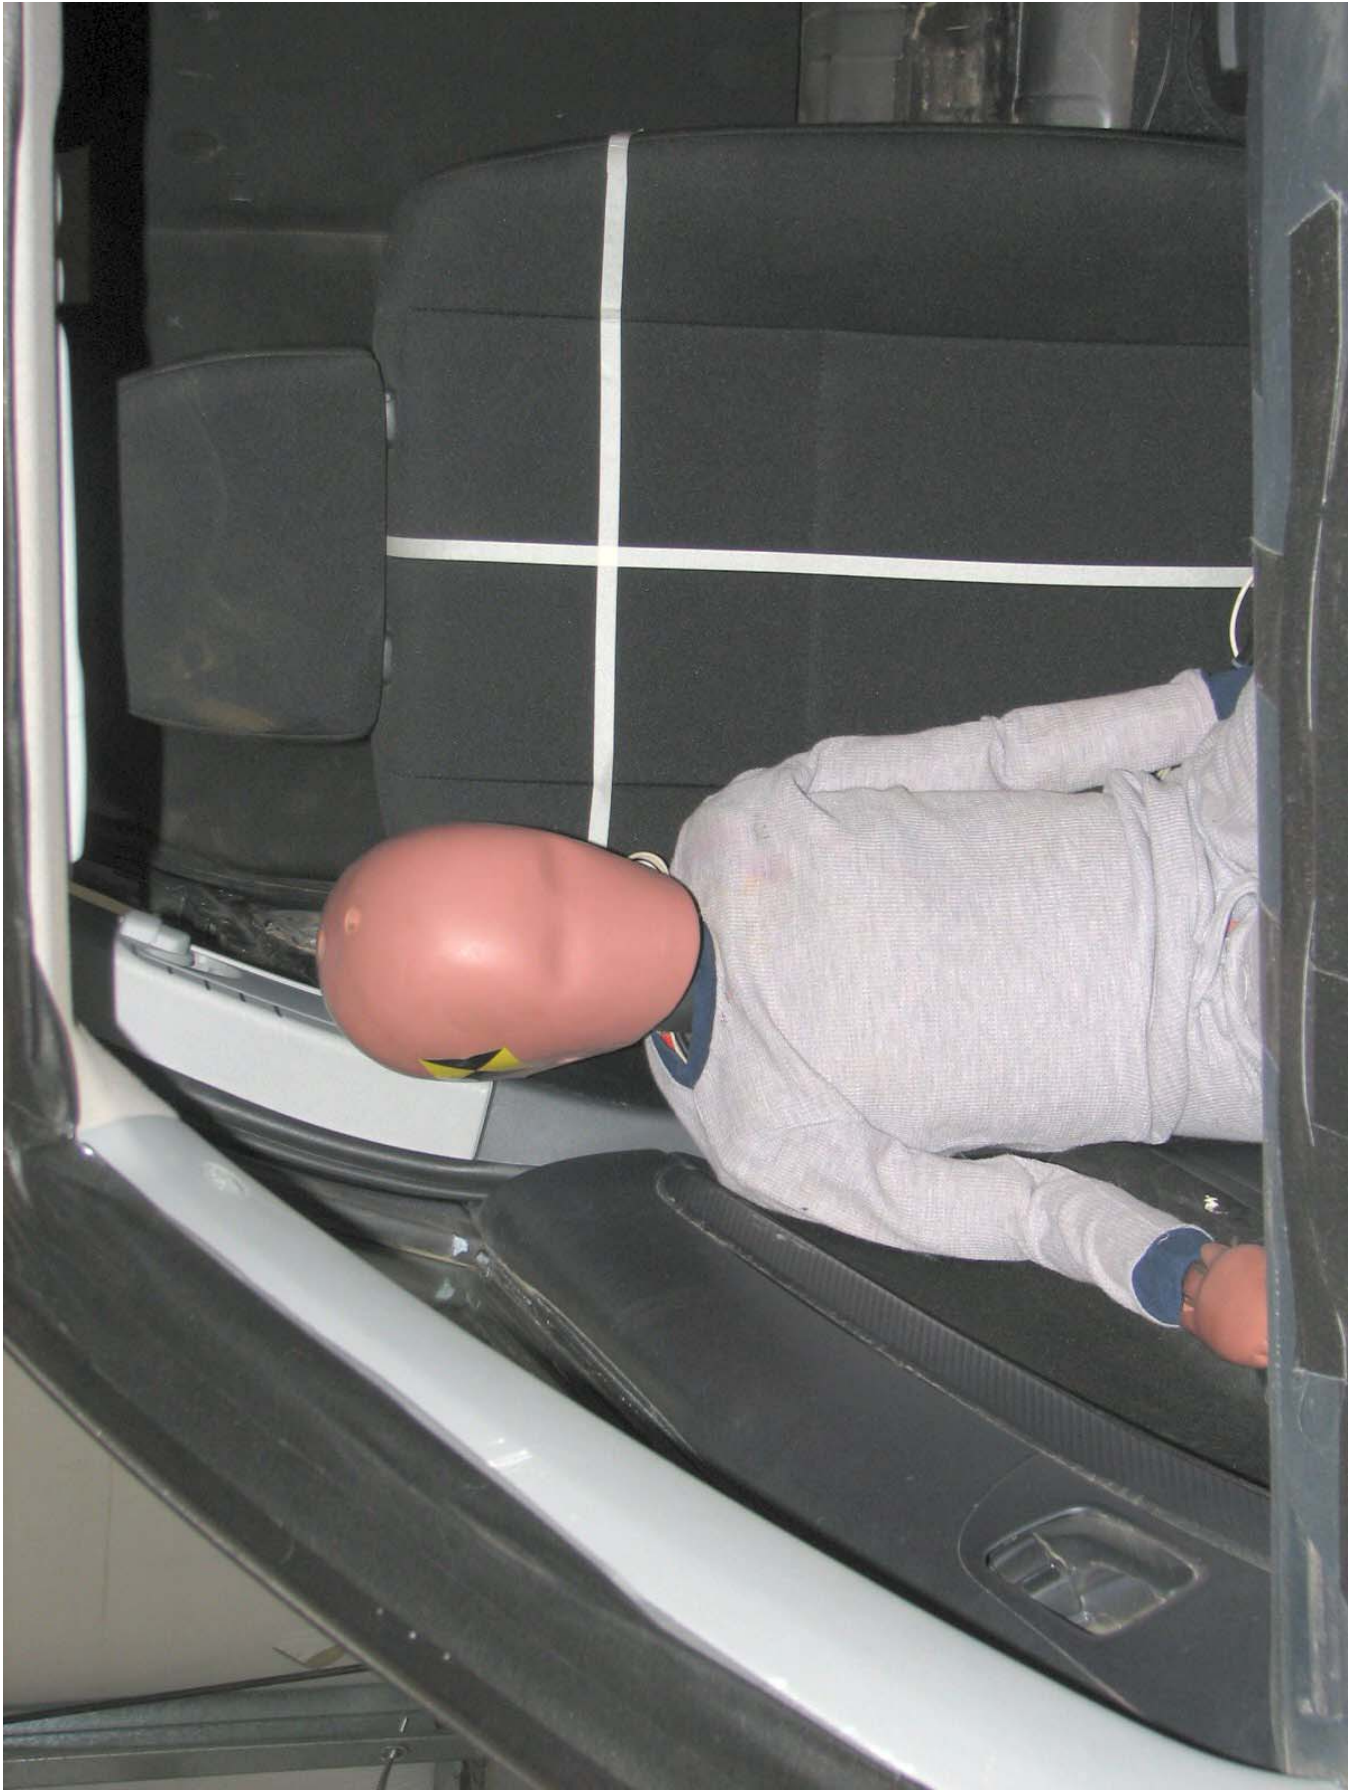
Figure A-7: Pre-Test Dummy Position, Front View

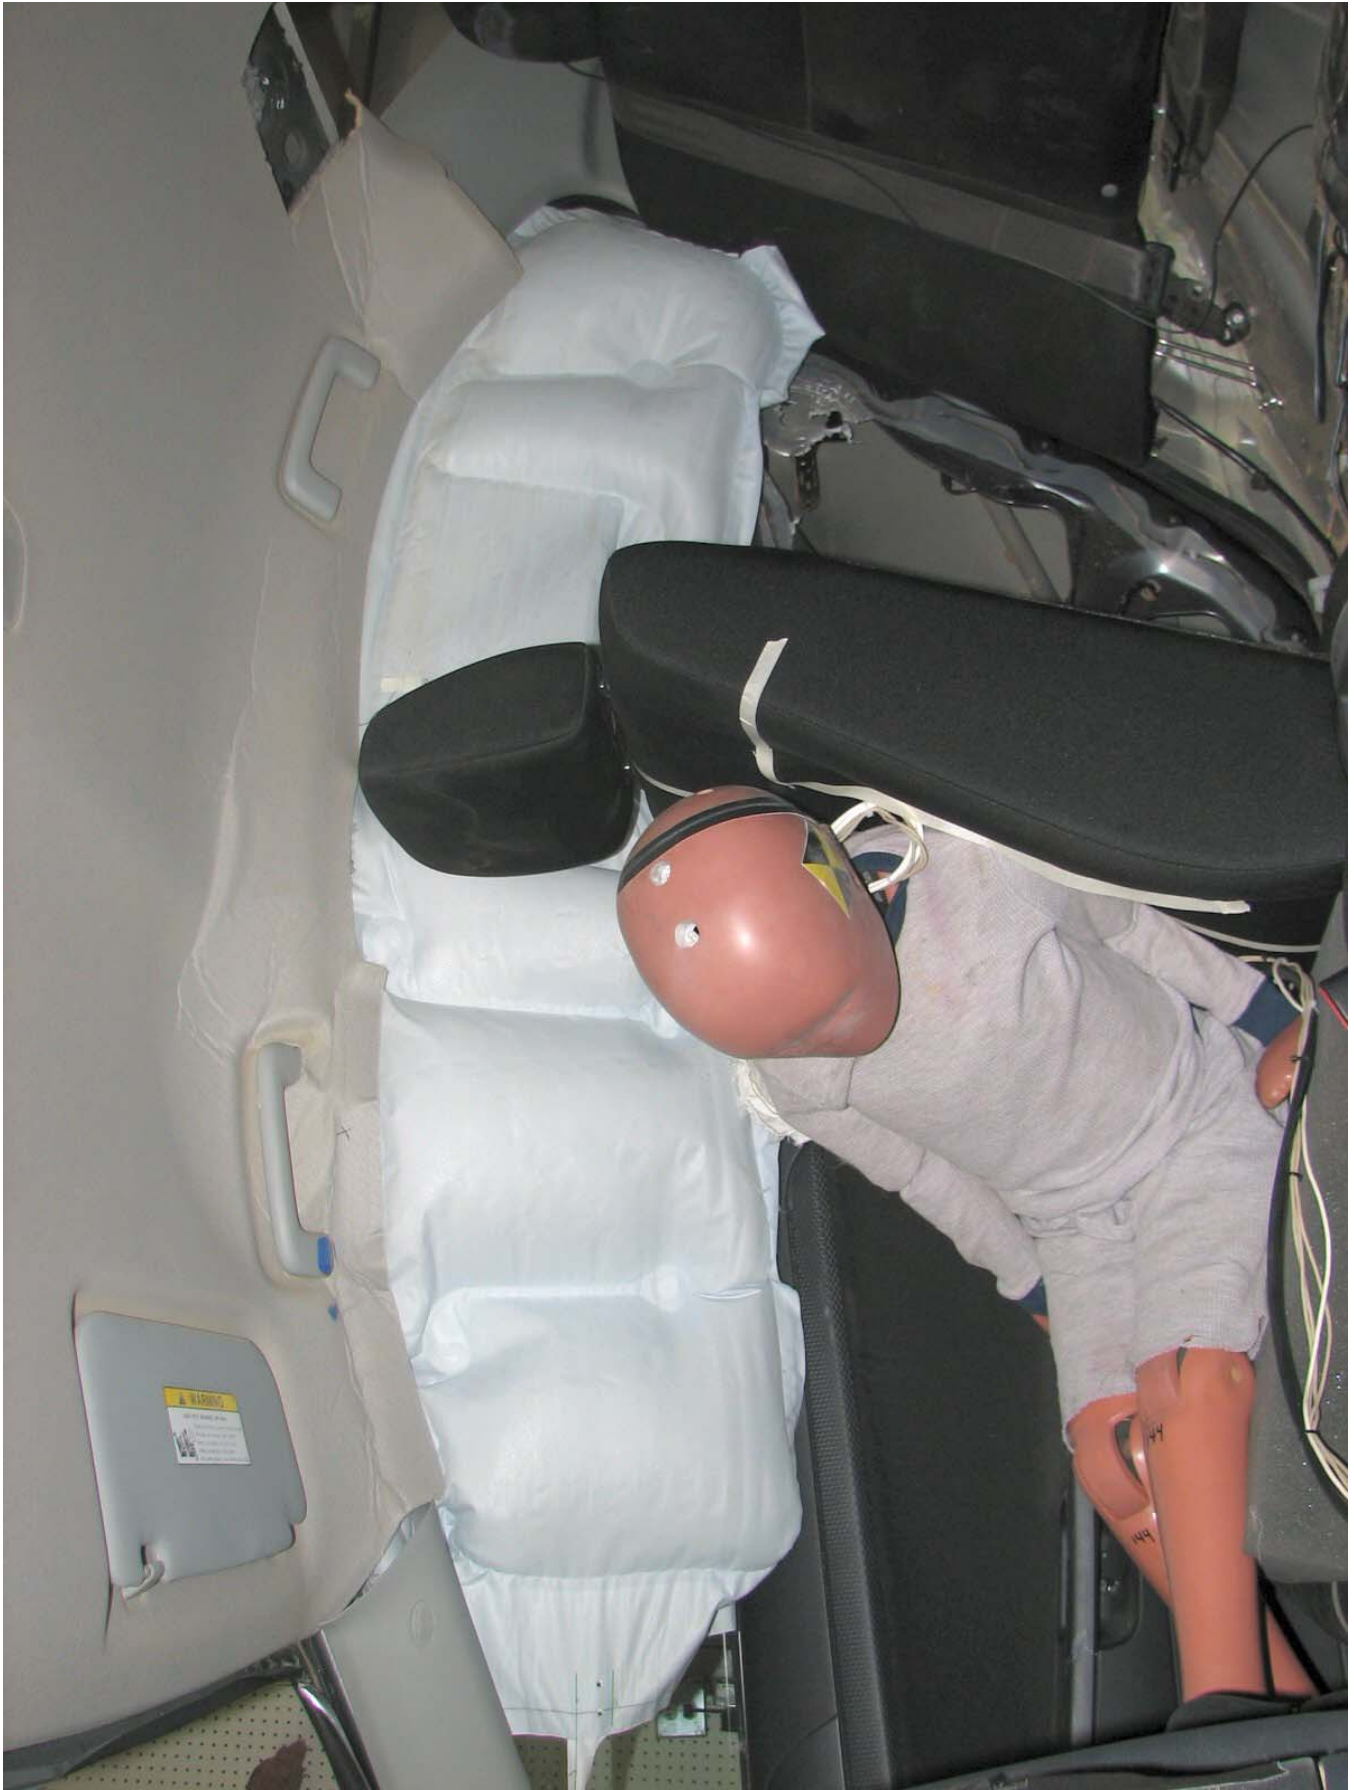
Figure A-8: Post-Test Dummy Position and Airbags, Left Side View

The Hybrid III 6-Year-Old Child Dummy's visible contact points were as follows: The torso airbag contacted the ATD's back. The curtain airbag contacted the ATD's head.

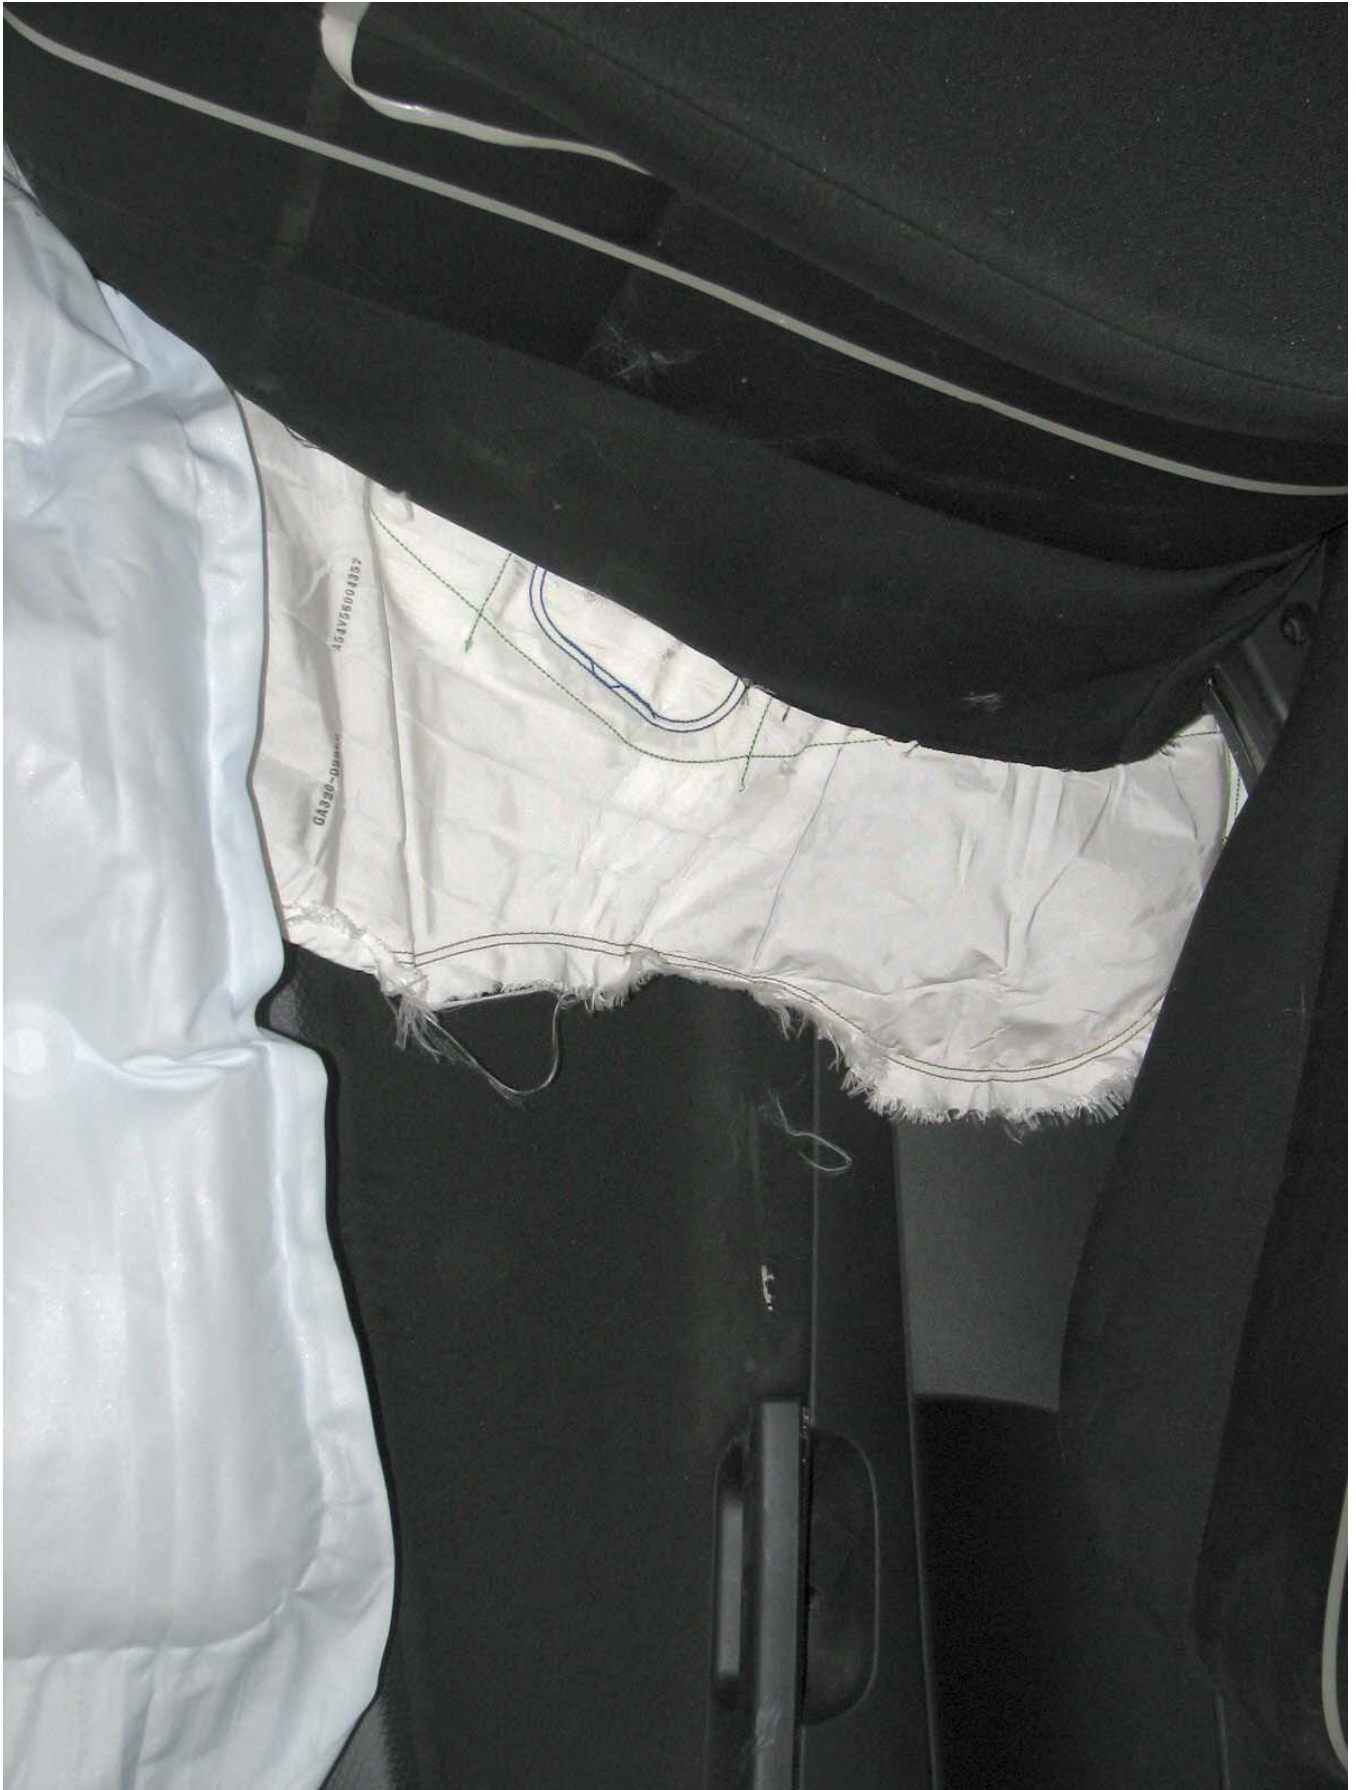
Figure A-10: Post-Test Airbags, Close-up View
