REPORT NUMBER: TWG-CAL07-08

**NEW CAR ASSESSMENT PROGRAM (NCAP)**  
SIDE AIRBAG OUT-OF-POSITION INJURY TESTING

MAZDA MOTOR CORPORATION  
2007 MAZDA CX-7  
MPV

NHTSA NUMBER: M75400TWG2

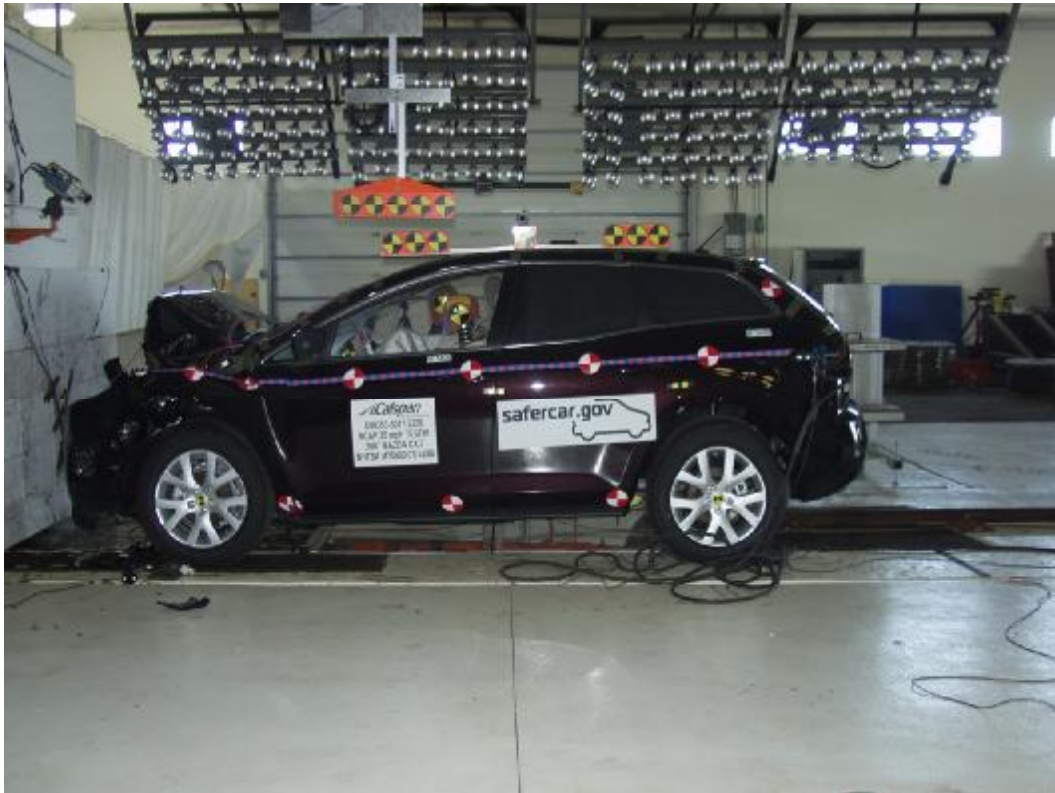
Figure A-2: Post-Test Vehicle Left Side View

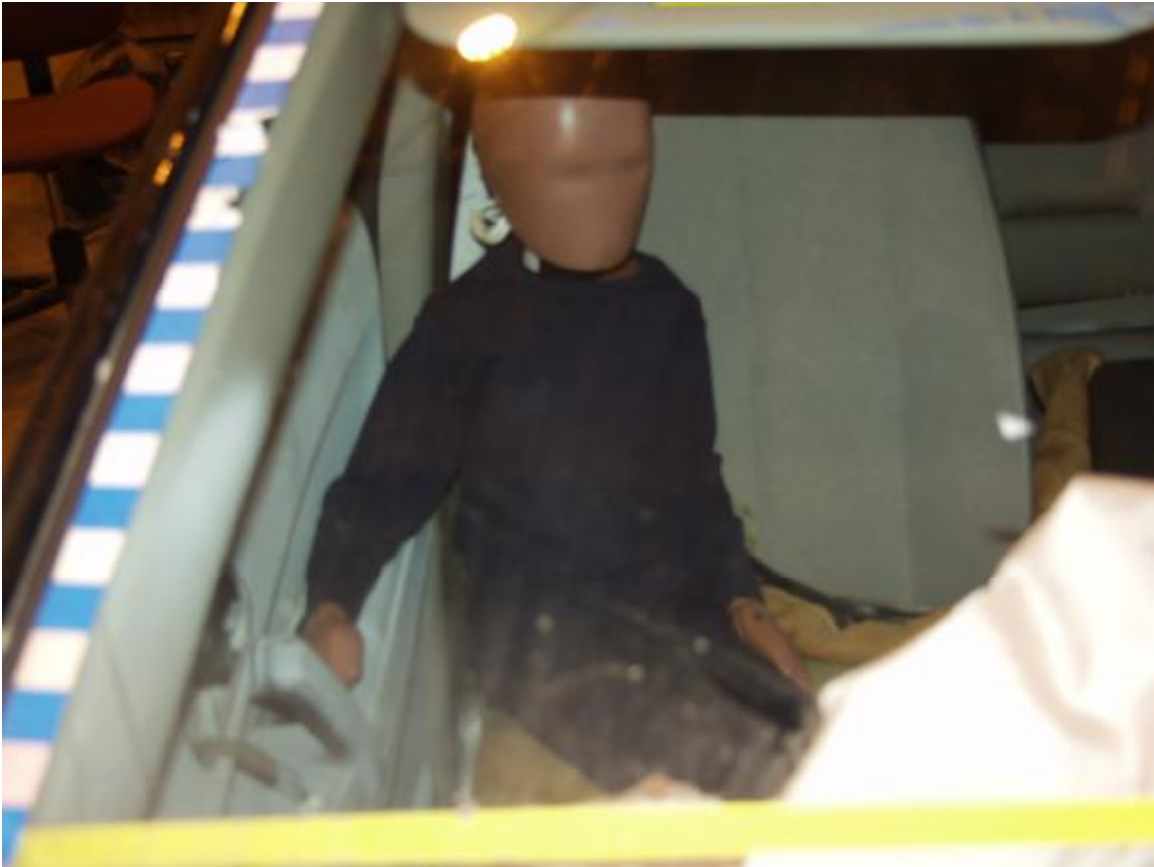
Figure A-5: Pre-Test Dummy Frontal View

The six-year old child dummy was placed on the outboard edge of foam block, aligning the upper spine with the deployment trajectory of the airbag. The dummy's head was placed in between the seat bolster and pillar trim to minimize the fore-aft clearance between the neck and the seatback. The head remained in its neutral orientation. The legs were aligned such that they crossed the heel placement points but the feet did overhang the seat cushion. The dummy was then positioned so the dummy's neck/torso junction was aligned vertically with the top edge of the airbag module. While maintaining the neck/torso top of the airbag module alignment, the vehicle door was closed and the pelvis was moved outboard until it made contact the door trim/armrest. The outboard forearm was placed on the armrest. The inboard arm was positioned such that the upper arm contacted the seat back and the fingertips contacted the booster seat. The dummy's arms were then bent at the elbow until the fingers contacted the booster seat. This orientation complies with section 3.3.3.5 of the TWG Recommended Procedures for Evaluating Occupant Injury Risk from Deploying Side Airbags as defined by Lund, et al and the Technical Working Group First Revision dated July, 2003.

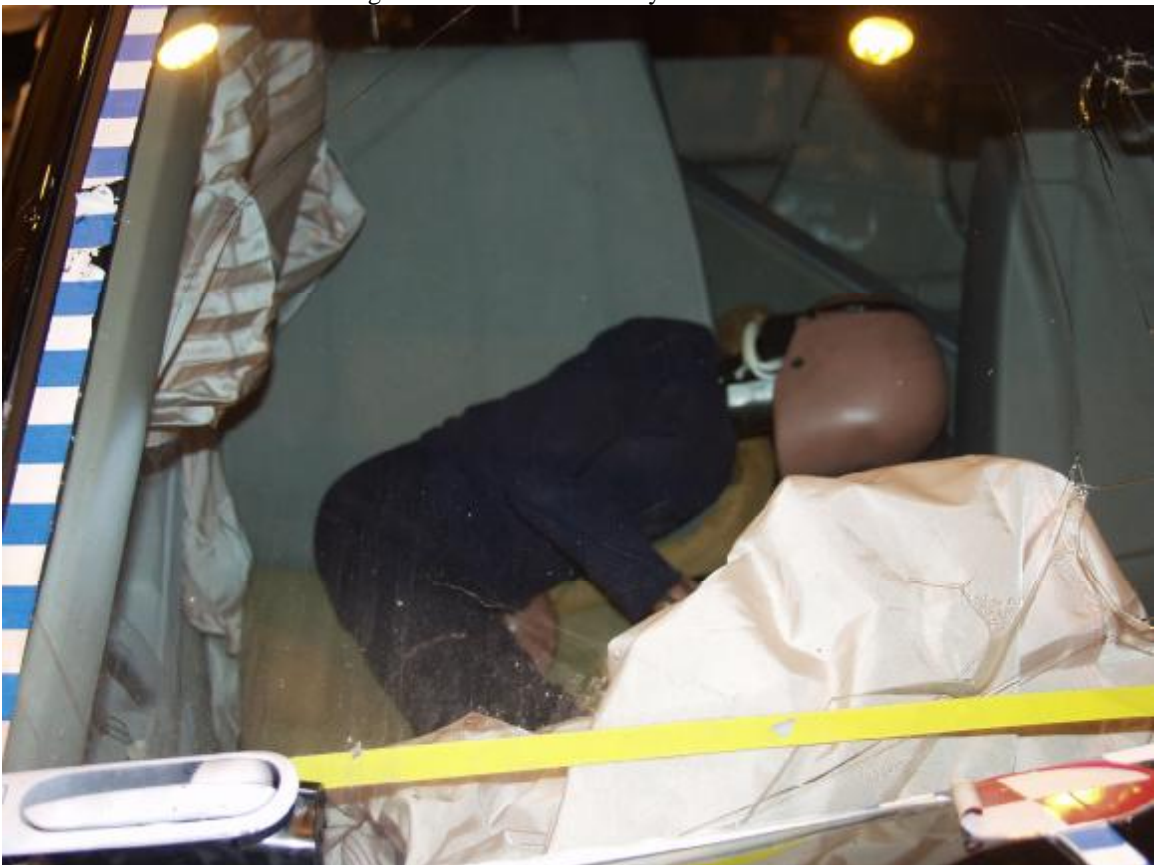
Figure A-6: Post-Test Dummy Frontal View

The Hybrid III six-year-old child dummy's visible contact points were as follows: The seat airbag to the right scapula and right side of the posterior thorax and pelvis and the curtain airbag to the top and the back of the head.

<b>Head Contact:</b>	The back (occipital) and the top (parietal) of the head by the side curtain.
<b>Upper Torso Contact:</b>	Side airbag to the right scapula and right side of the posterior thorax
<b>Lower Torso Contact:</b>	Side airbag to the right side of the pelvis (ilium)
<b>Left Knee Contact:</b>	None
<b>Right Knee Contact:</b>	None

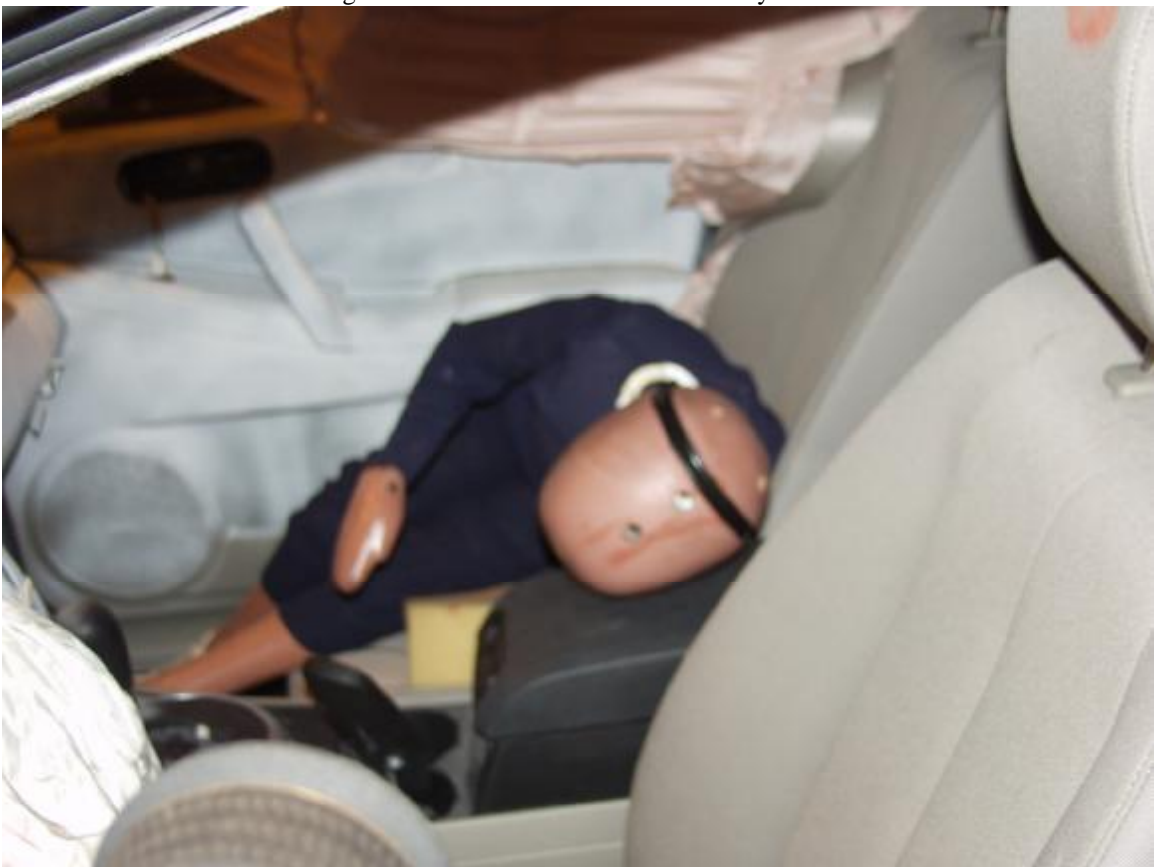
Figure A-8: Post-Test Left Side of Dummy View

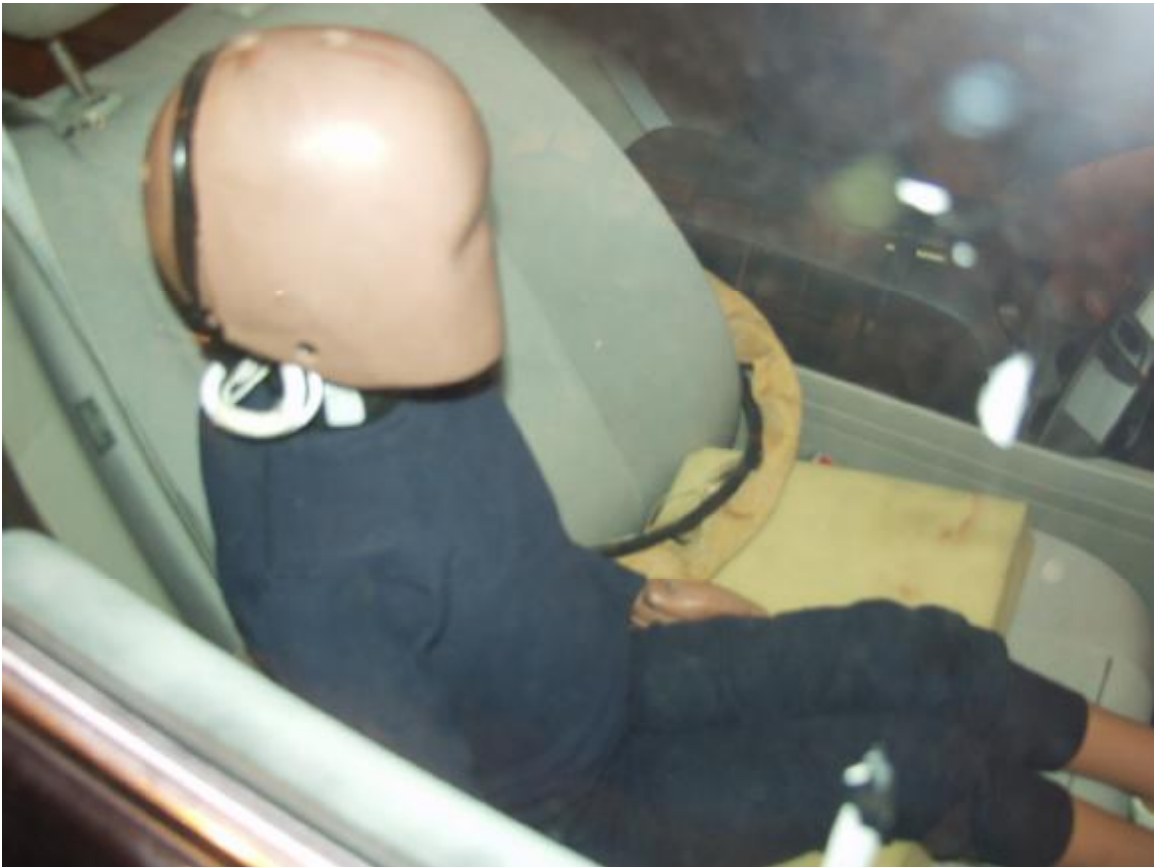
Figure A-9: Pre-Test Right Side of Dummy View

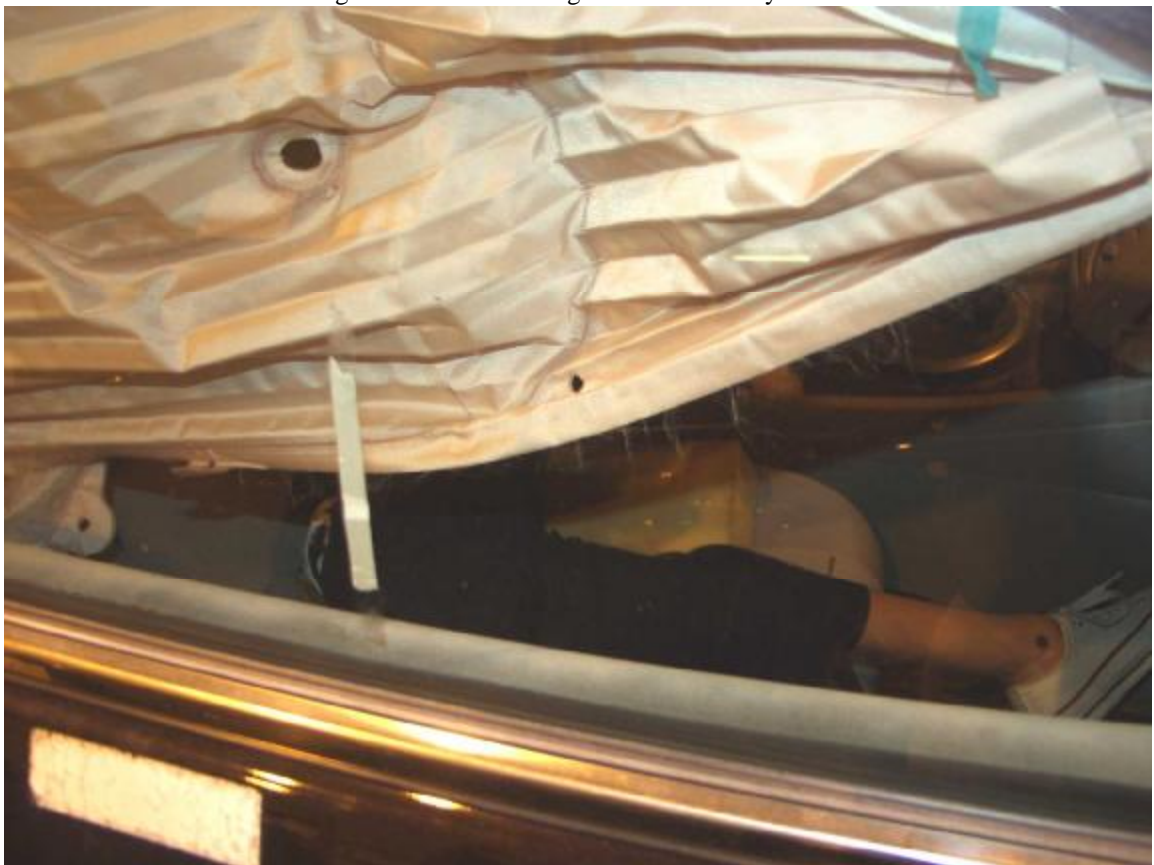
Figure A-10: Post-Test Right Side of Dummy View
