REPORT NUMBER: TWG-CAL07-03

**NEW CAR ASSESSMENT PROGRAM (NCAP)**  
SIDE AIRBAG OUT-OF-POSITION INJURY TESTING

2007 HONDA ELEMENT  
FOUR DOOR MULTIPURPOSE VEHICLE

NHTSA NUMBER: M75306TWG2

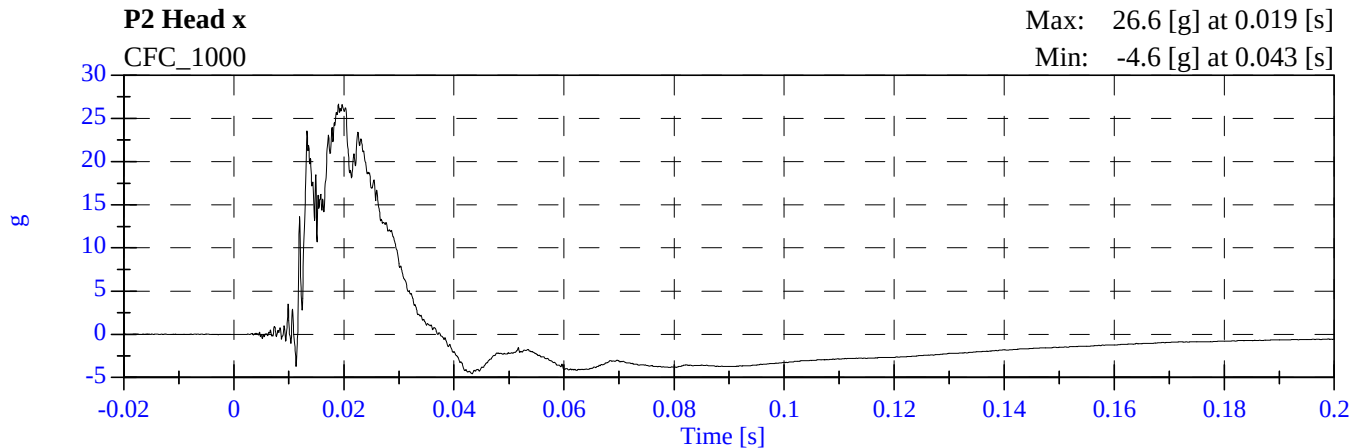
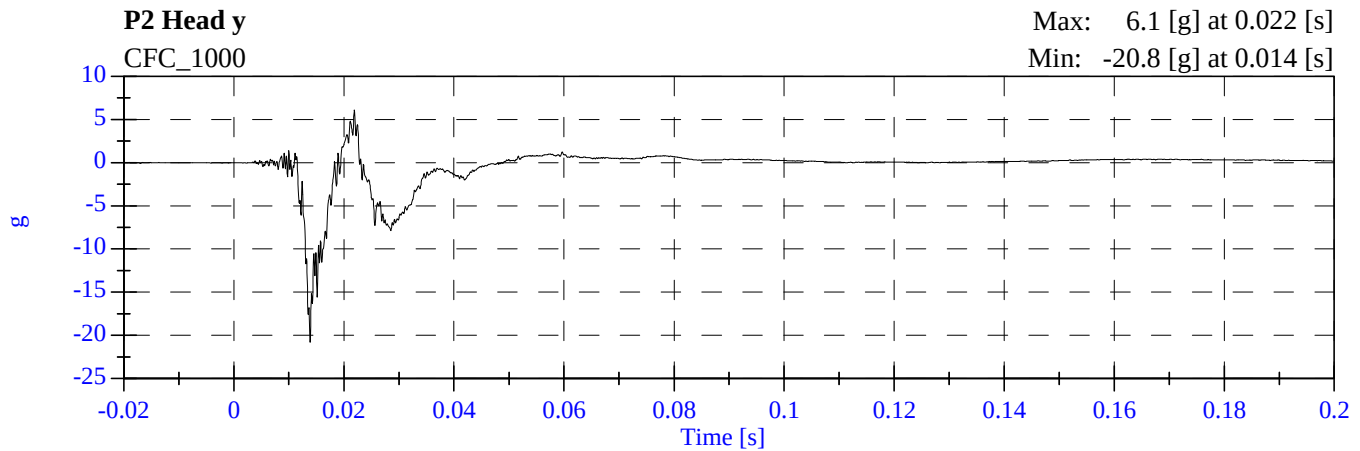
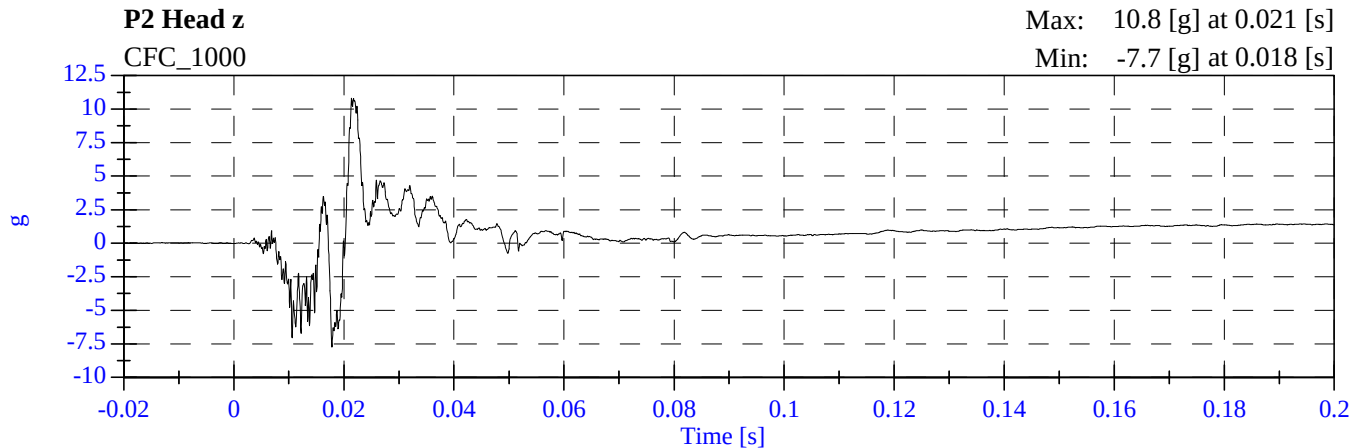
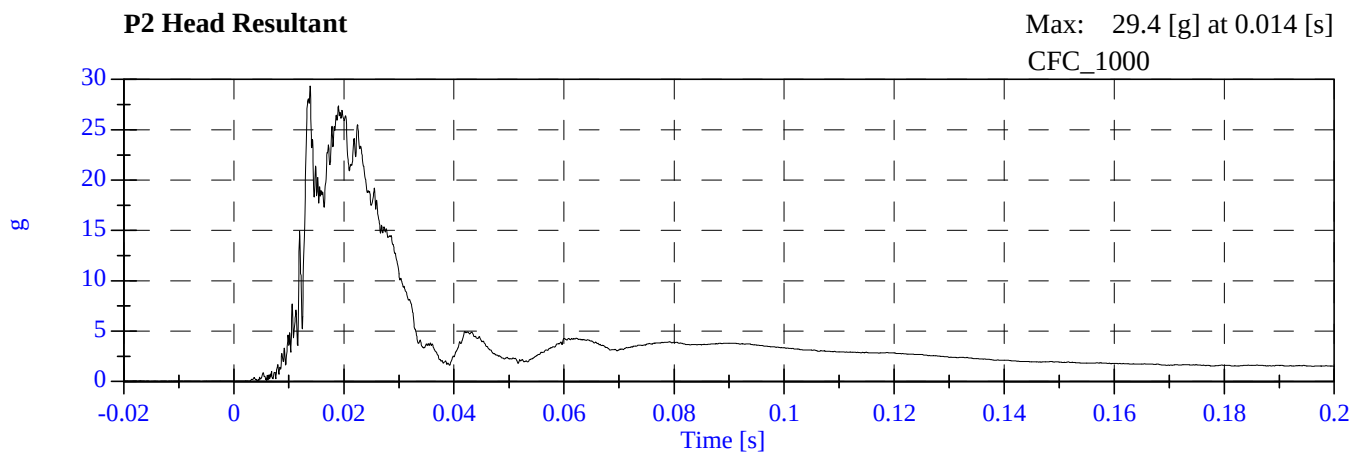
# 2007 TWG Test 3 2007 Honda Element M75306TWG2 - May 15, 2007

| PLOT | PLOT NAME[UNITS, CHANNEL FILTER CLASS] | PAGE |
|---|---|---|
| 1 | P2 Head x [g, CFC_1000] | B-3 |
| 2 | P2 Head y [g, CFC_1000] | B-3 |
| 3 | P2 Head z [g, CFC_1000] | B-3 |
| 4 | P2 Head Resultant [g, CFC_1000] | B-3 |

| | | MAXIMUM VALUE | | | |
|---|---|---|---|---|---|
| Head X | g | 26.6 | 19.0 | -4.6 | 43.3 |
| Head Y | g | 6.1 | 21.9 | -20.8 | 13.8 |
| Head Z | g | 10.8 | 21.4 | -7.7 | 17.8 |
| Head Resultant | g | 29.4 | 13.8 | 0.0 | -19.2 |

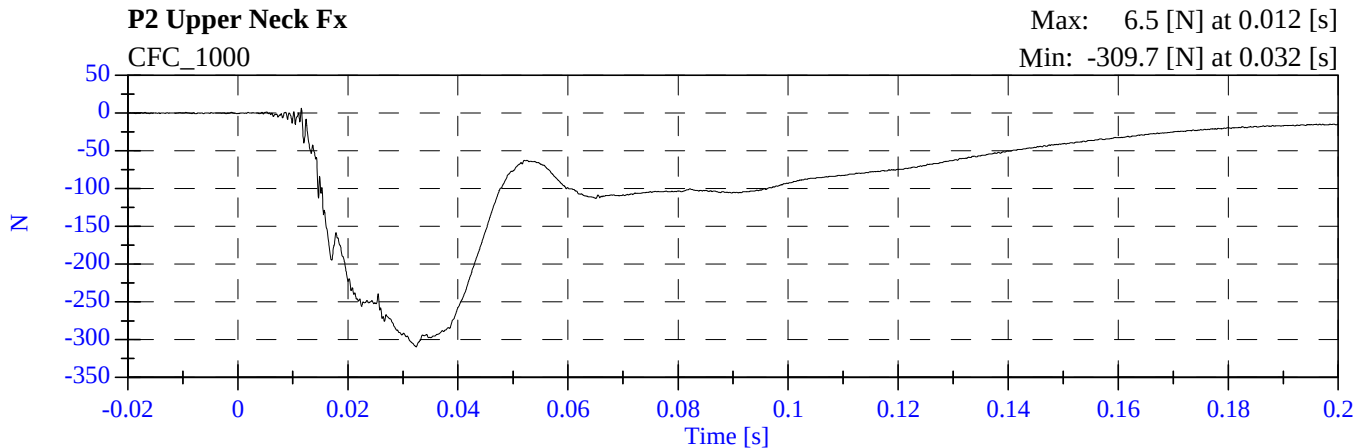
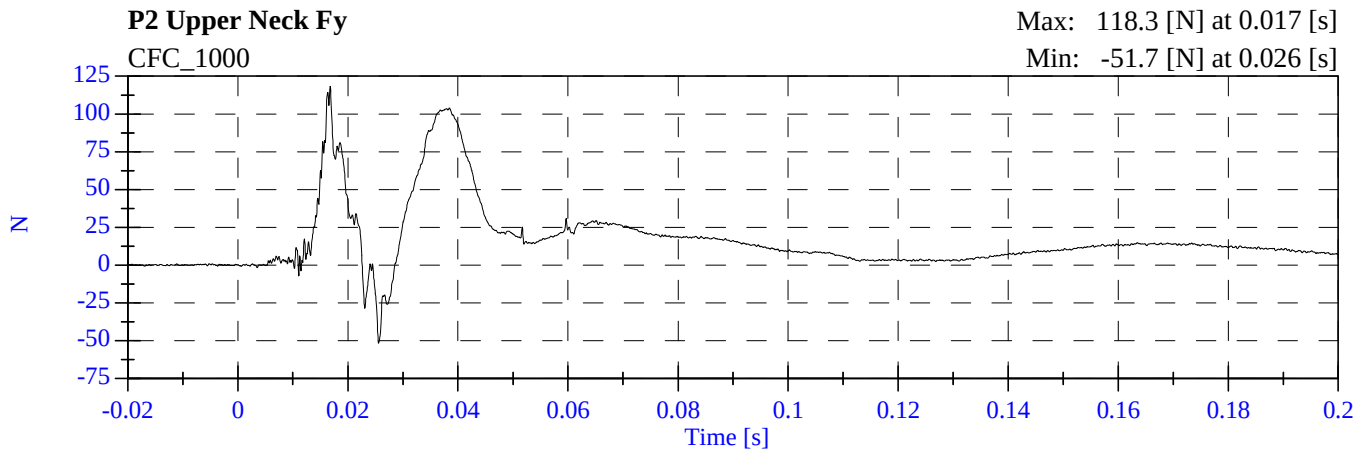
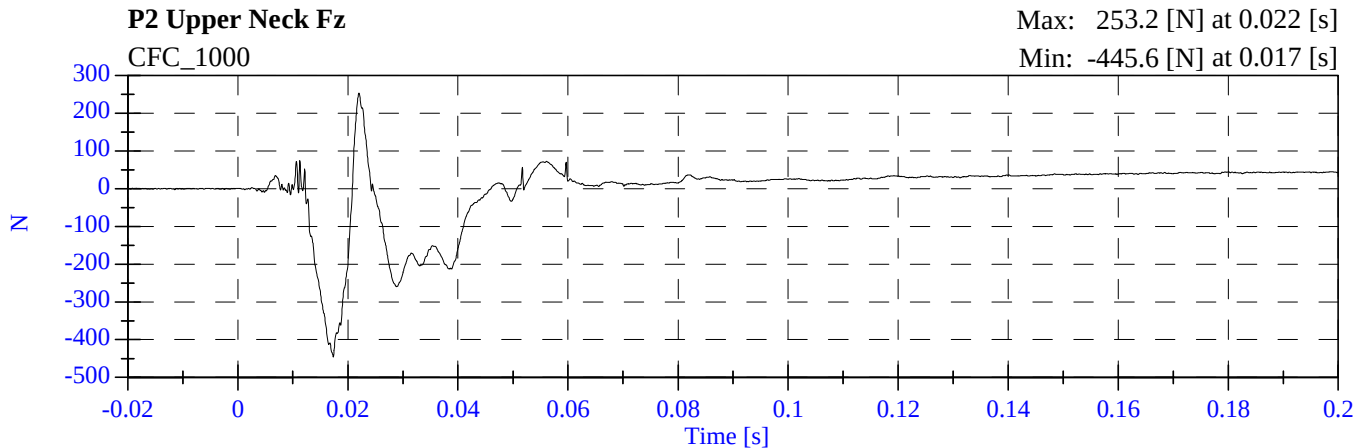
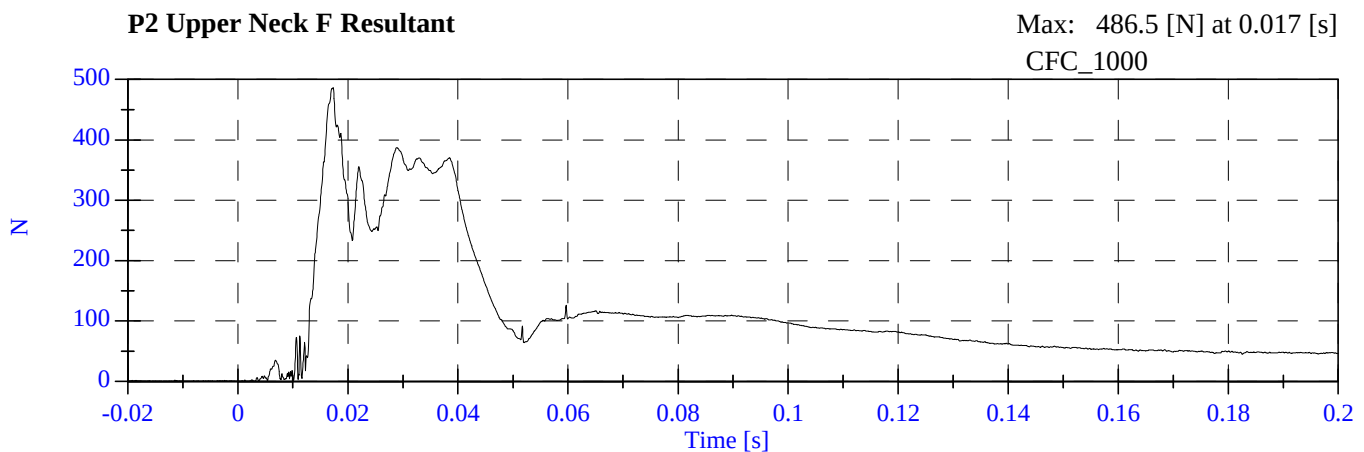
# 2007 TWG Test 3 2007 Honda Element M75306TWG2 - May 15, 2007

| PLOT | PLOT NAME[UNITS, CHANNEL FILTER CLASS] | PAGE |
|---|---|---|
| 5 | P2 Upper Neck Fx [N, CFC_1000] | B-4 |
| 6 | P2 Upper Neck Fy [N, CFC_1000] | B-4 |
| 7 | P2 Upper Neck Fz [N, CFC_1000] | B-4 |
| 8 | P2 Upper Neck F Resultant [N, CFC_1000] | B-4 |

| | | MAXIMUM VALUE | | | |
|---|---|---|---|---|---|
| Upper Neck Fx | N | 6.5 | 11.5 | -309.7 | 32.4 |
| Upper Neck Fy | N | 118.3 | 16.8 | -51.7 | 25.6 |
| Upper Neck Fz | N | 253.2 | 22.0 | -445.6 | 17.4 |
| Upper Neck F Resultant | N | 486.5 | 17.3 | 0.1 | -11.8 |

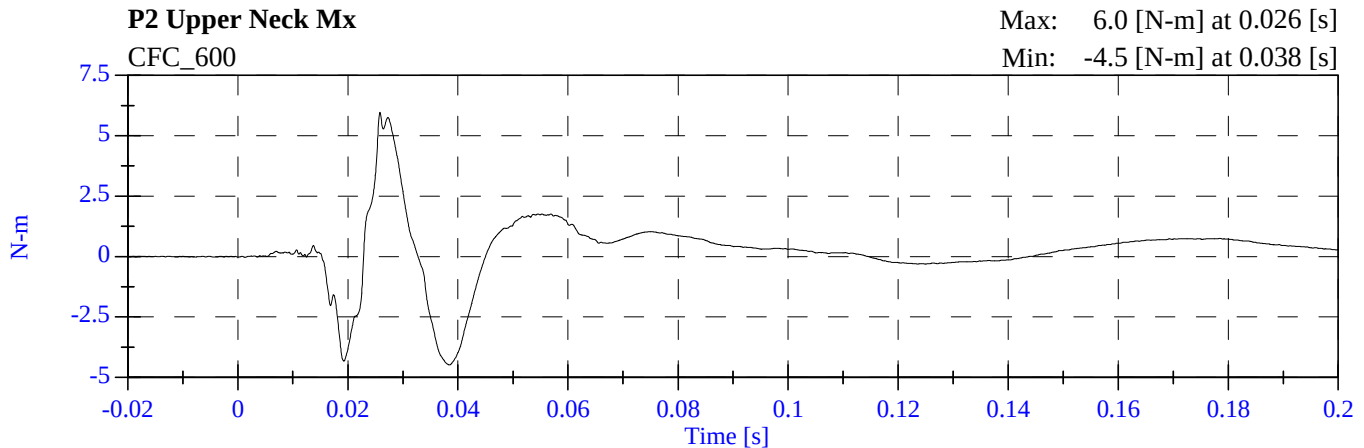
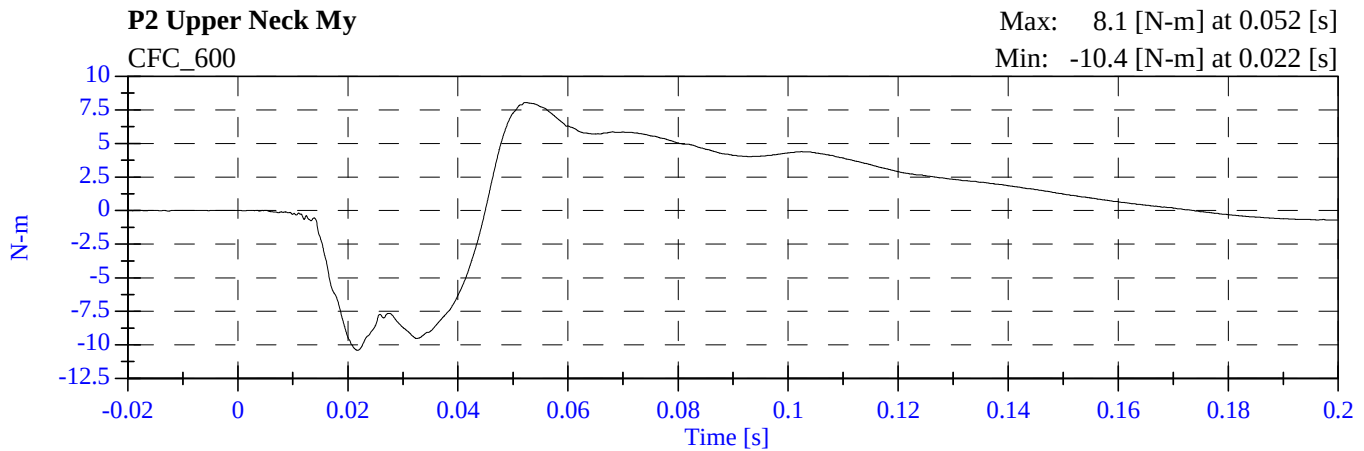
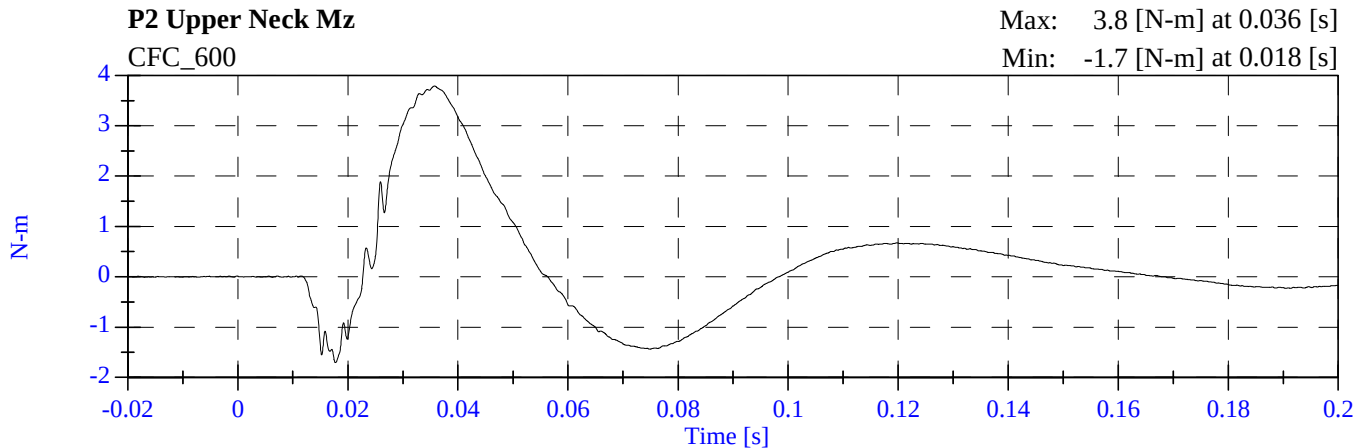
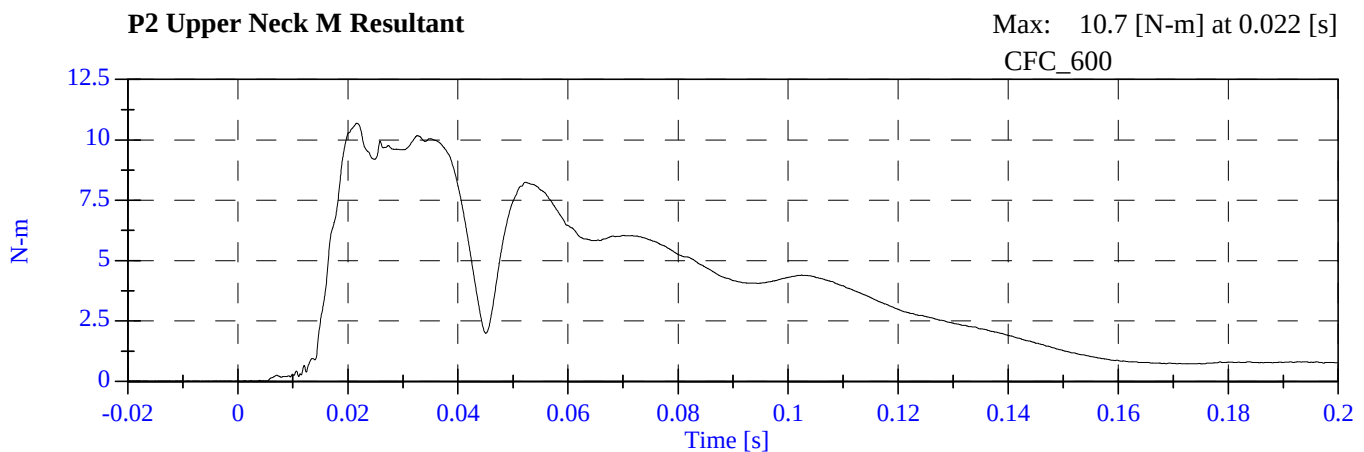
# 2007 TWG Test 3 2007 Honda Element M75306TWG2 - May 15, 2007

| PLOT | PLOT NAME[UNITS, CHANNEL FILTER CLASS] | PAGE |
|---|---|---|
| 9 | P2 Upper Neck Mx [N-m, CFC_600] | B-5 |
| 10 | P2 Upper Neck My [N-m, CFC_600] | B-5 |
| 11 | P2 Upper Neck Mz [N-m, CFC_600] | B-5 |
| 12 | P2 Upper Neck M Resultant [N-m, CFC_600] | B-5 |

| | | MAXIMUM VALUE | | | |
|---|---|---|---|---|---|
| Upper Neck Mx | N-m | 6.0 | 25.8 | -4.5 | 38.4 |
| Upper Neck My | N-m | 8.1 | 52.2 | -10.4 | 21.6 |
| Upper Neck Mz | N-m | 3.8 | 35.8 | -1.7 | 17.8 |
| Upper Neck M Resultant | N-m | 10.7 | 21.6 | 0.0 | 1.7 |

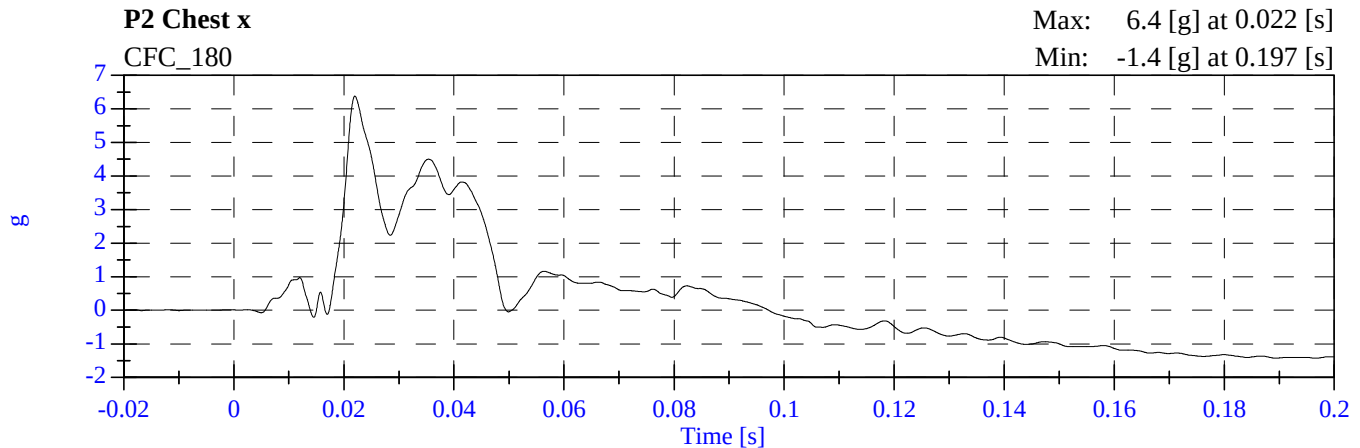
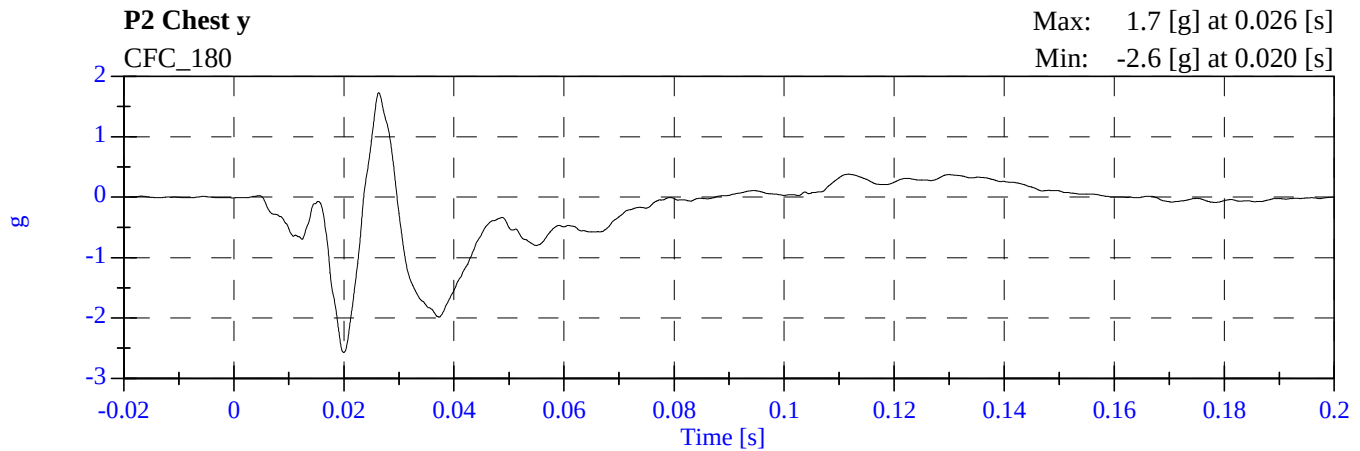
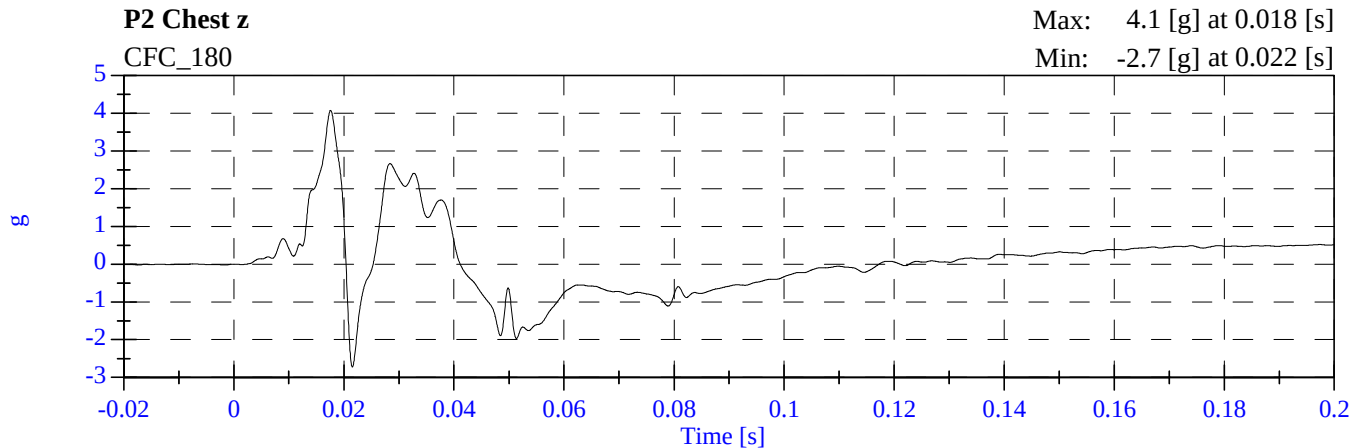
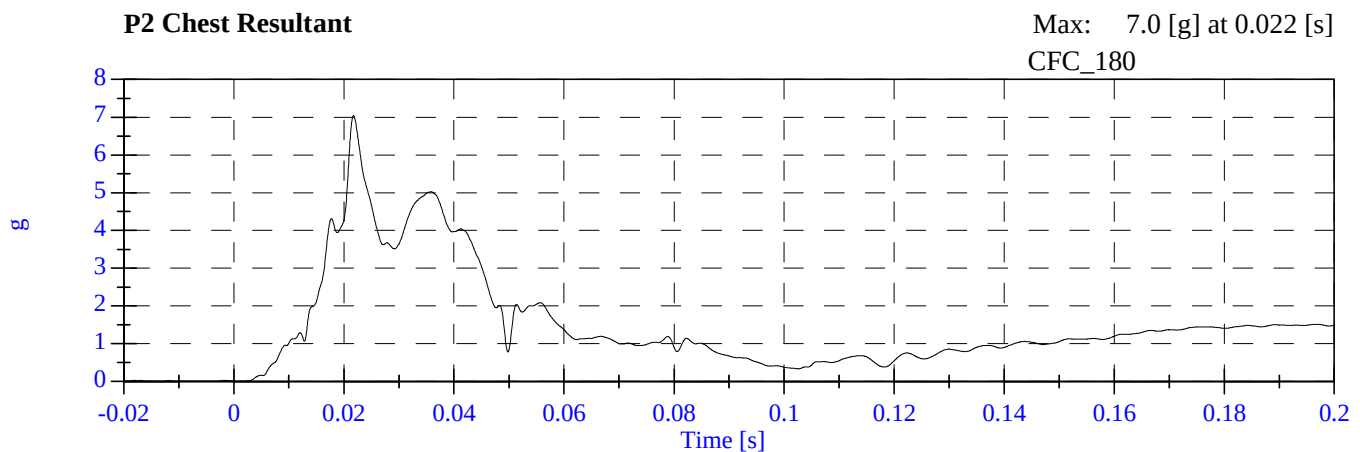
# 2007 TWG Test 3 2007 Honda Element M75306TWG2 - May 15, 2007

| PLOT | PLOT NAME[UNITS, CHANNEL FILTER CLASS] | PAGE |
|---|---|---|
| 13 | P2 Chest x [g, CFC_180] | B-6 |
| 14 | P2 Chest y [g, CFC_180] | B-6 |
| 15 | P2 Chest z [g, CFC_180] | B-6 |
| 16 | P2 Chest Resultant [g, CFC_180] | B-6 |

| | | MAXIMUM VALUE | | | |
|---|---|---|---|---|---|
| Chest X | g | 6.4 | 22.0 | -1.4 | 196.7 |
| Chest Y | g | 1.7 | 26.3 | -2.6 | 19.9 |
| Chest Z | g | 4.1 | 17.6 | -2.7 | 21.6 |
| Chest Resultant | g | 7.0 | 21.8 | 0.0 | -10.6 |

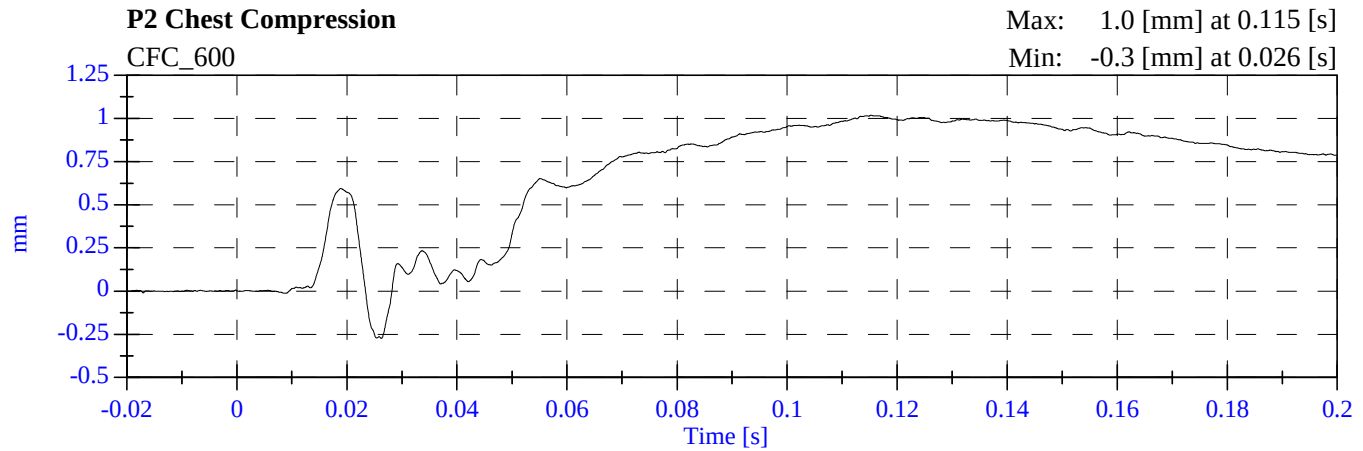
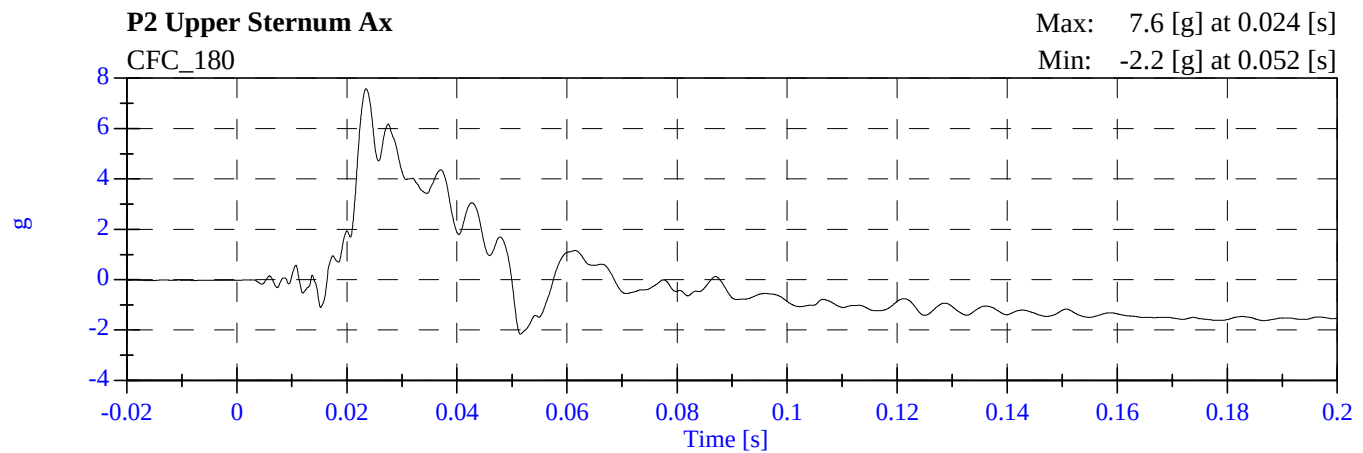
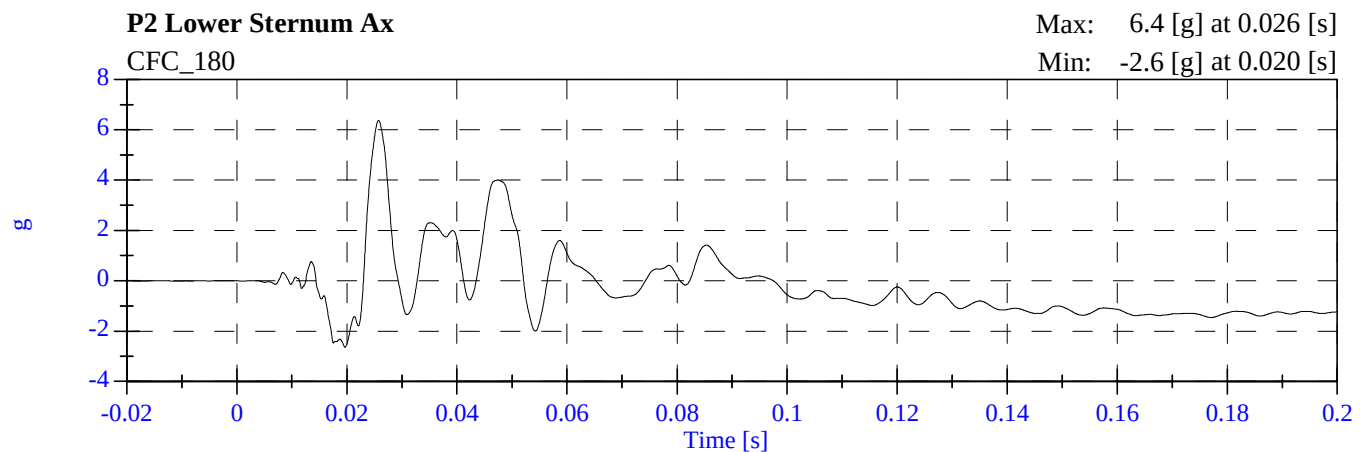
**2007 TWG Test 3 2007 Honda Element**  
**M75306TWG2 - May 15, 2007**

| PLOT | PLOT NAME[UNITS, CHANNEL FILTER CLASS] | PAGE |
|---|---|---|
| 17 | P2 Chest Compression [mm, CFC_600] | B-7 |
| 18 | P2 Upper Sternum Ax [g, CFC_180] | B-7 |
| 19 | P2 Lower Sternum Ax [g, CFC_180] | B-7 |

| | | MAXIMUM VALUE | | | |
|---|---|---|---|---|---|
| Chest Displacement | mm | 1.0 | 115.3 | -0.3 | 26.3 |
| Upper Sternum Ax | g | 7.6 | 23.5 | -2.2 | 51.5 |
| Lower Sternum Ax | g | 6.4 | 25.8 | -2.6 | 19.7 |

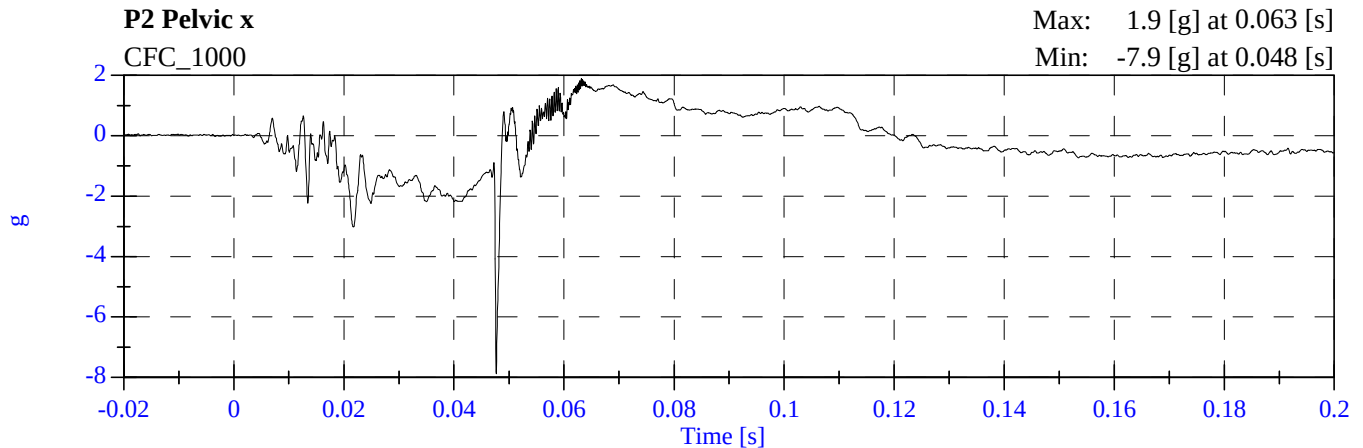
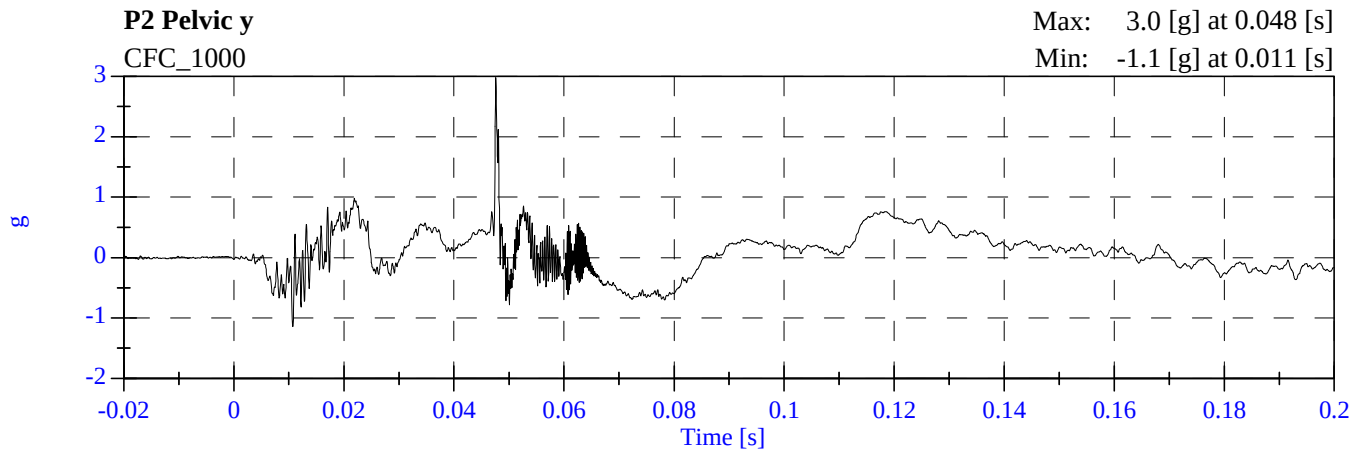
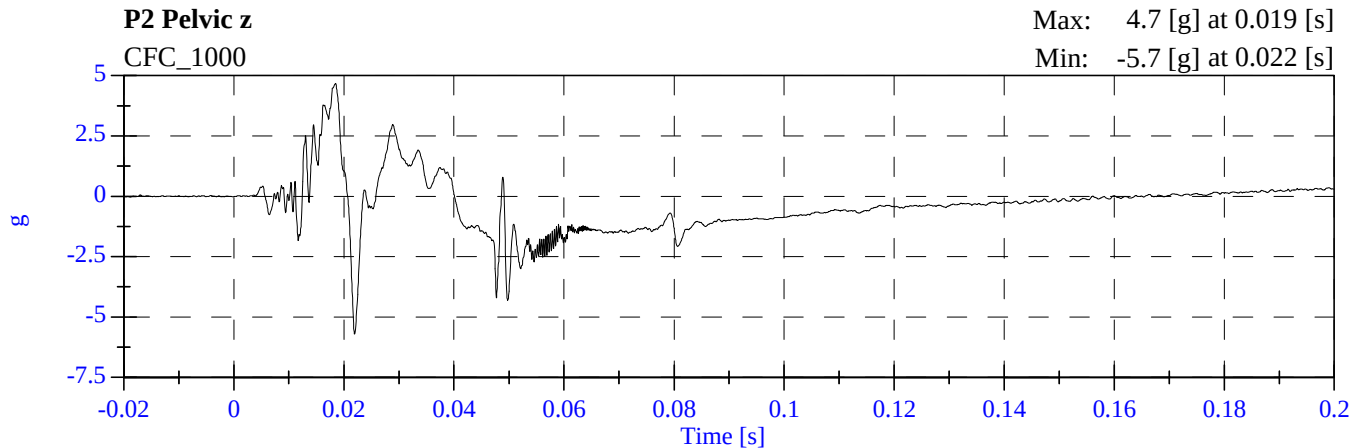
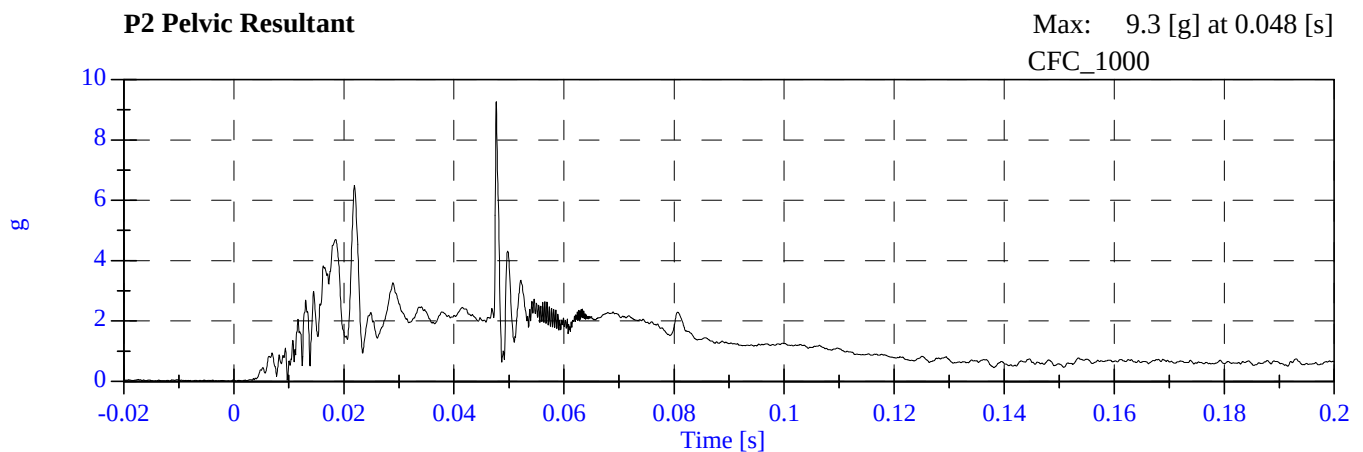
# 2007 TWG Test 3 2007 Honda Element M75306TWG2 - May 15, 2007

| PLOT | PLOT NAME[UNITS, CHANNEL FILTER CLASS] | PAGE |
|---|---|---|
| 20 | P2 Pelvic x [g, CFC_1000] | B-8 |
| 21 | P2 Pelvic y [g, CFC_1000] | B-8 |
| 22 | P2 Pelvic z [g, CFC_1000] | B-8 |
| 23 | P2 Pelvic Resultant [g, CFC_1000] | B-8 |

| | | MAXIMUM VALUE | | | |
|---|---|---|---|---|---|
| Pelvic X | g | 1.9 | 63.1 | -7.9 | 47.7 |
| Pelvic Y | g | 3.0 | 47.6 | -1.1 | 10.7 |
| Pelvic Z | g | 4.7 | 18.5 | -5.7 | 21.9 |
| Pelvic Resultant | g | 9.3 | 47.7 | 0.0 | -7.6 |

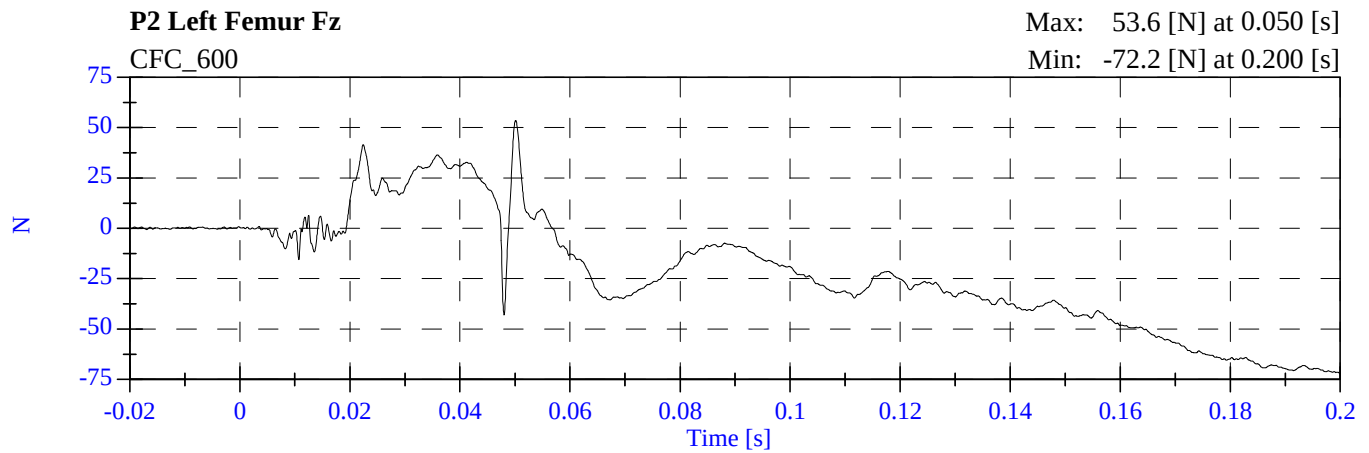
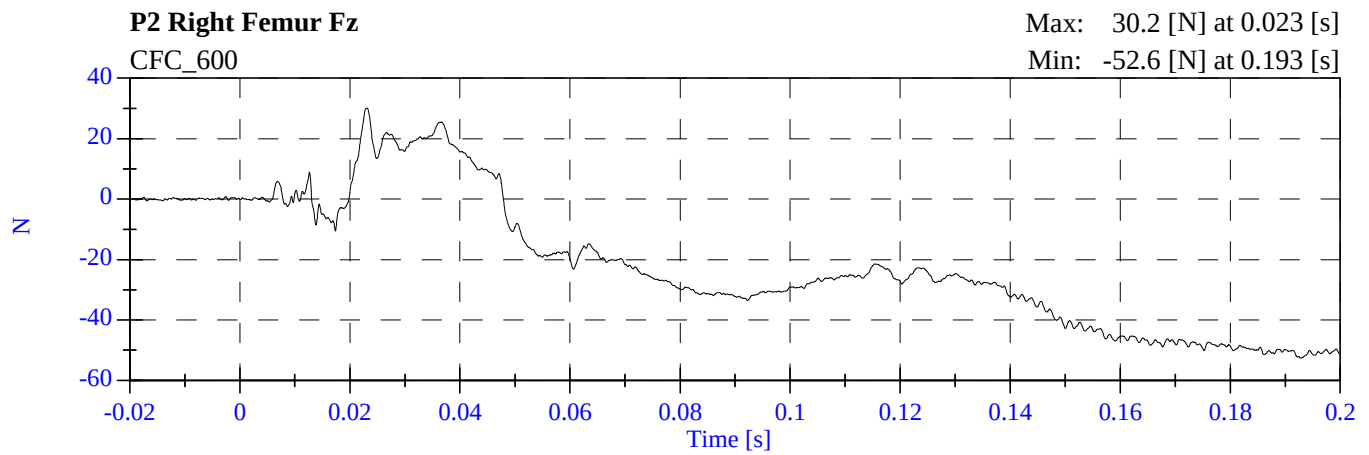
## M75306TWG2 - May 15, 2007

| PLOT | PLOT NAME[UNITS, CHANNEL FILTER CLASS] | PAGE |
|---|---|---|
| 24 | P2 Left Femur Fz [N, CFC_600] | B-9 |
| 25 | P2 Right Femur Fz [N, CFC_600] | B-9 |

| | | MAXIMUM VALUE | | | |
|---|---|---|---|---|---|
| Left Femur | N | 53.6 | 50.1 | -72.2 | 199.9 |
| Right Femur | N | 30.2 | 23.2 | -52.6 | 192.8 |
