REPORT NUMBER: TWG-CAL07-01

**NEW CAR ASSESSMENT PROGRAM (NCAP)**  
SIDE AIRBAG OUT-OF-POSITION INJURY TESTING

2007 HONDA CR-V  
FOUR DOOR MULTIPURPOSE VEHICLE

NHTSA NUMBER: M75305TWG2

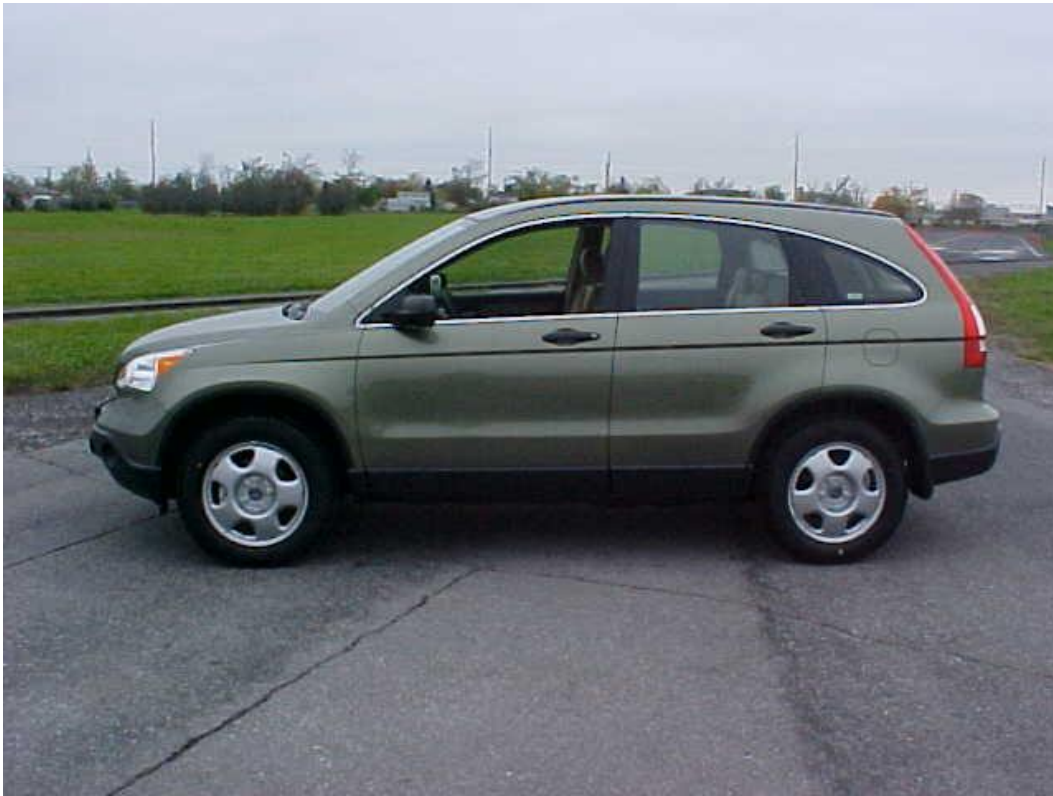
Figure A-1: Pre-Test Vehicle Left Side View

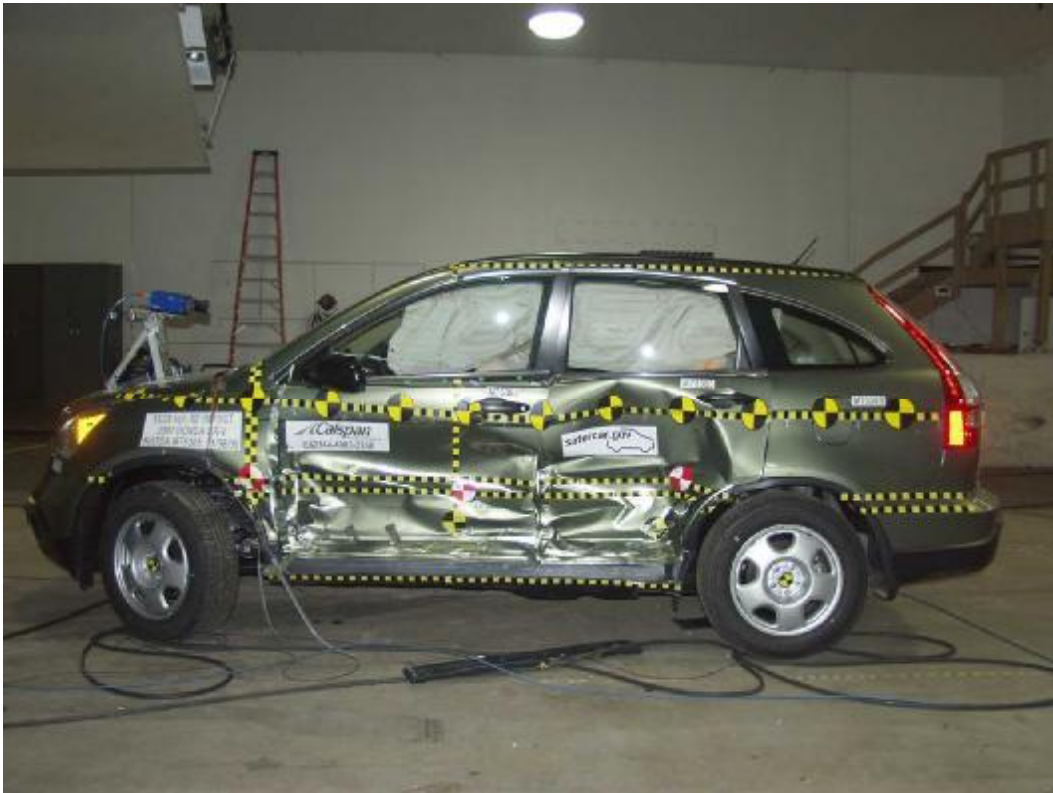
Figure A-2: Post-Test Vehicle Left Side View

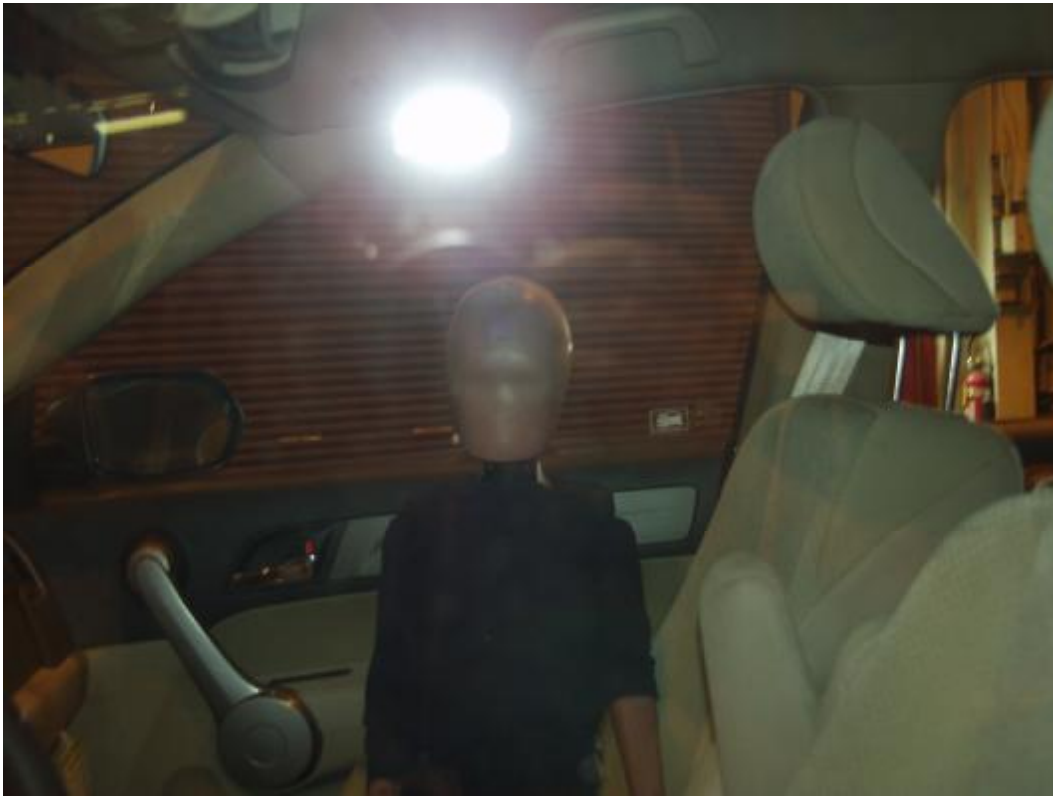
Figure A-5: Pre-Test Dummy Frontal View

The six-year old child dummy was placed with its arms hanging at its sides on the foam block facing inboard with its legs extended. The seat track was adjusted to 140 mm rearward of full forward to minimize the vertical distance between the dummy's head and the roof-rail module and to maximize the cushion to head interaction. While keeping the head in neutral orientation, the dummy's pelvis was moved outboard until the dummy's back contacted the door trim panel armrest and the center of gravity of the head was centered in the deployment trajectory of the airbag. The dummy was then moved to maintain the vertical plane through the centerline of the dummy's shoulder bolts parallel to the vehicle centerline. The dummy's arms were then bent at the elbow until the fingers contacted the booster seat. This orientation complies with section 3.3.5.1 of the TWG Recommended Procedures for Evaluating Occupant Injury Risk from Deploying Side Airbags as defined by Lund, et al and the Technical Working Group First Revision dated July, 2003.

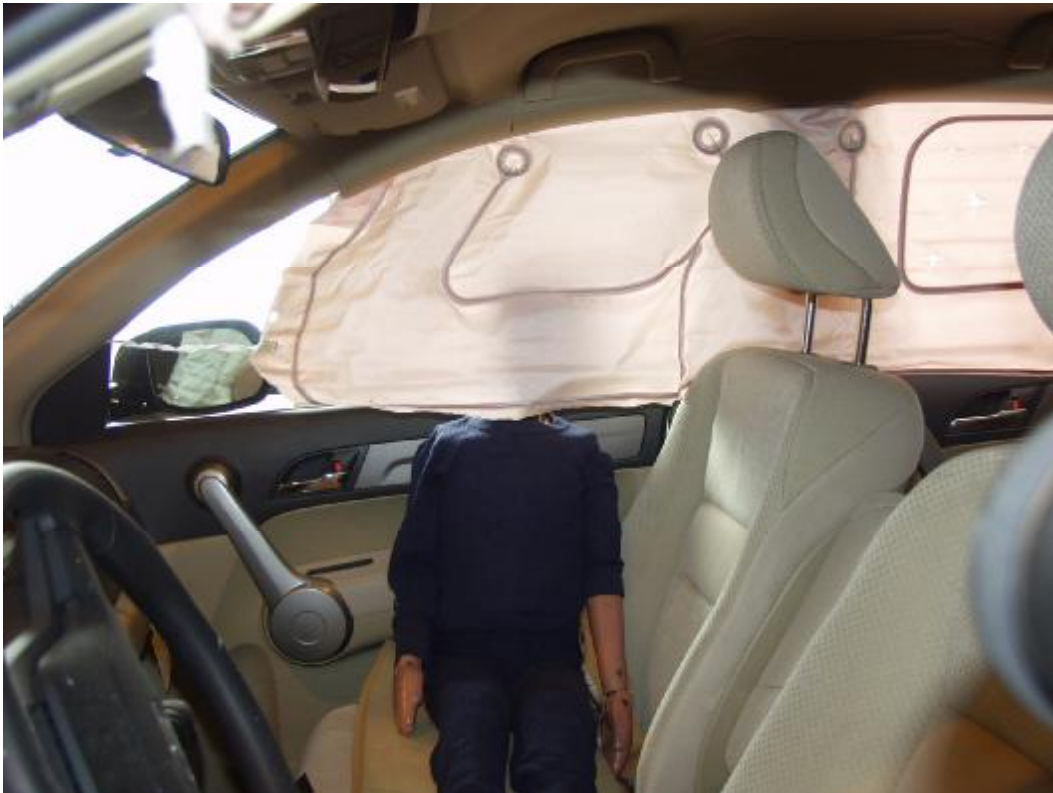
Figure A-6: Post-Test Dummy Frontal View

The Hybrid III six-year-old child dummy's visible contact points were as follows: The side curtain airbag to the top and the back of the head.

| <b>Head Contact:</b> | The back (occipital) and top (parietal) of the head and face by the side curtain. |

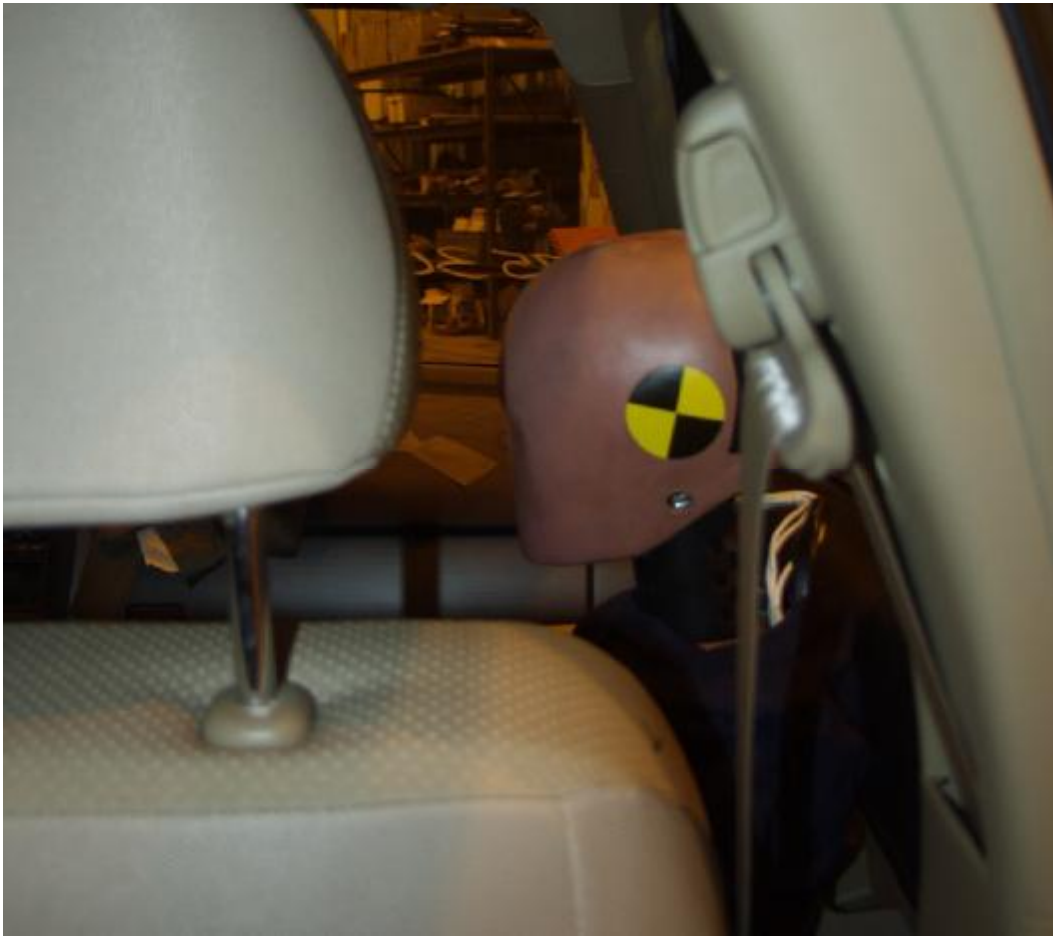
Figure A-7: Pre-Test Left Side of Dummy View

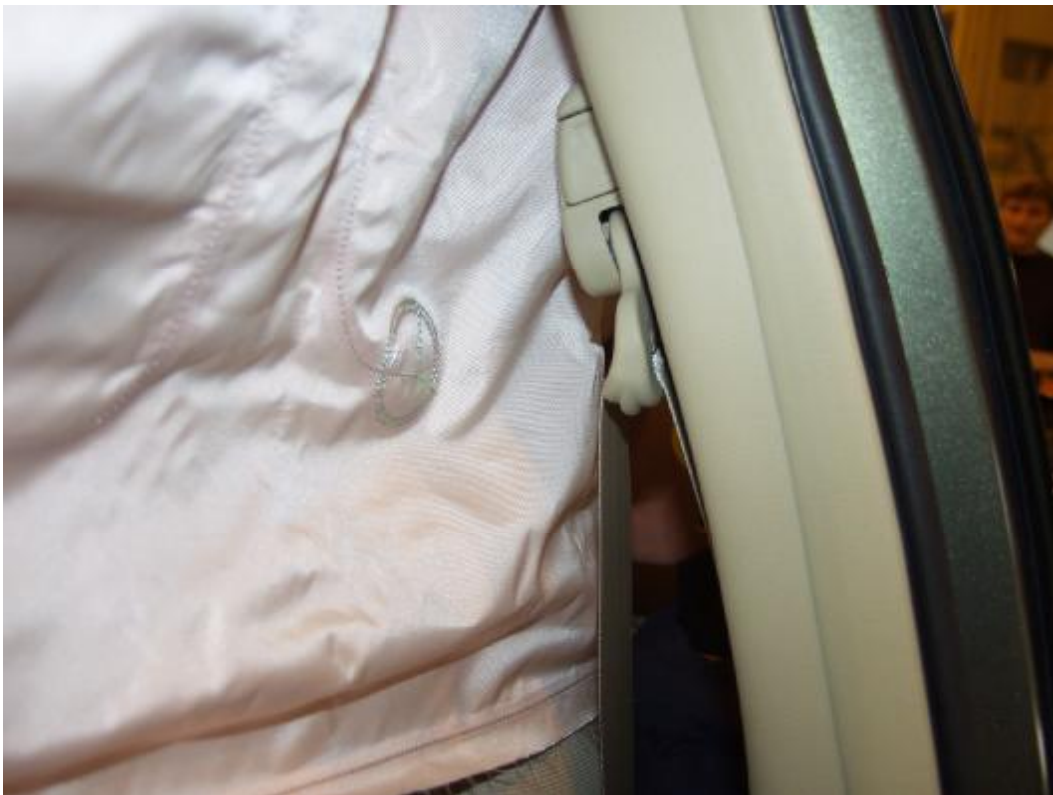
Figure A-8: Post-Test Left Side of Dummy View

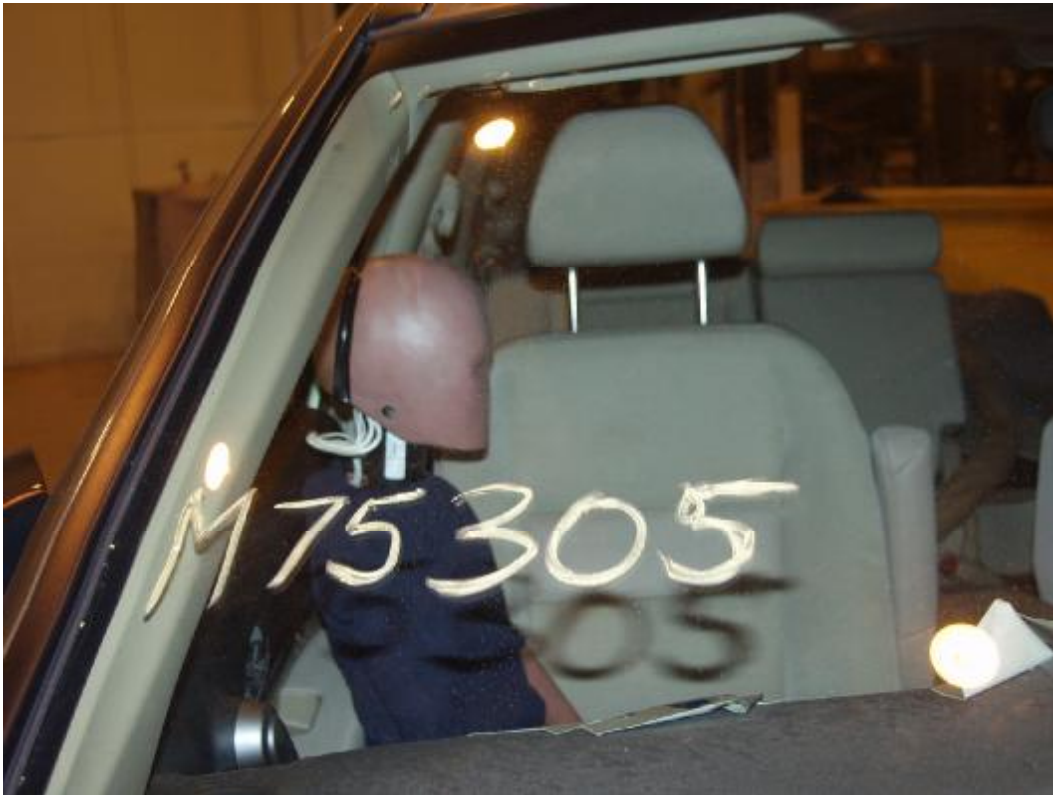
Figure A-9: Pre-Test Right Side of Dummy View

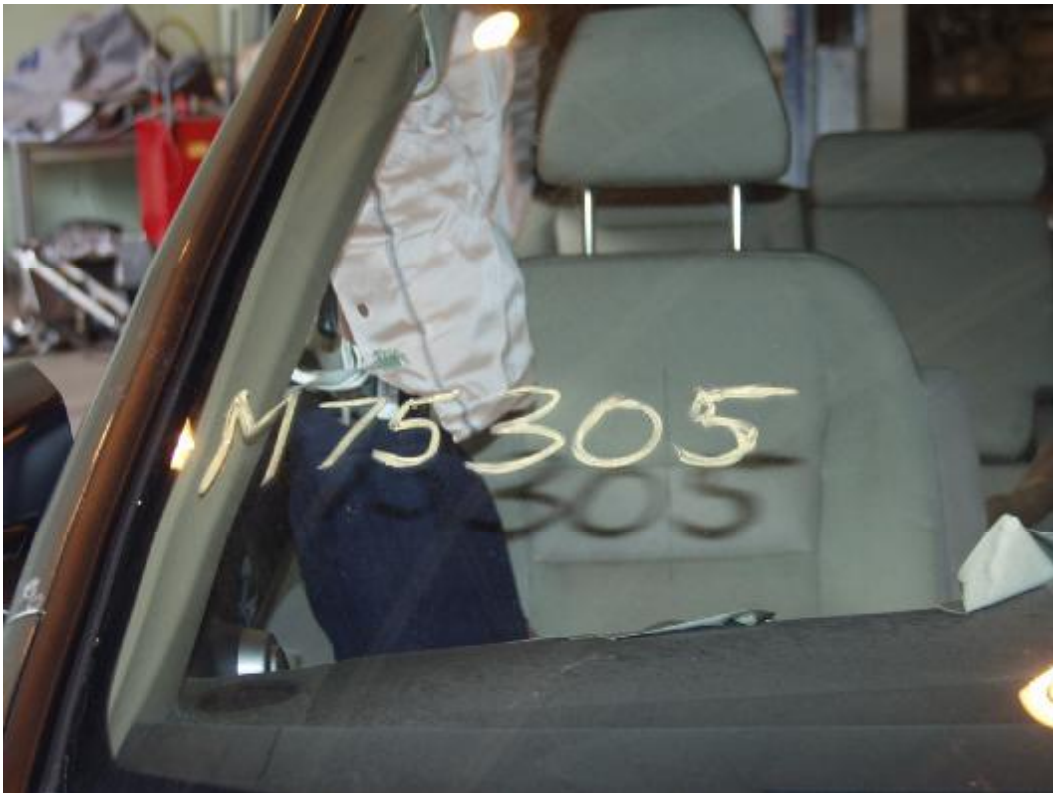
Figure A-10: Post-Test Right Side of Dummy View
