**REPORT NUMBER: TWG-MGA-2007-004**

**NEW CAR ASSESSMENT PROGRAM  
SIDE AIRBAG OUT-OF-POSITION INJURY TESTING**

**NISSAN MOTOR CO., LTD.  
2007 NISSAN SENTRA 4-DOOR  
NHTSA NUMBER: M75204TWG2**

**PREPARED BY:  
MGA RESEARCH CORPORATION  
5000 WARREN ROAD  
BURLINGTON, WI 53105**

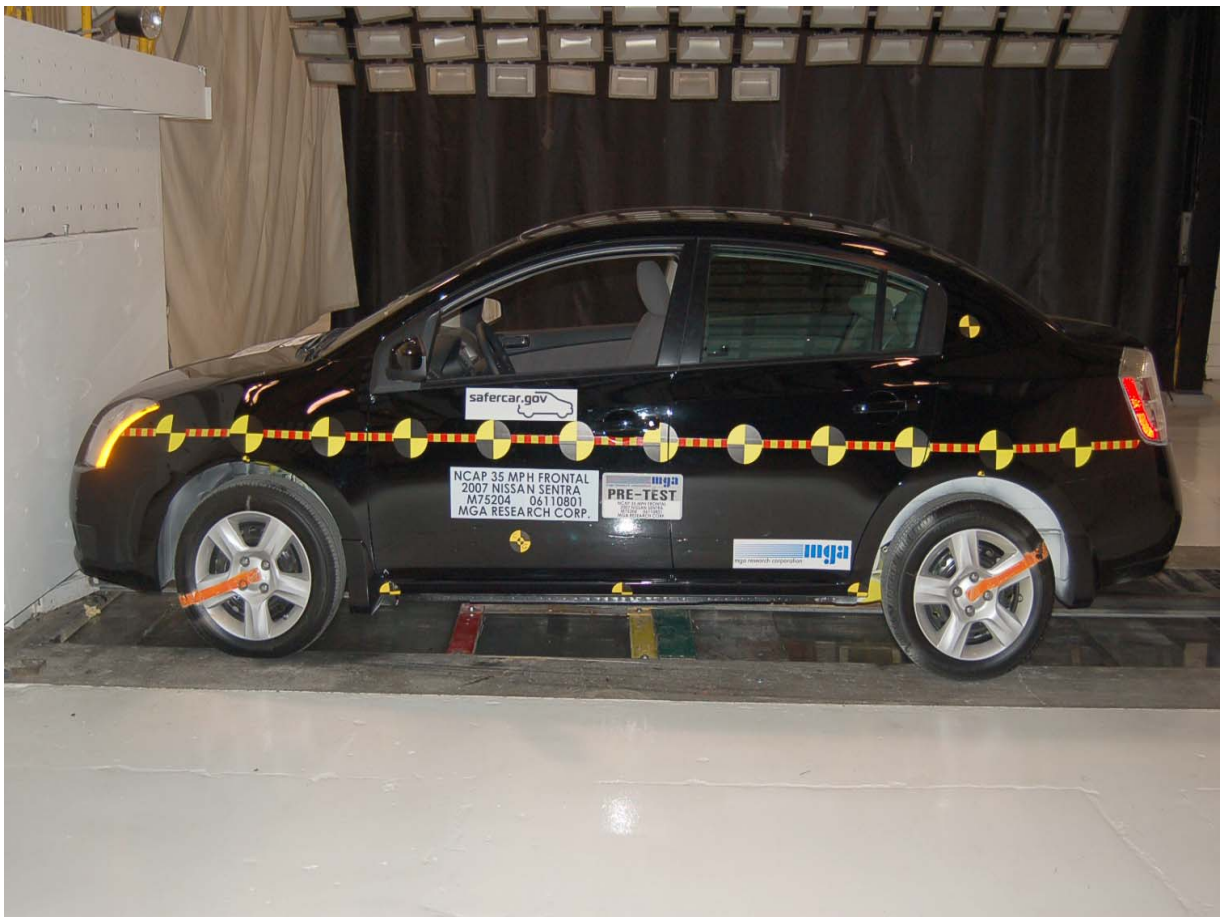
Pre-Test Vehicle Left Side View

| | | <u>Page No.</u> |
|---|---|---|
| Photo No. 1. | Pre-Test Vehicle Left Side View | A-2 |

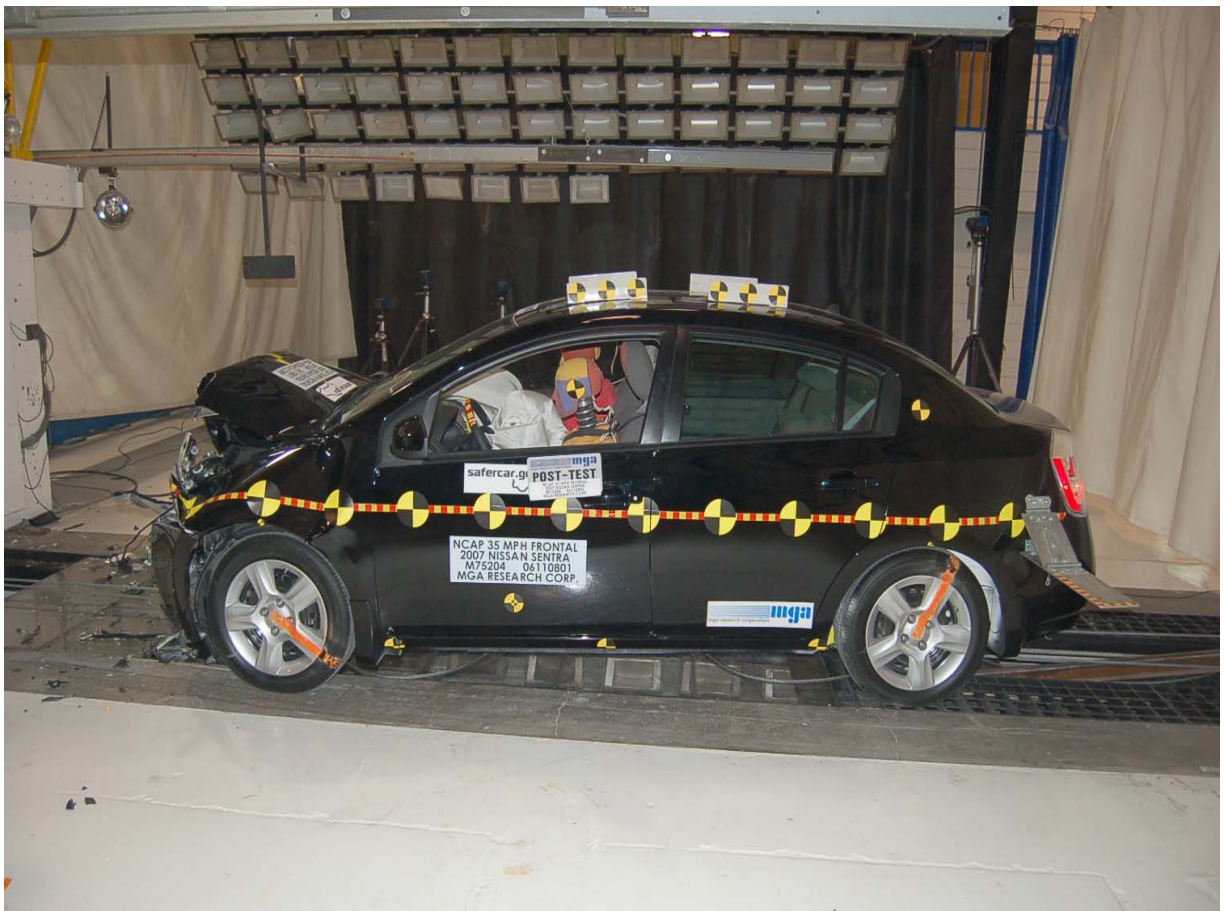
Post-Test Vehicle Left Side View

| | | <u>Page No.</u> |
|---|---|---|
| Photo No. 2. | Post-Test Vehicle Left Side View | A-2 |

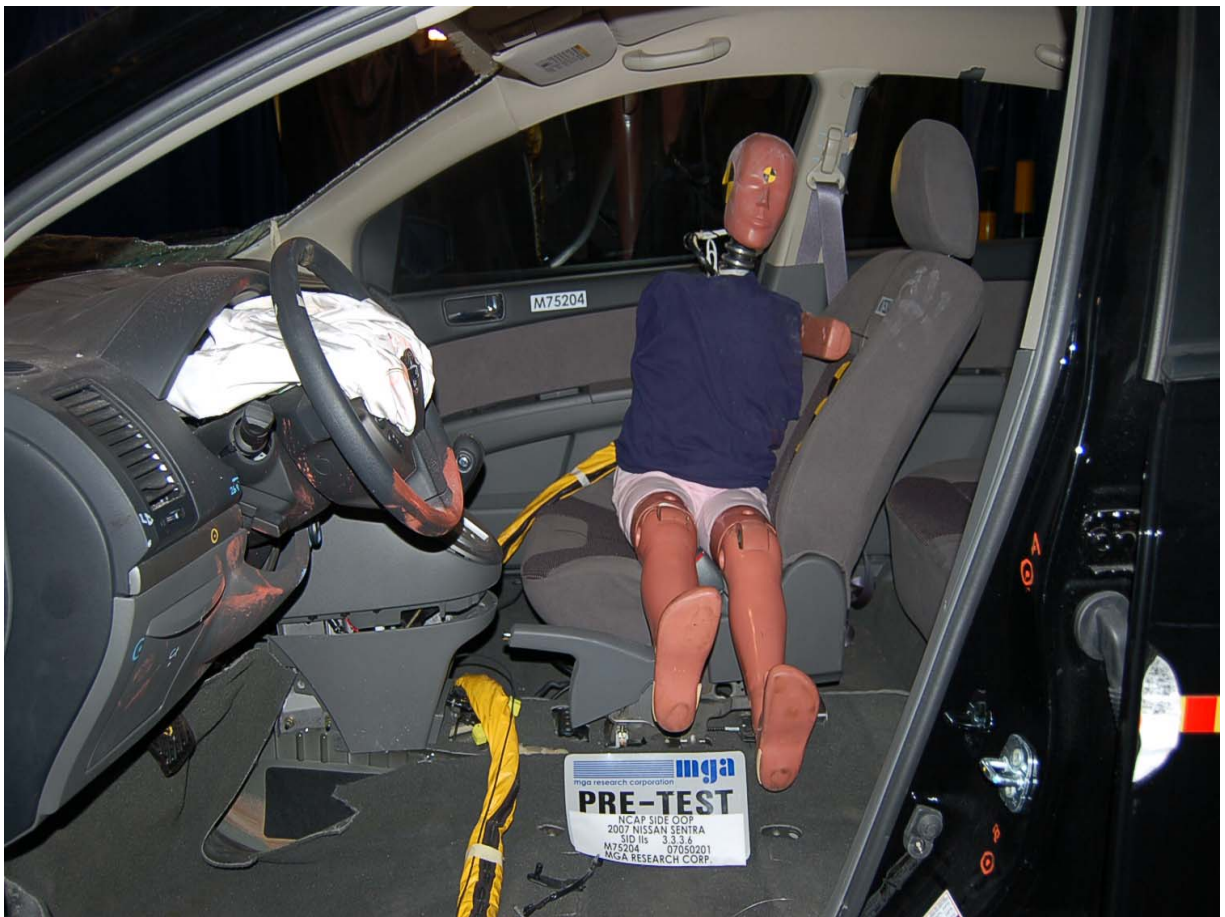
Pre-Test SID-IIs Dummy Frontal View

| | | <u>Page No.</u> |
|---|---|---|
| Photo No. 5. | Pre-Test SID-IIs Dummy Frontal View | A-4 |

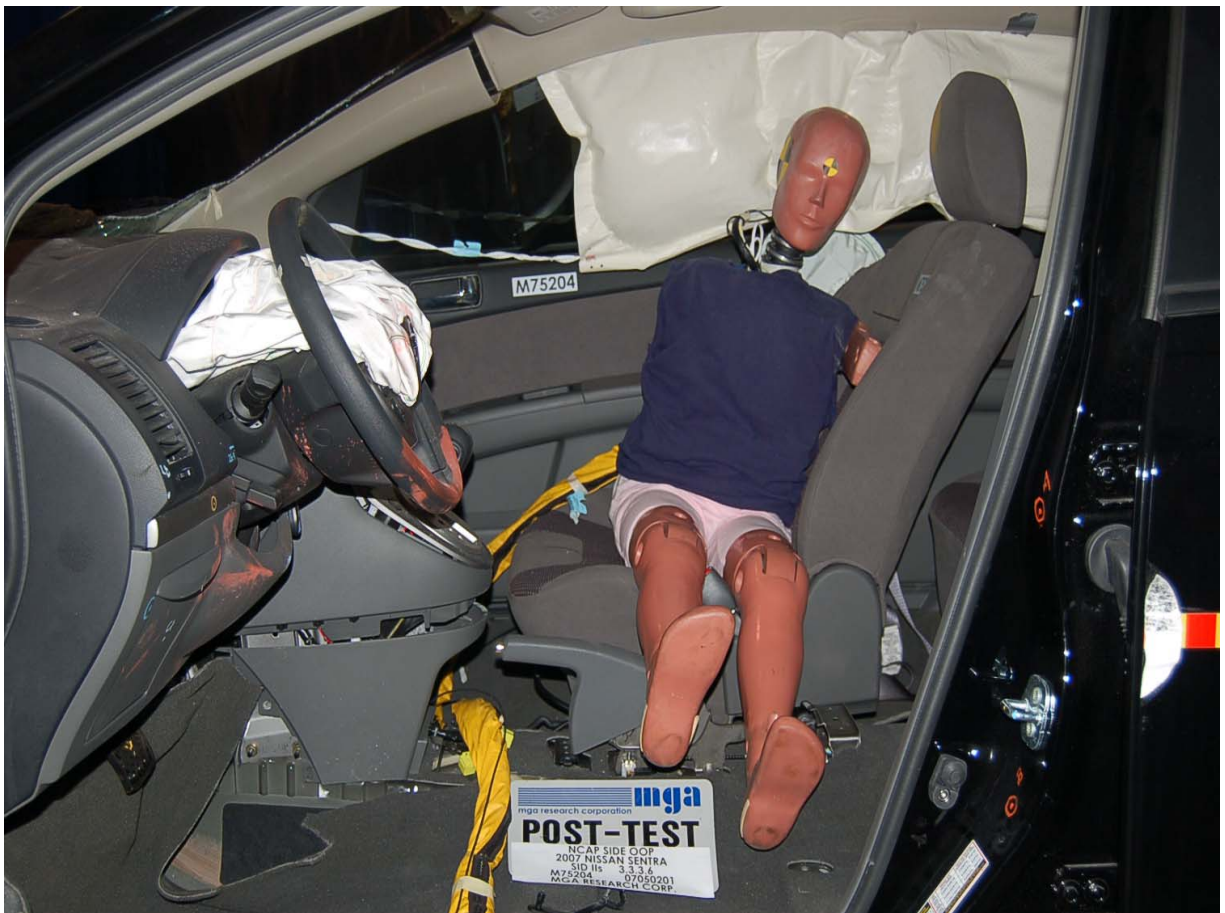
Post-Test SID-IIs Dummy Frontal View

The SID-IIs dummy's visible contact points were as follows: The curtain airbag to the top and back of the head. The torso bag to the left shoulder and torso of the dummy.

| | | <u>Page No.</u> |
|---|---|---|
| Photo No. 6. | Post-Test SID-IIs Dummy Frontal View | A-4 |

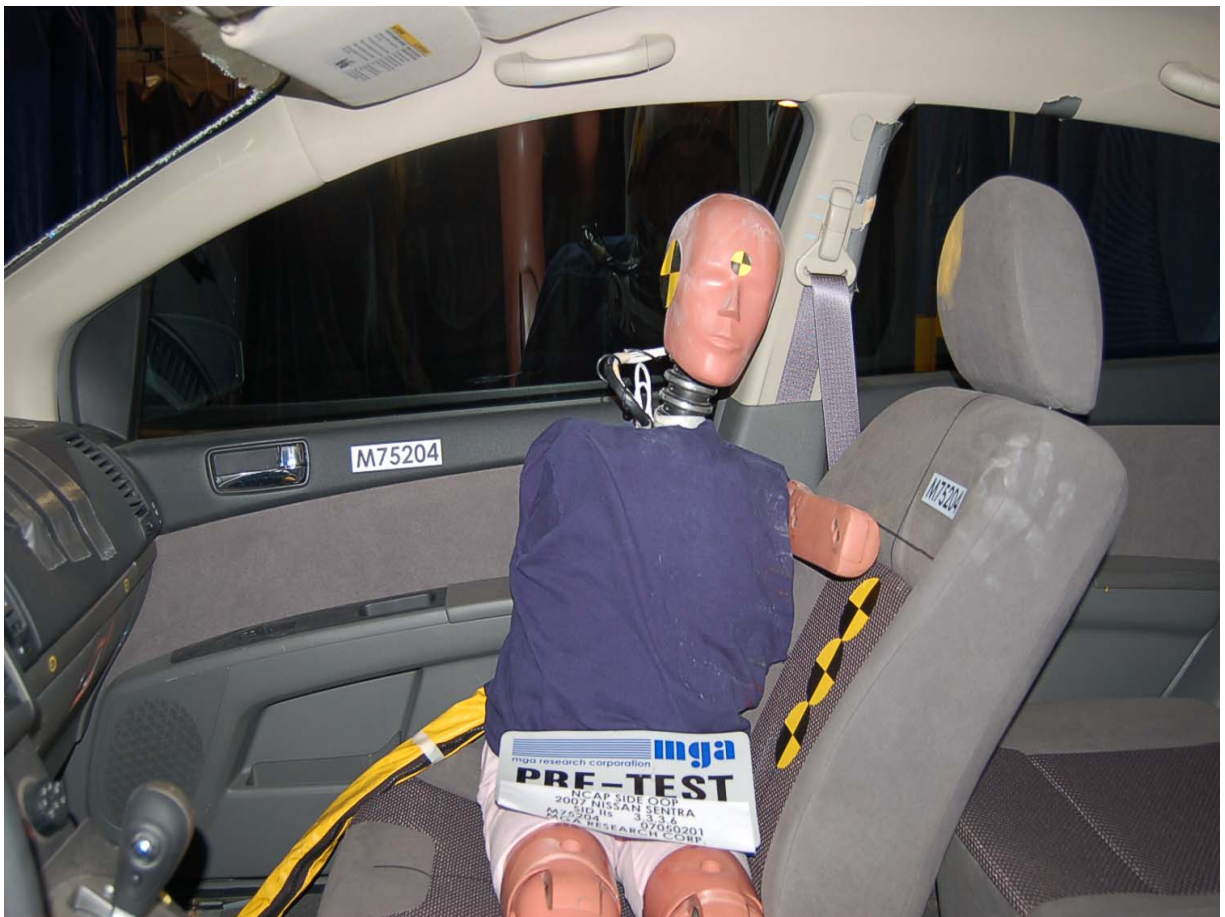
Pre-Test SID-IIs Dummy Frontal Closeup View

| | | <u>Page No.</u> |
|---|---|---|
| Photo No. 7. | Pre-Test SID-IIs Dummy Frontal Closeup View | A-5 |

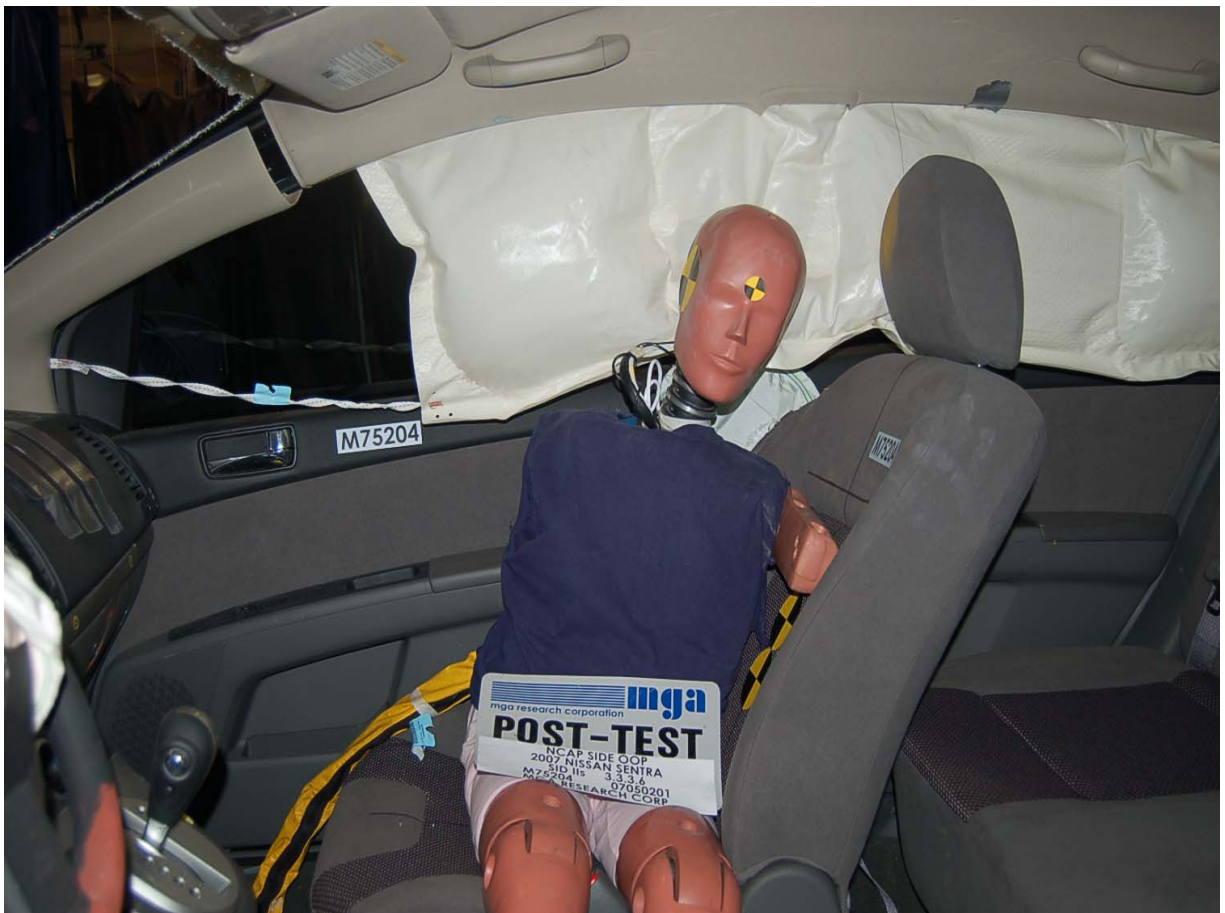
Post-Test SID-IIs Dummy Frontal Closeup View

| | | <u>Page No.</u> |
|---|---|---|
| Photo No. 8. | Post-Test SID-IIs Dummy Frontal Closeup View | A-5 |

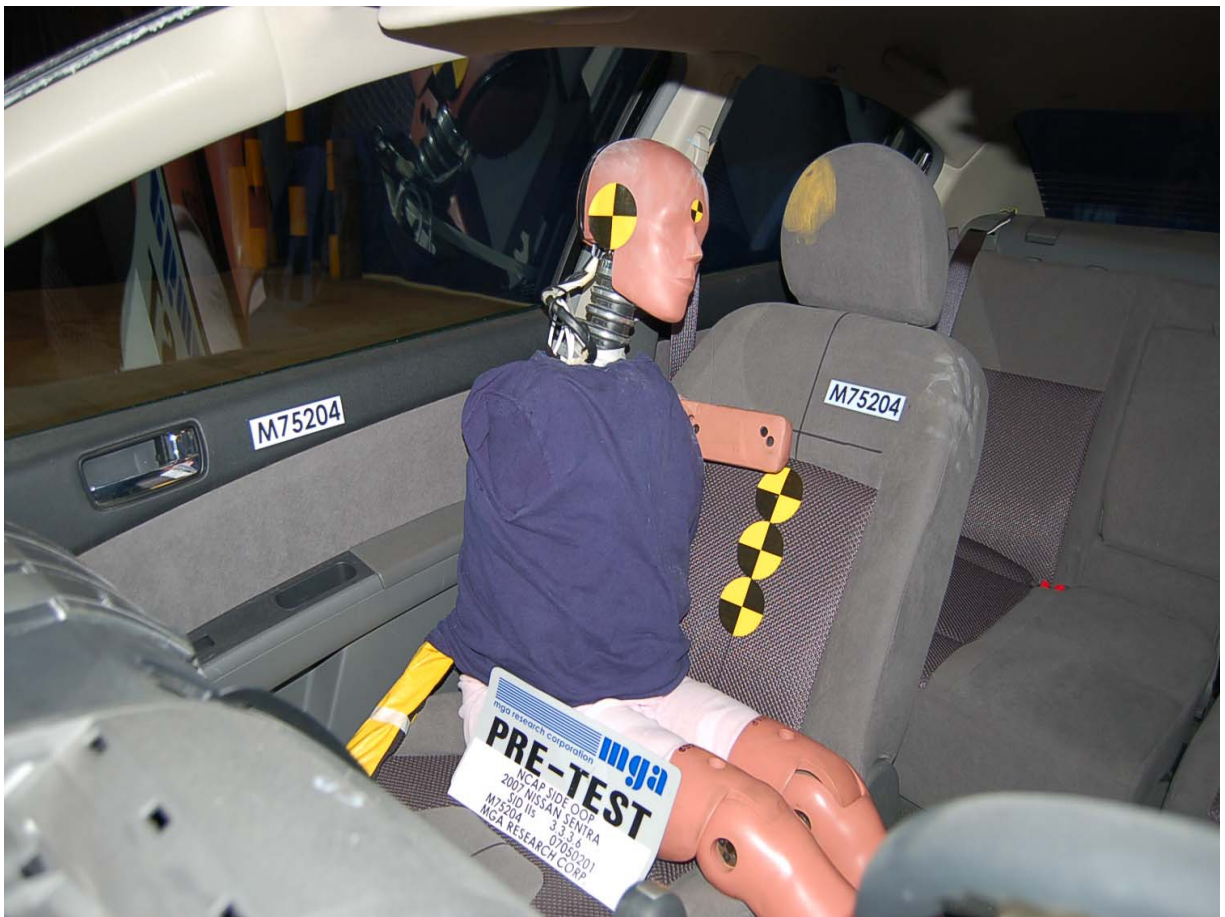
Pre-Test SID-11s Dummy Right 3/4 Front View

| | | <u>Page No.</u> |
|---|---|---|
| Photo No. 9. | Pre-Test SID-IIs Dummy Right $\frac{3}{4}$ Front View | A-6 |

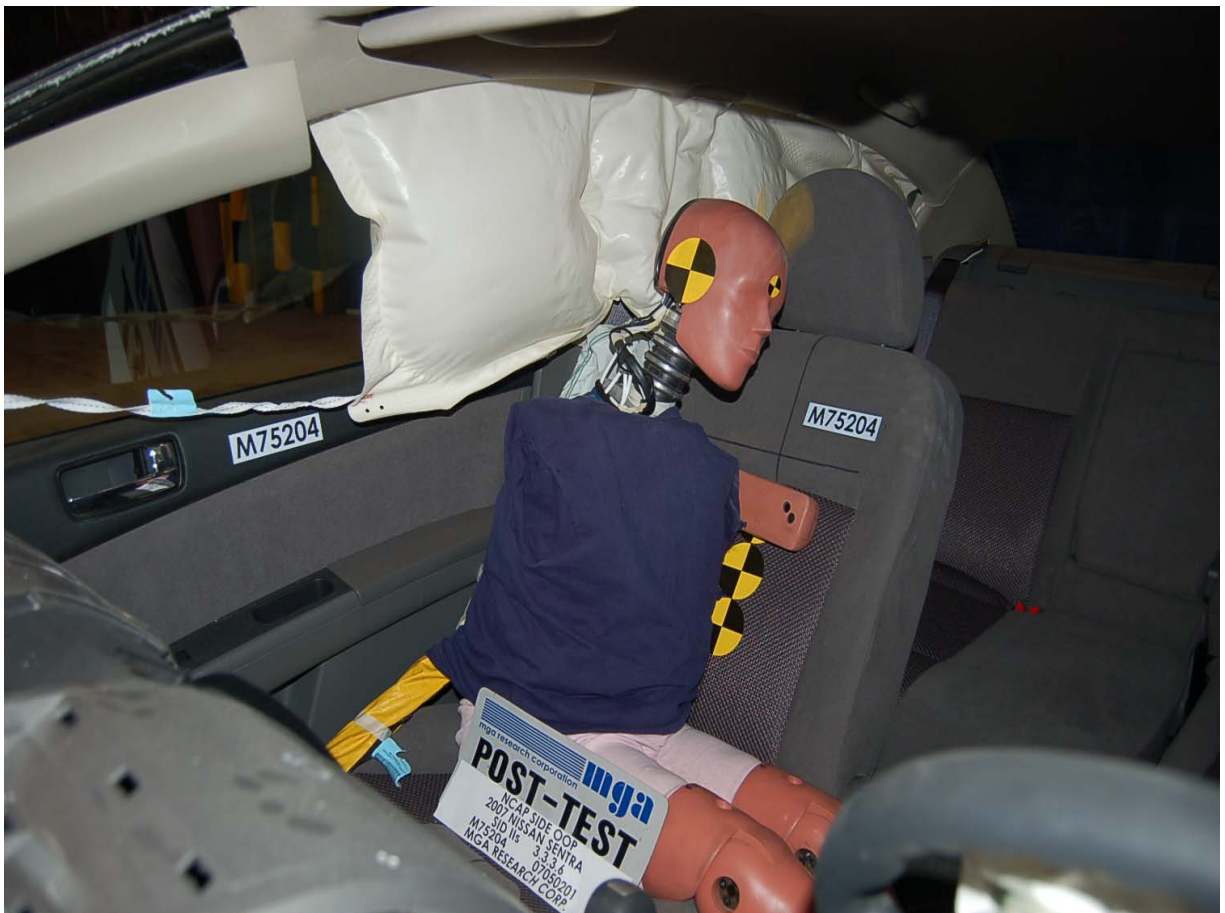
Post-Test SID-11s Dummy Right 3/4 Front View

| | | <u>Page No.</u> |
|---|---|---|
| Photo No. 10. | Post-Test SID-IIs Dummy Right $\frac{3}{4}$ Front View | A-6 |

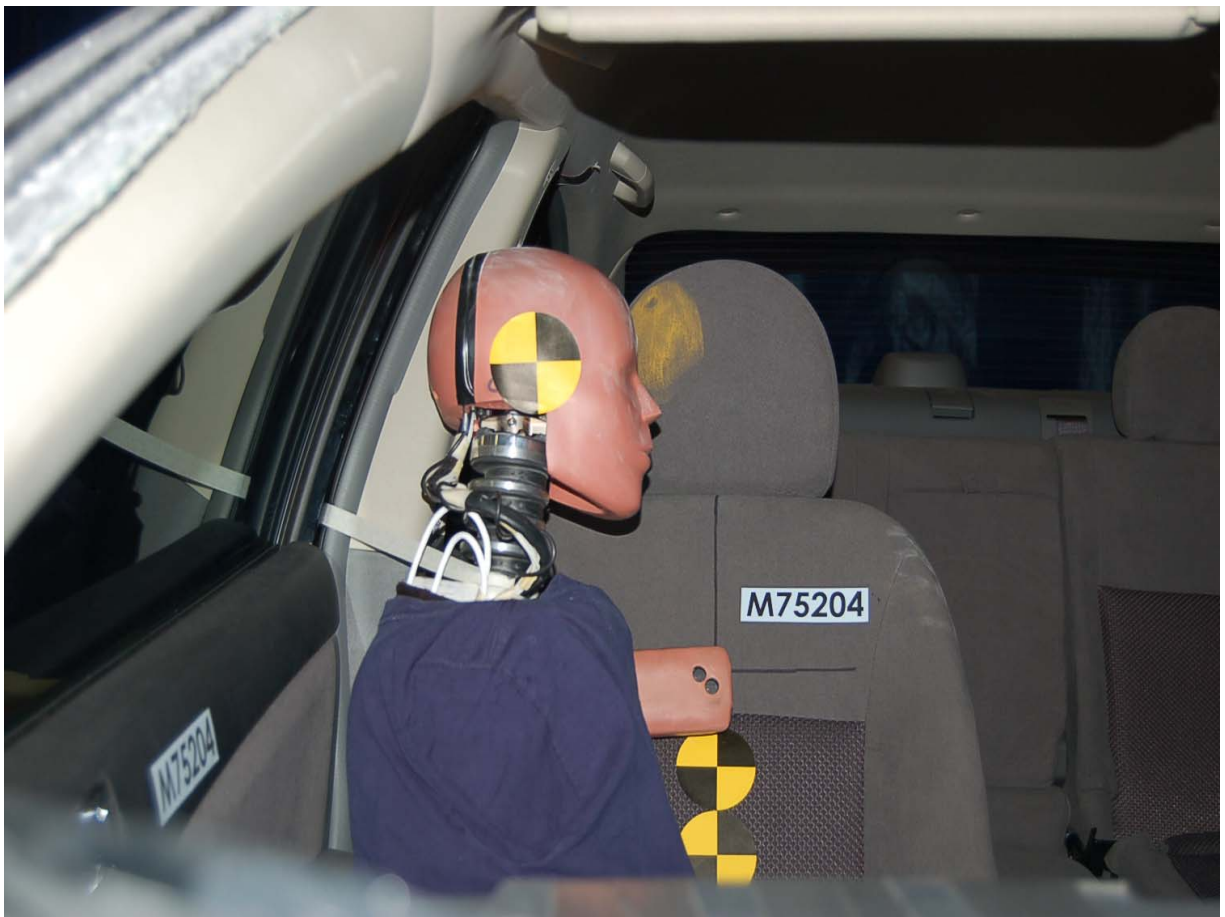
Pre-Test SID-III Dummy Right Side Head View

| | | <u>Page No.</u> |
|---|---|---|
| Photo No. 11. | Pre-Test SID-IIs Dummy Right Side Head View | A-7 |

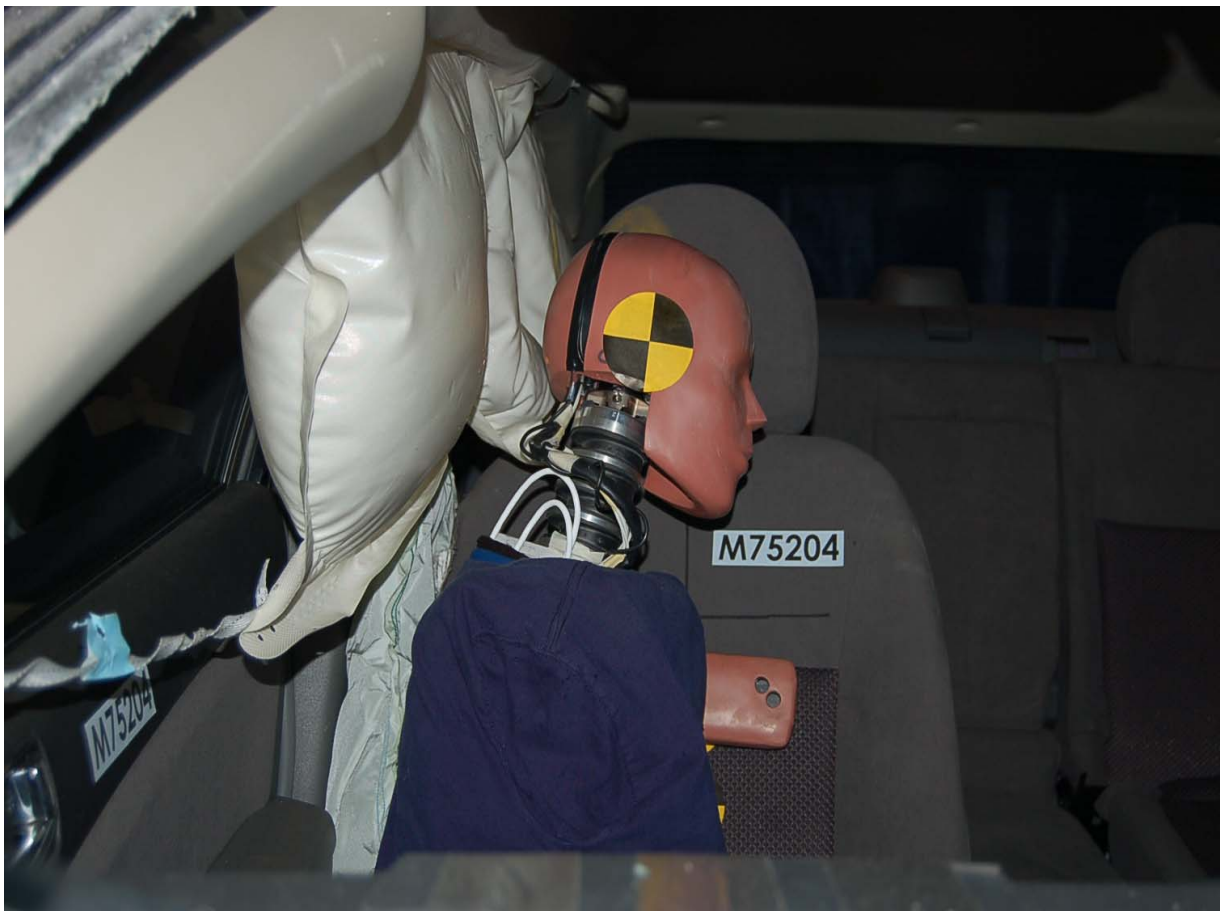
Post-Test SID-III Dummy Right Side Head View

| | | <u>Page No.</u> |
|---|---|---|
| Photo No. 12. | Post-Test SID-IIs Dummy Right Side Head View | A-7 |

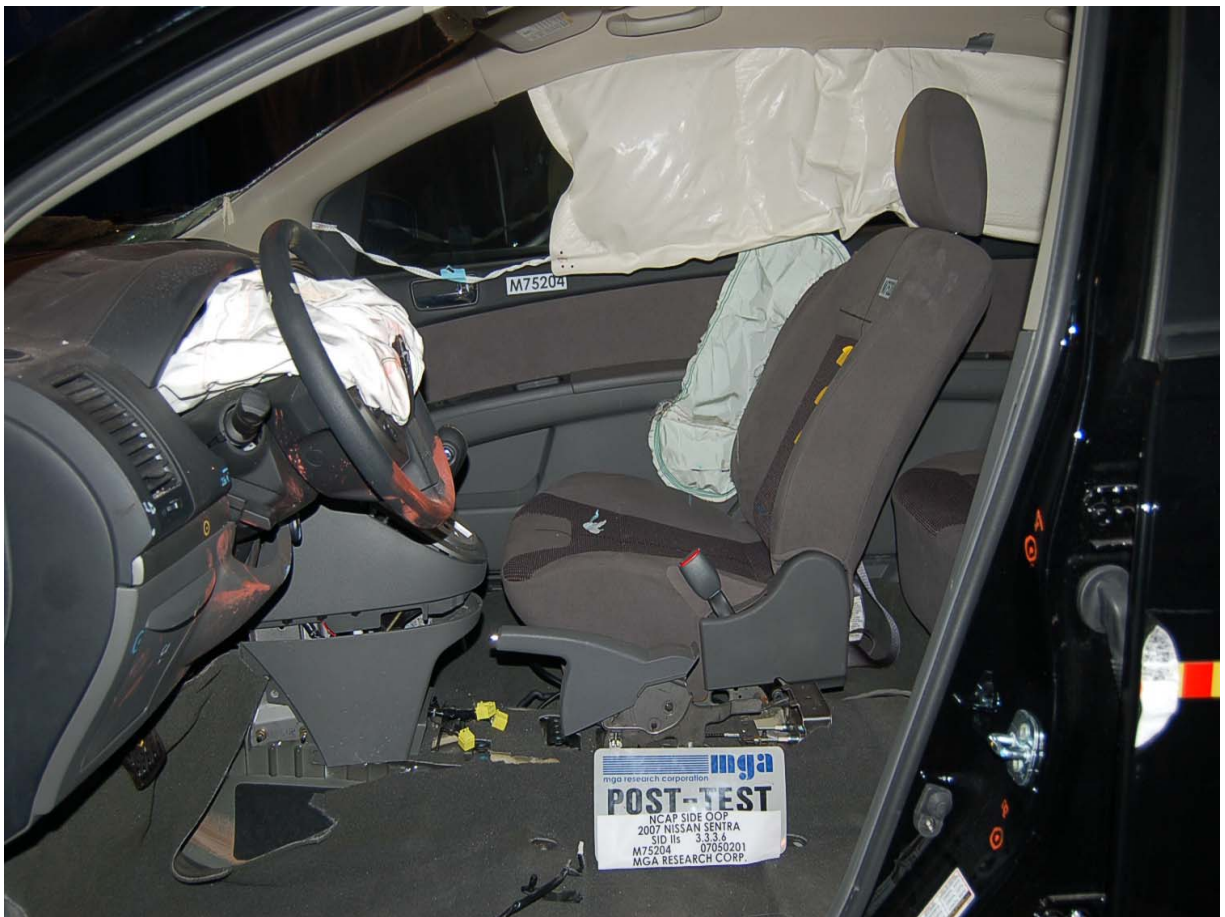
Post-Test Right Front Passenger Compartment View

| | | <u>Page No.</u> |
|---|---|---|
| Photo No. 13. | Post-Test Right Front Passenger Compartment View | A-8 |

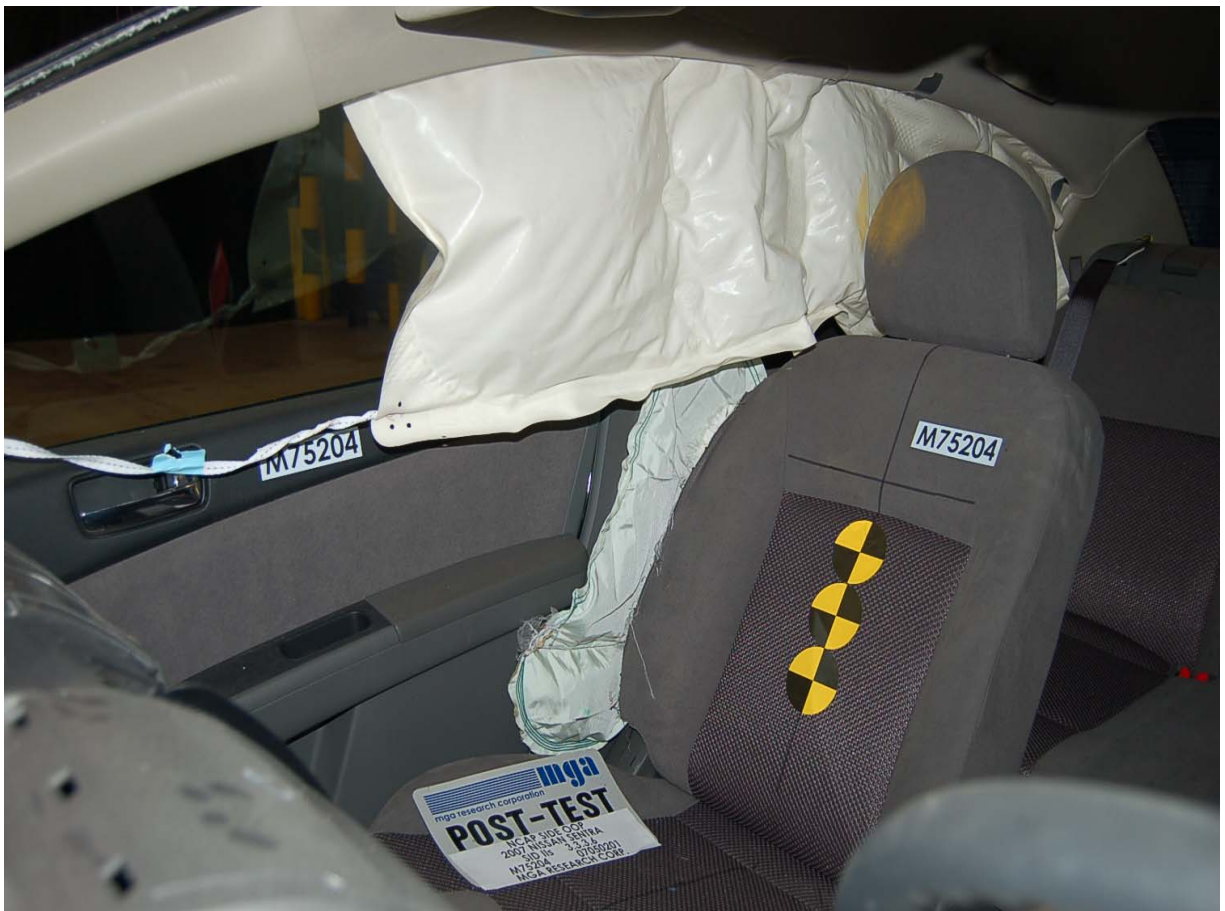
Post-Test Curtain and Torso Airbag View

| | | <u>Page No.</u> |
|---|---|---|
| Photo No. 14. | Post-Test Curtain and Torso Airbag View | A-8 |

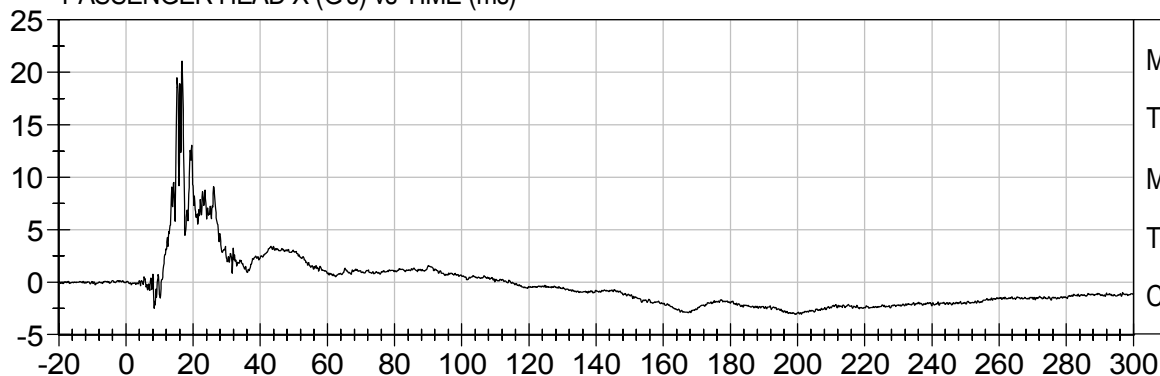
PASSENGER HEAD X (G's) vs TIME (ms)

Max: 21.1 G's  
Tmax: 16.7 ms  
Min: -3.1 G's  
Tmin: 201.2 ms  
CFC 1000

| | | MAXIMUM VALUE | | | |
|---|---|---|---|---|---|
| Head X | g | 21.1 | 16.7 | -3.1 | 201.2 |

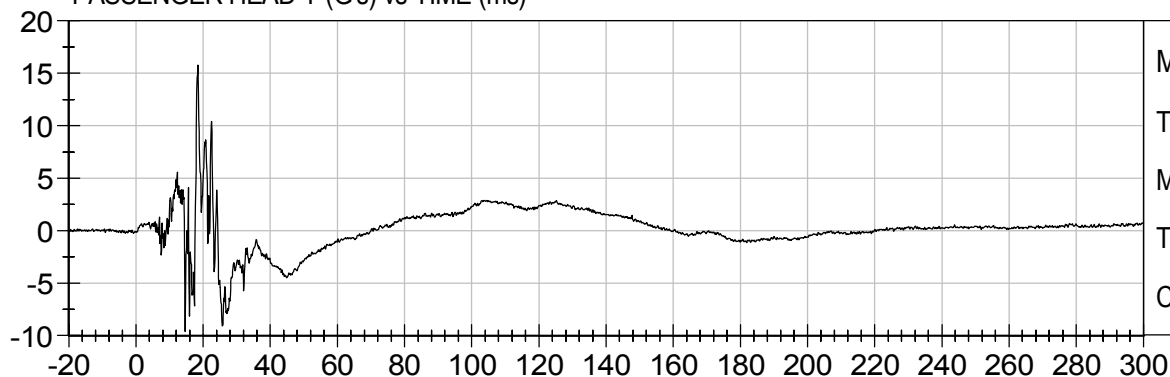
PASSENGER HEAD Y (G's) vs TIME (ms)

Max: 15.8 G's  
Tmax: 18.4 ms  
Min: -9.6 G's  
Tmin: 14.7 ms  
CFC 1000

| | | MAXIMUM VALUE | | | |
|---|---|---|---|---|---|
| Head Y | g | 15.8 | 18.4 | -9.6 | 14.7 |

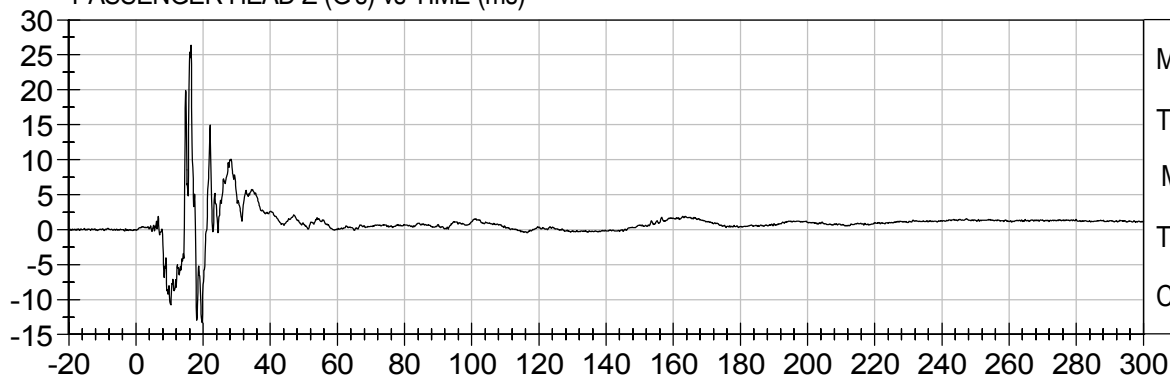
PASSENGER HEAD Z (G's) vs TIME (ms)

Max: 26.4 G's  
Tmax: 16.4 ms  
Min: -13.3 G's  
Tmin: 19.7 ms  
CFC 1000

| | | MAXIMUM VALUE | | | |
|---|---|---|---|---|---|
| Head Z | g | 26.4 | 16.4 | -13.3 | 19.7 |

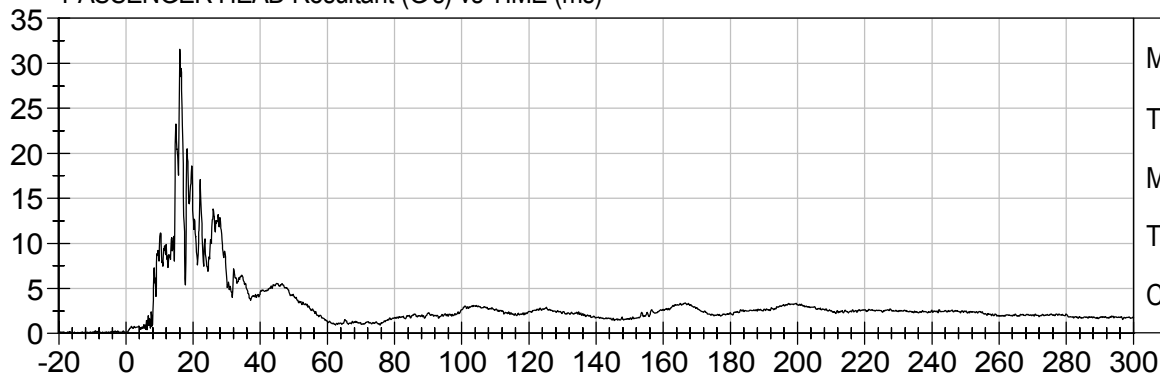
PASSENGER HEAD Resultant (G's) vs TIME (ms)

Max: 31.6 G's  
Tmax: 16.1 ms  
Min: 0.0 G's  
Tmin: 0.0 ms  
CFC 1000

| | | MAXIMUM VALUE | | | |
|---|---|---|---|---|---|
| Head Resultant | g | 31.6 | 16.1 | | |

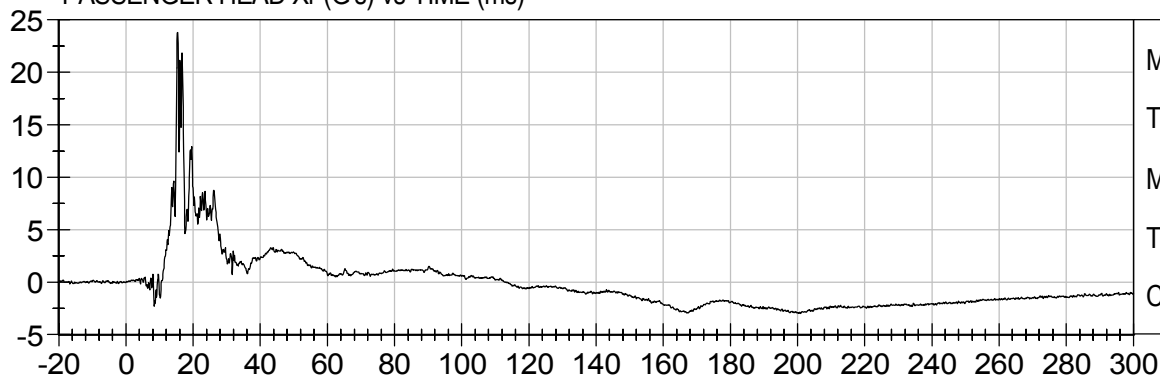
PASSENGER HEAD Xr (G's) vs TIME (ms)

Max: 23.8 G's  
Tmax: 15.4 ms  
Min: -3.0 G's  
Tmin: 200.9 ms  
CFC 1000

| | | MAXIMUM VALUE | | | |
|---|---|---|---|---|---|
| Head X Redundant | g | 23.8 | 15.4 | -3.0 | 200.9 |

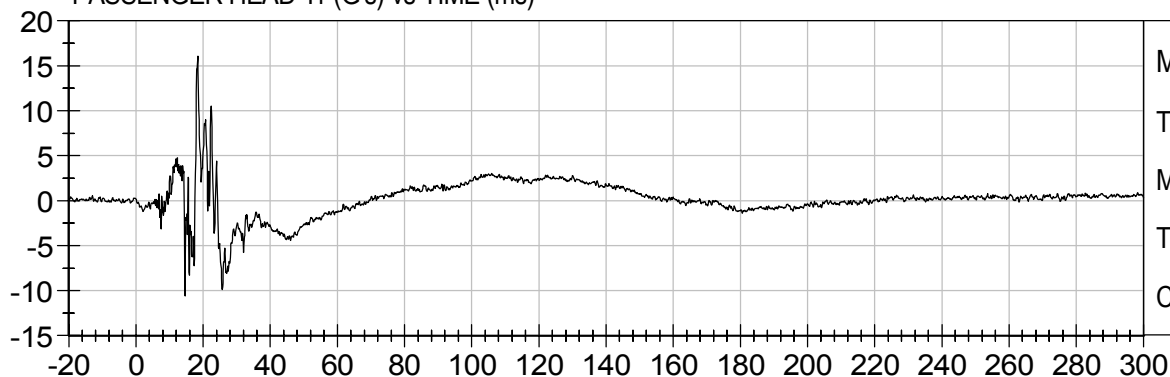
PASSENGER HEAD Yr (G's) vs TIME (ms)

Max: 16.1 G's  
Tmax: 18.4 ms  
Min: -10.6 G's  
Tmin: 14.6 ms  
CFC 1000

| | | MAXIMUM VALUE | | | |
|---|---|---|---|---|---|
| Head Y Redundant | g | 16.1 | 18.4 | -10.6 | 14.6 |

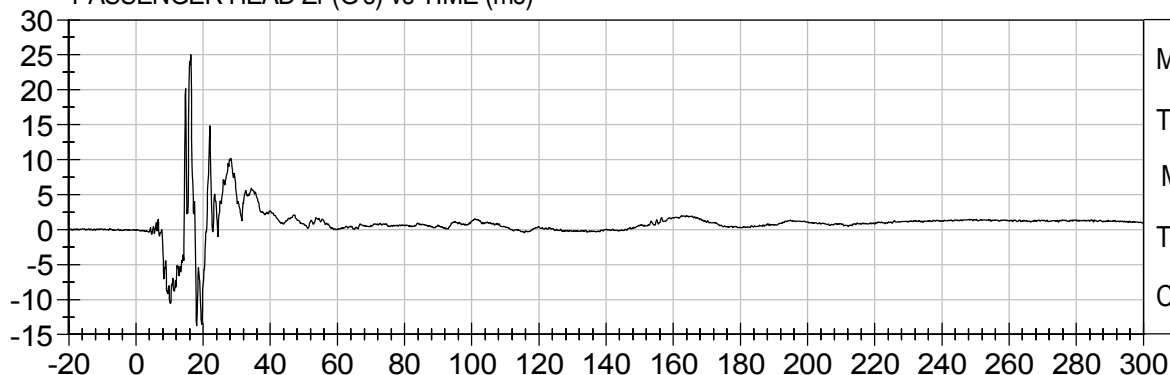
PASSENGER HEAD Zr (G's) vs TIME (ms)

Max: 25.0 G's  
Tmax: 16.3 ms  
Min: -13.8 G's  
Tmin: 18.1 ms  
CFC 1000

| | | MAXIMUM VALUE | | | |
|---|---|---|---|---|---|
| Head Z Redundant | g | 25.0 | 16.3 | -13.8 | 18.1 |

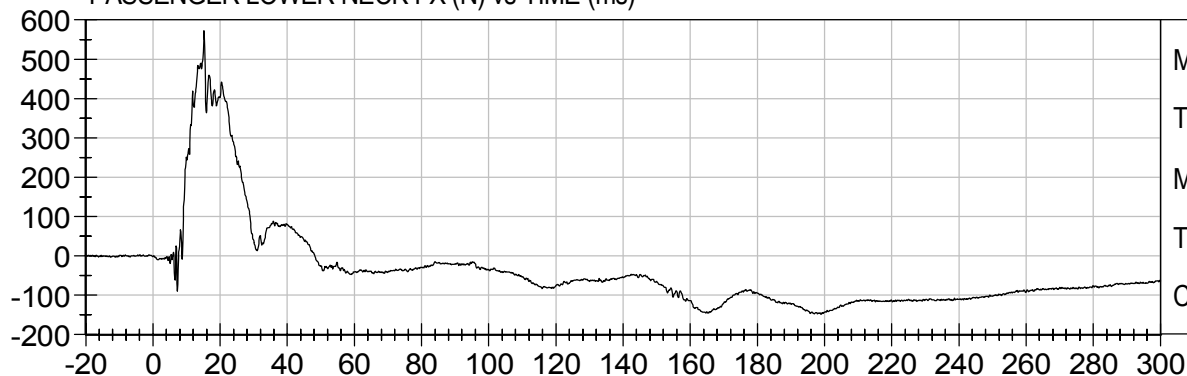
PASSENGER LOWER NECK FX (N) vs TIME (ms)

Max: 572.0 N  
Tmax: 15.2 ms  
Min: -148.3 N  
Tmin: 199.0 ms  
CFC 1000

| | | MAXIMUM VALUE | | | |
|---|---|---|---|---|---|
| Lower Neck Fx | N | 572.0 | 15.2 | -148.3 | 199.0 |

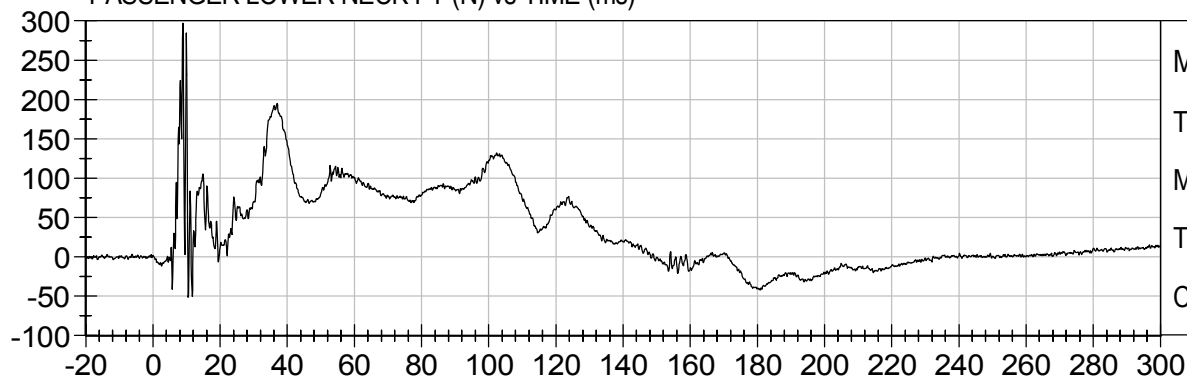
PASSENGER LOWER NECK FY (N) vs TIME (ms)

Max: 297.1 N  
Tmax: 8.9 ms  
Min: -51.6 N  
Tmin: 10.5 ms  
CFC 1000

| | | MAXIMUM VALUE | | | |
|---|---|---|---|---|---|
| Lower Neck Fy | N | 297.1 | 8.9 | -51.6 | 10.5 |

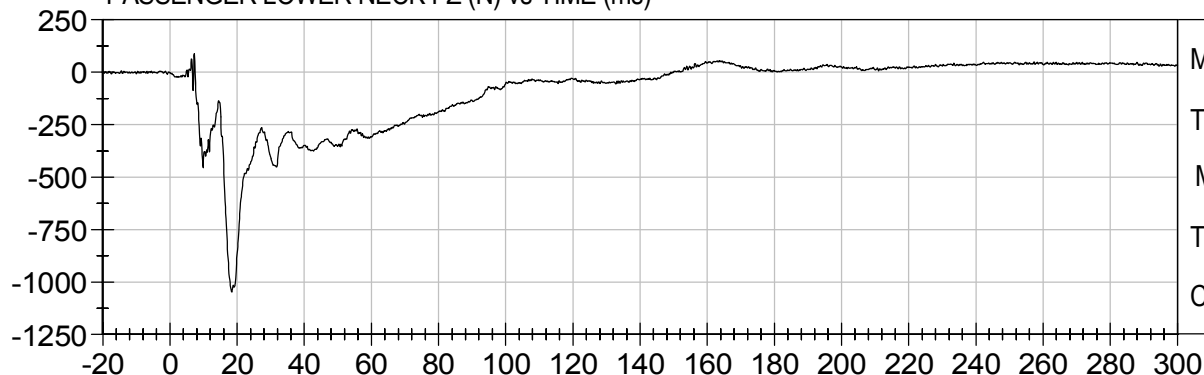
PASSENGER LOWER NECK FZ (N) vs TIME (ms)

Max: 89.1 N  
Tmax: 7.3 ms  
Min: -1047.8 N  
Tmin: 18.4 ms  
CFC 1000

| | | MAXIMUM VALUE | | | |
|---|---|---|---|---|---|
| Lower Neck Fz | N | 89.1 | 7.3 | -1047.8 | 18.4 |

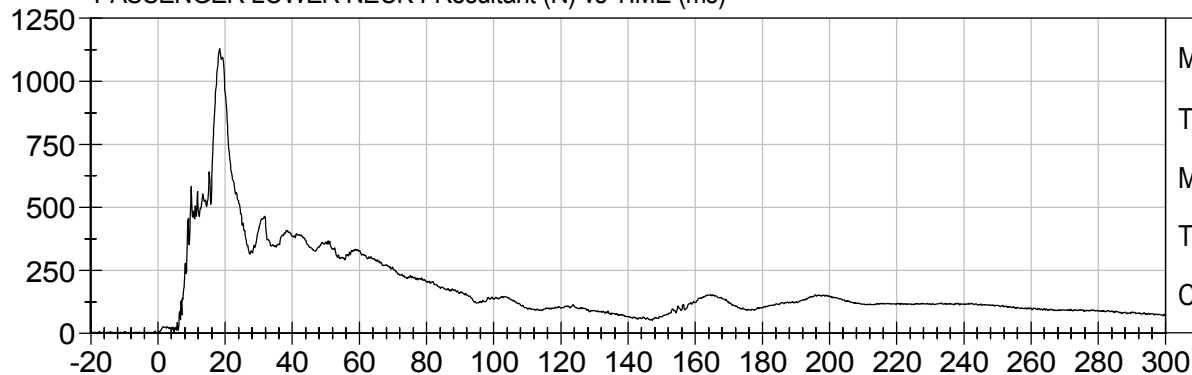
PASSENGER LOWER NECK FResultant (N) vs TIME (ms)

Max: 1128.6 N  
Tmax: 18.4 ms  
Min: 0.6 N  
Tmin: 0.0 ms  
CFC 1000

| | | MAXIMUM VALUE | | | |
|---|---|---|---|---|---|
| Lower Neck F Resultant | N | 1128.6 | 18.4 | | |
