**REPORT NUMBER TR-P27082-06-NC**

**SIDE AIRBAG OCCUPANT RISK PROGRAM  
OCCUPANT OUT-OF-POSITION TESTS**

**CAMI AUTOMOTIVE INC. CANADA  
2007 SUZUKI XL7  
5-DOOR MPV**

**NHTSA NUMBER: M70512TWG2**

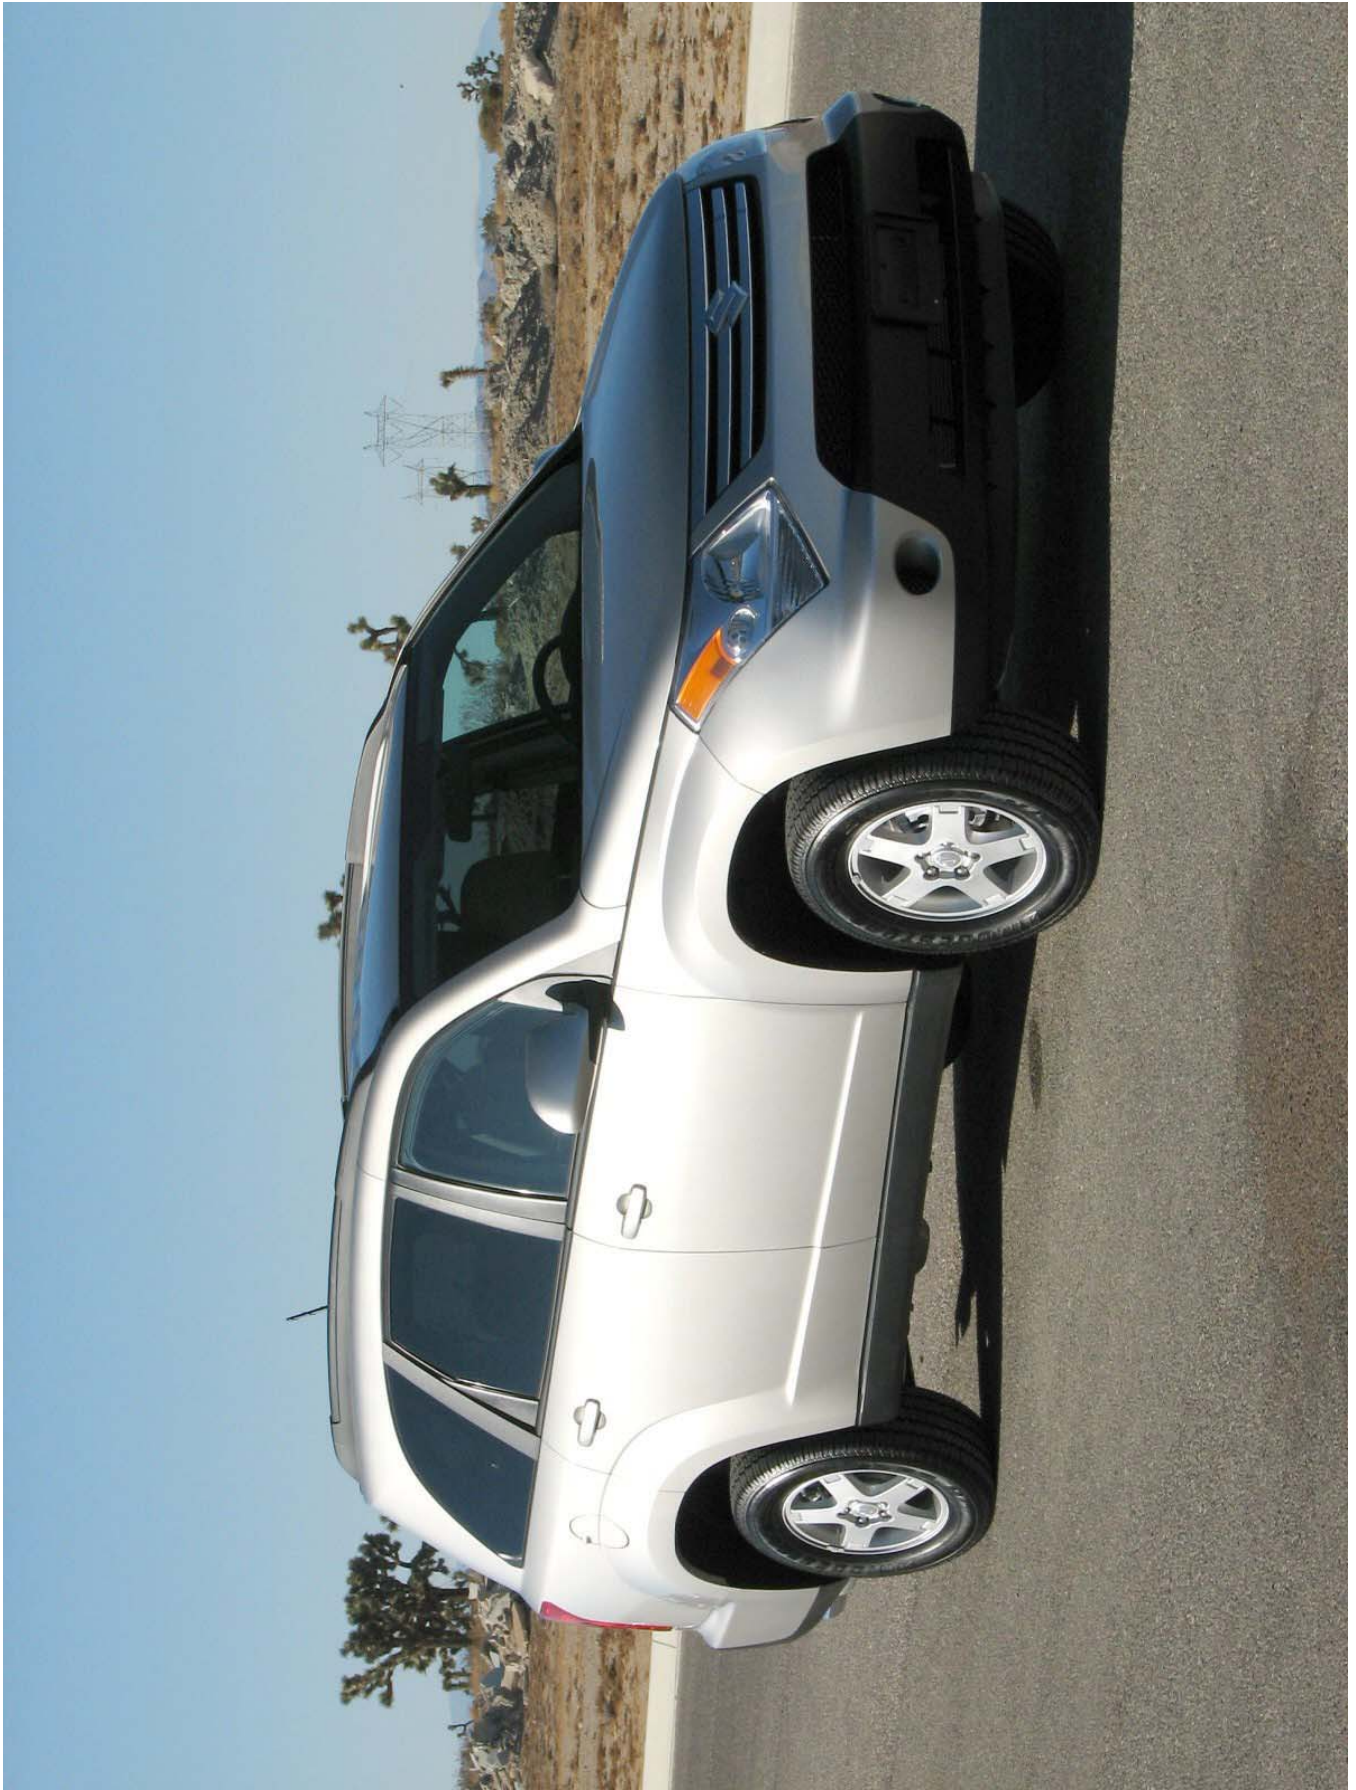
Figure A-1: Right Front  $\frac{3}{4}$  View, As Received

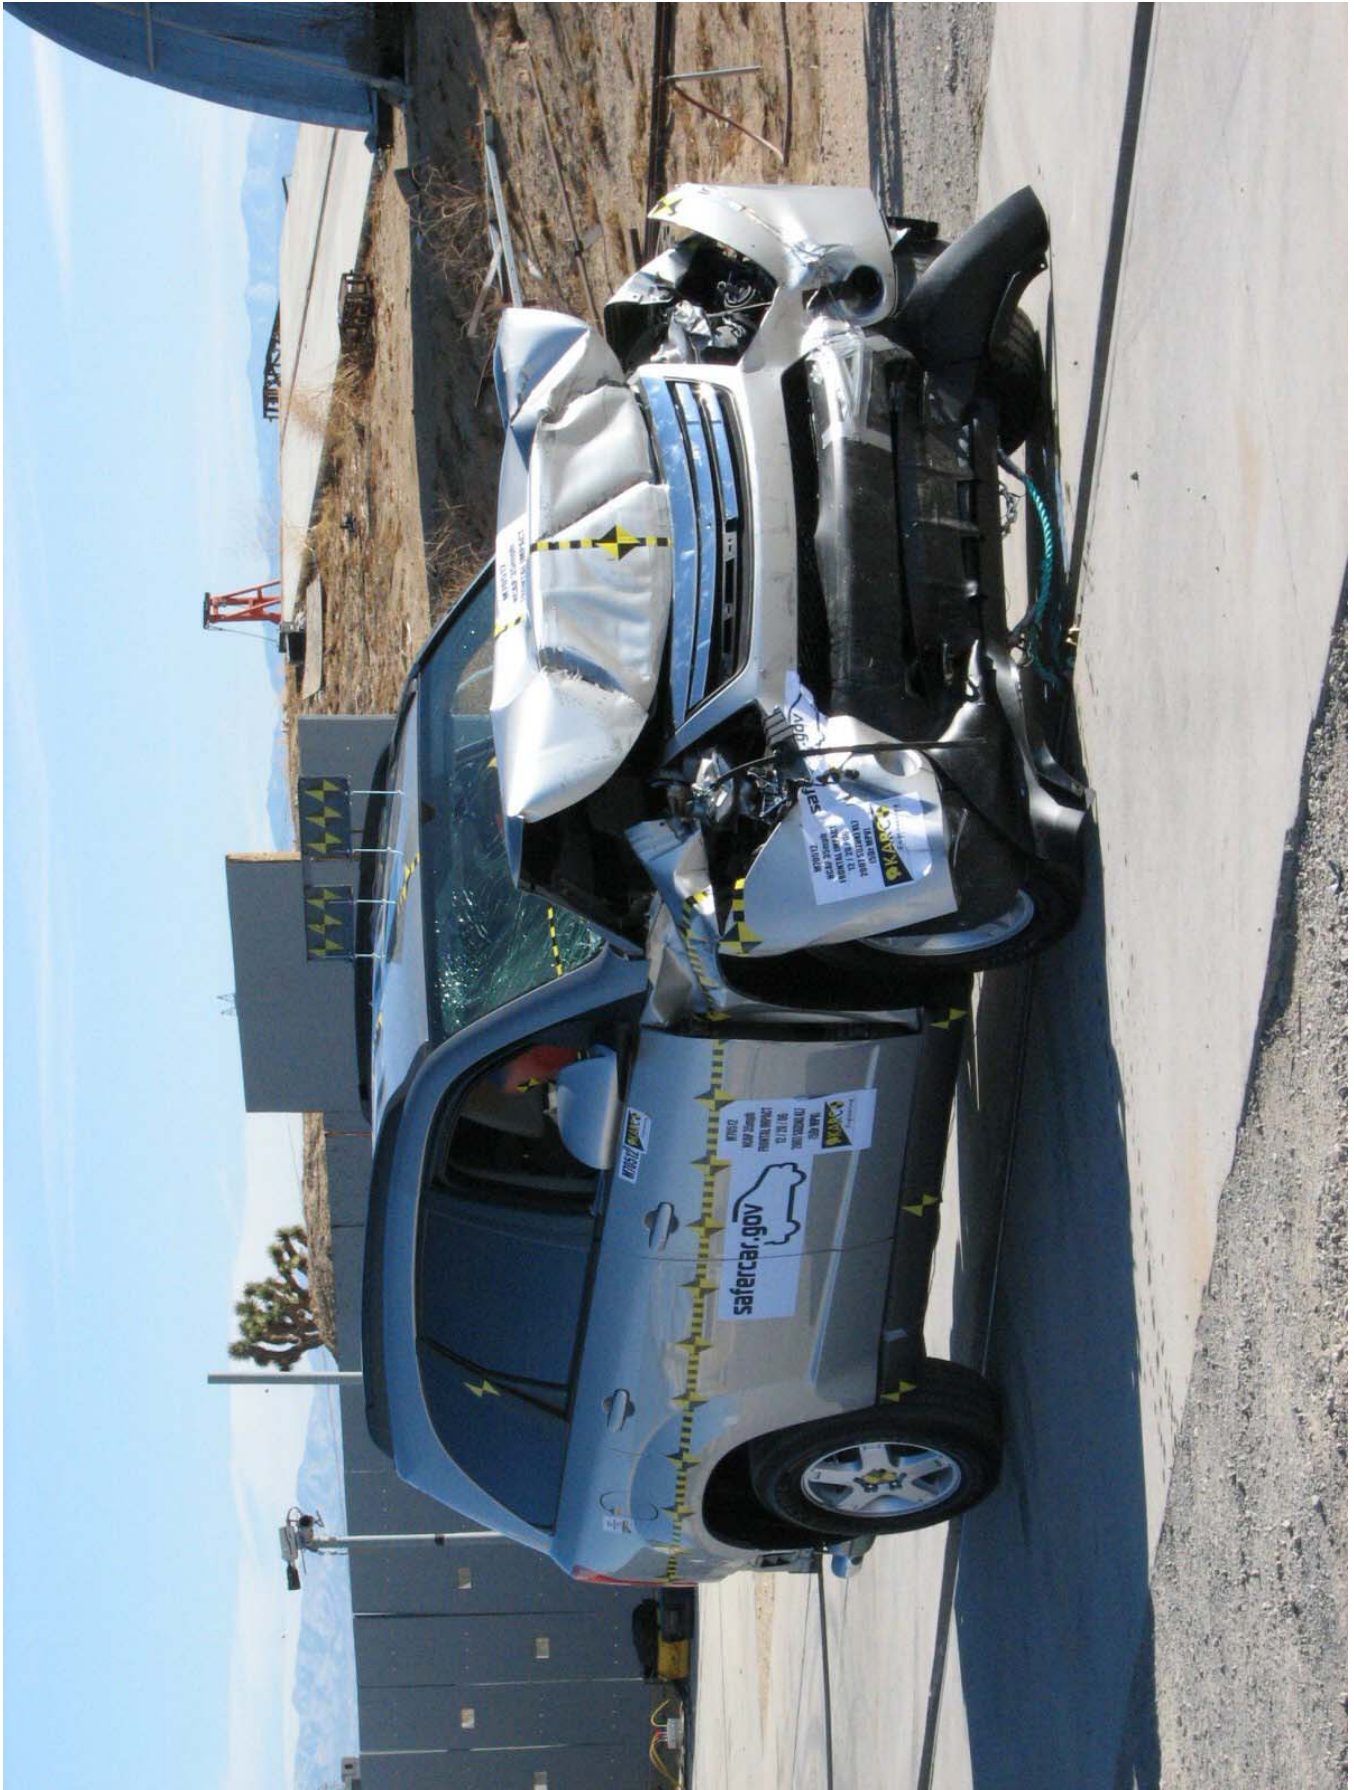
Figure A-3: Post-Test Right Front  $\frac{3}{4}$  View of Frontal NCAP Test

\* Vehicle had undergone New Car Assessment Program Frontal Impact Testing on December 20, 2006

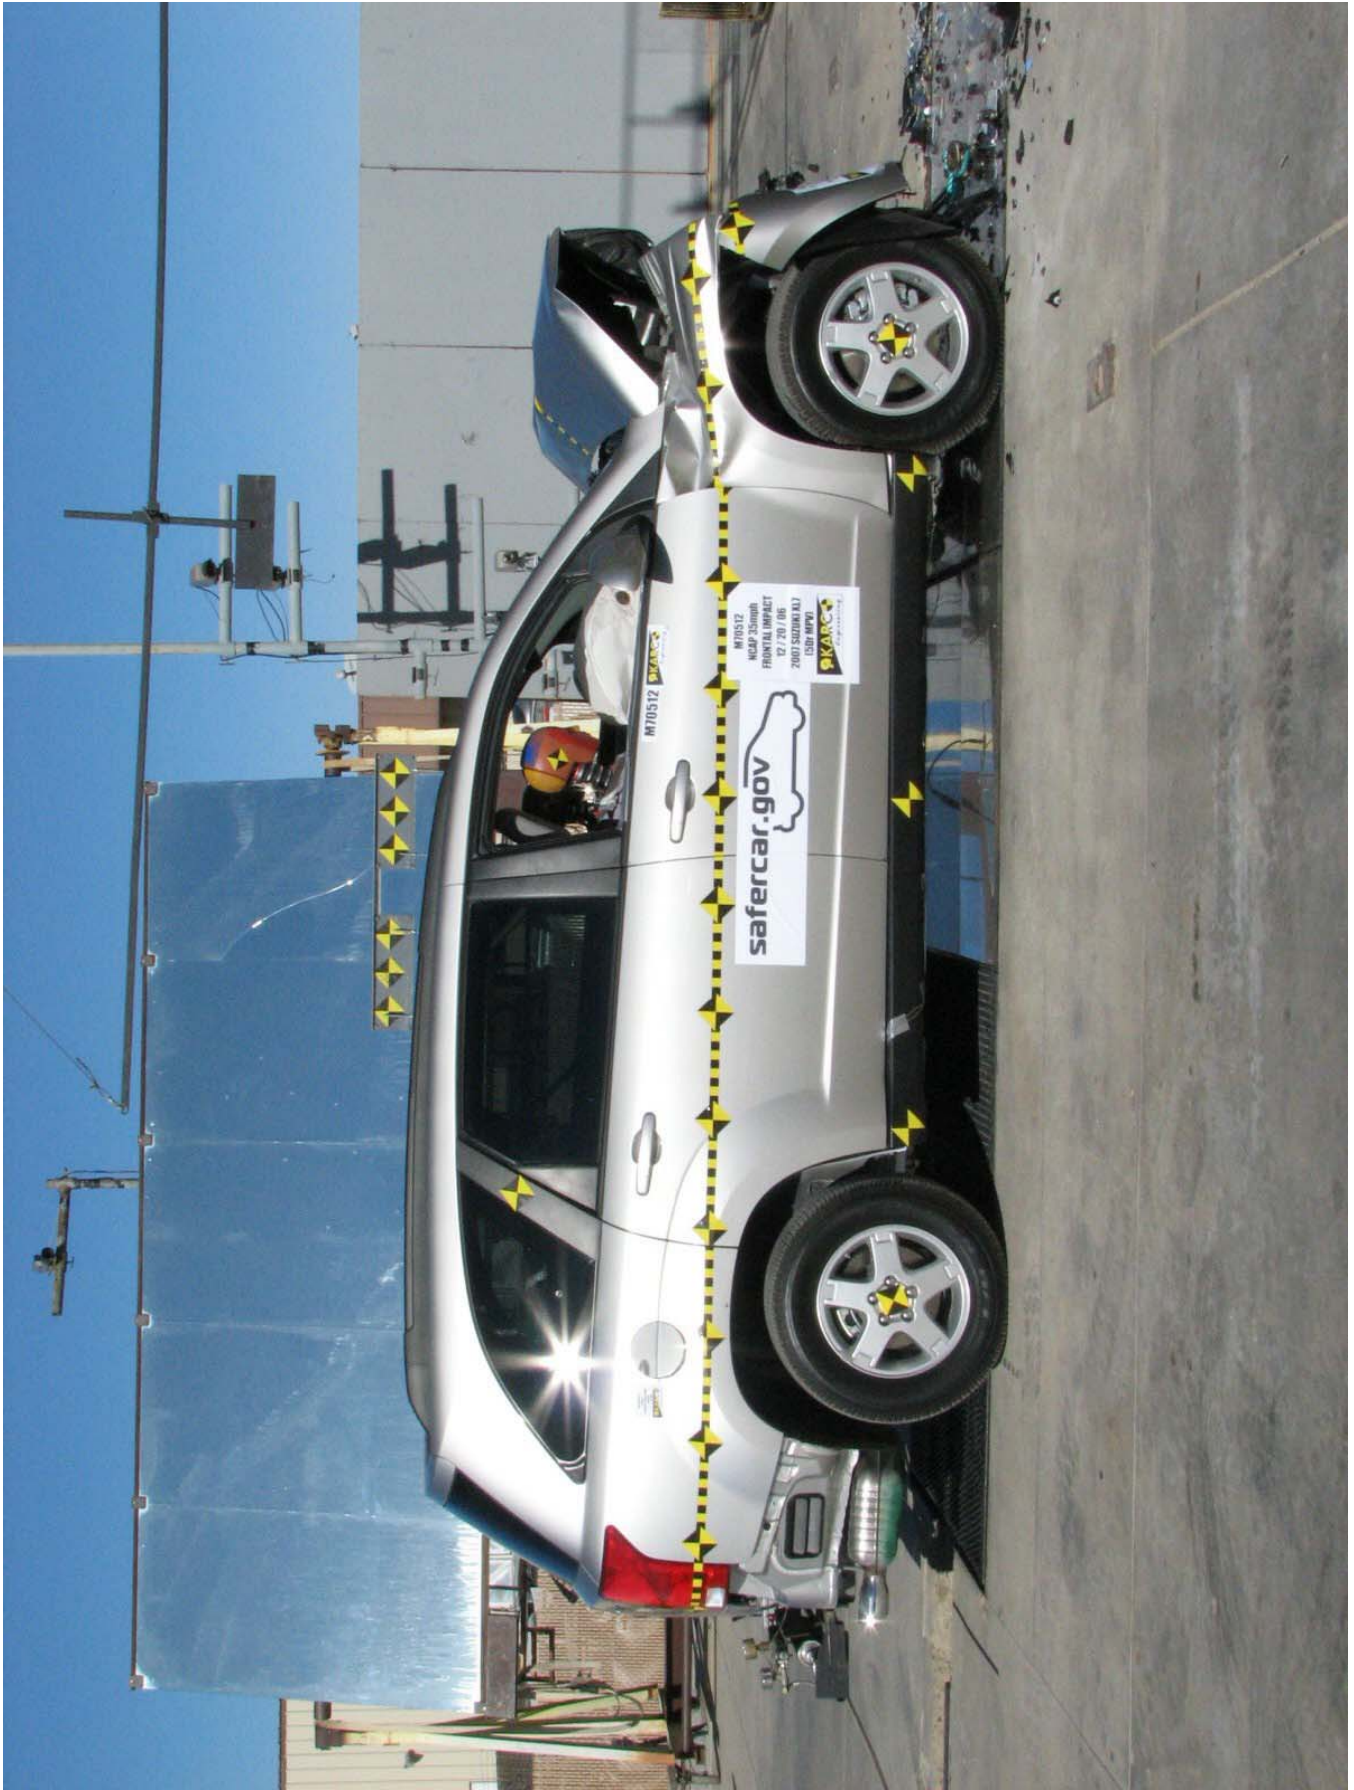
Figure A-4: Post-Test Right Side View of Frontal NCAP Test

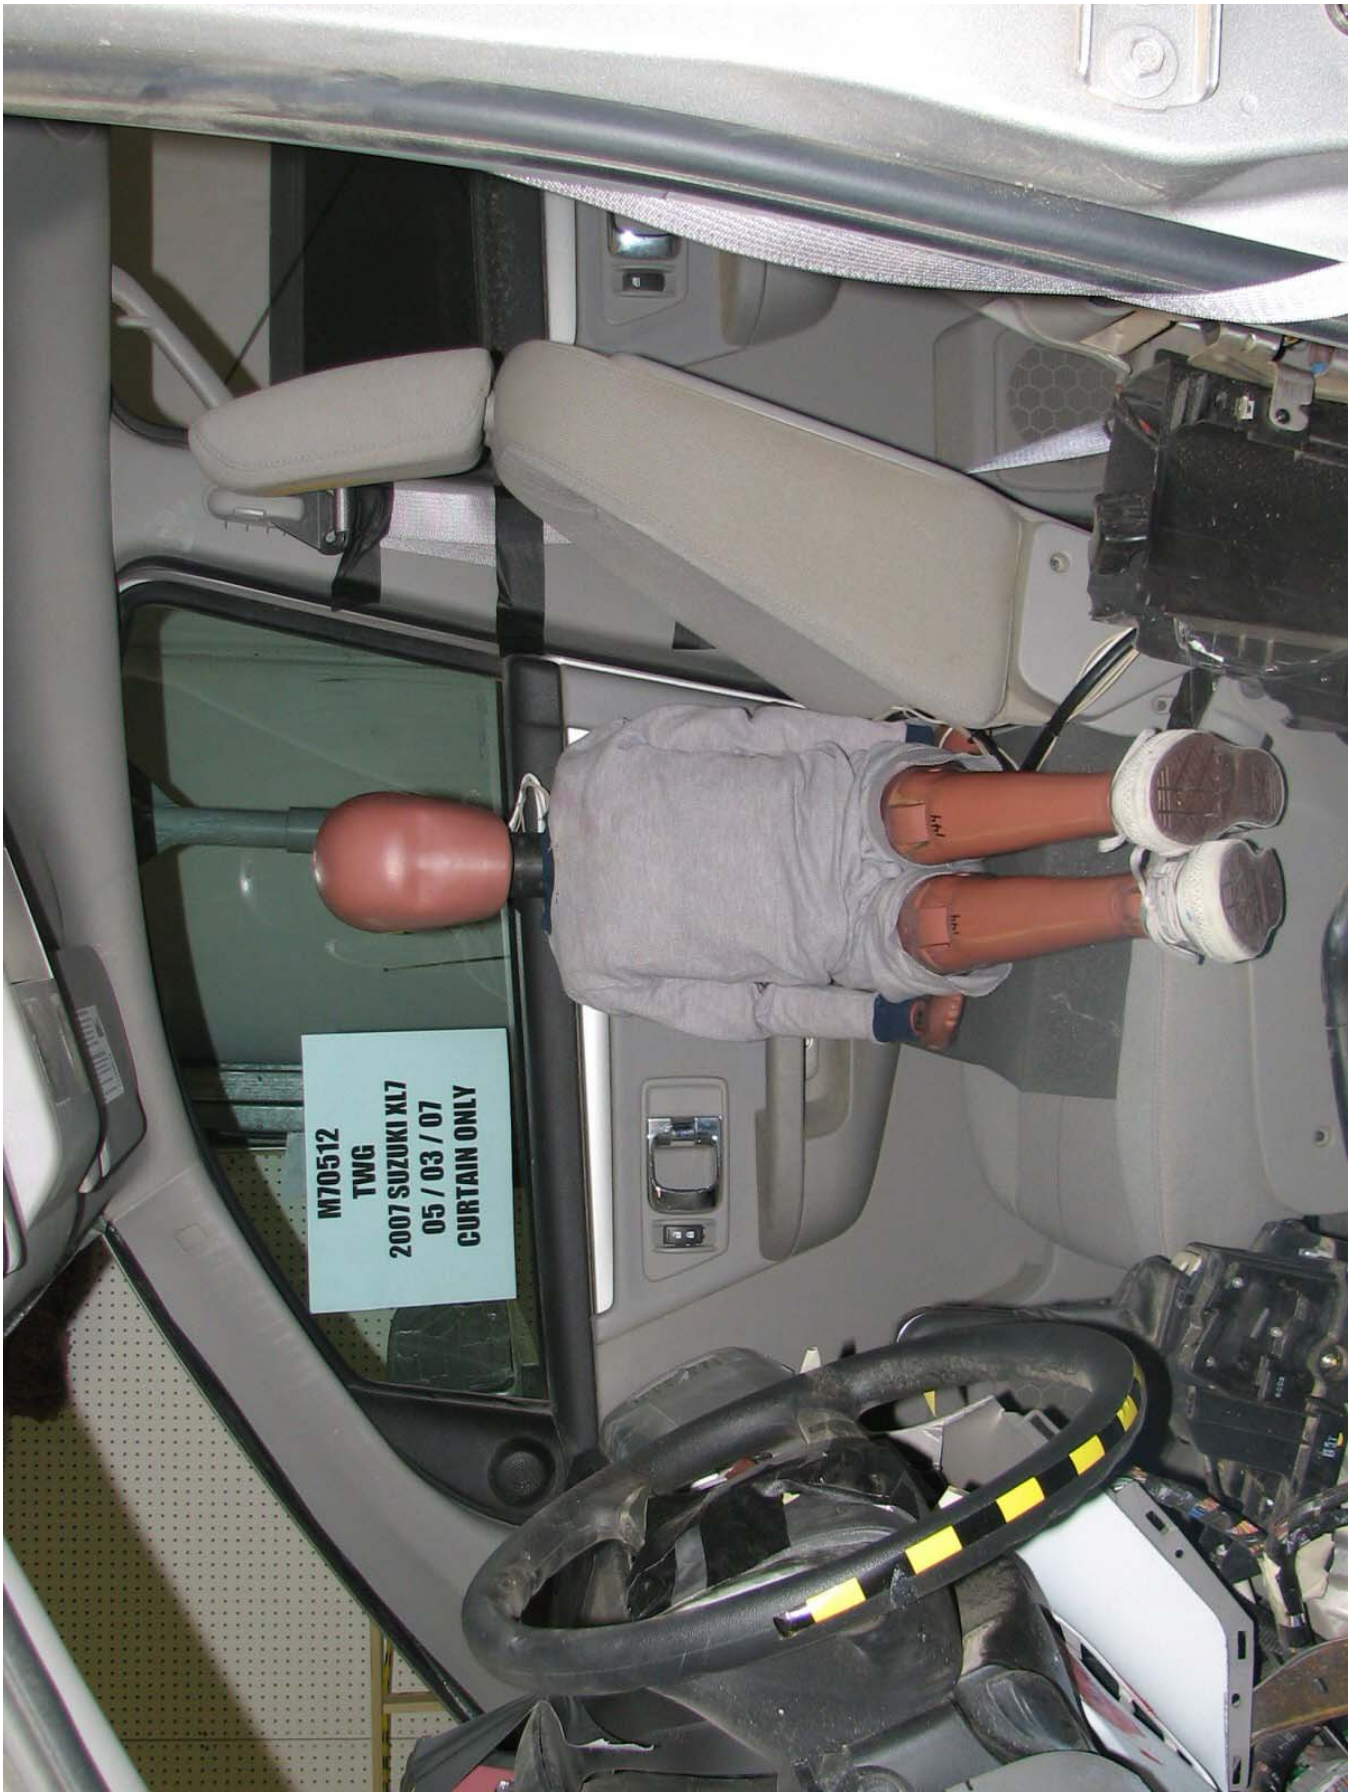
Figure A-5: Pre-Test Dummy Position, Left Side View

Orientation of the Hybrid III 6 Year-old Child Dummy was in the inboard facing position leaning against the front passenger door. The dummy's spine was aligned with the deploying trajectory of the curtain airbag. The lower legs were extended. Synthetic foam was used to raise the dummy. This orientation complies with section 3.3.5.1 of the Technical Working Group (TWG) recommendation in the Recommended Procedures for Evaluating Occupant Injury Risk from Deploying Side Airbags.

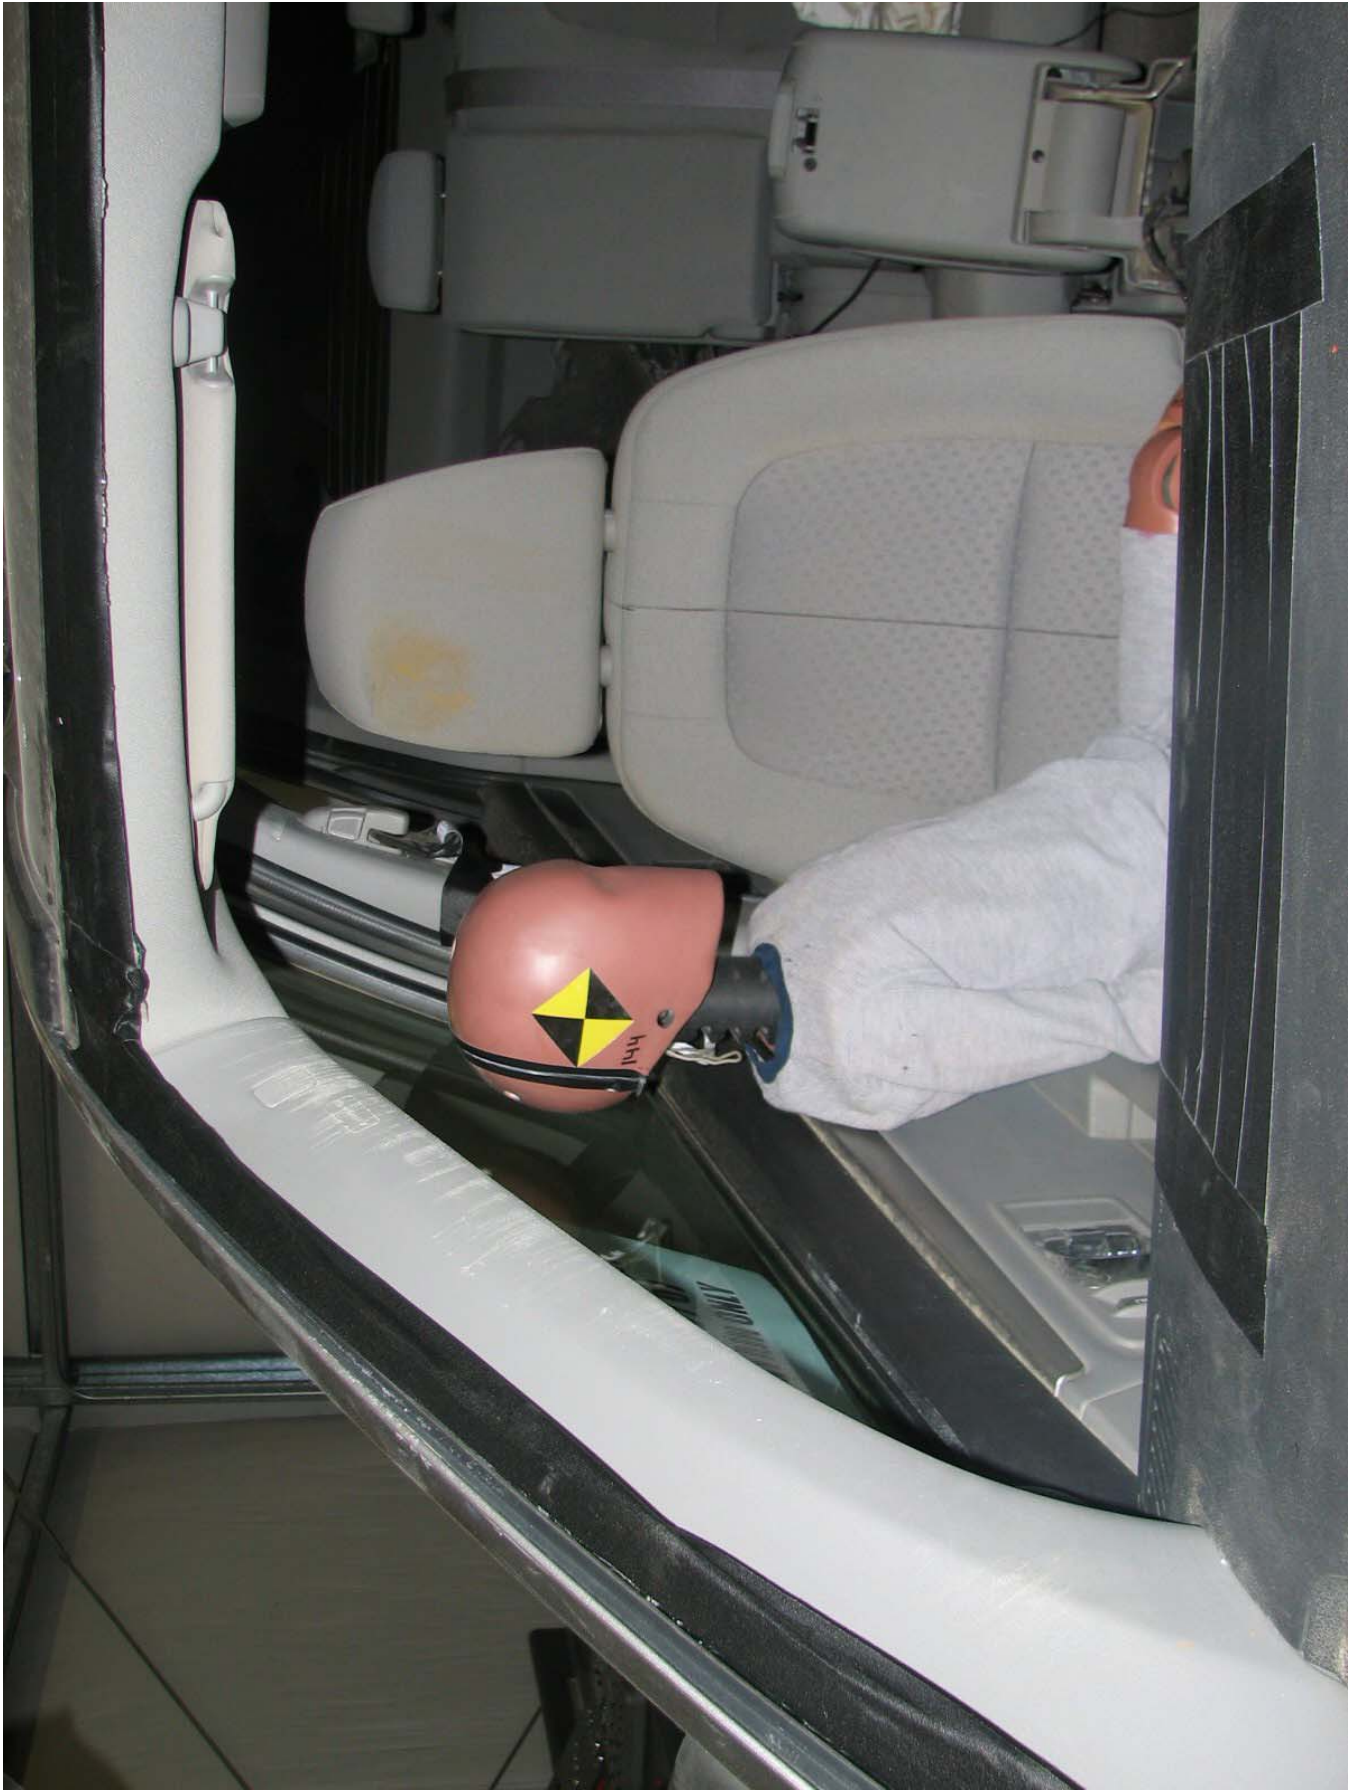
Figure A-7: Pre-Test Dummy Position, Front View

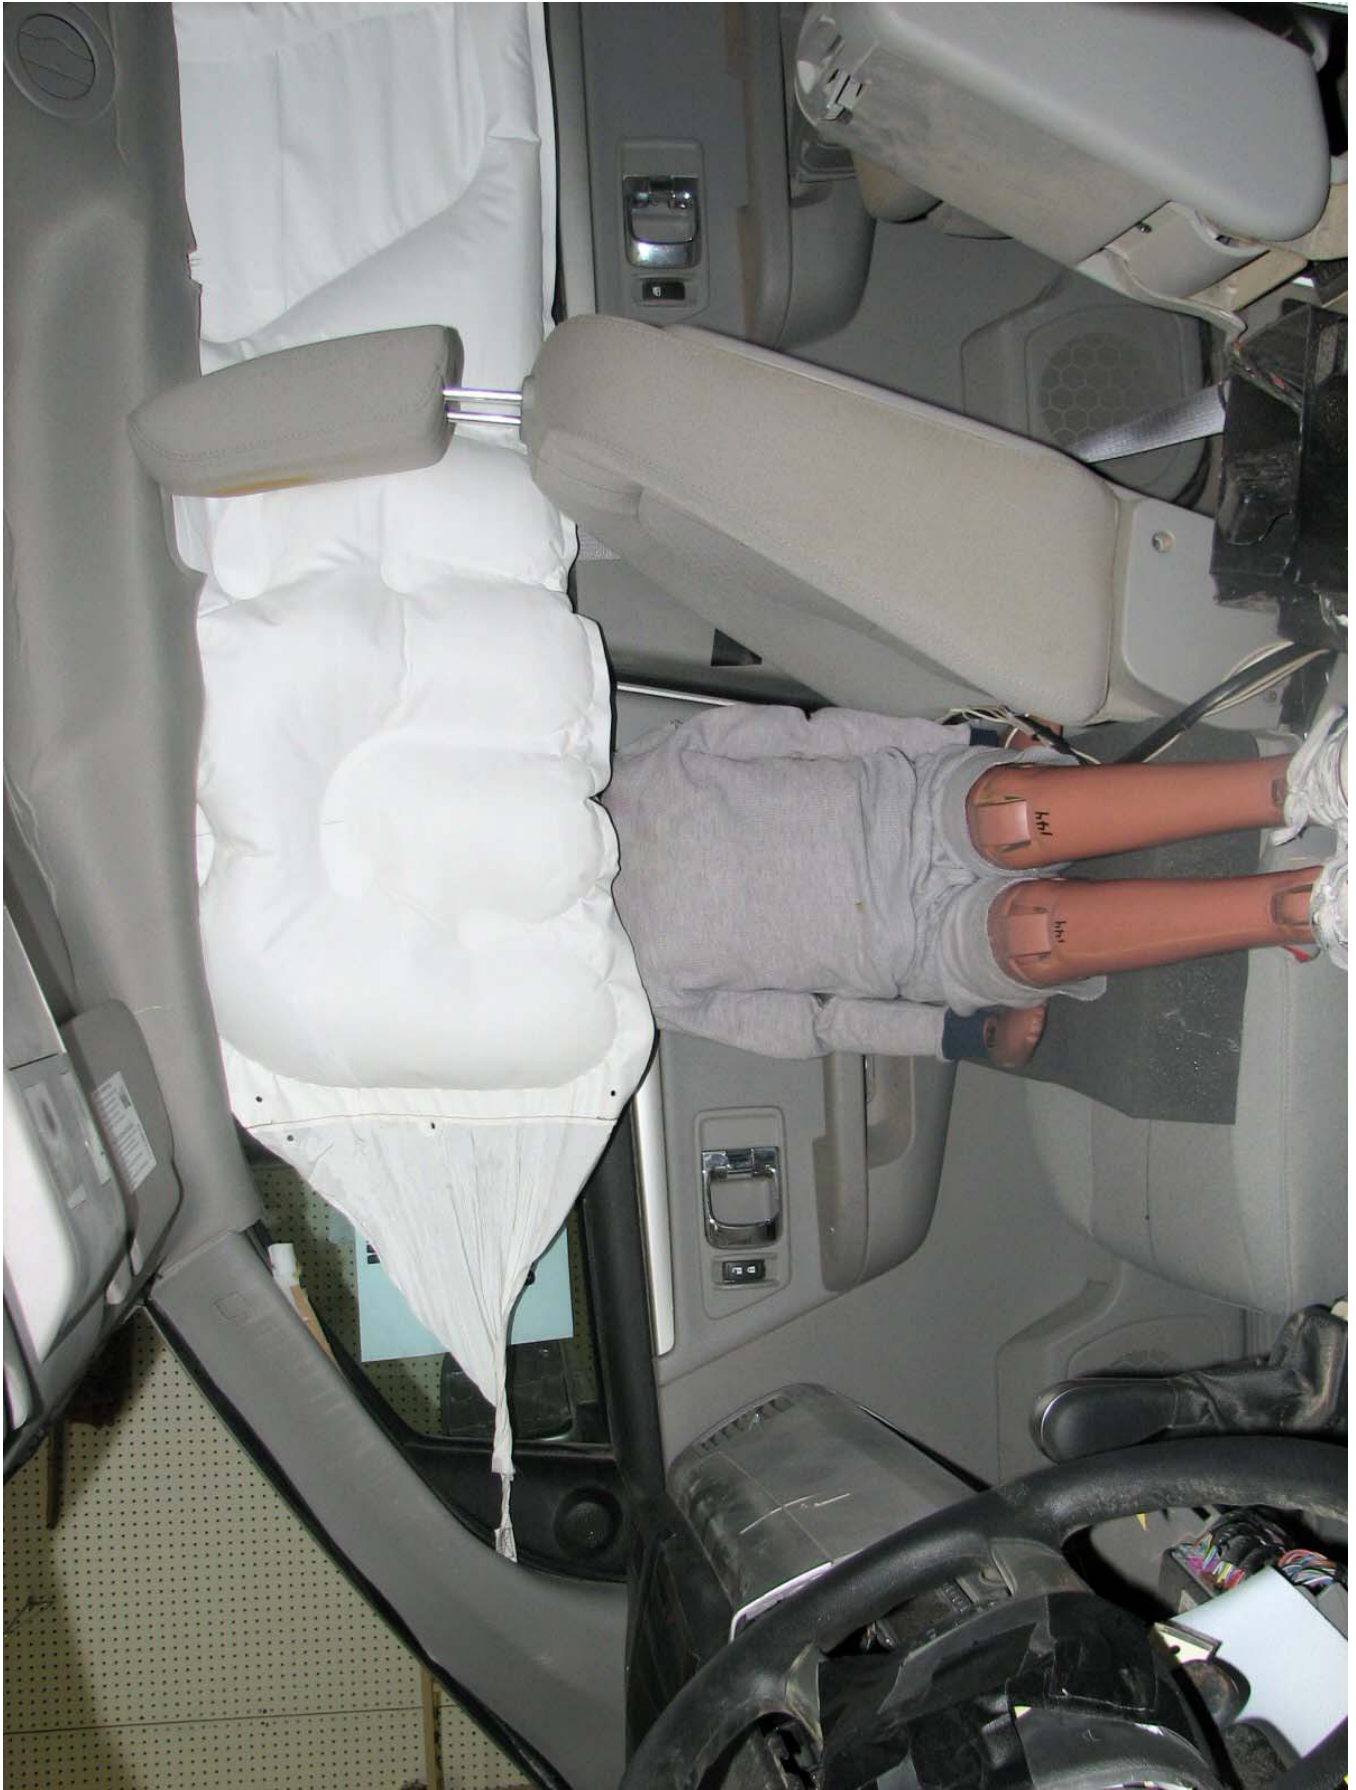
Figure A-8: Post-Test Dummy Position and Airbags, Left Side View

The Hybrid III 6-Year-Old Child Dummy's visible contact points were as follows: The curtain airbag contacted the ATD's head.

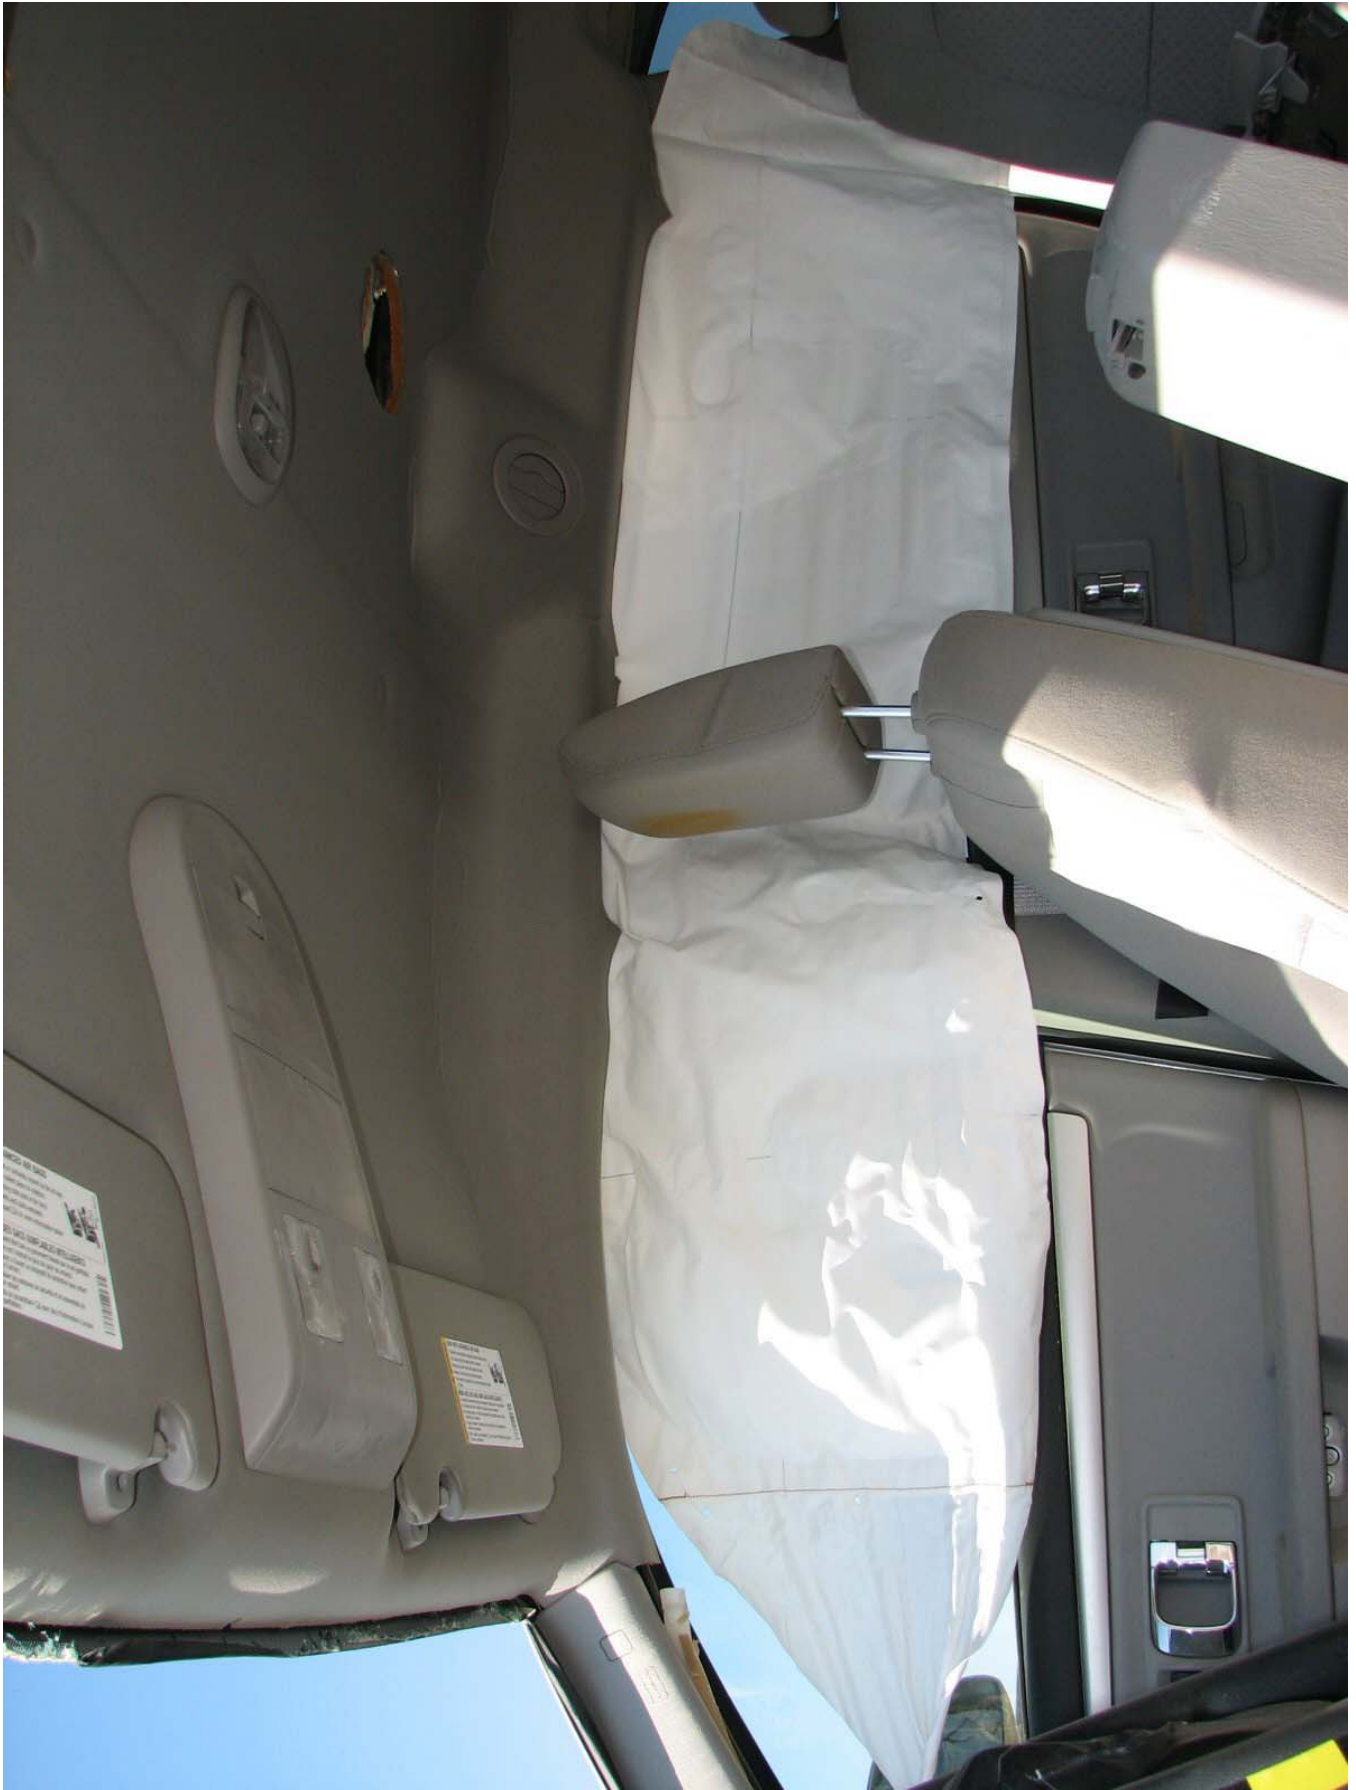
Figure A-9: Post-Test Airbags, Left Side View

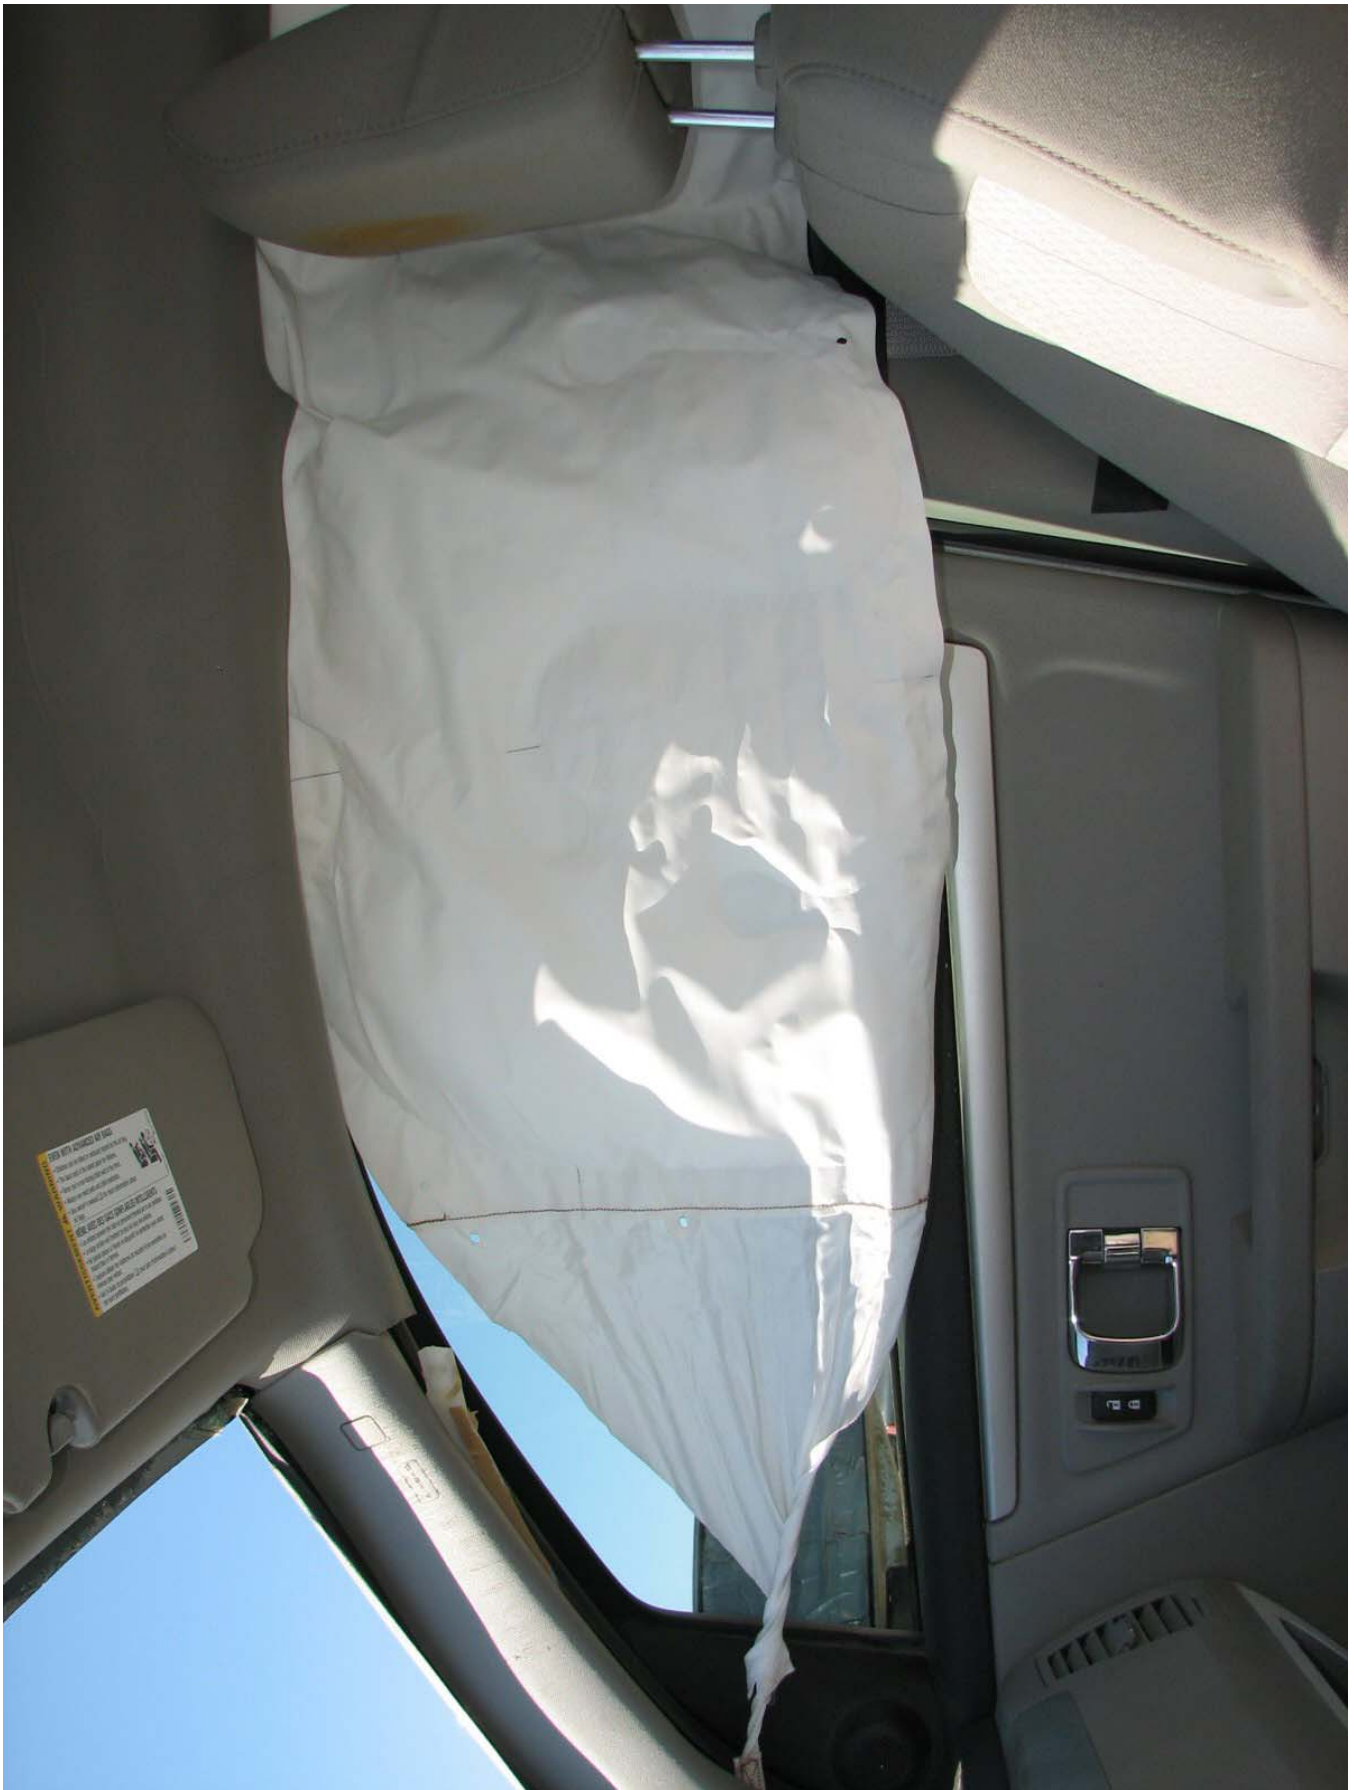
Figure A-10: Post-Test Airbags, Close-up View
