**REPORT NUMBER: TWG-MGA-2007-007**

**NEW CAR ASSESSMENT PROGRAM  
SIDE AIRBAG OUT-OF-POSITION INJURY TESTING**

**GM DAEWOO AUTO & TECHNOLOGY COMPANY  
2007 SUZUKI FORENZA 4-DOOR  
NHTSA NUMBER: M70511TWG2**

**PREPARED BY:  
MGA RESEARCH CORPORATION  
5000 WARREN ROAD  
BURLINGTON, WI 53105**

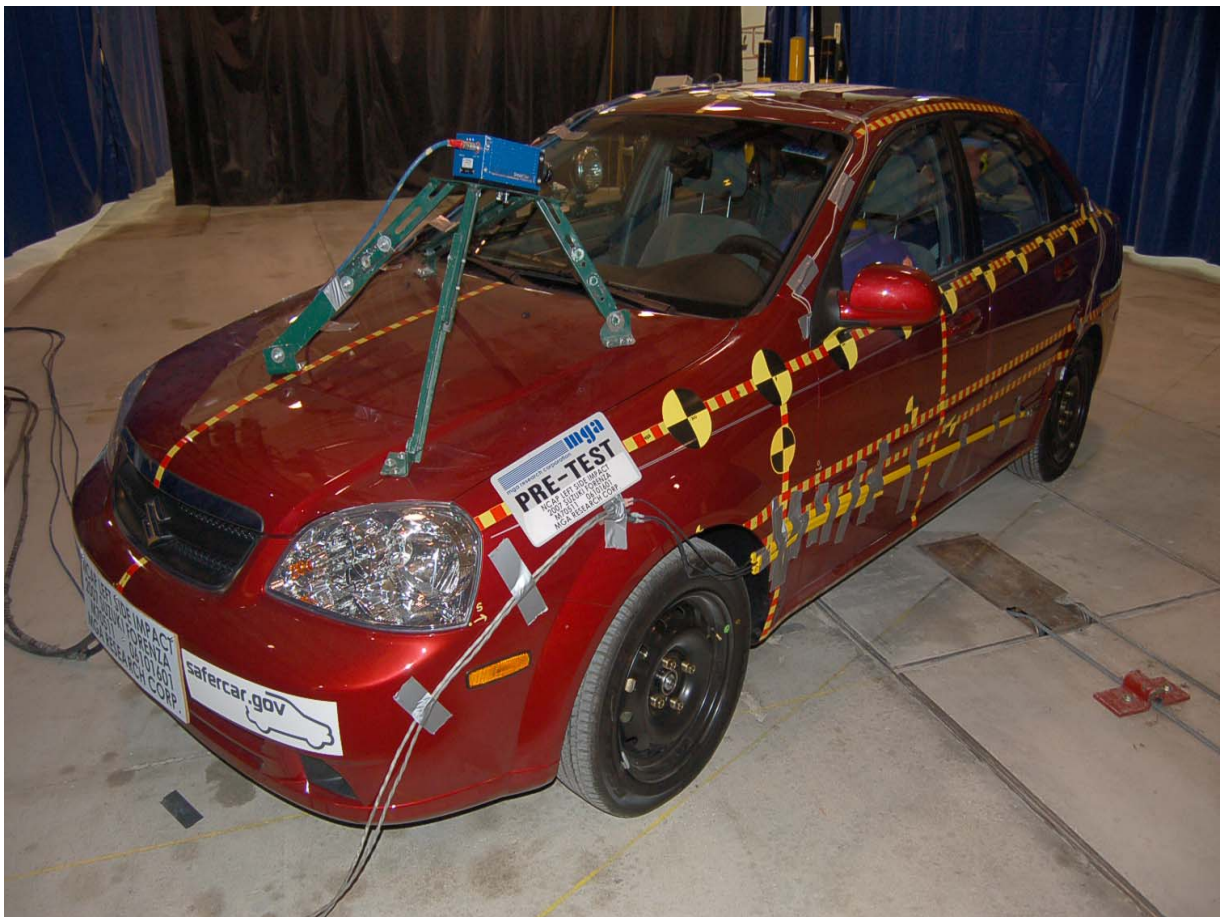
Pre-Test Vehicle Left Front  $\frac{3}{4}$  View

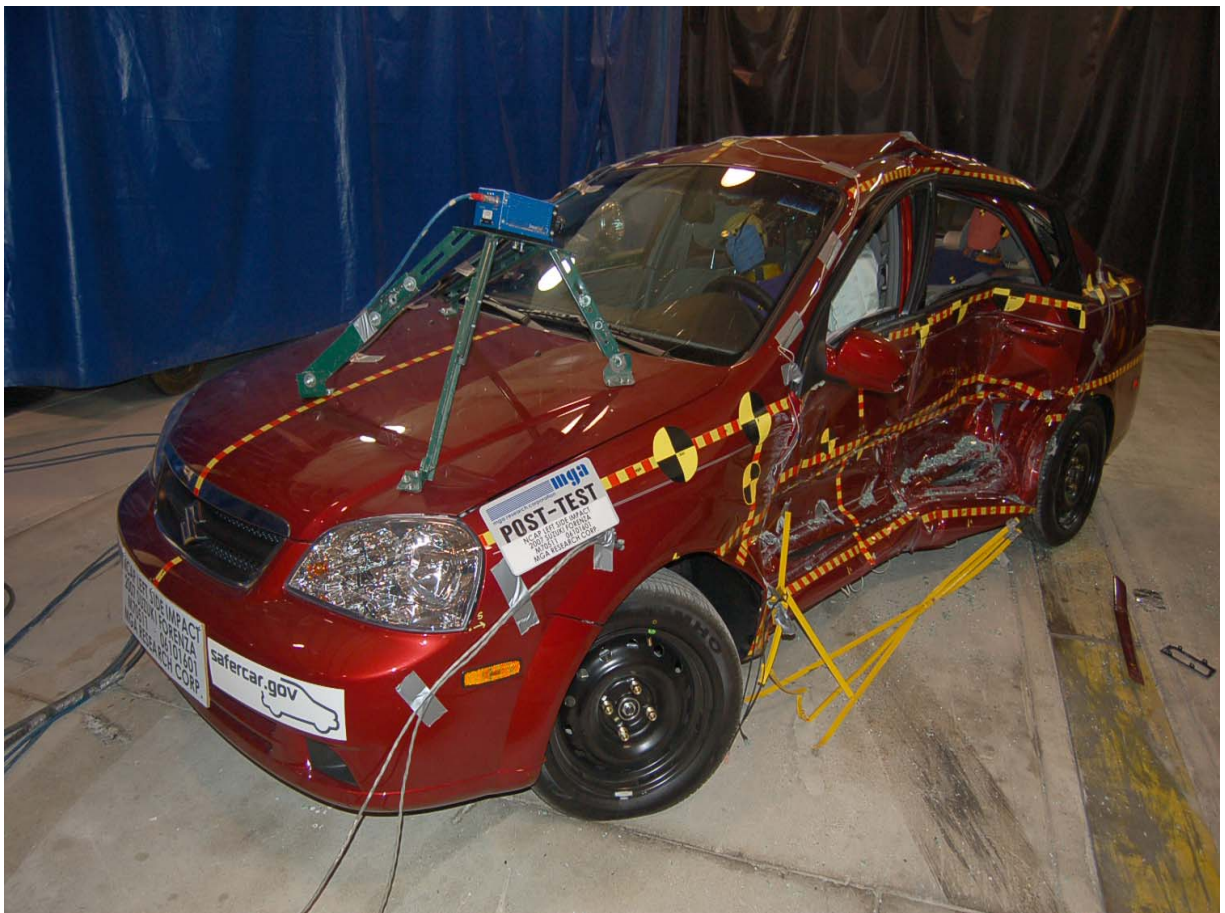
Post-Test Vehicle Left Front  $\frac{3}{4}$  View

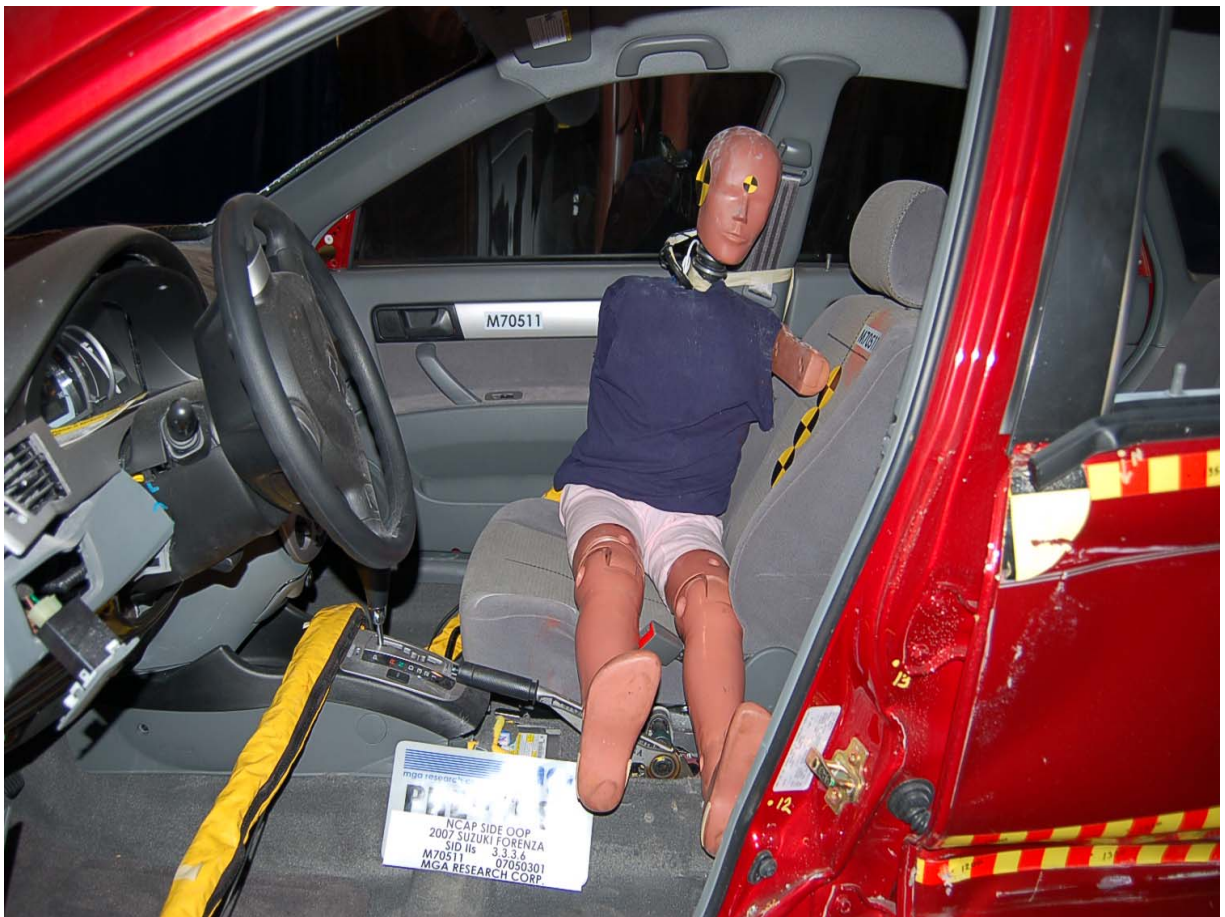
Pre-Test SID-IIs Dummy Frontal View

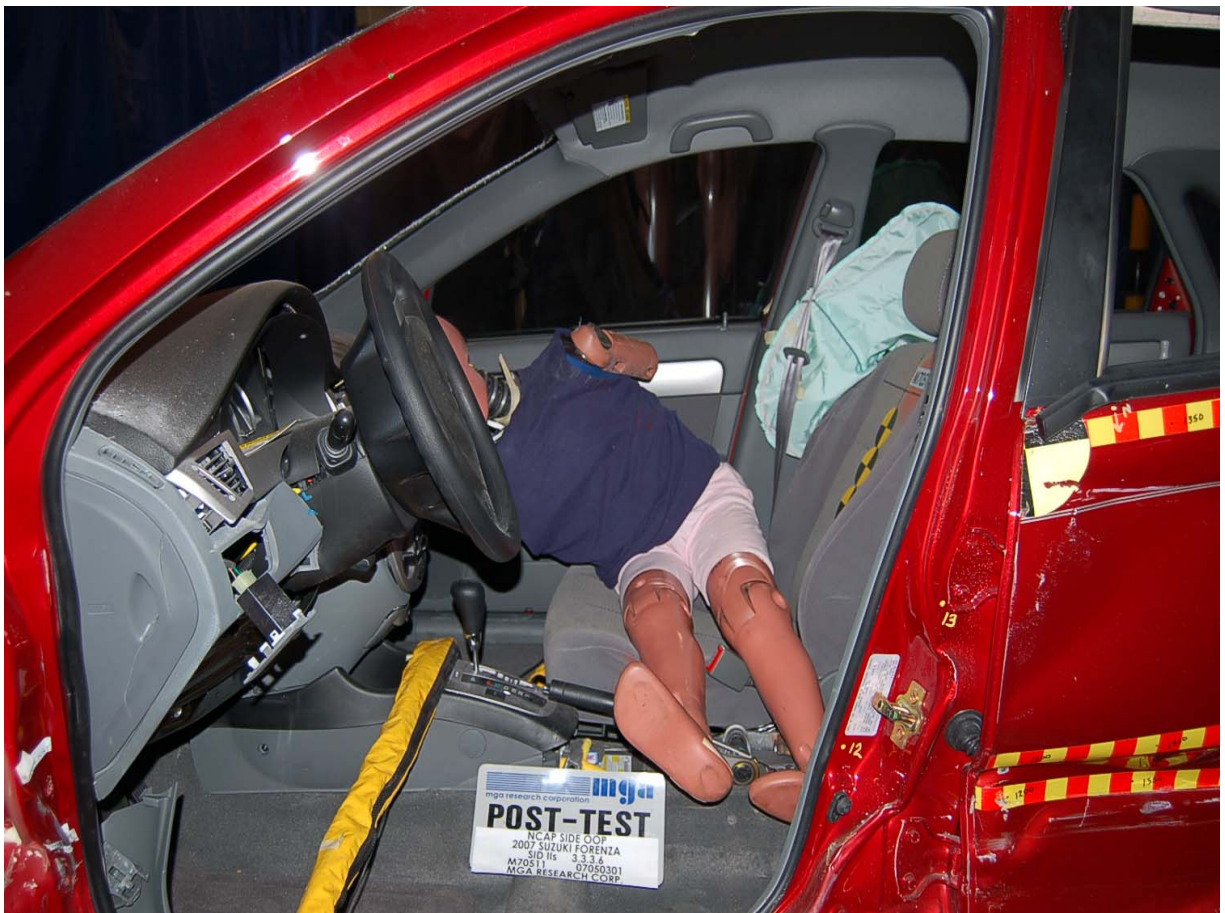
Post-Test SID-IIs Dummy Frontal View

The SID-IIs dummy's visible contact points were as follows: The combo bag to the left shoulder of the dummy.

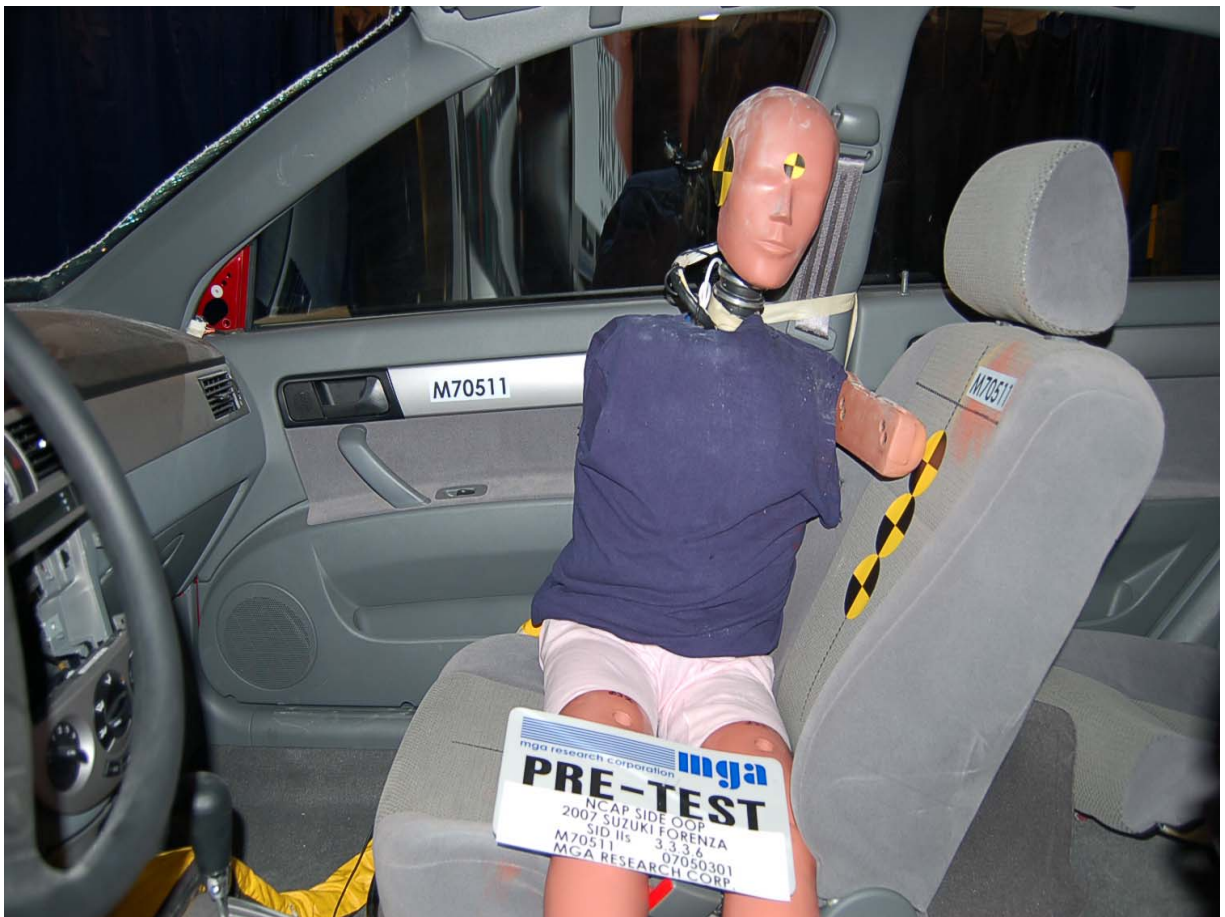
Pre-Test SID-IIs Dummy Frontal Closeup View

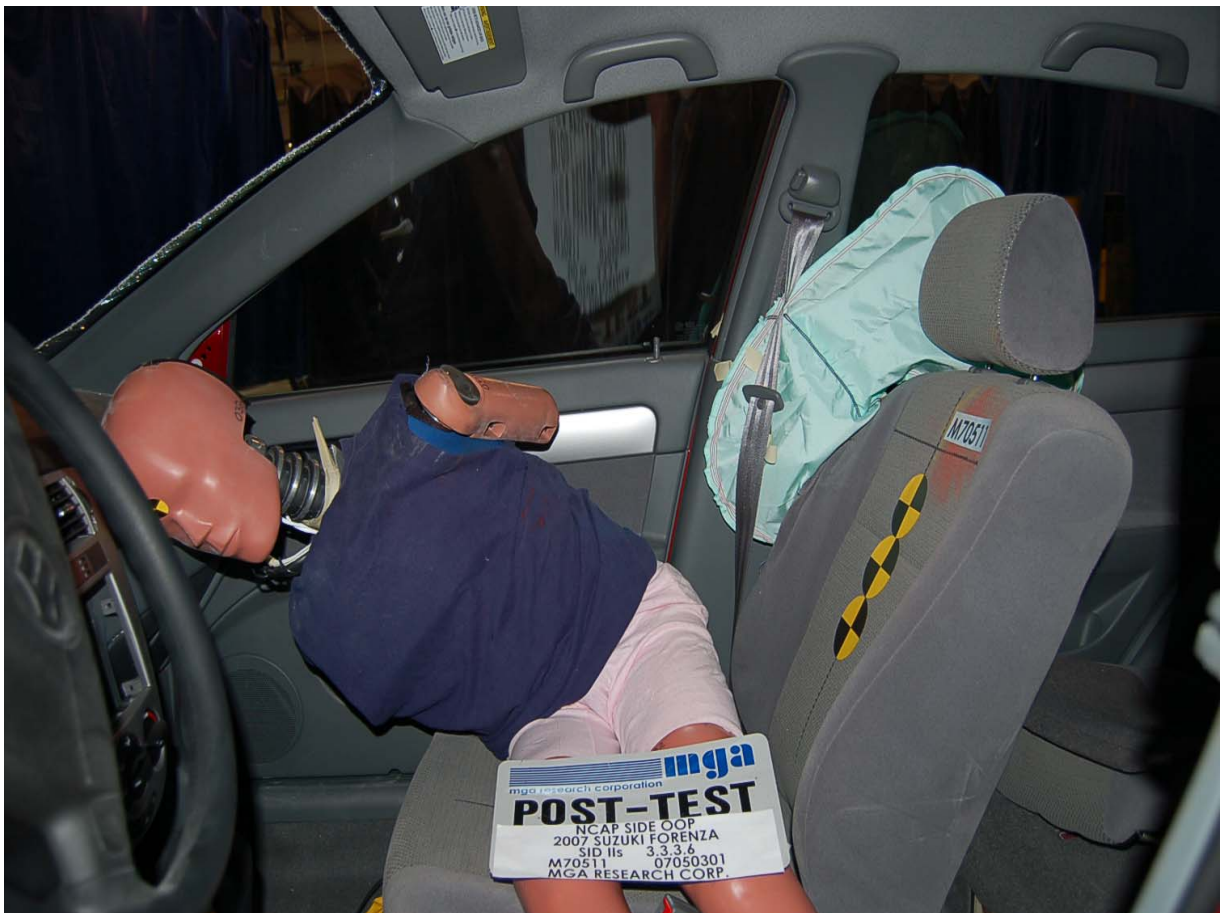
Post-Test SID-IIs Dummy Frontal Closeup View

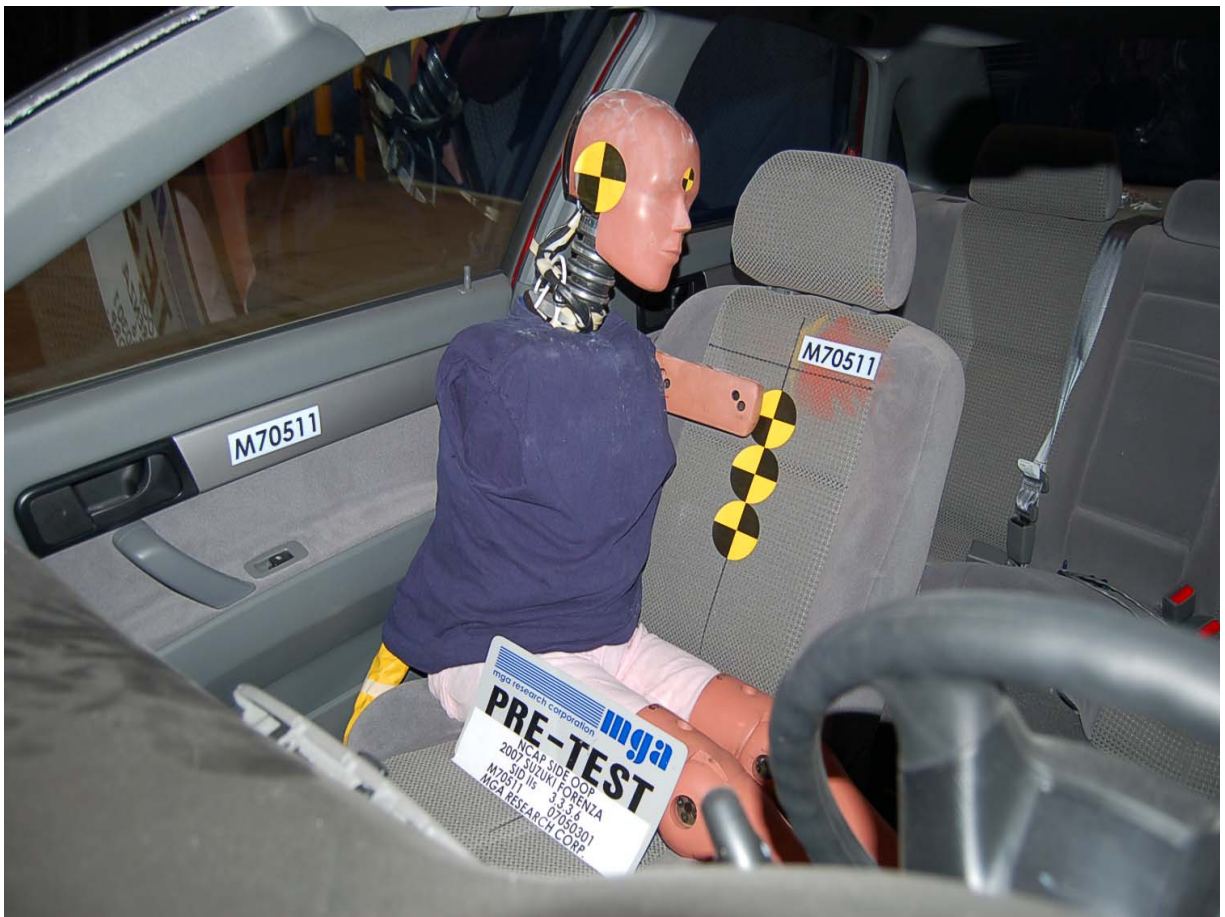
Pre-Test SID-IIs Dummy Right ¾ Front View

The SID-II's dummy was placed in the right front passenger seat facing toward the center of the vehicle with its arm against the seatback. The dummy's pelvis was adjusted until the dummy contacted the door trim panel. The arm was rotated to a horizontal orientation. The dummy's pelvis was then adjusted forward/rearward, with respect to the vehicle, to lean the dummy rearward to align the center of the first thoracic rib with the top edge of the airbag module. The dummy's spine was aligned such that a vertical plane through the centerline of the dummy's shoulder rib stiffener and shoulder bolt was parallel to the longitudinal plane of the vehicle. Masking tape was wrapped around the dummy's neck bracket to hold the dummy in place, if necessary.

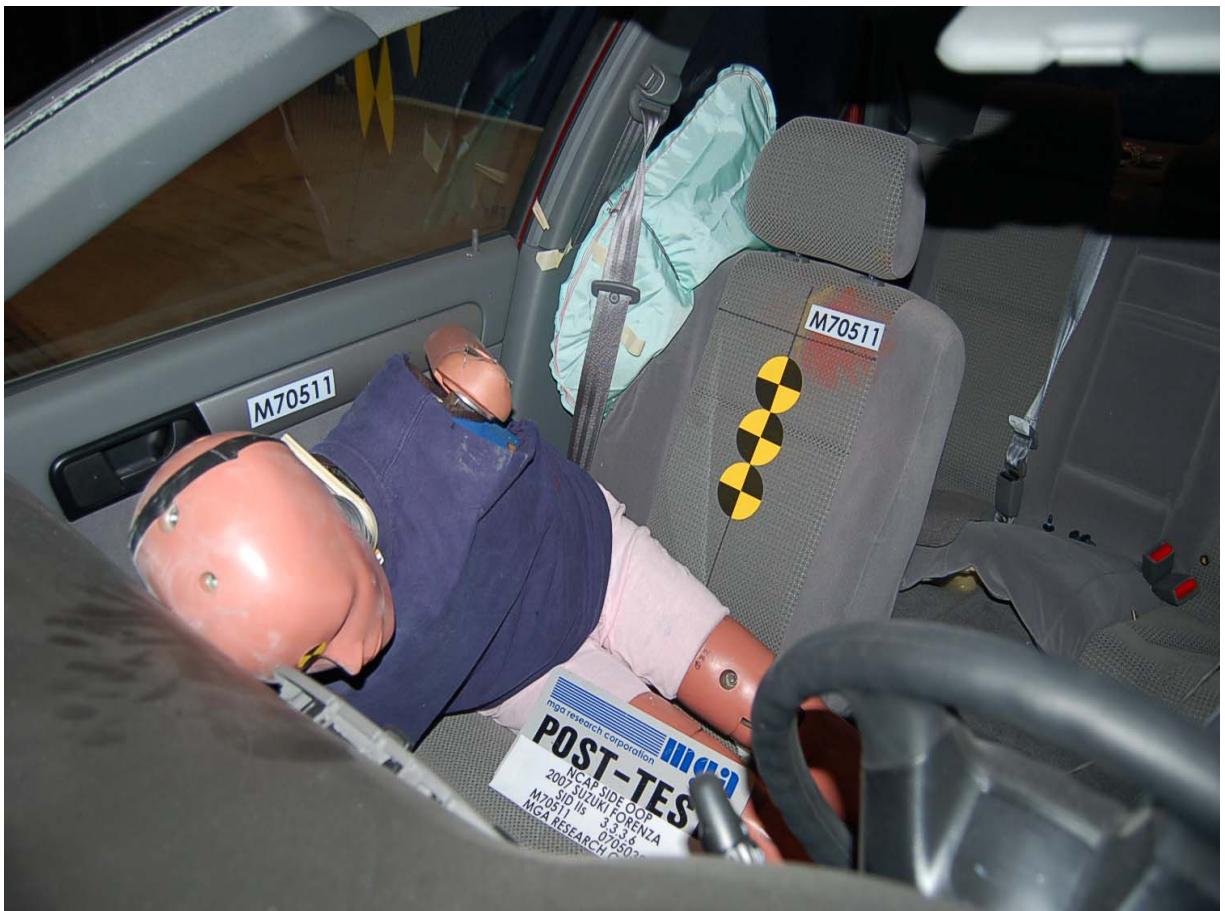
Post-Test SID-IIs Dummy Right ¾ Front View

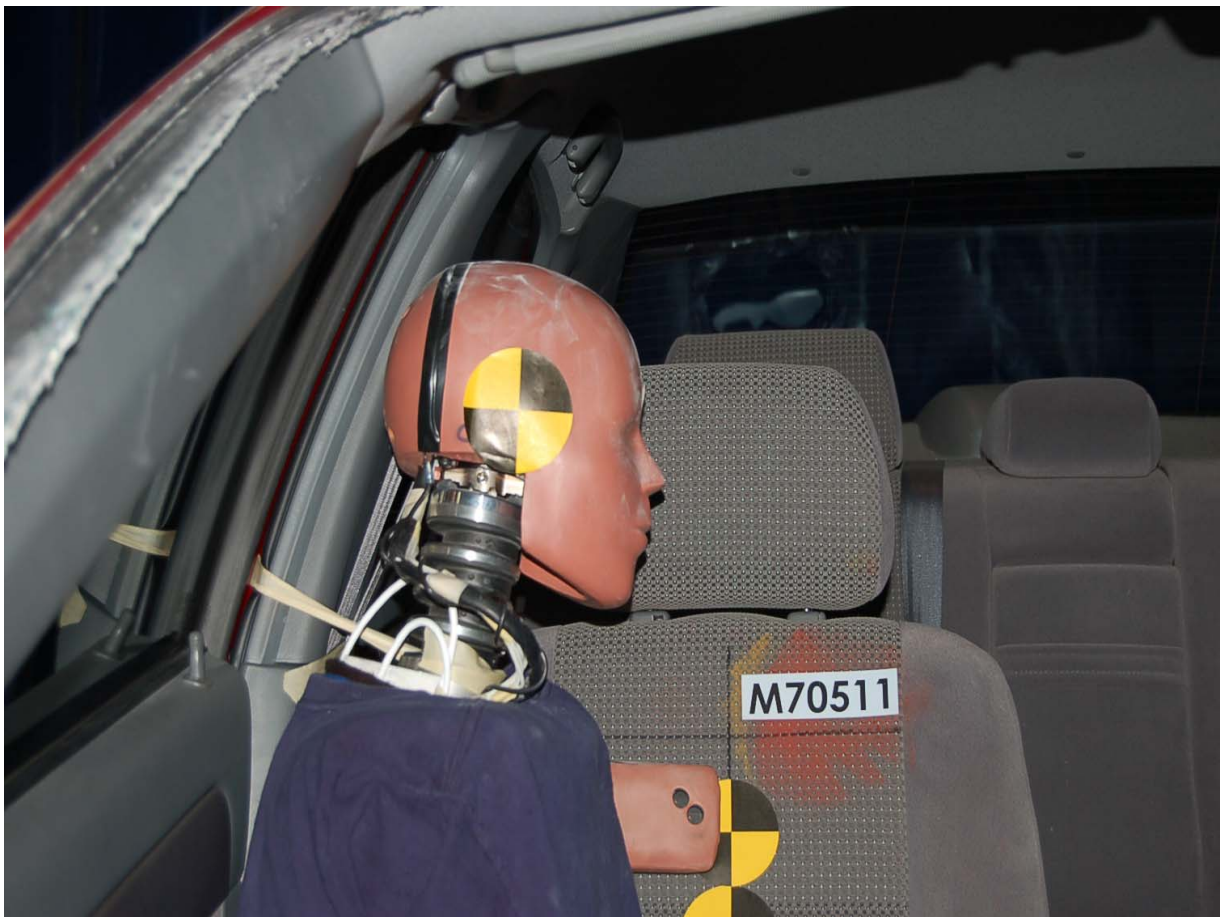
Pre-Test SID-IIs Dummy Right Side Head View

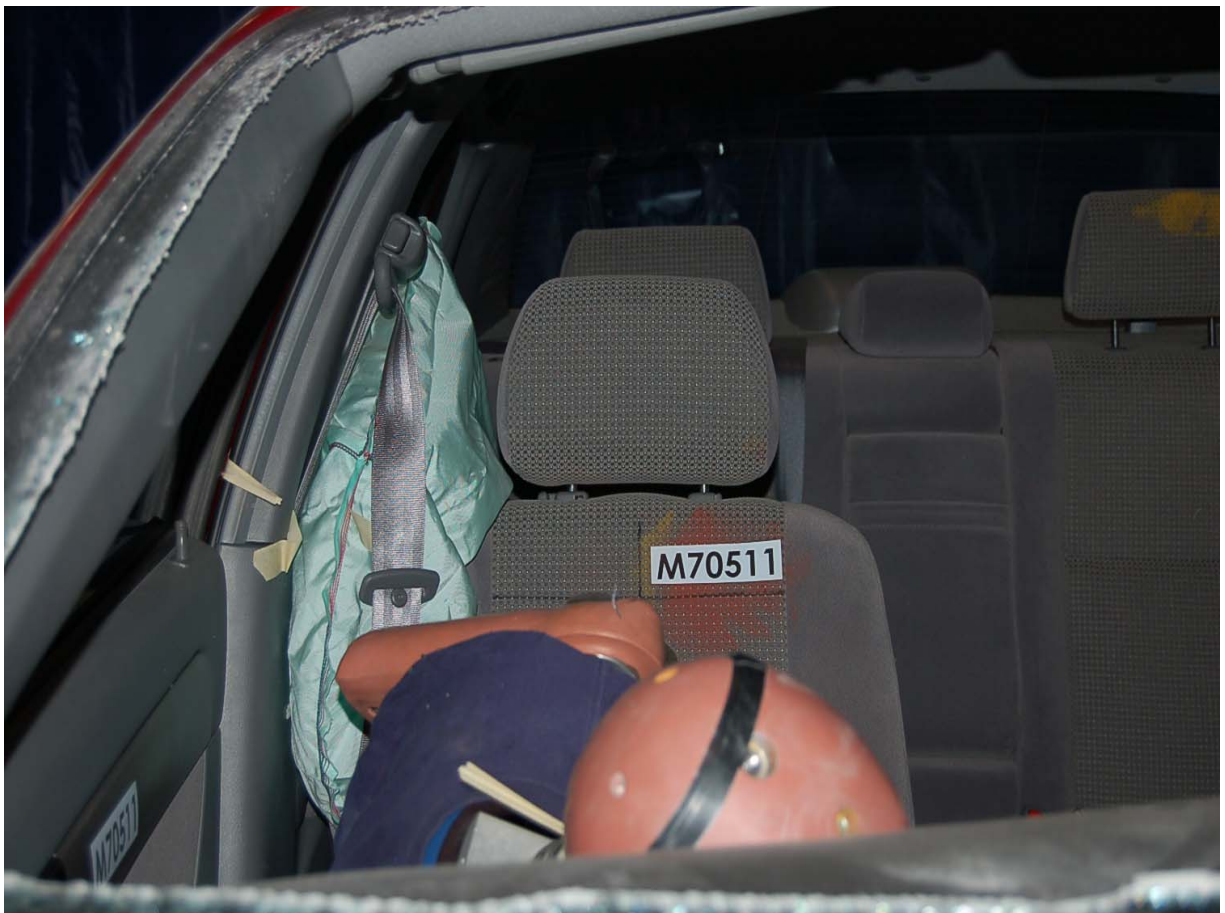
Post-Test SID-IIs Dummy Right Side Head View

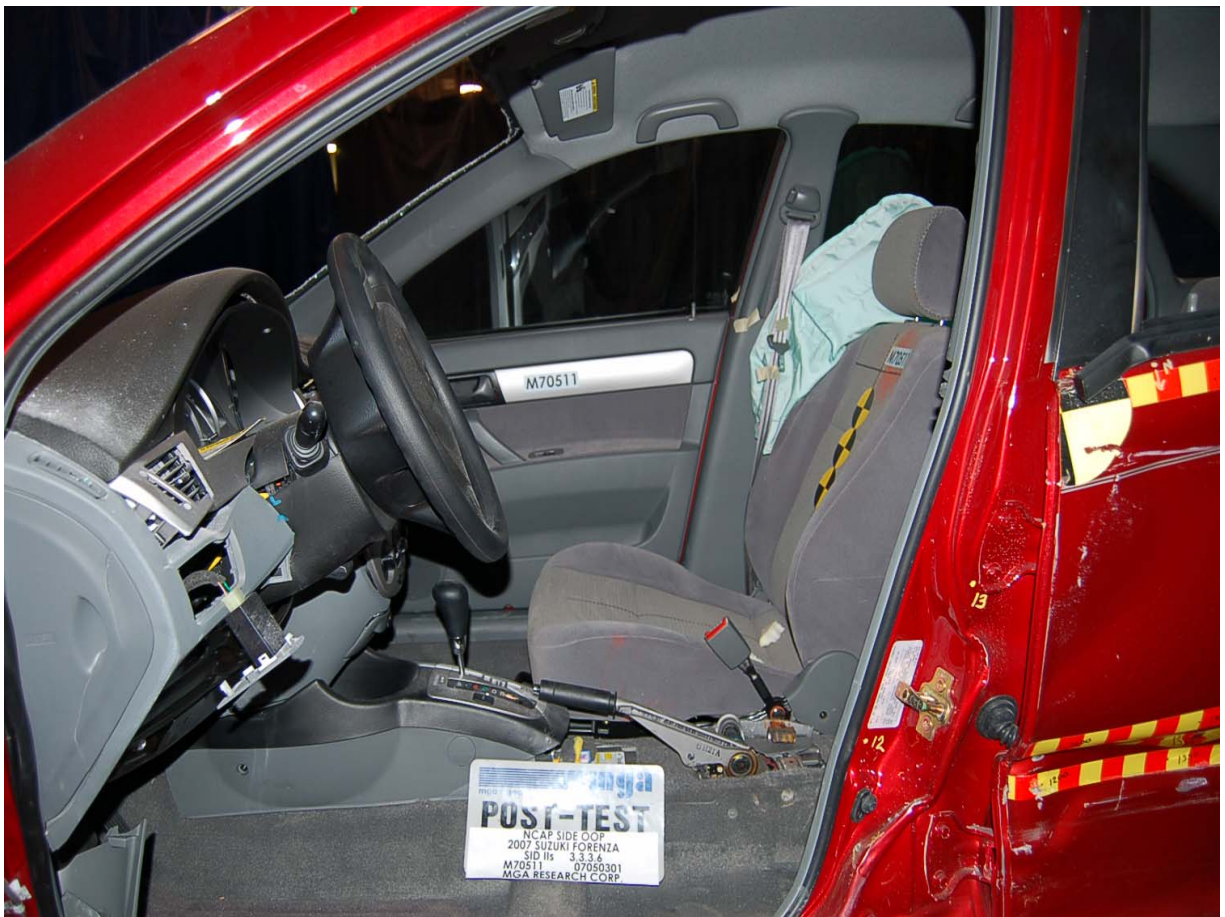
Post-Test Right Front Passenger Compartment View

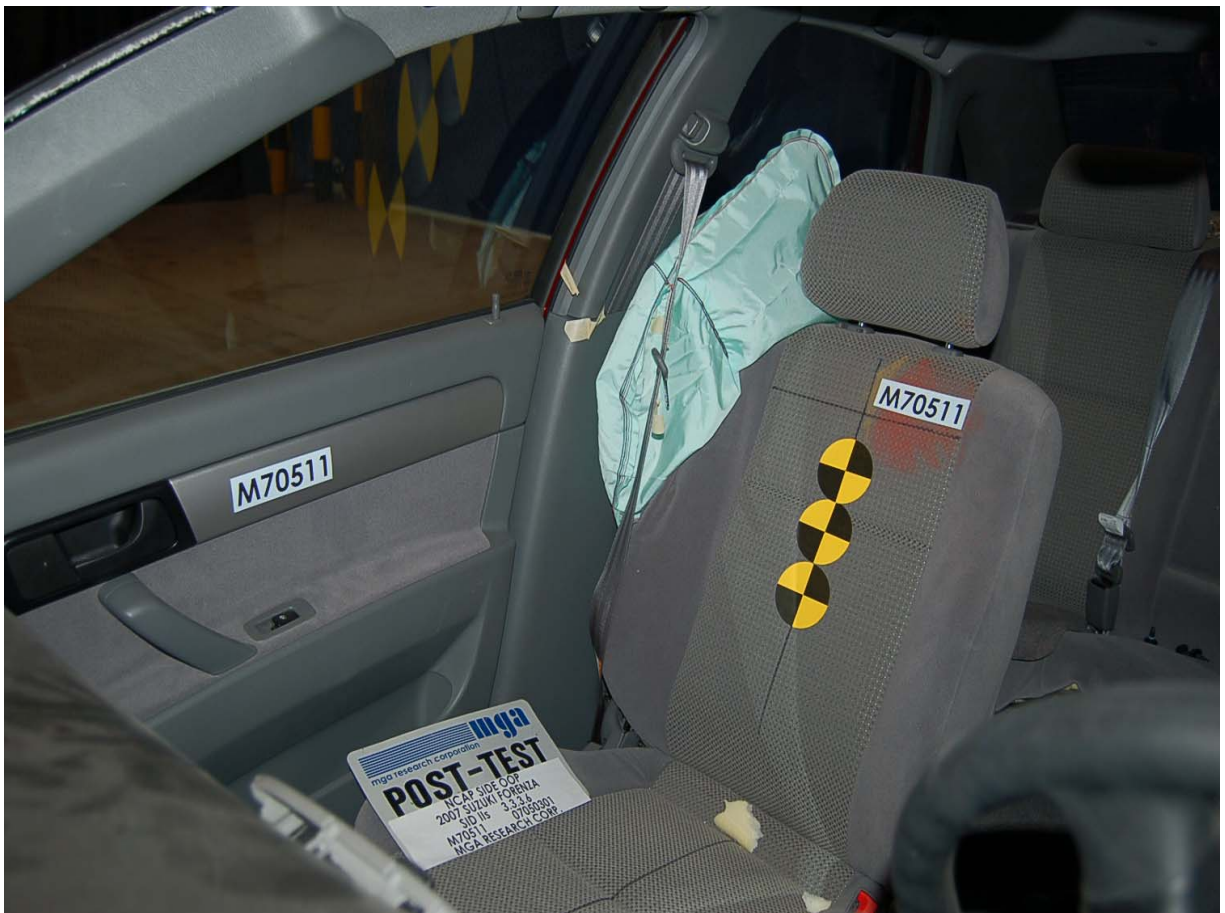
Post-Test Combo Airbag View

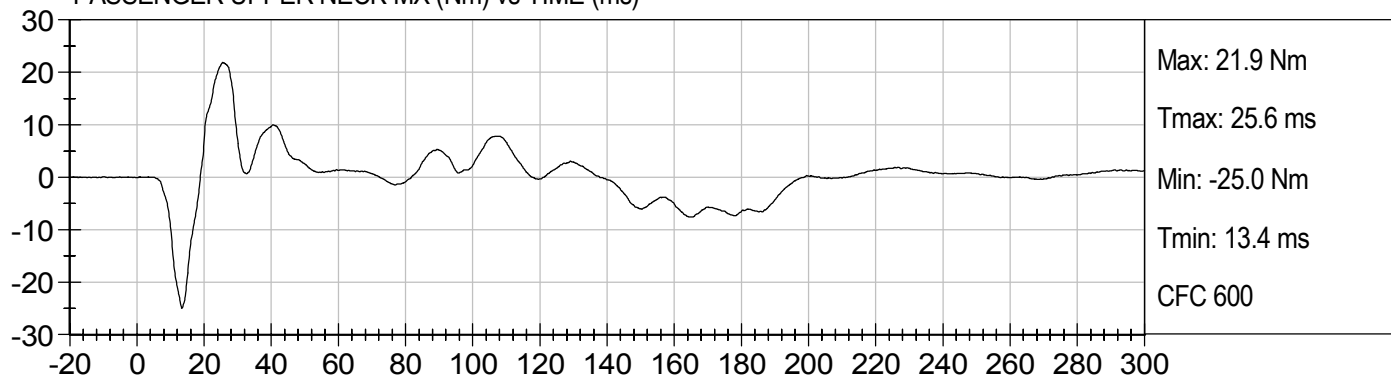
PASSENGER UPPER NECK MX (Nm) vs TIME (ms)

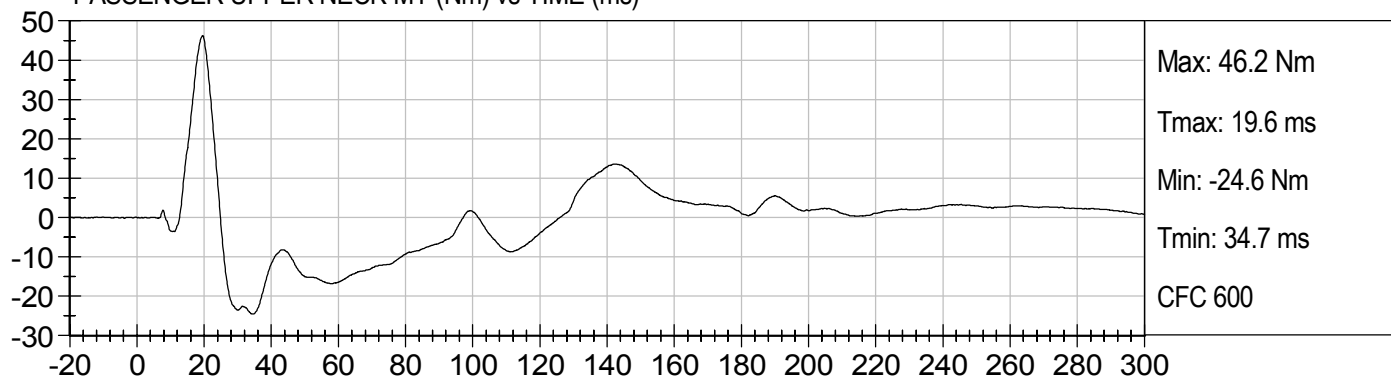
PASSENGER UPPER NECK MY (Nm) vs TIME (ms)

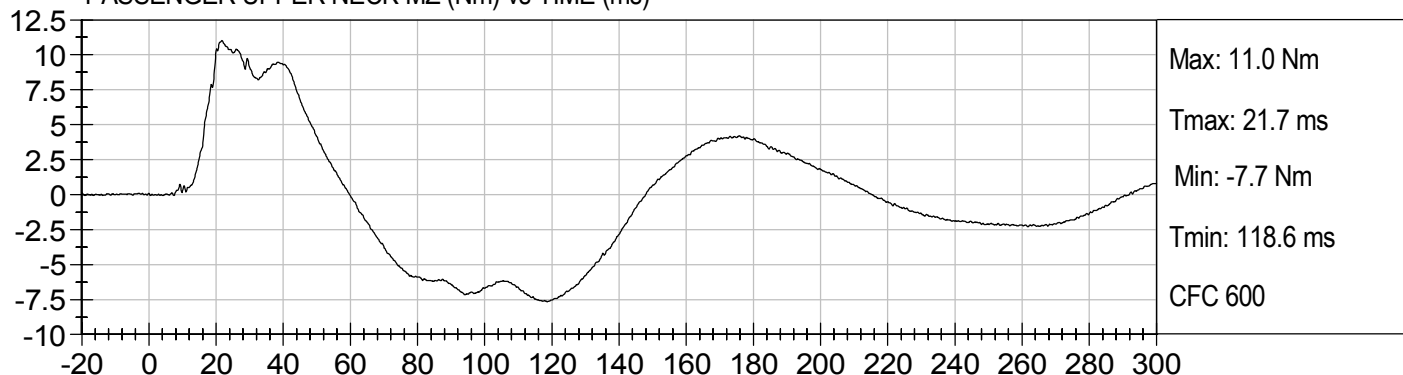
PASSENGER UPPER NECK MZ (Nm) vs TIME (ms)

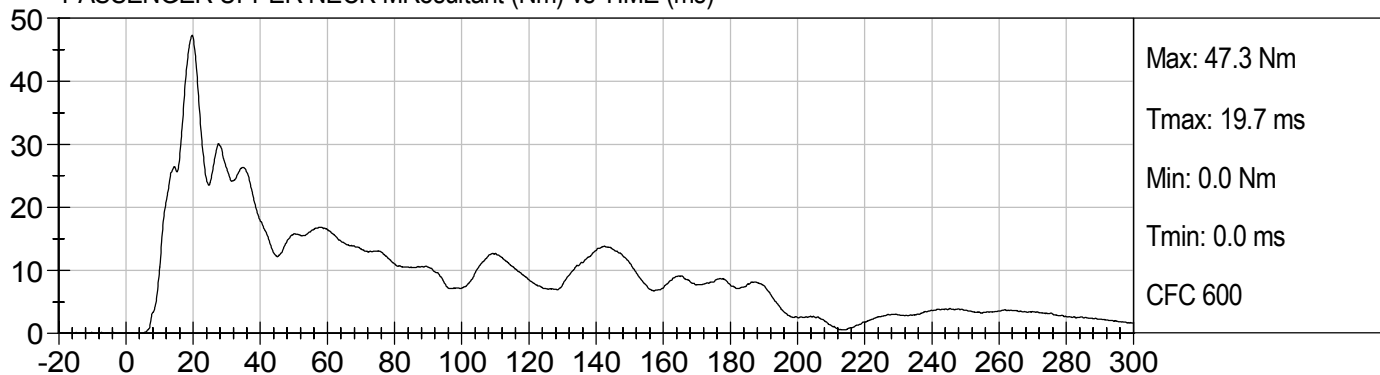
PASSENGER UPPER NECK MResultant (Nm) vs TIME (ms)

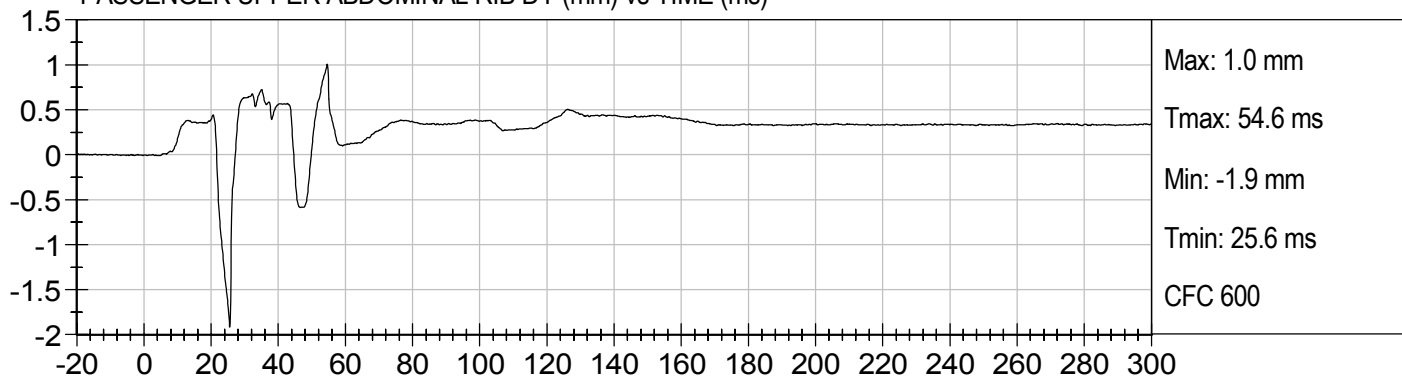
PASSENGER UPPER ABDOMINAL RIB DY (mm) vs TIME (ms)

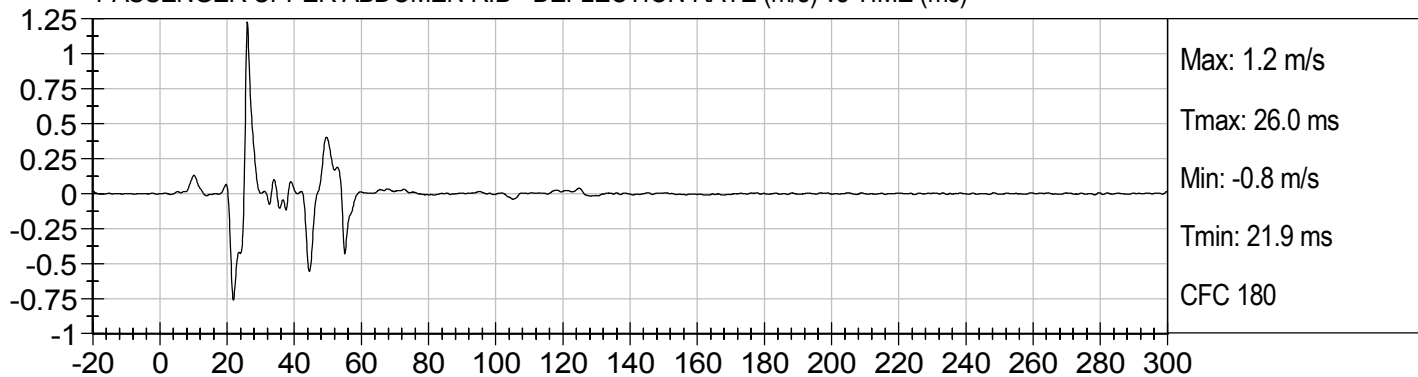
PASSENGER UPPER ABDOMEN RIB - DEFLECTION RATE (m/s) vs TIME (ms)

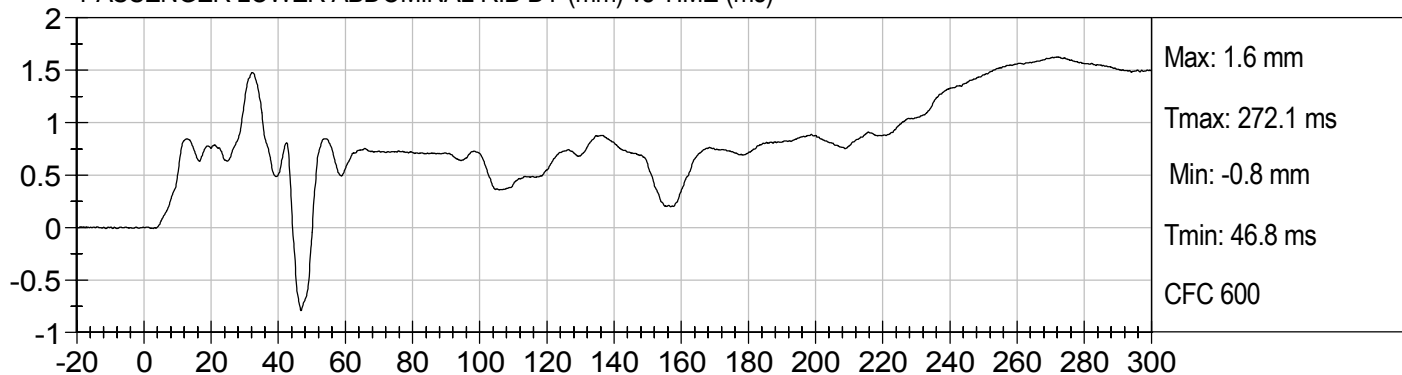
PASSENGER LOWER ABDOMINAL RIB DY (mm) vs TIME (ms)

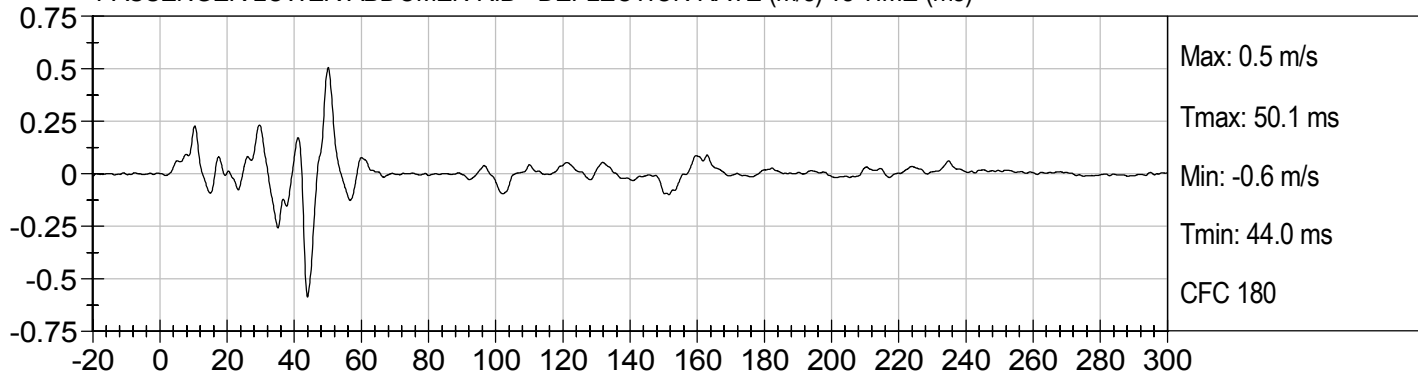
PASSENGER LOWER ABDOMEN RIB - DEFLECTION RATE (m/s) vs TIME (ms)

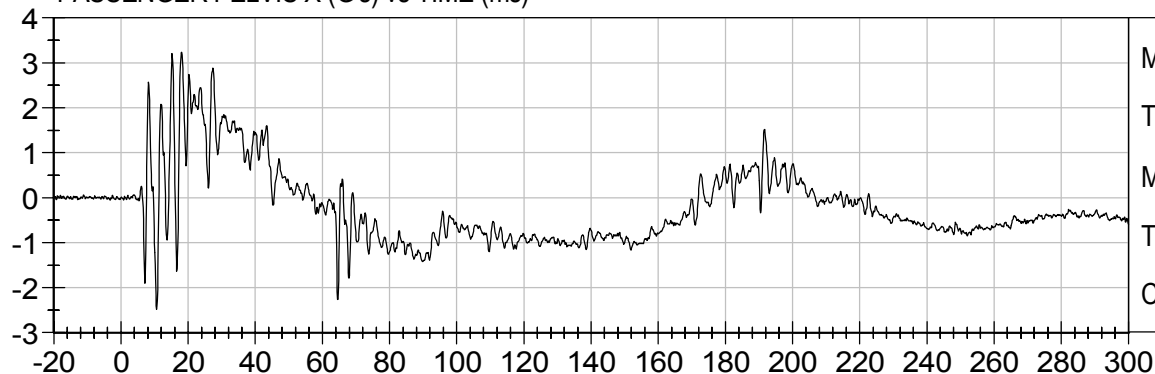
PASSENGER PELVIS X (G's) vs TIME (ms)

Max: 3.2 G's  
Tmax: 18.1 ms  
Min: -2.5 G's  
Tmin: 10.6 ms  
CFC 1000

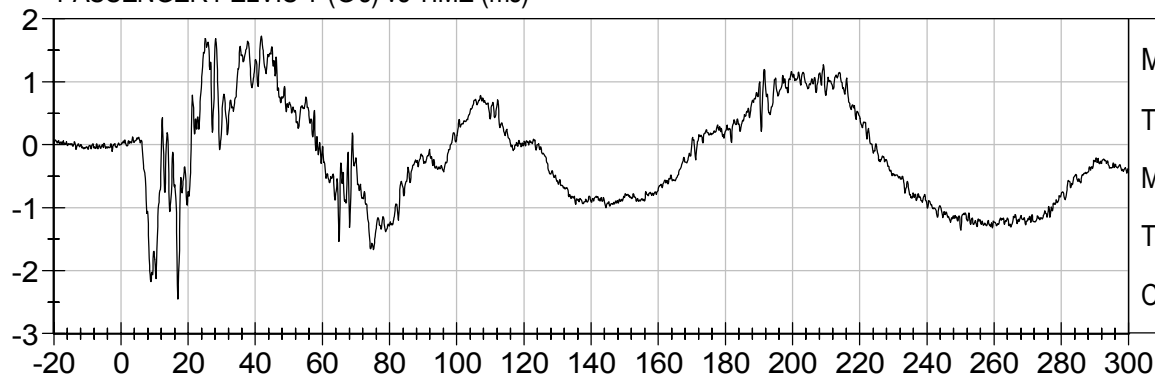
PASSENGER PELVIS Y (G's) vs TIME (ms)

Max: 1.7 G's  
Tmax: 41.8 ms  
Min: -2.5 G's  
Tmin: 16.9 ms  
CFC 1000

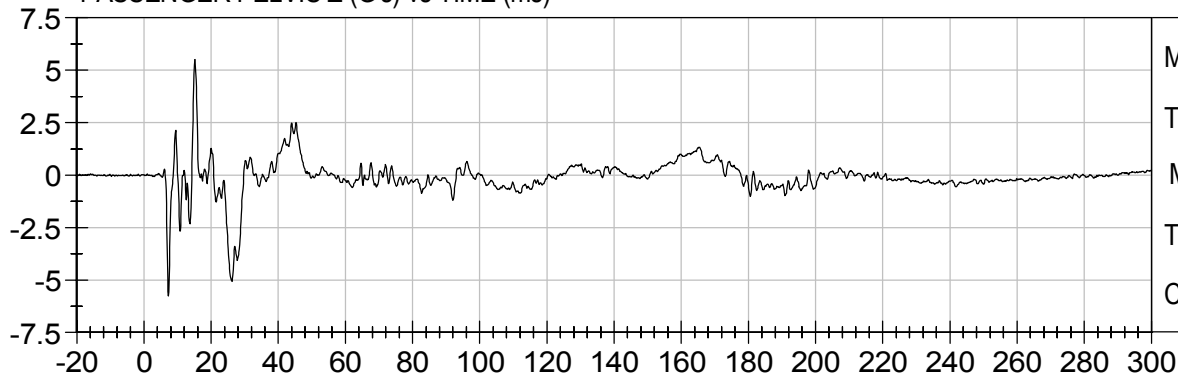
PASSENGER PELVIS Z (G's) vs TIME (ms)

Max: 5.5 G's  
Tmax: 15.1 ms  
Min: -5.8 G's  
Tmin: 7.3 ms  
CFC 1000
