REPORT NUMBER: TWG-CAL07-02

**NEW CAR ASSESSMENT PROGRAM (NCAP)**  
SIDE AIRBAG OUT-OF-POSITION INJURY TESTING

2007 KIA SPECTRA  
FOUR DOOR SEDAN

NHTSA NUMBER: M70507TWG2

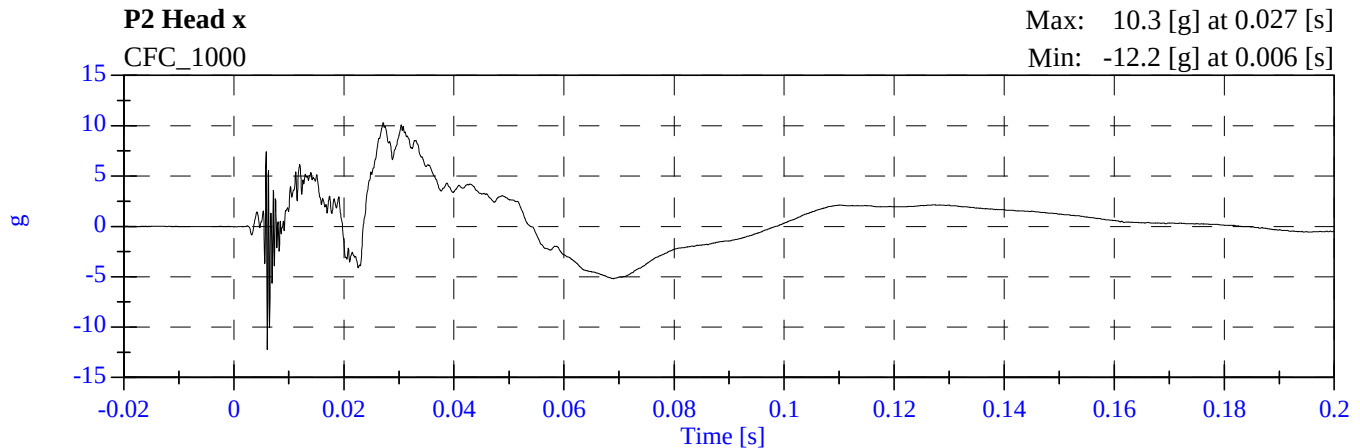
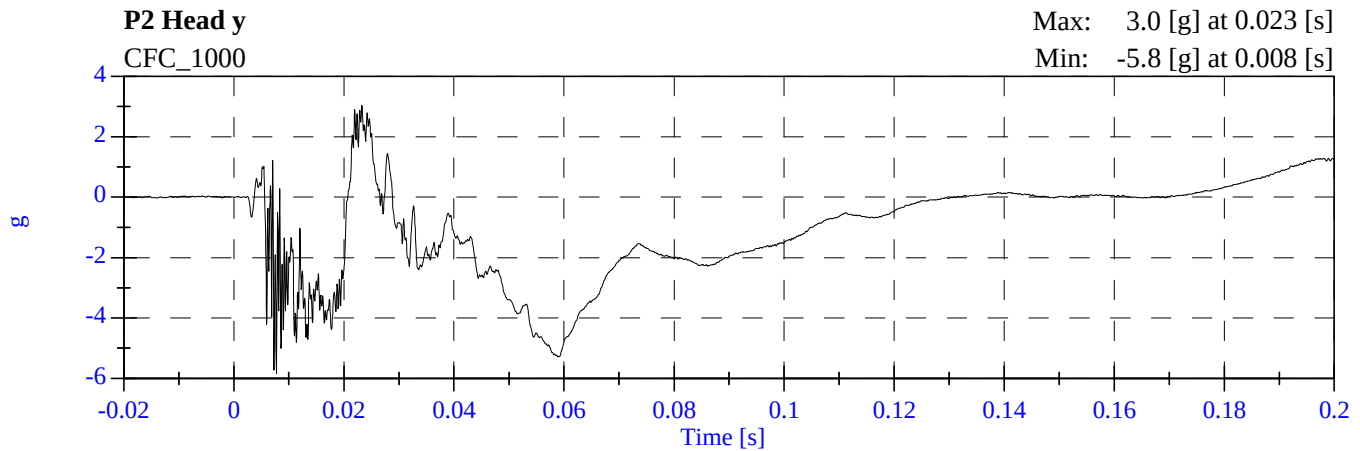
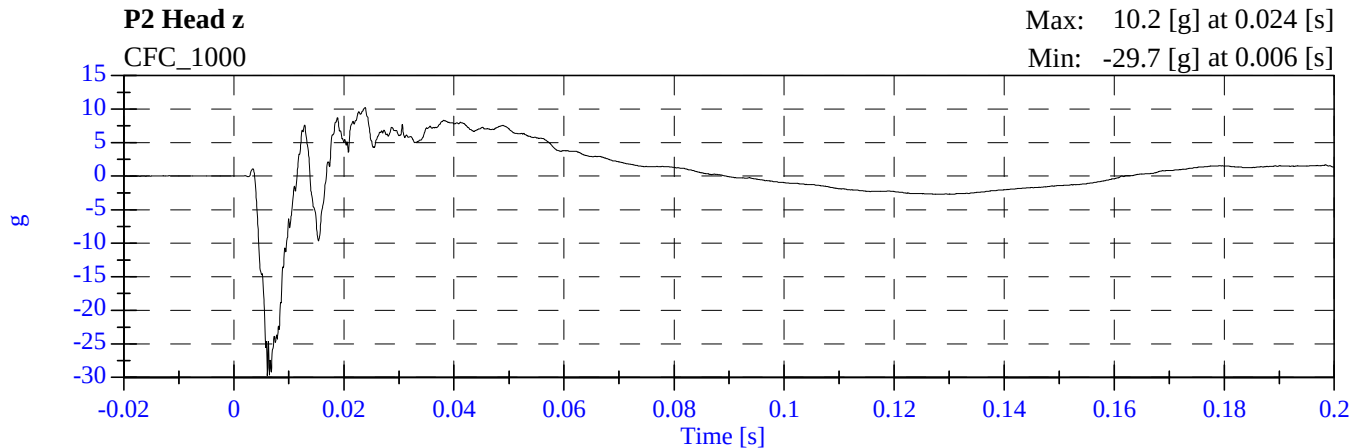
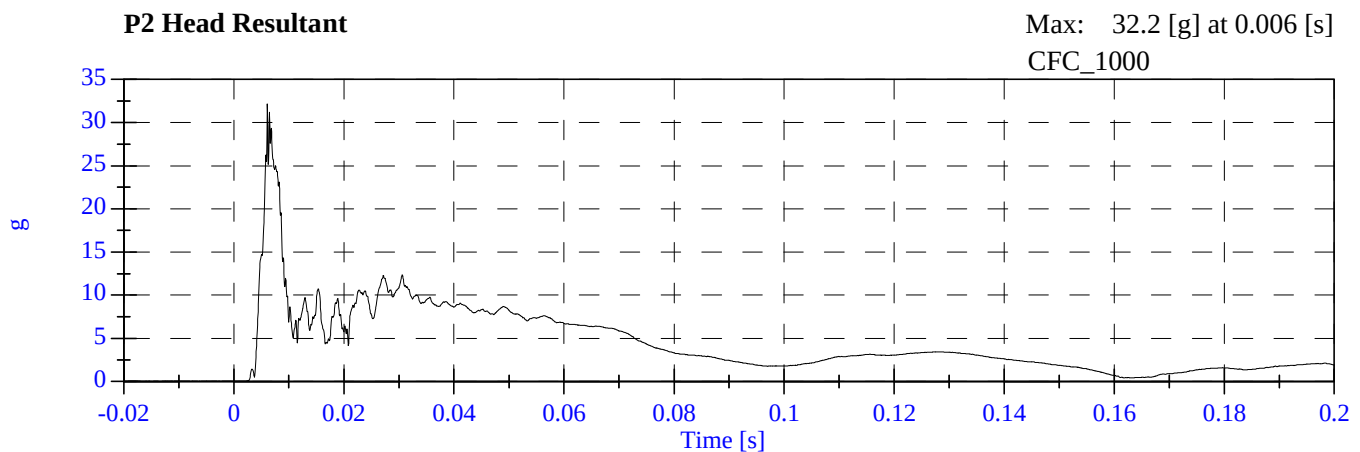
# 2007 TWG Test 2 2007 Kia Spectra M70507TWG2 - May 14, 2007

| PLOT | PLOT NAME[UNITS, CHANNEL FILTER CLASS] | PAGE |
|---|---|---|
| 1 | P2 Head x [g, CFC_1000] | B-3 |
| 2 | P2 Head y [g, CFC_1000] | B-3 |
| 3 | P2 Head z [g, CFC_1000] | B-3 |
| 4 | P2 Head Resultant [g, CFC_1000] | B-3 |

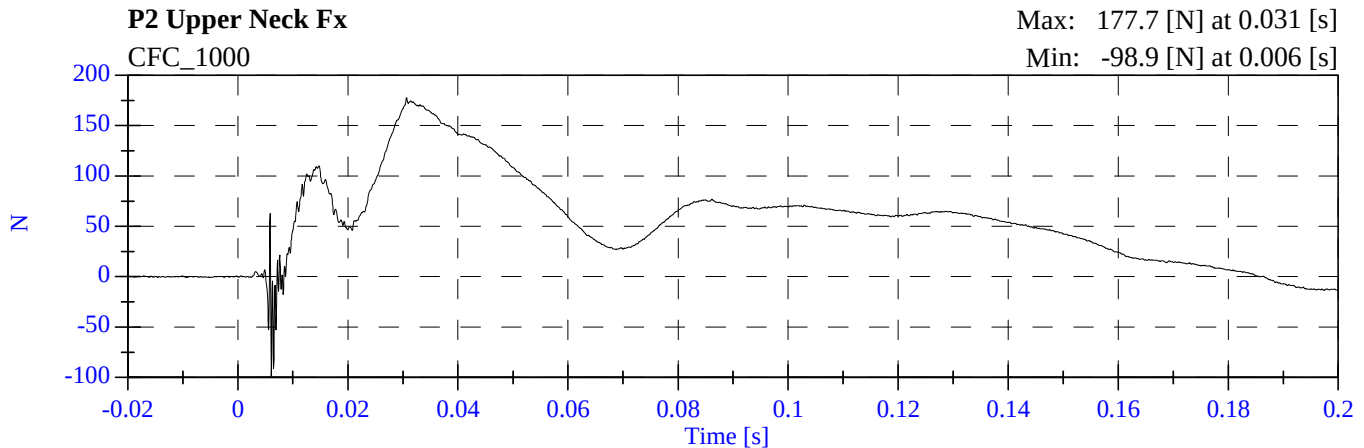
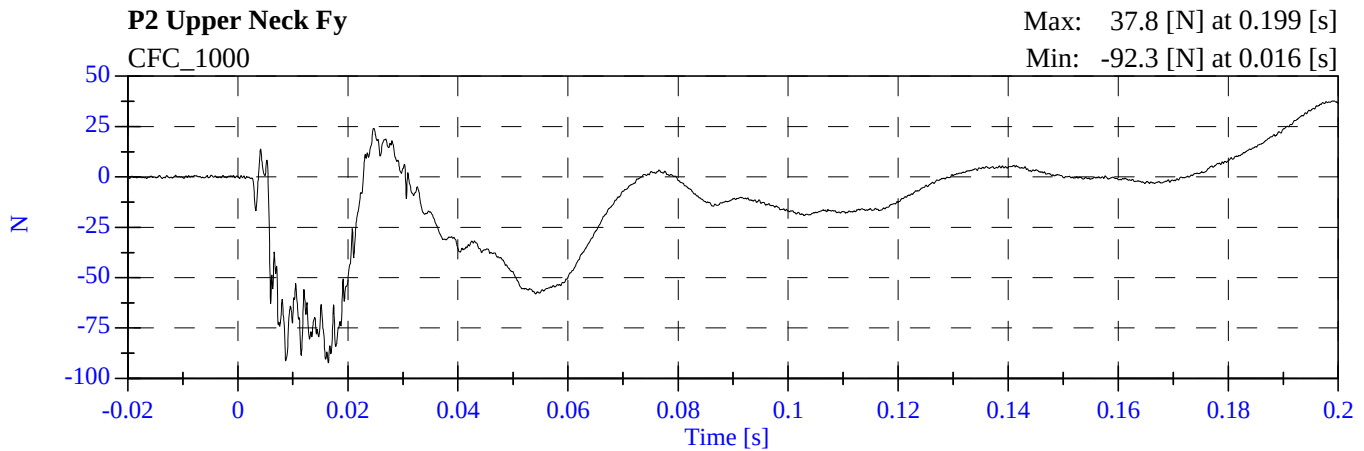
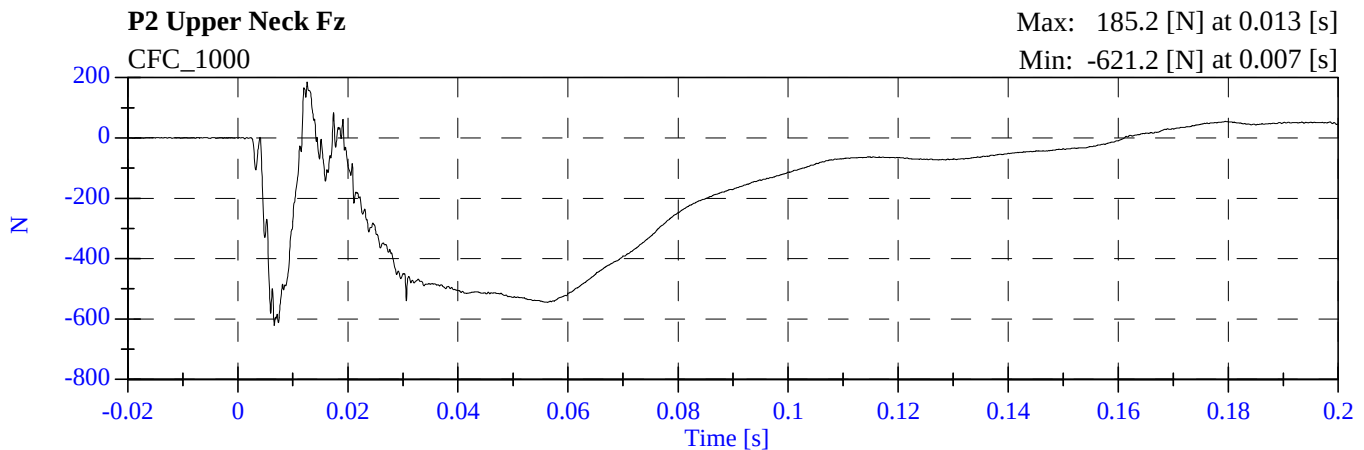
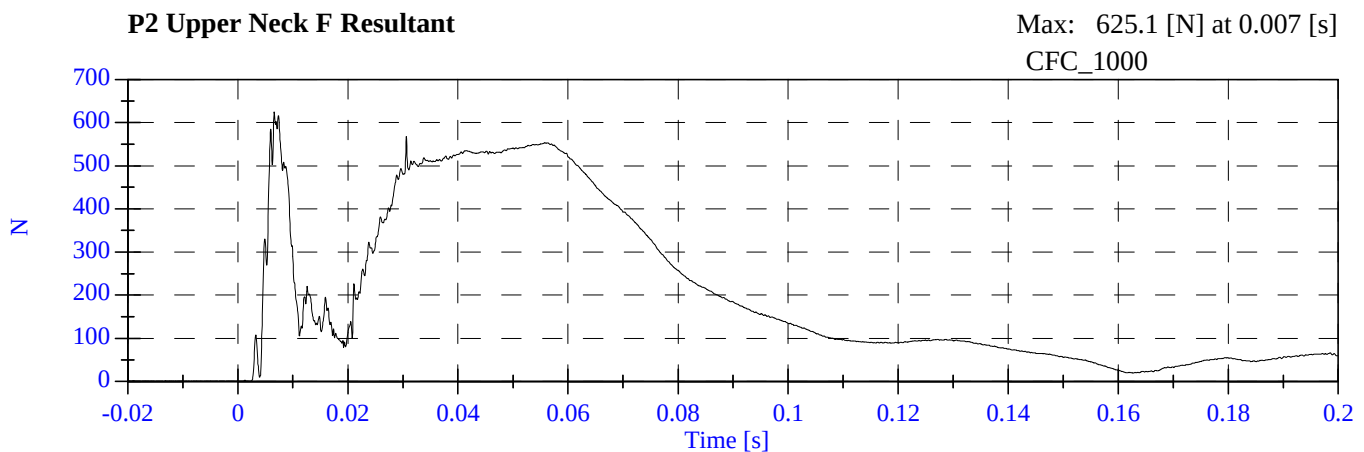
# 2007 TWG Test 2 2007 Kia Spectra

| PLOT | PLOT NAME[UNITS, CHANNEL FILTER CLASS] | PAGE |
|---|---|---|
| 5 | P2 Upper Neck Fx [N, CFC_1000] | B-4 |
| 6 | P2 Upper Neck Fy [N, CFC_1000] | B-4 |
| 7 | P2 Upper Neck Fz [N, CFC_1000] | B-4 |
| 8 | P2 Upper Neck F Resultant [N, CFC_1000] | B-4 |

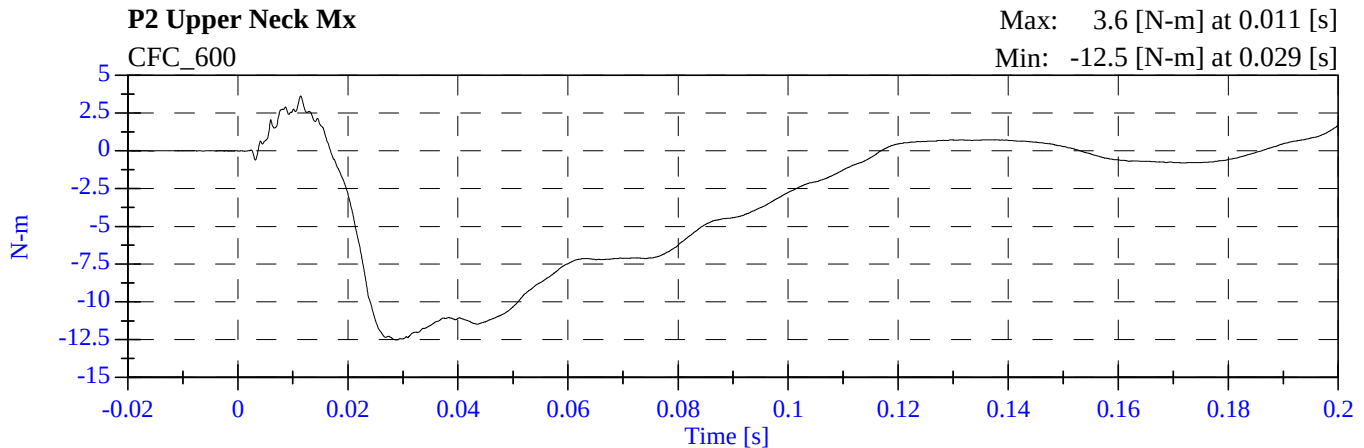
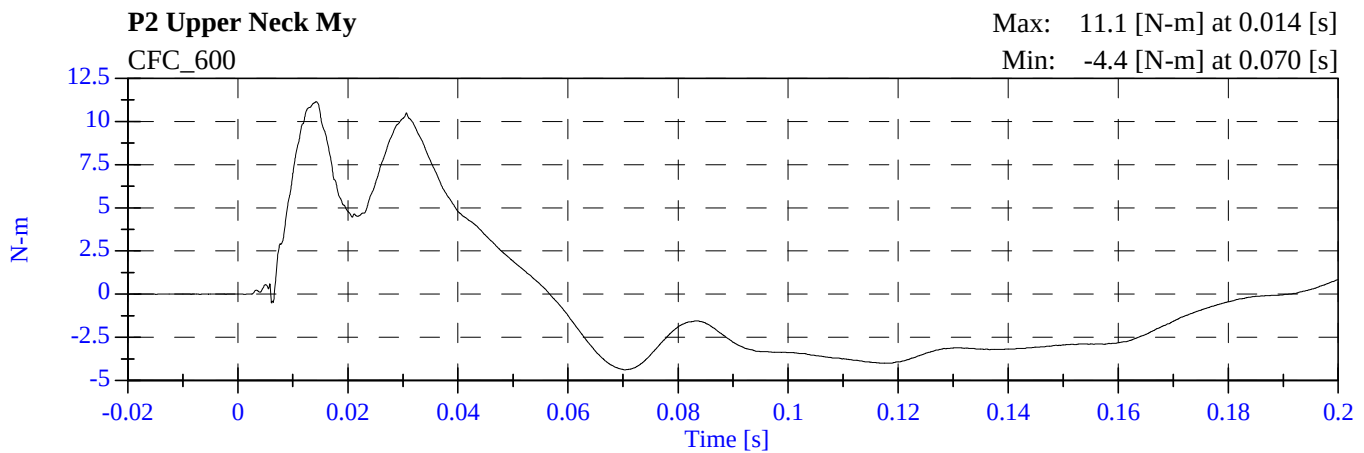
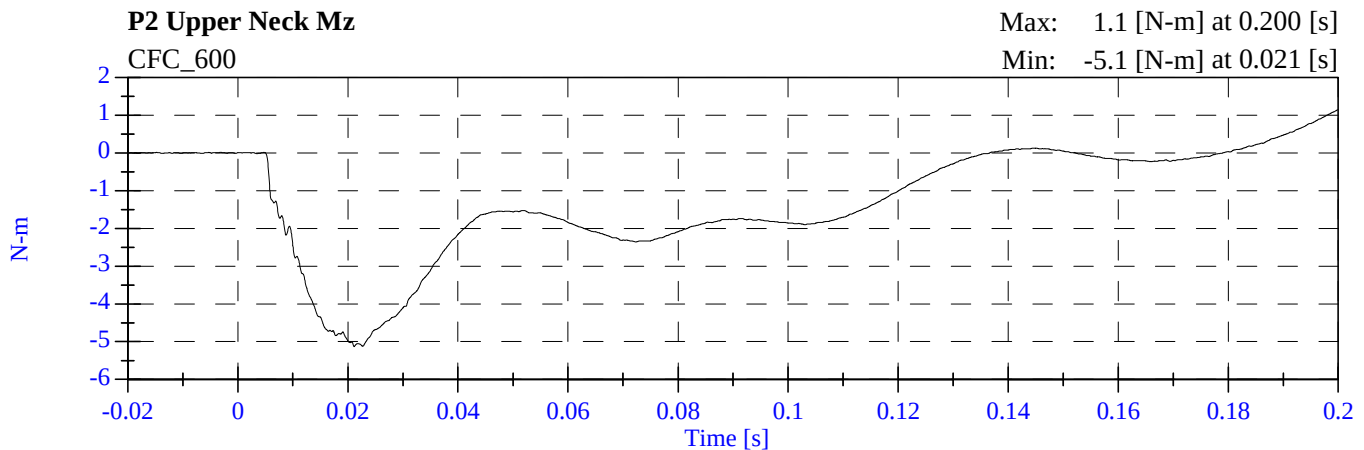
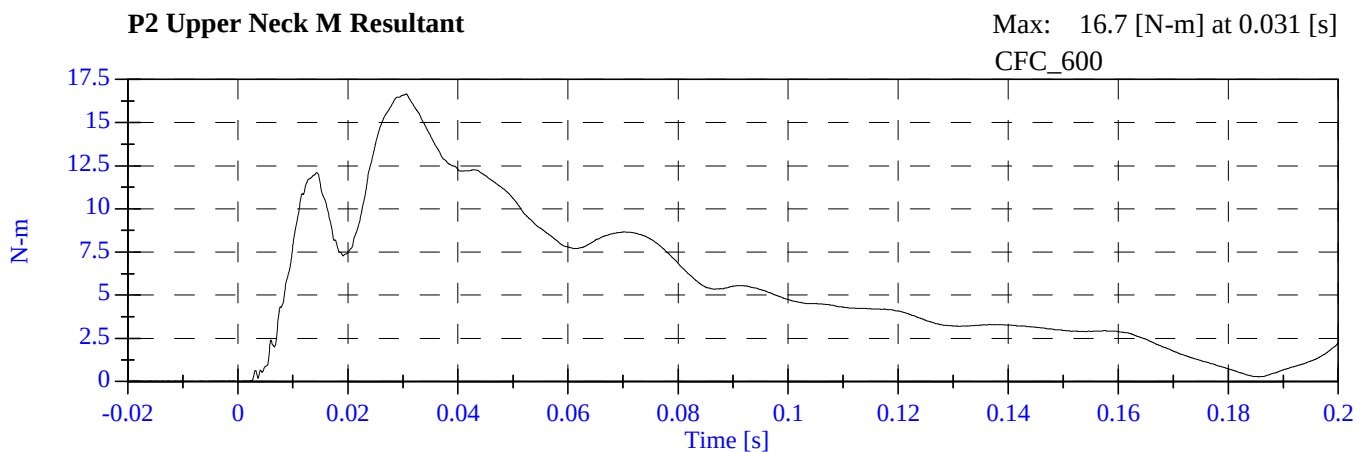
# 2007 TWG Test 2 2007 Kia Spectra

| PLOT | PLOT NAME[UNITS, CHANNEL FILTER CLASS] | PAGE |
|---|---|---|
| 9 | P2 Upper Neck Mx [N-m, CFC_600] | B-5 |
| 10 | P2 Upper Neck My [N-m, CFC_600] | B-5 |
| 11 | P2 Upper Neck Mz [N-m, CFC_600] | B-5 |
| 12 | P2 Upper Neck M Resultant [N-m, CFC_600] | B-5 |

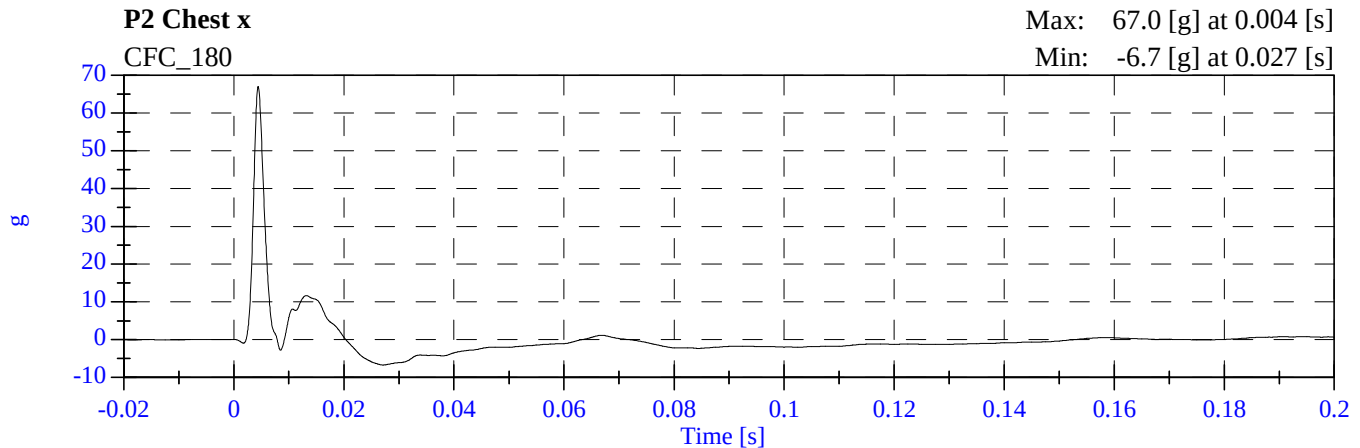
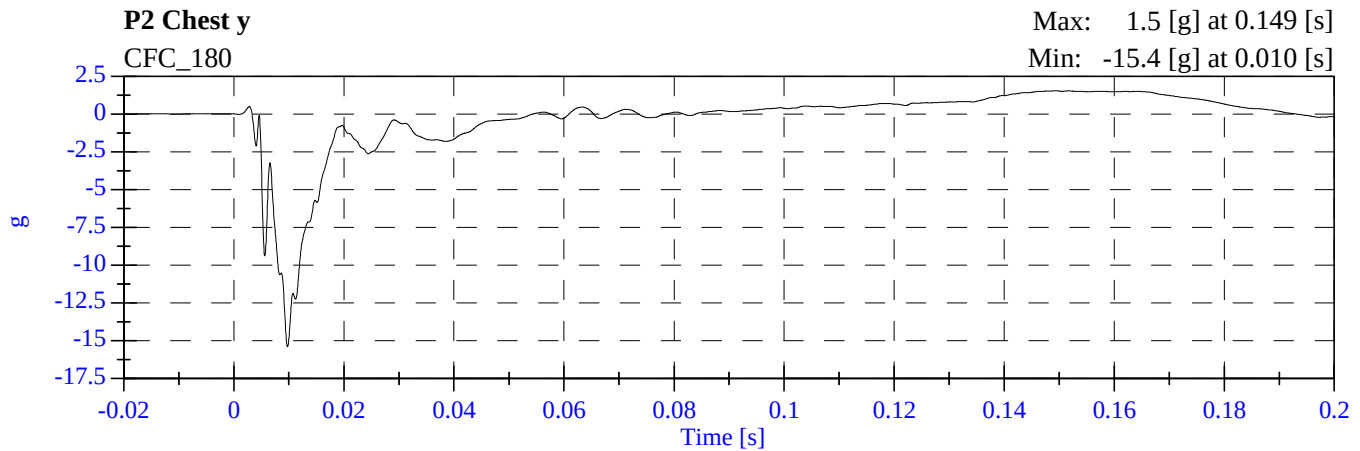
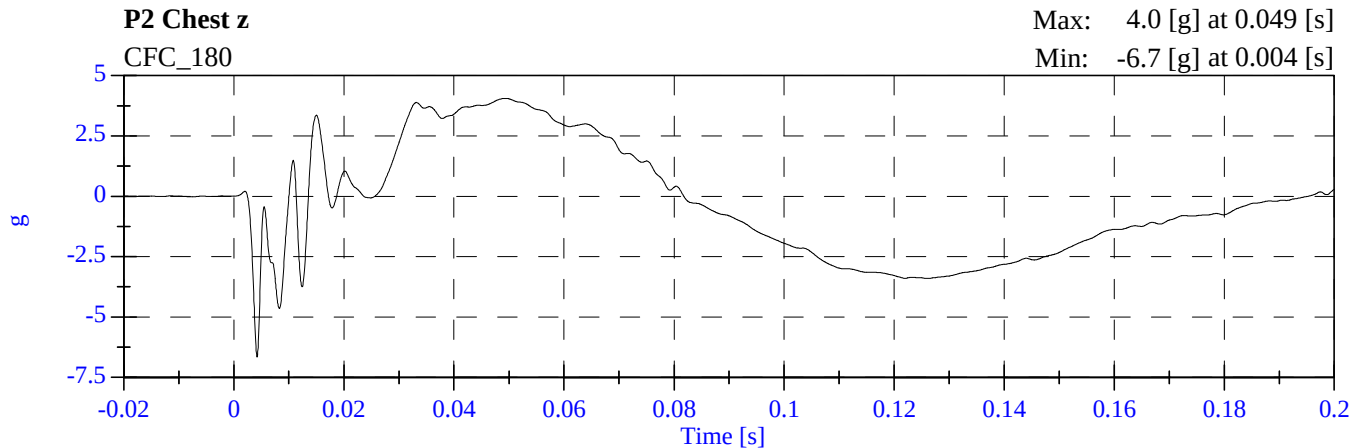
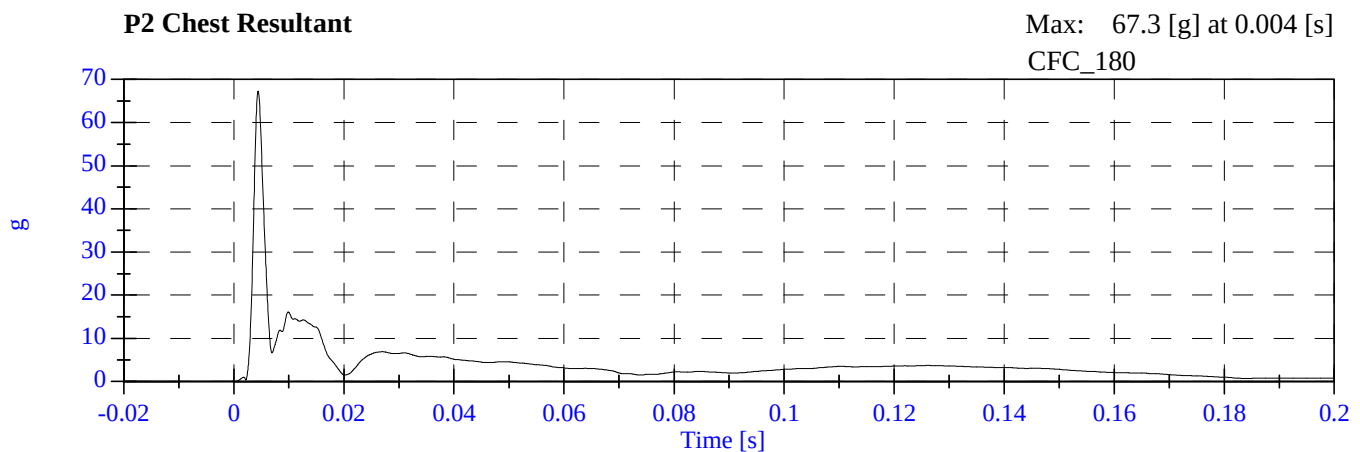
# 2007 TWG Test 2 2007 Kia Spectra M70507TWG2 - May 14, 2007

| PLOT | PLOT NAME[UNITS, CHANNEL FILTER CLASS] | PAGE |
|---|---|---|
| 13 | P2 Chest x [g, CFC_180] | B-6 |
| 14 | P2 Chest y [g, CFC_180] | B-6 |
| 15 | P2 Chest z [g, CFC_180] | B-6 |
| 16 | P2 Chest Resultant [g, CFC_180] | B-6 |

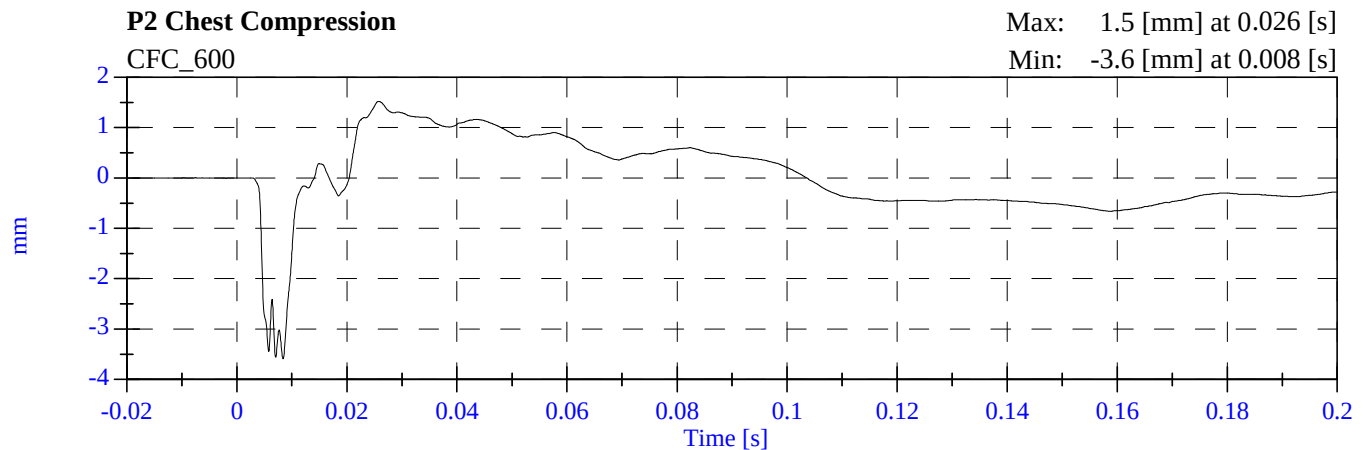
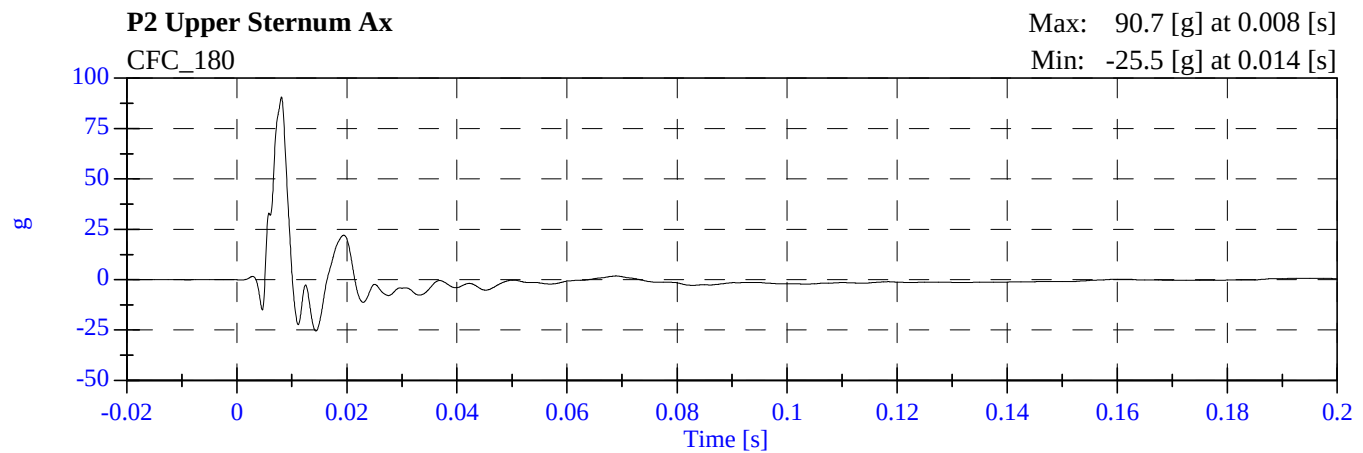
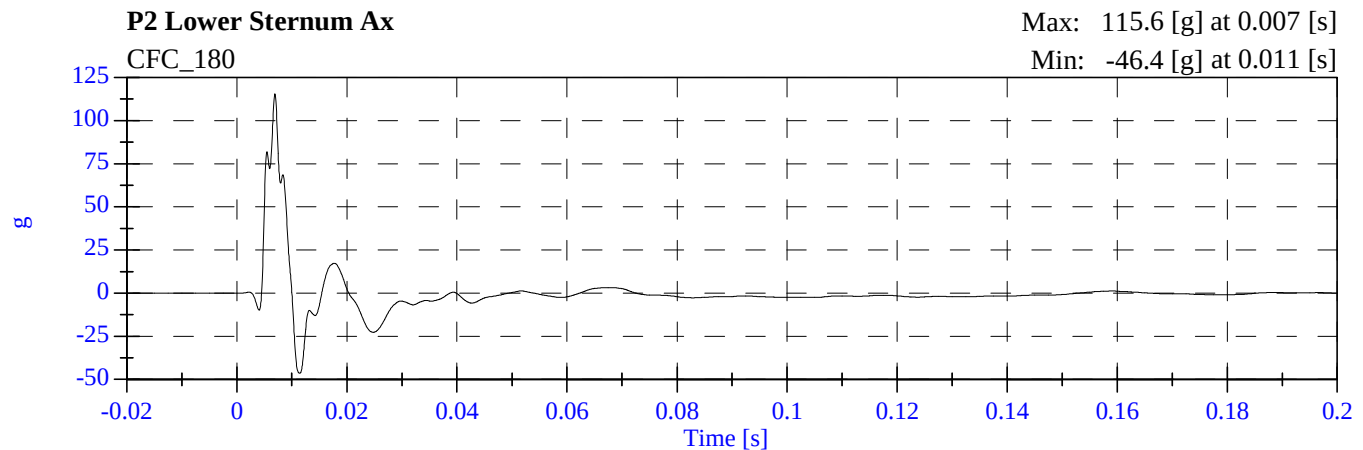
# 2007 TWG Test 2 2007 Kia Spectra M70507TWG2 - May 14, 2007

| PLOT | PLOT NAME[UNITS, CHANNEL FILTER CLASS] | PAGE |
|---|---|---|
| 17 | P2 Chest Compression [mm, CFC_600] | B-7 |
| 18 | P2 Upper Sternum Ax [g, CFC_180] | B-7 |
| 19 | P2 Lower Sternum Ax [g, CFC_180] | B-7 |

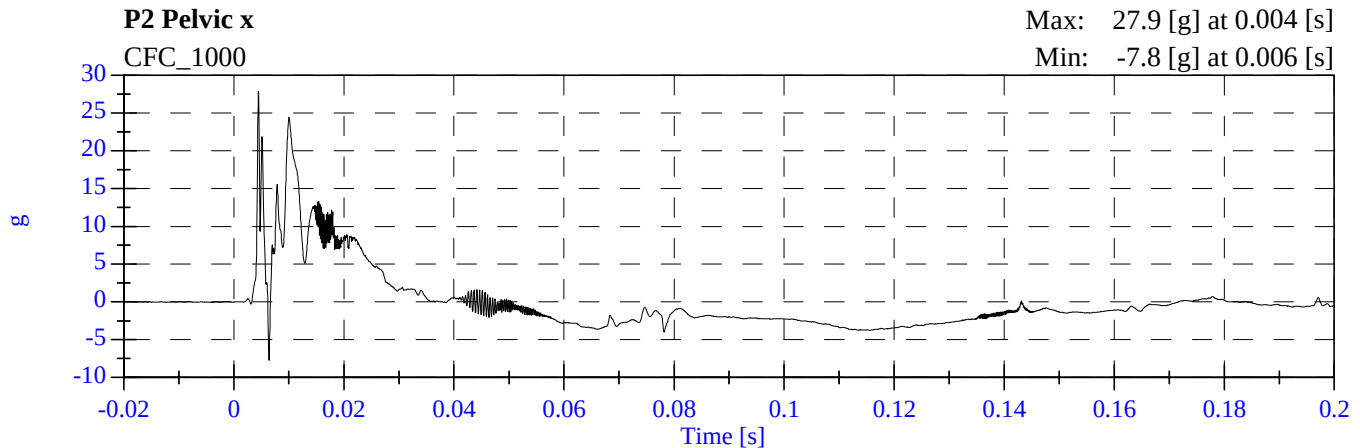
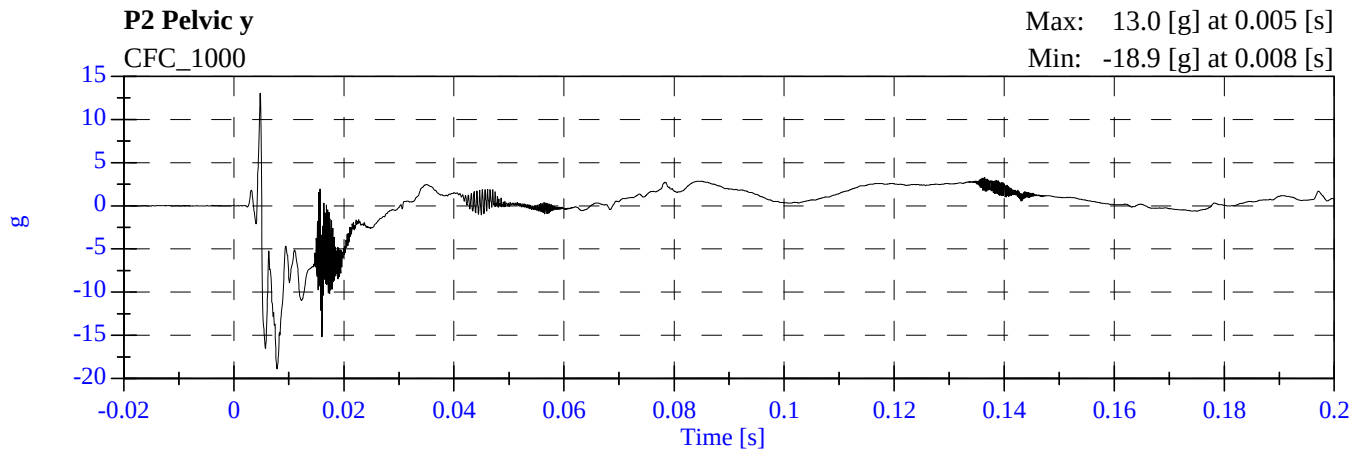
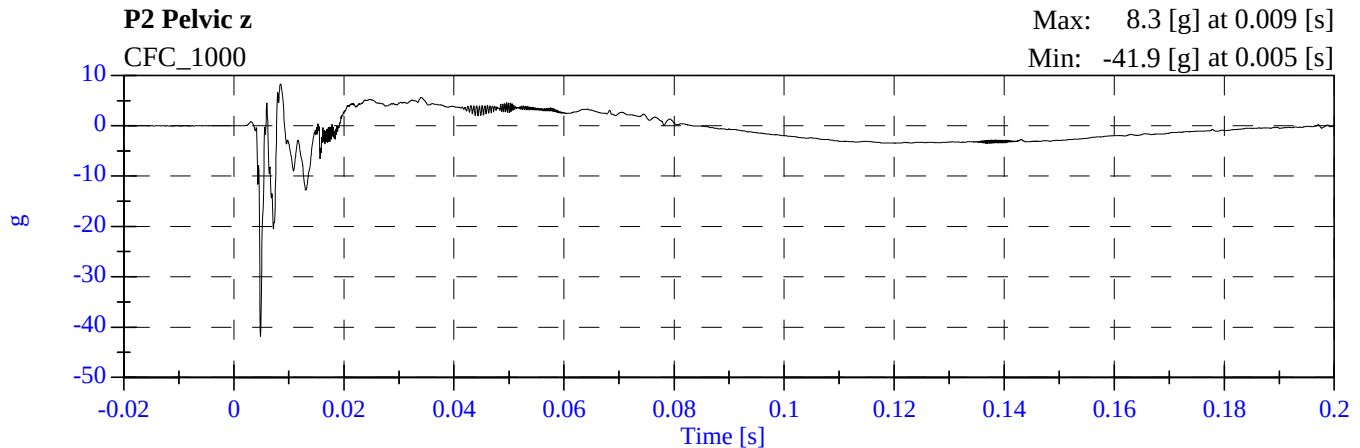
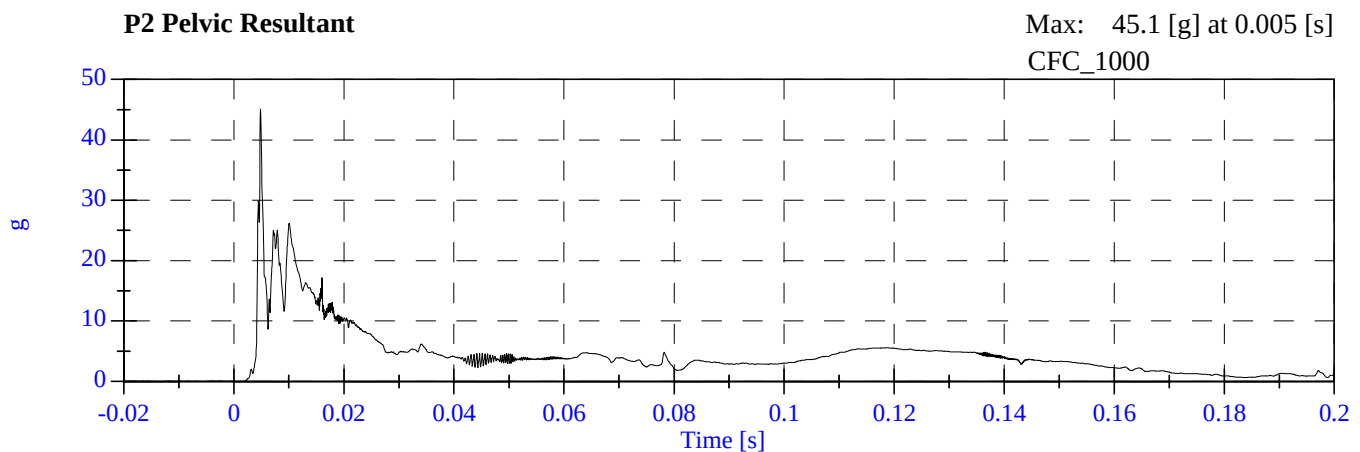
# 2007 TWG Test 2 2007 Kia Spectra

| PLOT | PLOT NAME[UNITS, CHANNEL FILTER CLASS] | PAGE |
|---|---|---|
| 20 | P2 Pelvic x [g, CFC_1000] | B-8 |
| 21 | P2 Pelvic y [g, CFC_1000] | B-8 |
| 22 | P2 Pelvic z [g, CFC_1000] | B-8 |
| 23 | P2 Pelvic Resultant [g, CFC_1000] | B-8 |

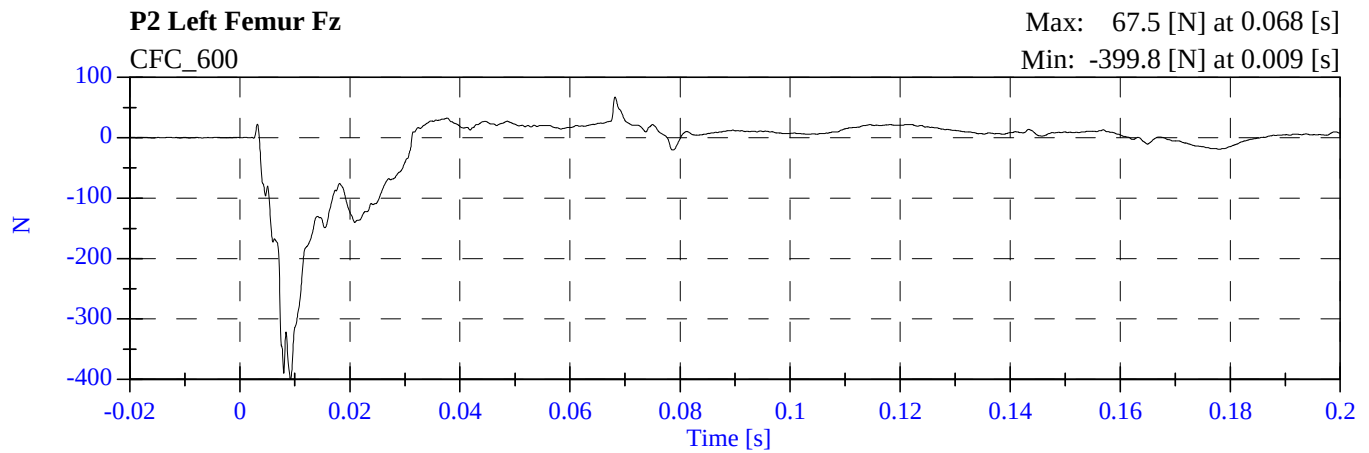
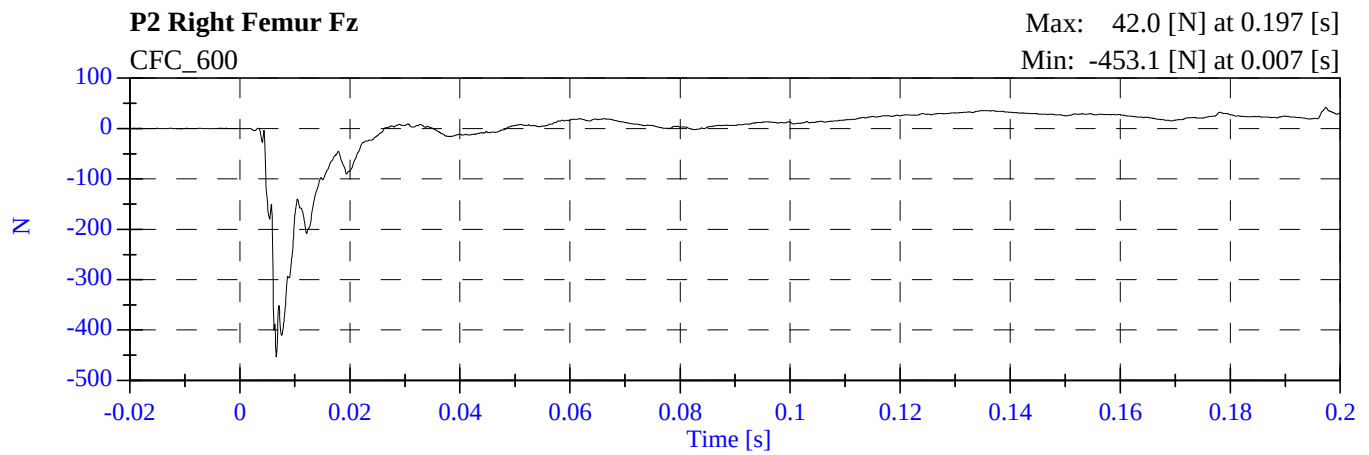
# 2007 TWG Test 2 2007 Kia Spectra

| PLOT | PLOT NAME[UNITS, CHANNEL FILTER CLASS] | PAGE |
|---|---|---|
| 24 | P2 Left Femur Fz [N, CFC_600] | B-9 |
| 25 | P2 Right Femur Fz [N, CFC_600] | B-9 |
