REPORT NUMBER: TWG-CAL07-05

**NEW CAR ASSESSMENT PROGRAM (NCAP)**  
SIDE AIRBAG OUT-OF-POSITION INJURY TESTING

2007 KIA RONDO  
FIVE DOOR WAGON

NHTSA NUMBER: M70504TWG2

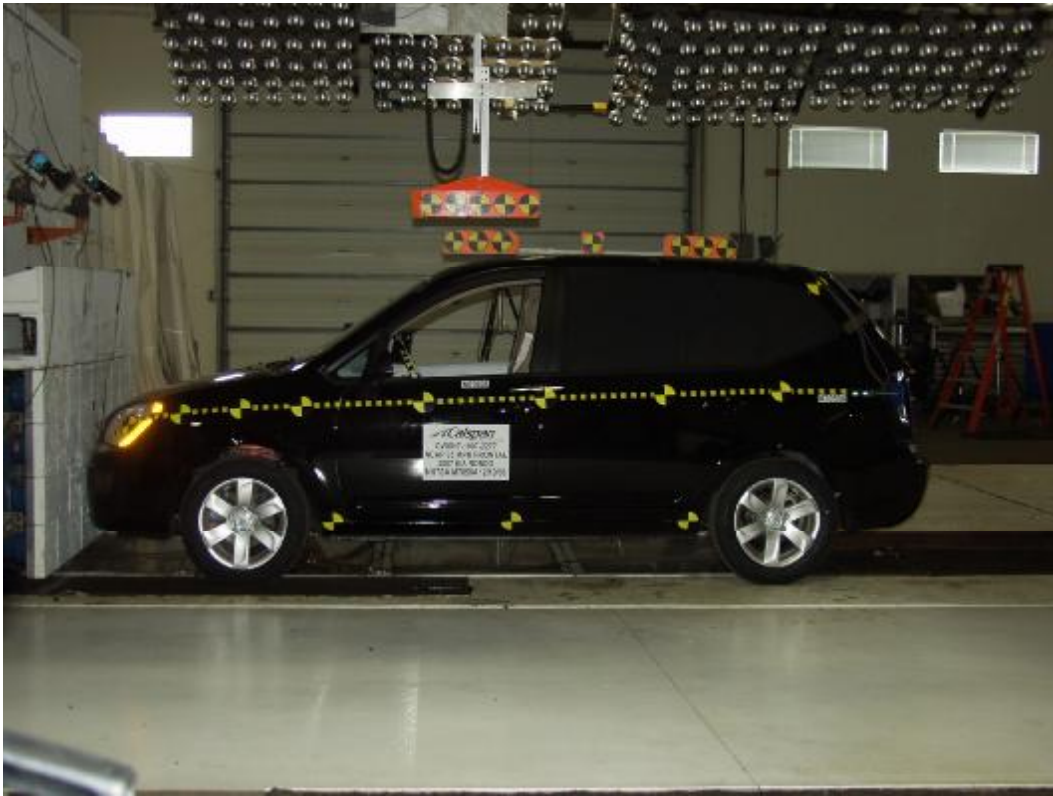
Figure A-1: Pre-Test Vehicle Left Side View

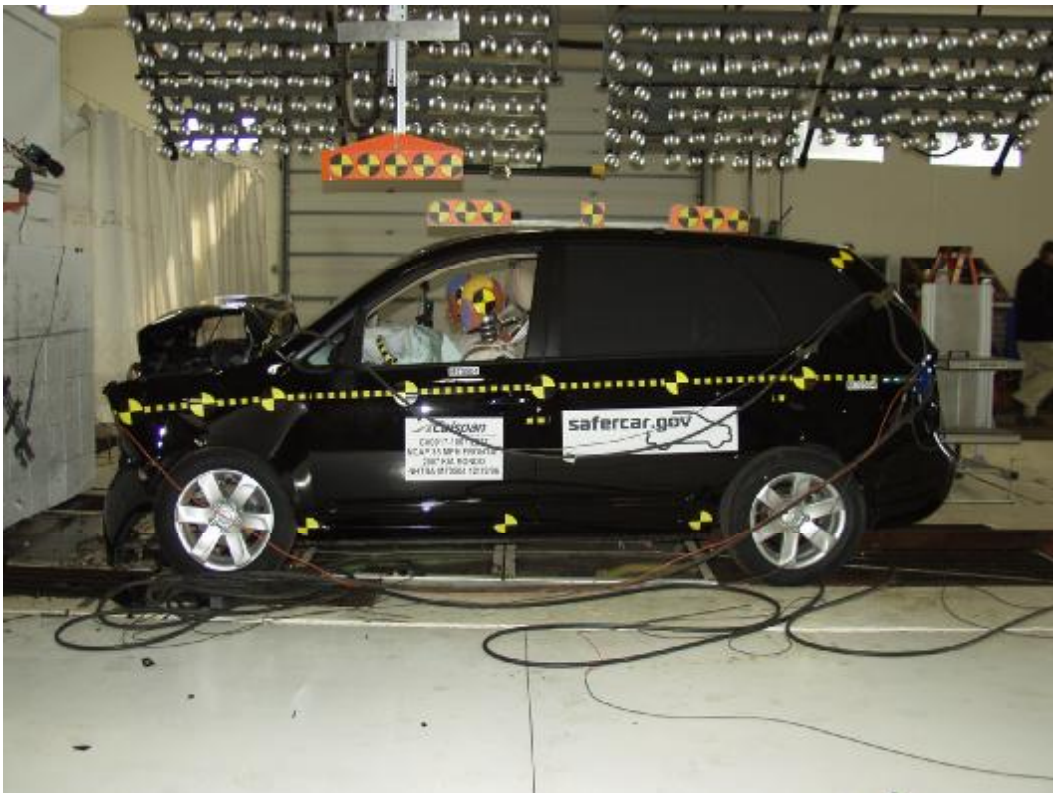
Figure A-2: Post-Test Vehicle Left Side View

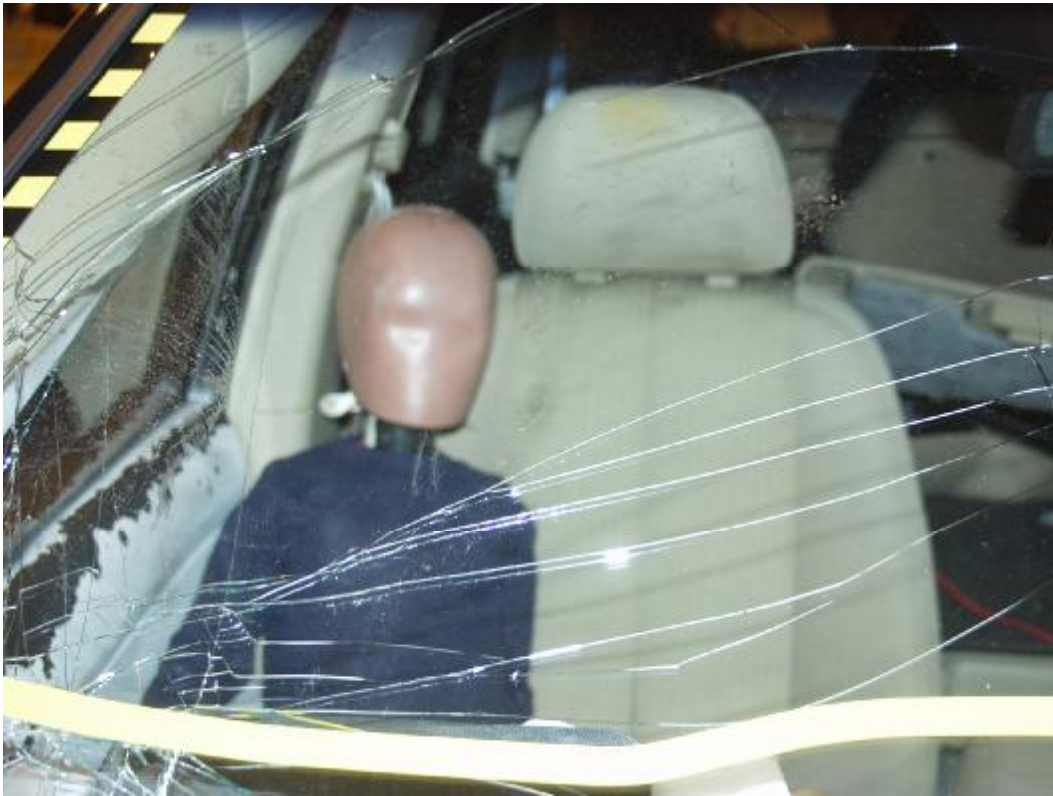
Figure A-5: Pre-Test Dummy Frontal View

The six-year old child dummy was placed on the outboard edge of foam block, aligning the upper spine with the deployment trajectory of the airbag. The dummy's head was placed in between the seat bolster and pillar trim to minimize the fore-aft clearance between the neck and the seatback. The head remained in its neutral orientation. The legs were aligned such that they crossed the heel placement points but the feet did overhang the seat cushion. The dummy was then positioned so the dummy's neck/torso junction was aligned vertically with the top edge of the airbag module. While maintaining the neck/torso top of the airbag module alignment, the vehicle door was closed and the pelvis was moved outboard until it made contact the door trim/armrest. The outboard forearm was placed on the armrest. The inboard arm was positioned such that the upper arm contacted the seat back and the fingertips contacted the booster seat. The dummy's arms were then bent at the elbow until the fingers contacted the booster seat. This orientation complies with section 3.3.3.5 of the TWG Recommended Procedures for Evaluating Occupant Injury Risk from Deploying Side Airbags as defined by Lund, et al and the Technical Working Group First Revision dated July, 2003.

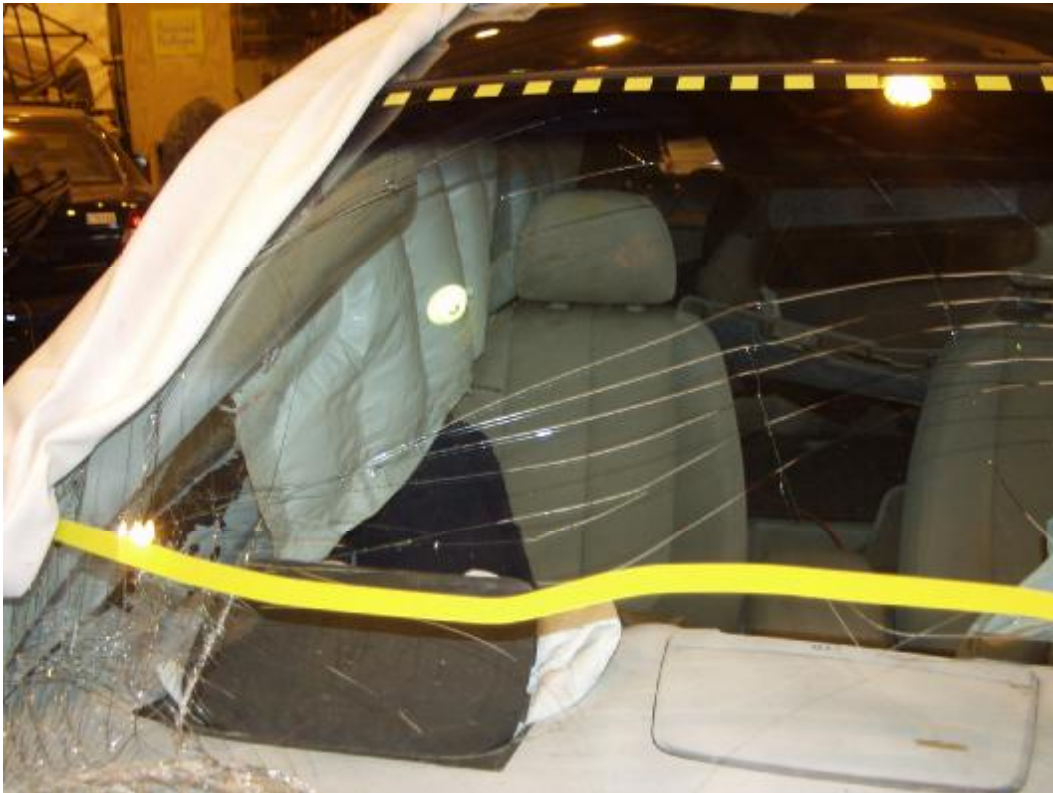
Figure A-6: Post-Test Dummy Frontal View

The Hybrid III six-year-old child dummy's visible contact points were as follows: The seat airbag to the right scapula and right side of the posterior thorax and pelvis and the curtain airbag to the top and the back of the head.

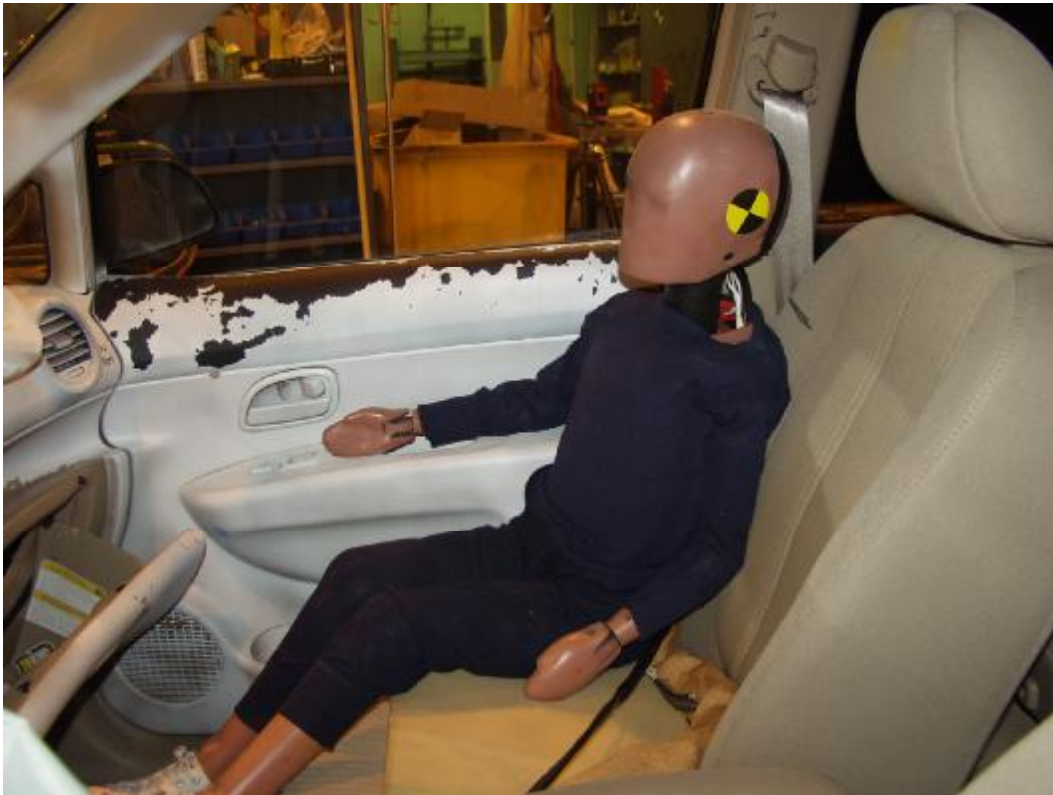
Figure A-7: Pre-Test Left Side of Dummy View

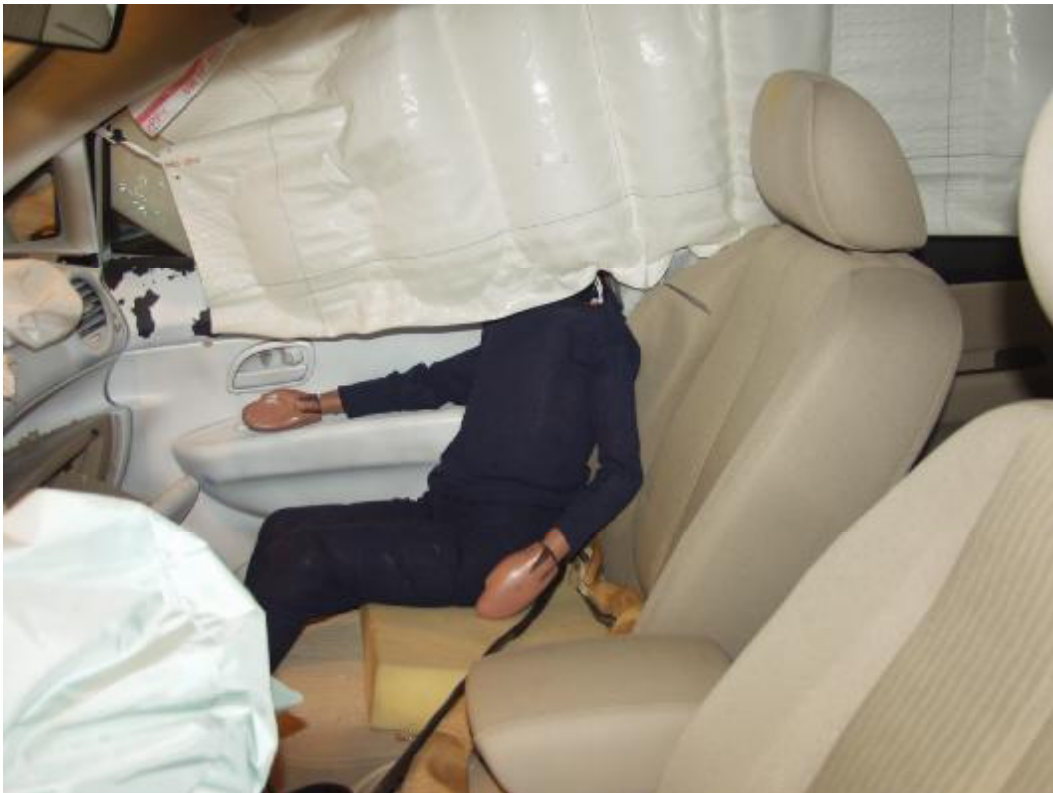
Figure A-8: Post-Test Left Side of Dummy View

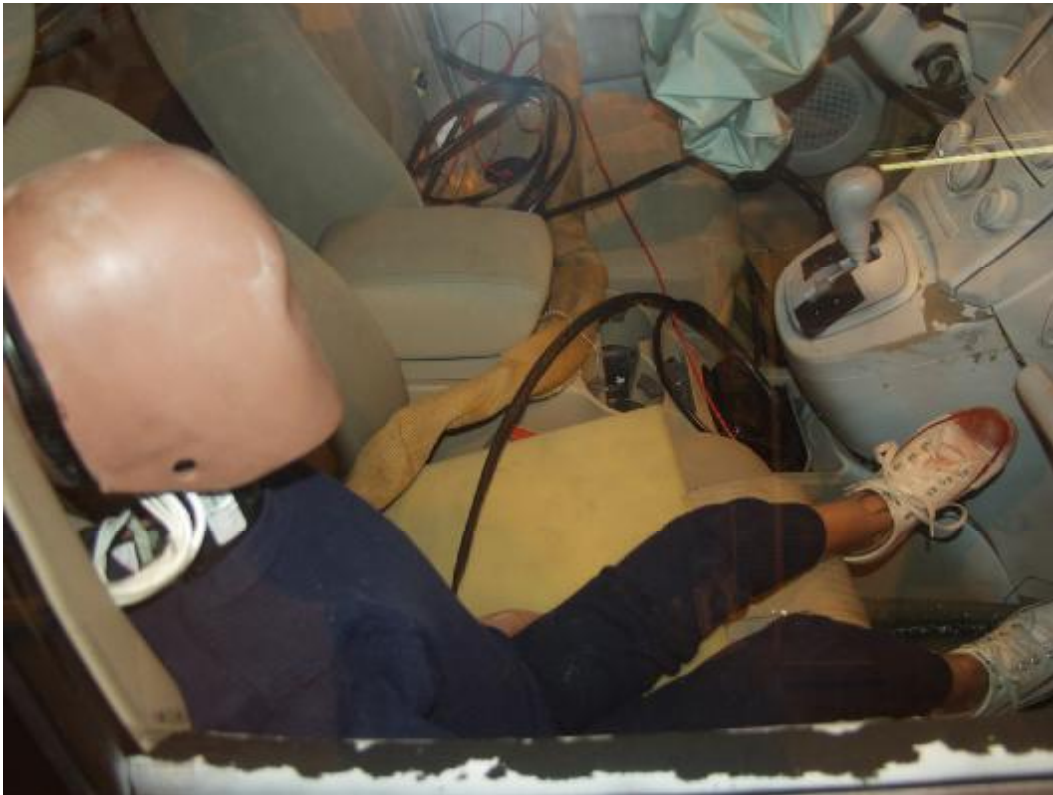
Figure A-9: Pre-Test Right Side of Dummy View

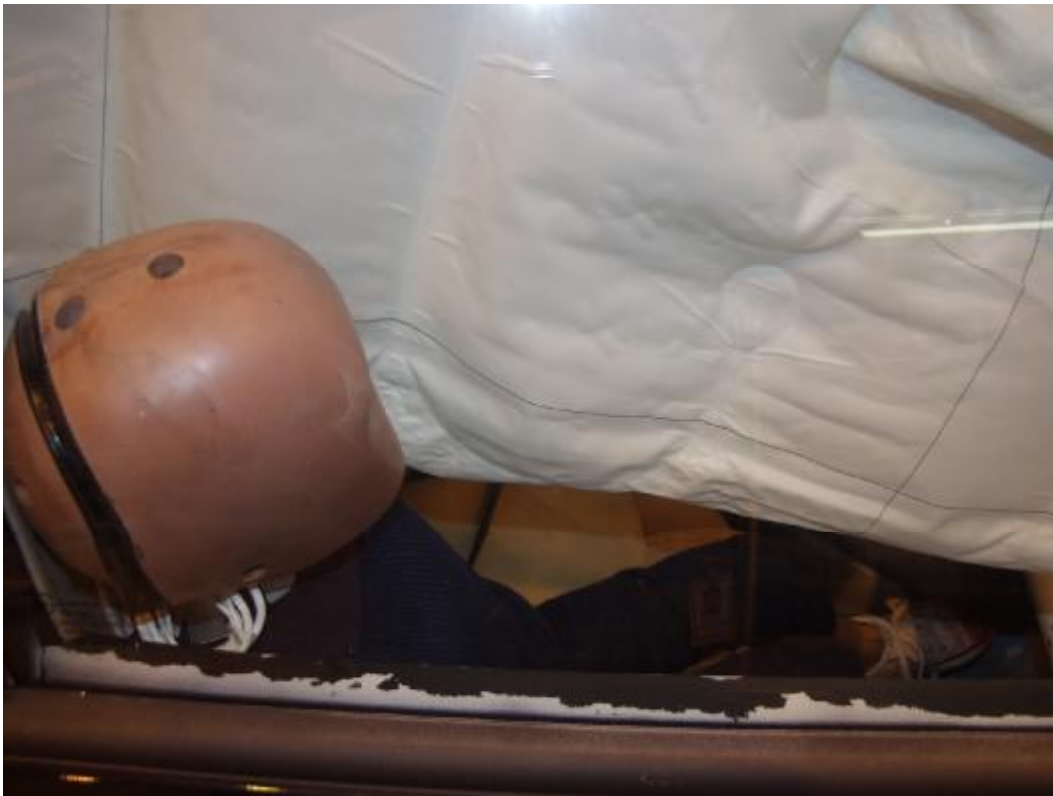
Figure A-10: Post-Test Right Side of Dummy View

| <b>Head Contact:</b> | The back (occipital) and the top (parietal) of the head by the side curtain. |
| <b>Upper Torso Contact:</b> | Side airbag to the right scapula and right side of the posterior thorax |
| <b>Lower Torso Contact:</b> | Side airbag to the right side of the pelvis (ilium) |

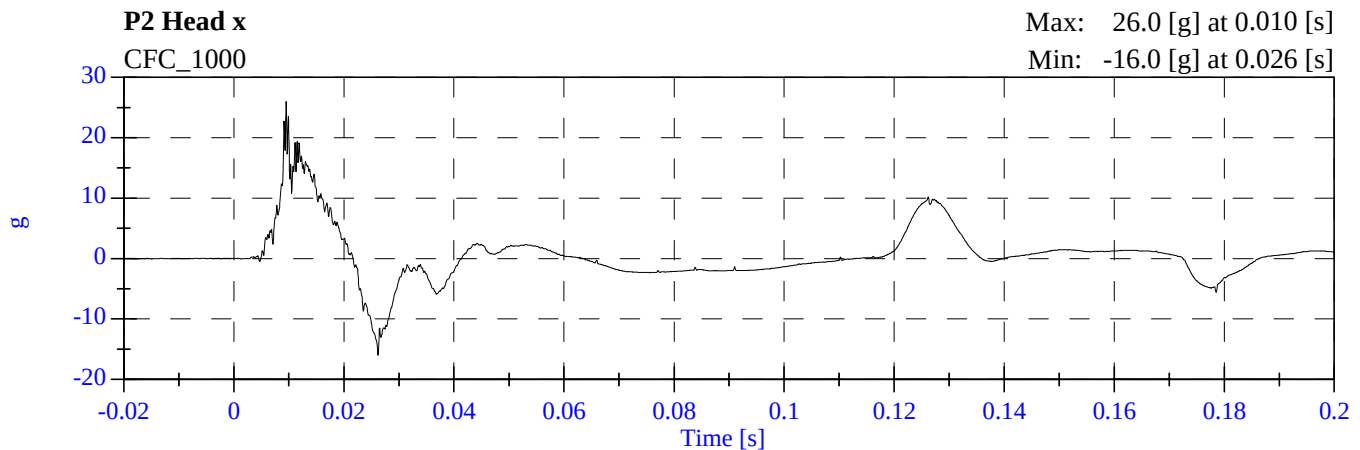
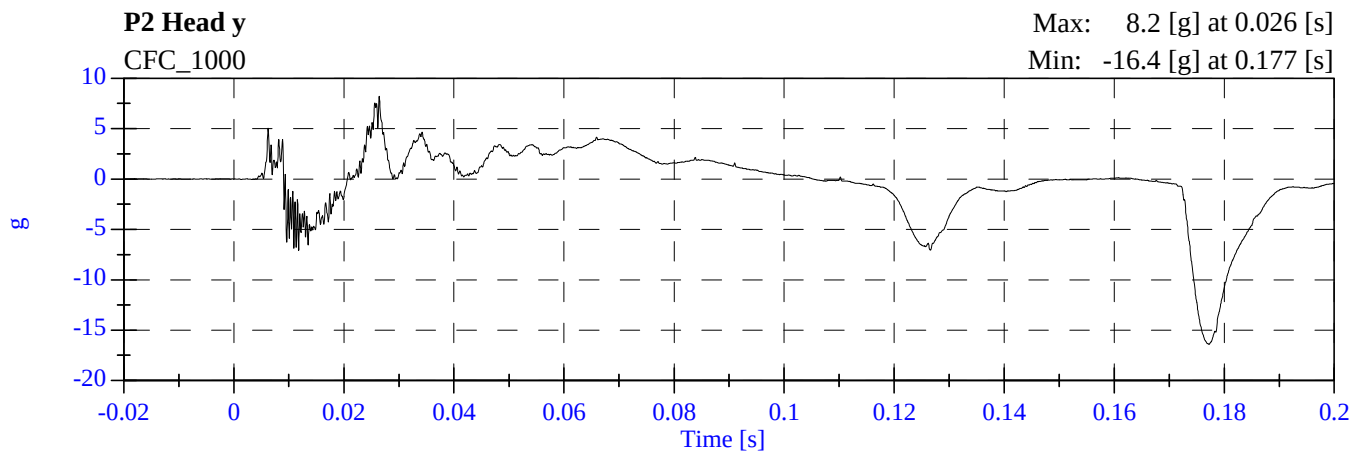
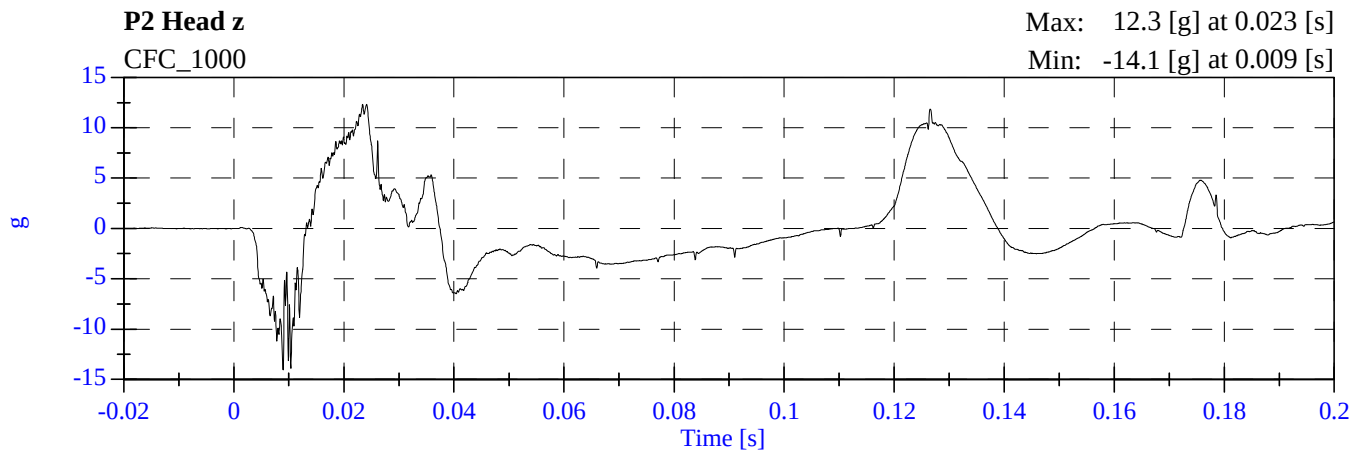
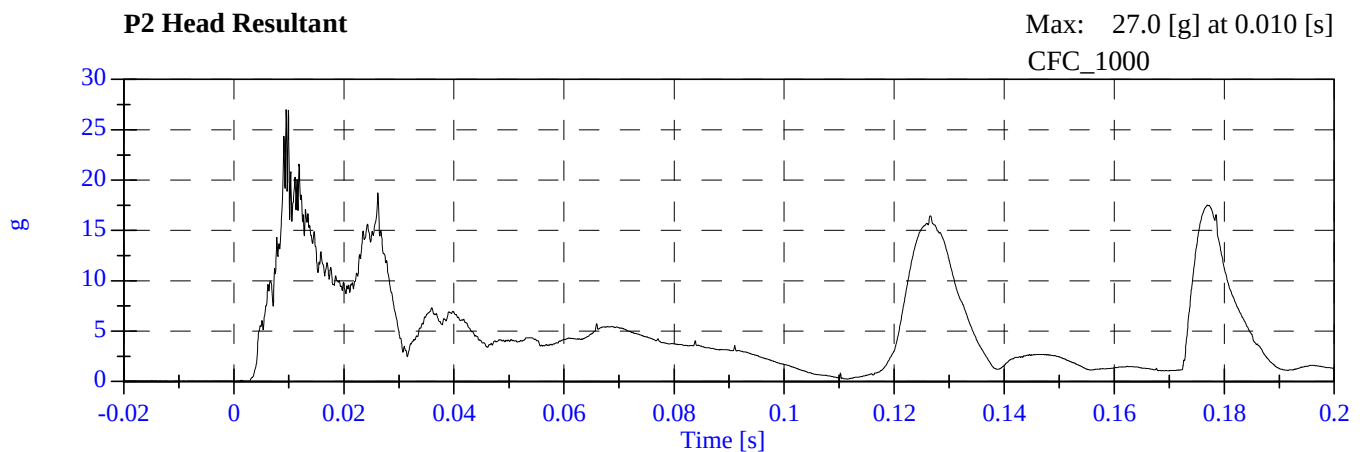
# 2007 TWG Test 5 2007 Kia Rondo

| <b>PLOT</b> | <b>PLOT NAME[UNITS, CHANNEL FILTER CLASS]</b> | <b>PAGE</b> |
|---|---|---|
| 1 | P2 Head x [g, CFC_1000] | B-3 |
| 2 | P2 Head y [g, CFC_1000] | B-3 |
| 3 | P2 Head z [g, CFC_1000] | B-3 |
| 4 | P2 Head Resultant [g, CFC_1000] | B-3 |

| | | MAXIMUM VALUE | | | |
|---|---|---|---|---|---|
| Head X | g | 26.0 | 9.5 | -16.0 | 26.2 |
| Head Y | g | 8.2 | 26.4 | -16.4 | 177.3 |
| Head Z | g | 12.3 | 23.4 | -14.1 | 8.9 |
| Head Resultant | g | 27.0 | 9.5 | 0.0 | 2.6 |
