REPORT NUMBER: TWG-MGA-2007-010

**NEW CAR ASSESSMENT PROGRAM
SIDE AIRBAG OUT-OF-POSITION INJURY TESTING**

**DAIMLERCHRYSLER CORPORATION
2007 DODGE NITRO SLT 4X4
NHTSA NUMBER: M70305TWG2**

**PREPARED BY:
MGA RESEARCH CORPORATION
5000 WARREN ROAD
BURLINGTON, WI 53105**

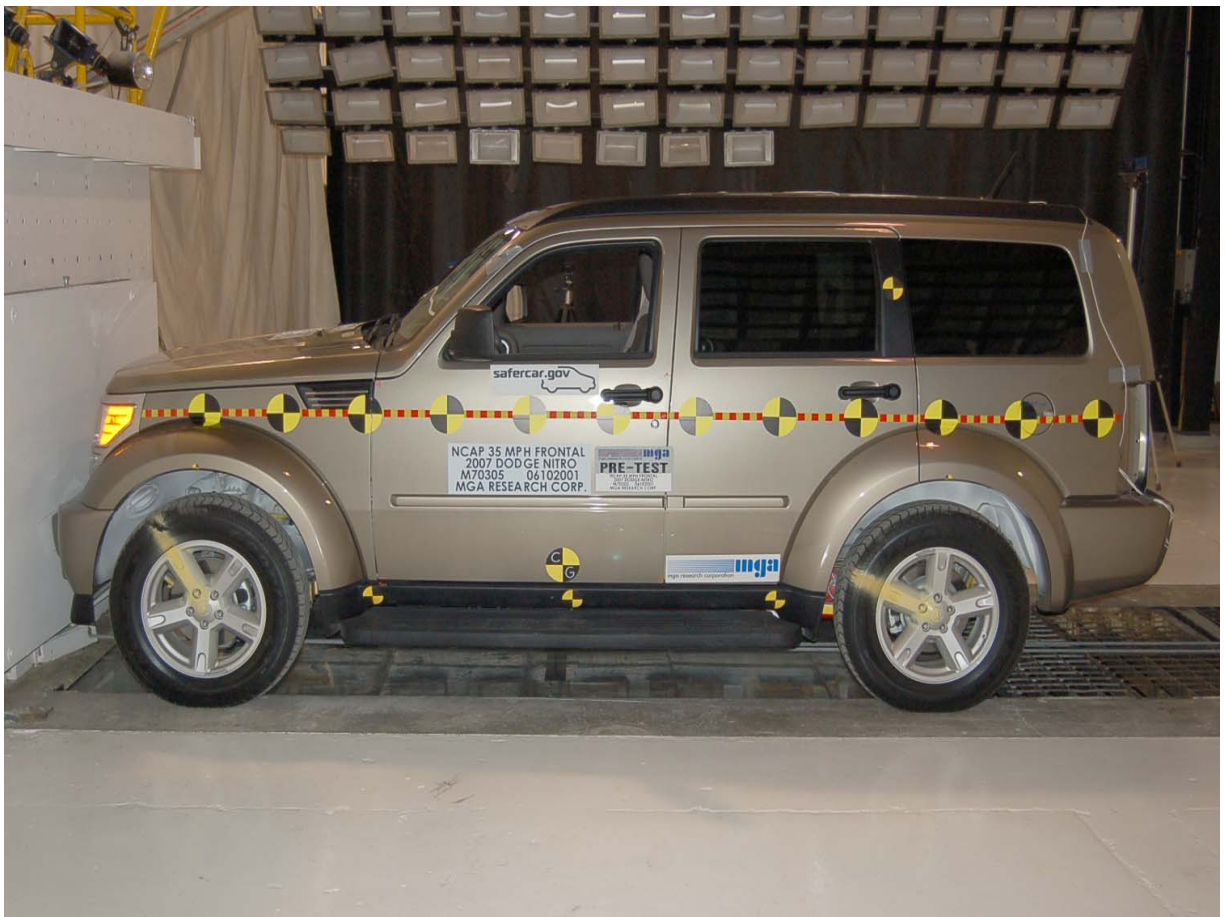
Pre-Test Vehicle Left Side View

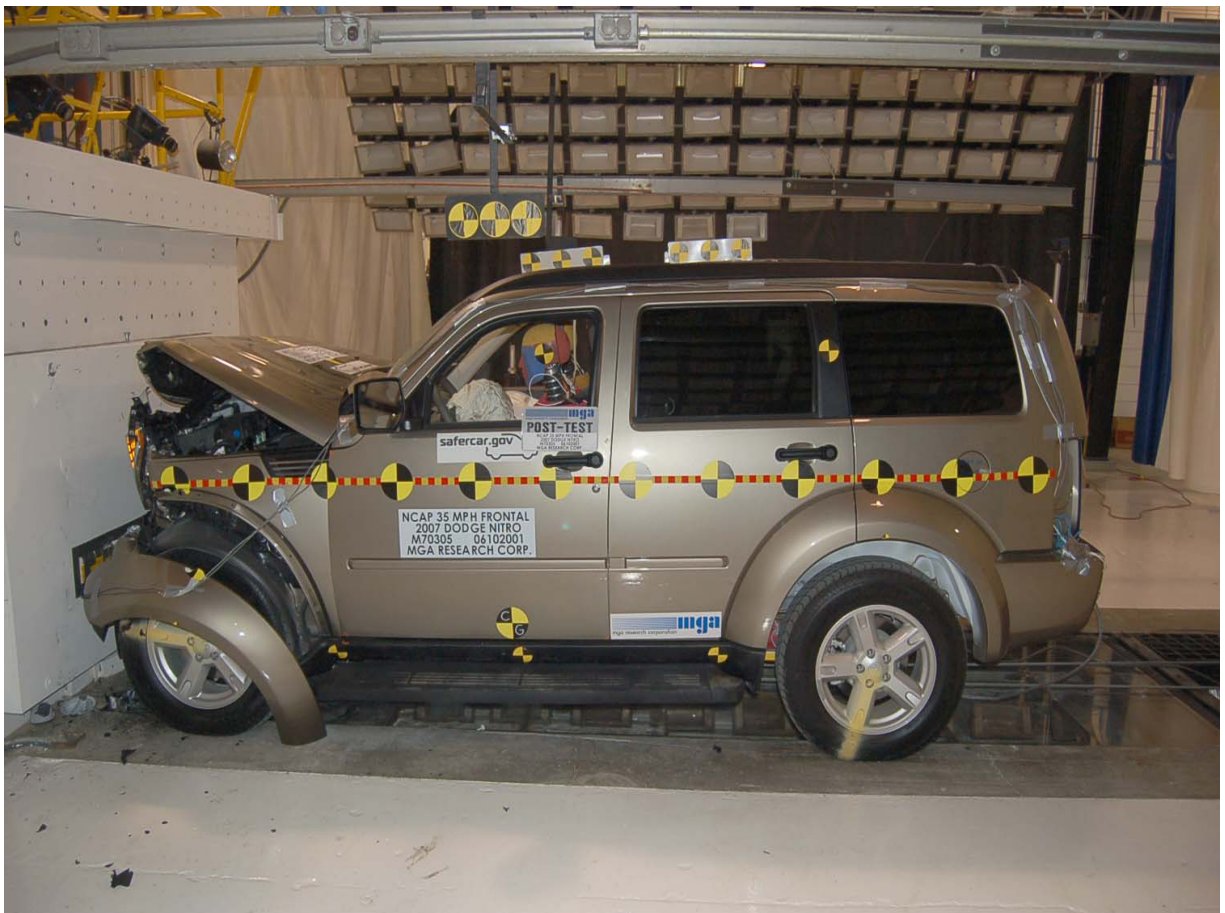
Post-Test Vehicle Left Side View

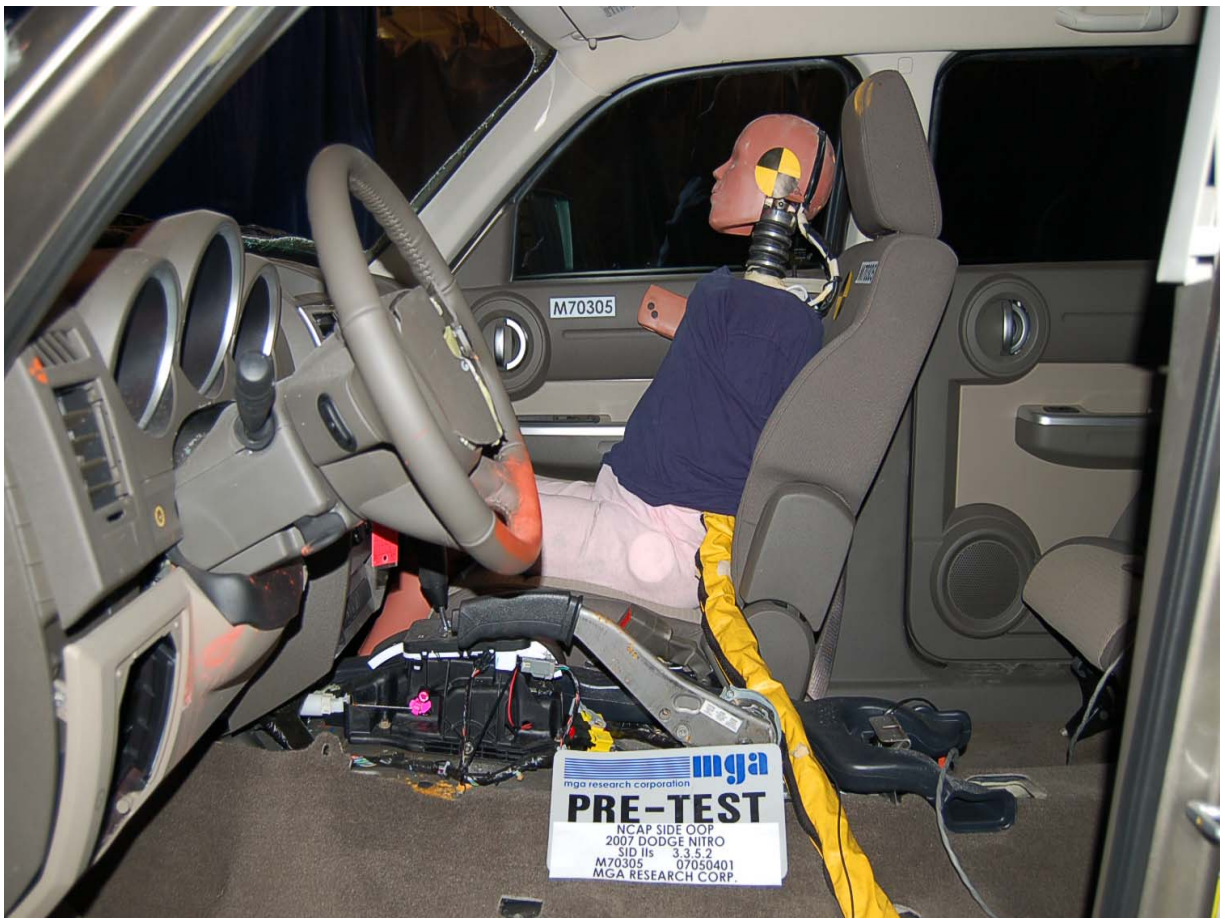
Pre-Test SID-IIs Dummy Left Side View

The SID-II's dummy was placed in the center of the right front passenger seat facing forward. The dummy's outboard arm was rotated horizontal in the forward direction with respect to the dummy to clear the armrest. The dummy was positioned outboard until it contacted the door trim panel. The dummy may have been leaned outboard to ensure that the deployment trajectory of the airbag intersected with the centerline of the top of the head. Masking tape was wrapped around the dummy's neck bracket to hold the dummy in place, if necessary.

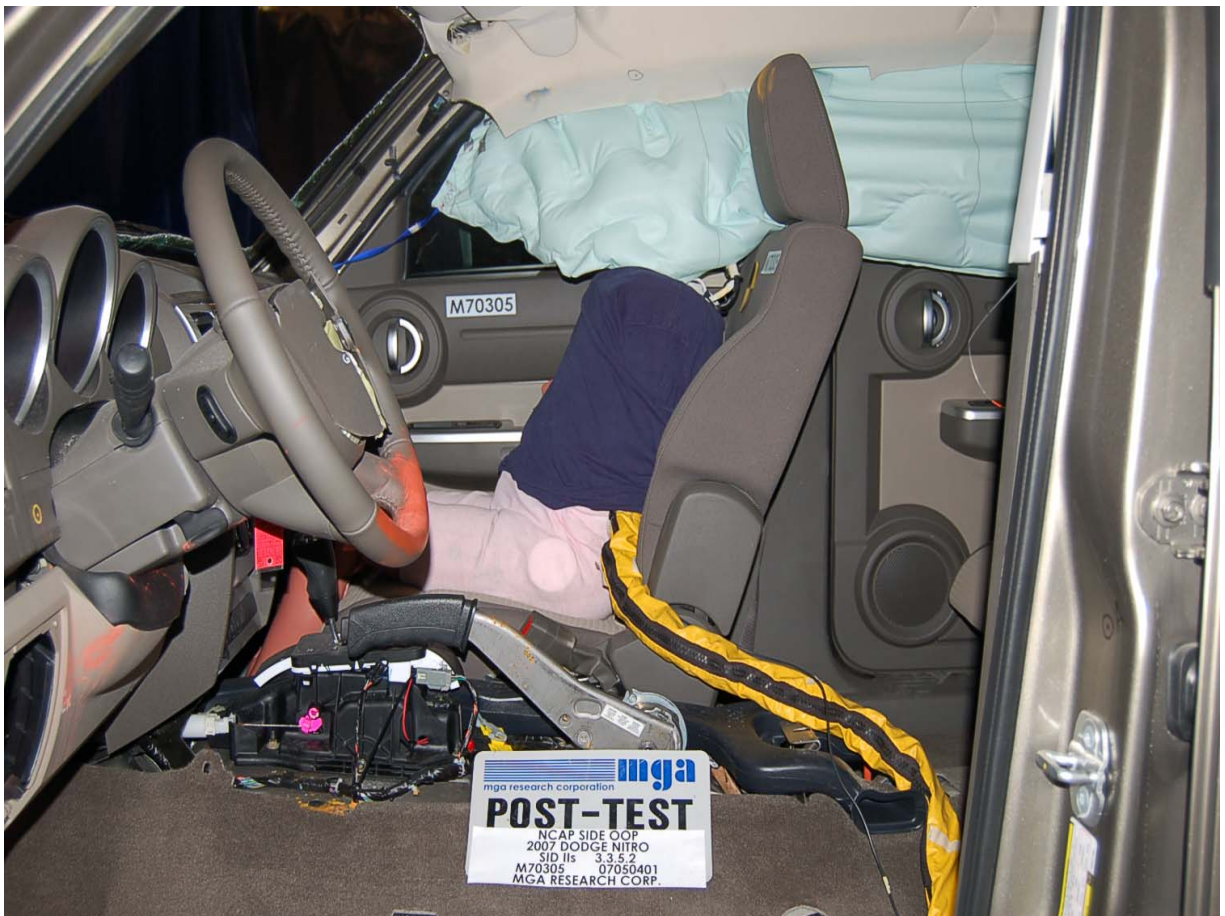
Post-Test SID-IIs Dummy Left Side View

The SID-IIs dummy's visible contact points were as follows: The curtain airbag to the top and left side of the head.

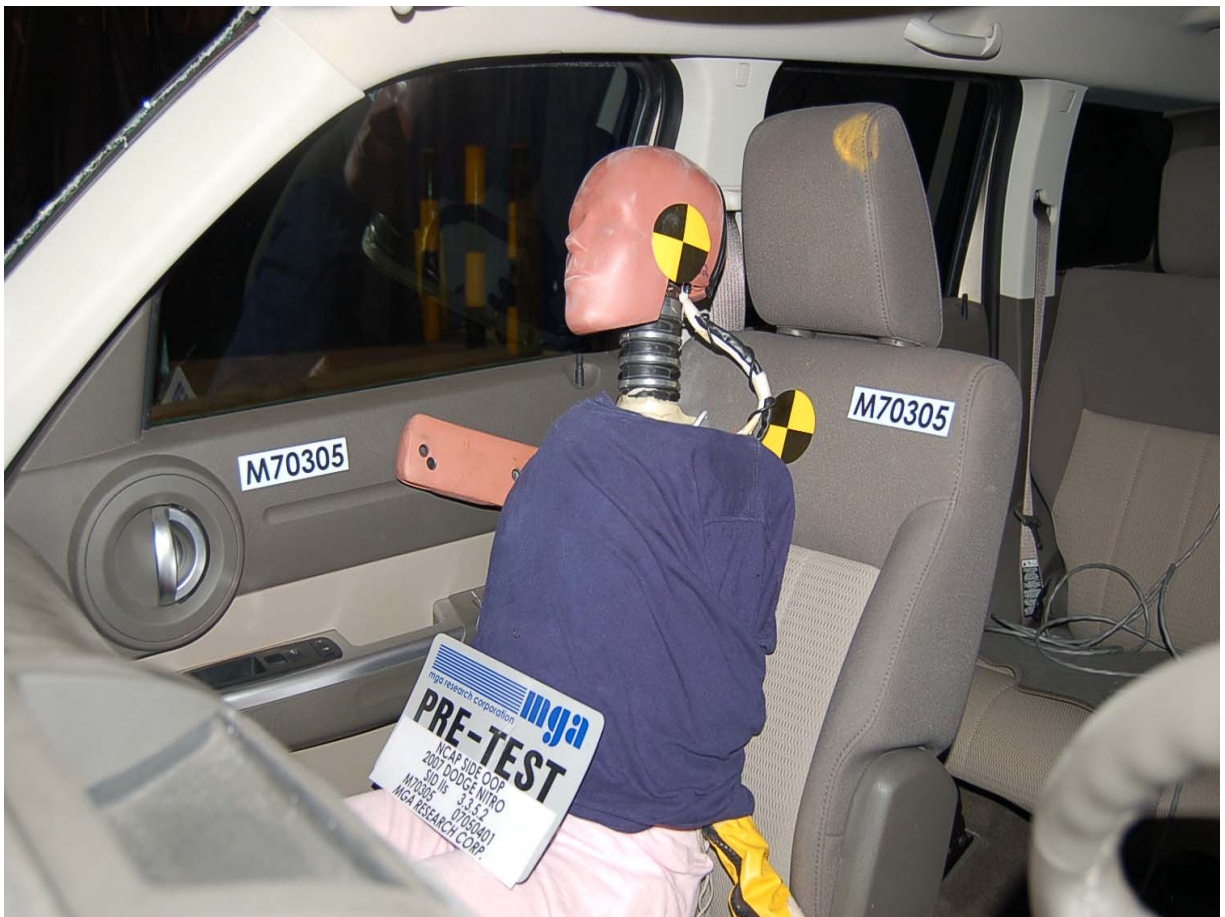
Pre-Test SID-IIs Dummy Left Side 3/4 view

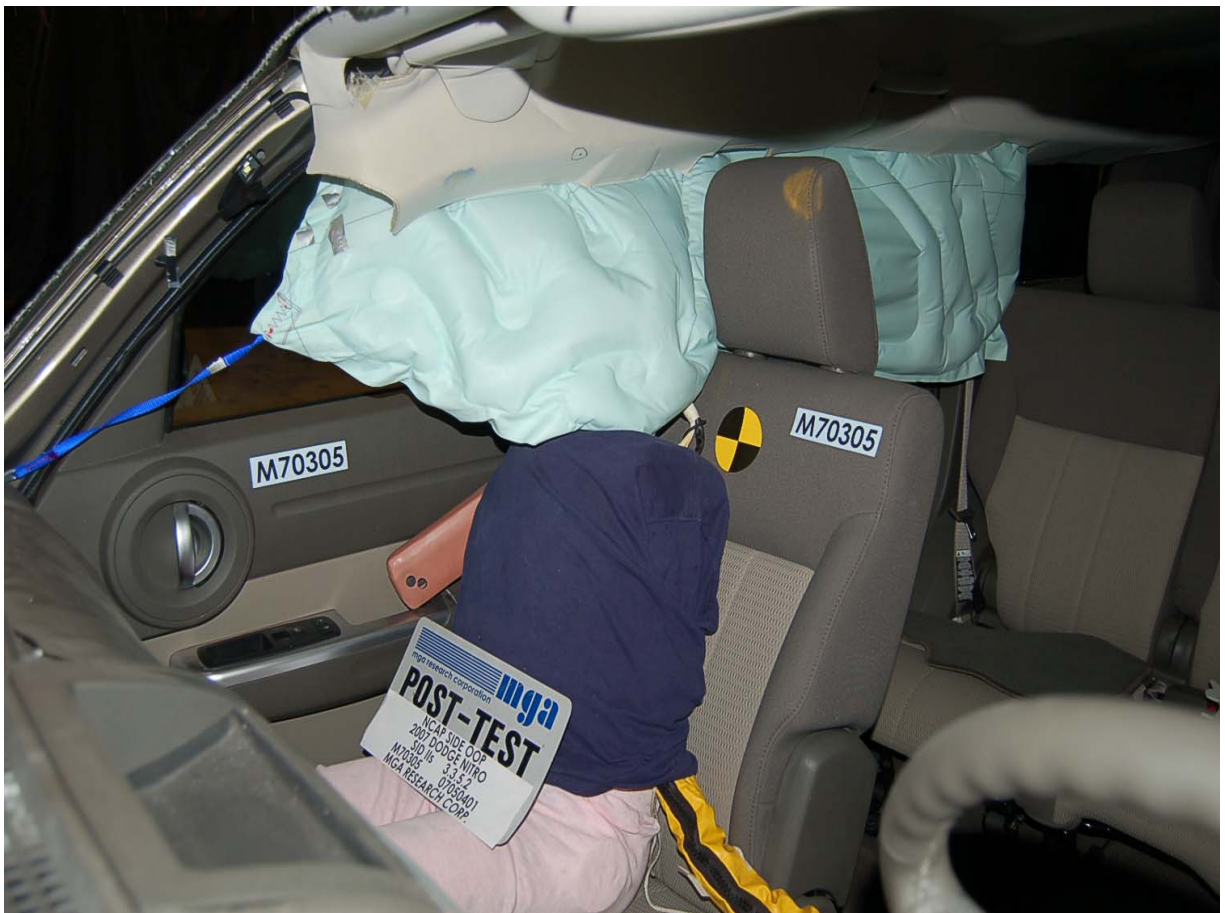
Post-Test SID-IIs Dummy Left Side 3/4 view

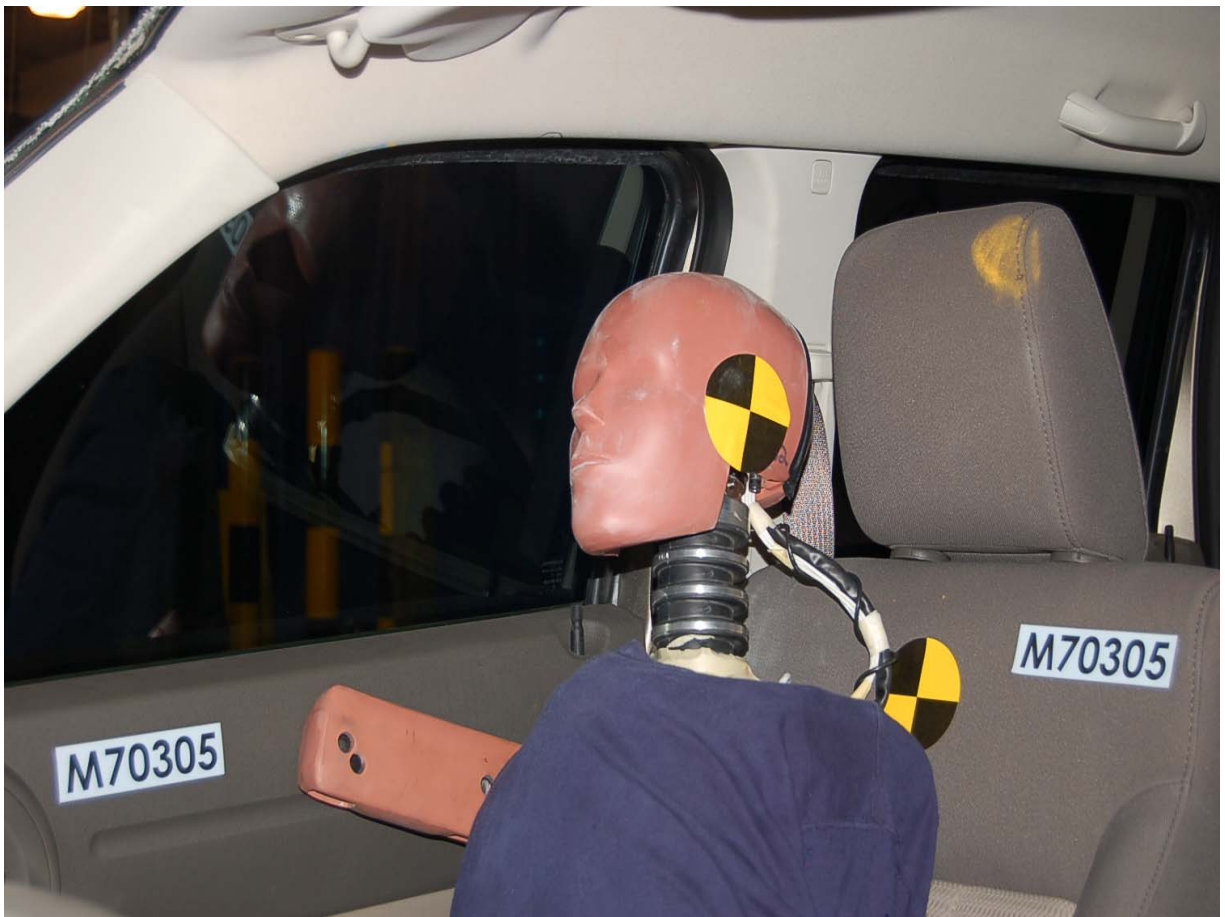
Pre-Test SID-IIs Dummy Left Side Closeup View

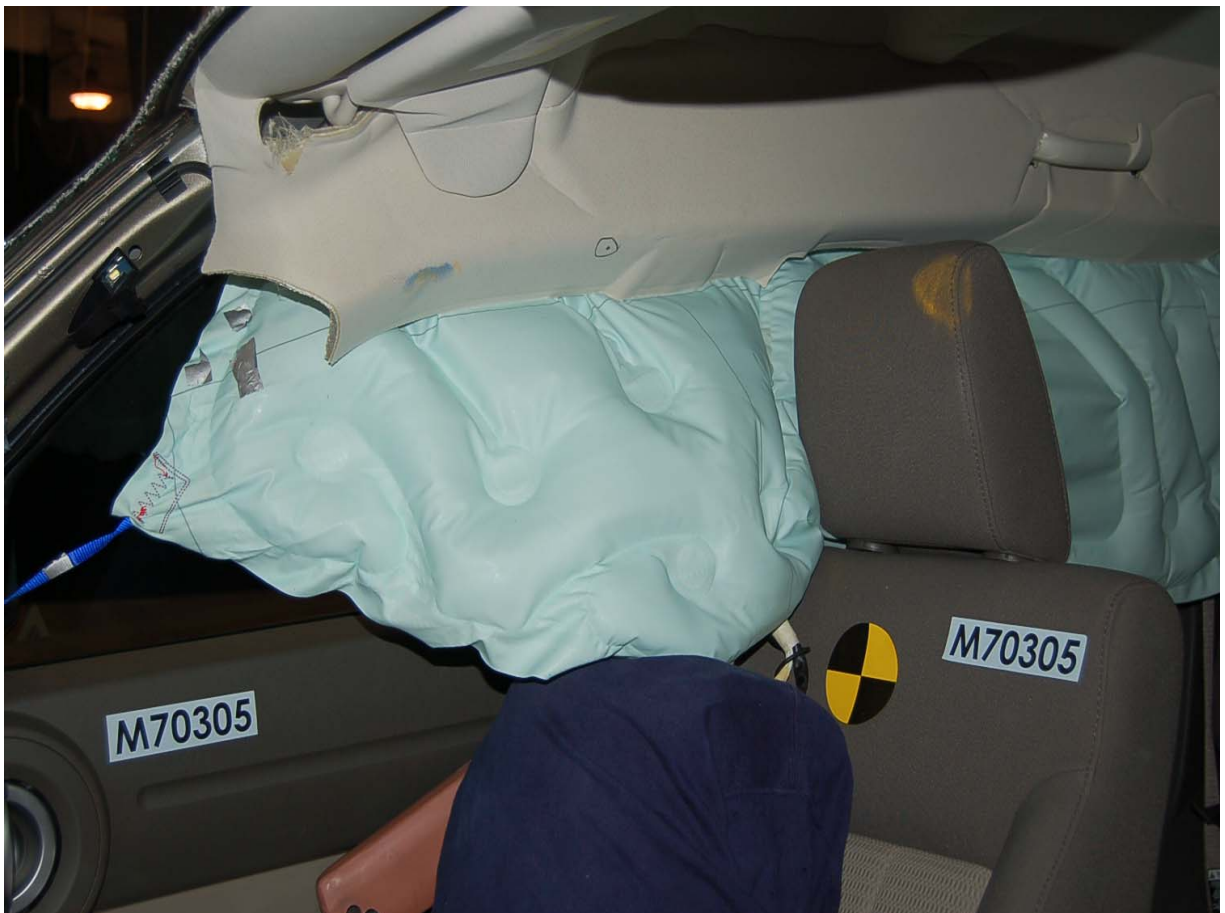
Post-Test SID-IIs Dummy Left Side Closeup View

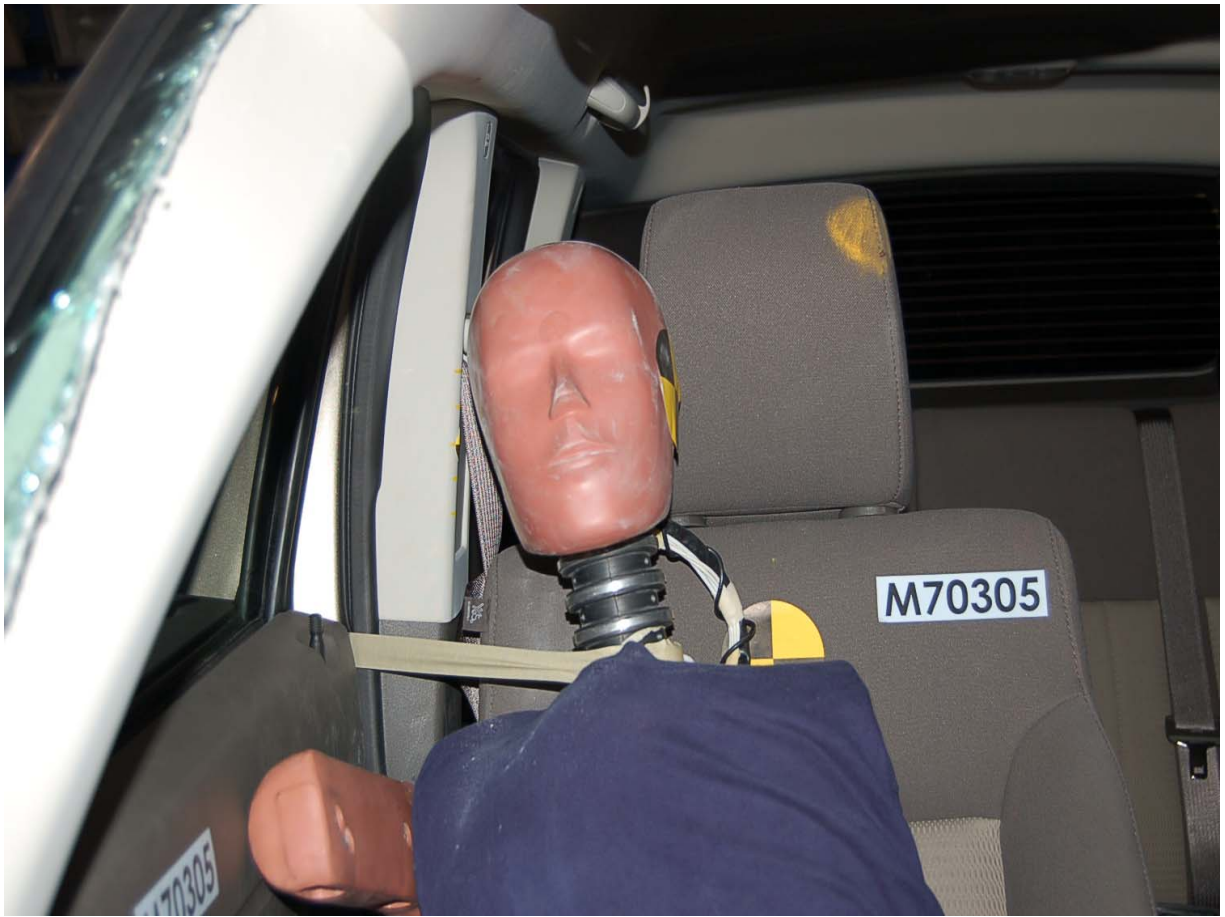
Pre-Test SID-IIs Dummy Front Head View

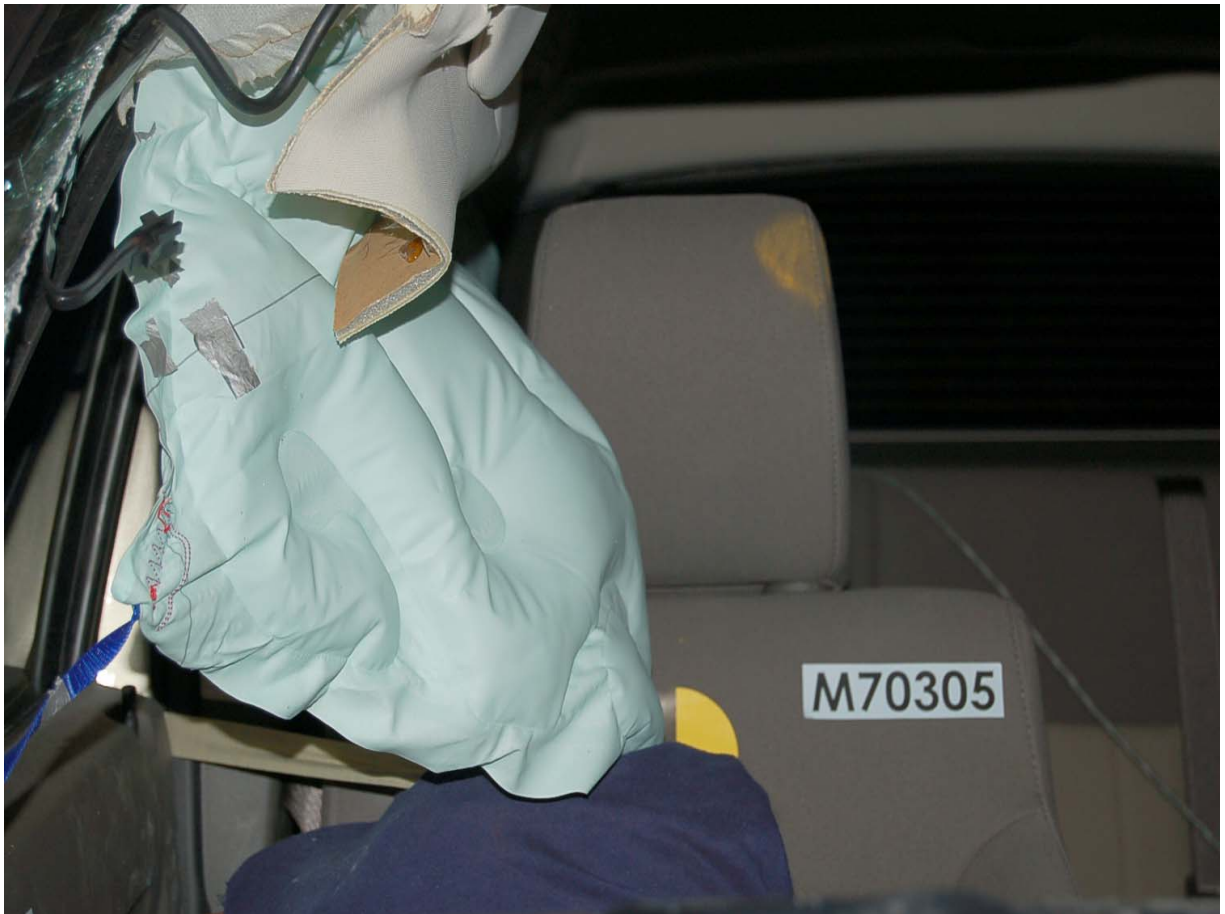
Post-Test SID-IIs Dummy Front Head View

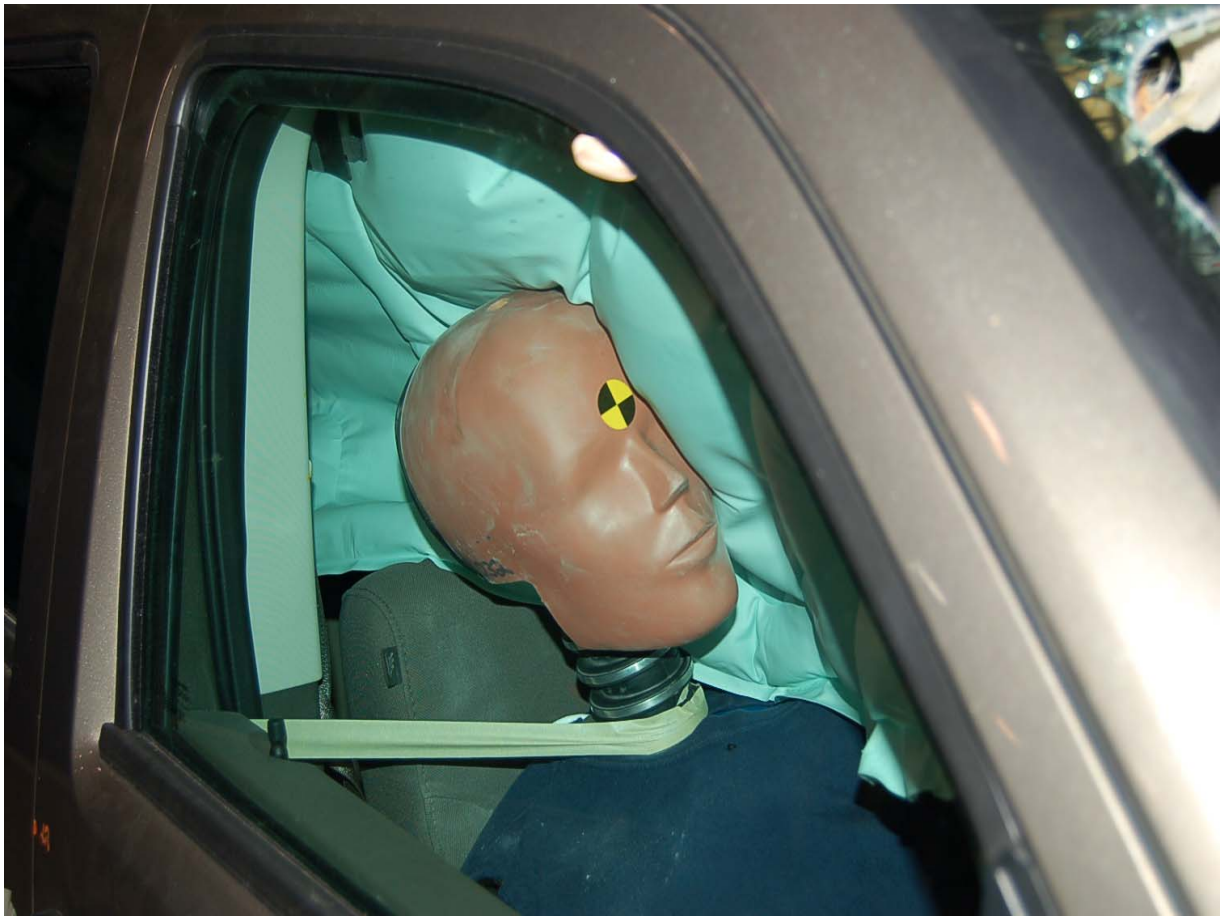
Post-Test SID-IIs Dummy View Through RF Window

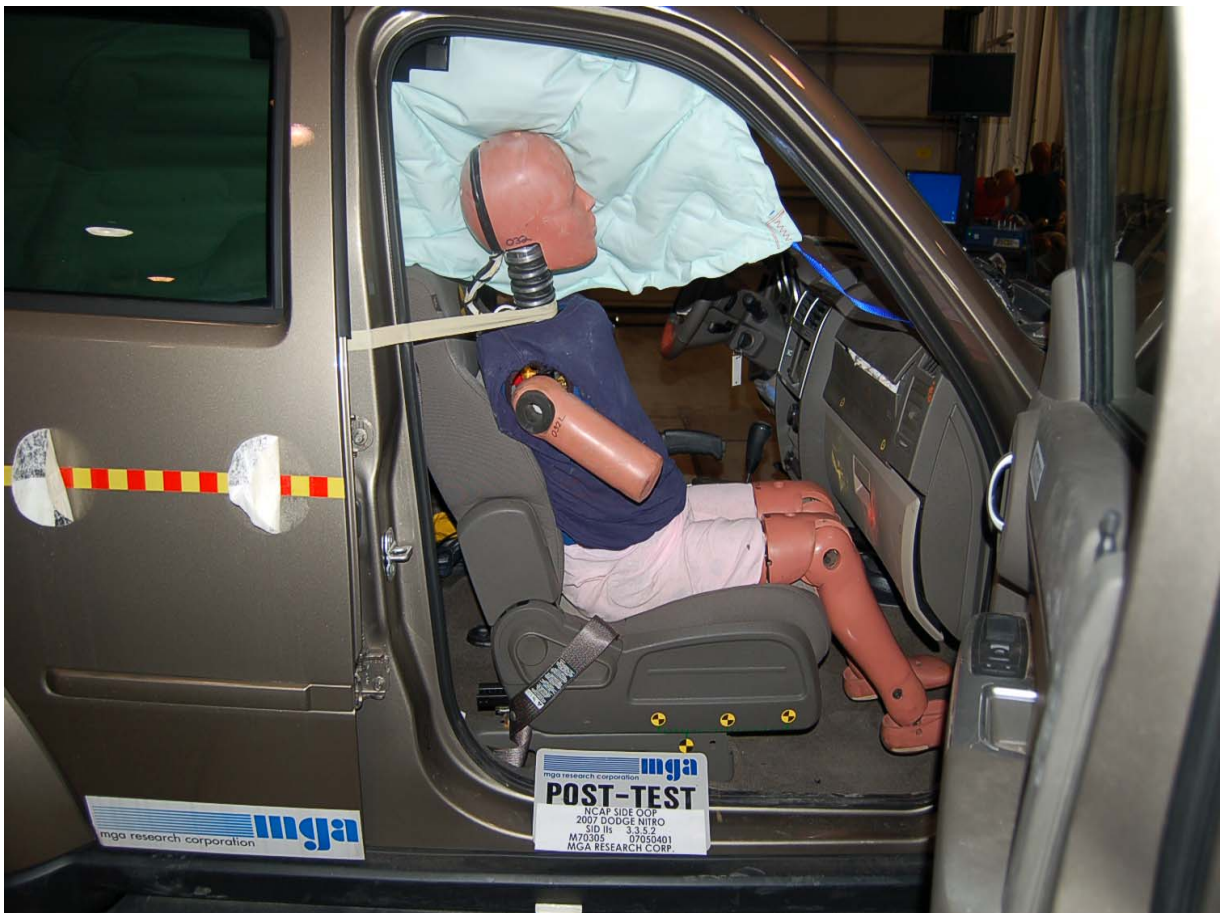
Post-Test Right Side Passenger Compartment View
