**REPORT NUMBER: TWG-MGA-2007-003**

**NEW CAR ASSESSMENT PROGRAM  
SIDE AIRBAG OUT-OF-POSITION INJURY TESTING**

**DAIMLERCHRYSLER CORPORATION  
2007 CHRYSLER SEBRING TOURING  
NHTSA NUMBER: M70304TWG2**

**FINAL REPORT**

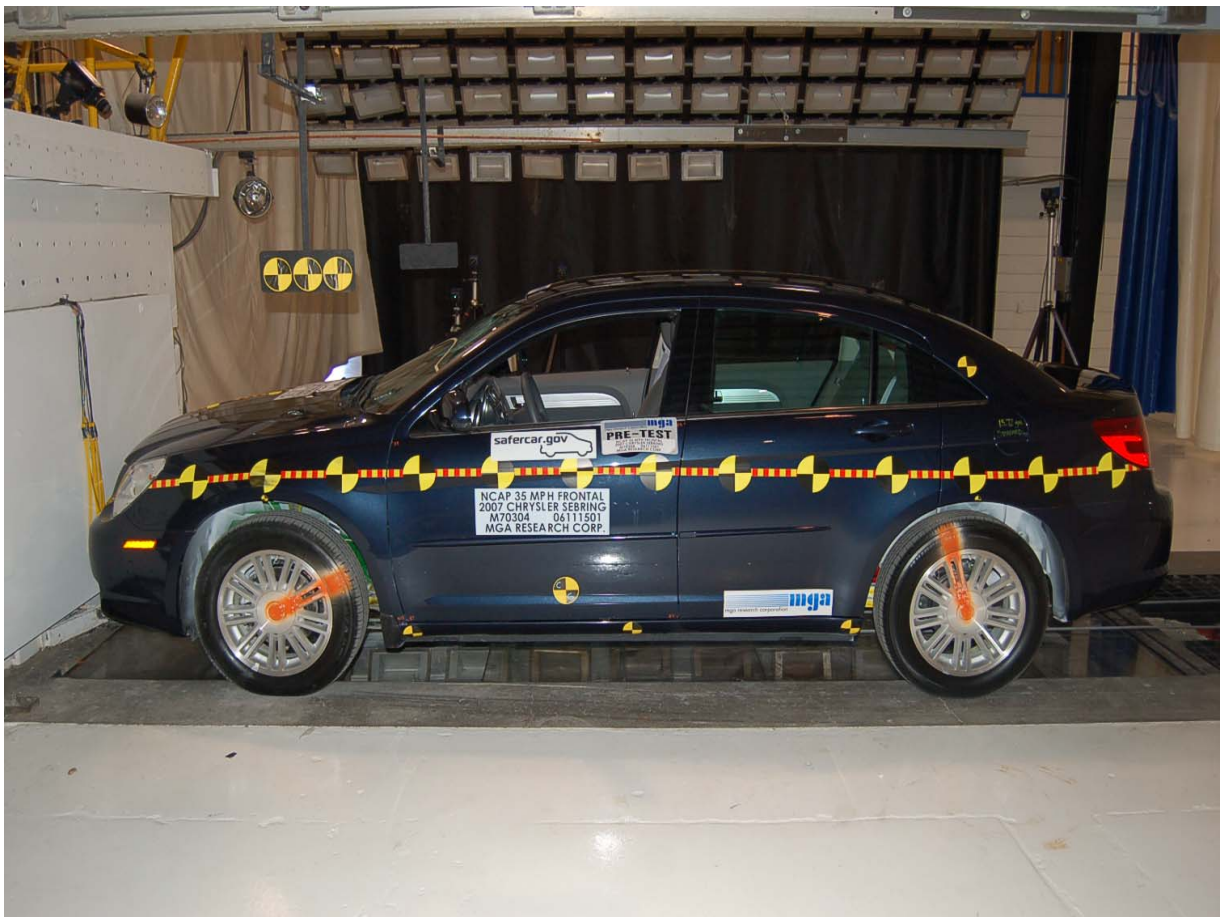
Pre-Test Vehicle Left Side View

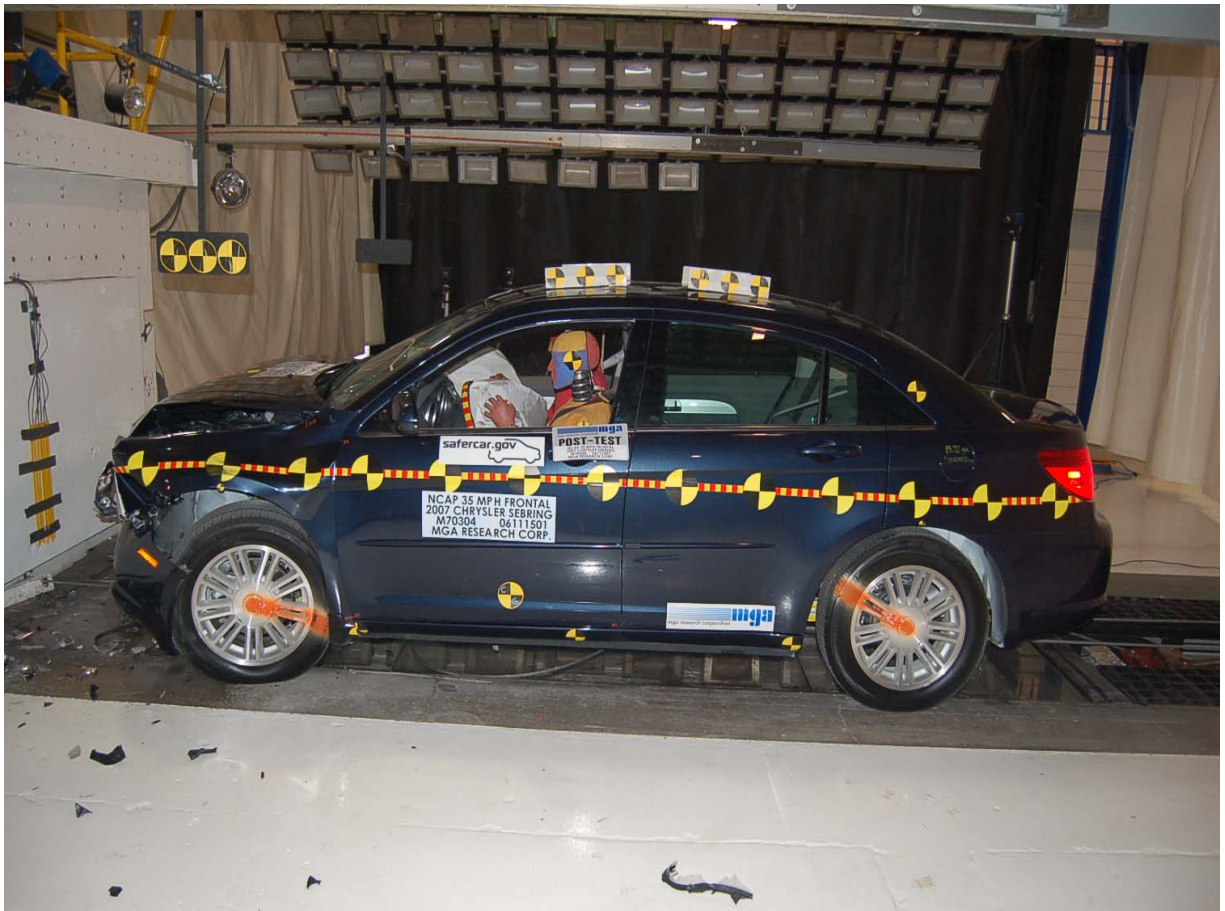
Post-Test Vehicle Left Side View

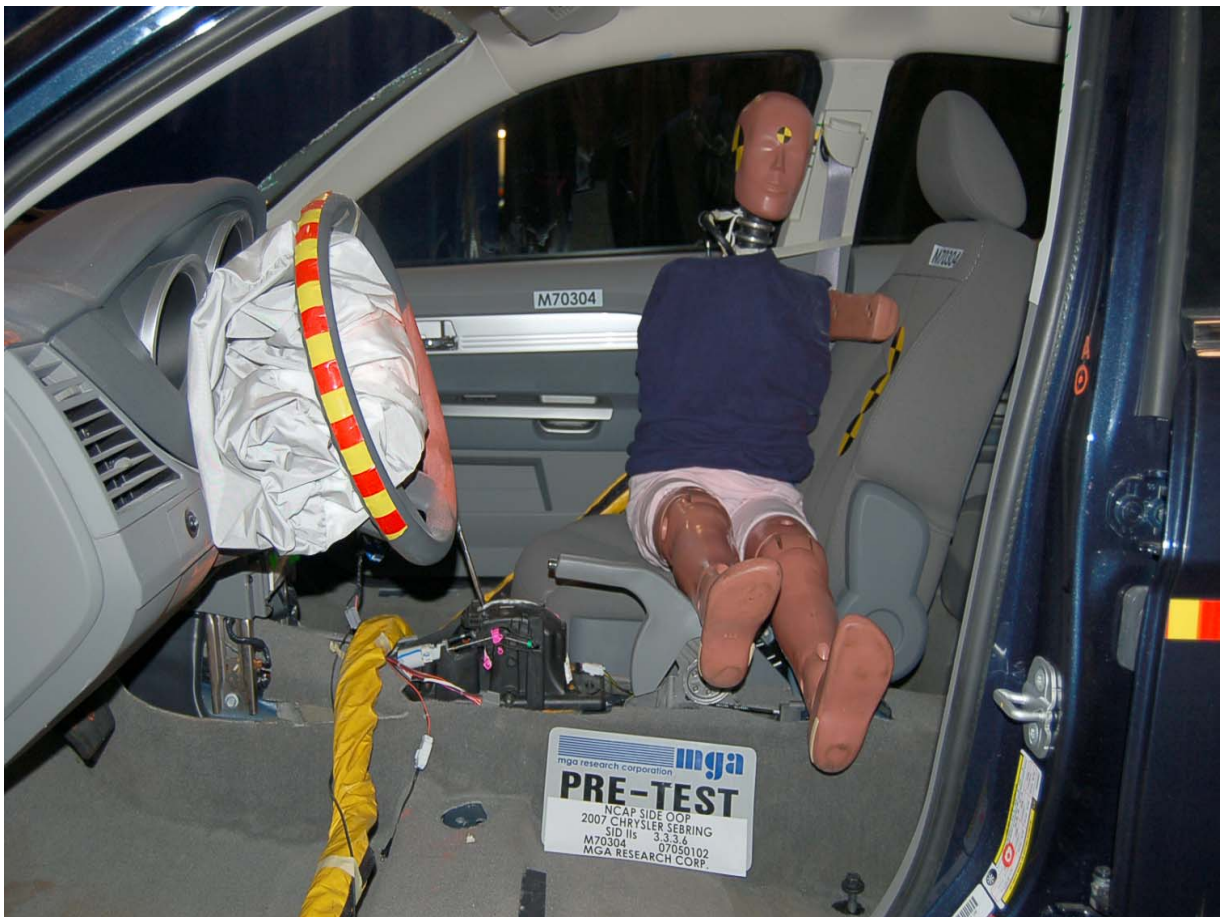
Pre-Test SID-IIs Dummy Frontal View

The SID-II's dummy was placed in the right front passenger seat facing toward the center of the vehicle with its arm against the seatback. The dummy's pelvis was adjusted until the dummy contacted the door trim panel. The arm was rotated to a horizontal orientation. The dummy's pelvis was then adjusted forward/rearward, with respect to the vehicle, to lean the dummy rearward to align the center of the first thoracic rib with the top edge of the airbag module. The dummy's spine was aligned such that a vertical plane through the centerline of the dummy's shoulder rib stiffener and shoulder bolt was parallel to the longitudinal plane of the vehicle. Masking tape was wrapped around the dummy's neck bracket to hold the dummy in place, if necessary.

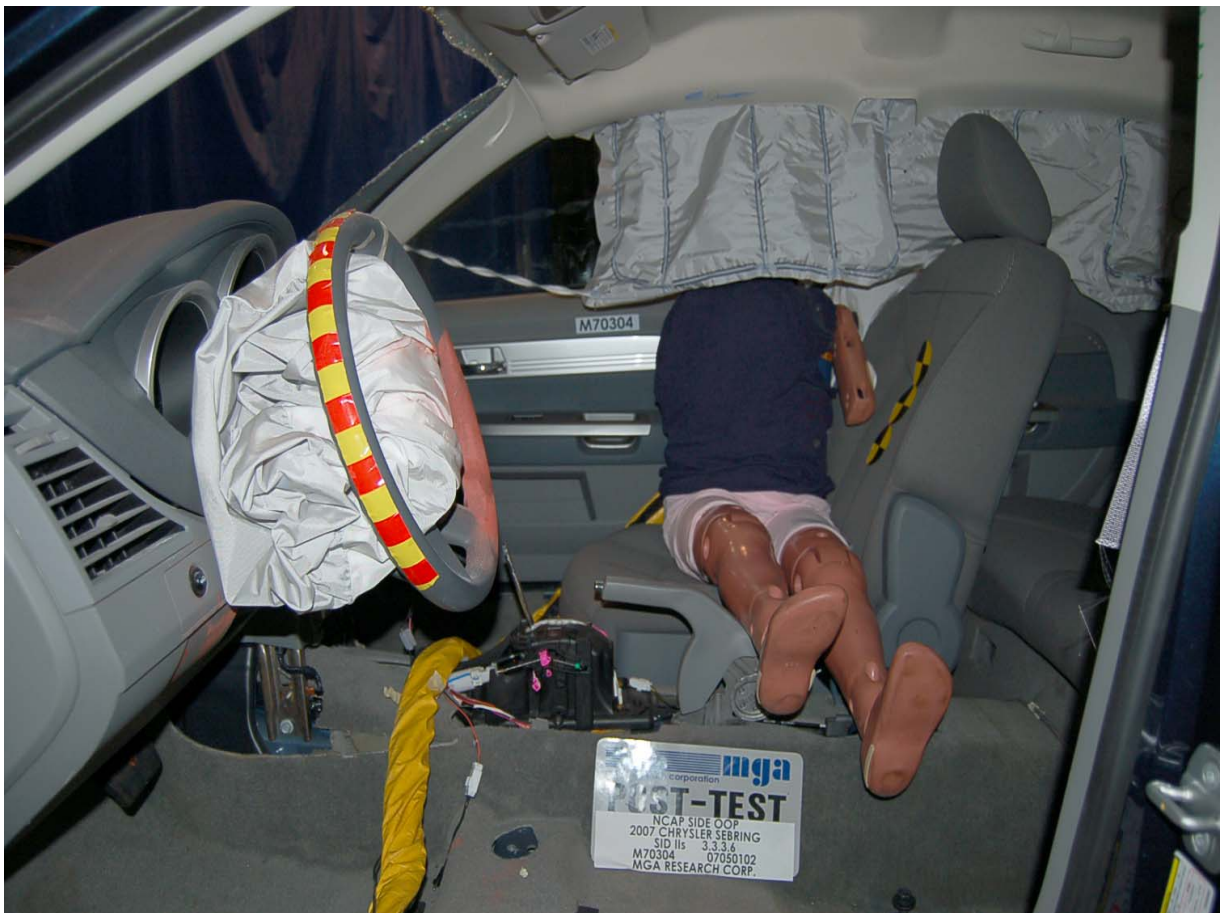
Post-Test SID-IIs Dummy Frontal View

The SID-IIs dummy's visible contact points were as follows: The curtain airbag to the top of the head and face. The torso bag to the left shoulder and torso of the dummy.

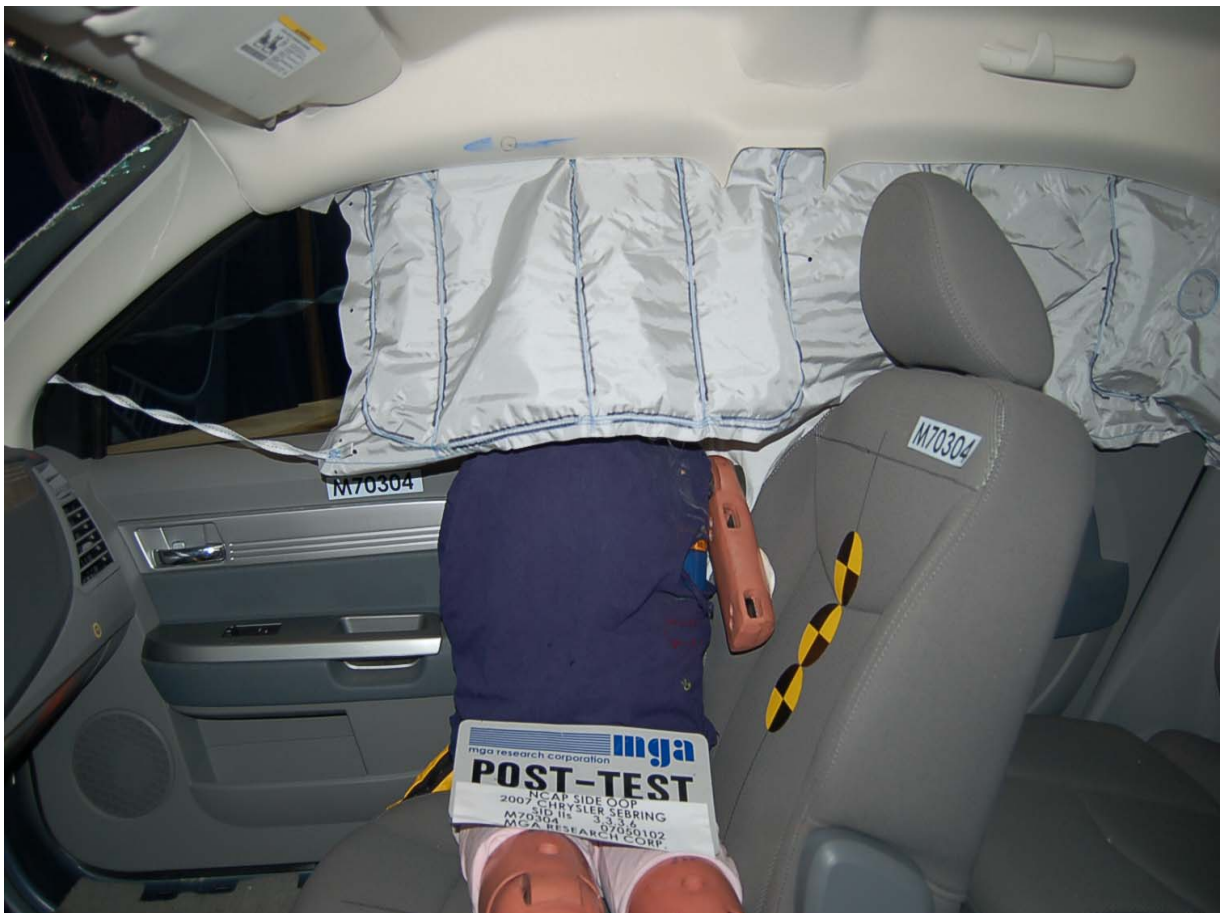
Post-Test SID-IIs Dummy Frontal Closeup View

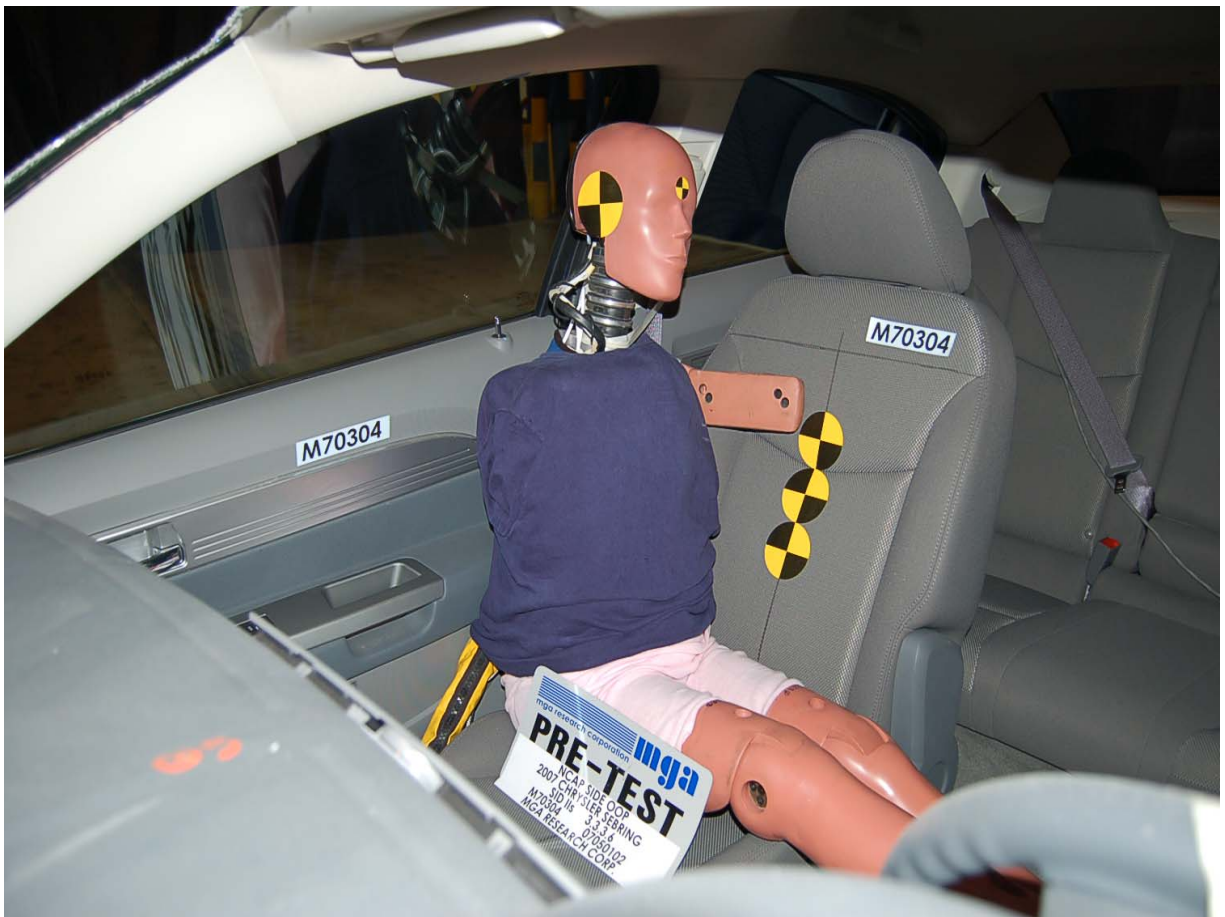
Pre-Test SID-IIs Dummy Right  $\frac{3}{4}$  Front View

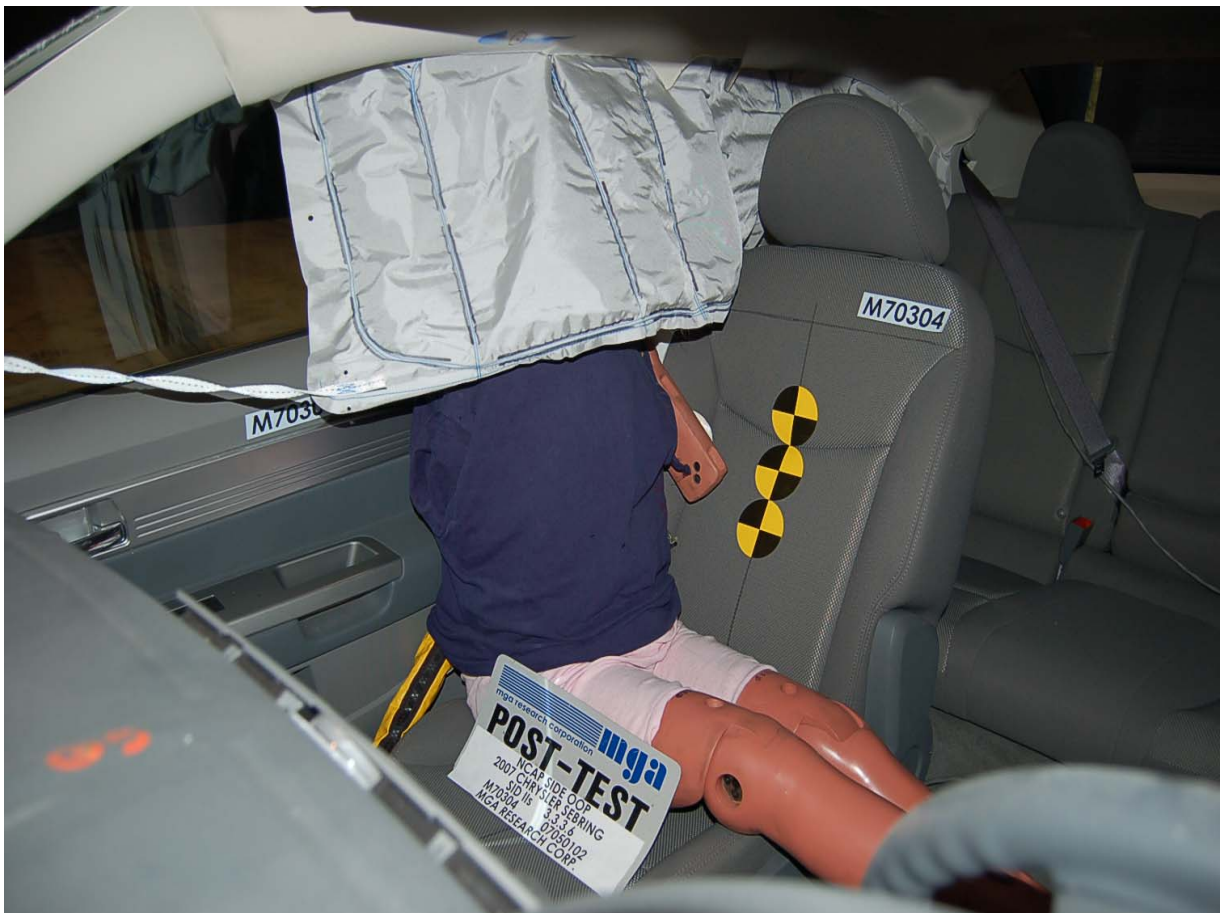
Post-Test SID-IIs Dummy Right  $\frac{3}{4}$  Front View

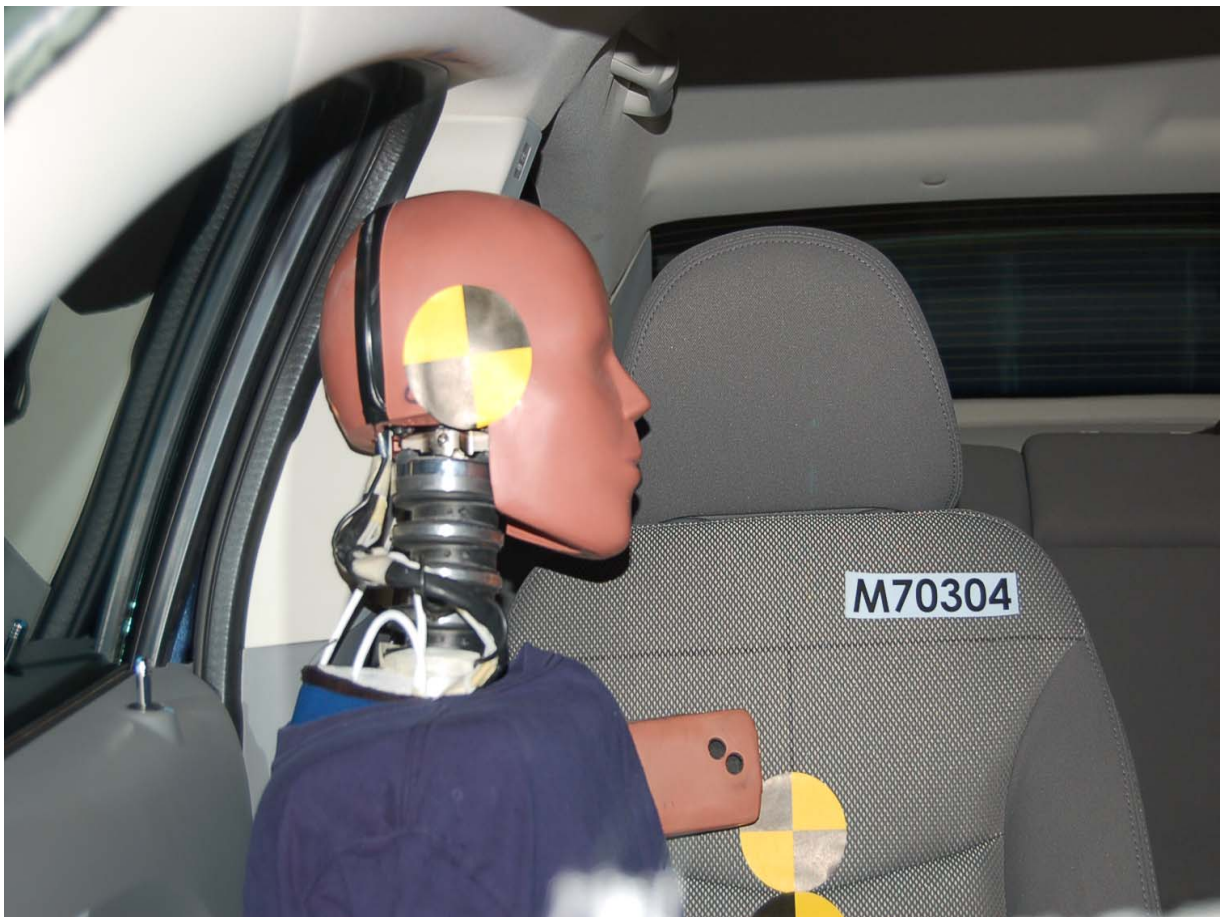
Pre-Test SID-IIs Dummy Right Side Head View

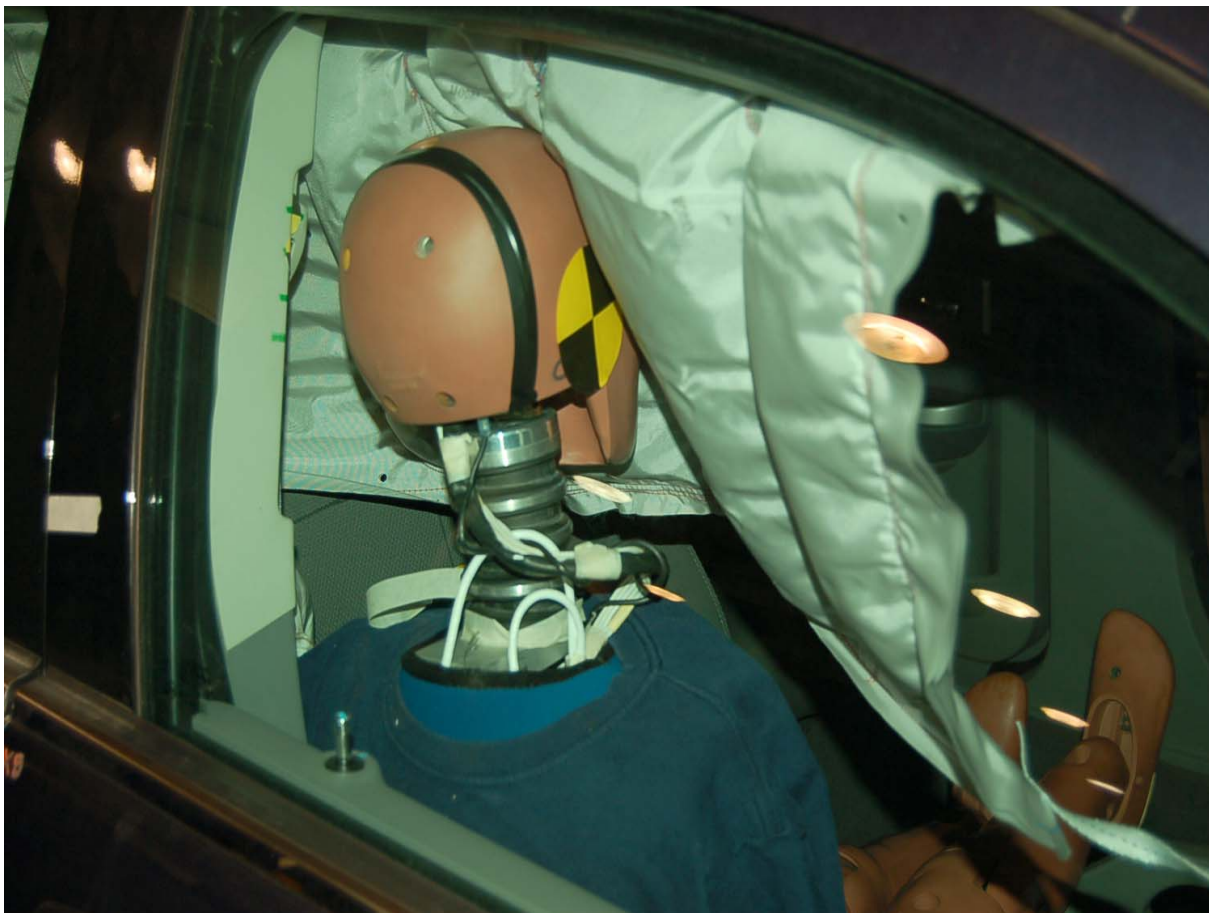
Post-Test SID-11s Dummy View Through RF Window

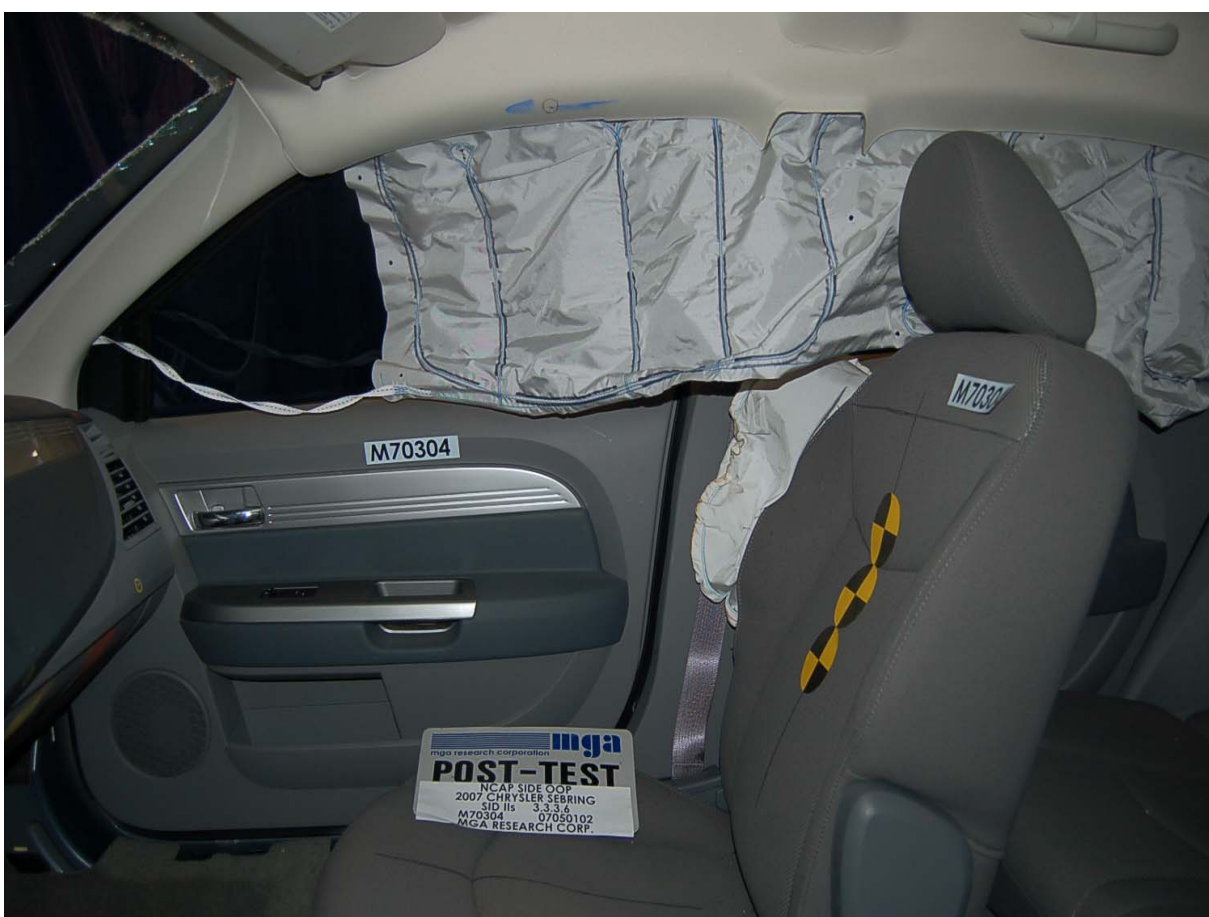
Post-Test Right Front Passenger Compartment View

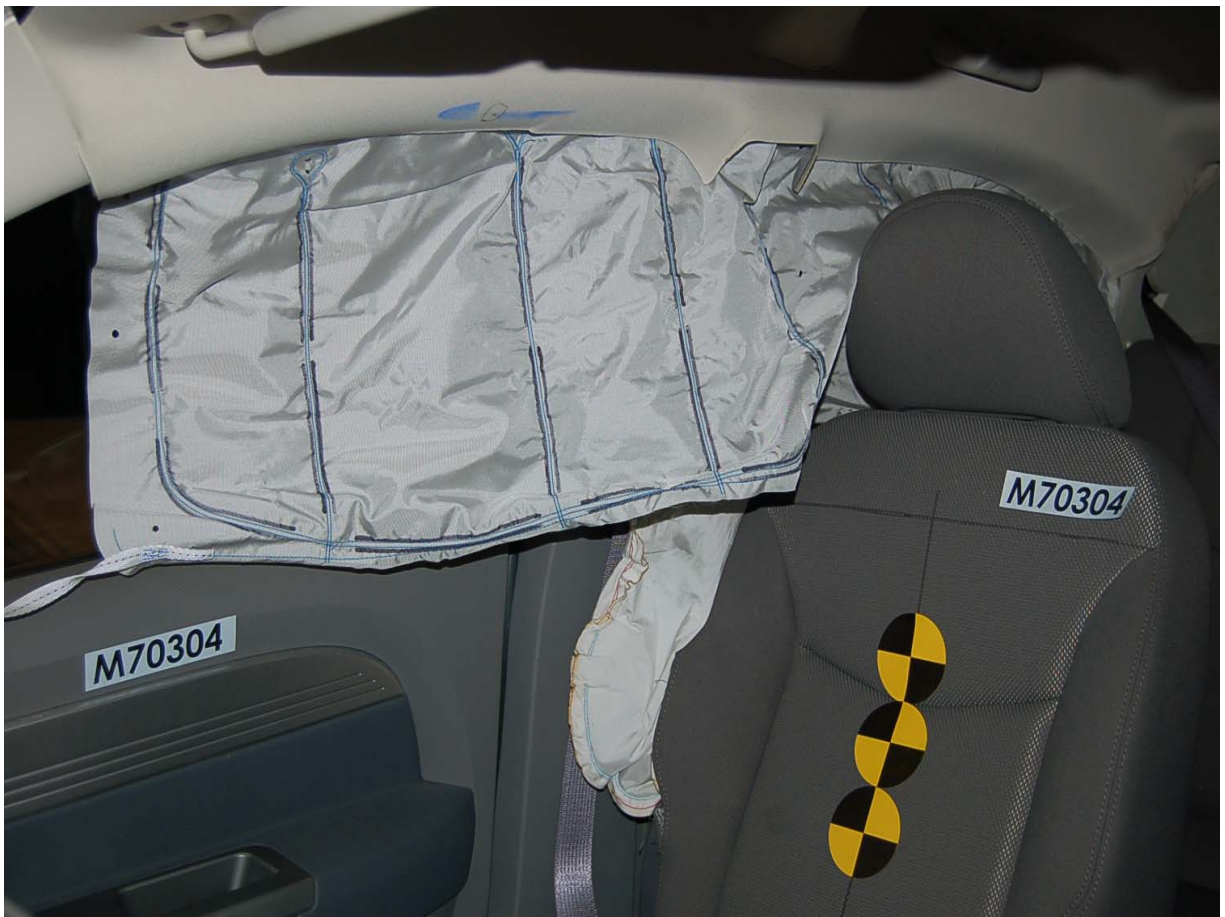
Post-Test Curtain and Torso Airbag View
