**NEW CAR ASSESSMENT PROGRAM  
SIDE IMPACT TEST**

**NISSAN MOTOR CO., LTD  
2007 NISSAN QUEST 3.5 SL  
5-DOOR MPV**

**NHTSA NUMBER: N85200**

**FINAL REPORT**

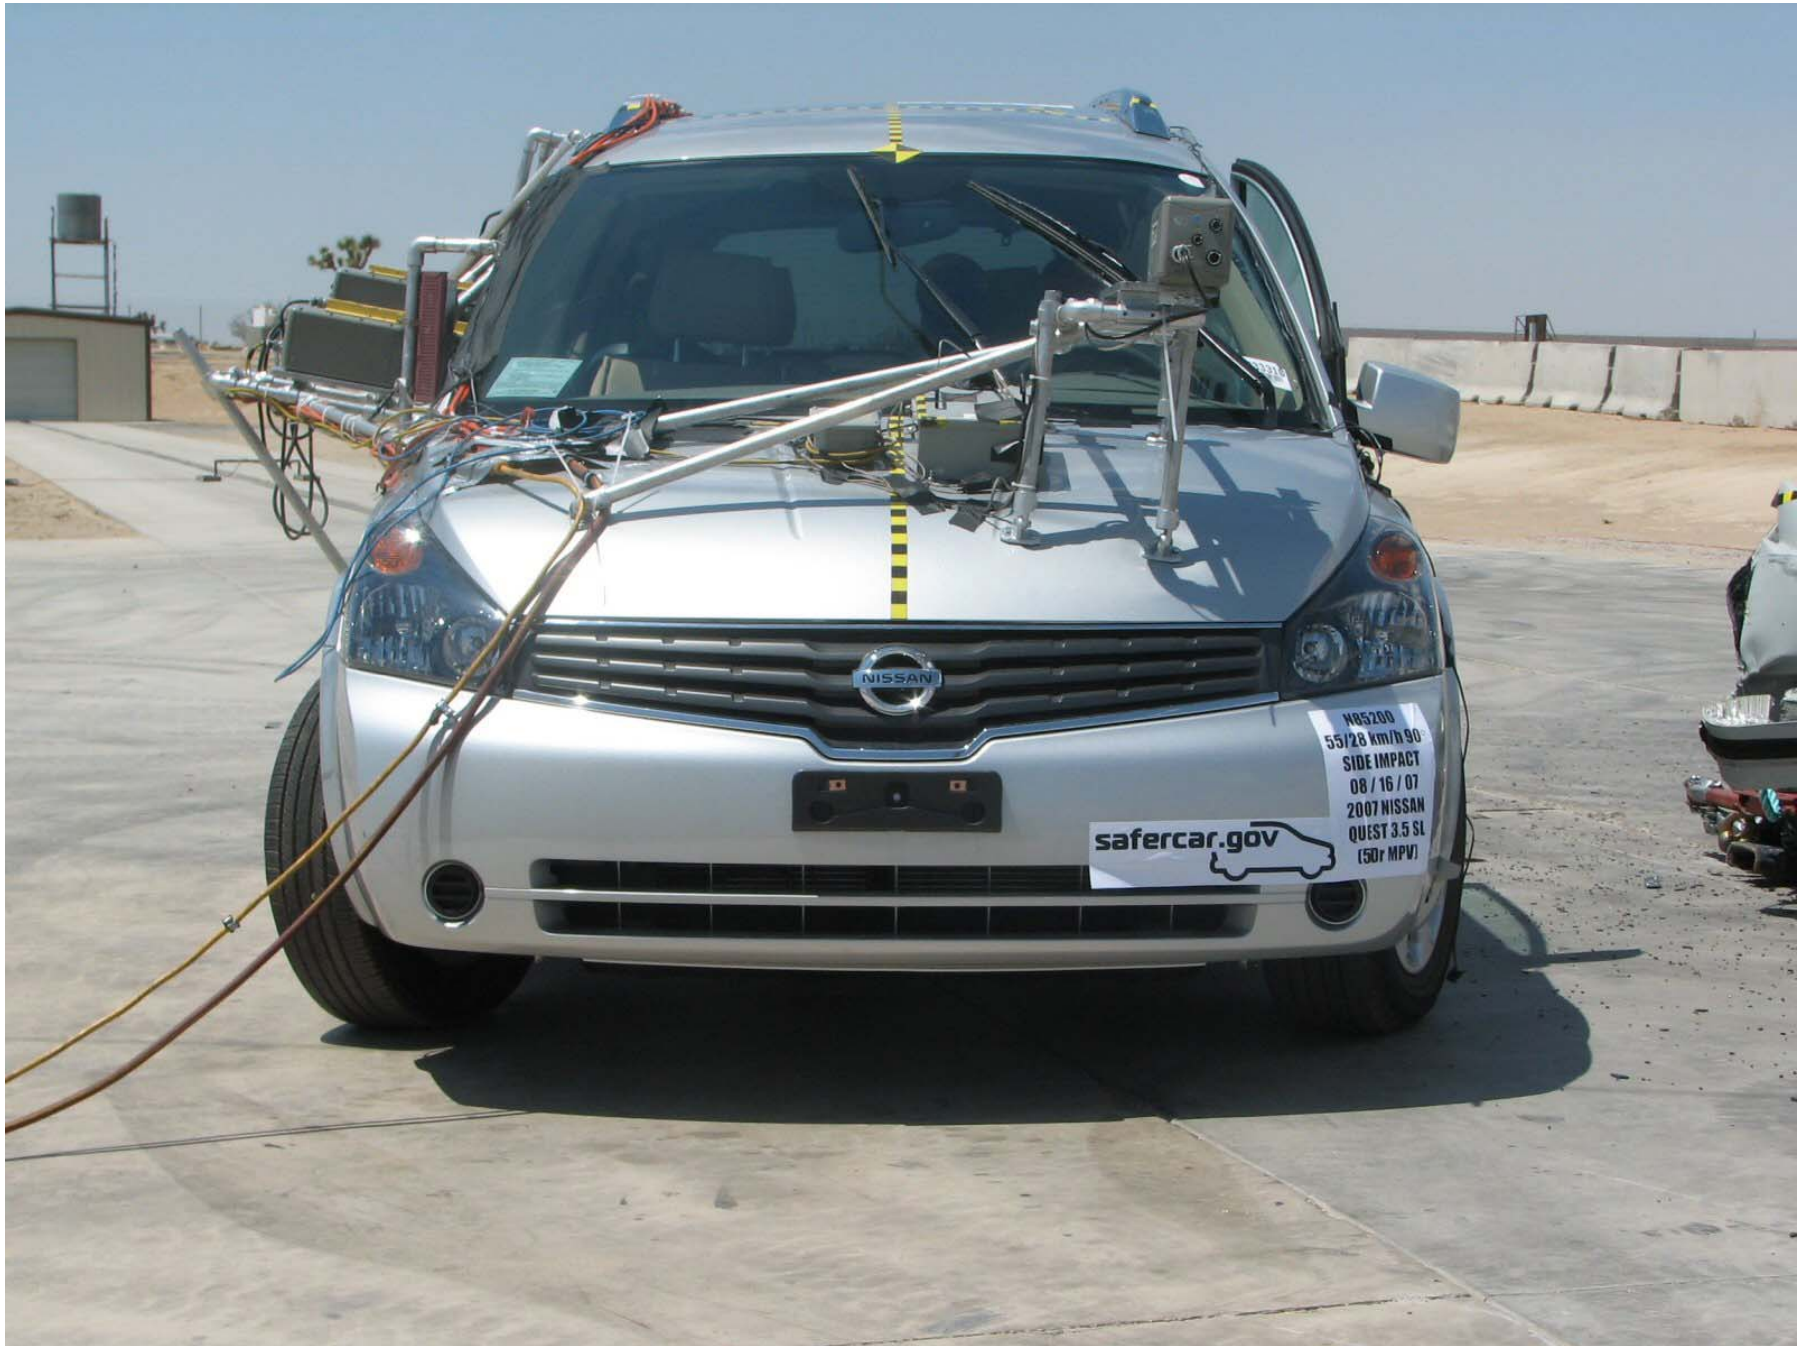
Figure A-6: Post-Test Front View

The driver and passenger doors remained closed during impact. The test vehicle sustained a maximum static crush of 345 mm at level 2, 1200 mm rearward of the left vertical impact point. The driver SID/Hybrid III, Serial No. 275 and the passenger SID/Hybrid III, Serial No. 274 were calibrated prior to this test. The SID/Hybrid III injury criteria is summarized as follows:

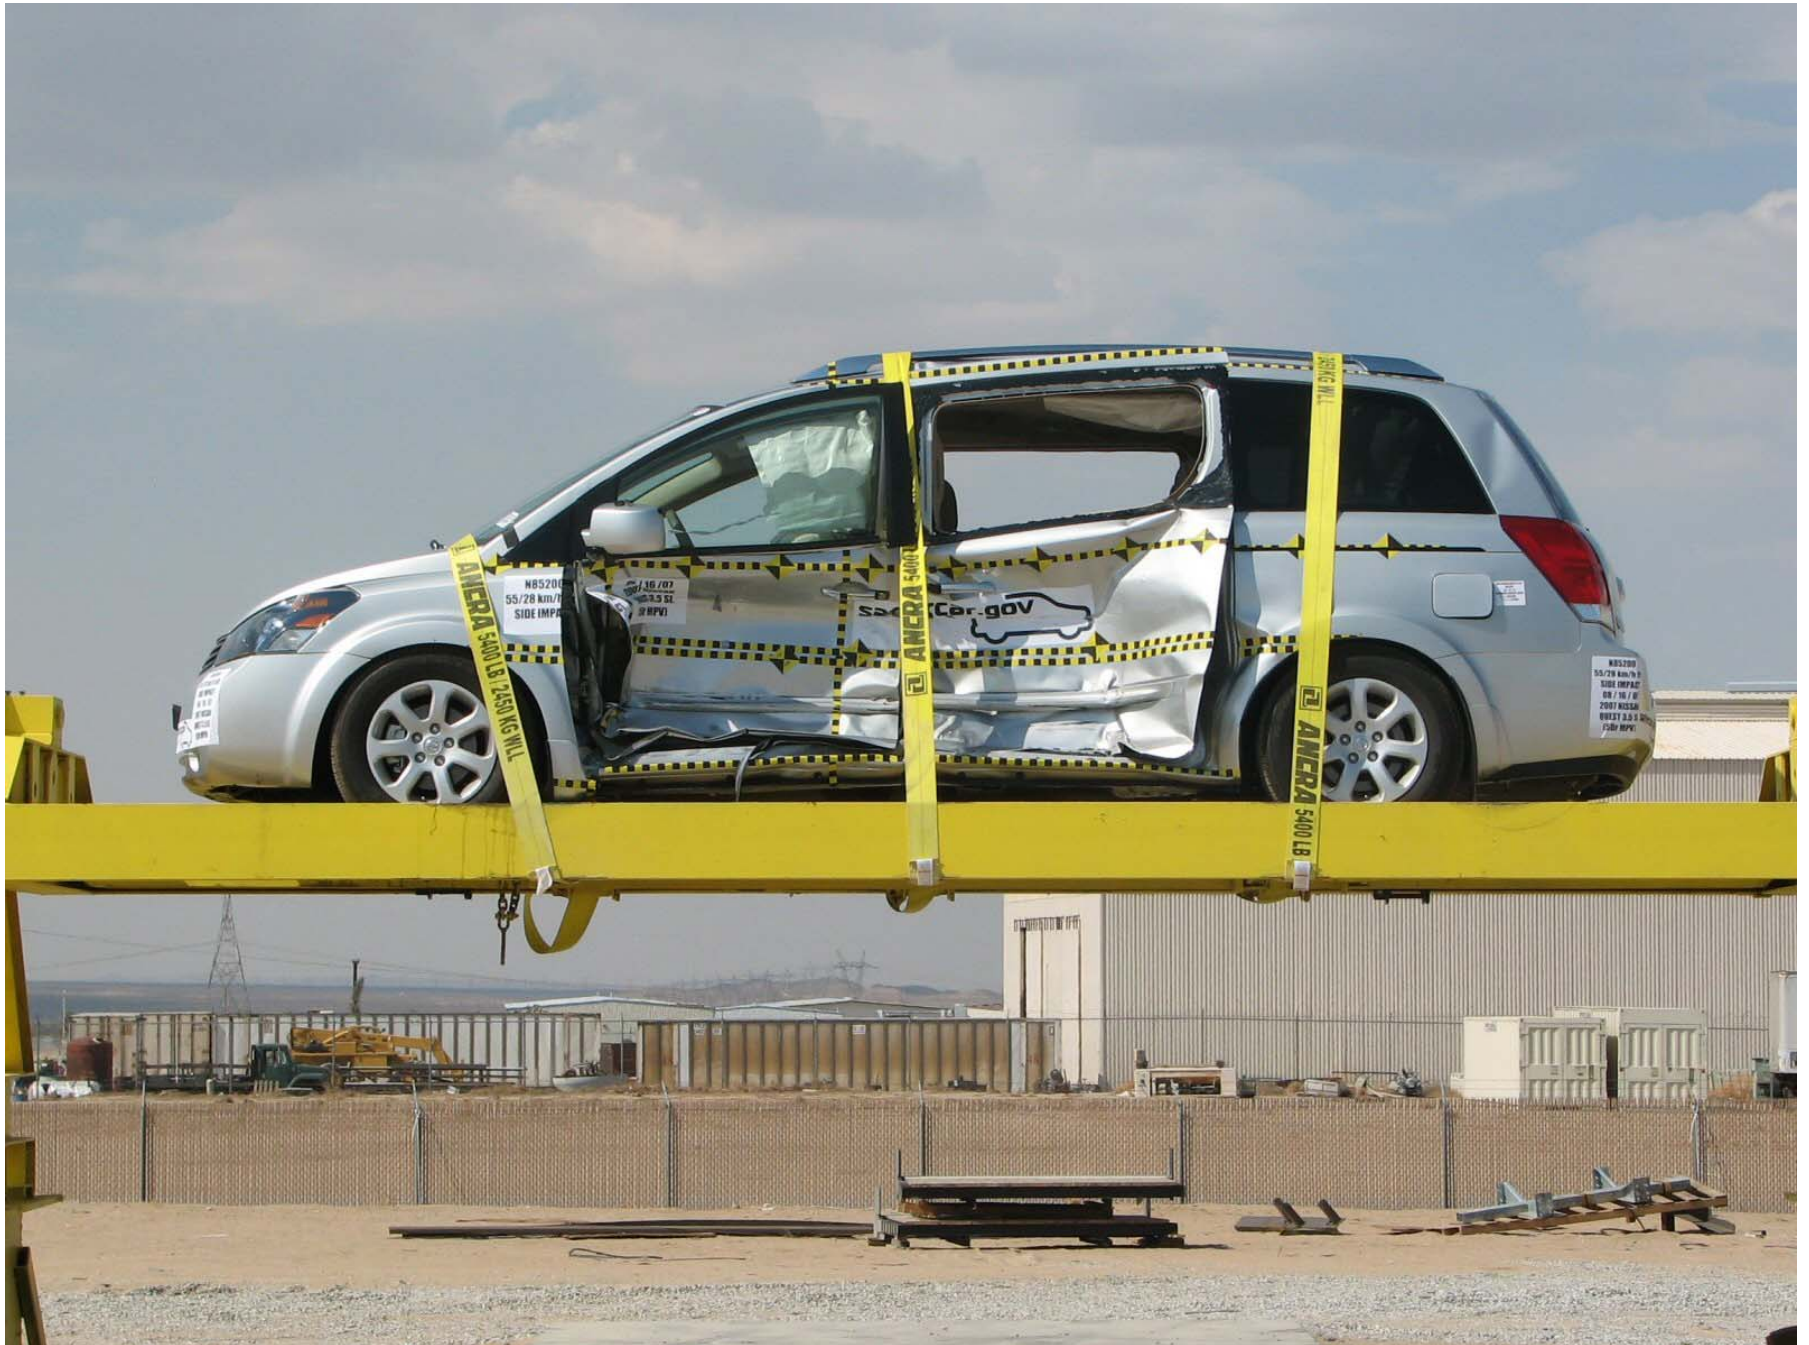
Figure A-61: Vehicle on Rollover Device (0°)

1. The specified fixture rollover rate for each 90° of rotation is 60 to 120 seconds.
  2. The position hold time at each position is 300 seconds (minimum).
  3. Details of Stoddard Solvent spillage locations.
- No solvent leakage occurred during static rollover testing.
