**REPORT NUMBER: MCW-DOT-08SN01**

**NEW CAR ASSESSMENT PROGRAM  
SIDE IMPACT TEST**

**2008 FORD MUSTANG 2-DOOR COUPE**

**FINAL REPORT**

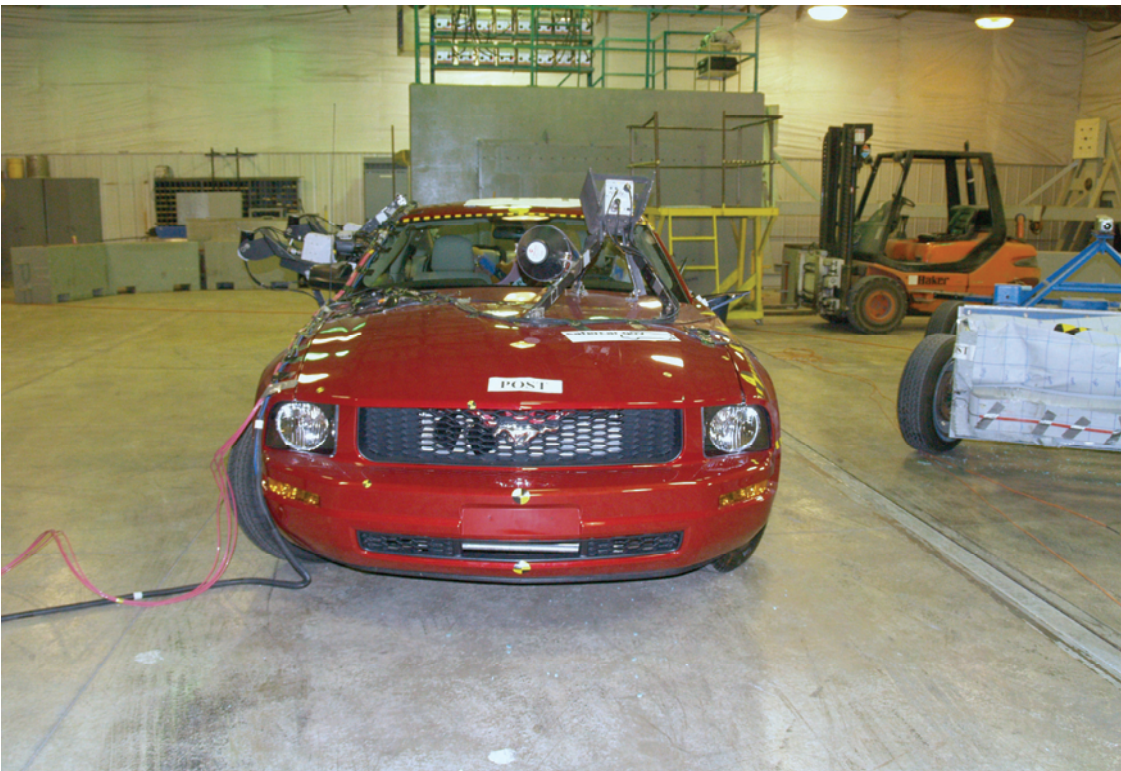
Figure A-6: Post test front view of test vehicle

| POST TEST STRUCTURAL OBSERVATIONS | |
|---|---|
| Windshield damage | ~660 mm crack across top of windshield and 580 mm crack across middle of windshield; both starting at A-pillar and going inboard |

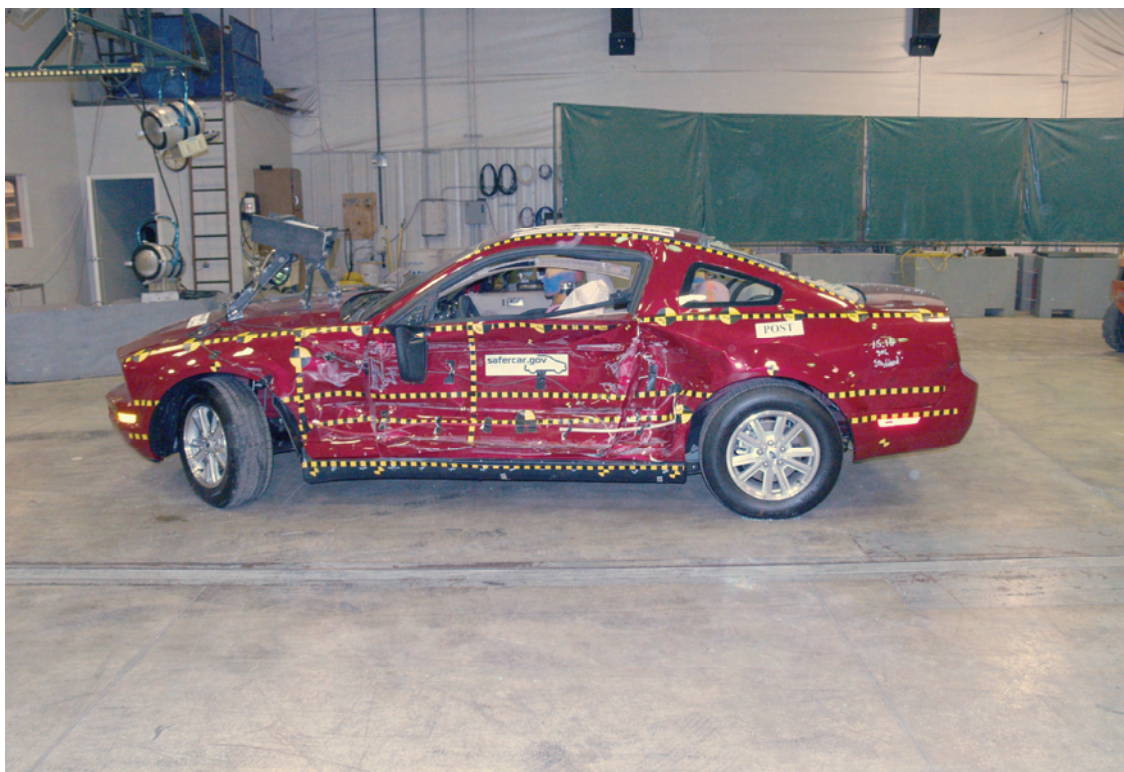
Figure A-10: Post test left side view of test vehicle

| POST TEST STRUCTURAL OBSERVATIONS | |
|---|---|
| Window damage | Front and rear struck side windows shattered at impact |

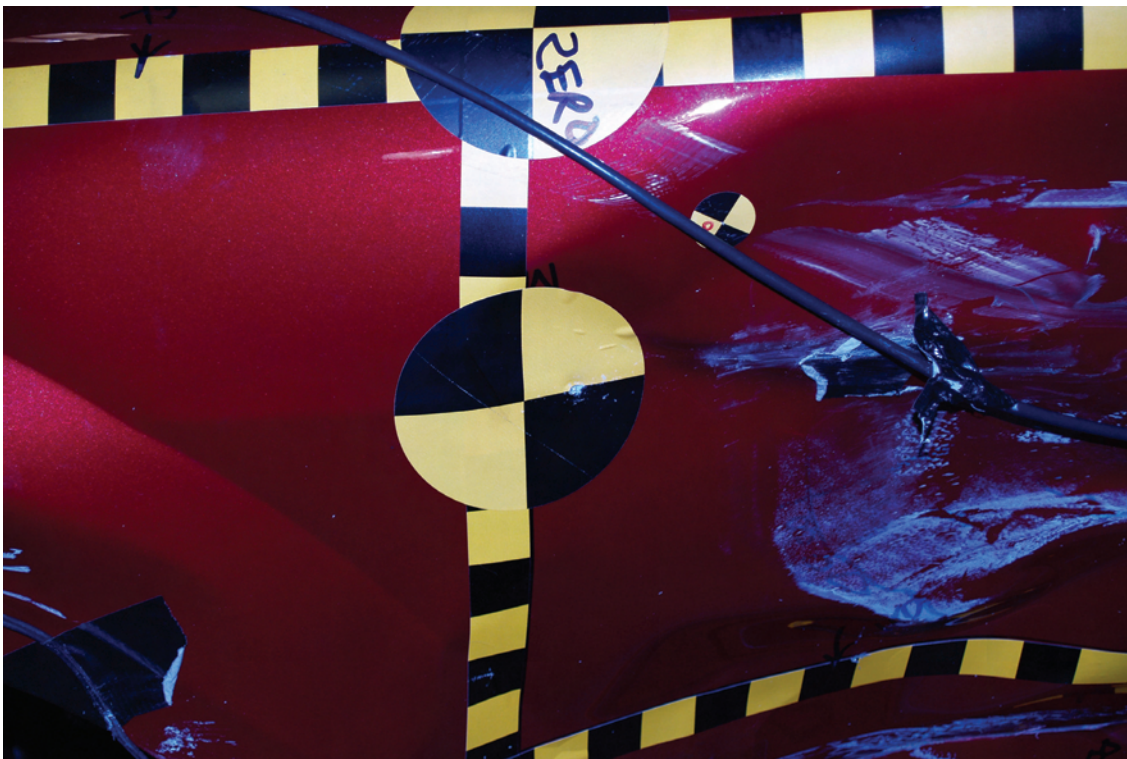
Figure A-26: Post test impact point

The test vehicle sustained a maximum static crush of 191 mm at level 3, 750 mm rearward of the vertical impact line.

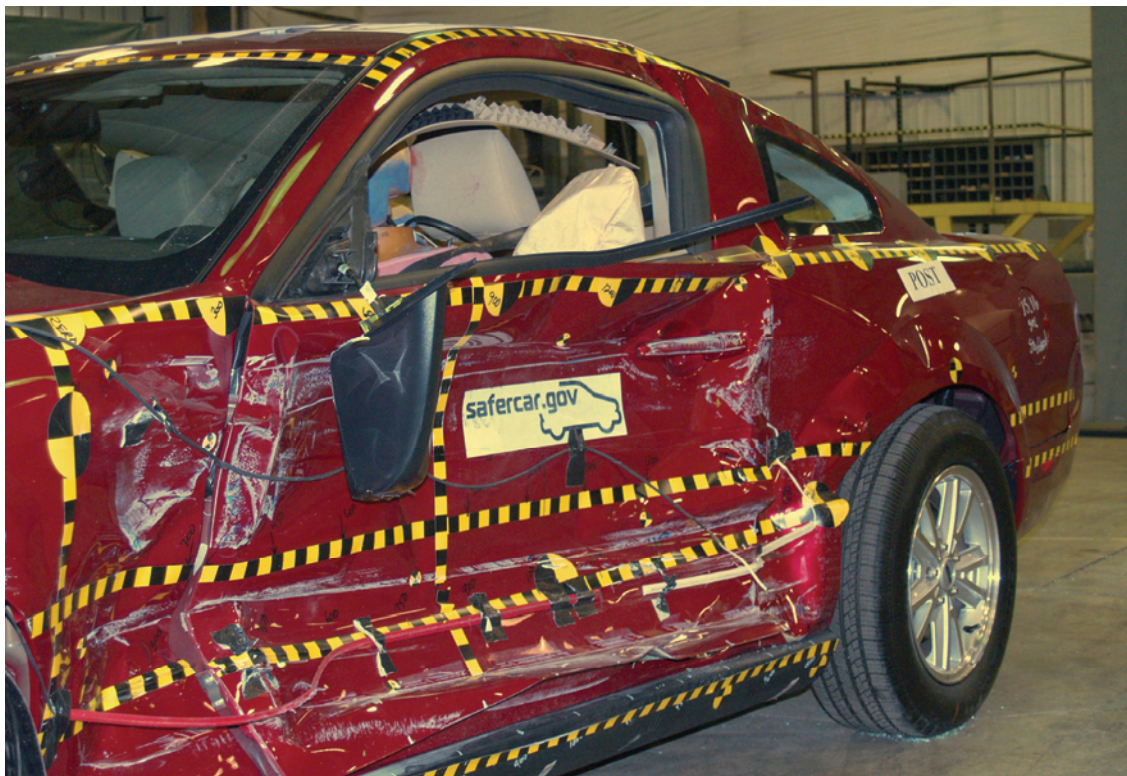
Figure A-32: Post test left front door

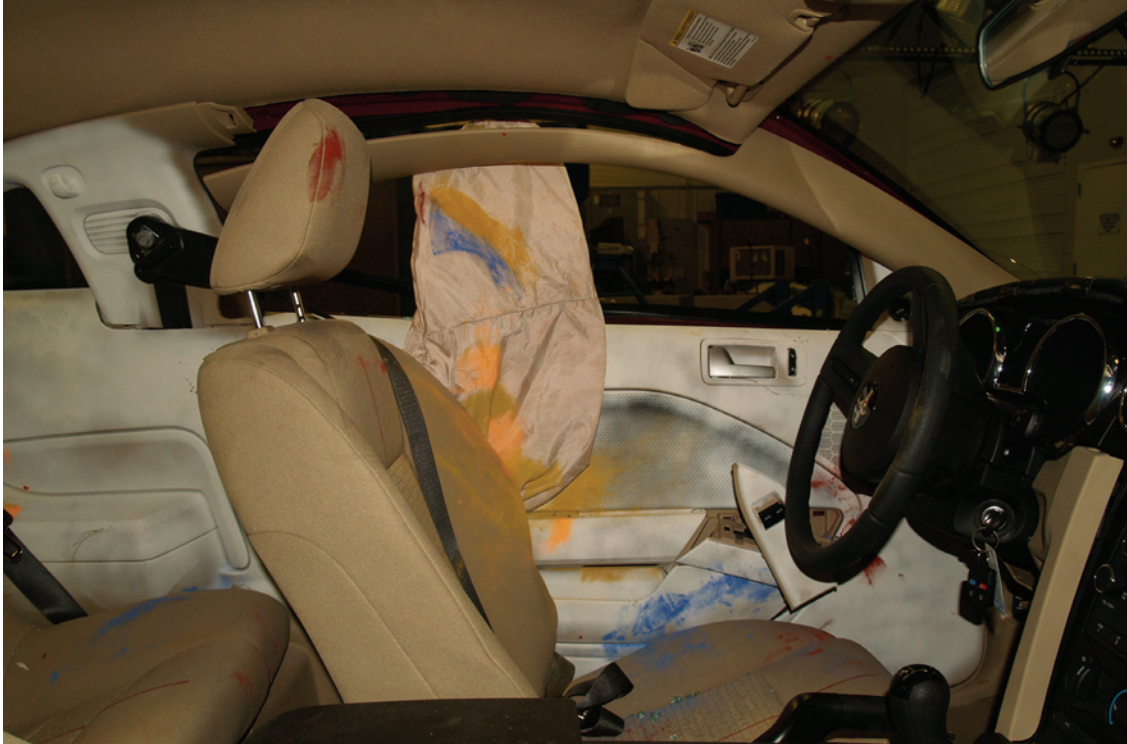
Figure A-39: Post test driver contact locations (1)

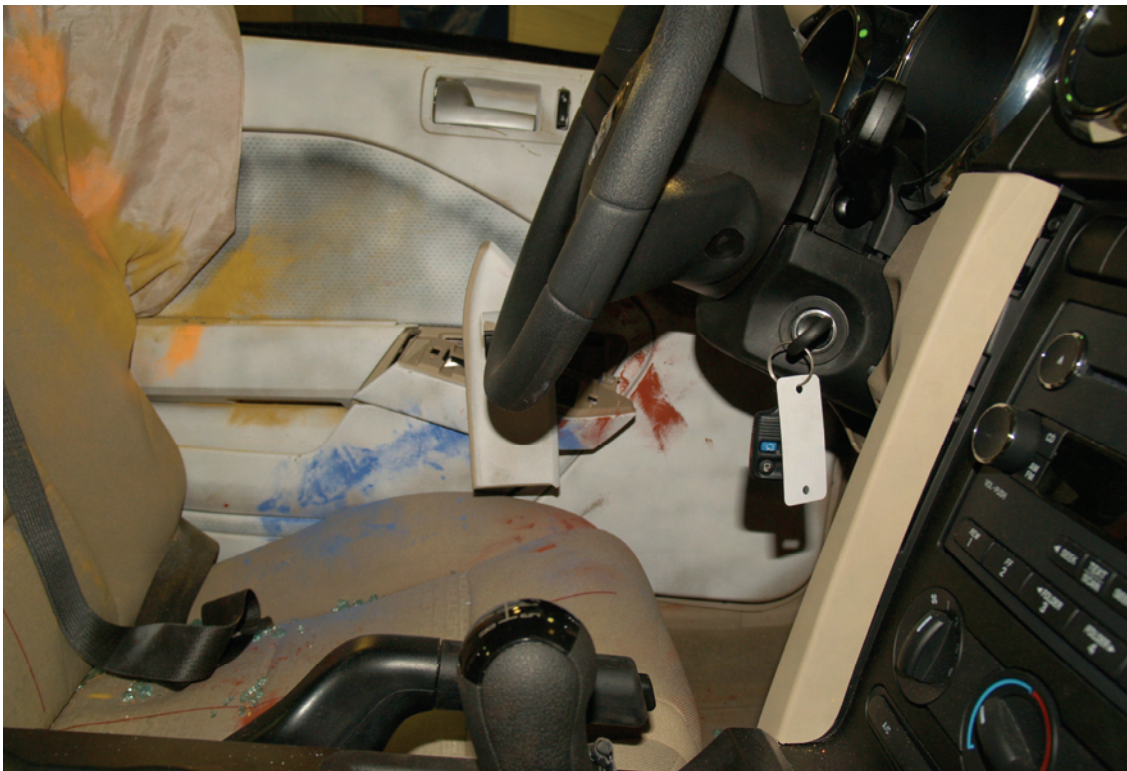
Figure A-40: Post test driver contact locations (2)

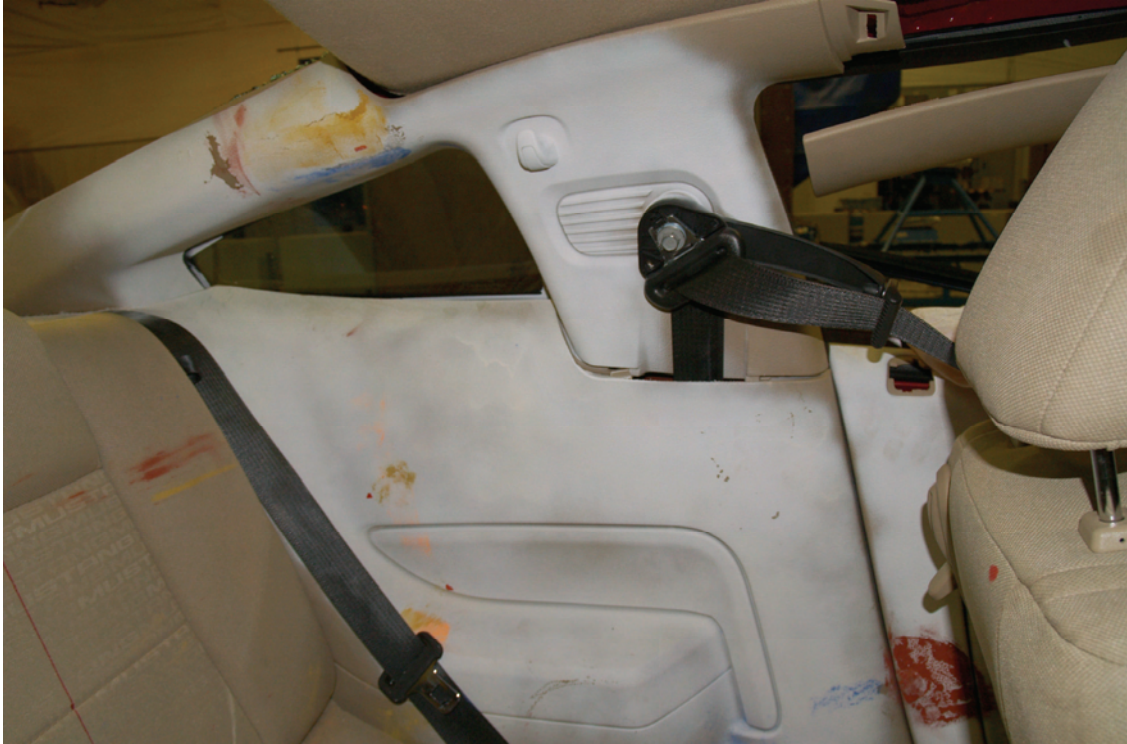
Figure A-47: Post test passenger contact locations (1)

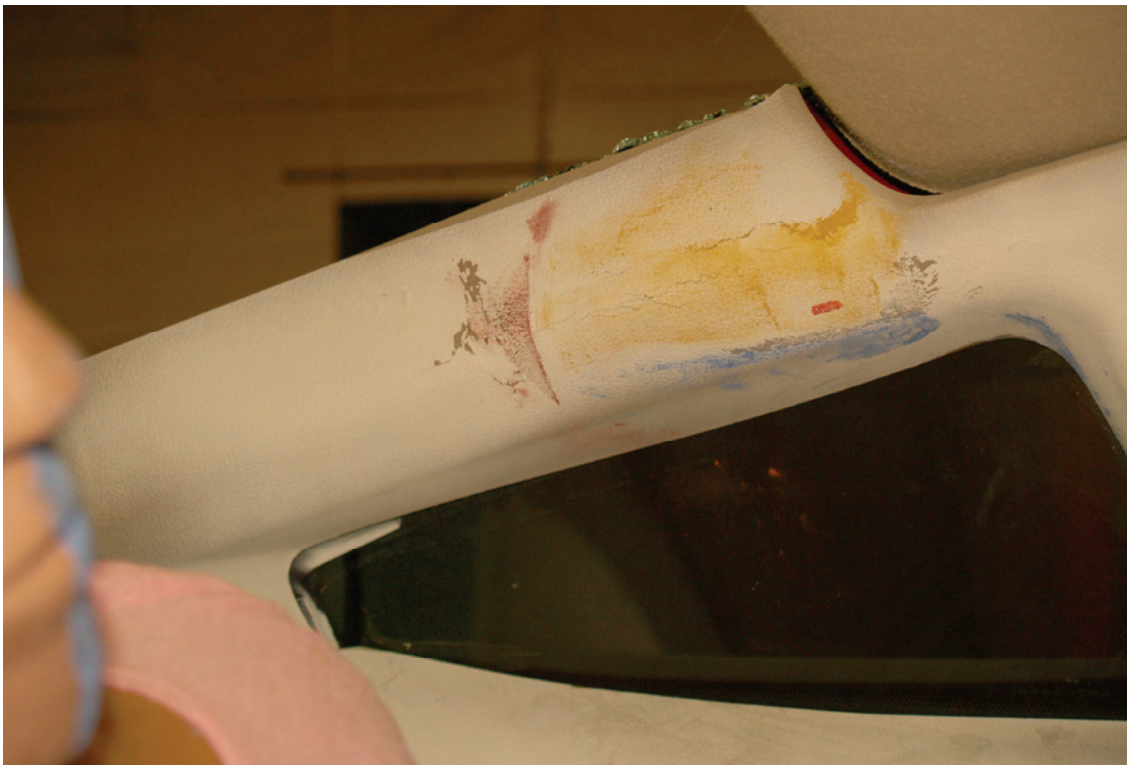
Figure A-48: Post test passenger contact locations (2)
