**REPORT NUMBER: NCAPSIDE-MGA-2008-001**

**NEW CAR ASSESSMENT PROGRAM  
SIDE IMPACT TEST**

**DAIMLERCHRYSLER CORPORATION  
2008 CHRYSLER SEBRING CONVERTIBLE  
NHTSA NUMBER: M80302**

**PREPARED BY:  
MGA RESEARCH CORPORATION  
5000 WARREN ROAD  
BURLINGTON, WI 53105**

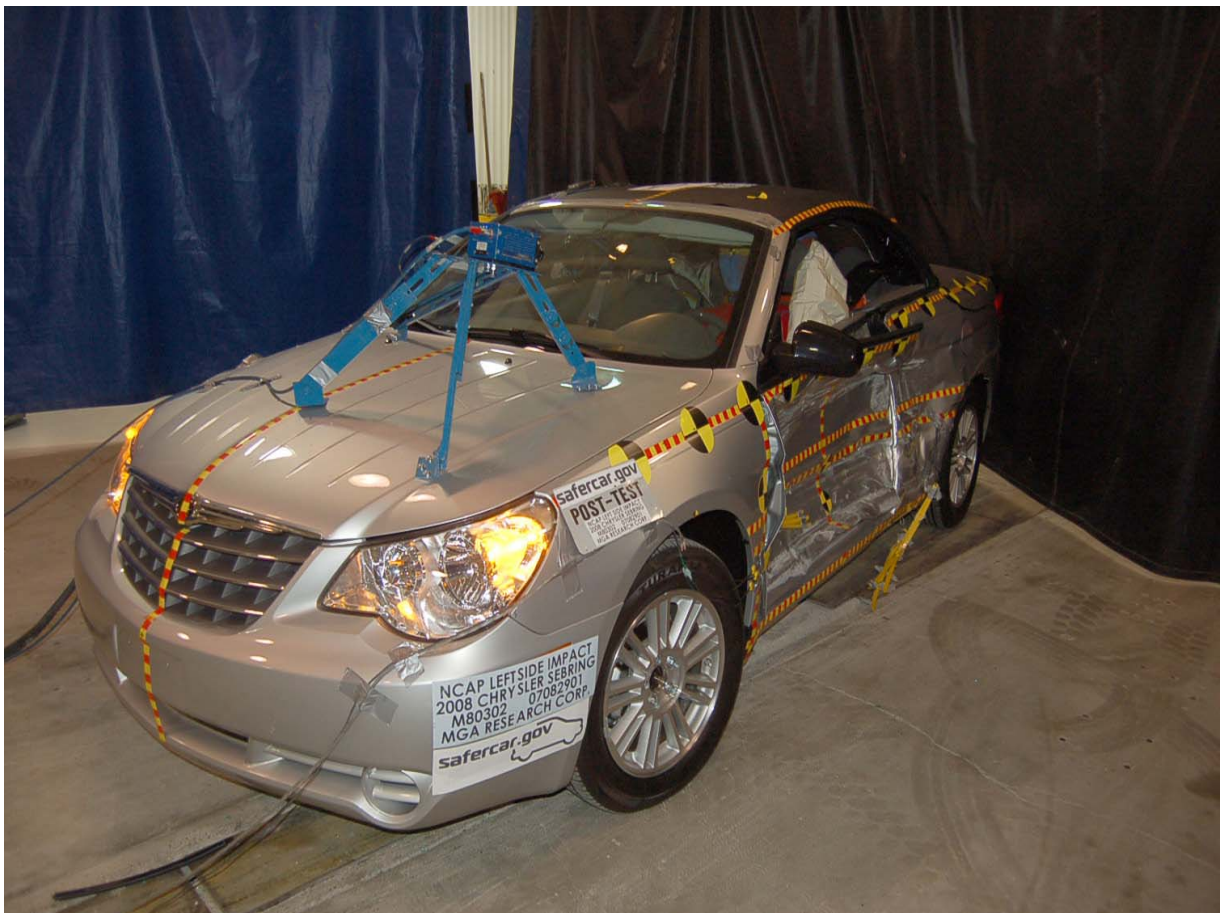
Post-Test Left Front  $\frac{3}{4}$  View

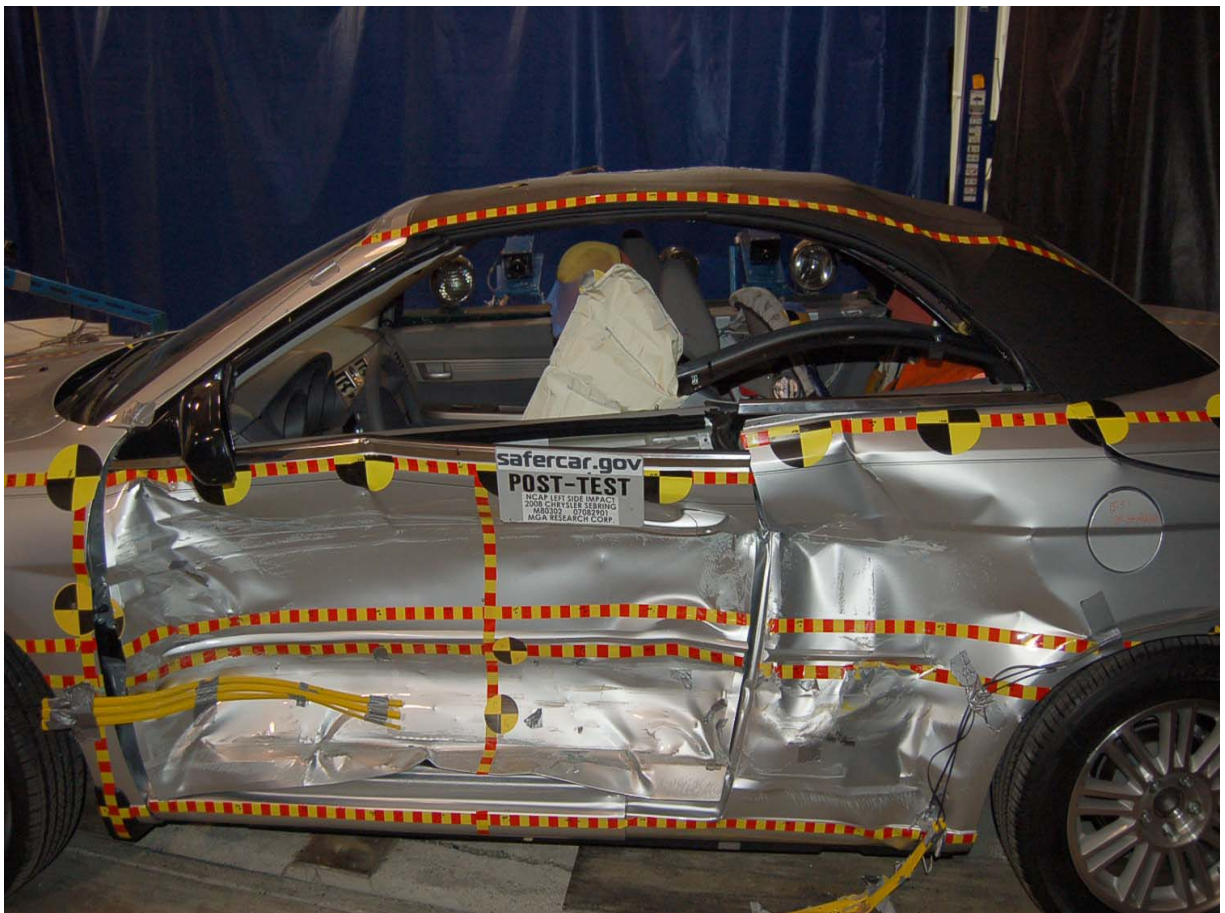
Post-Test Left Side Impact Close-up

The test vehicle sustained a maximum static crush of 177 mm at level 3, 1050 mm rearward of the vertical impact point. The driver and passenger SID/HIIIs, Serial Nos. 271 and 904 respectively, were calibrated just prior to this test.

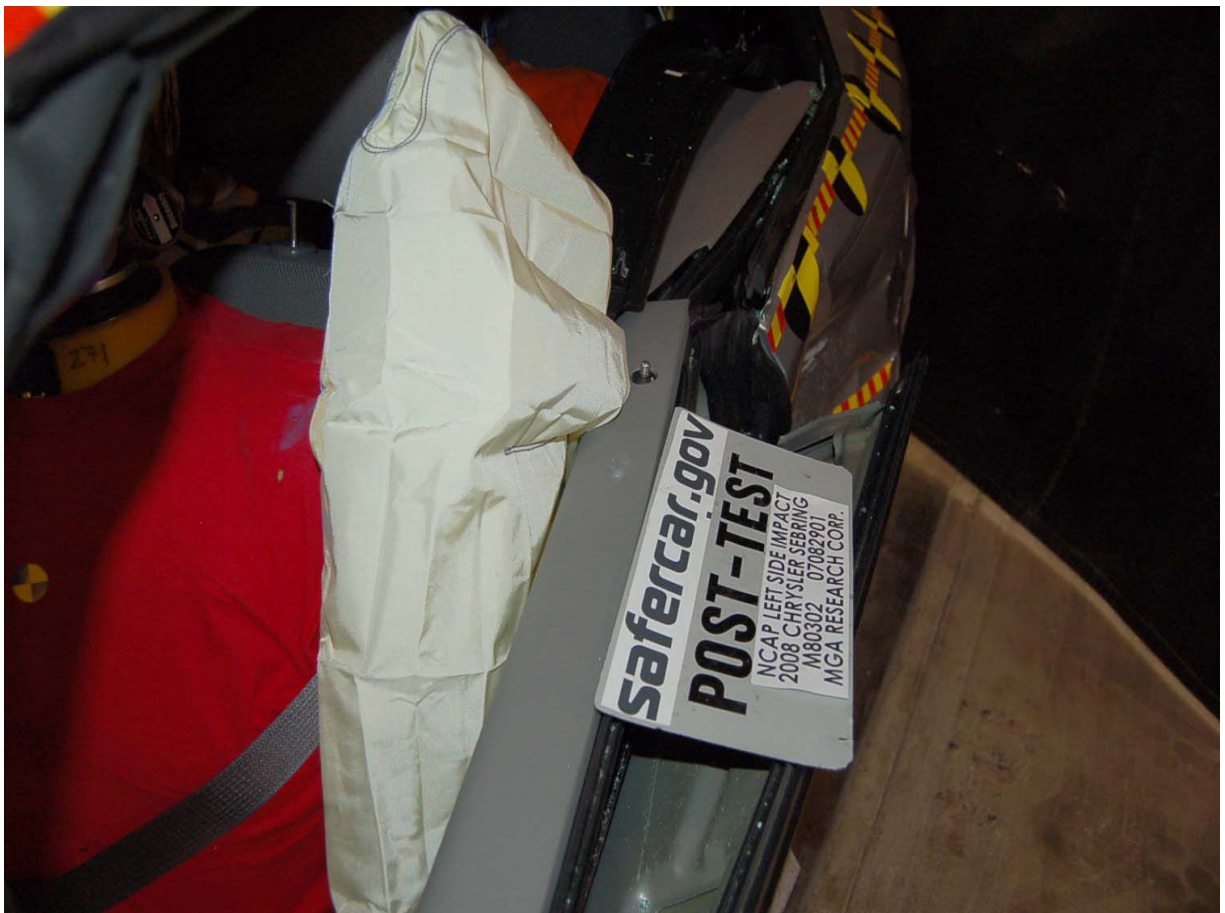
Post-Test Driver Dummy Clearance From Door
