REPORT NUMBER: NCAP-MGA-2008-002

**NEW CAR ASSESSMENT PROGRAM
FRONTAL BARRIER IMPACT TEST**

**DAIMLERCHRYSLER CORPORATION
2008 DODGE GRAND CARAVAN SE
NHTSA NUMBER: M80307**

**PREPARED BY:
MGA RESEARCH CORPORATION
5000 WARREN ROAD
BURLINGTON, WI 53105**

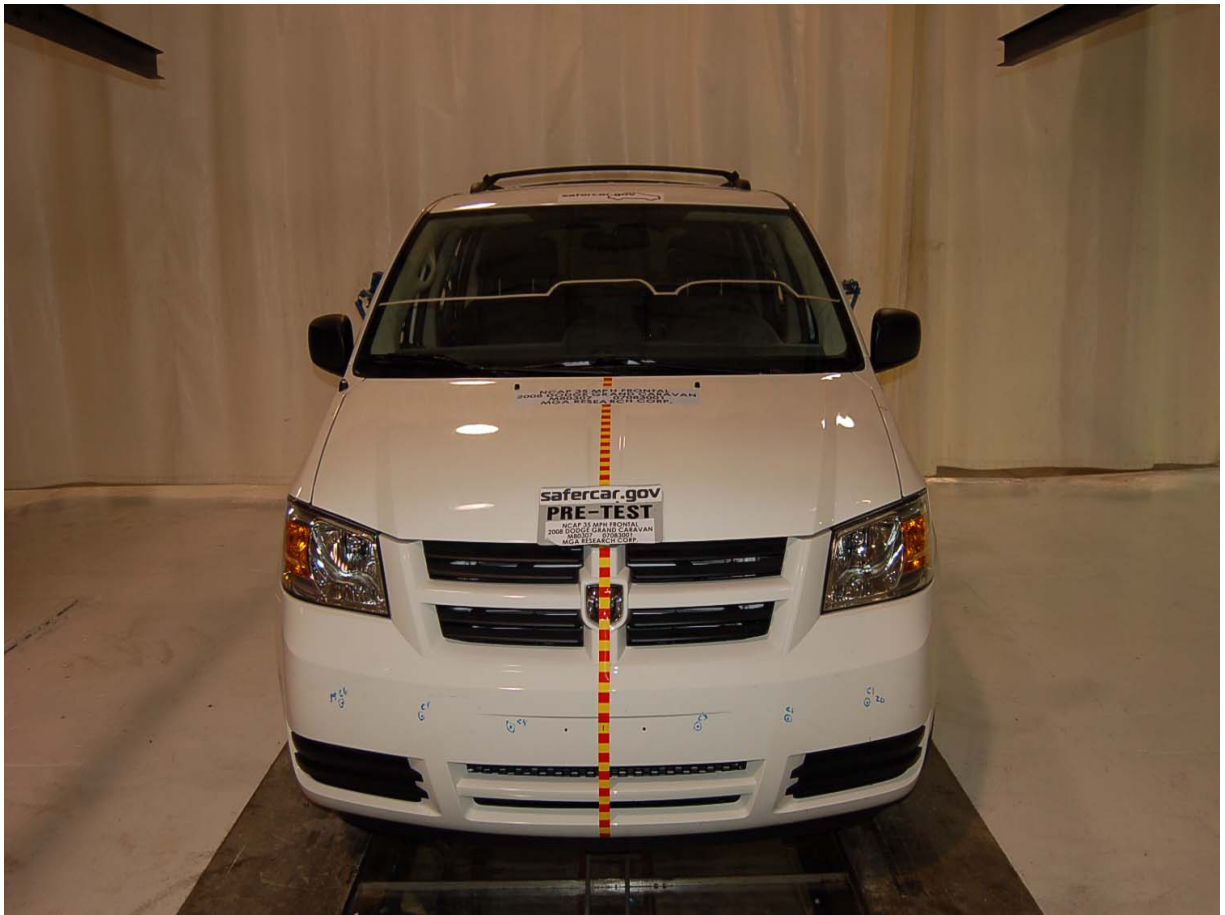
Pre-Test Front View

Post-Test Front View

The maximum static crush of the vehicle was 615 mm and both the driver and passenger side doors remained closed and latched during the impact event and were operable after the impact.

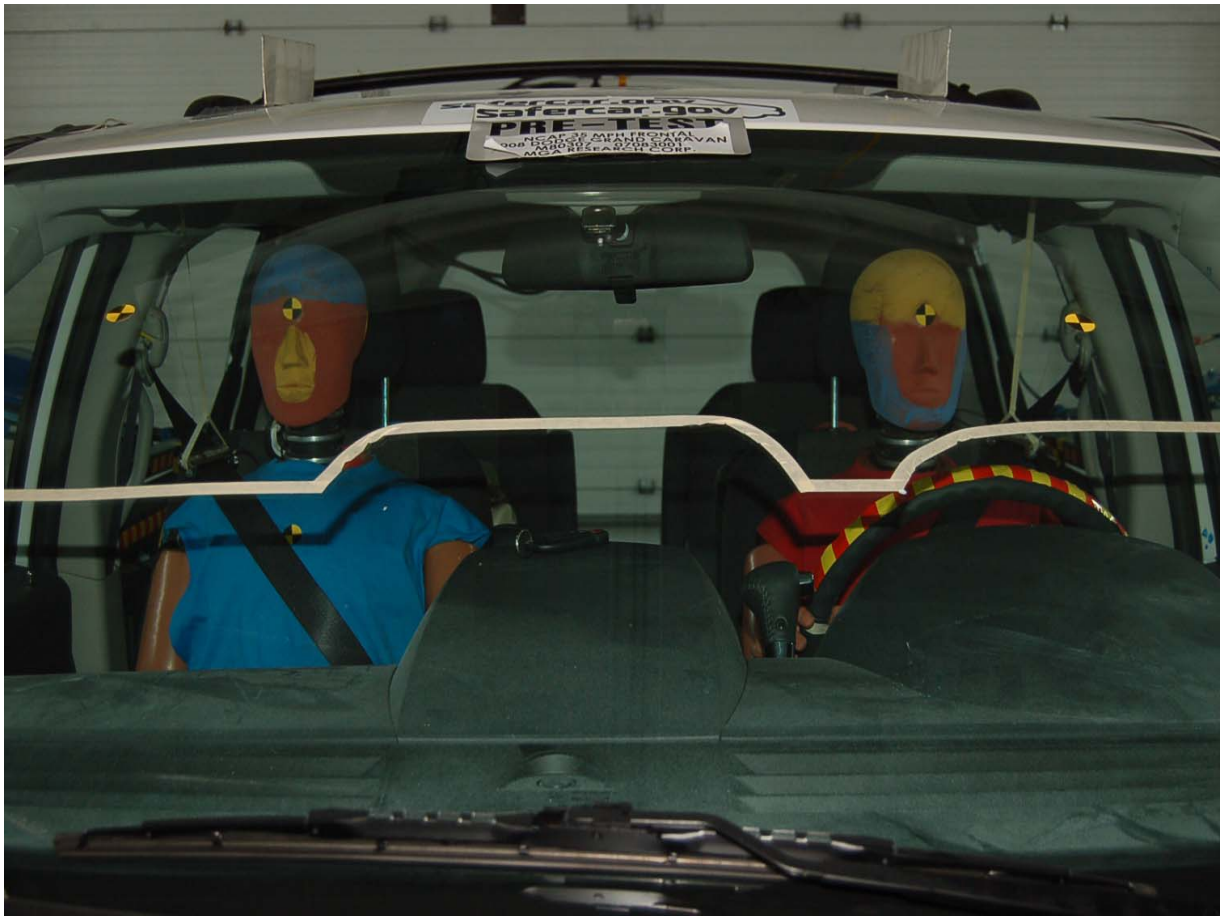
Pre-Test Windshield View

There was 100 percent windshield retention and no intrusion into the protected zone of the windshield during the event. There was no Stoddard Solvent leakage after the event or during any phase of the static rollover.

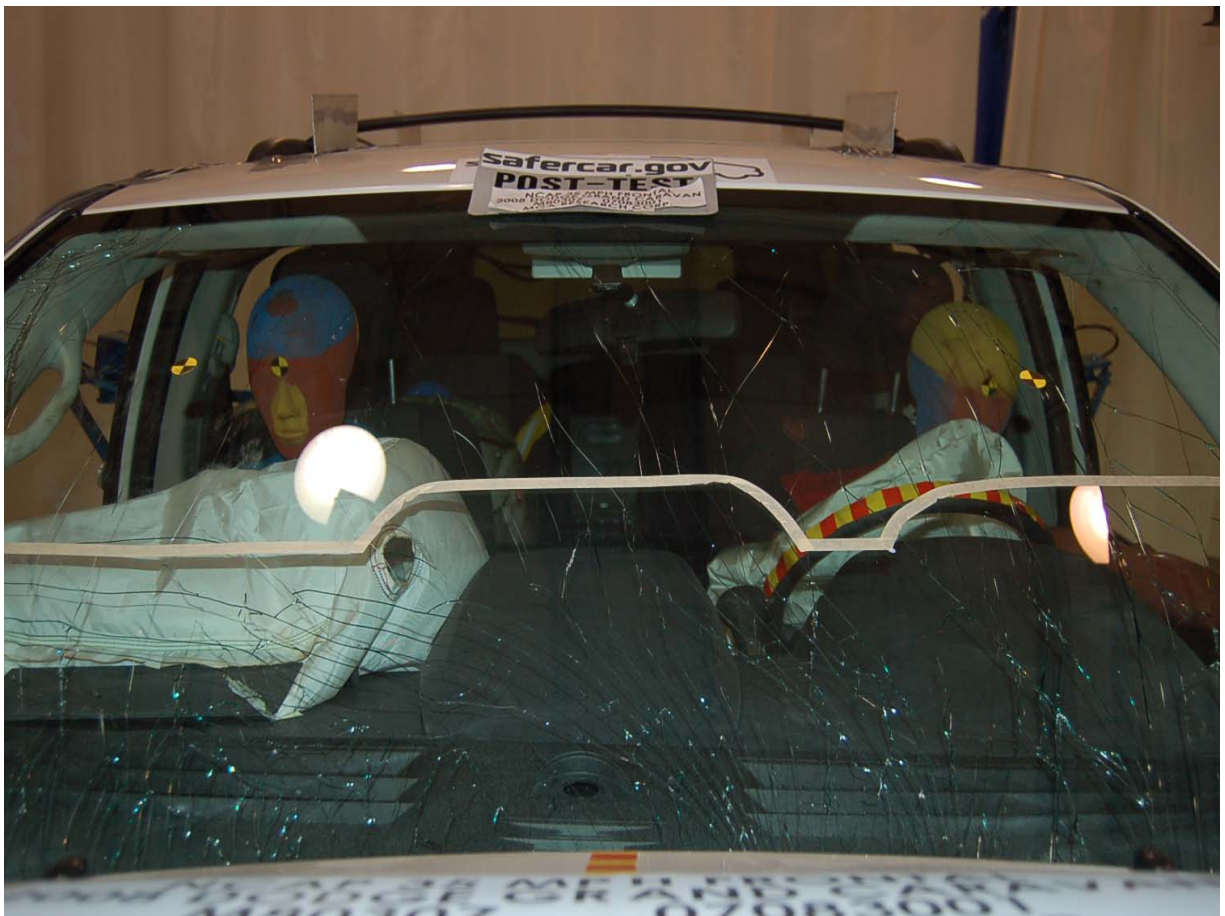
Post-Test Windshield View

Description	Driver	Passenger
Locked/Unlocked Doors	Doors were unlocked	Doors were unlocked
Front Door Opening	Door remained closed and latched; Door opened without tools	Door remained closed and latched; Door opened without tools
Rear Door Opening		
Seat Track Shift (mm)	0	0
Seat Back Failure	None	None
Glazing Damage	The windshield cracked.

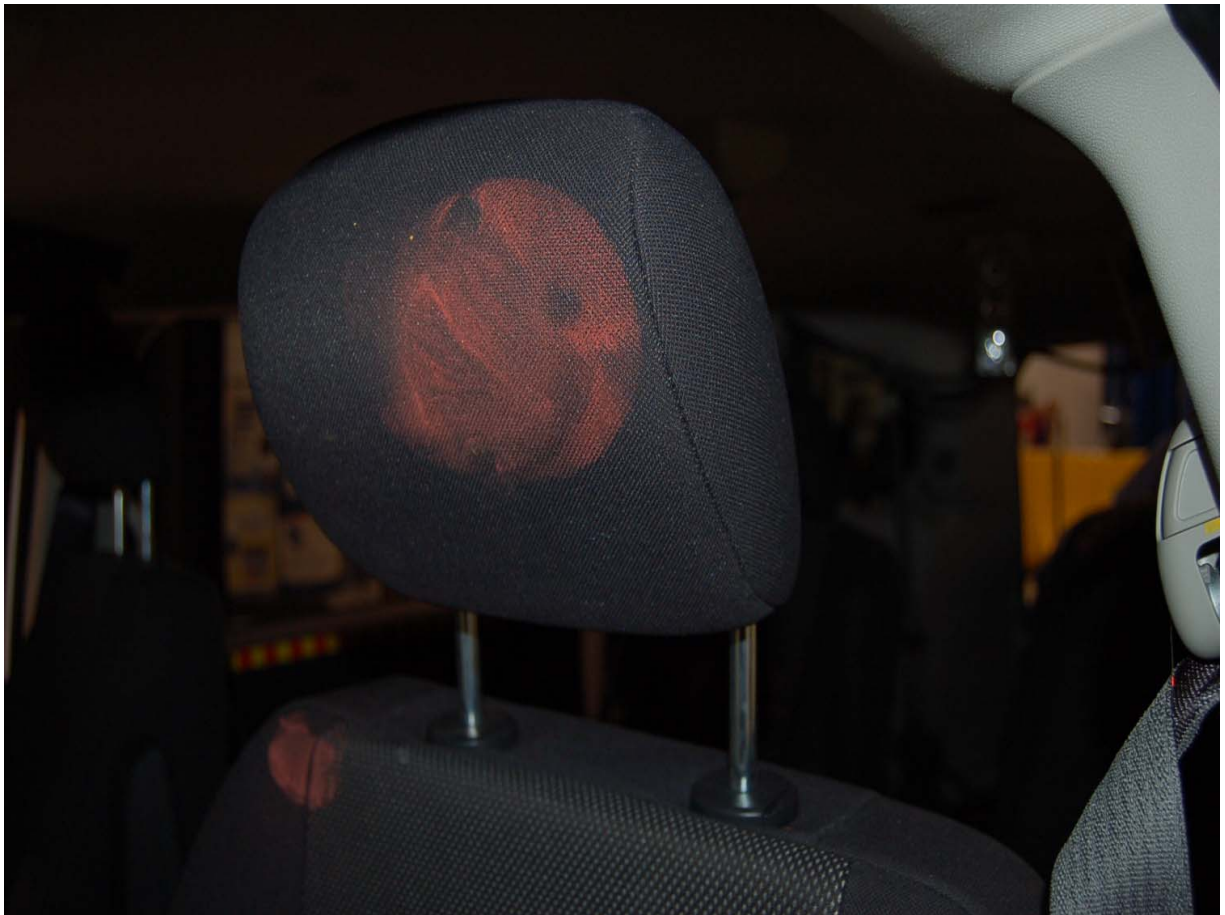
Post-Test Driver Dummy Head Contact (headrest)

Post-Test Driver Dummy Knee Contact

The driver's head and chest contacted the airbag. The driver's head also contacted the headrest. The driver's knees contacted the knee bolster. The passenger's head and chest contacted the airbag. The passenger's head also contacted the headrest and headliner/visor. The passenger's knees contacted the glove box.

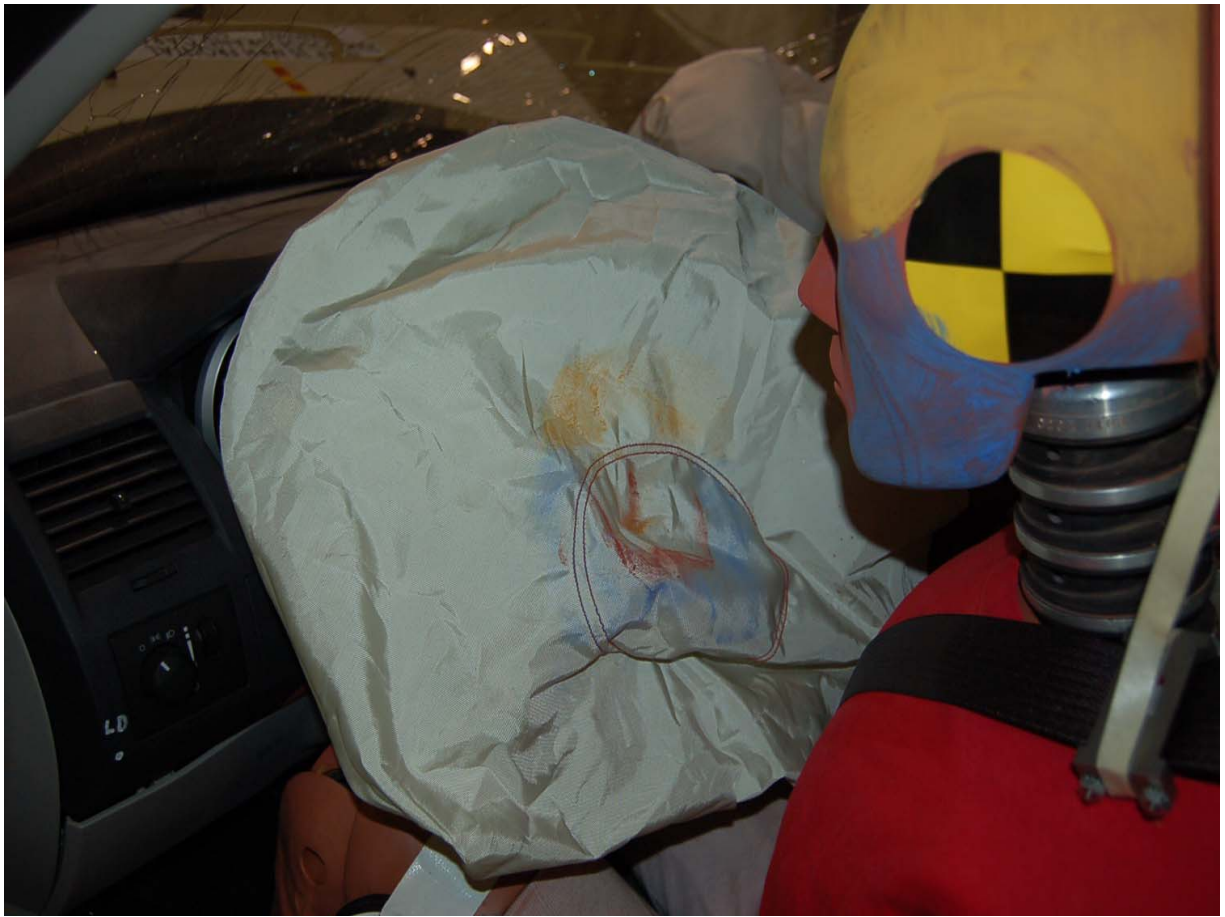
Post-Test Driver Dummy Airbag Contact

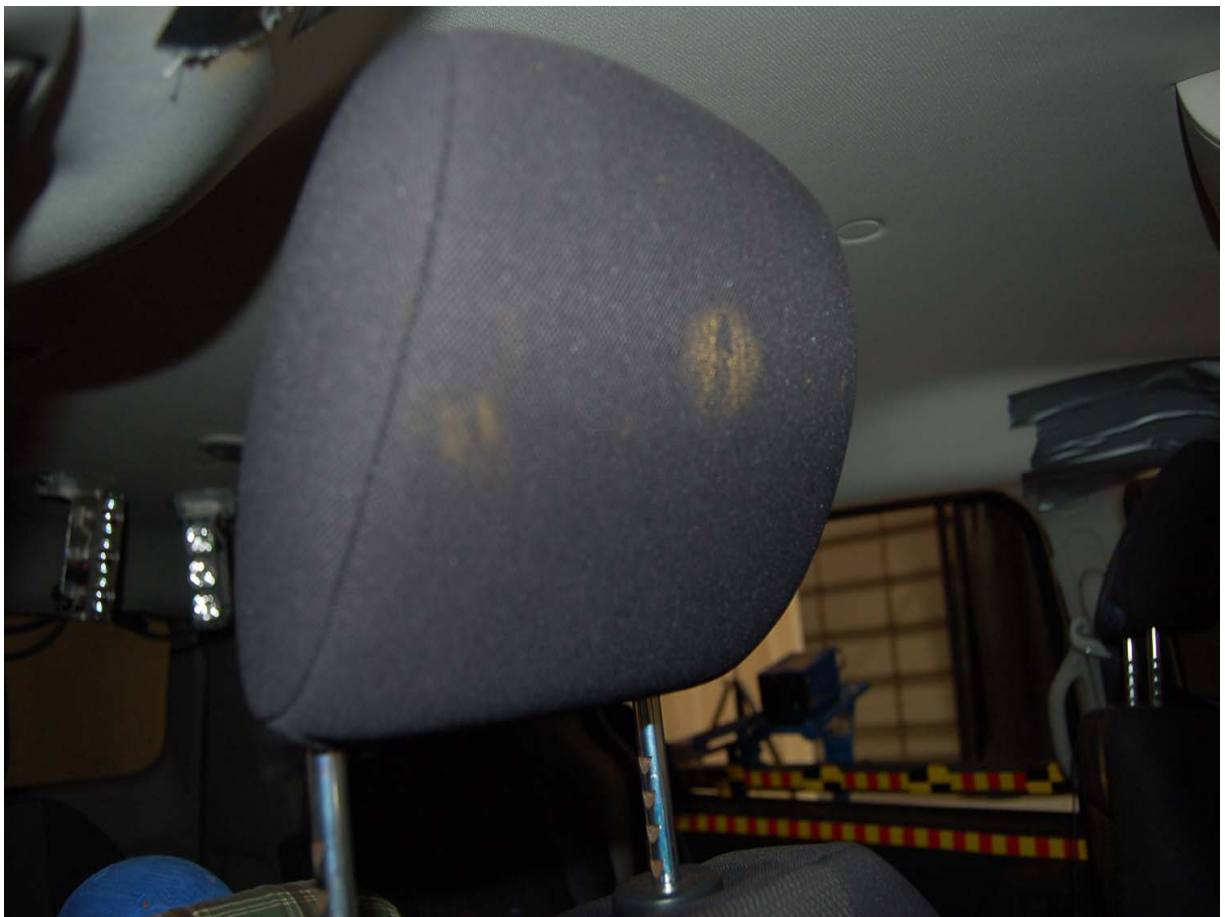
Post-Test Passenger Dummy Head Contact (headrest)

Post-Test Passenger Dummy Head Contact (visor)

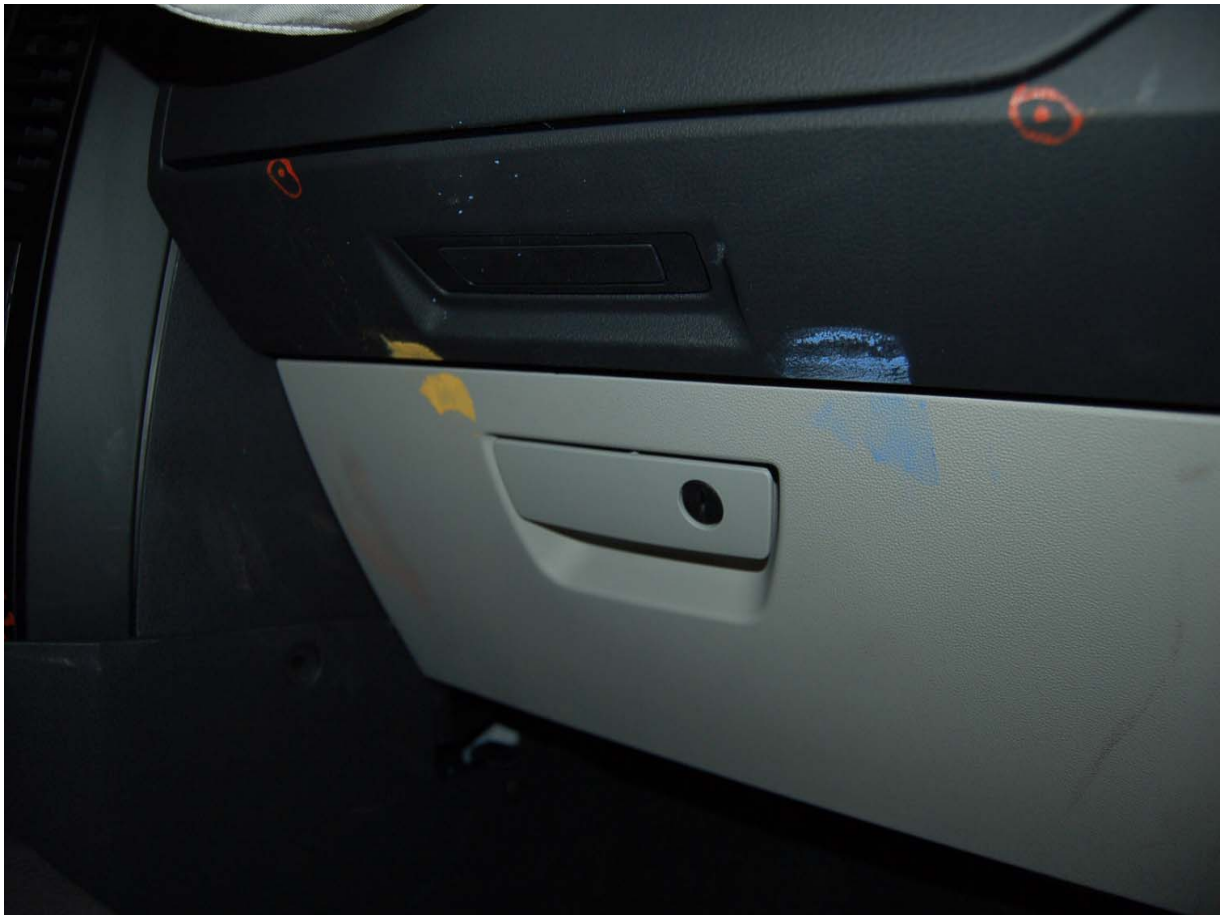
Post-Test Passenger Dummy Knee Contact

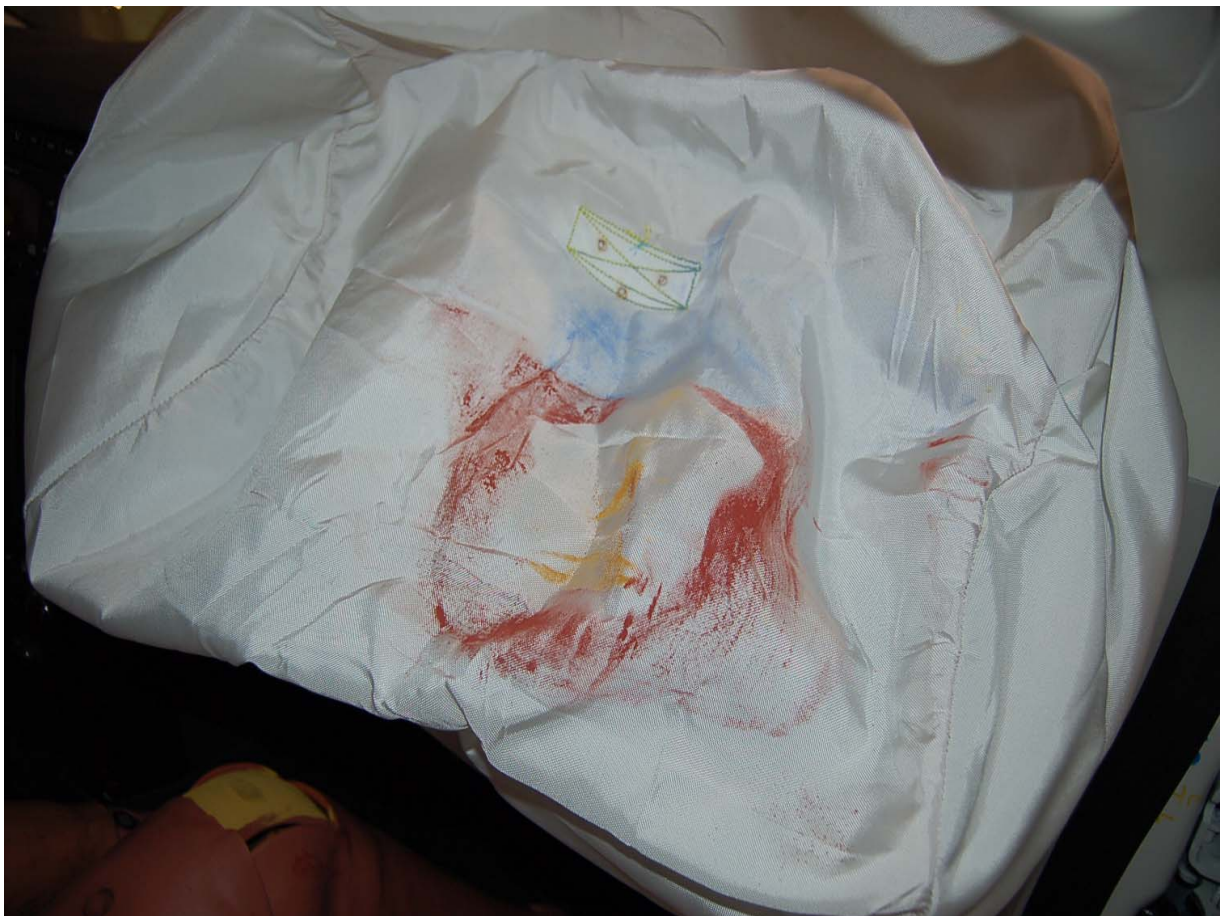
Post-Test Passenger Dummy Airbag Contact

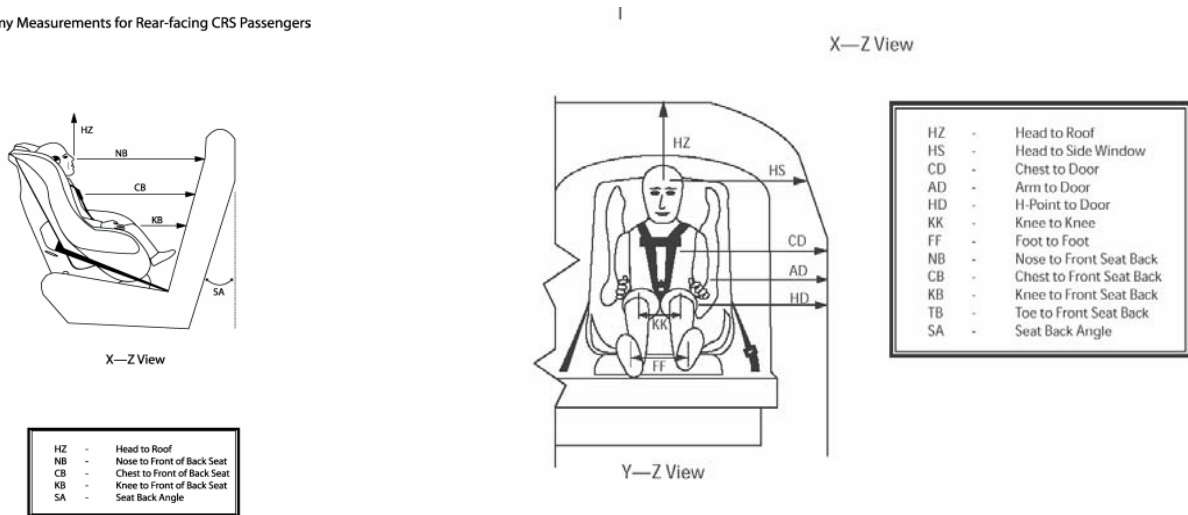
Dummy Measurements for Rear-facing CRS Passengers

Measurement	Pre-Test (mm)	Post-Test (mm)
	P4 CRS (090)	P4 CRS (090)
SA (deg)	18.8	
HS	455	1008
CD	430	937
AD	325	834
HD	361	779
HZ	455	775
NB	480	1203
CB	410	1024
KK	103	101
FF	105	120
KB - LEFT	188	803
KB - RIGHT	189	760
TB - LEFT	73	779
TB - RIGHT	69	732

All dimensions in mm (unless noted)
 P4 – Left Rear Passenger (Rear facing)
