**REPORT NUMBER: MCW-DOT-08SN02**

**NEW CAR ASSESSMENT PROGRAM  
SIDE IMPACT TEST**

**2008 CHRYSLER SEBRING 4-DOOR SEDAN**

**FINAL REPORT**

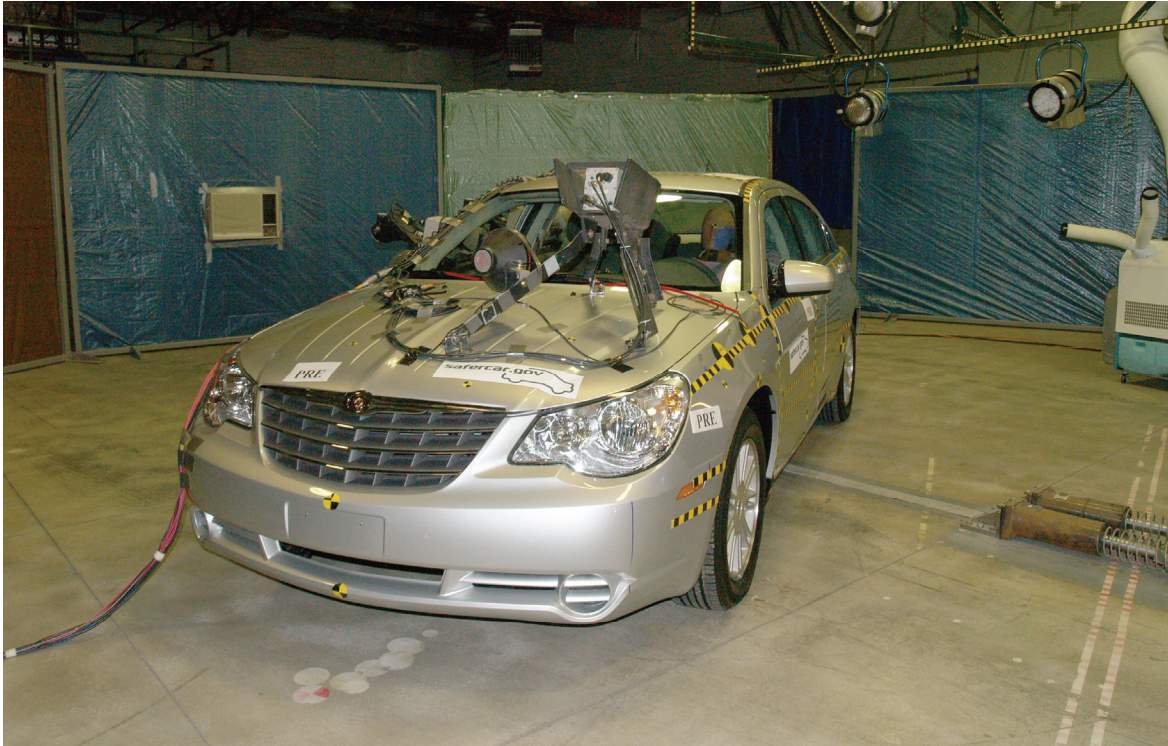
Figure A-6: Post test front view of test vehicle

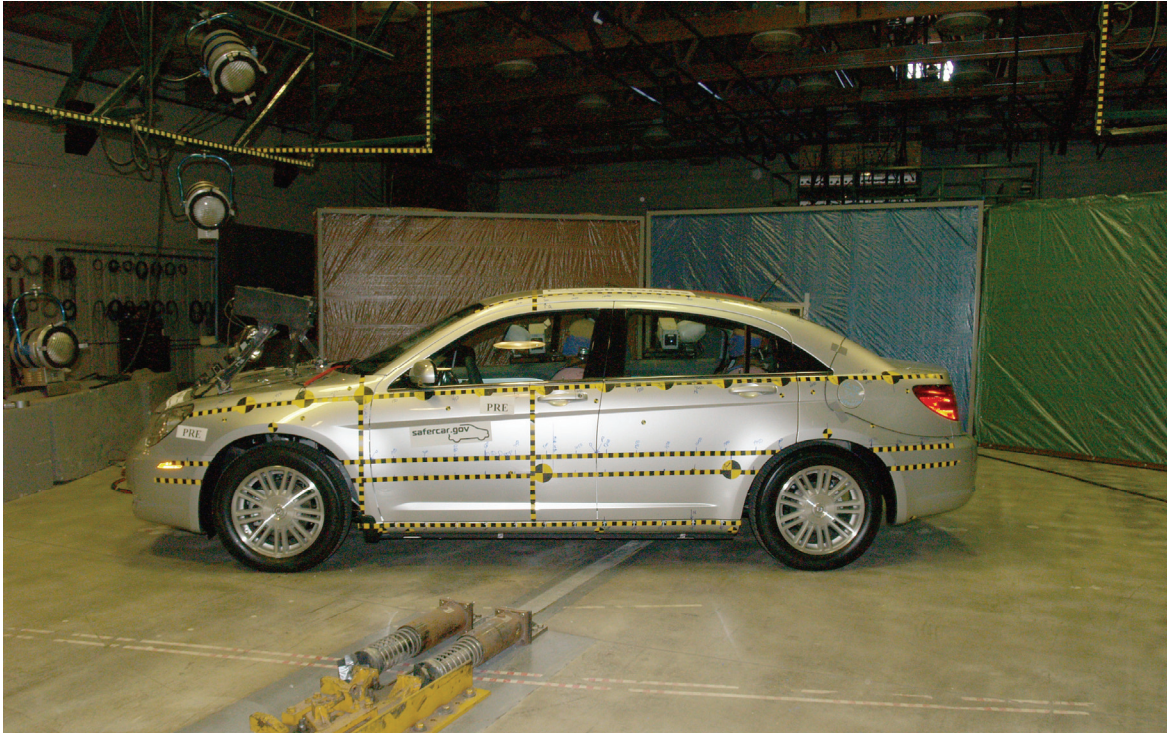
Figure A-8: Post test left front 3/4 view of test vehicle

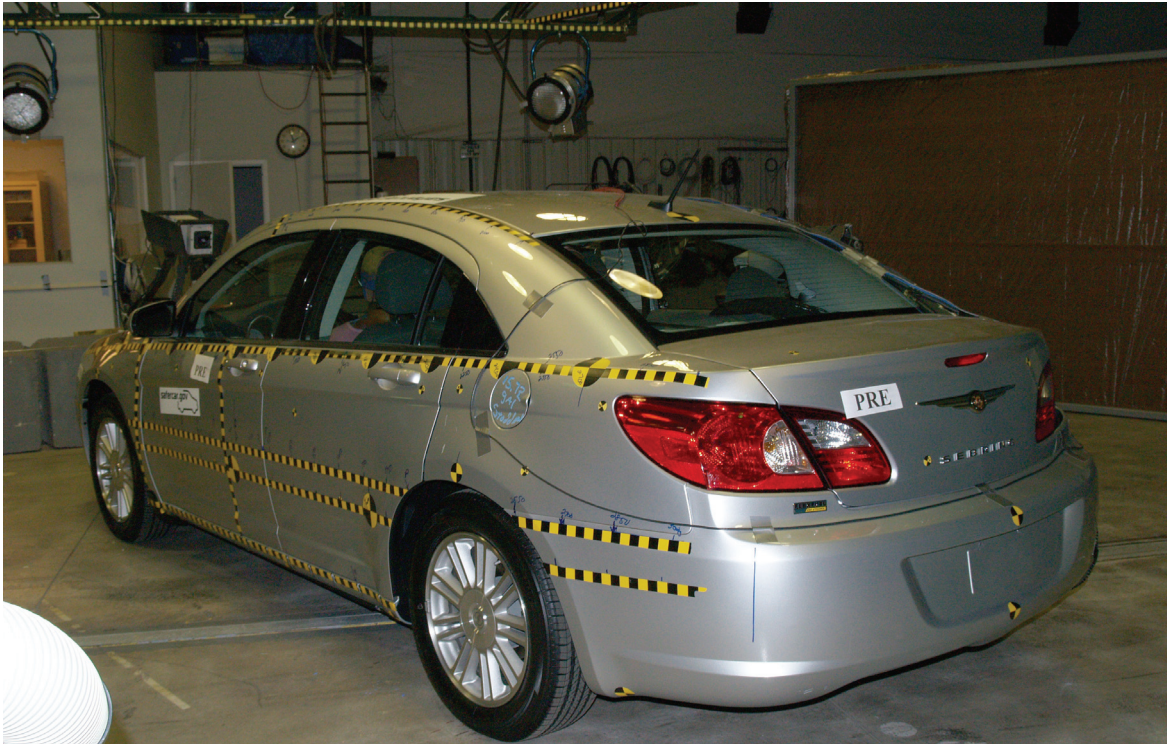
Figure A-10: Post test left side view of test vehicle

The test vehicle sustained a maximum static crush of 253 mm at level 2, 1350 mm rearward of the vertical impact line.

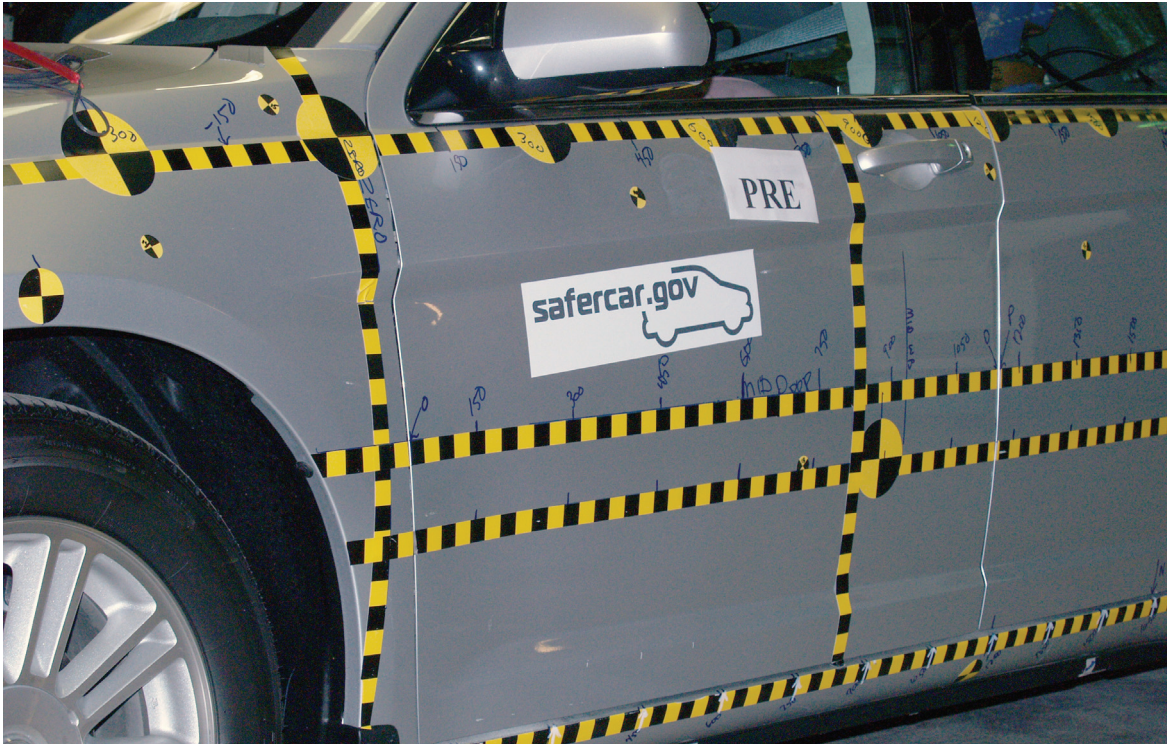
Figure A-26: Post test impact point

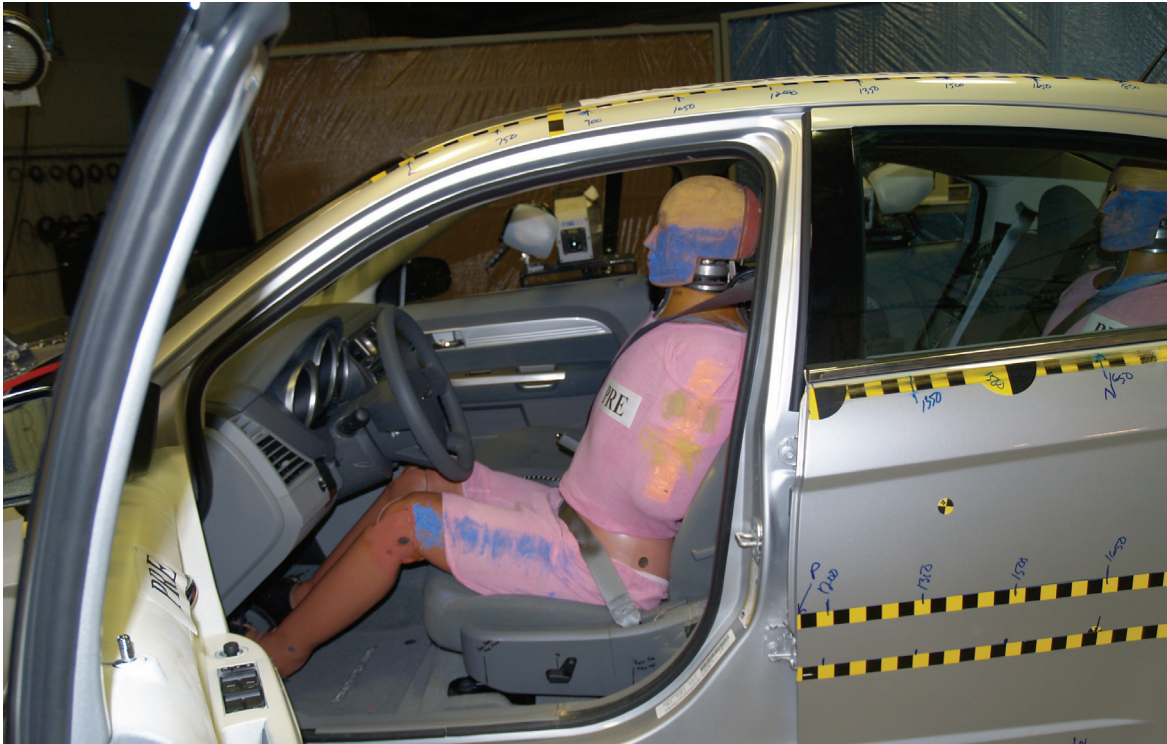
Figure A-32: Post test left front door

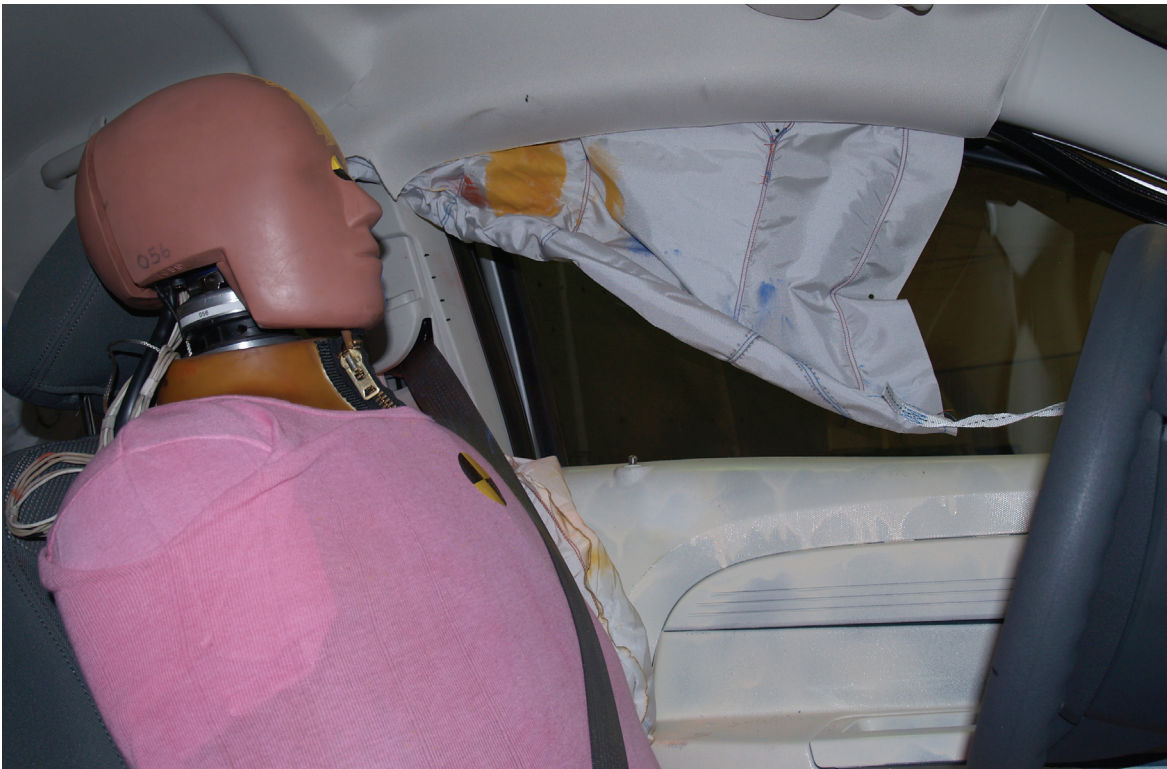
Figure A-39: Post test driver contact locations (1)

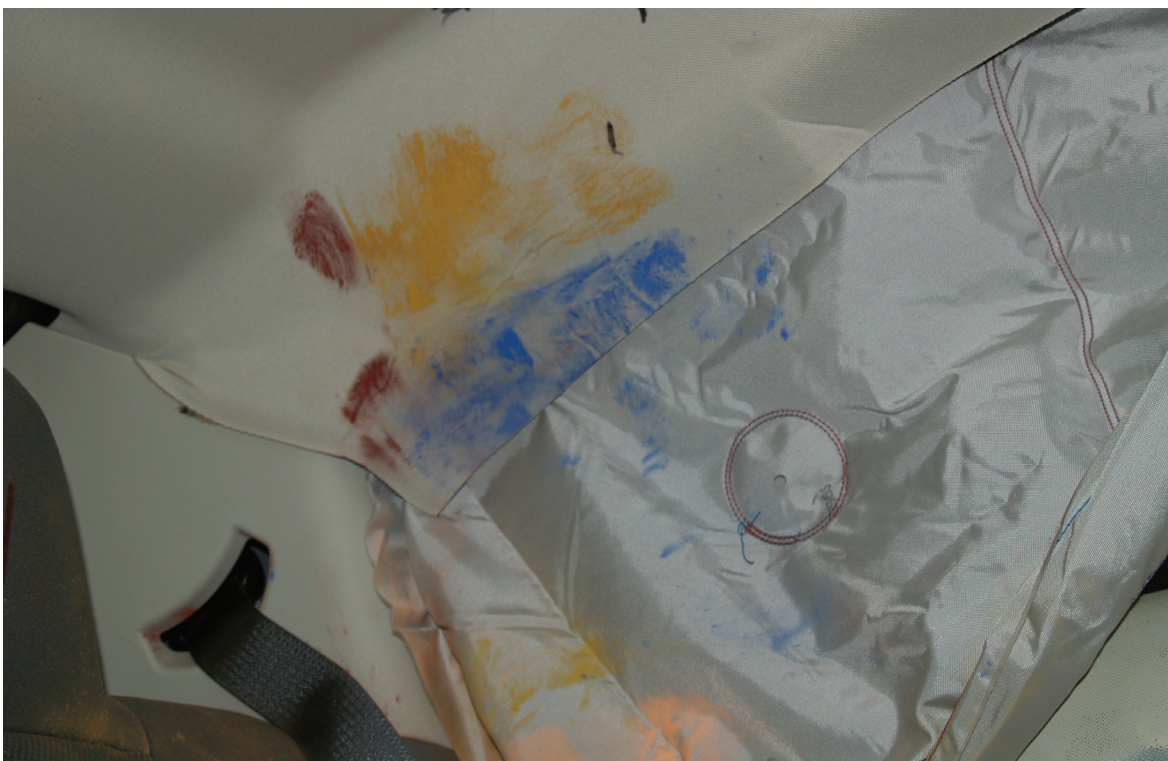
Figure A-47: Post test passenger contact locations (1)

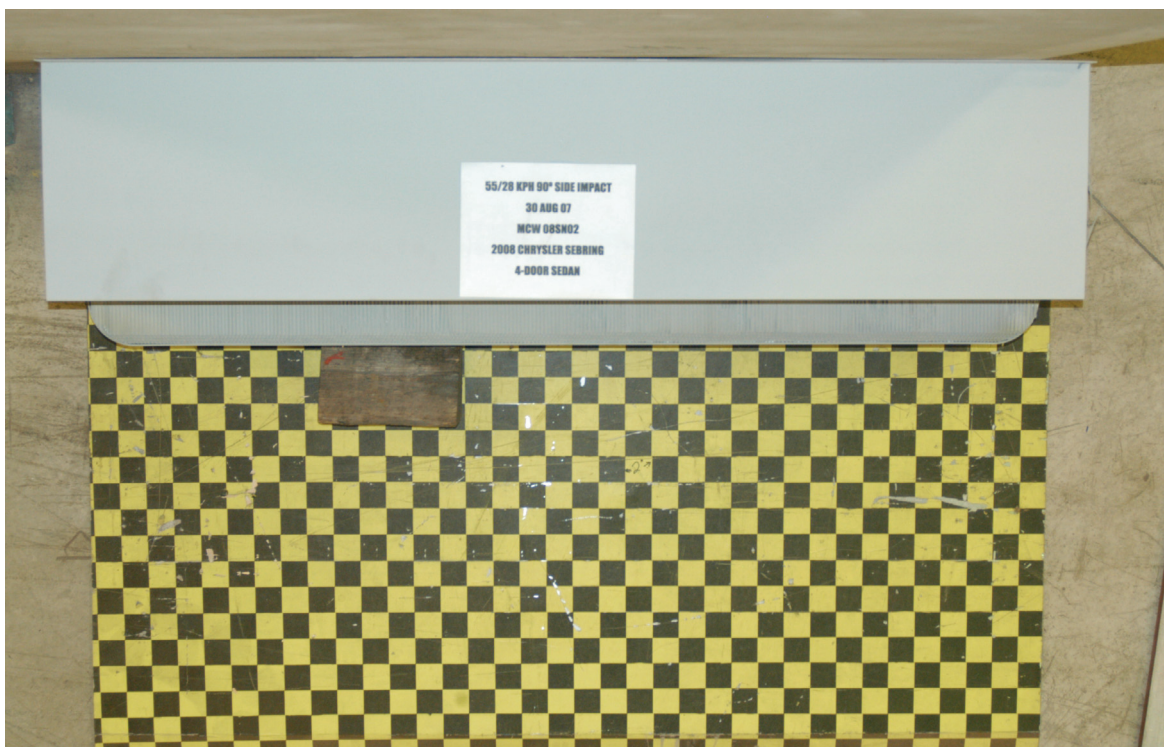
Figure A-50: Post test front view of MDB barrier face
