**REPORT NUMBER TR-P28003-01-NC**

**NEW CAR ASSESSMENT PROGRAM  
SIDE IMPACT TEST**

**TOYOTA MOTOR MANUFACTURING CANADA  
2008 LEXUS RX350  
5-DOOR MPV**

**NHTSA NUMBER: M85103**

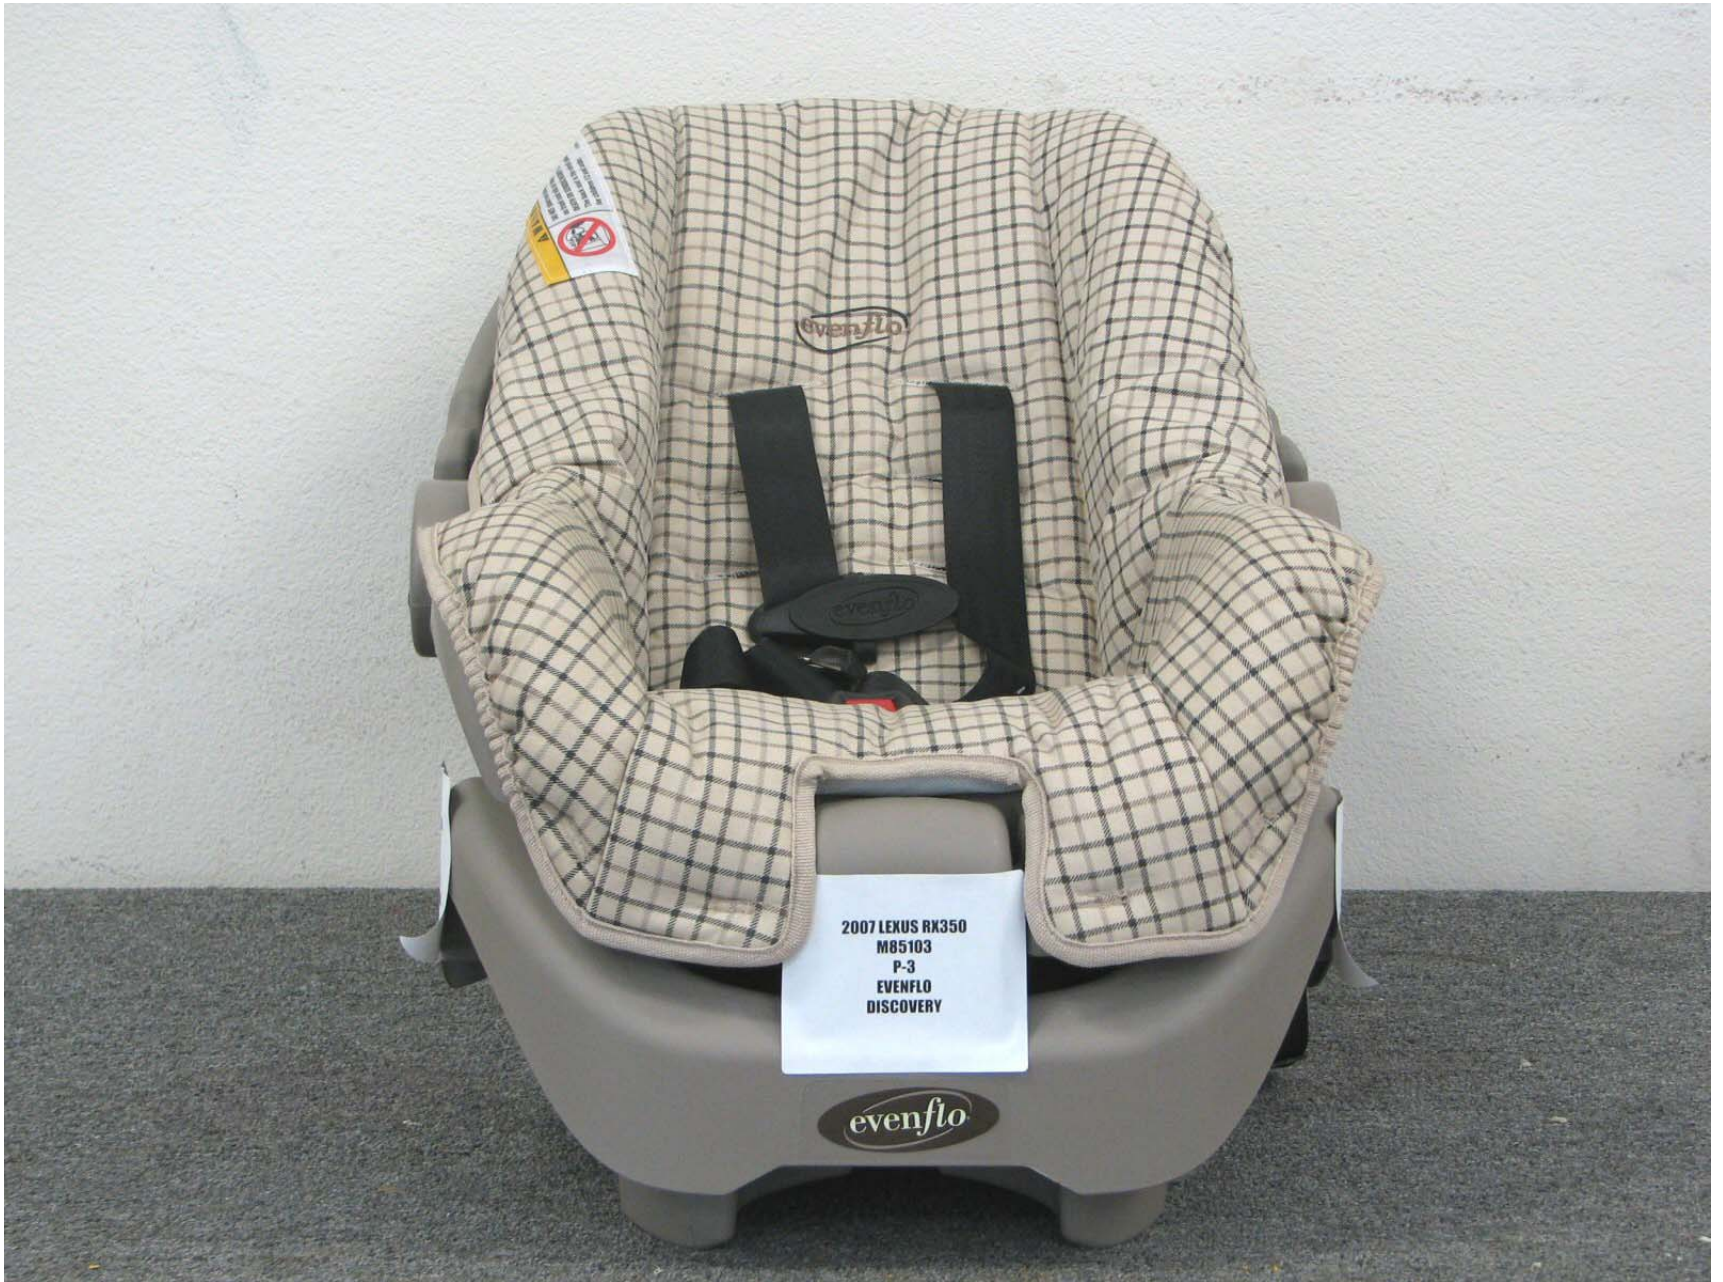
Figure D2-2: Pre-Test Frontal View of Position 3 CRS

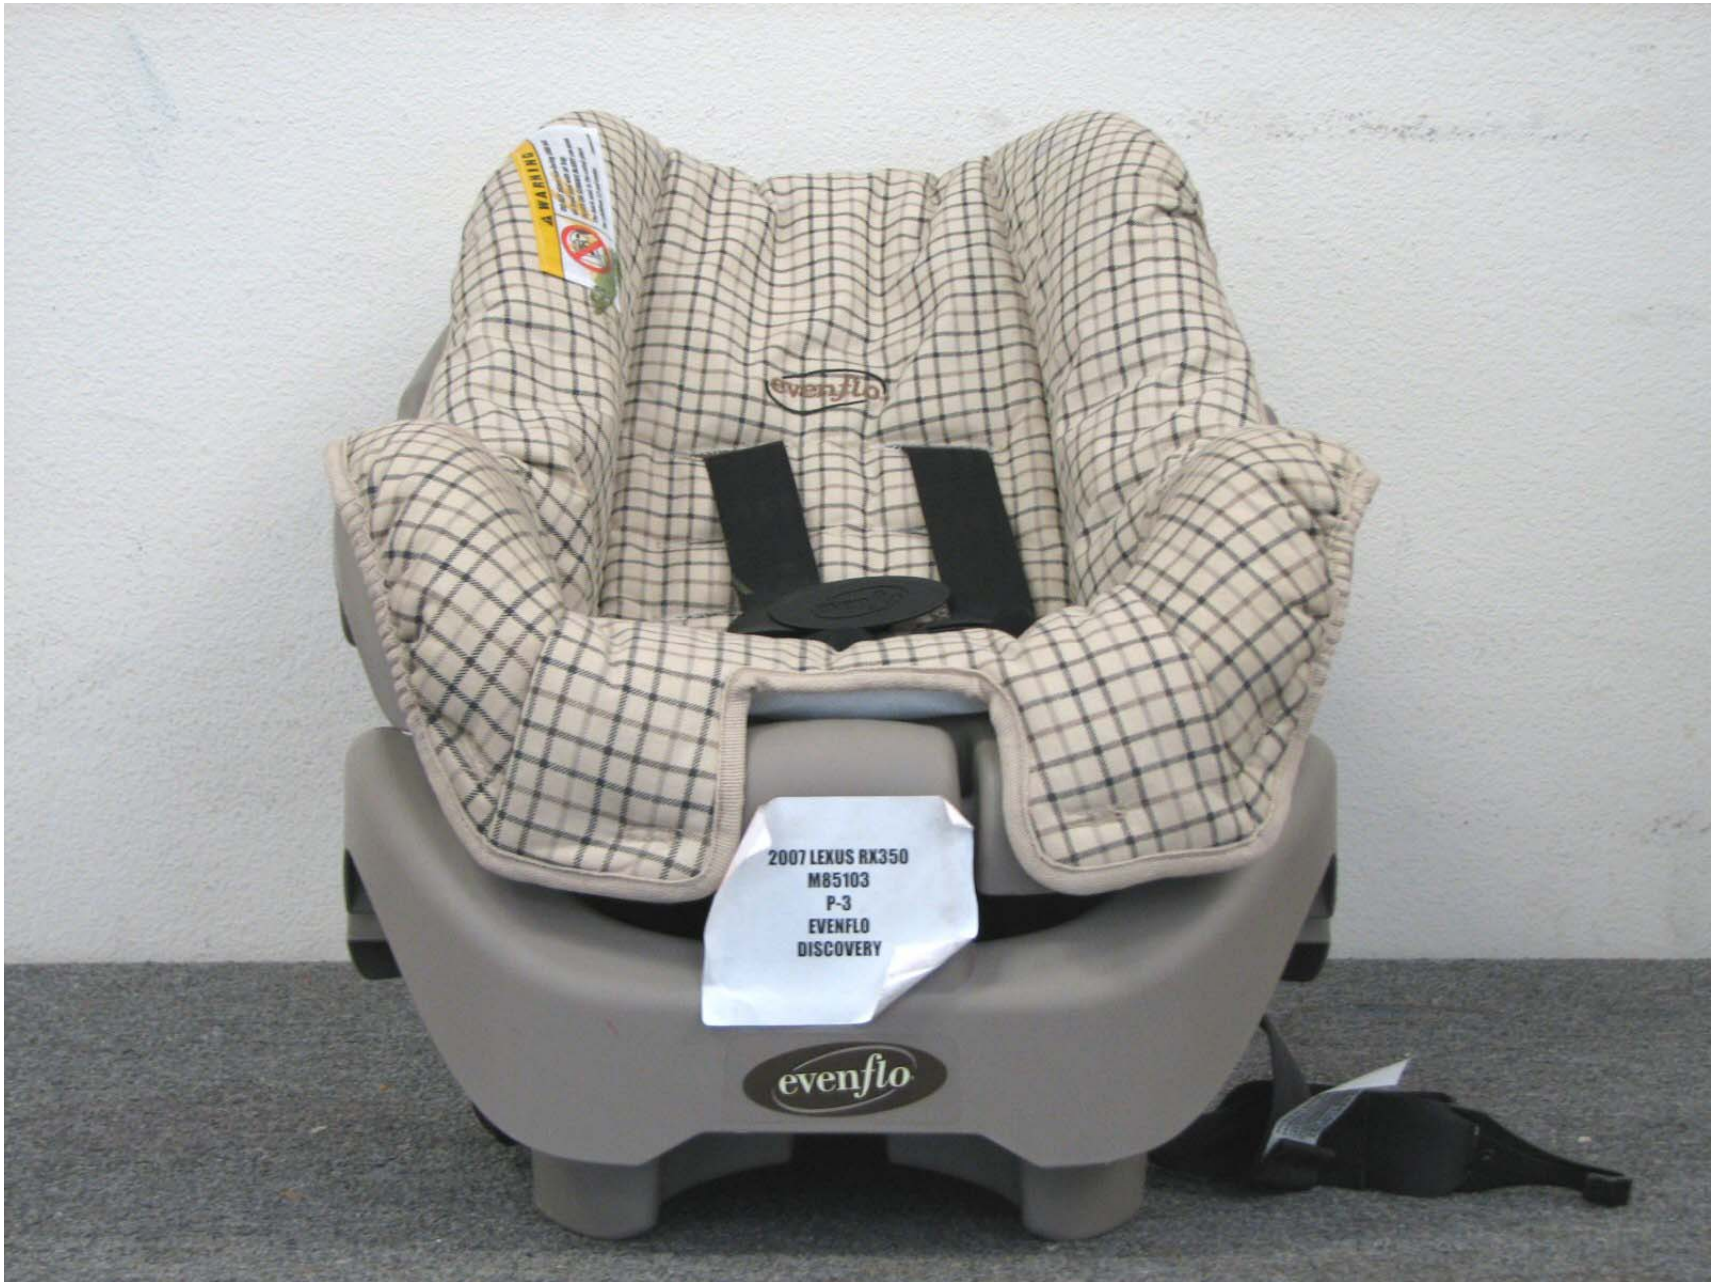
Figure D2-3: Post-Test Frontal View of Position 3 CRS

\*CRS seat separated from CRS base during impact.

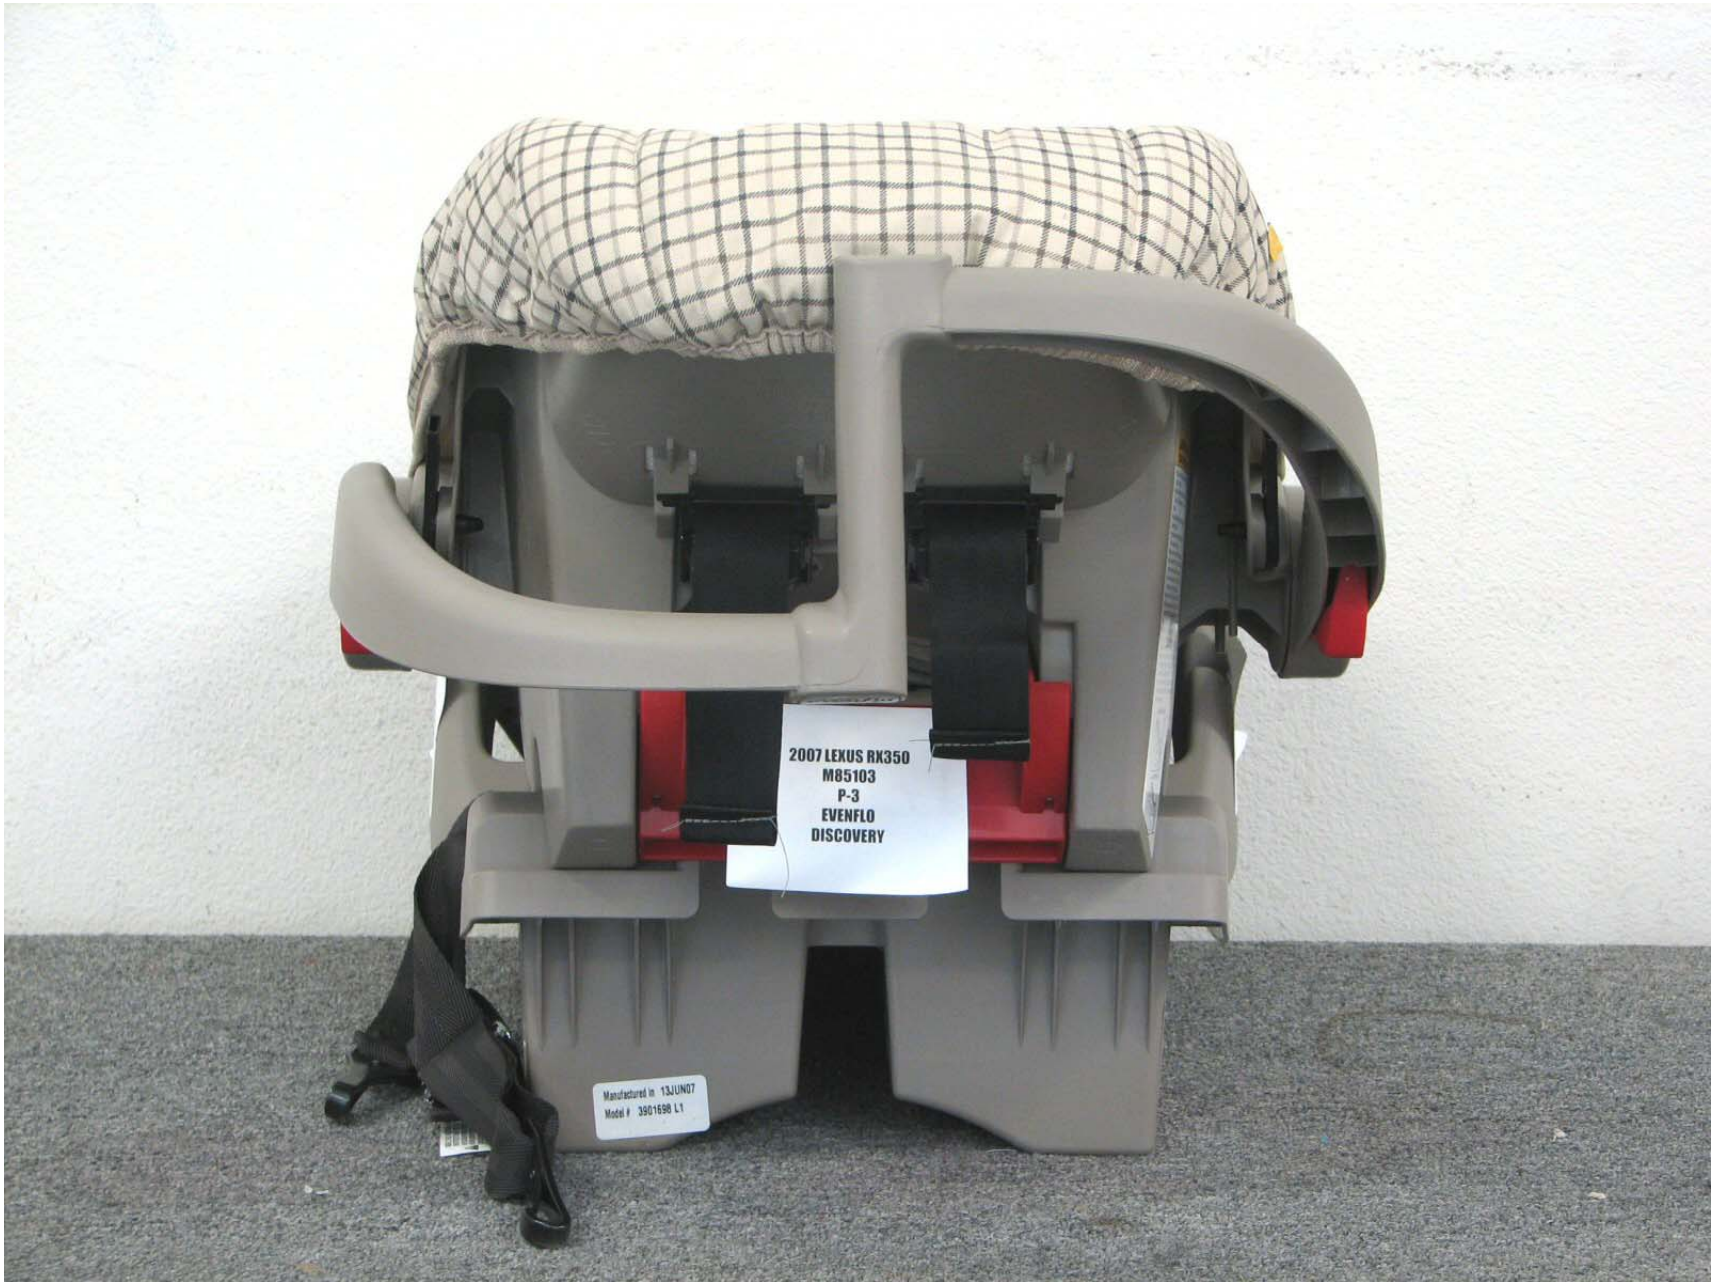
Figure D2-4: Pre-Test Rear View of Position 3 CRS

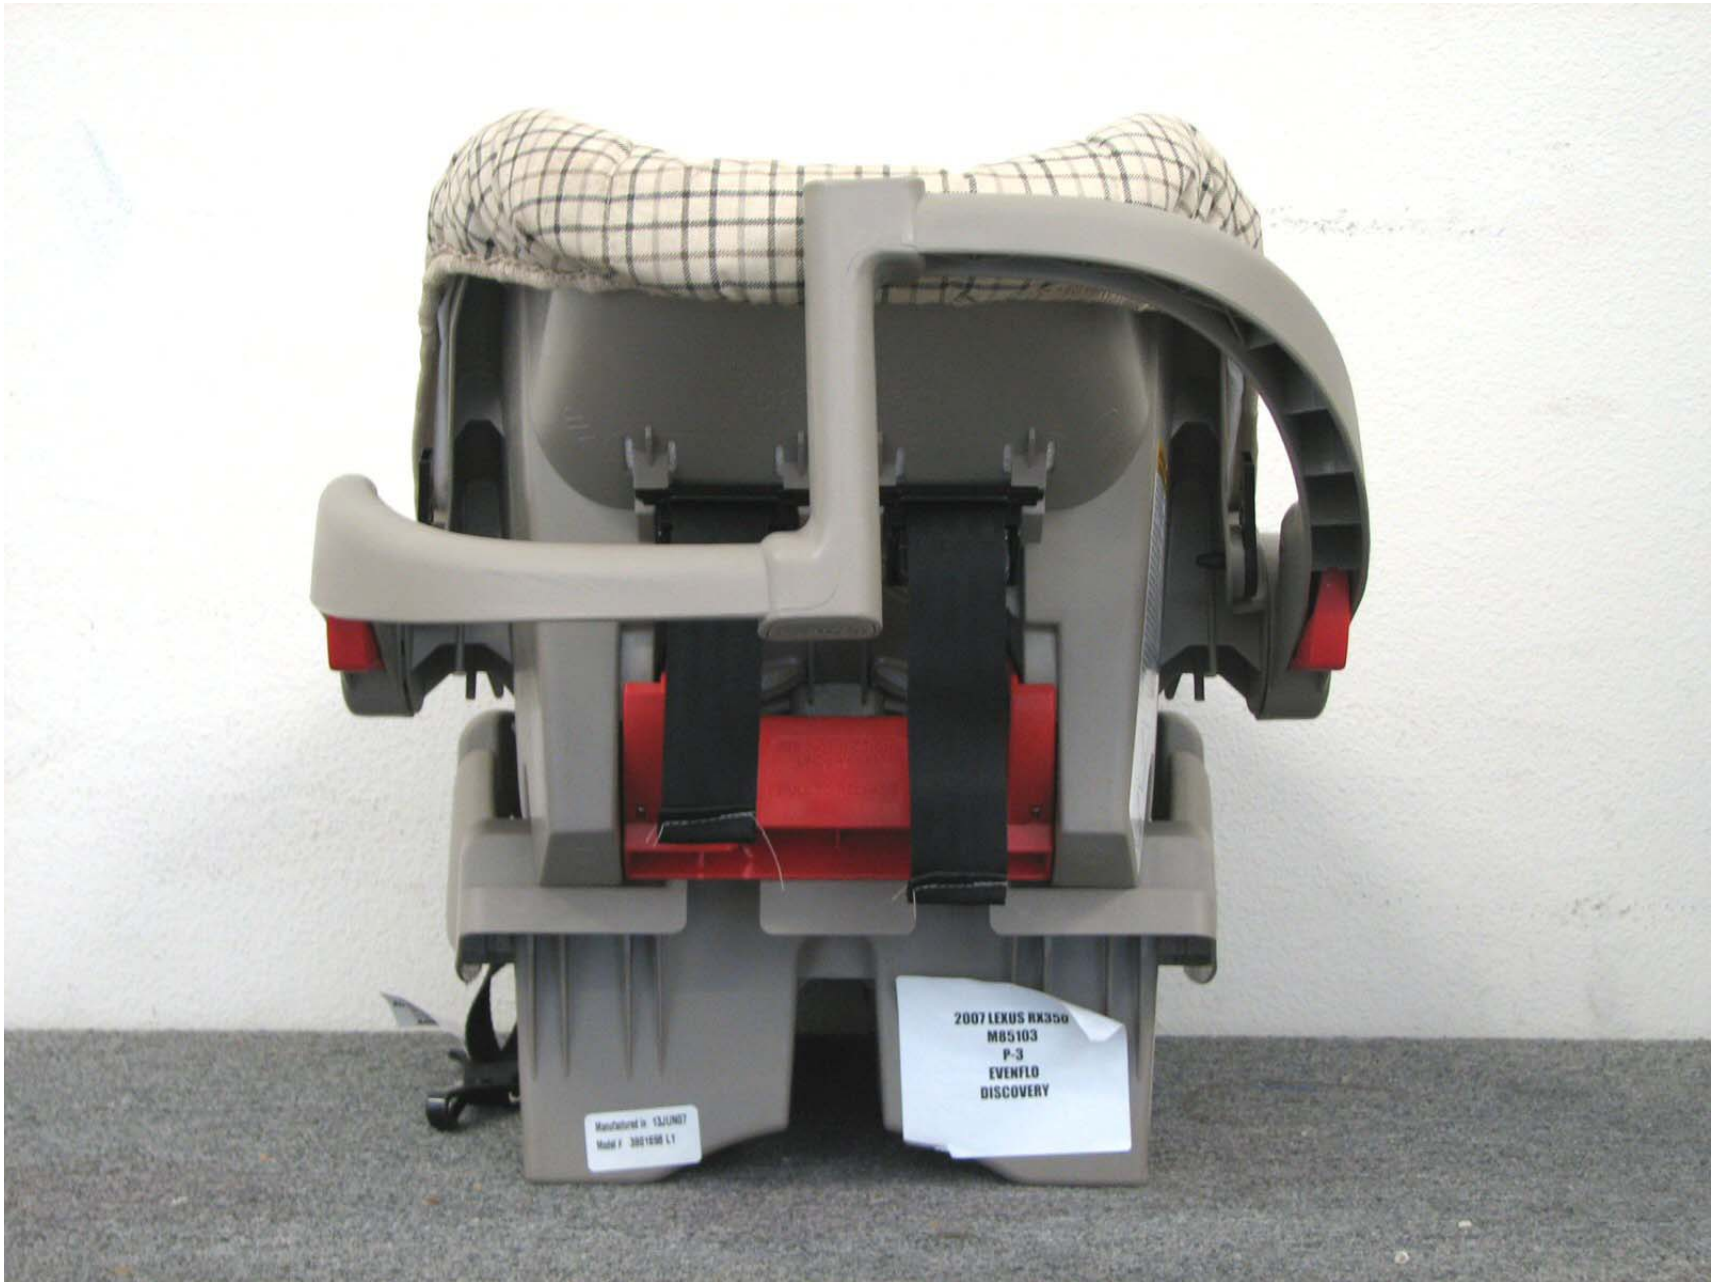
Figure D2-5: Post-Test Rear View of Position 3 CRS

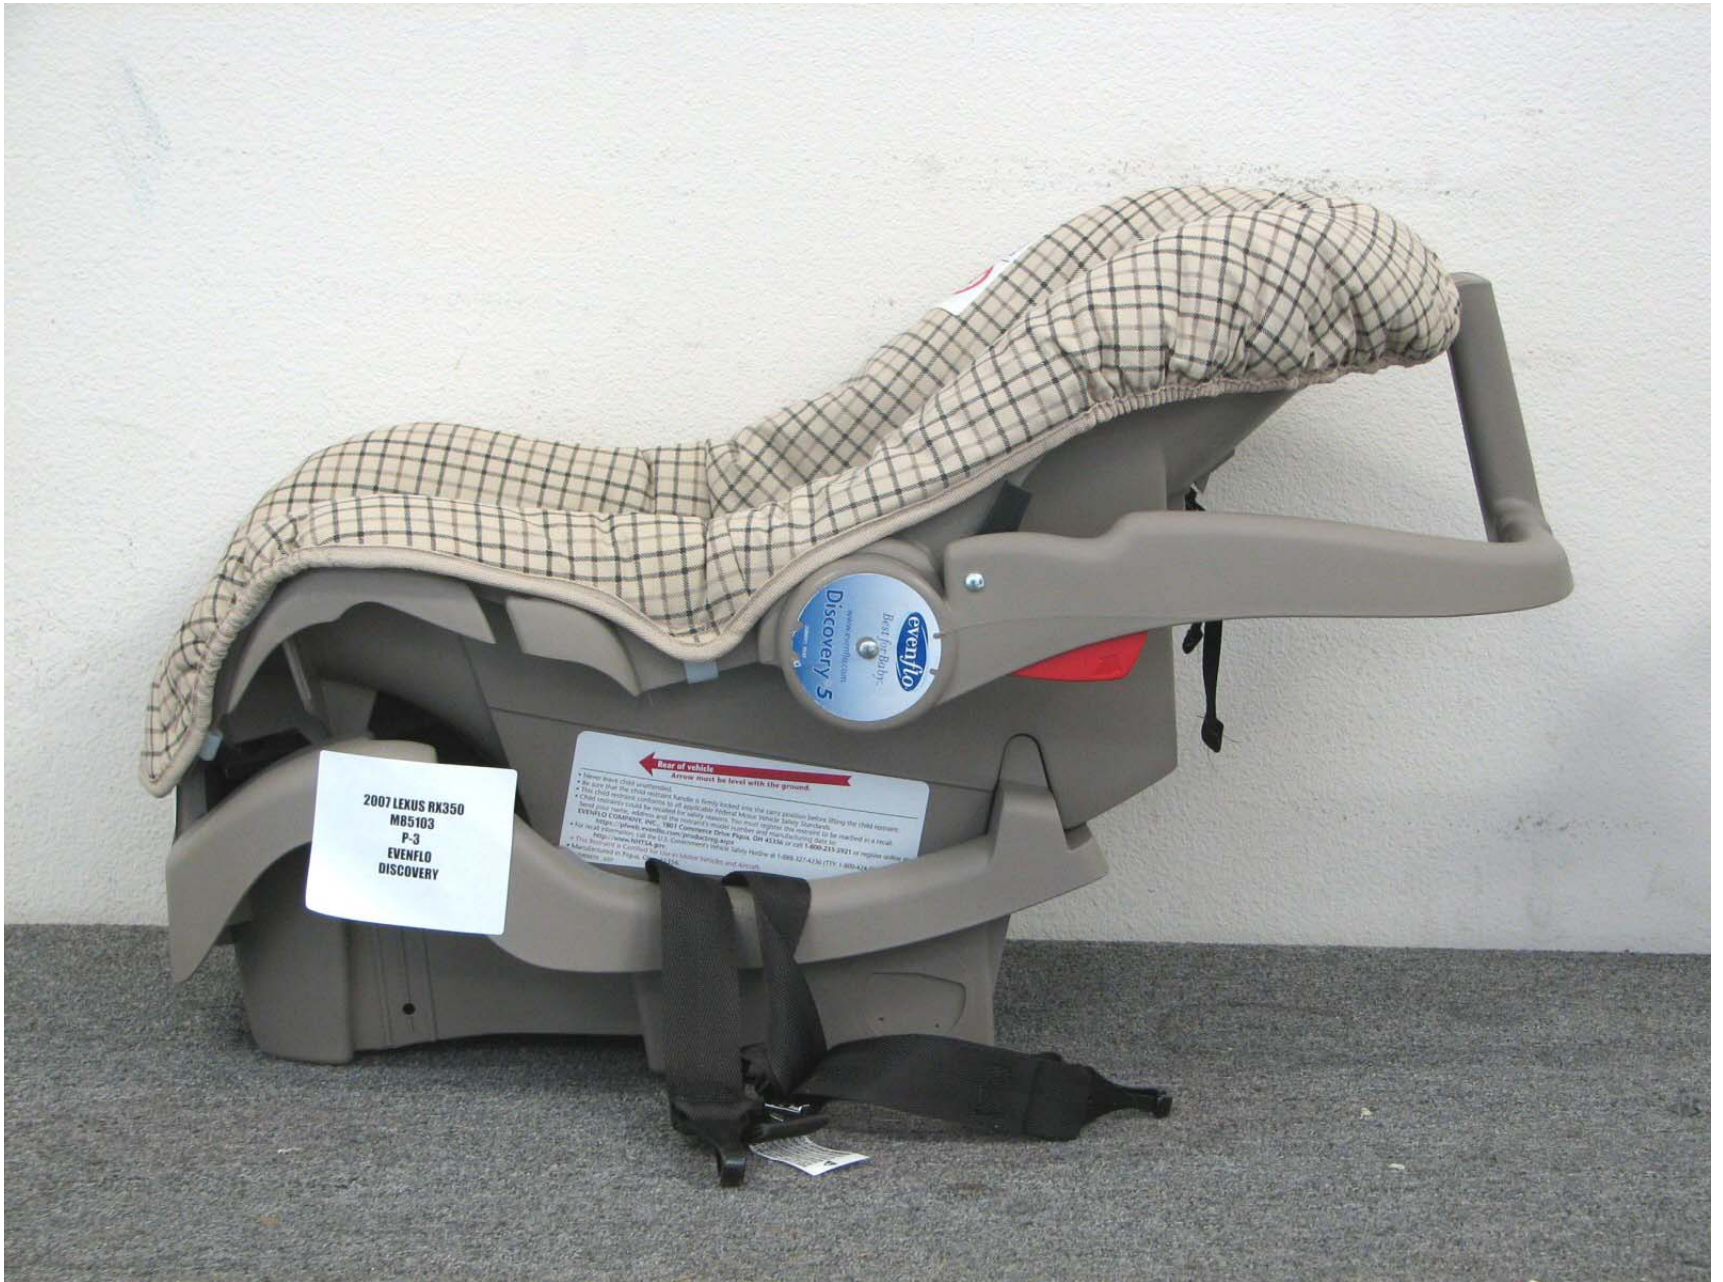
Figure D2-6: Pre-Test Left Side View of Position 3 CRS

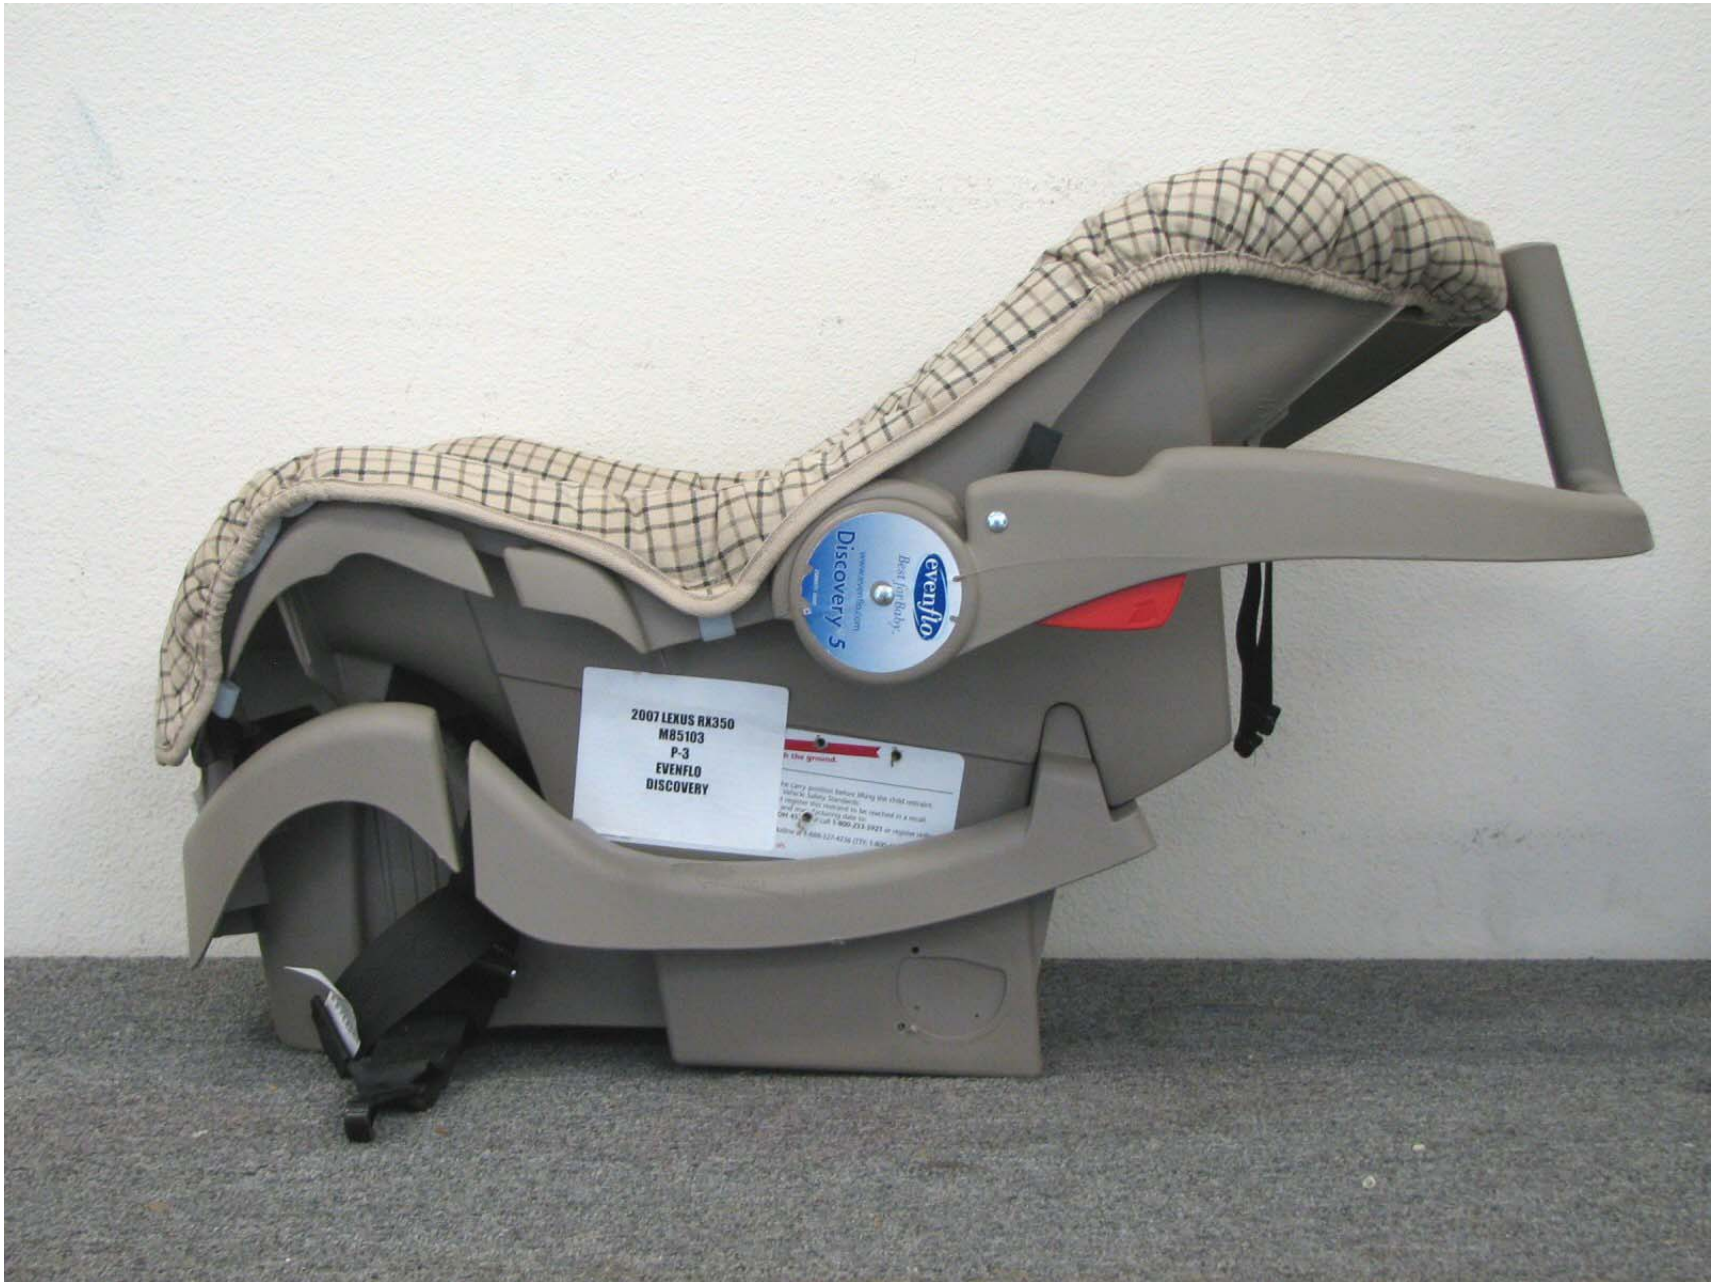
Figure D2-7: Post-Test Left Side View of Position 3 CRS

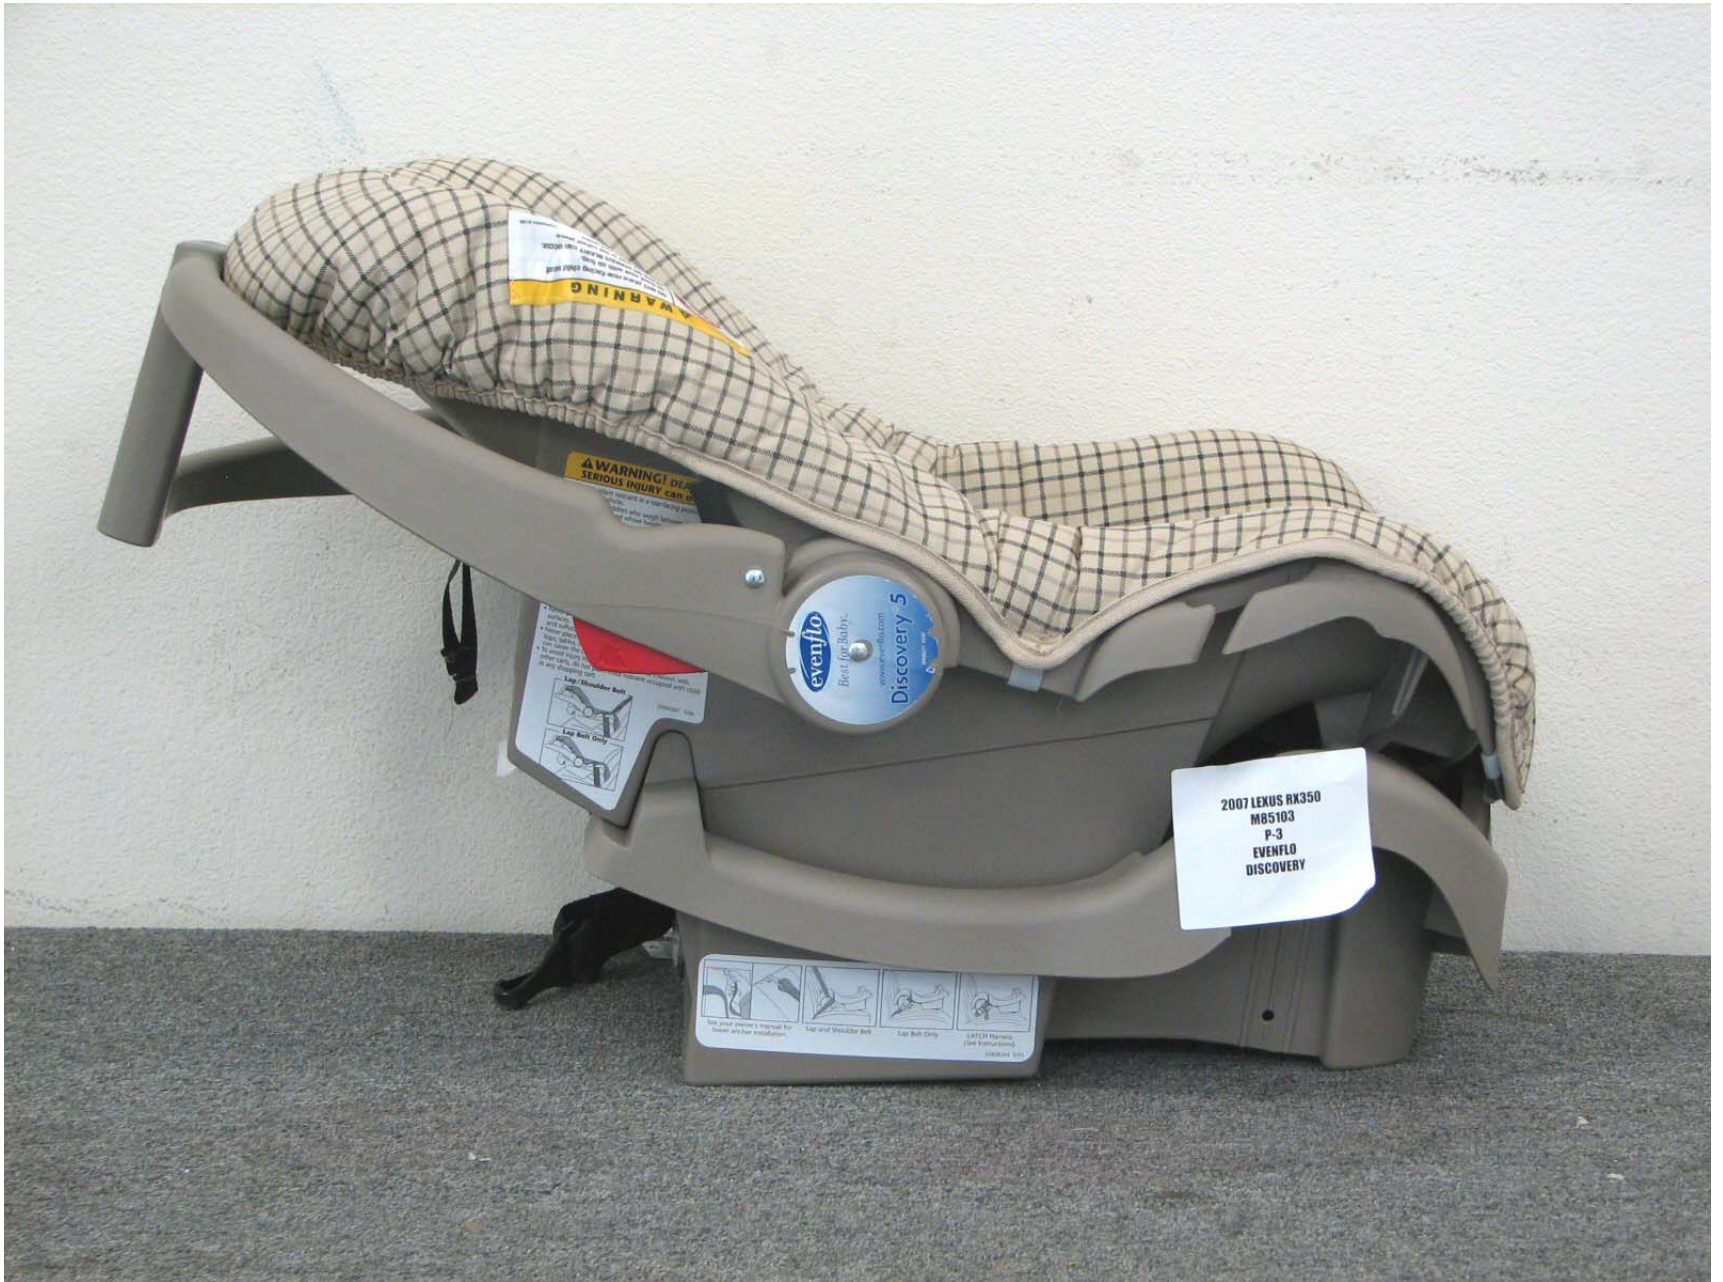
Figure D2-8: Pre-Test Right Side View of Position 3 CRS

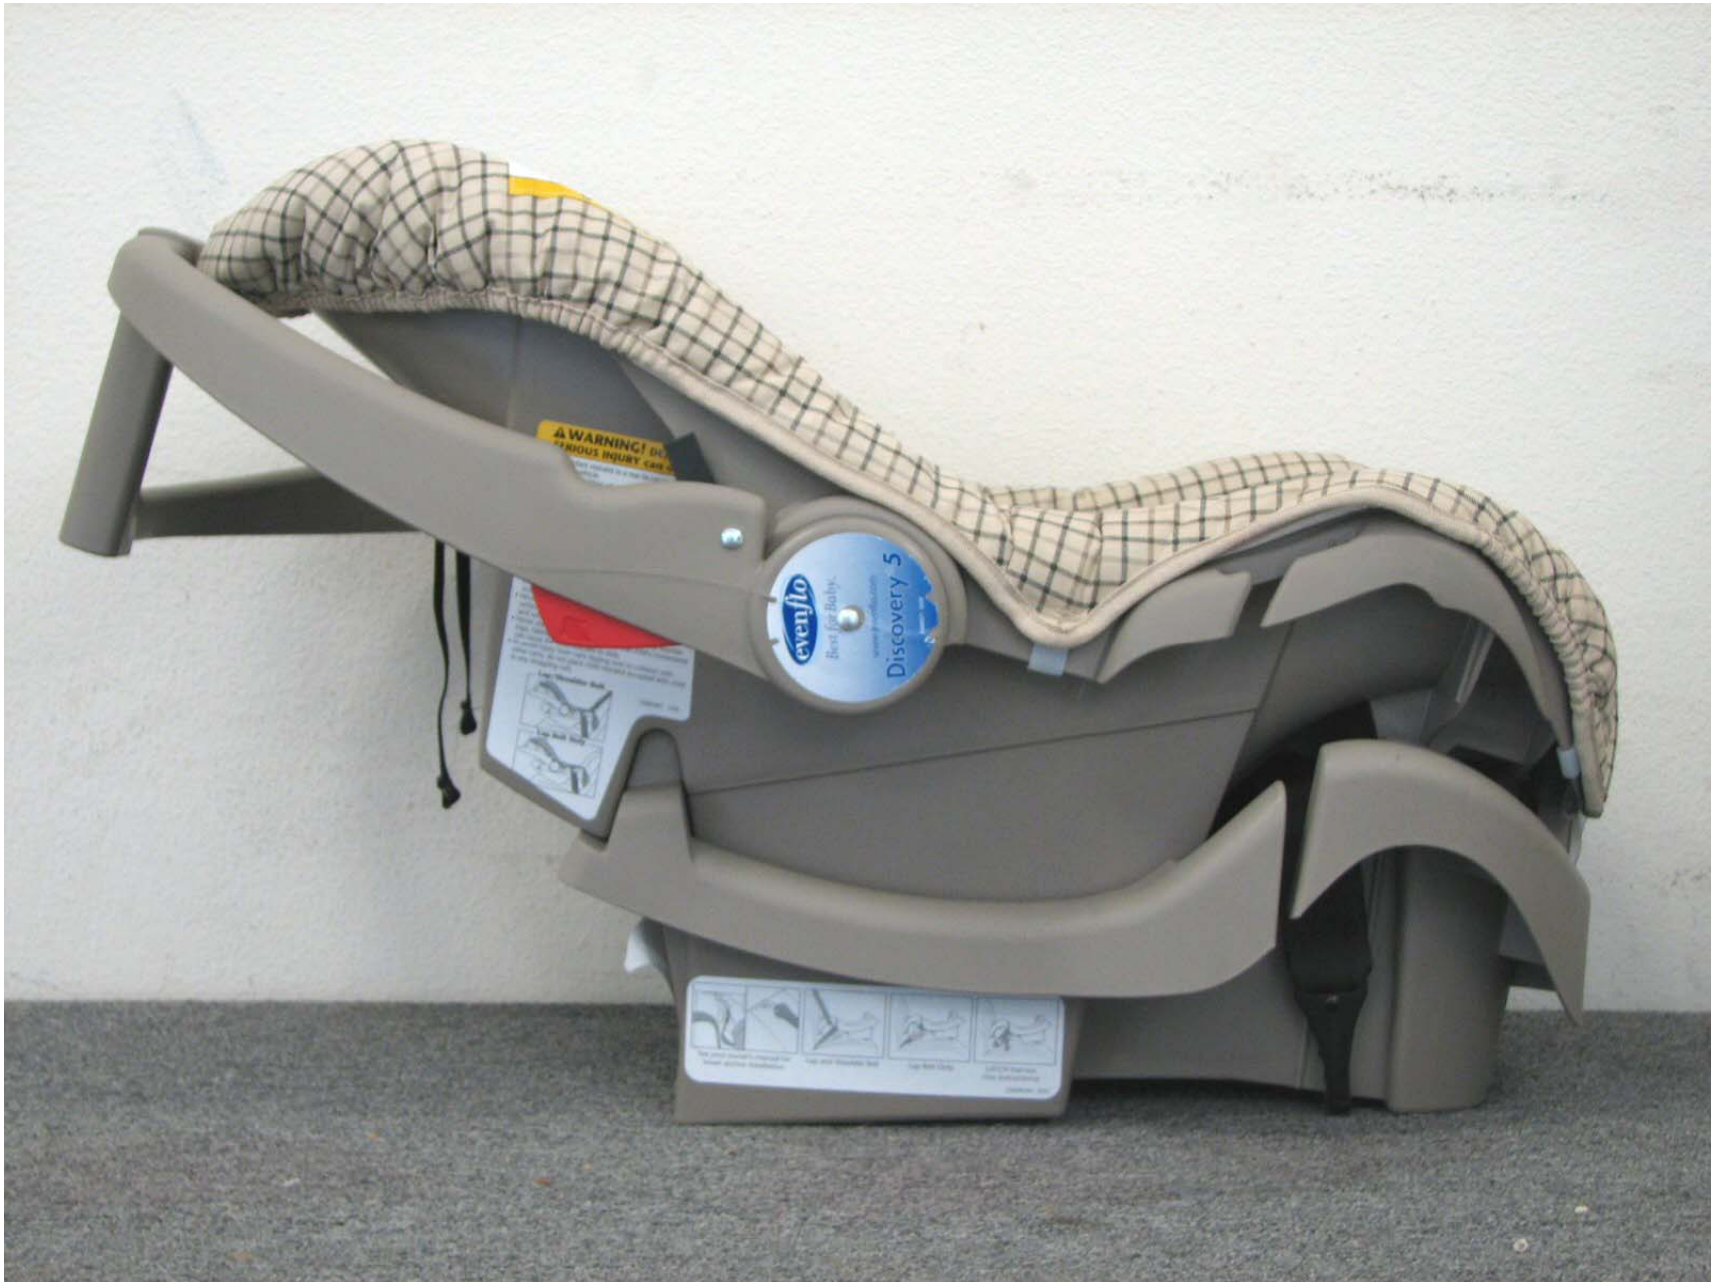
Figure D2-9: Post-Test Right Side View of Position 3 CRS

| Description | Position #3 CRS |
|---|---|
| Head Contact | Right Side of CRS |

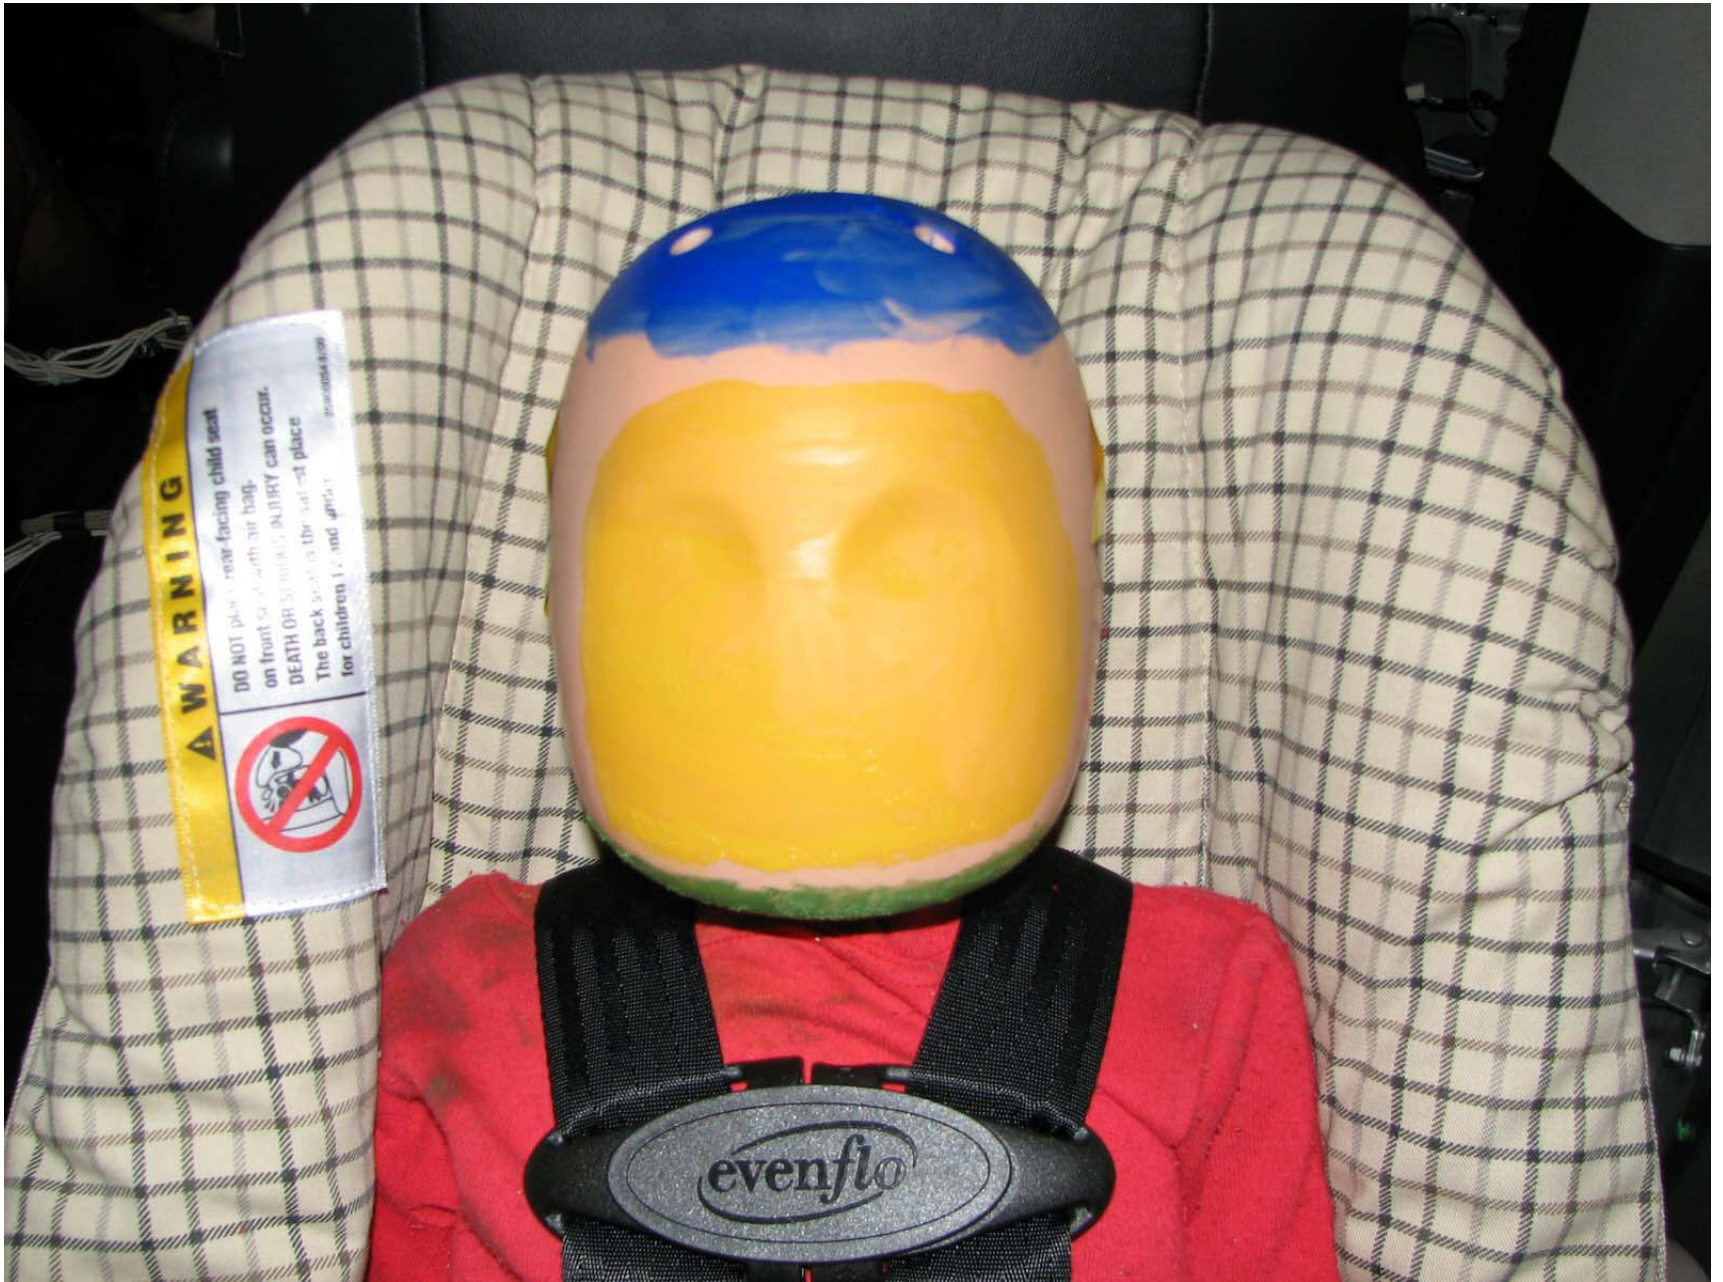
Figure D2-10: Pre-Test Position 3 Front View (Head and Seat Belt Position)

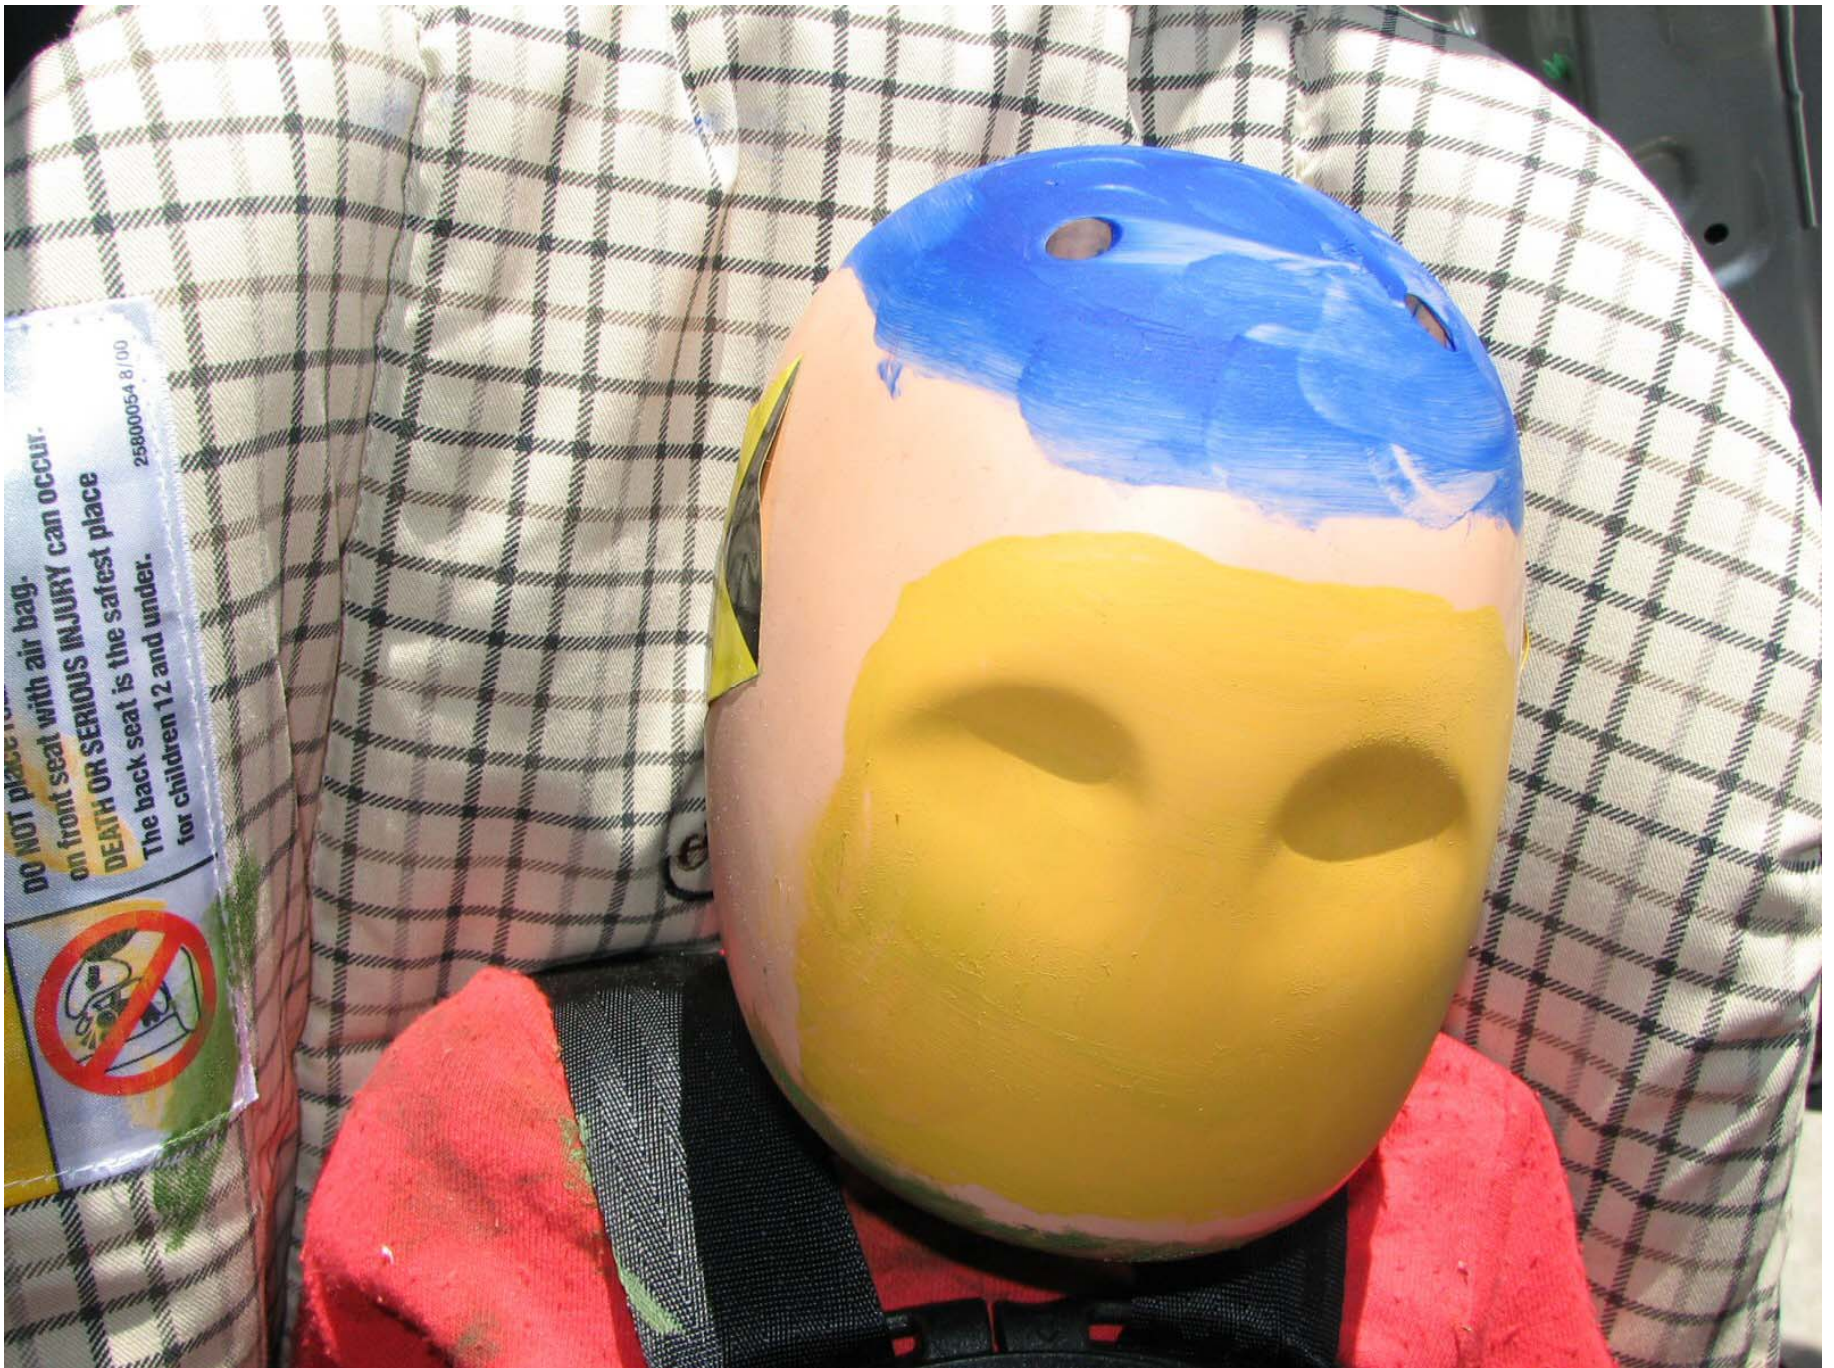
Figure D2-11: Post-Test Position 3 Front View (Head and Seat Belt Position)
