**REPORT NUMBER TR-P28003-01-NC**

**NEW CAR ASSESSMENT PROGRAM  
SIDE IMPACT TEST**

**TOYOTA MOTOR MANUFACTURING CANADA  
2008 LEXUS RX350  
5-DOOR MPV**

**NHTSA NUMBER: M85103**

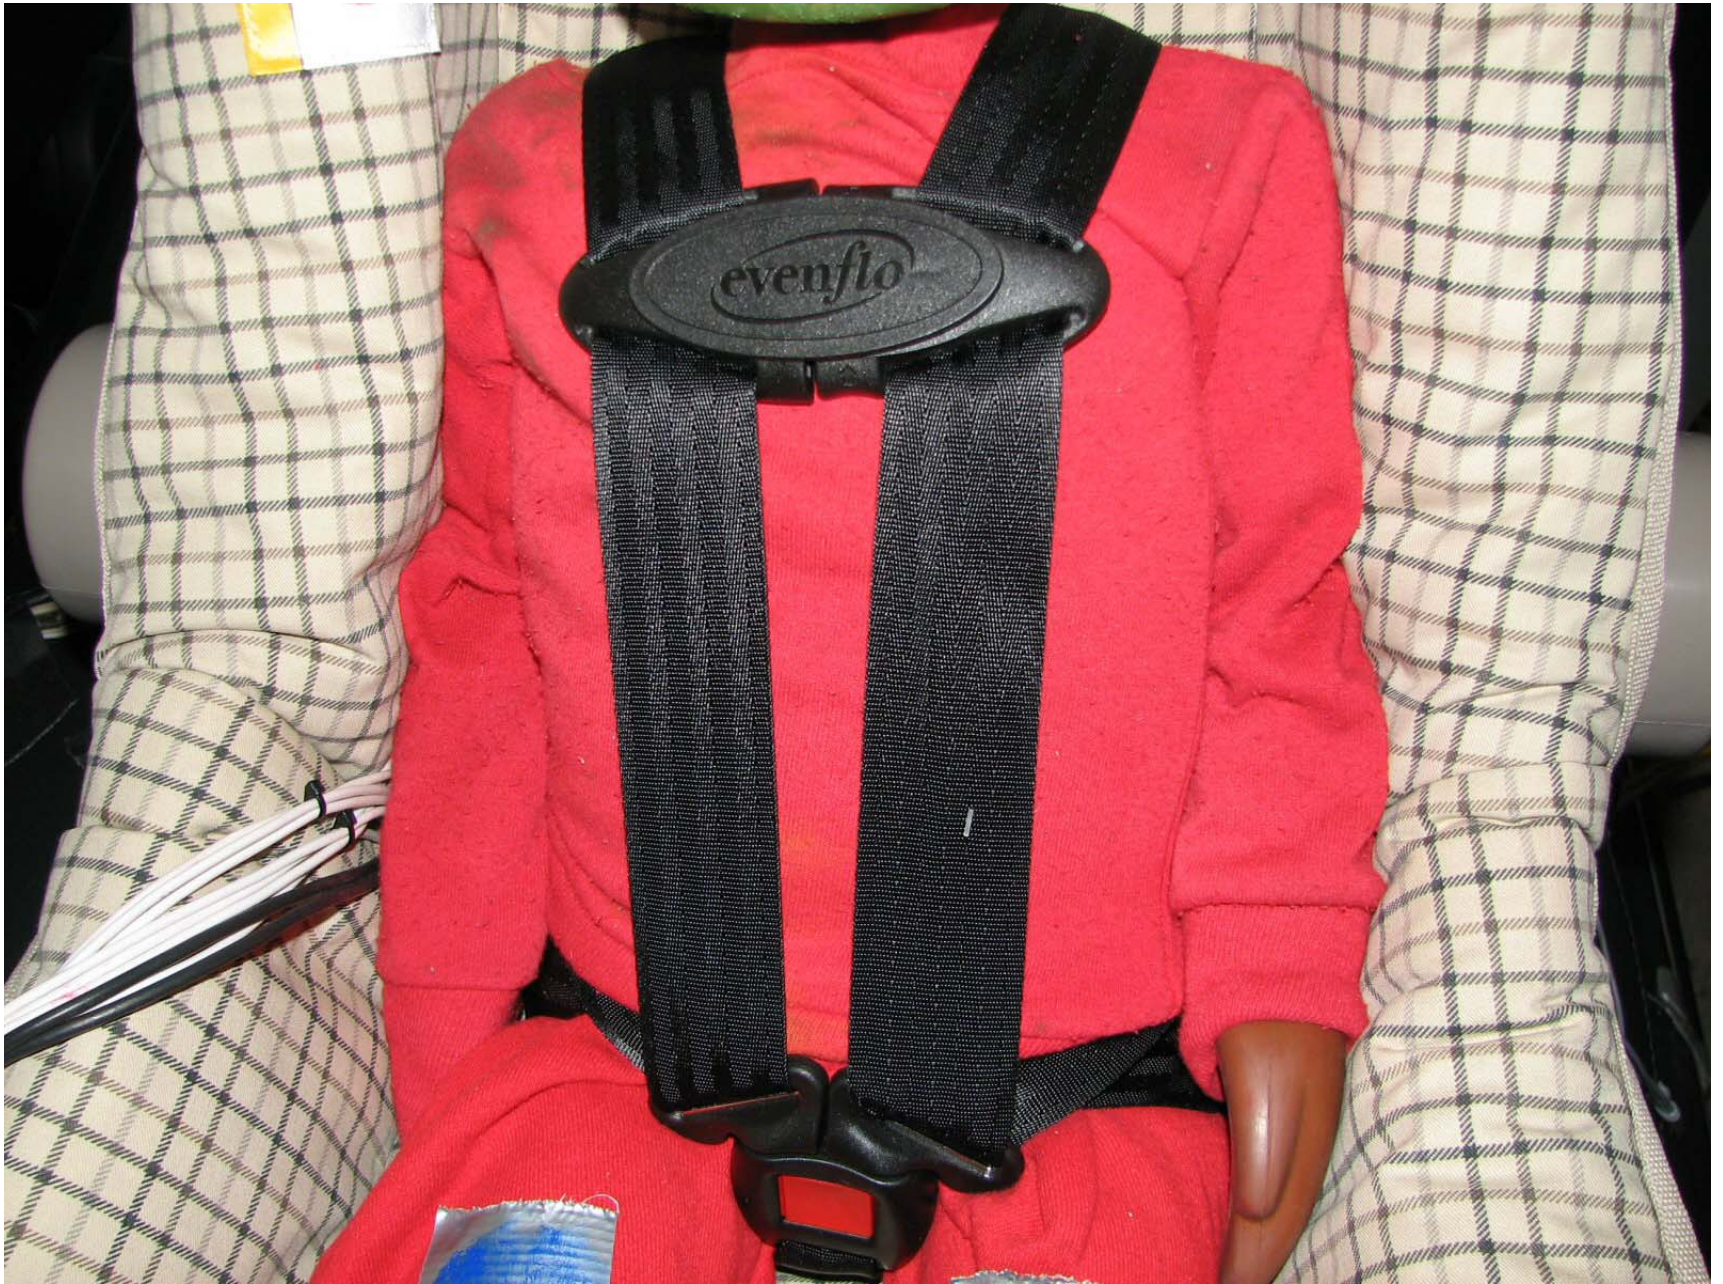
Figure D2-12: Pre-Test Position 3 Front View (Seat Belt Position)

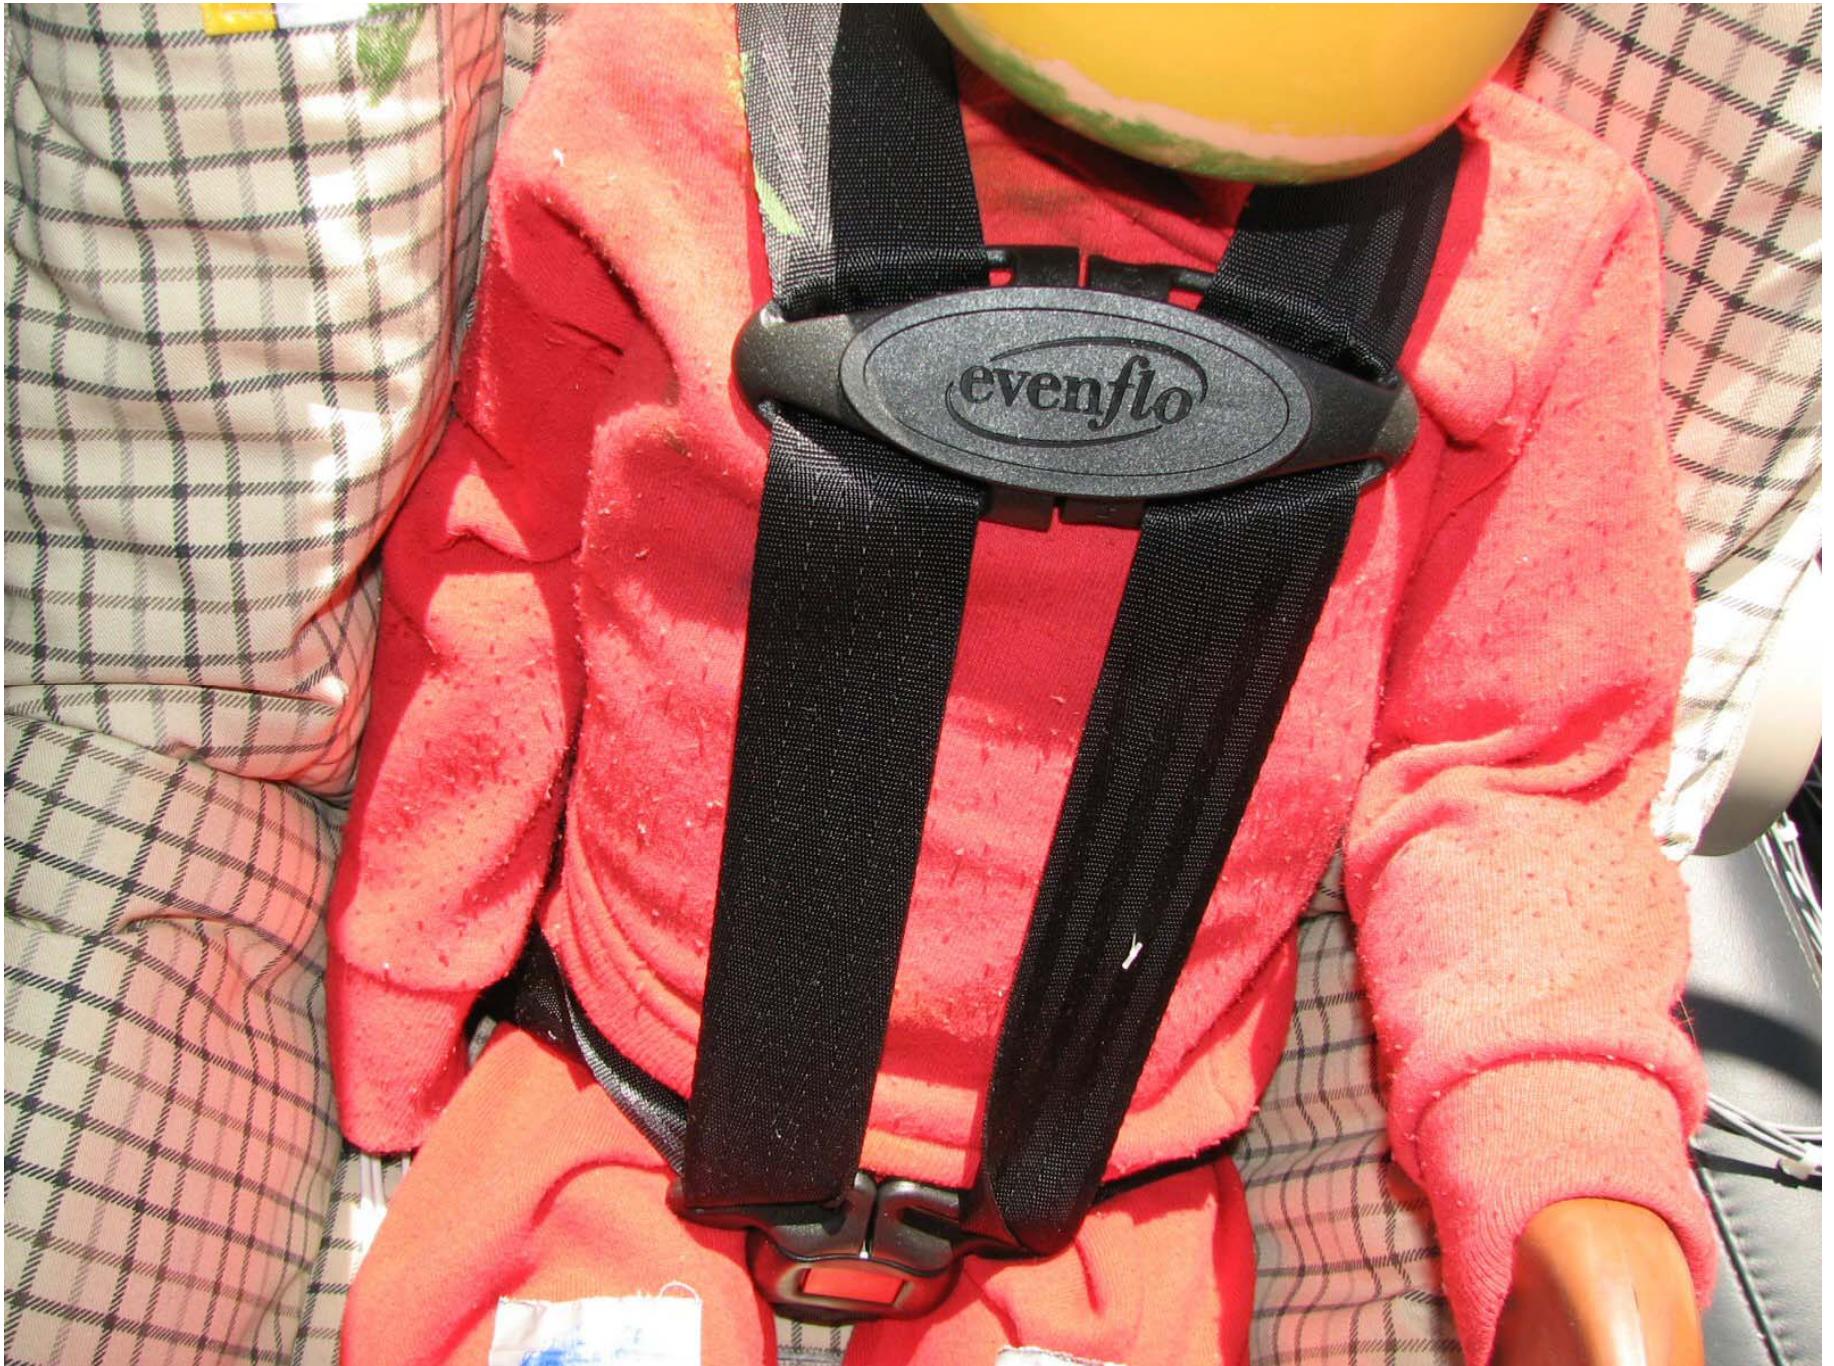
Figure D2-13: Post-Test Position 3 Front View (Seat Belt Position)

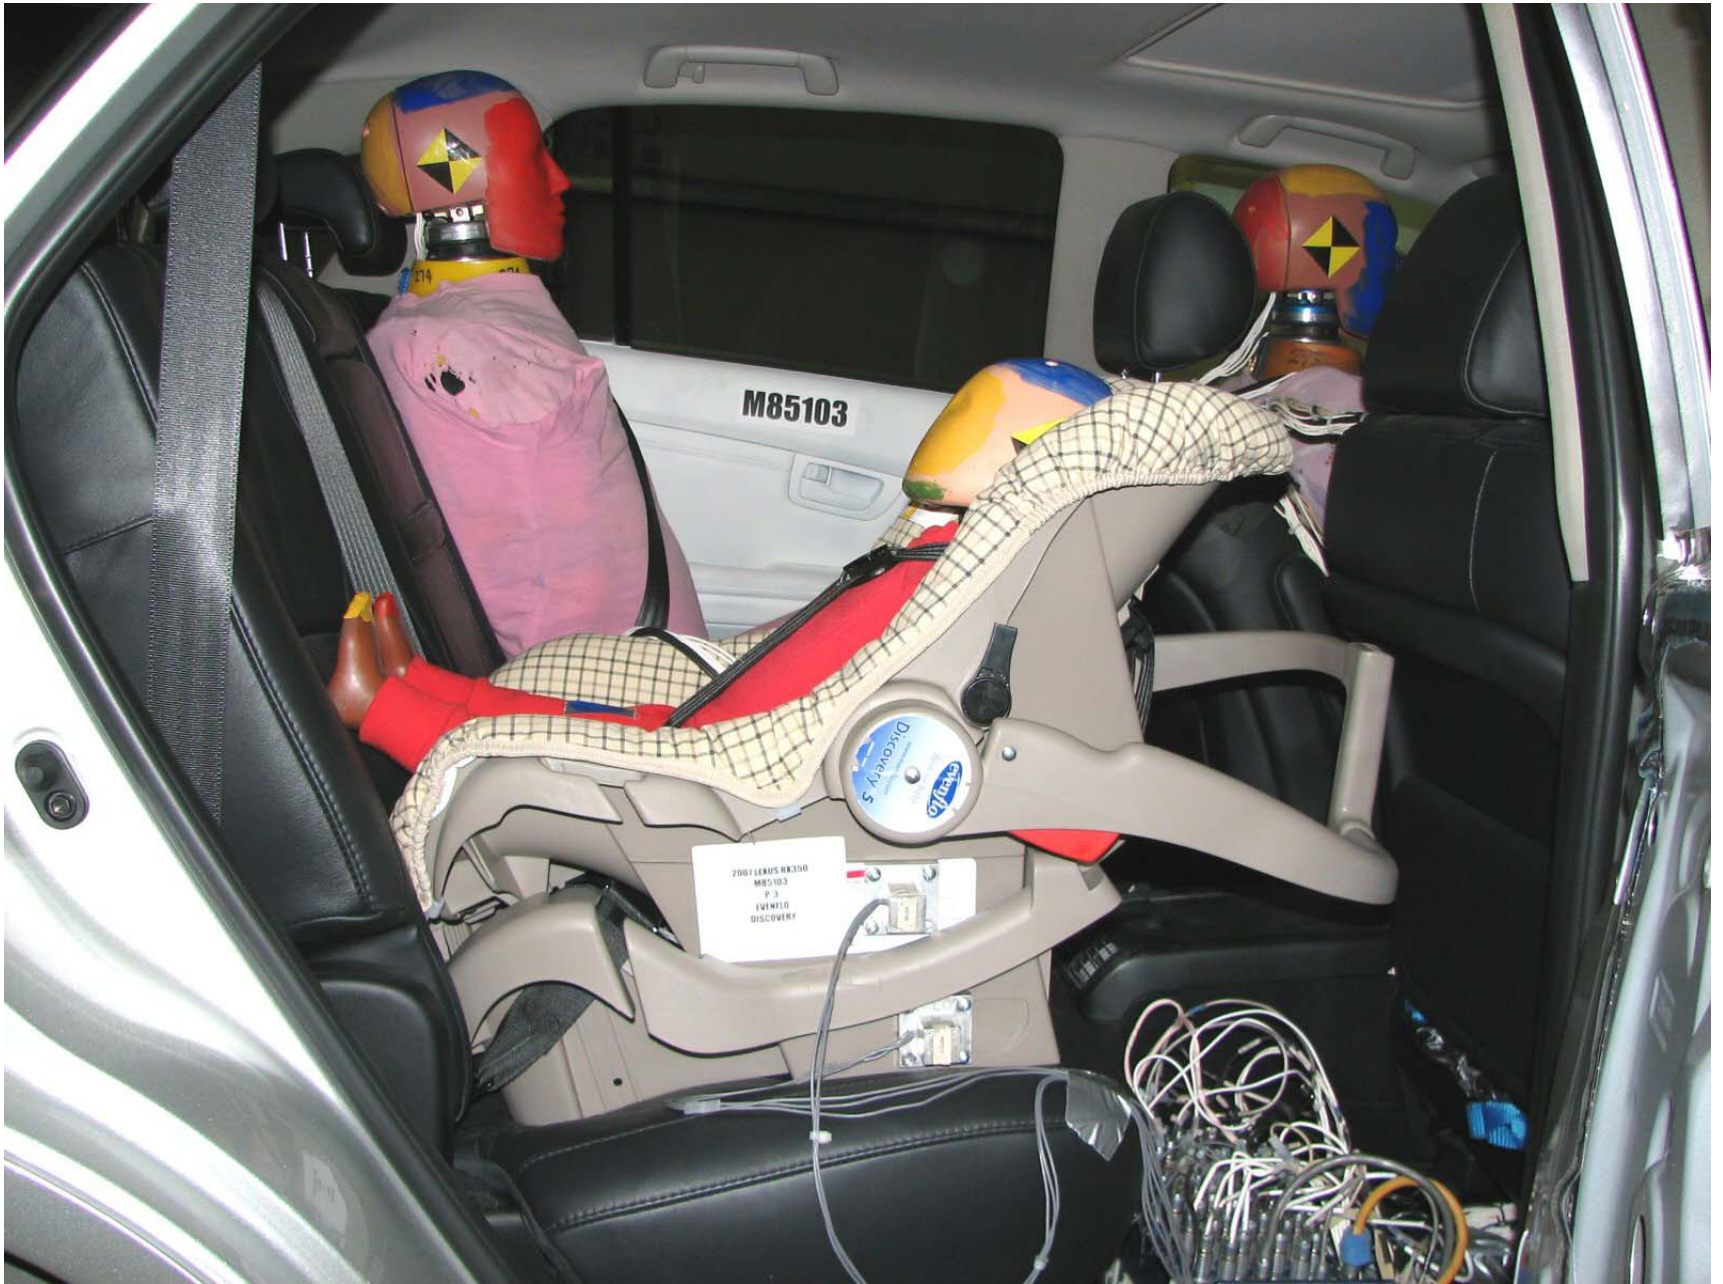
Figure D2-14: Pre-Test Position 3 Right Side View

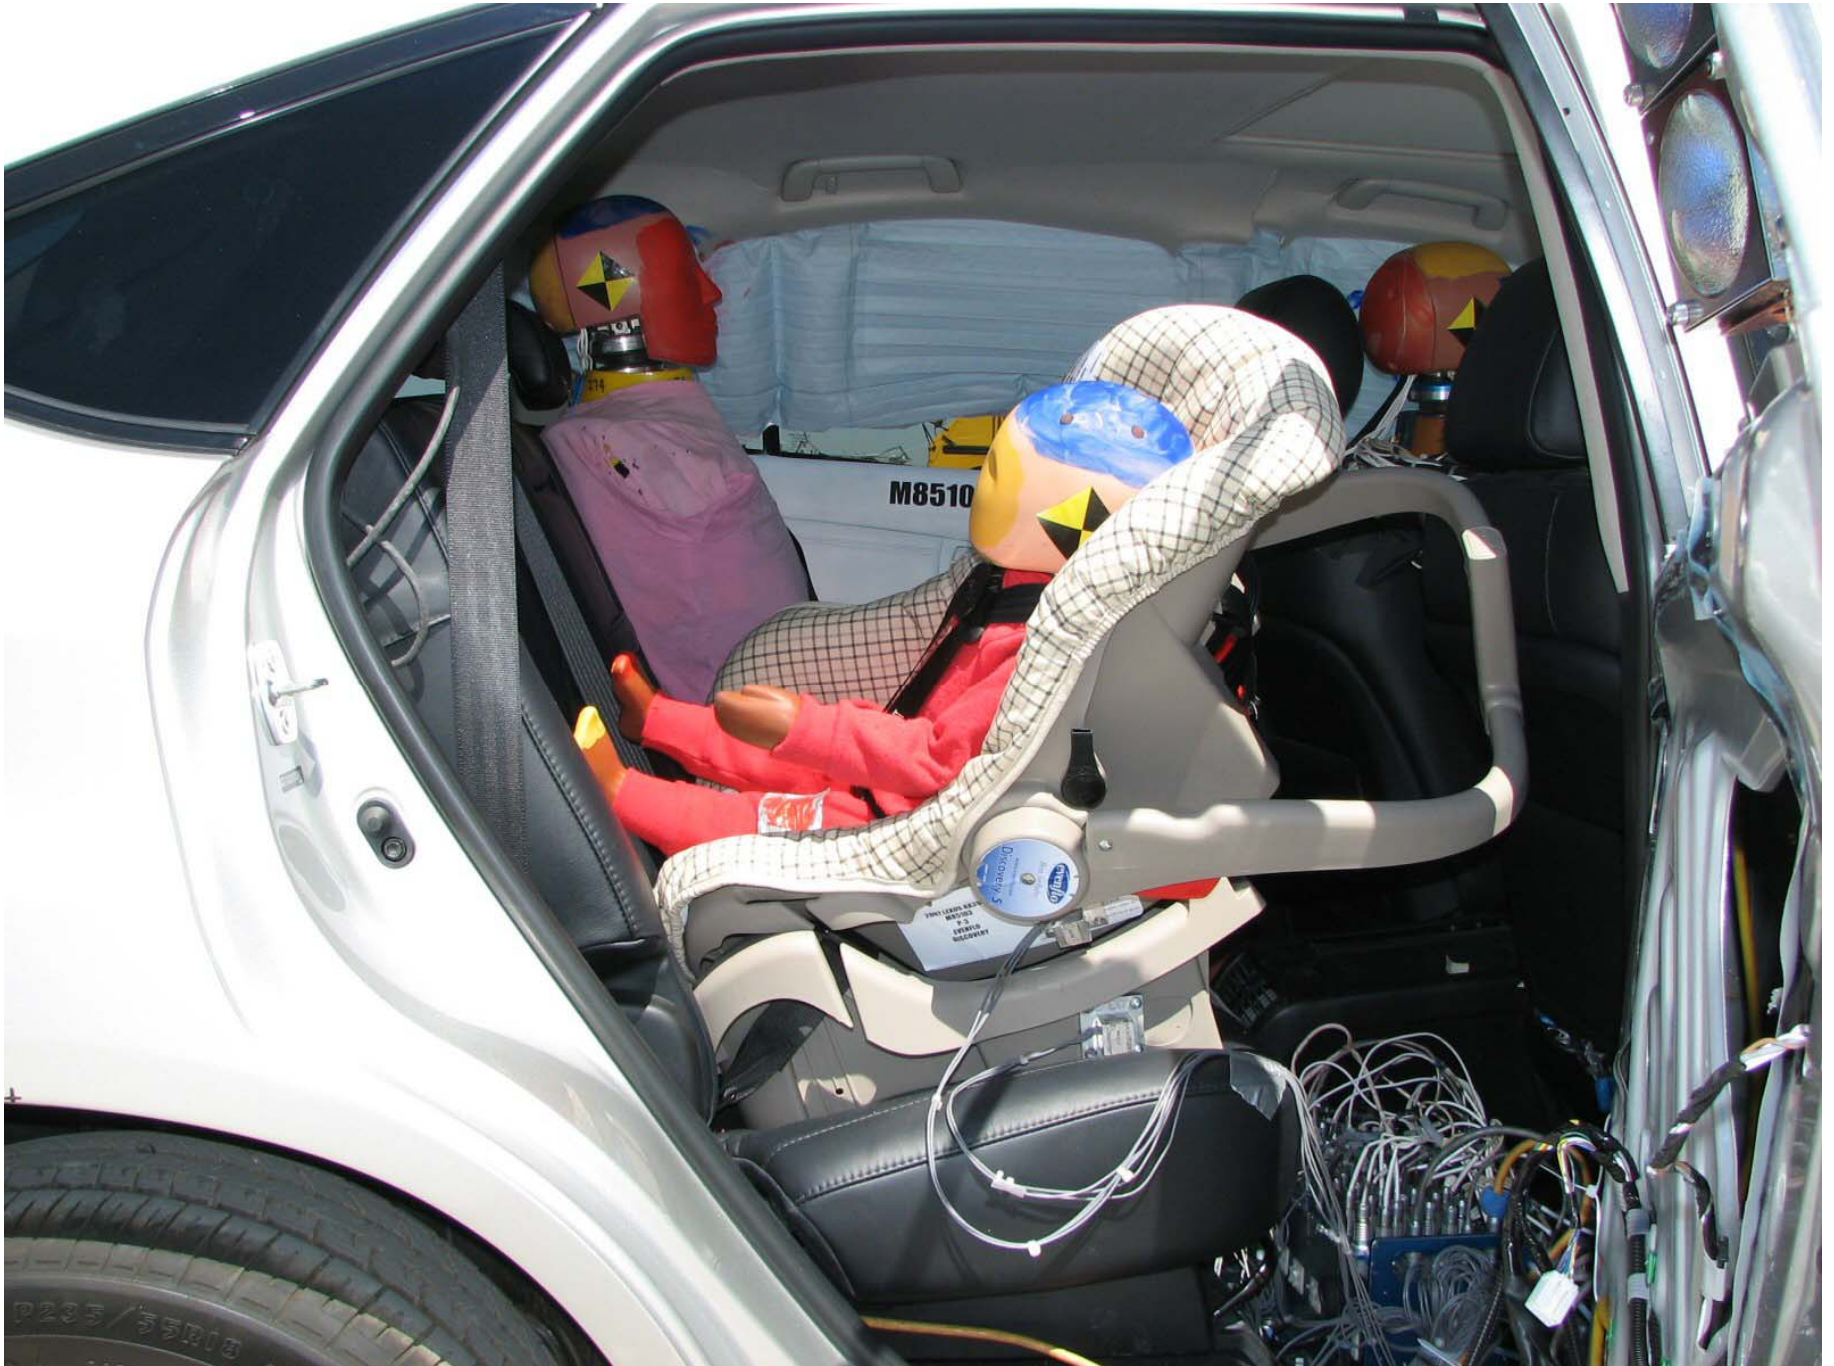
Figure D2-15: Post-Test Position 3 Right Side View

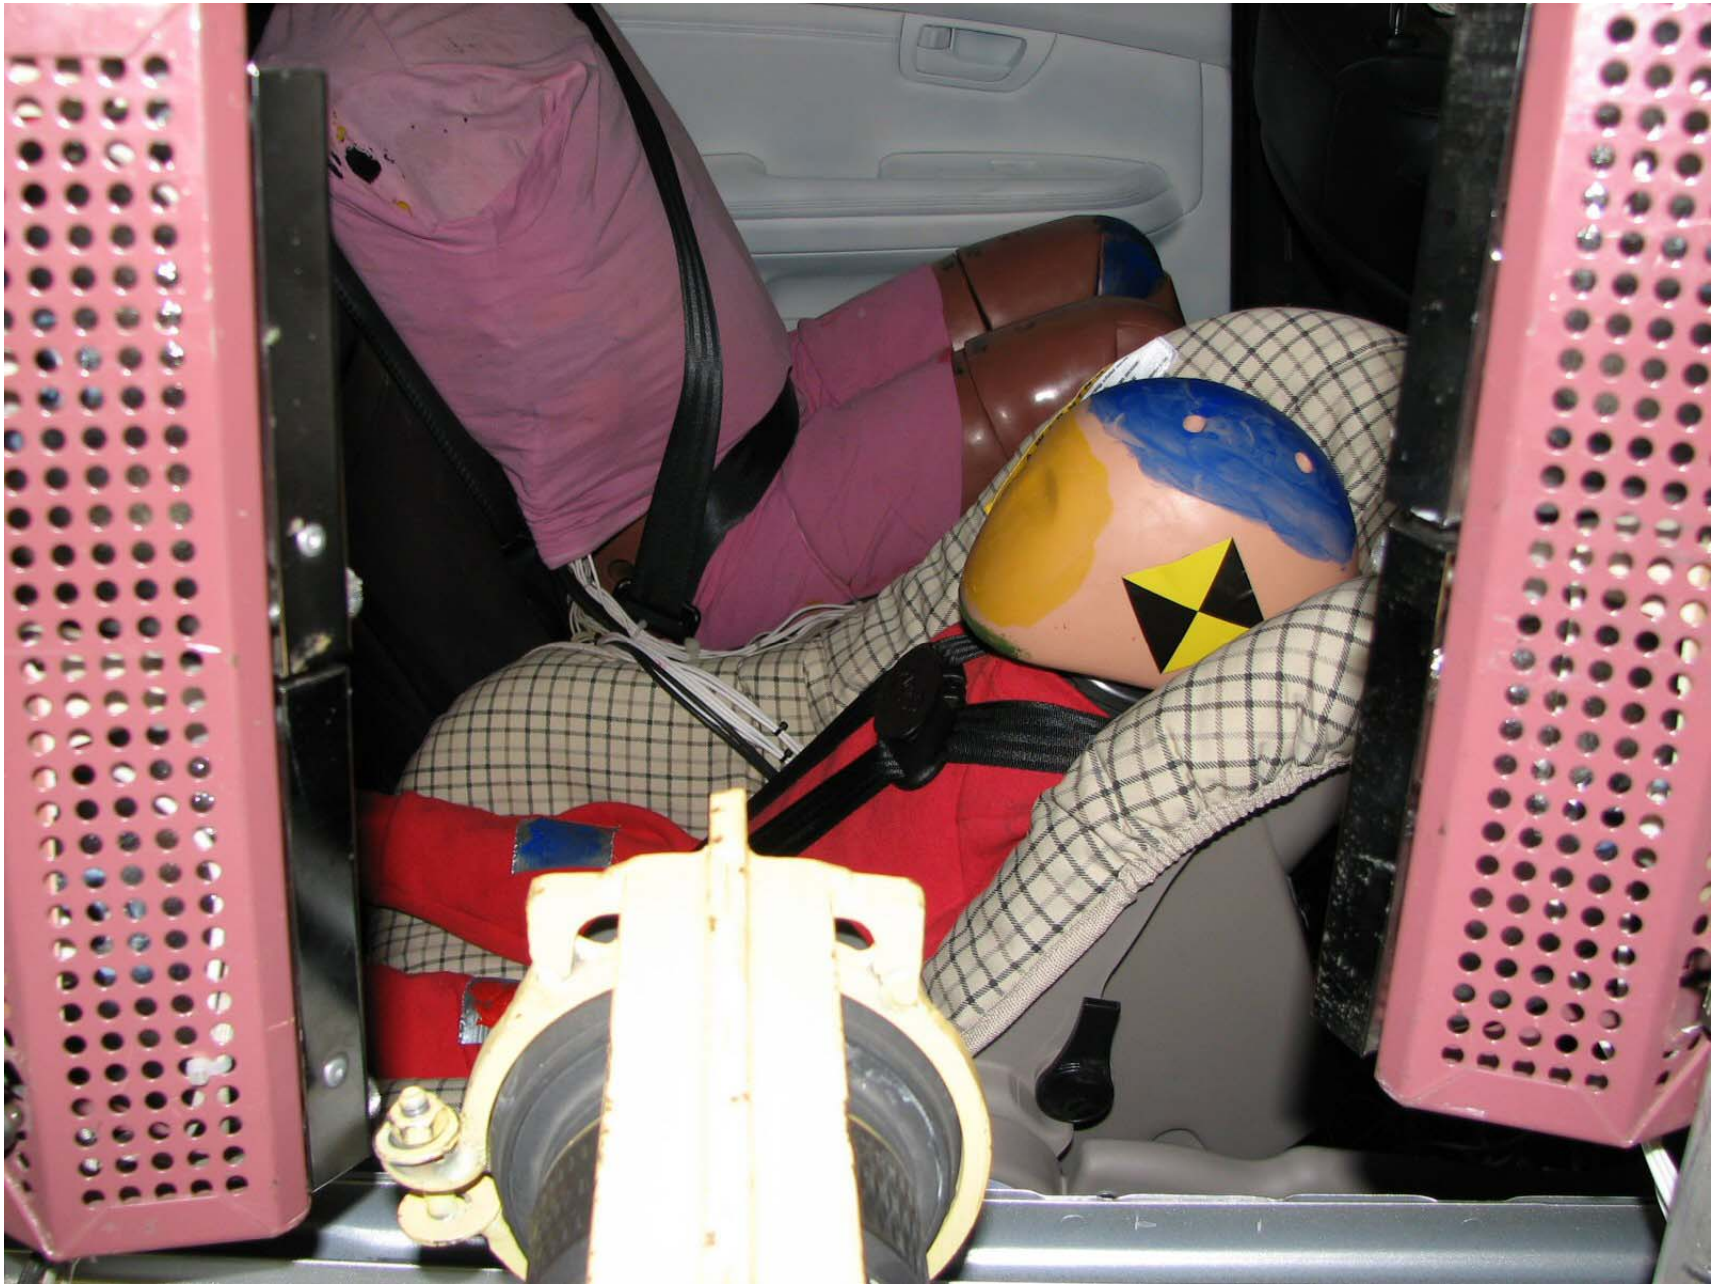
Figure D2-16: Pre-Test Position 3 Right Side View (Through Window)

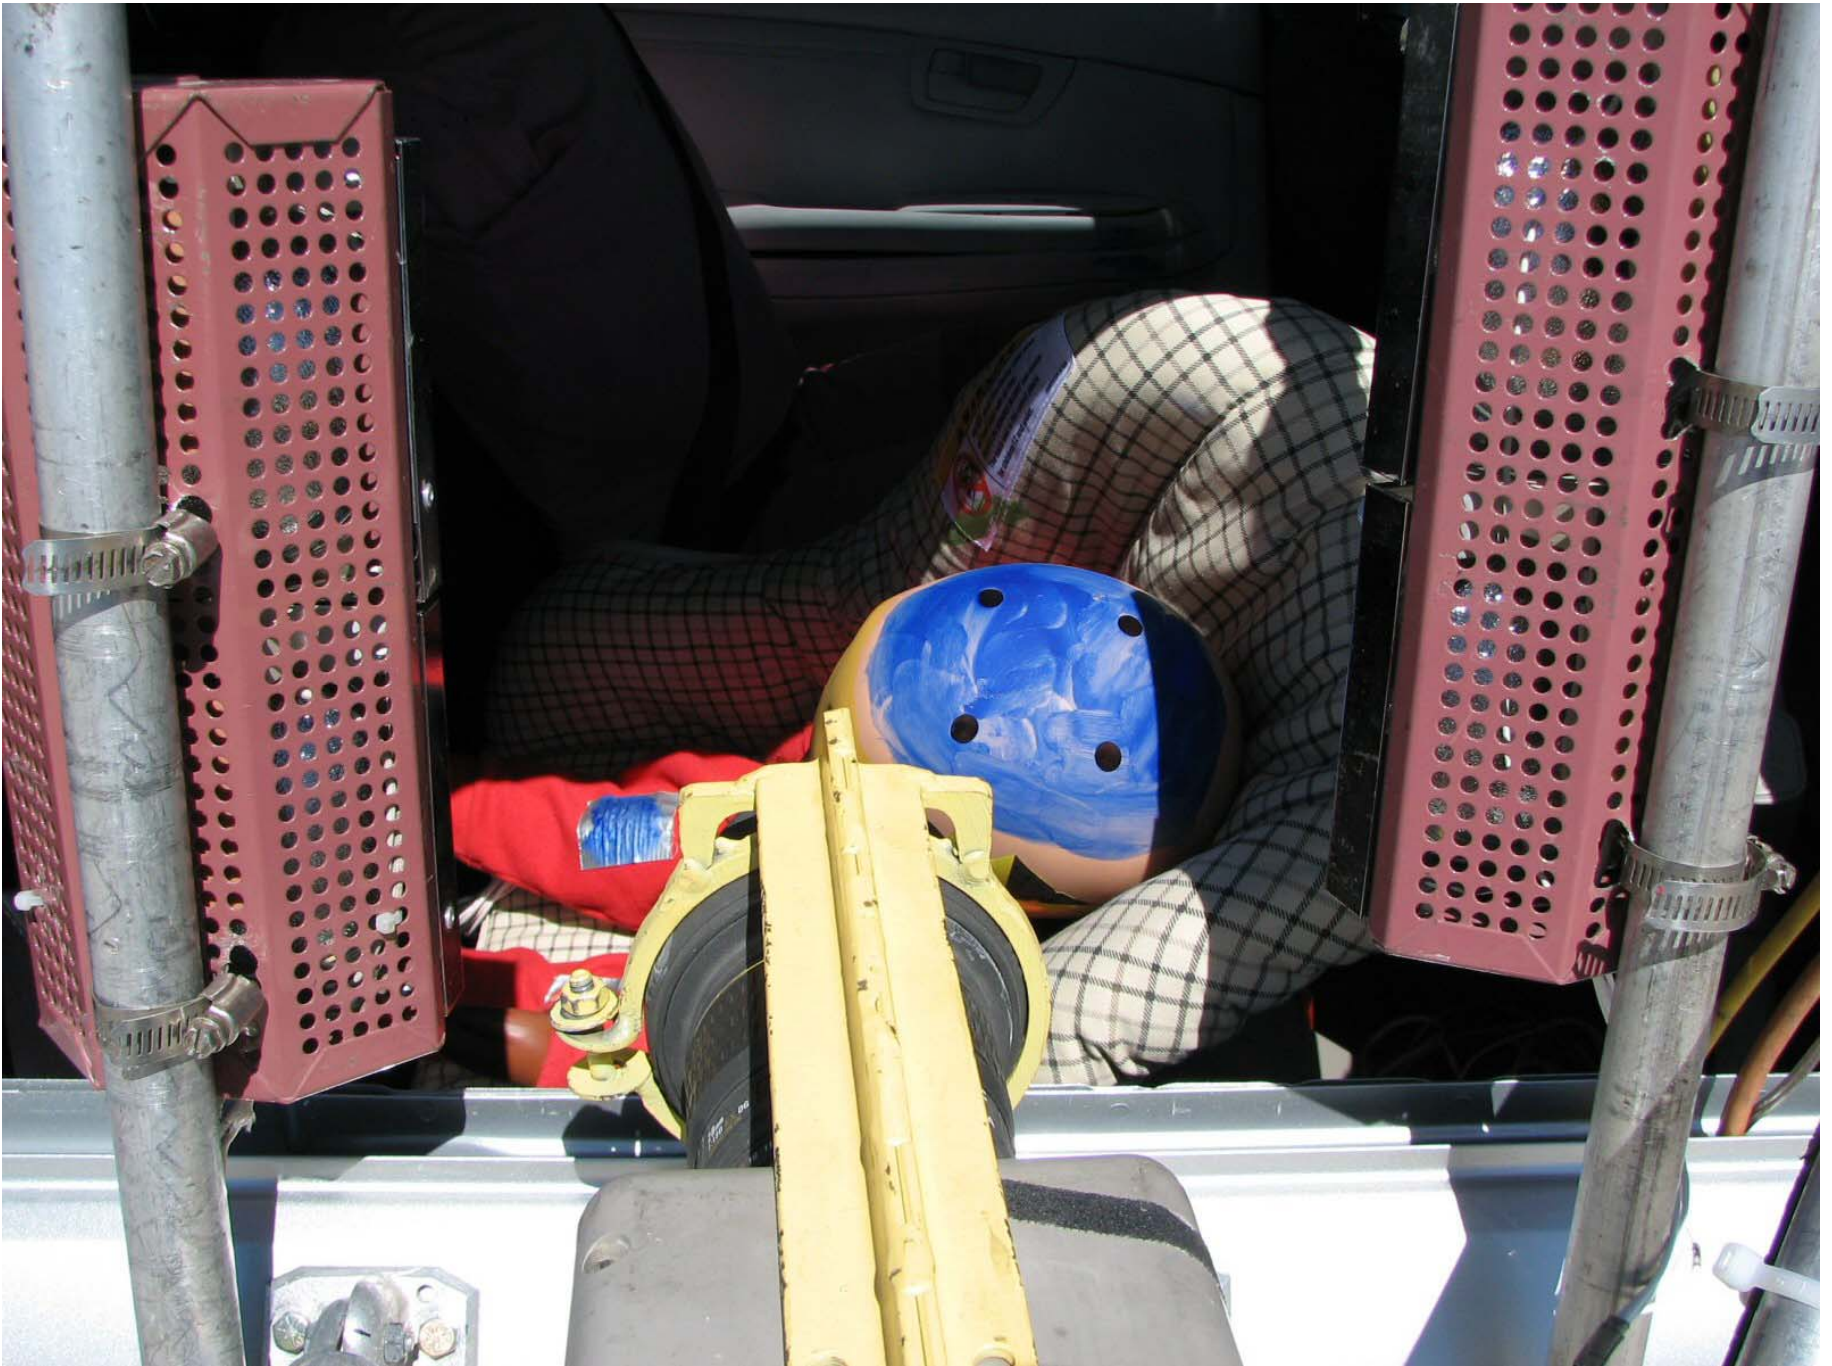
Figure D2-17: Post-Test Position 3 Right Side View (Through Window)
