REPORT NUMBER: CAL-08-01

**NEW CAR ASSESSMENT PROGRAM (NCAP)  
FRONTAL BARRIER IMPACT TEST**

FUJI HEAVY INDUSTRIES, LTD.  
2008 SUBARU IMPREZA  
4-DOOR SEDAN

FINAL REPORT

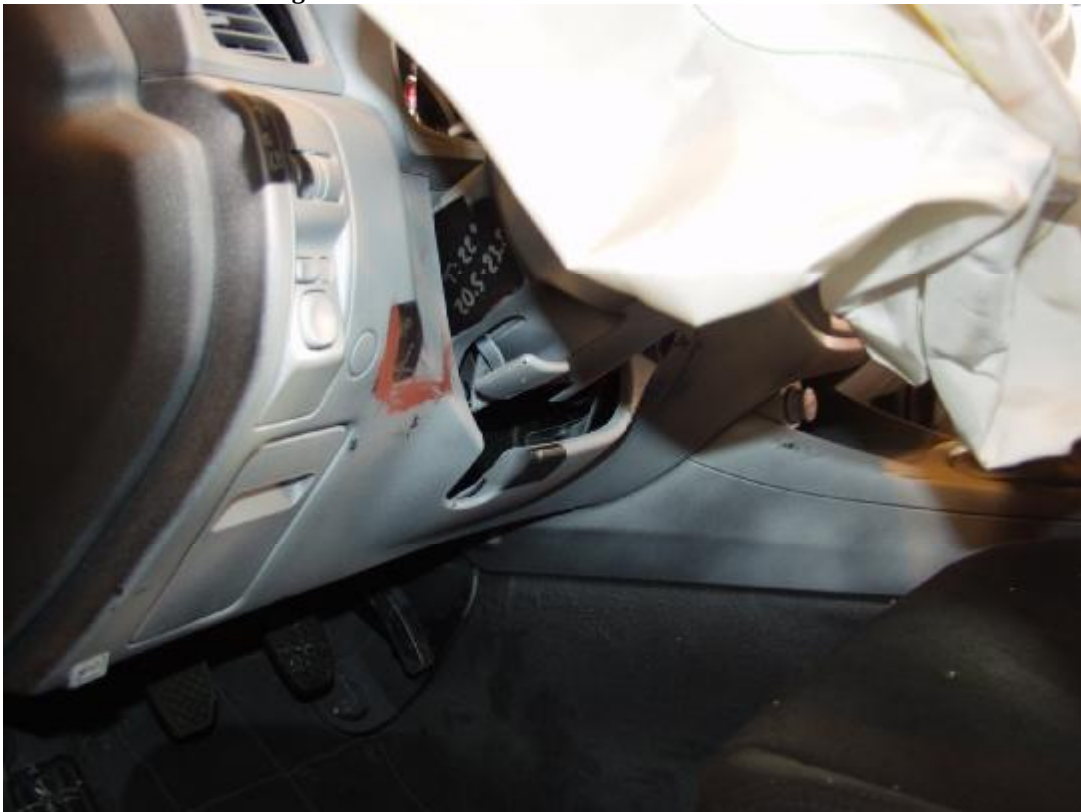
**Figure A-39: Post-Test Driver Knee Bolster View**

| | DRIVER | PASSENGER |
|---|---|---|
| Left Knee Contact: | Knee Bolster | Knee Bolster |
| Right Knee Contact: | Knee Bolster | Knee Bolster |
