**REPORT NUMBER: NCAPSIDE-MGA-2008-004**

**NEW CAR ASSESSMENT PROGRAM  
SIDE IMPACT TEST**

**FORD MOTOR COMPANY  
2008 FORD MUSTANG CONVERTIBLE  
NHTSA NUMBER: M80208**

**PREPARED BY:  
MGA RESEARCH CORPORATION  
5000 WARREN ROAD  
BURLINGTON, WI 53105**

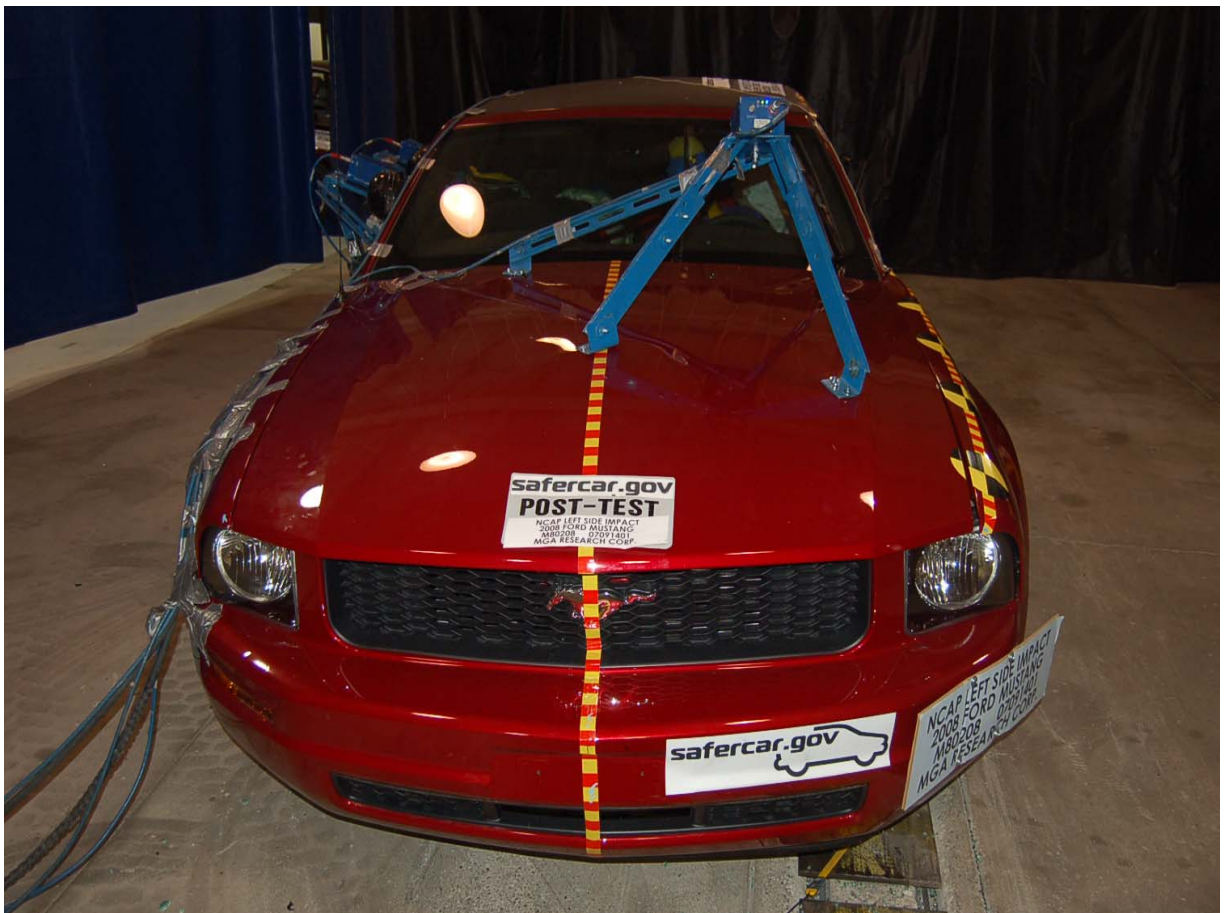
Post-Test Front View

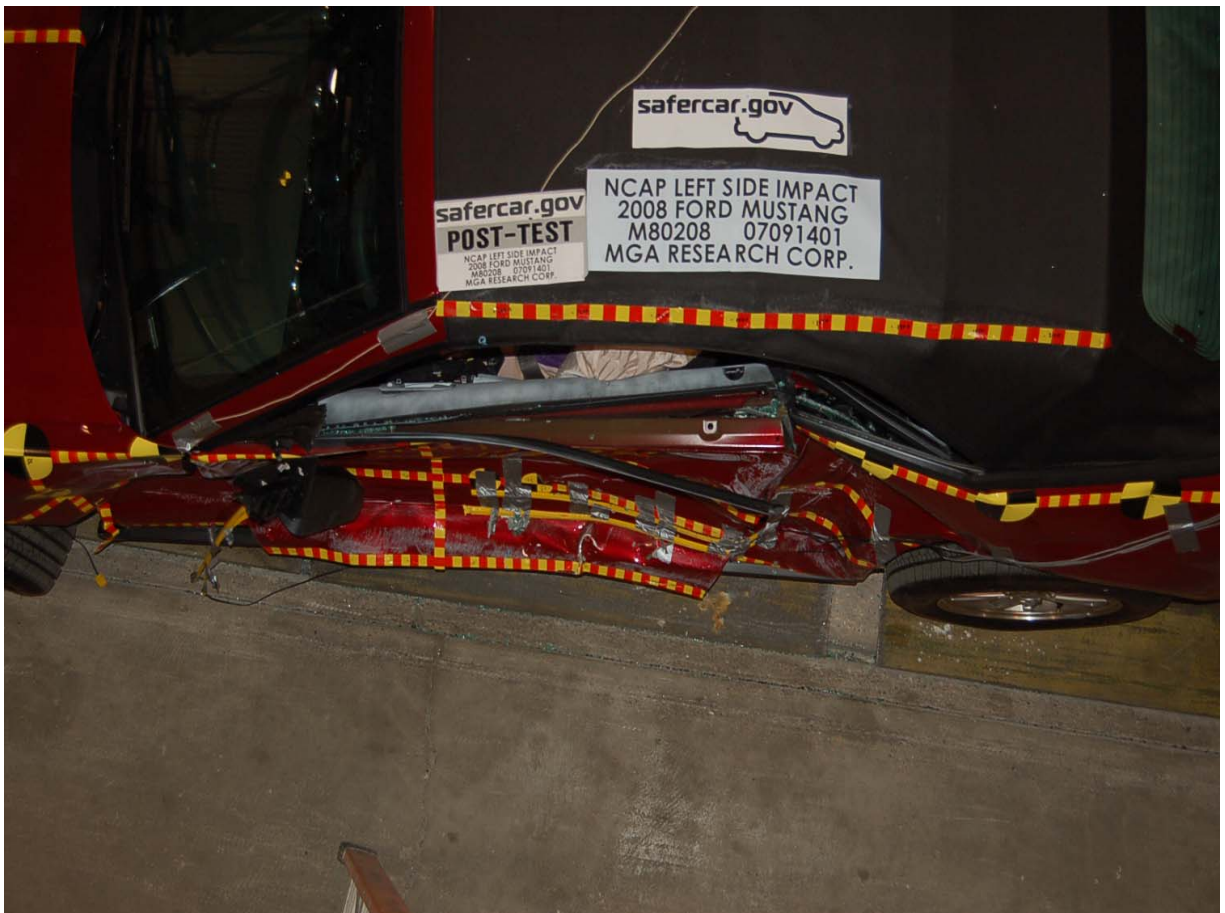
Post-Test Overhead View

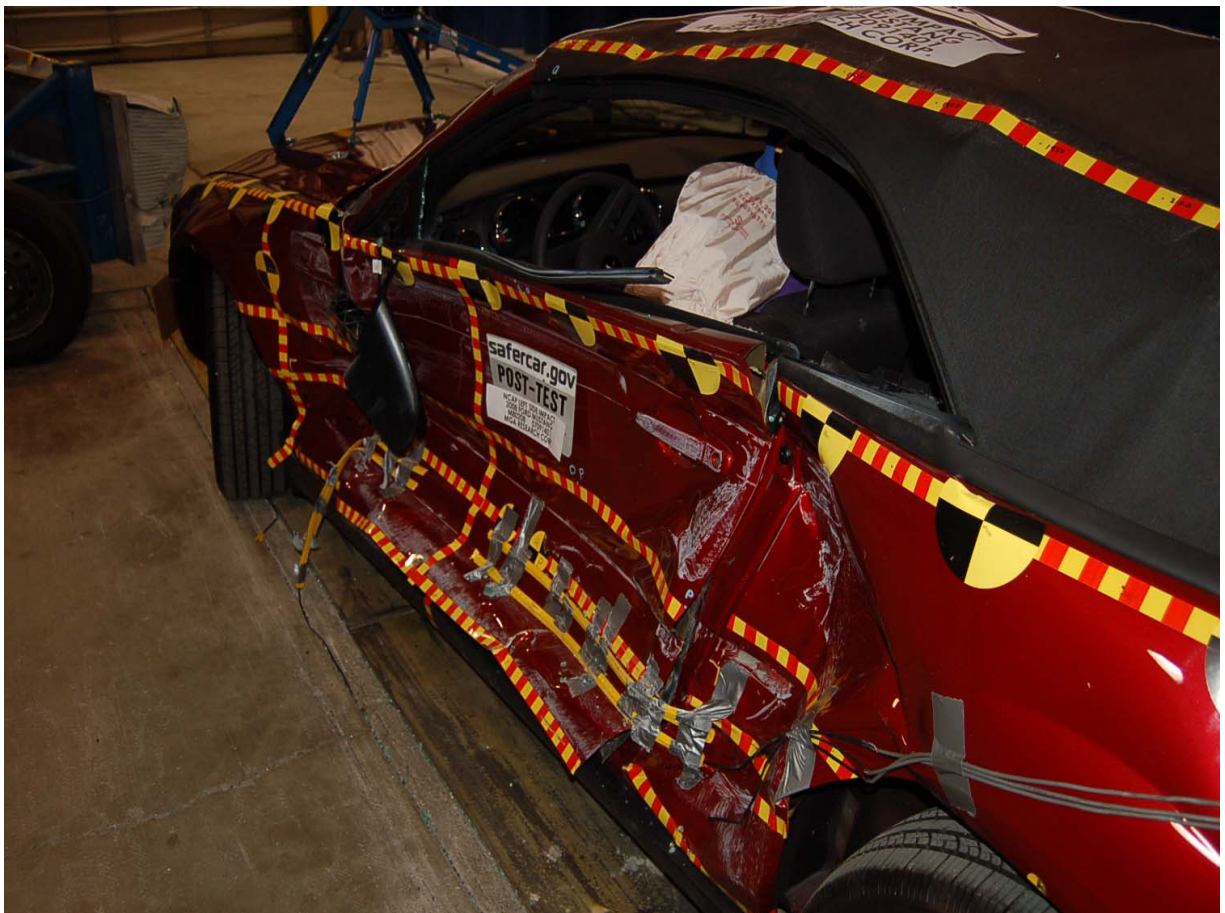
Post-Test Rear  $\frac{3}{4}$  View of Left Side Doors

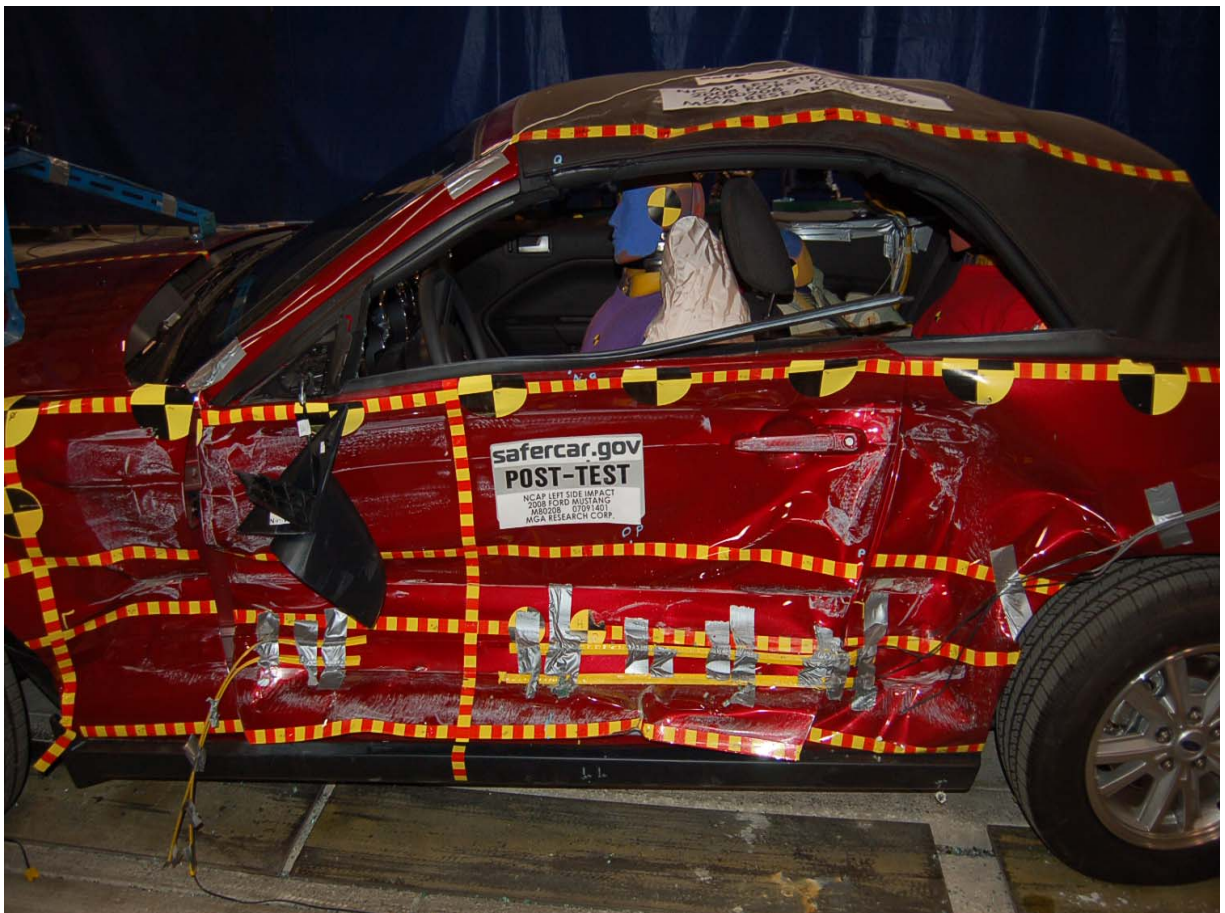
Post-Test Left Side Impact Close-up

The test vehicle sustained a maximum static crush of 223 mm at level 3, 1200 mm rearward of the vertical impact point. The driver and passenger SID/HIIs, Serial Nos. 272 and 271 respectively, were calibrated just prior to this test.
