**REPORT NUMBER: MCW-DOT-08SN03**

**NEW CAR ASSESSMENT PROGRAM  
SIDE IMPACT TEST**

**2008 NISSAN ALTIMA 4-DOOR SEDAN**

**FINAL REPORT**

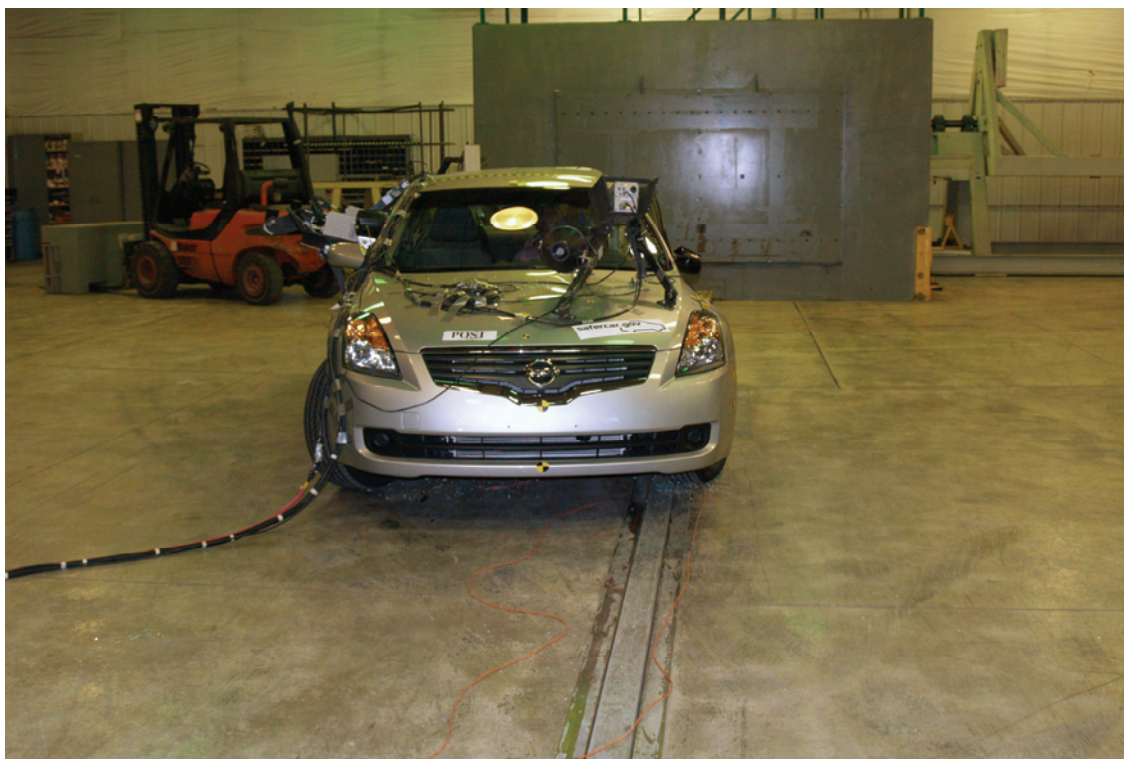
Figure A-6: Post test front view of test vehicle

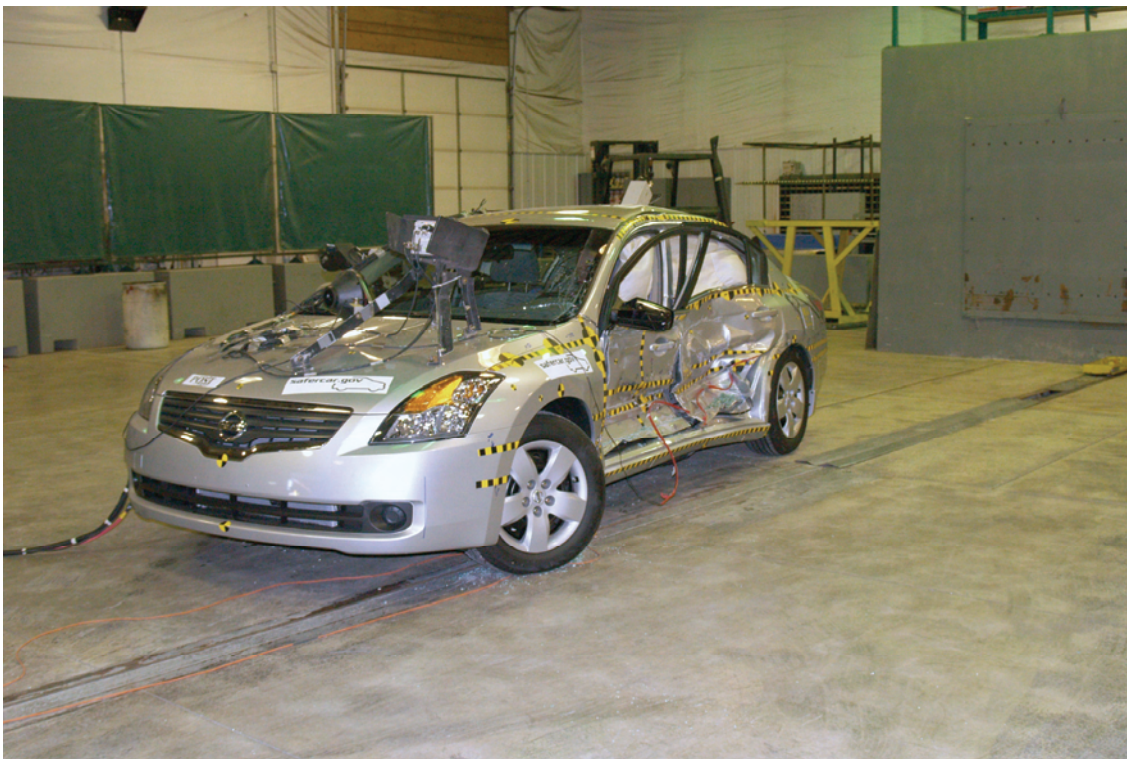
Figure A-8: Post test left front 3/4 view of test vehicle

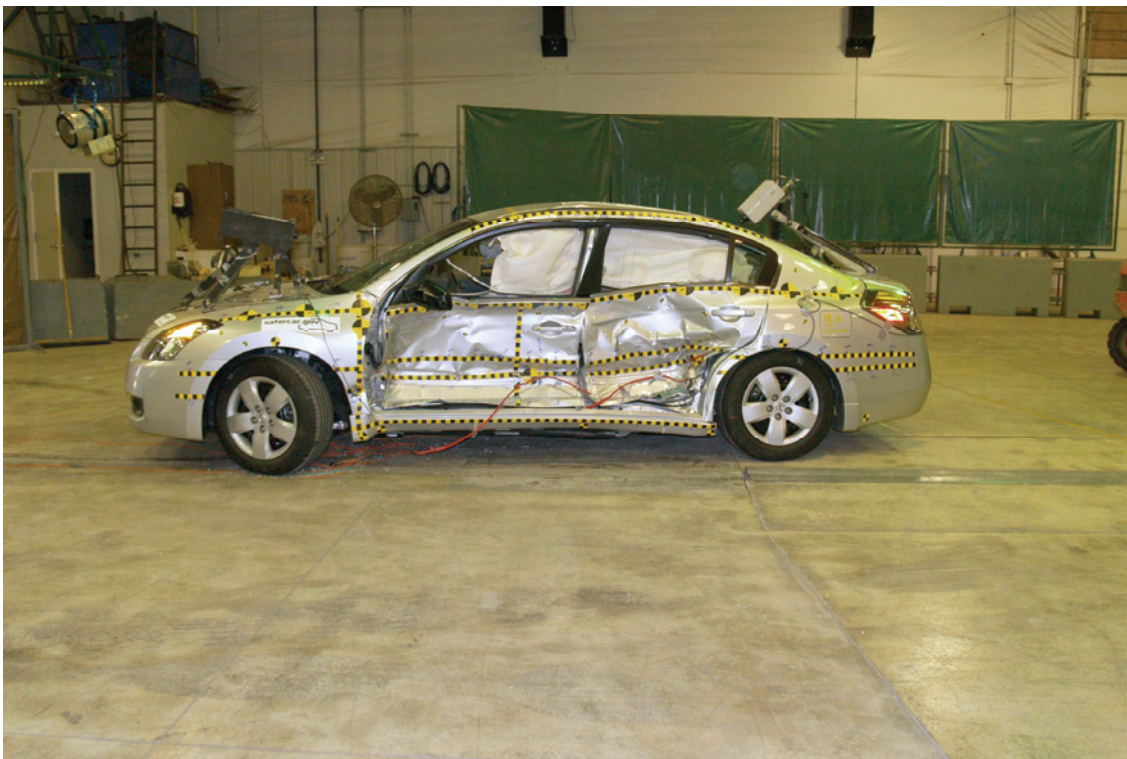
The test vehicle sustained a maximum static crush of 327 mm at level 2, 1500 mm rearward of the vertical impact line.

Figure A-10: Post test left side view of test vehicle

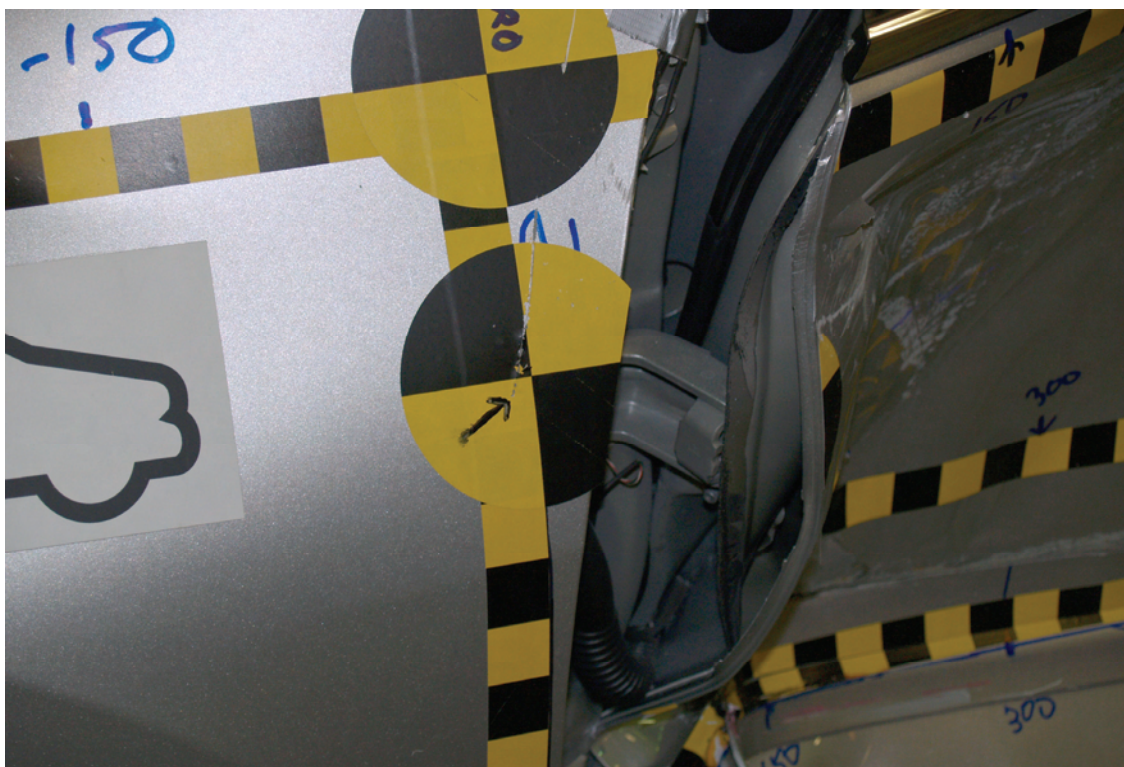
Figure A-26: Post test impact point

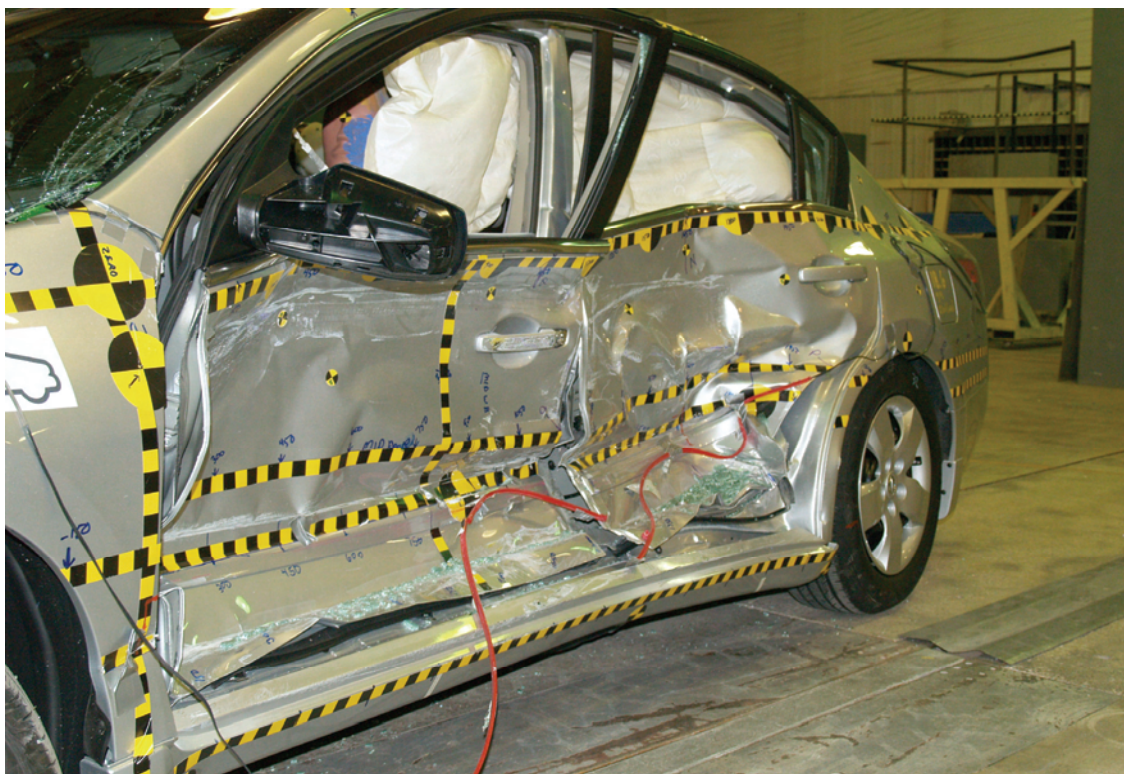
Figure A-28: Post test front 3/4 view of left side doors

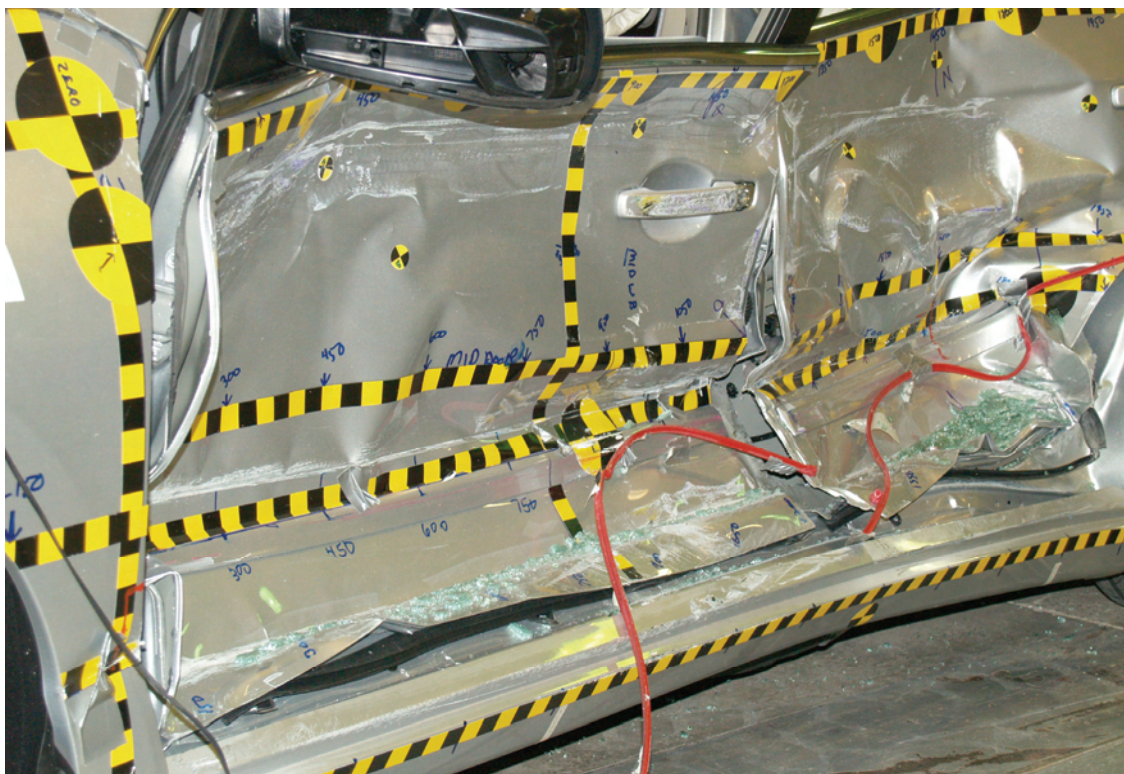
Figure A-32: Post test left front door

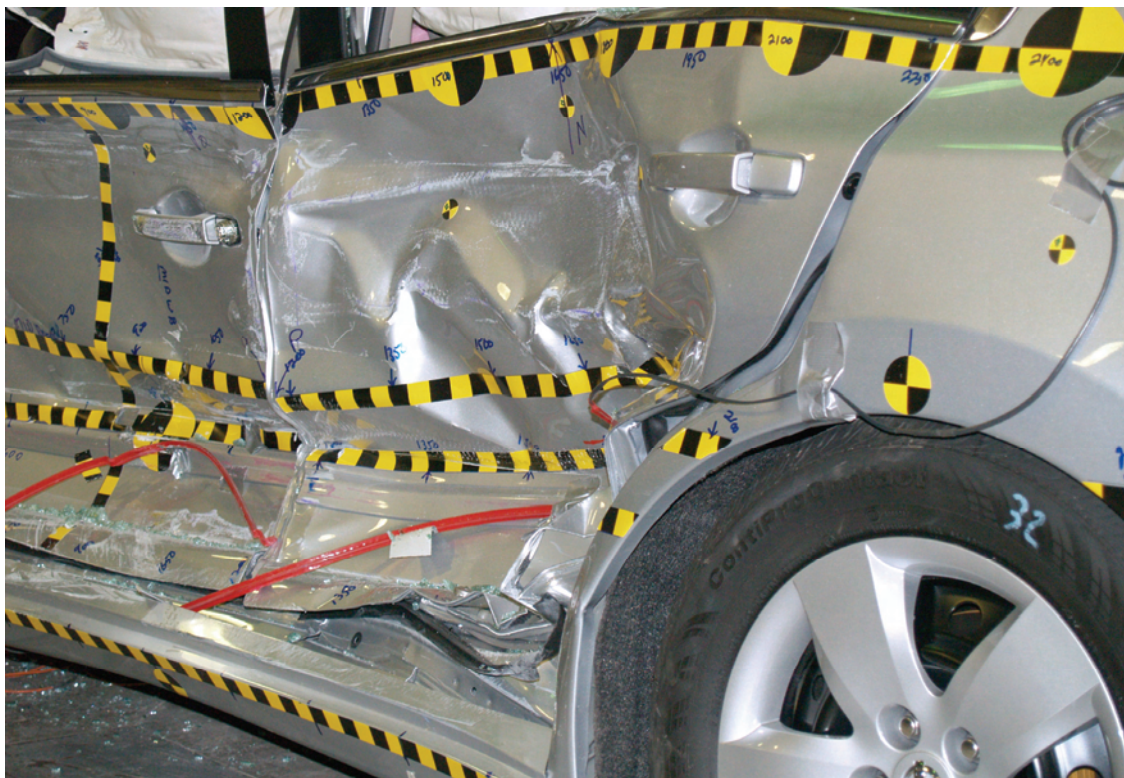
Figure A-34: Post test left rear door

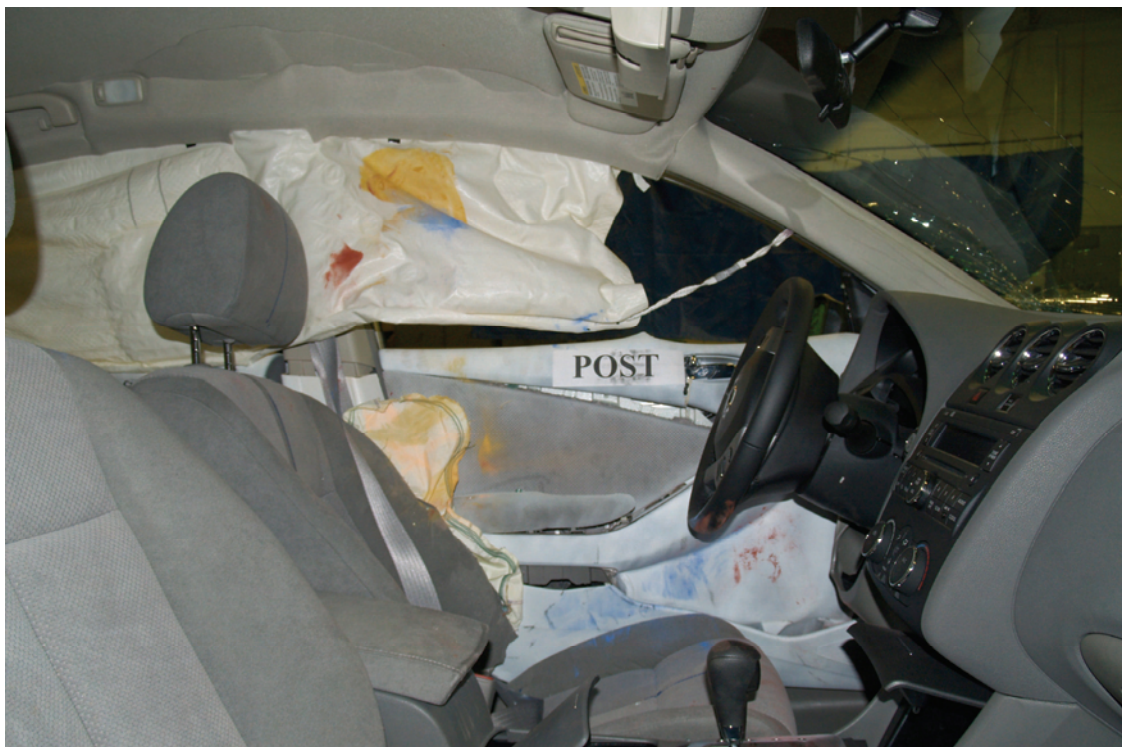
Figure A-41: Post test driver contact locations (1)

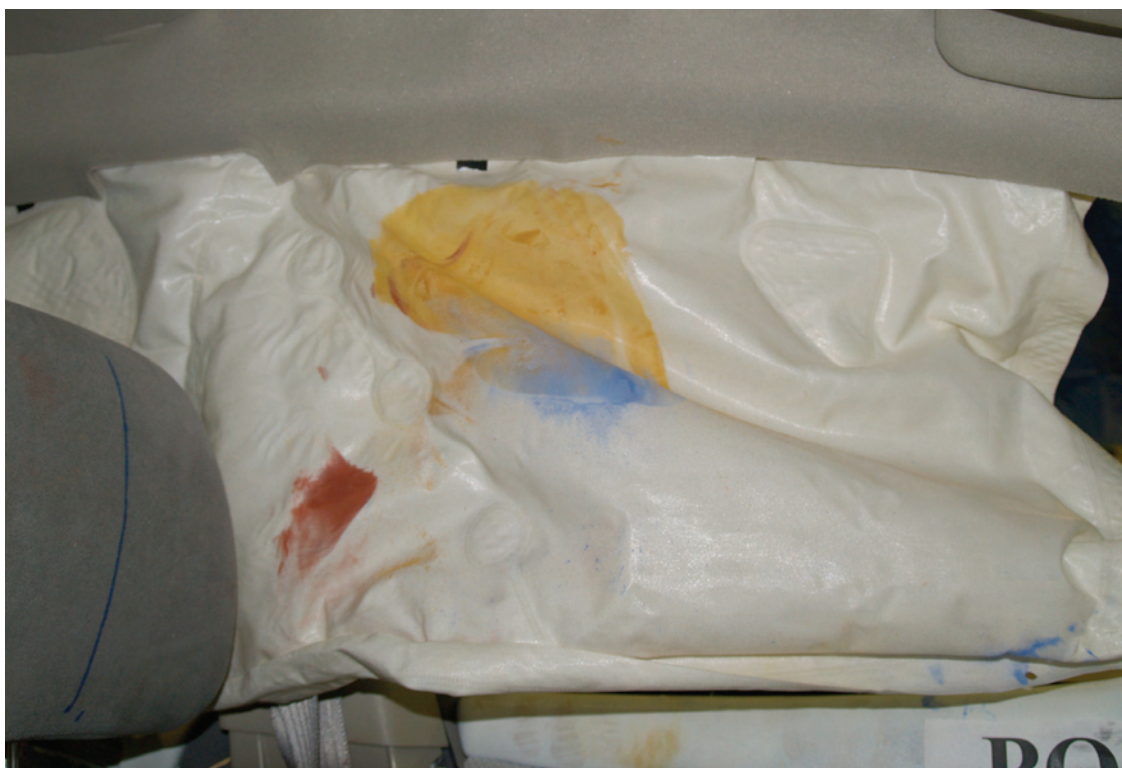
Figure A-42: Post test driver contact locations (2)

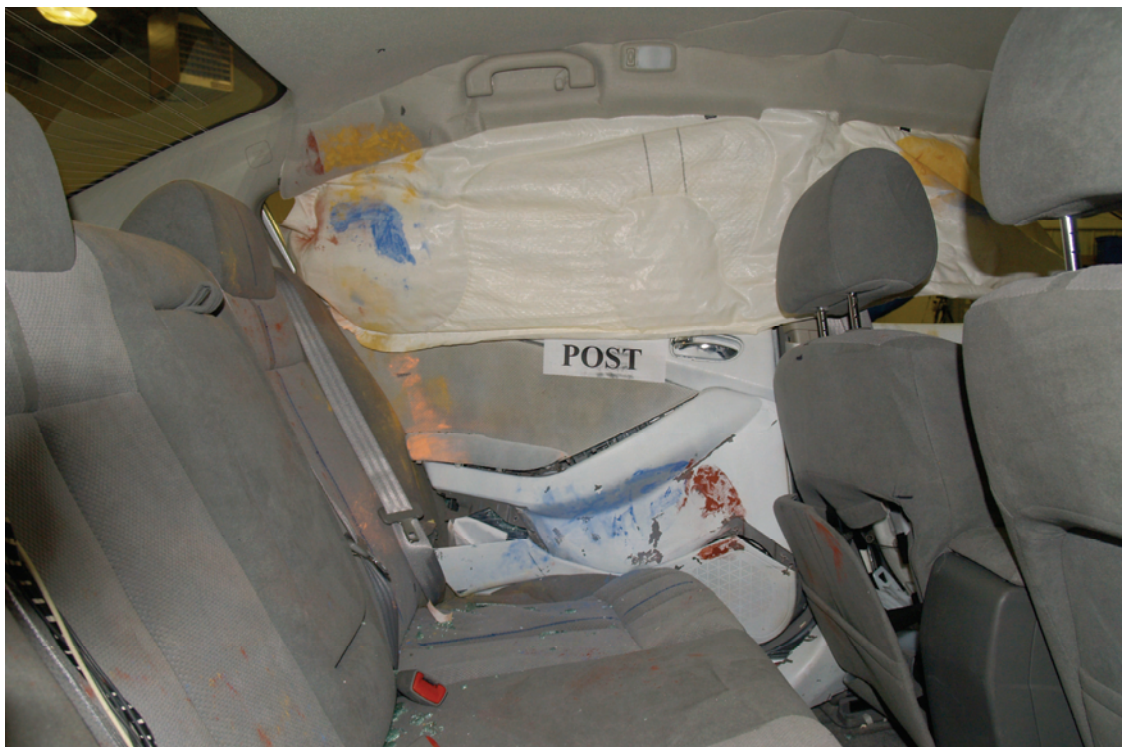
Figure A-49: Post test passenger contact locations (1)

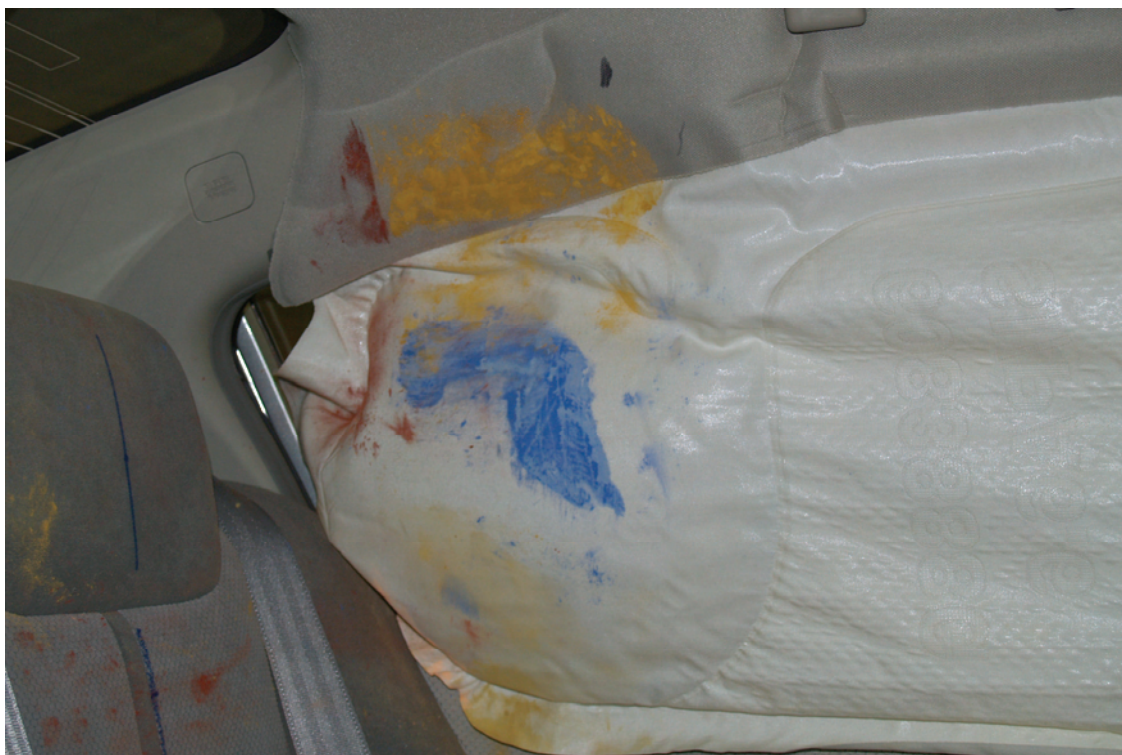
Figure A-50: Post test passenger contact locations (2)

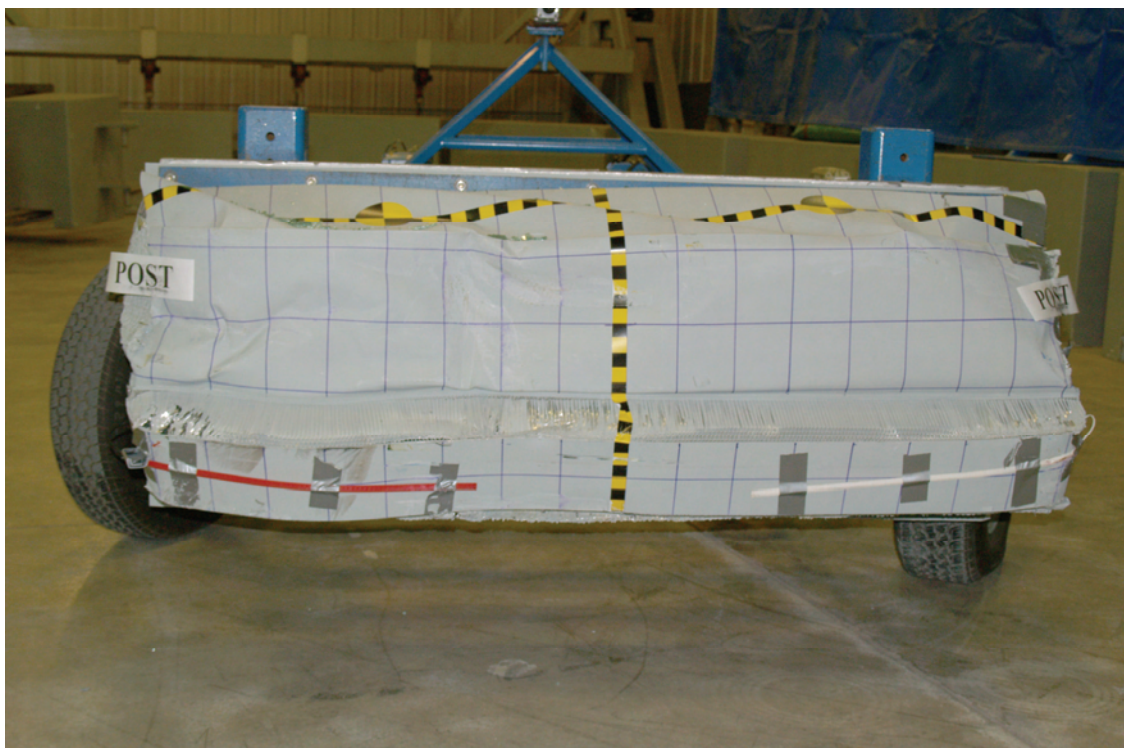
Figure A-52: Post test front view of MDB barrier face
