REPORT NUMBER: CAL-08-02

**NEW CAR ASSESSMENT PROGRAM (NCAP)  
FRONTAL BARRIER IMPACT TEST**

TOYOTA MOTOR CORPORATION  
2008 SCION xD  
5-DOOR WAGON

NHTSA NUMBER: M85113

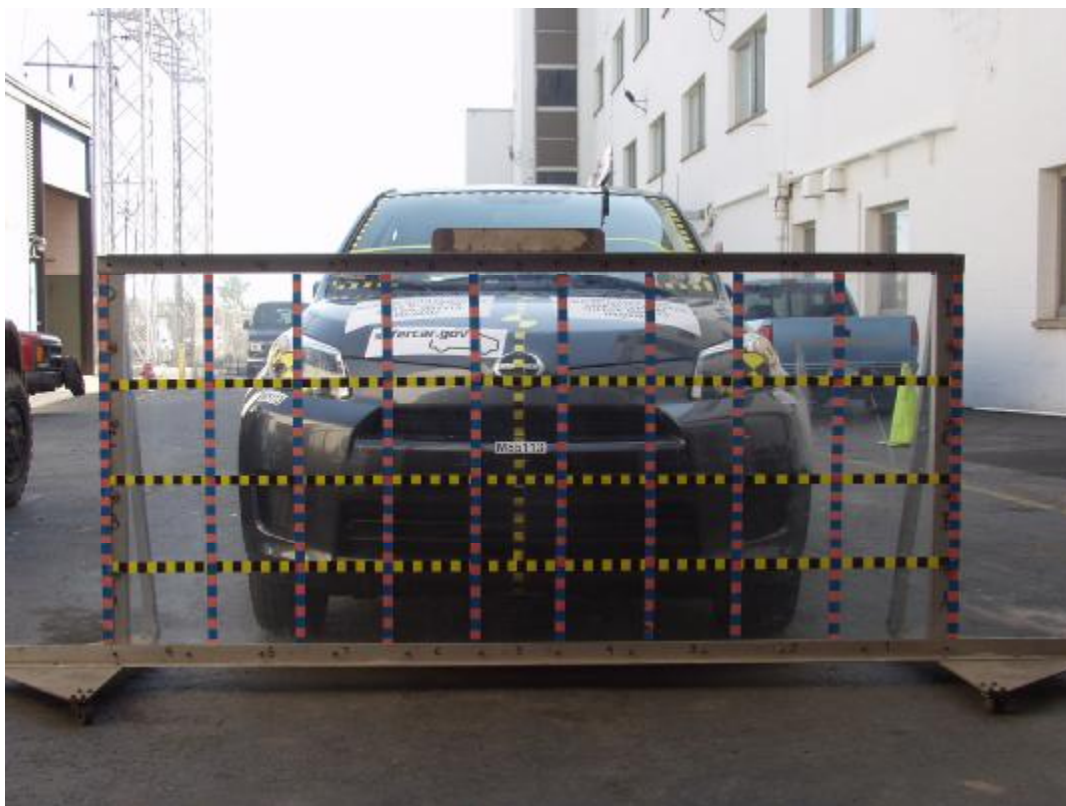
**Figure A-1: Load Cell Locations**

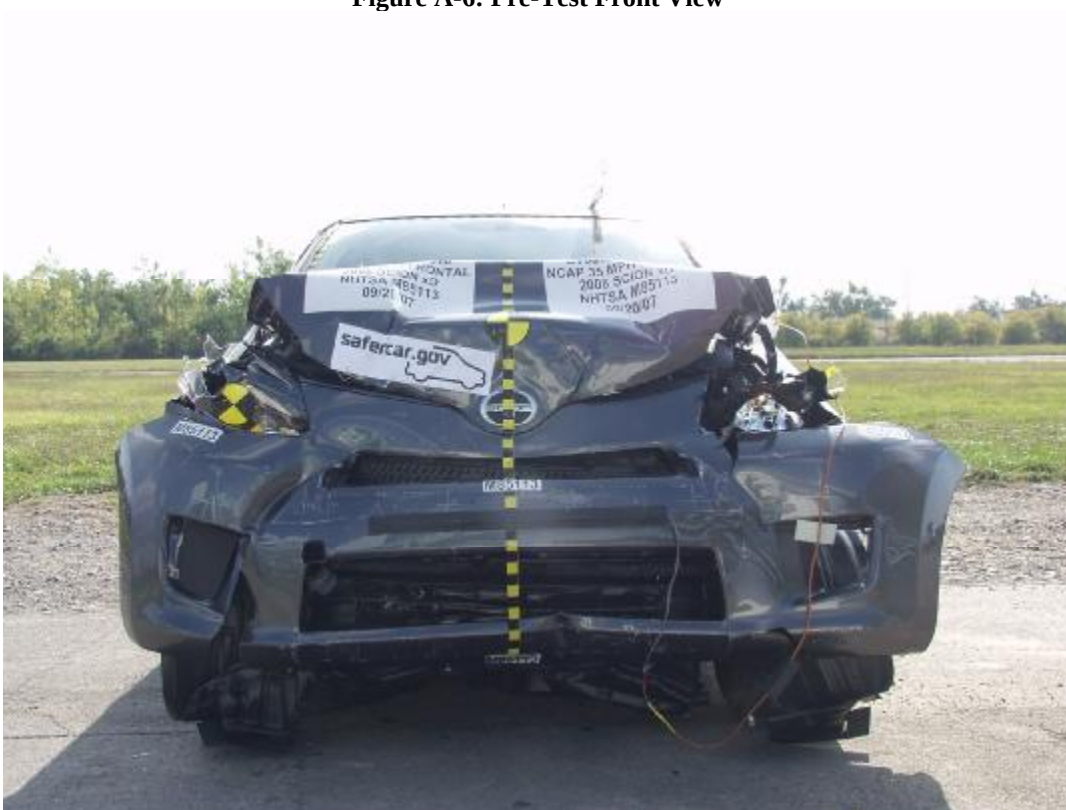
**Figure A-7: Post-Test Front View**

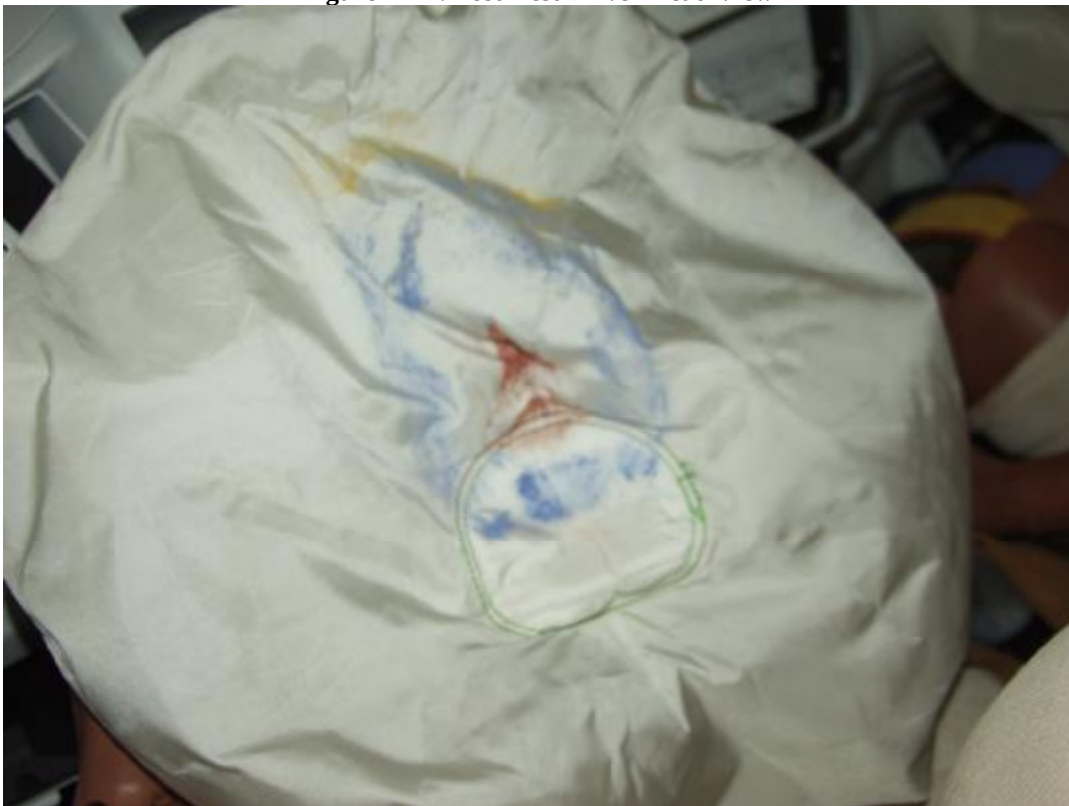
**Figure A-43: Post-Test Driver Contact to Airbag**

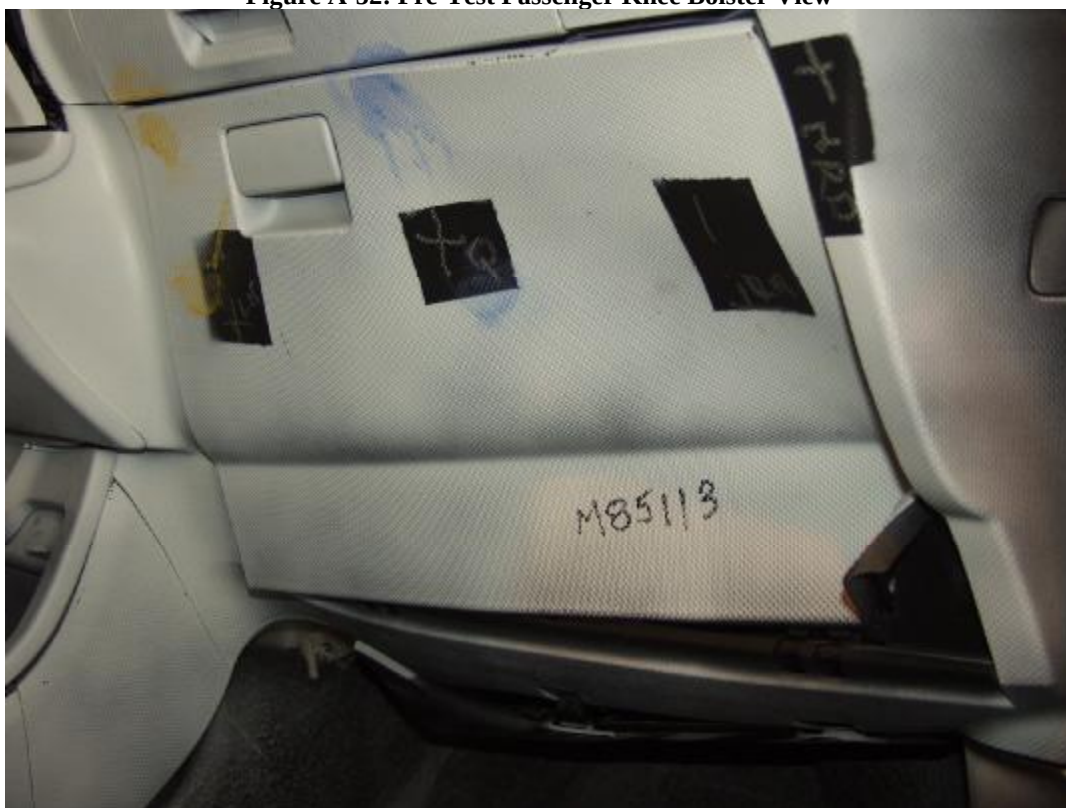
**Figure A-53: Post-Test Passenger Knee Bolster View**

| | DRIVER | PASSENGER |
|---|---|---|
| Left Knee Contact: | Knee bolster | Glove Box Door |
| Right Knee Contact: | Knee bolster | Glove Box Door |

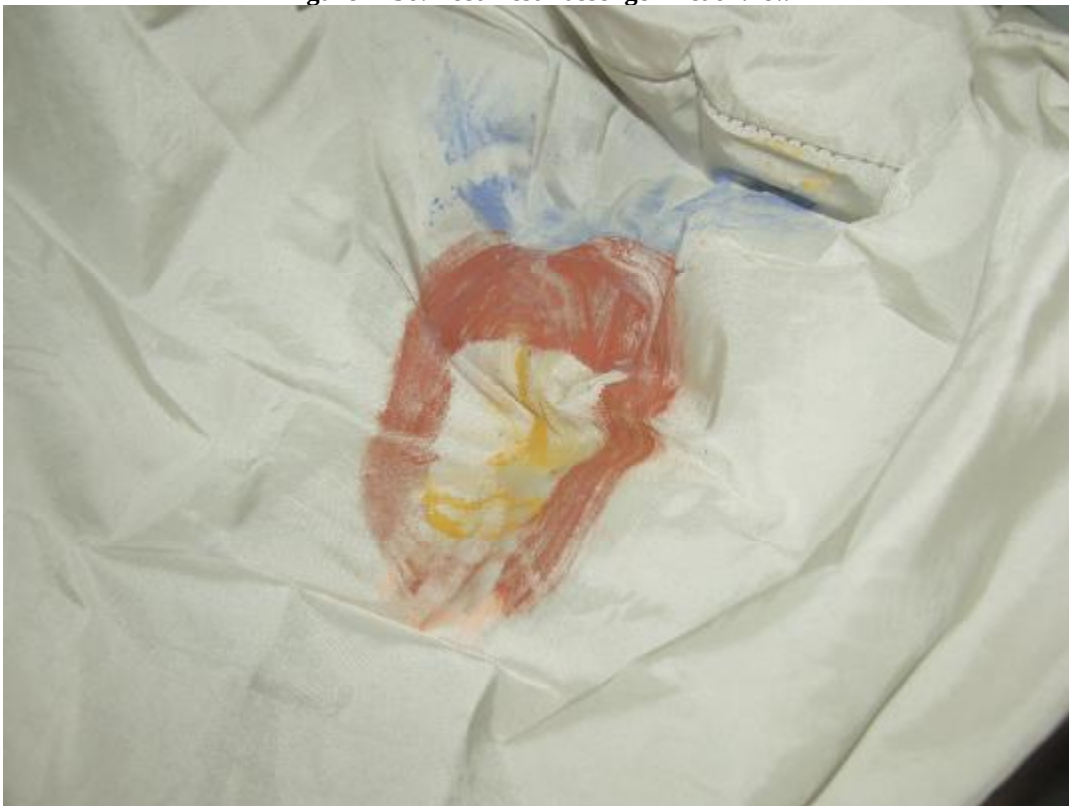
**Figure A-57: Post-Test Passenger Contact to Airbag**
