REPORT NUMBER: CAL-08-03

**NEW CAR ASSESSMENT PROGRAM (NCAP)
FRONTAL BARRIER IMPACT TEST**

GENERAL MOTORS DE MEXICO
2008 SATURN VUE
MPV

NHTSA NUMBER: M80104

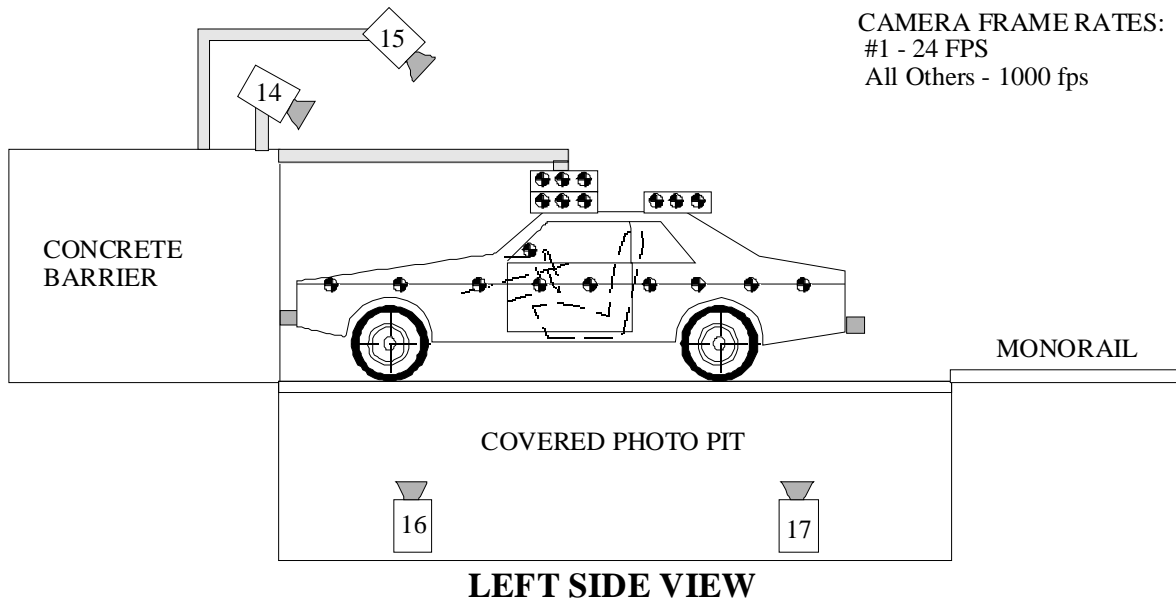
DATA SHEET NO.11
HIGH-SPEED CAMERA LOCATIONS

CAMERA FRAME RATES:
#1 - 24 FPS
All Others - 1000 fps

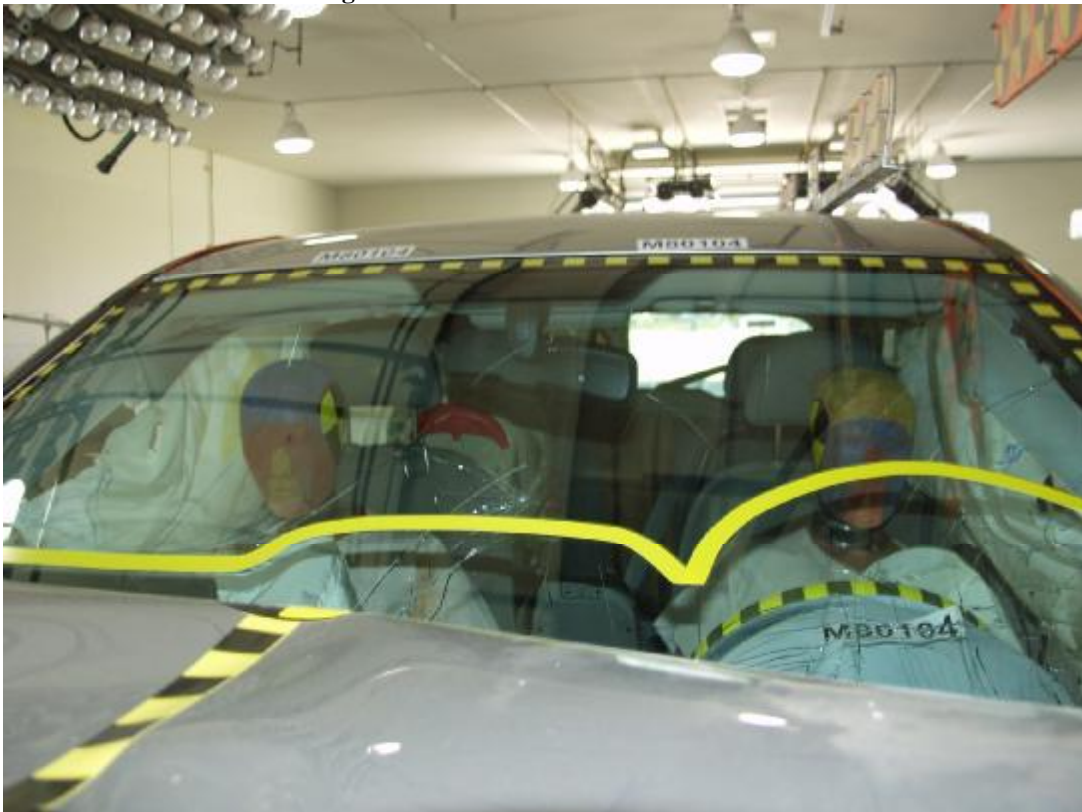
Figure A-19: Post-Test Windshield View

Description	Driver Side	Passenger Side
Door Lock Status	Locked Condition	Locked Condition
Front Door Opening	Closed and operable without tools	Closed and operable without tools
Rear Door Opening	Closed and operable without tools	Closed and operable without tools
Hatch/Other Door Opening	Closed and operable without tools	
Front Seat Track Shift (mm)	0	0
Front Seat Back Failure	None	None
Glazing Damage	Windshield was cracked from airbag deployment

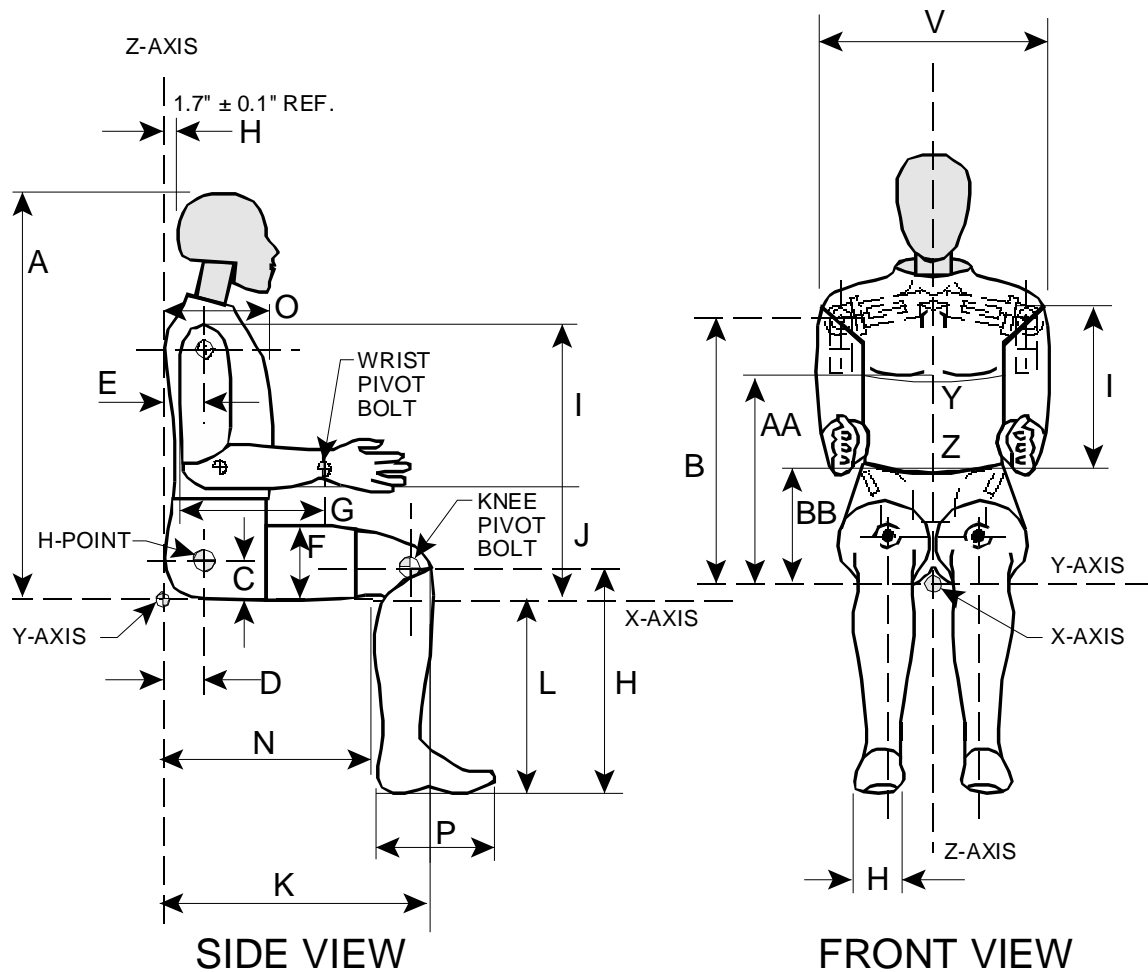
EXTERNAL DIMENSIONS SPECIFICATIONS

NOTE: Figure is referenced to the erect seated position. The curved lumbar does not allow the Hybrid III to be positioned in a perfect erect attitude. (REF: S572.31(A)(6))
