**REPORT NUMBER: SNCAP-CAL-07-04**

**NEW CAR ASSESSMENT PROGRAM  
SIDE IMPACT TEST**

**MERCEDES-BENZ U.S. INTL., INC.  
2007 MERCEDES-BENZ ML350  
FOUR-DOOR MPV**

**FINAL REPORT**

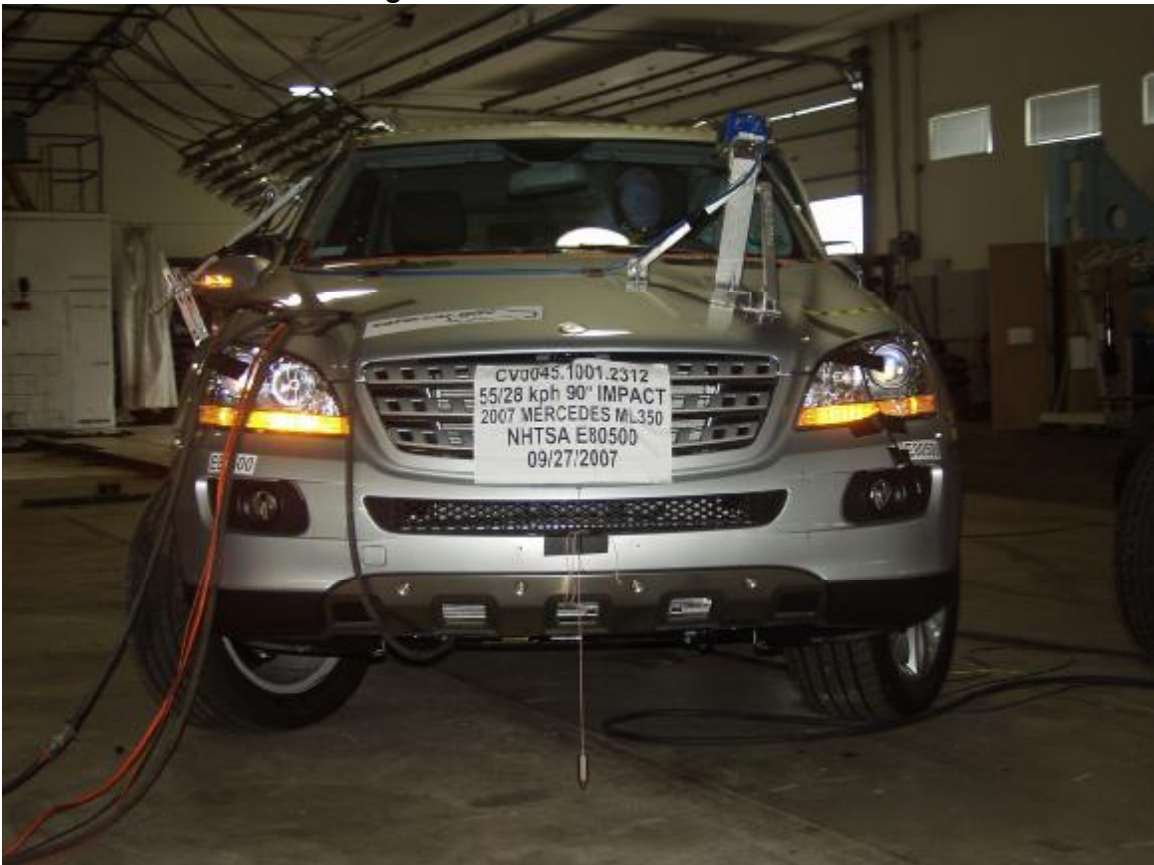
**Figure A-6: Post-Test Front View**

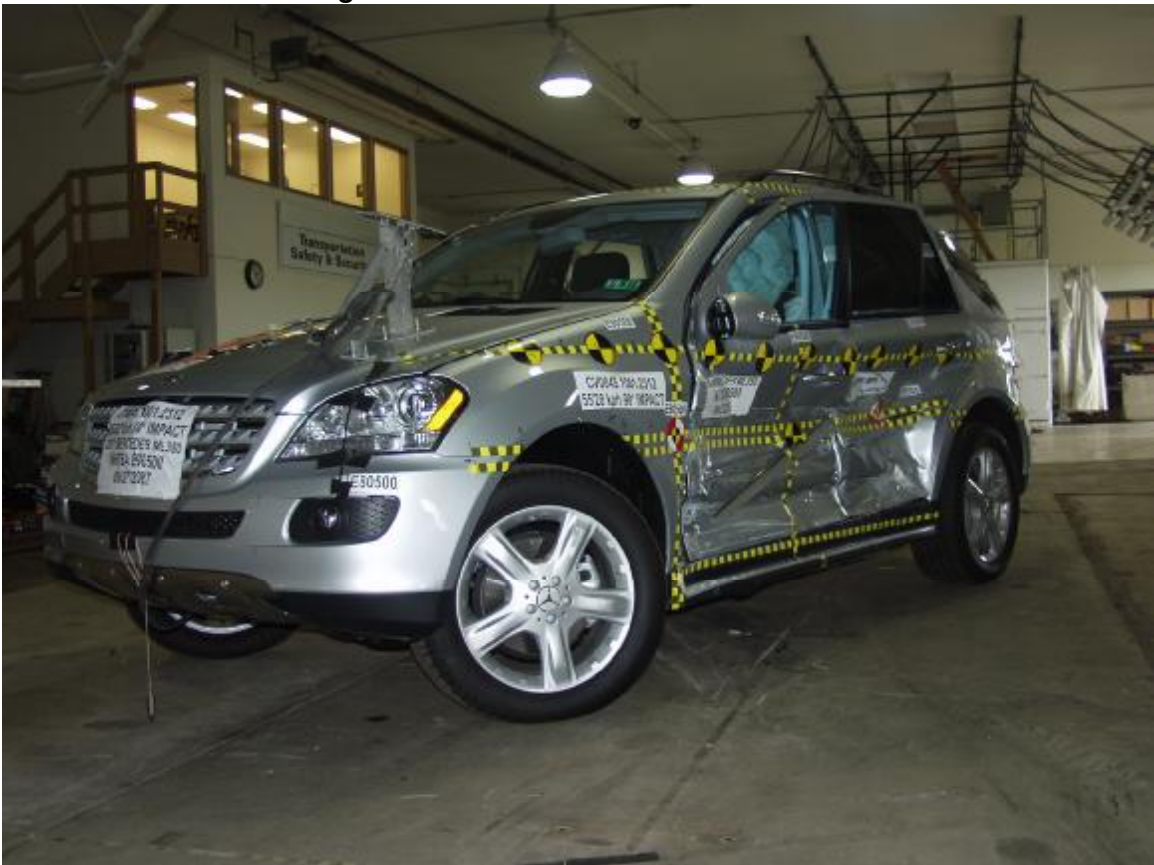
**Figure A-8: Post-Test Left Front  $\frac{3}{4}$  View**

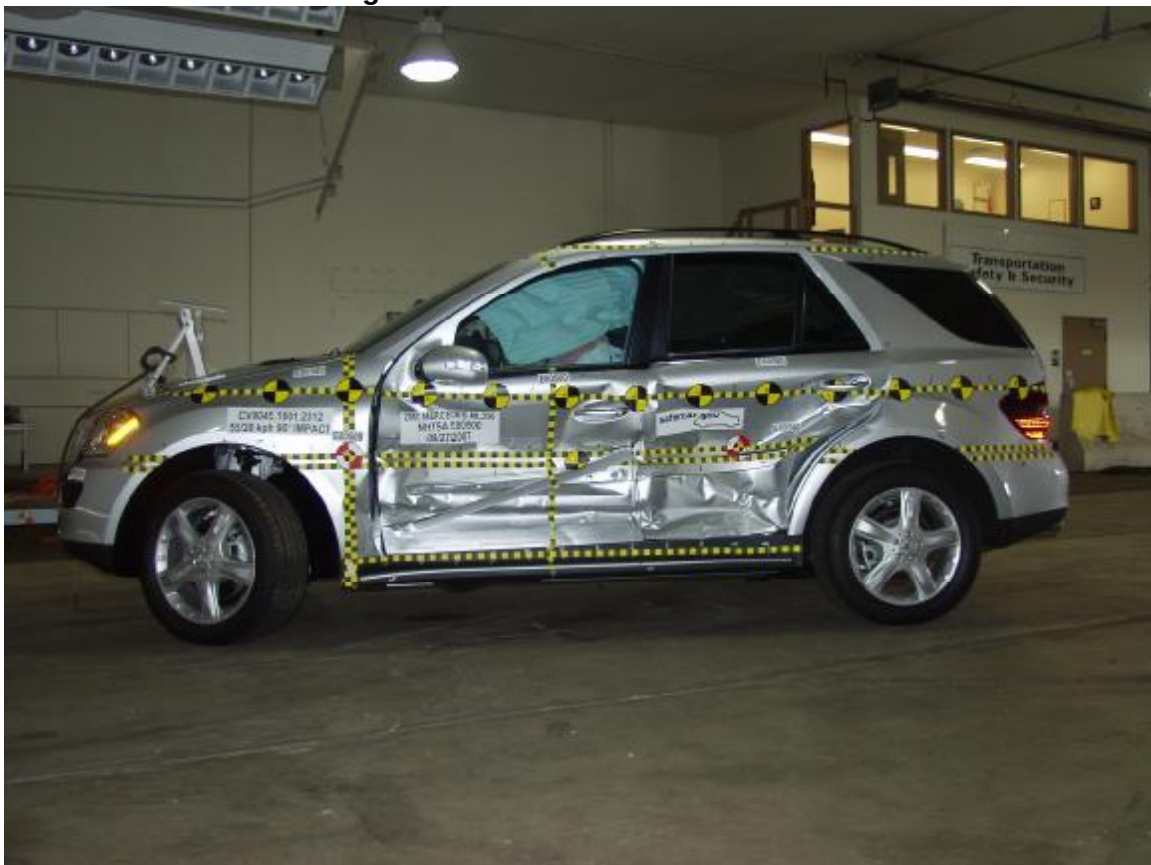
**Figure A-10: Post-Test Left Side View**

The test vehicle sustained a maximum static crush of 203 mm at level 3, 1590 mm rearward of the left vertical impact point. The driver and passenger SID/HII's, Serial Nos. 270 and 269 respectively, were calibrated just prior to this test.

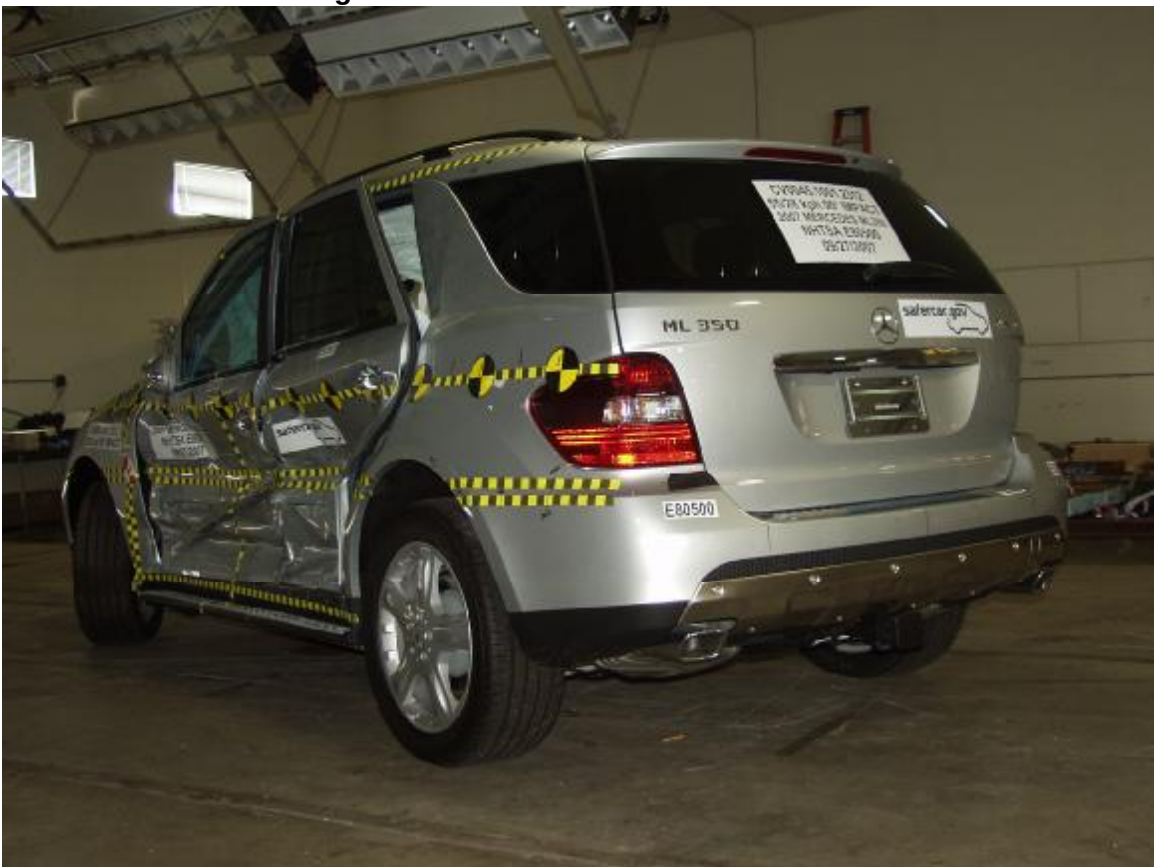
**Figure A-12: Post-Test Left Rear  $\frac{3}{4}$  View**

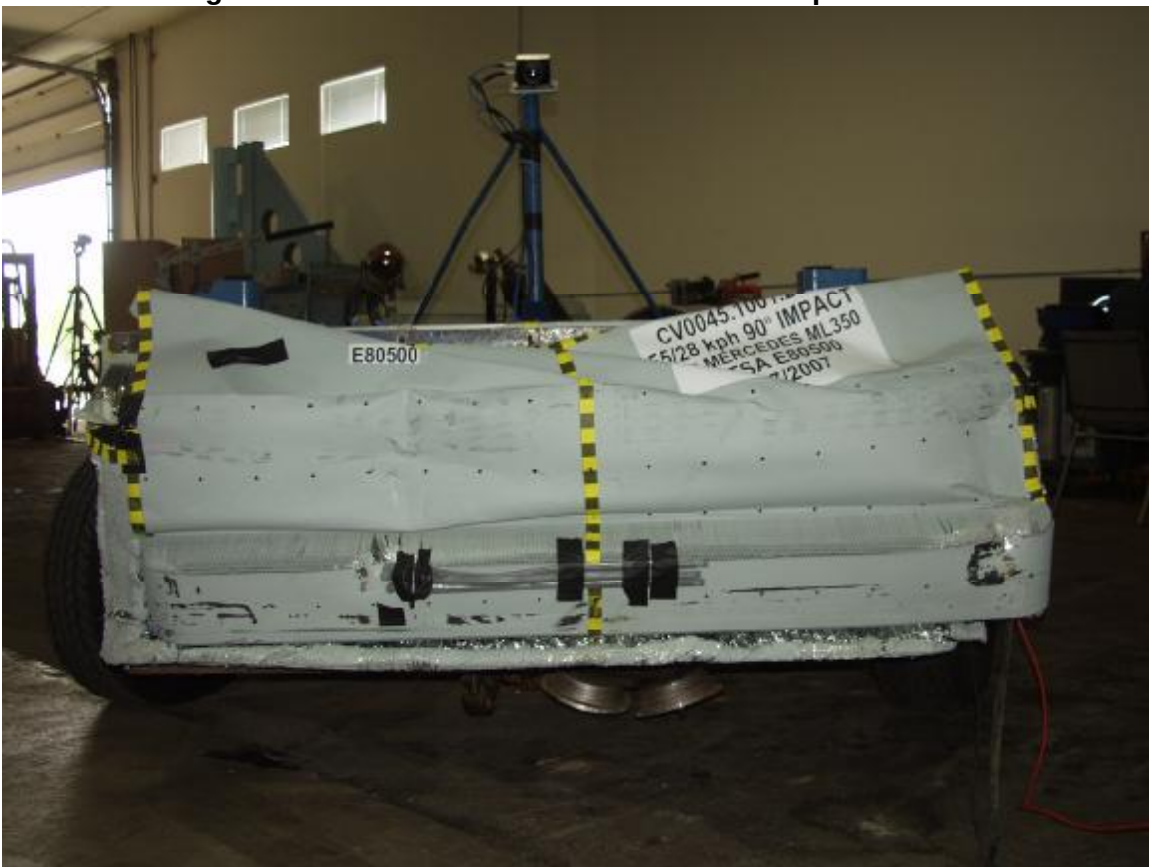
Figure A-22: Post-Test Frontal View of MDB Impactor Face

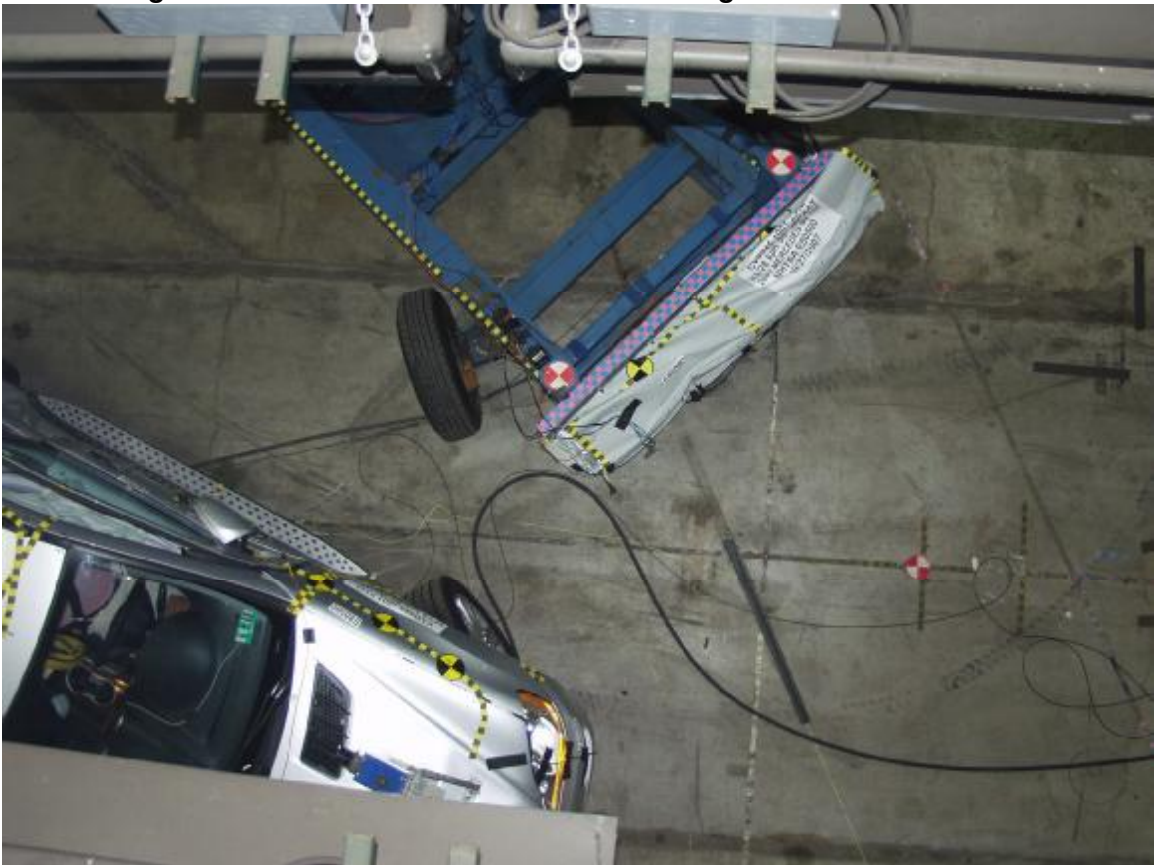
**Figure A-32: Post-Test Overhead View of MDB and Vehicle**

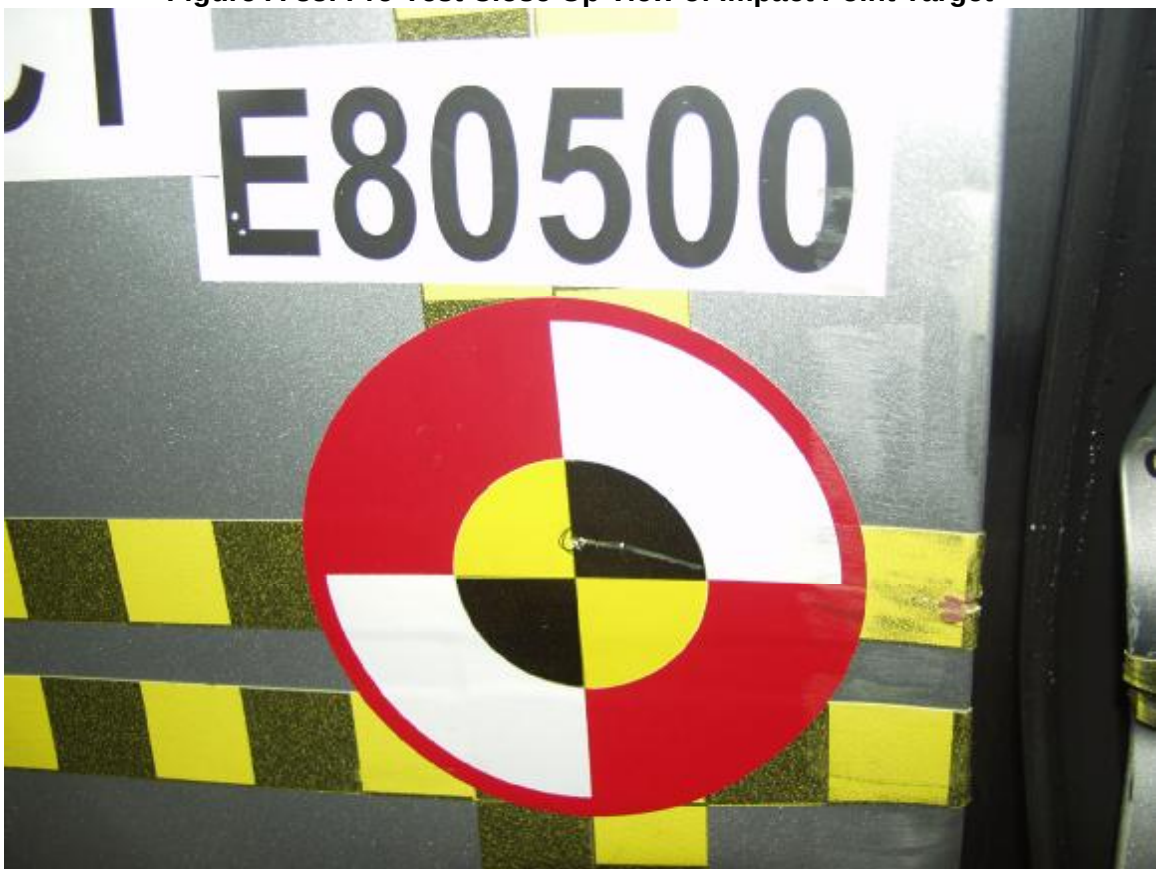
**Figure A-34: Post-Test Close-Up View of Impact Point Target**

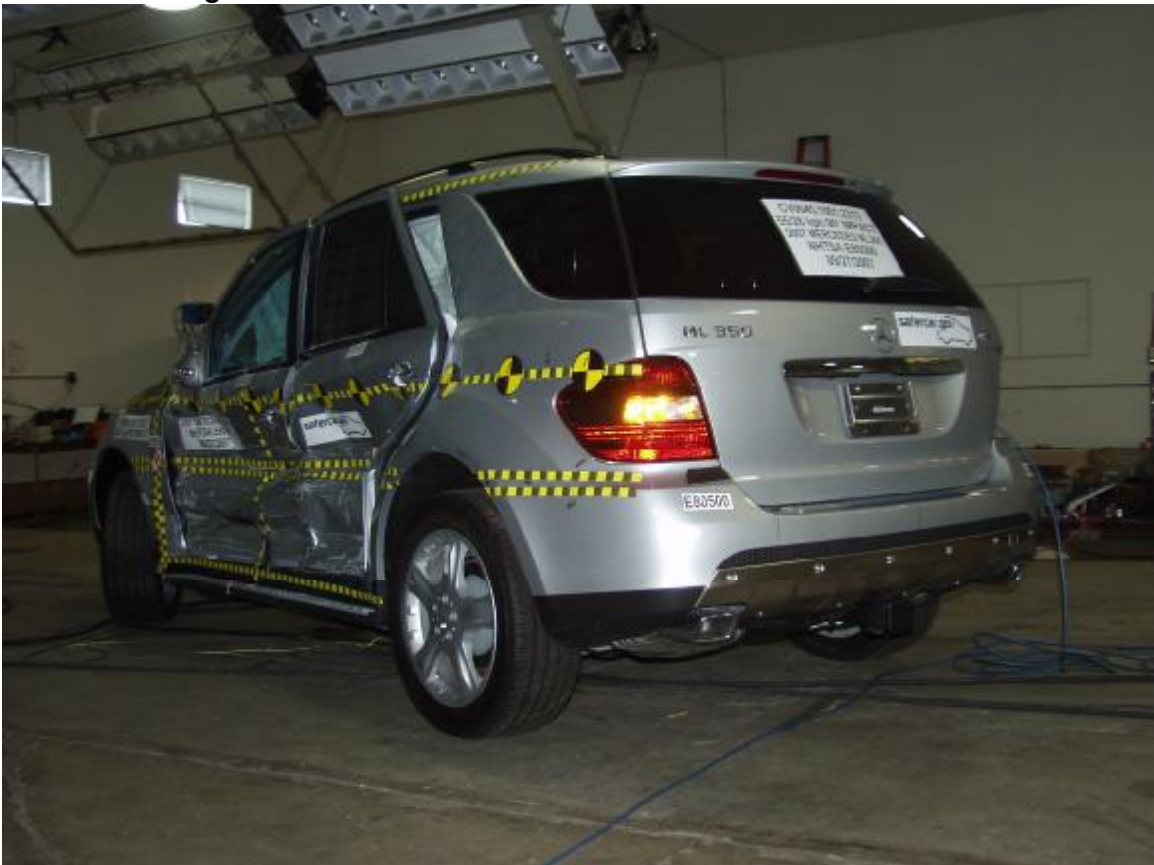
**Figure A-50: Post-Test Left Rear  $\frac{3}{4}$  View of Left Side Doors**
