**NEW CAR ASSESSMENT PROGRAM  
FRONTAL BARRIER IMPACT TEST**

**NISSAN MOTOR COMPANY, LTD.  
2008 NISSAN ARMADA SE  
5-DOOR MPV**

**NHTSA NUMBER: M85205**

**FINAL REPORT**

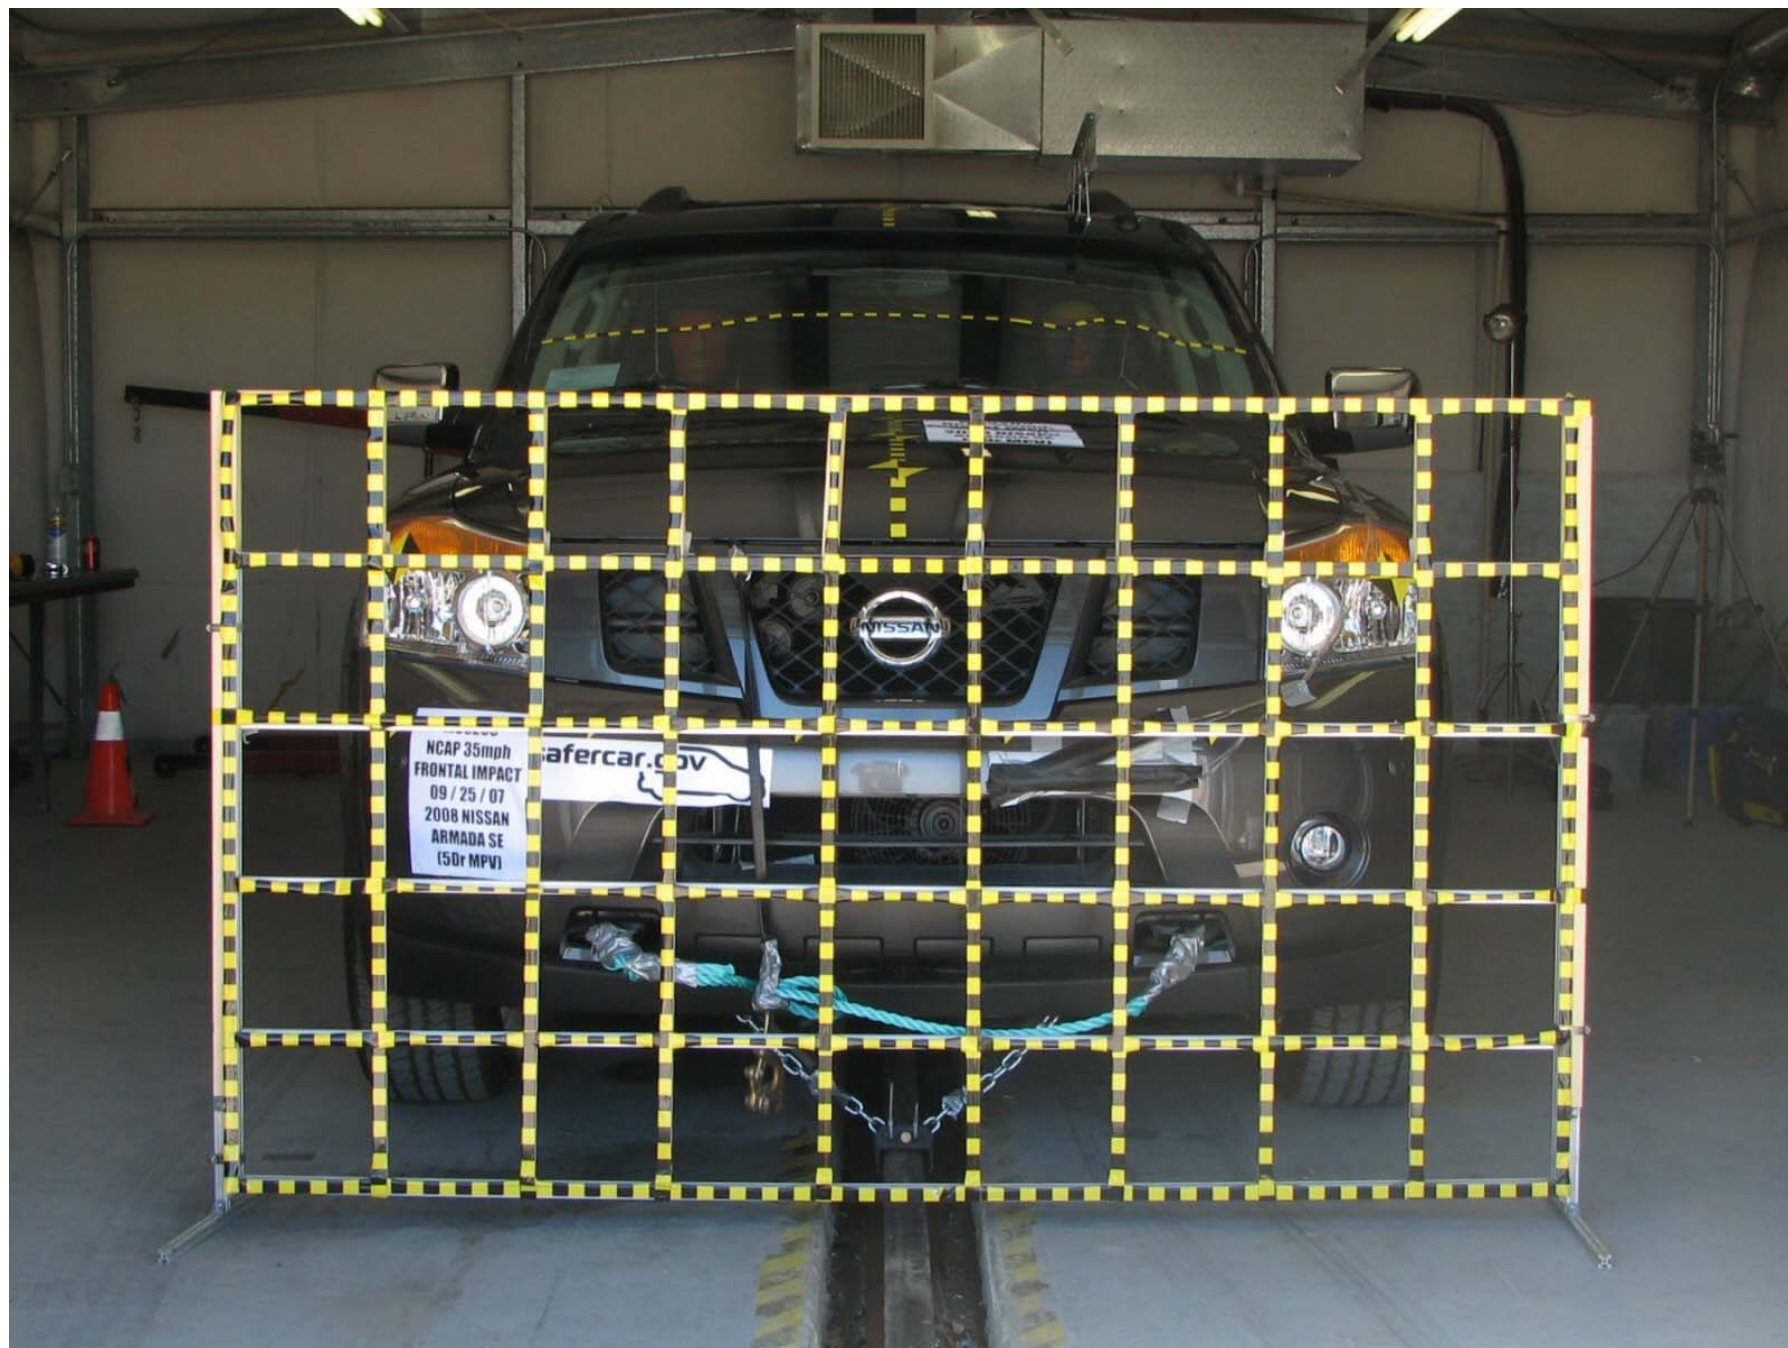
Figure A-1: Load Cell Location

A load cell barrier consisting of 45 load cells was impacted by a 2008 Nissan Armada SE 5-Door MPV at a velocity of 56.53 km/h. The test was performed at Karco Engineering, LLC on September 25, 2007.

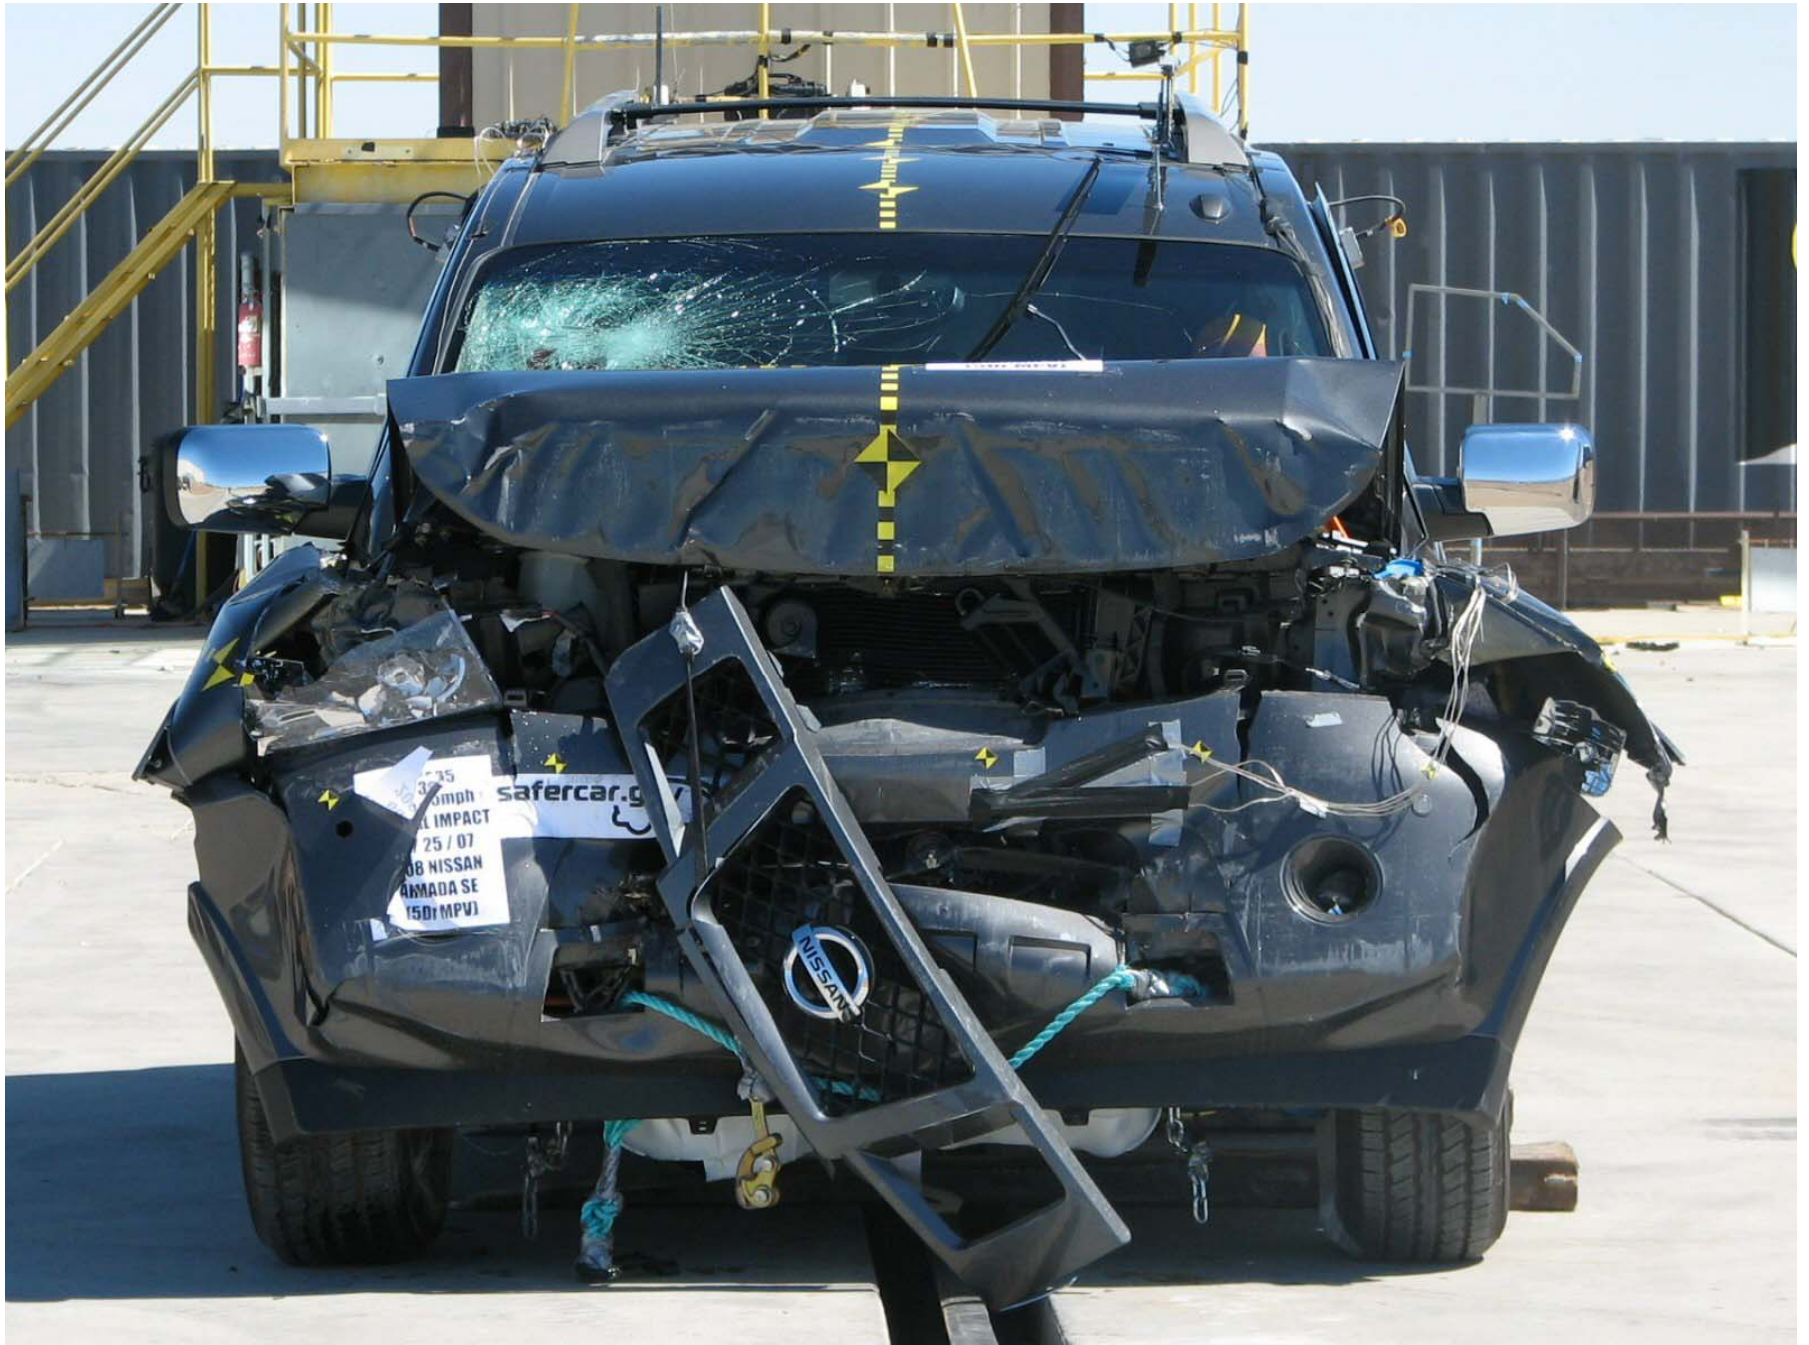
Figure A-7: Post-Test Front View (Vehicle Moved)

The maximum static crush of the vehicle was 480 mm at the vehicle's centerline and both the driver and the passenger side doors remained closed and latched during the impact event, and were operable after the impact.

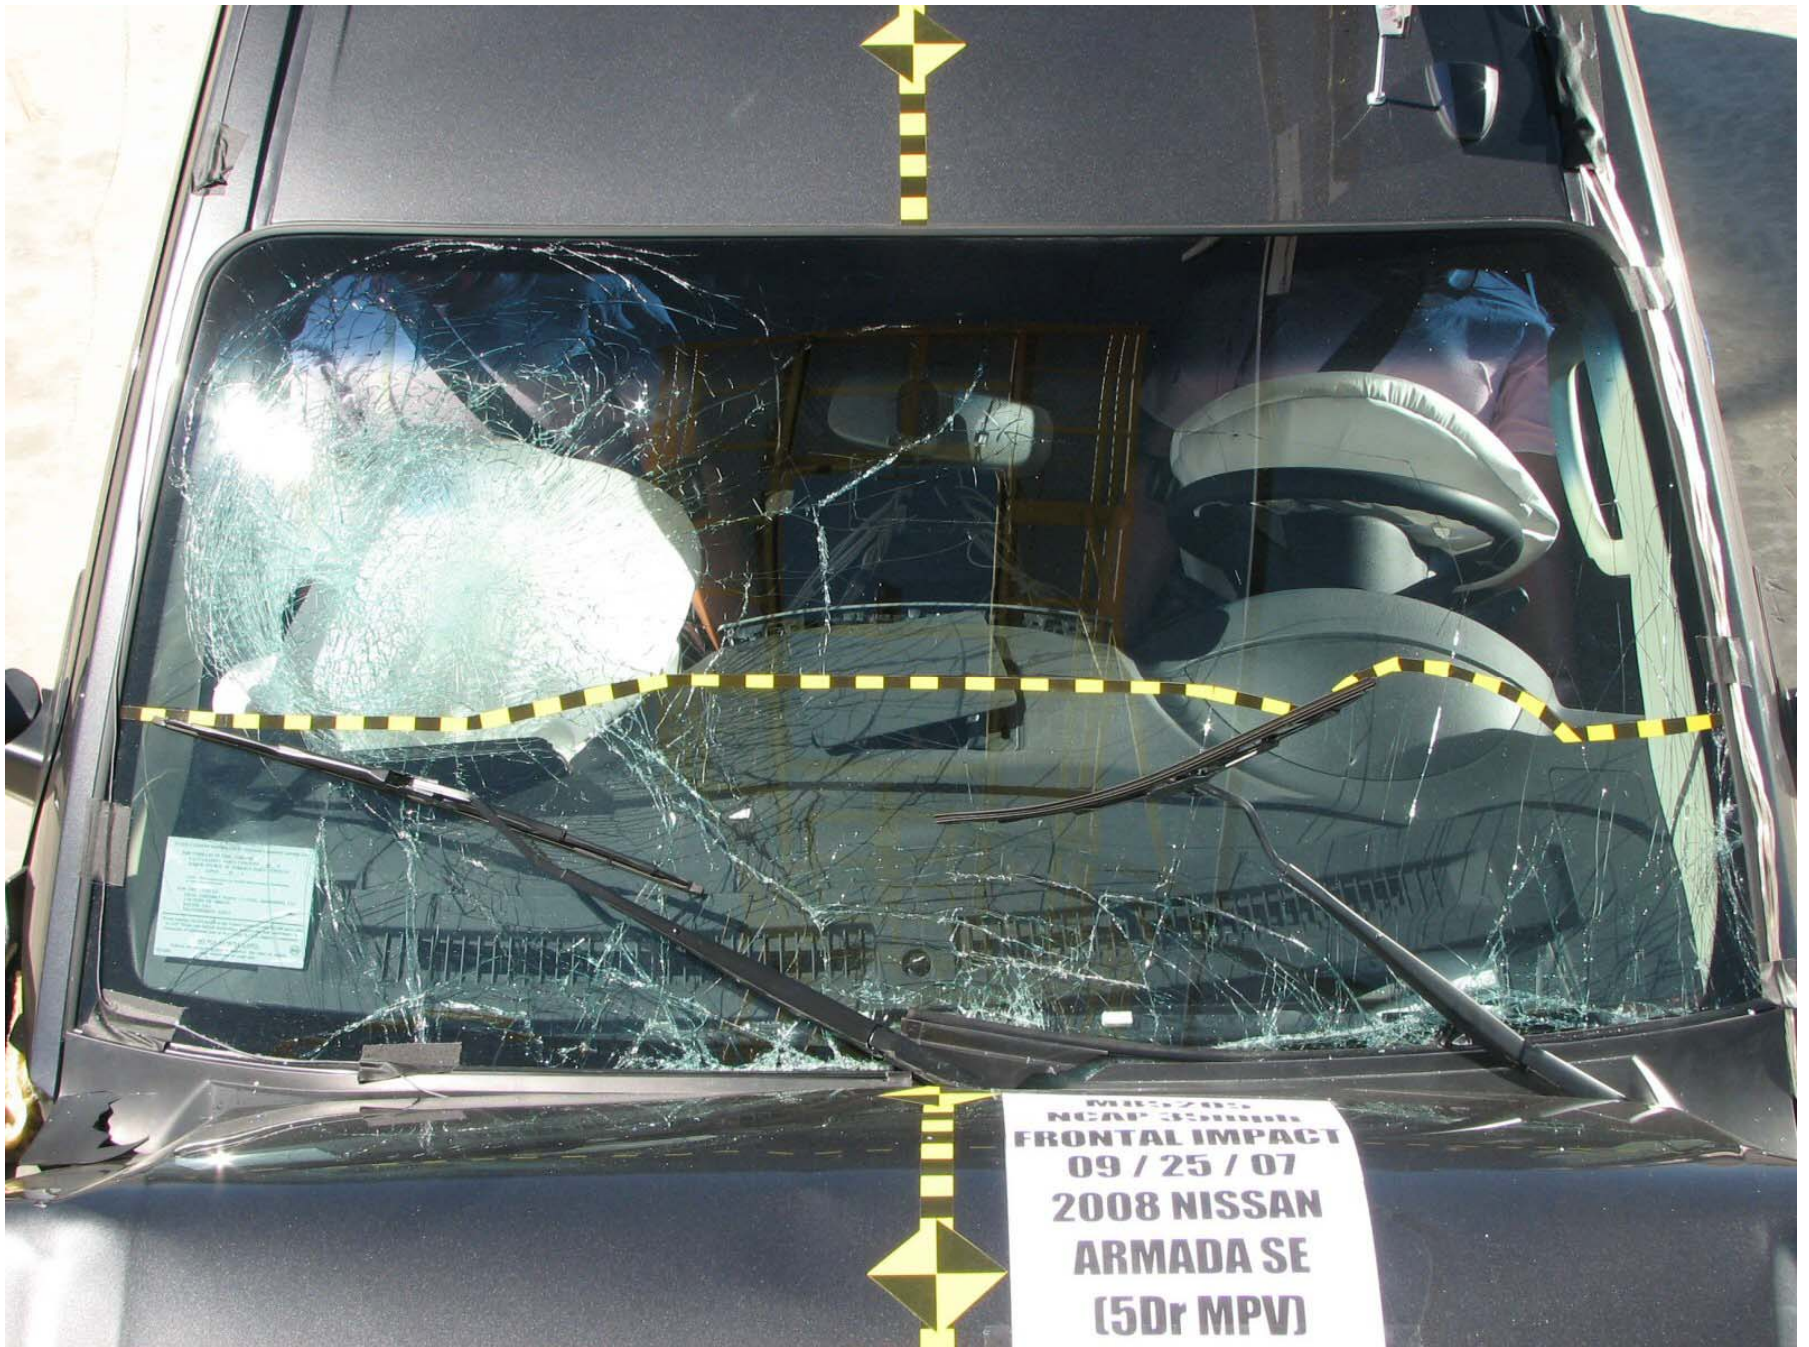
Figure A-19: Post-Test Windshield

There was 100 percent windshield retention and there was no intrusion into the protected zone of the windshield during the impact event. There was no stoddard solvent leakage after the event or during any phase of the static rollover.

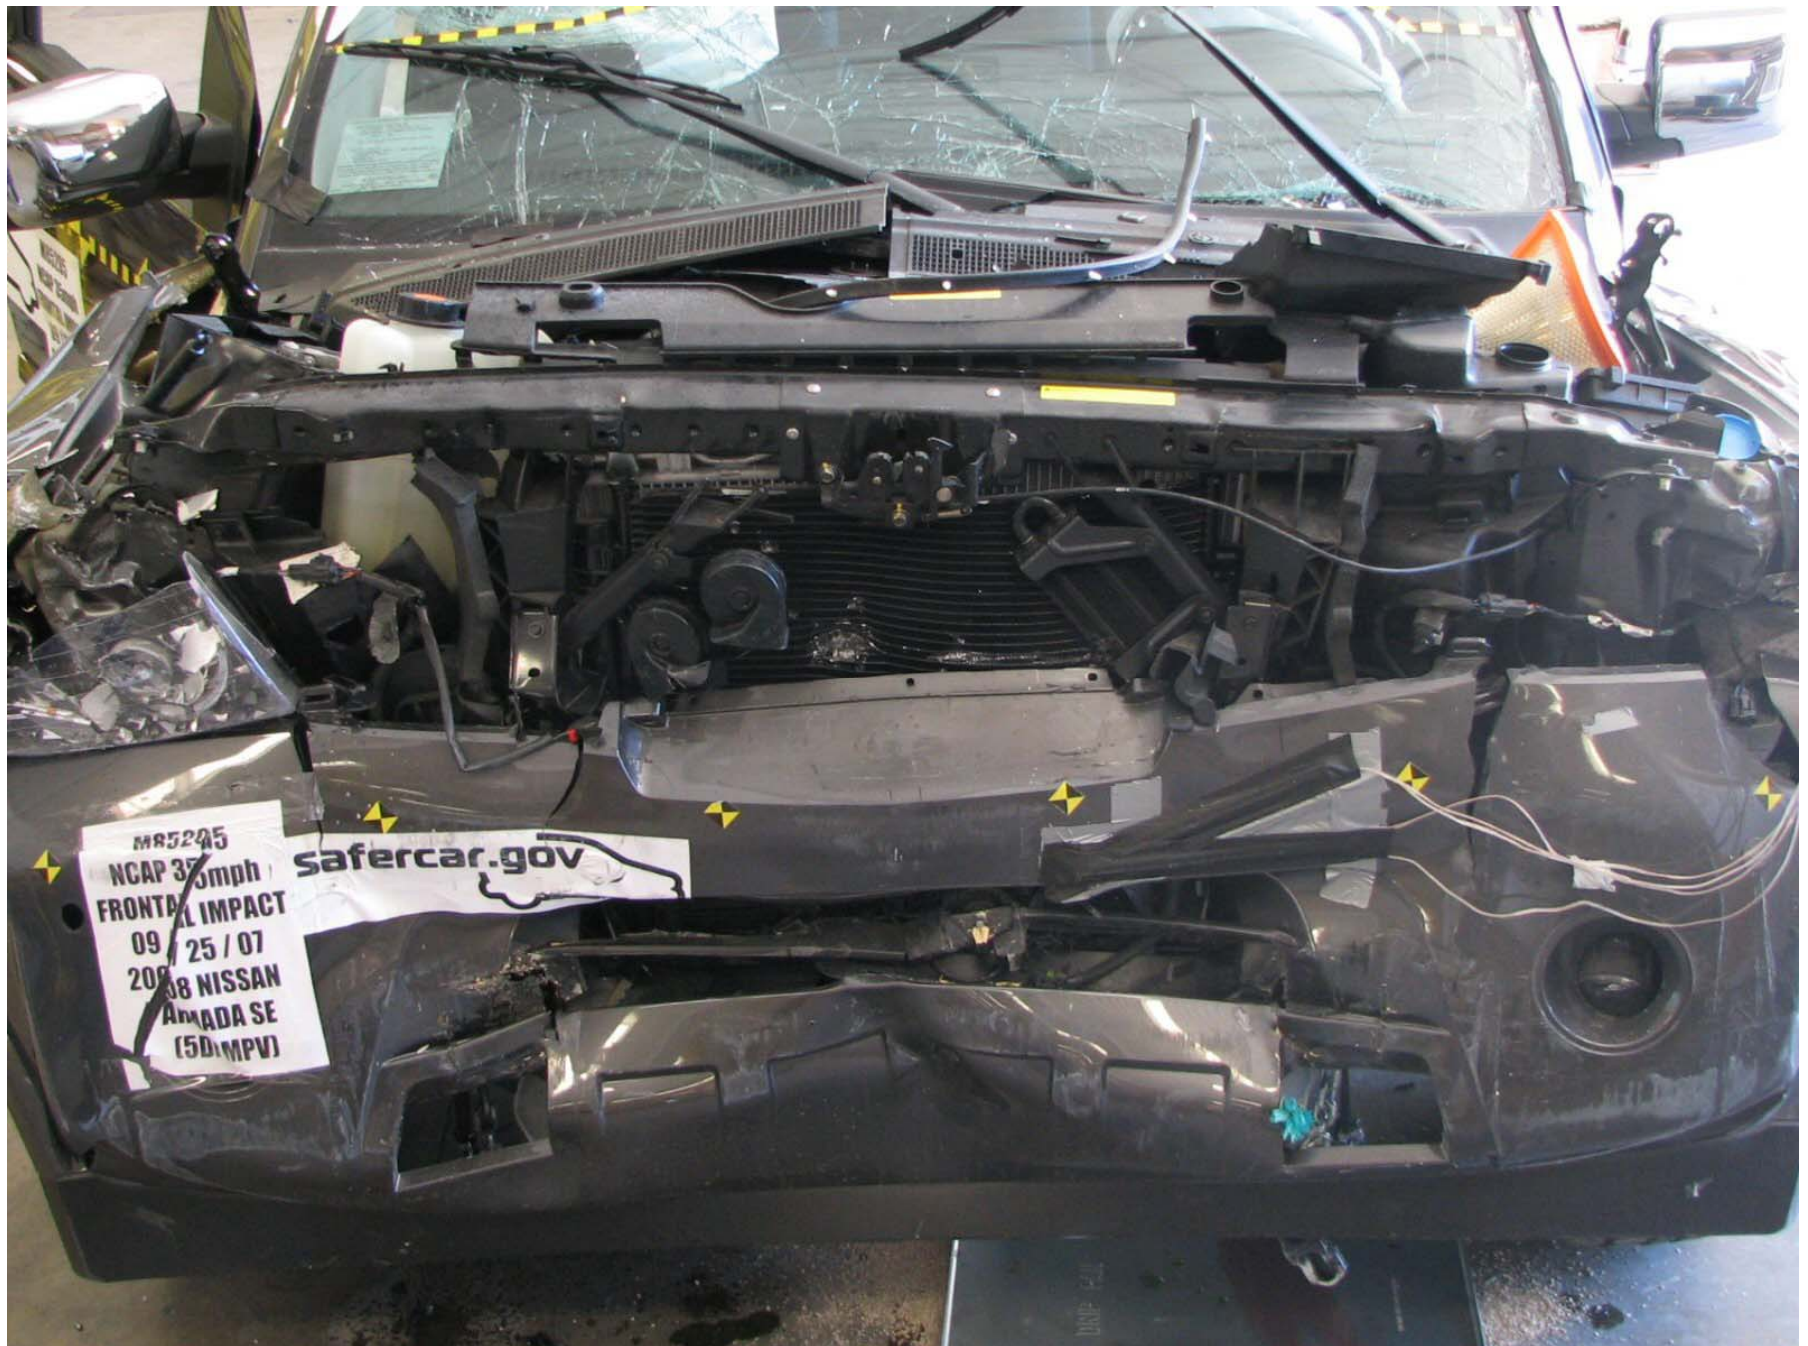
Figure A-21: Post-Test Engine Compartment (Vehicle Moved)

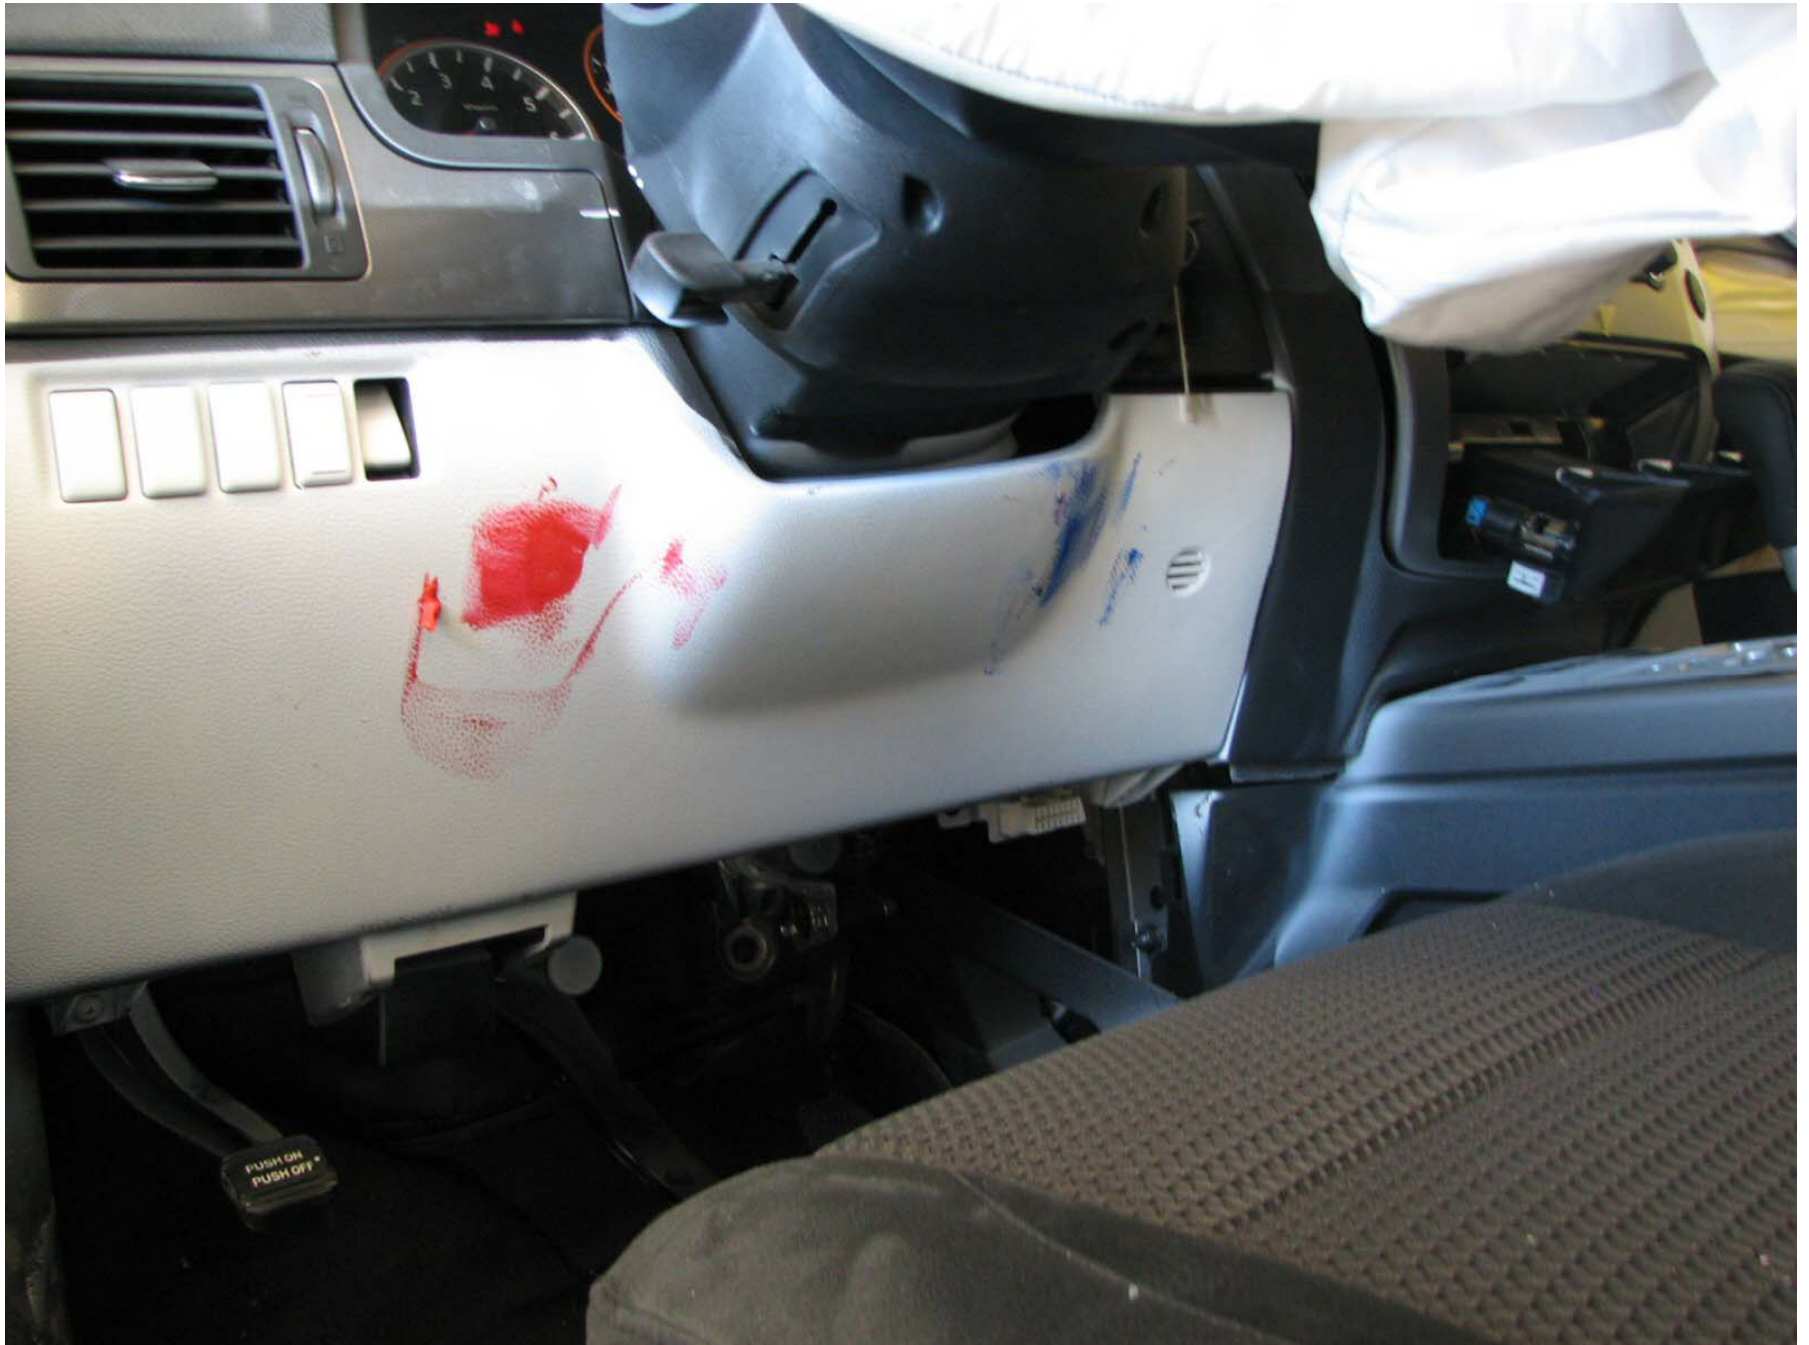
Figure A-39: Post-Test Driver Side Knee Bolster

The driver's visible contact points were as follows: The driver ATD's head, chest and abdomen contacted the airbag. The head also contacted the headrest. Both the left and right knees contacted the knee bolster.

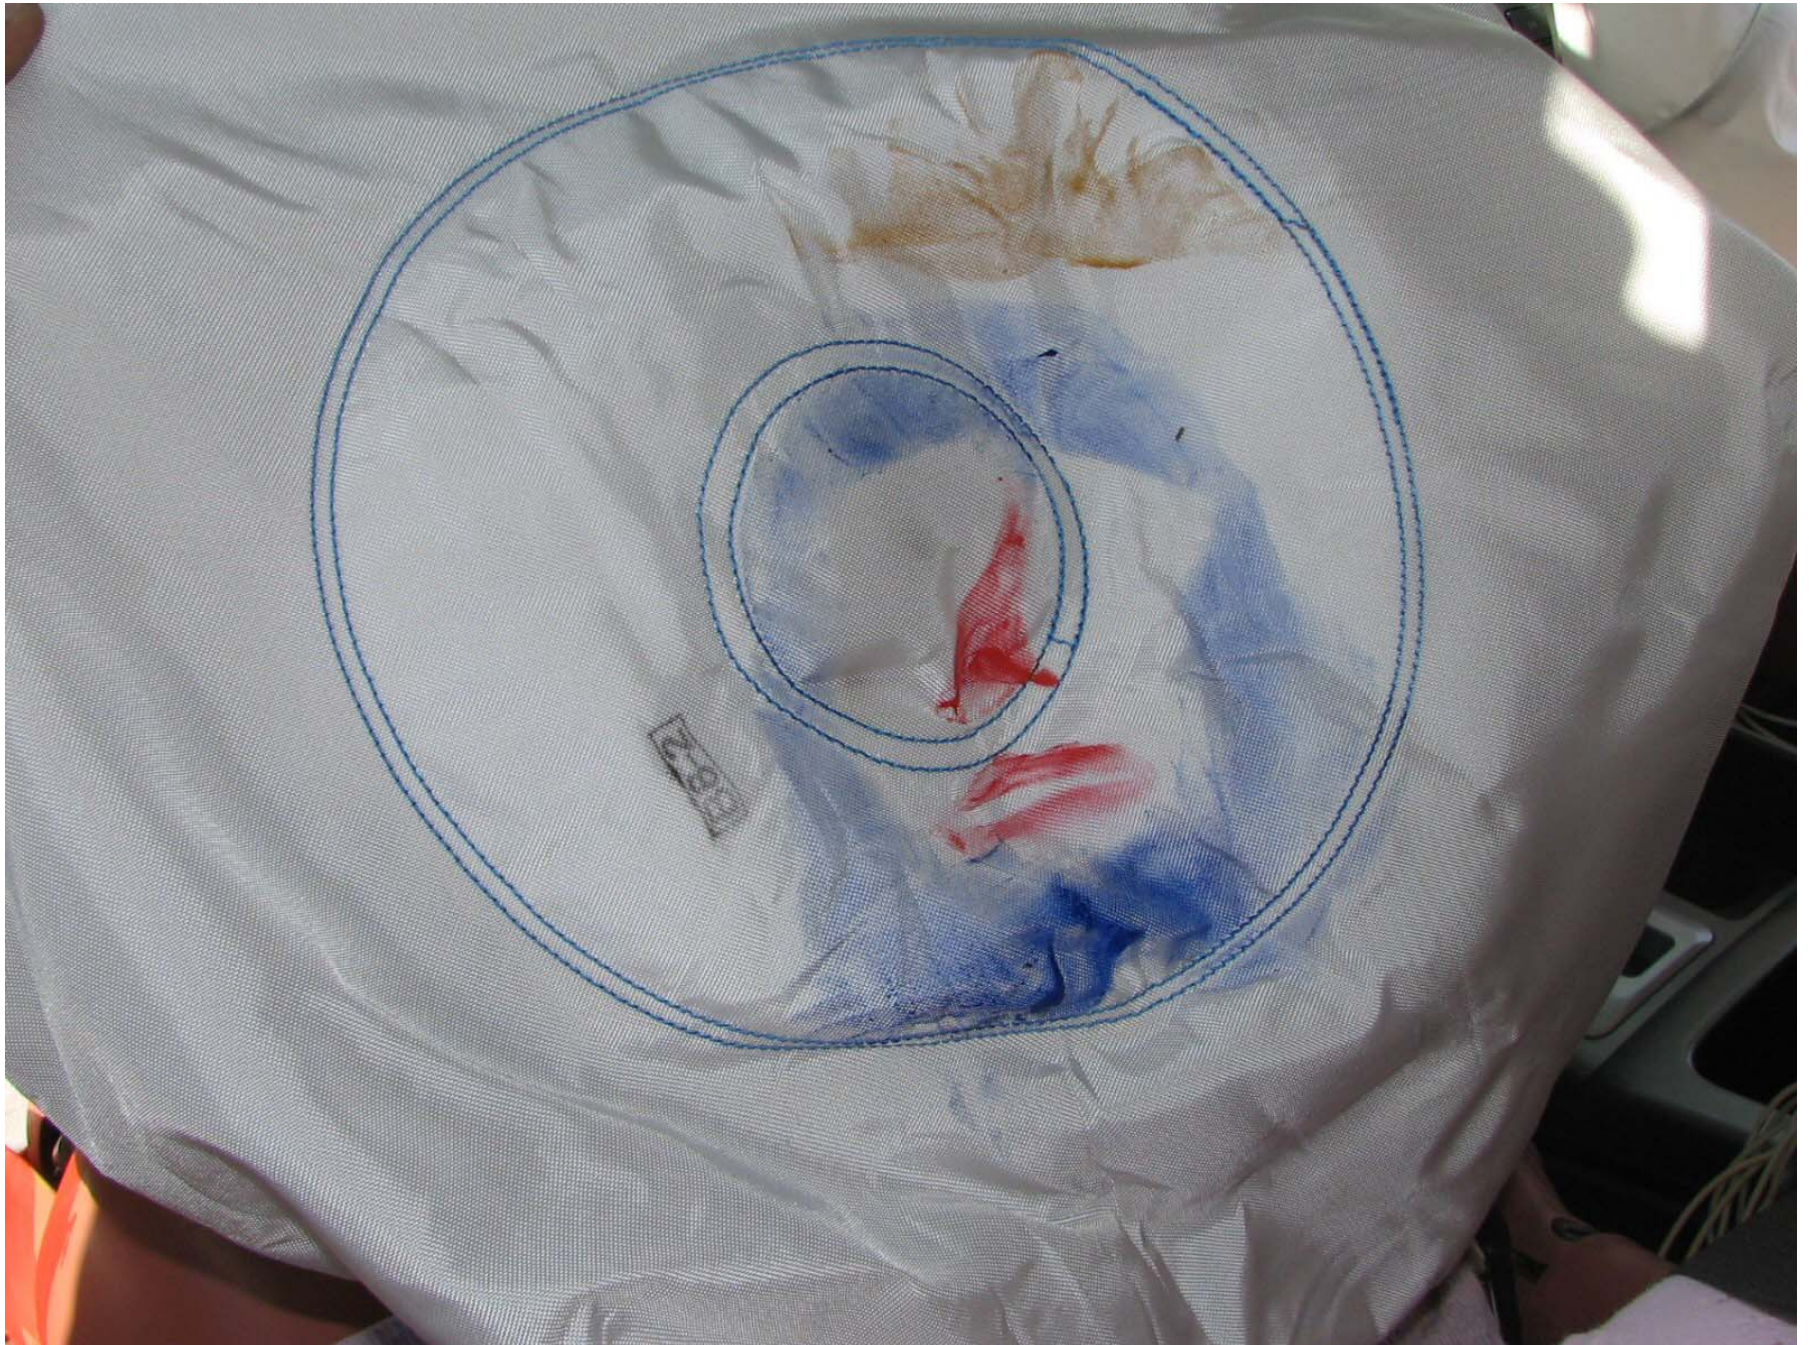
Figure A-43: Post-Test Driver Dummy Airbag Contact

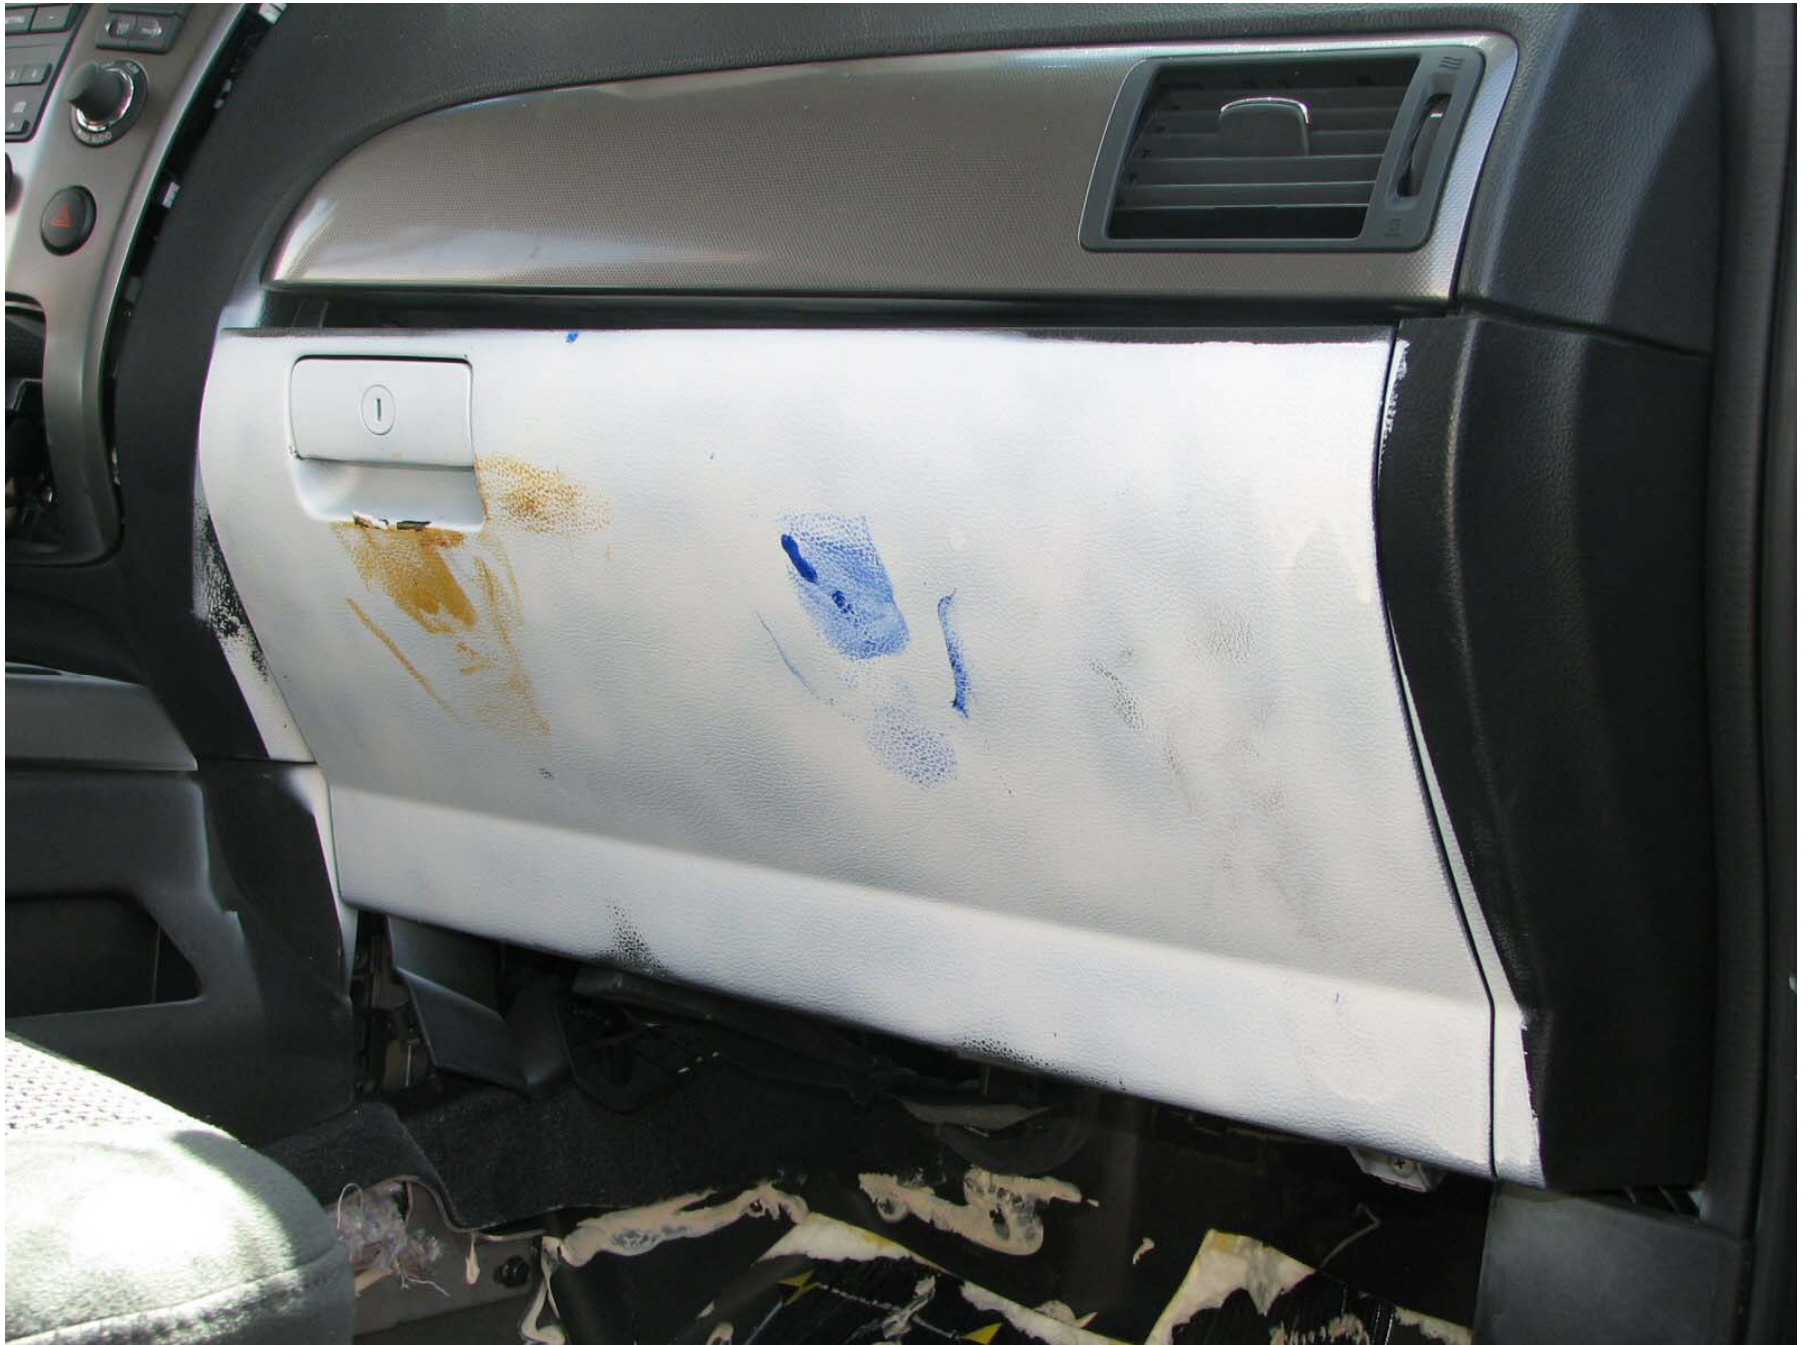
Figure A-53: Post-Test Passenger Side Glove Box

The passenger's visible contact points were as follows: The passenger ATD's head contacted the airbag and headrest. The chest also contacted the airbag. Both knees contacted the glove box.
