**REPORT NUMBER: MCW-DOT-08SN04**

**NEW CAR ASSESSMENT PROGRAM  
SIDE IMPACT TEST**

**2008 TOYOTA SCION TC 3-DOOR HATCHBACK**

**FINAL REPORT**

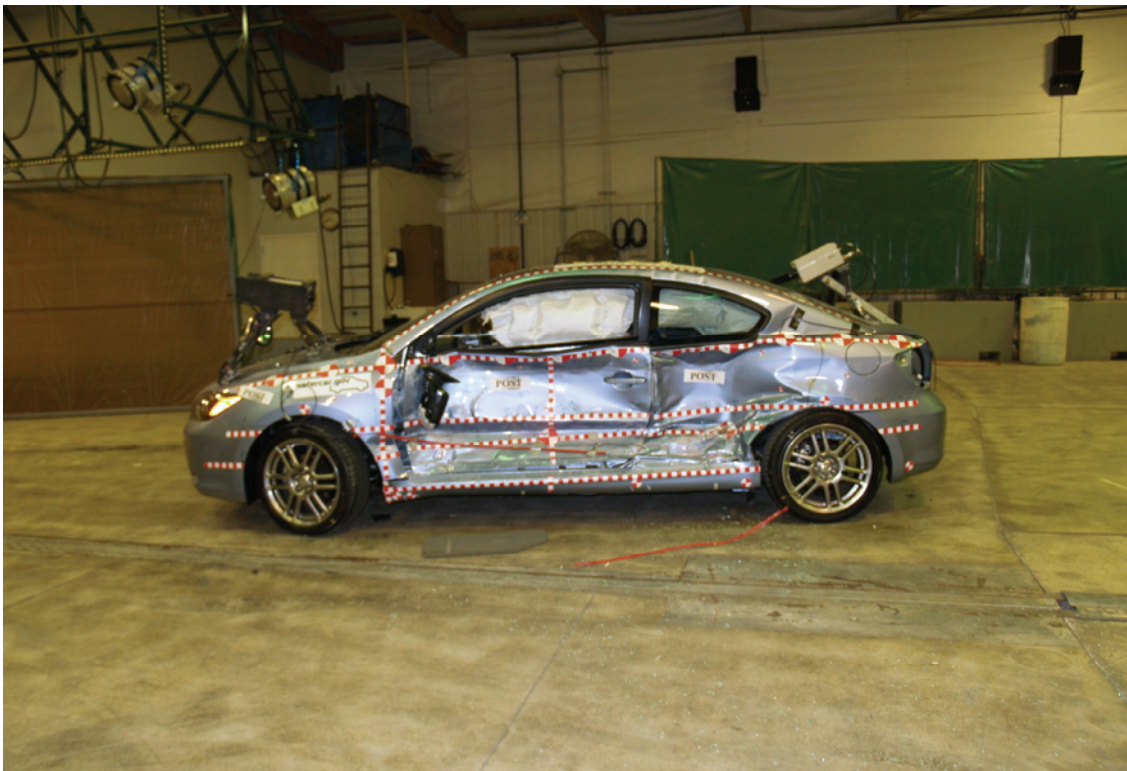
Figure A-10: Post test left side view of test vehicle

The test vehicle sustained a maximum static crush of 265 mm at level 2, 1350 mm rearward of the vertical impact line.
