**REPORT NUMBER: MCW-DOT-08SN05**

**NEW CAR ASSESSMENT PROGRAM  
SIDE IMPACT TEST**

**2008 TOYOTA FJ CRUISER UTILITY VEHICLE**

**FINAL REPORT**

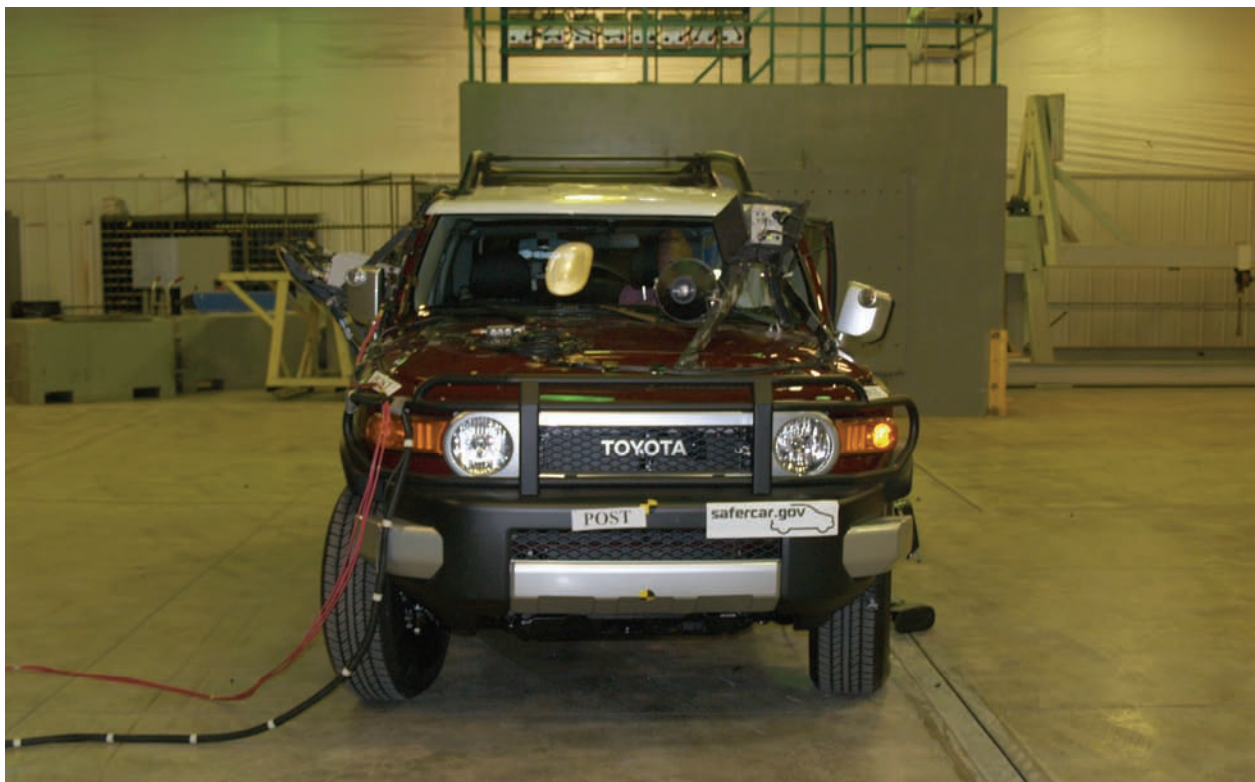
Figure A-6: Post test front view of test vehicle

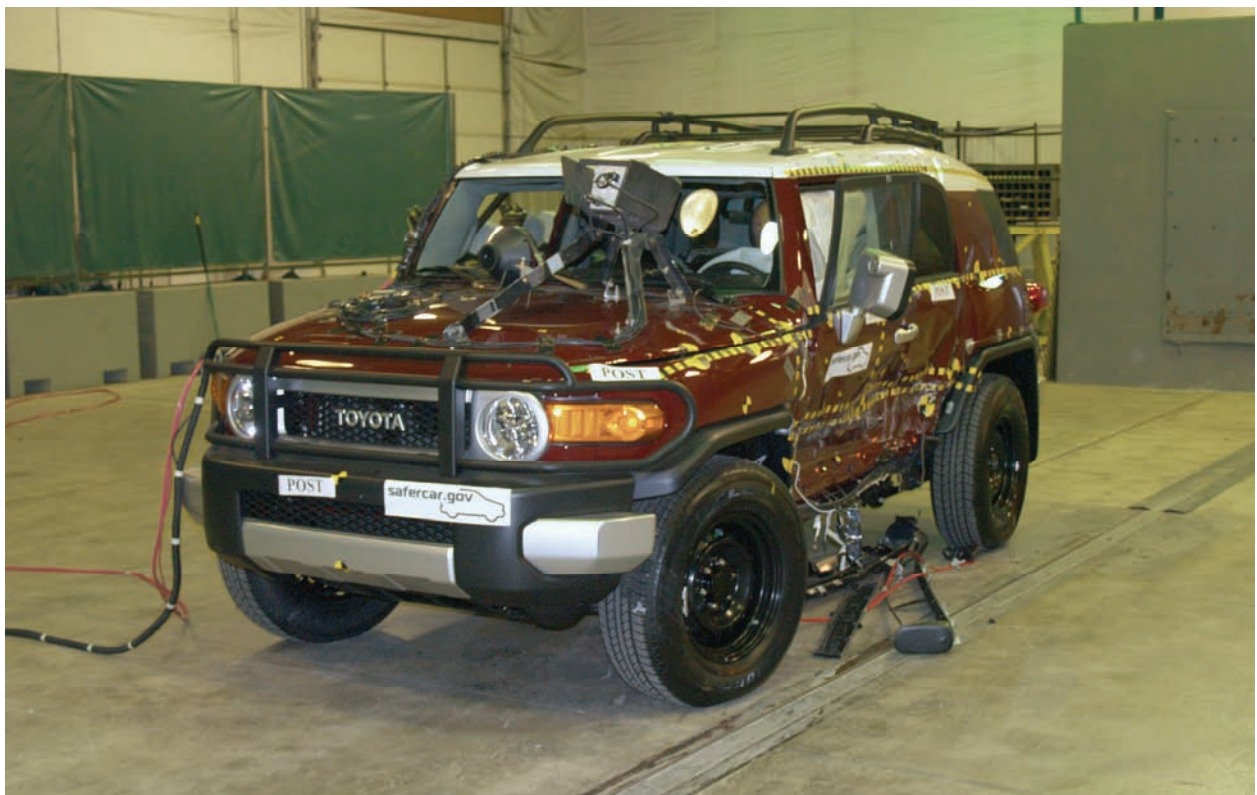
Figure A-8: Post test left front 3/4 view of test vehicle

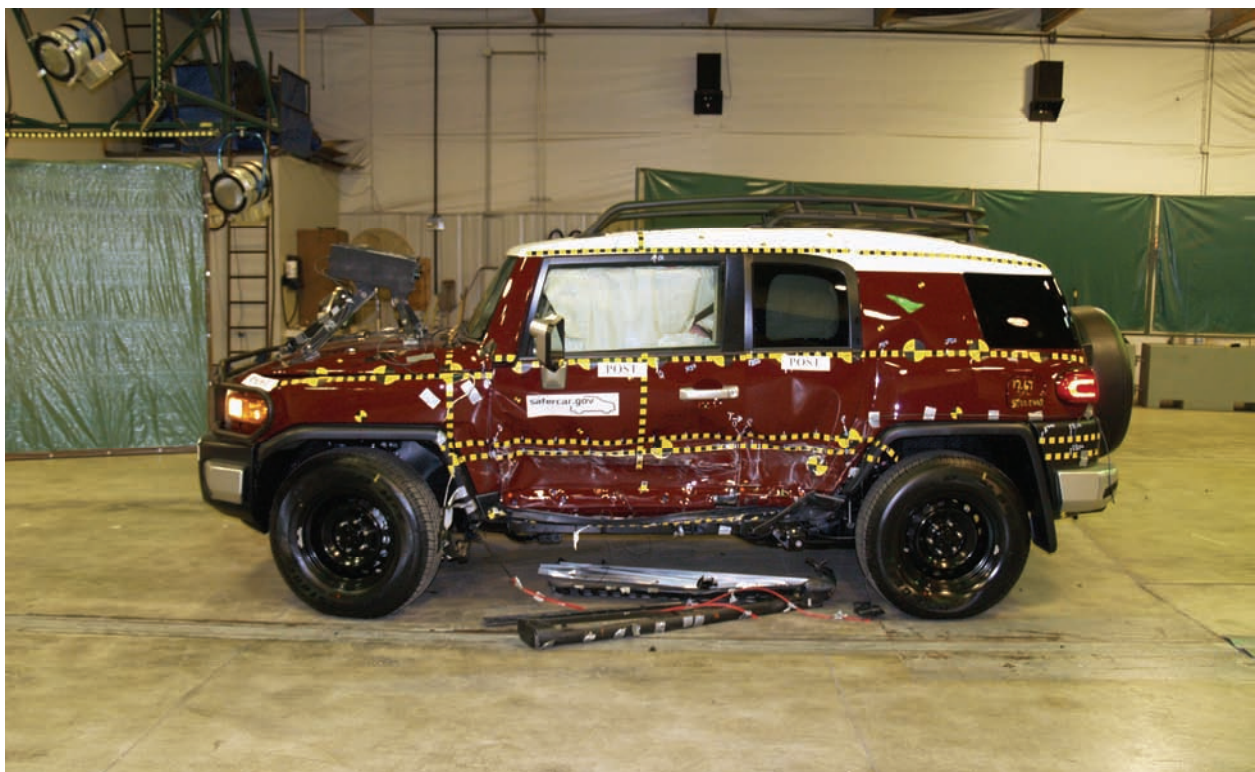
Figure A-10: Post test left side view of test vehicle

The test vehicle sustained a maximum static crush of 215 mm at level 2, 1200 mm rearward of the vertical impact line.

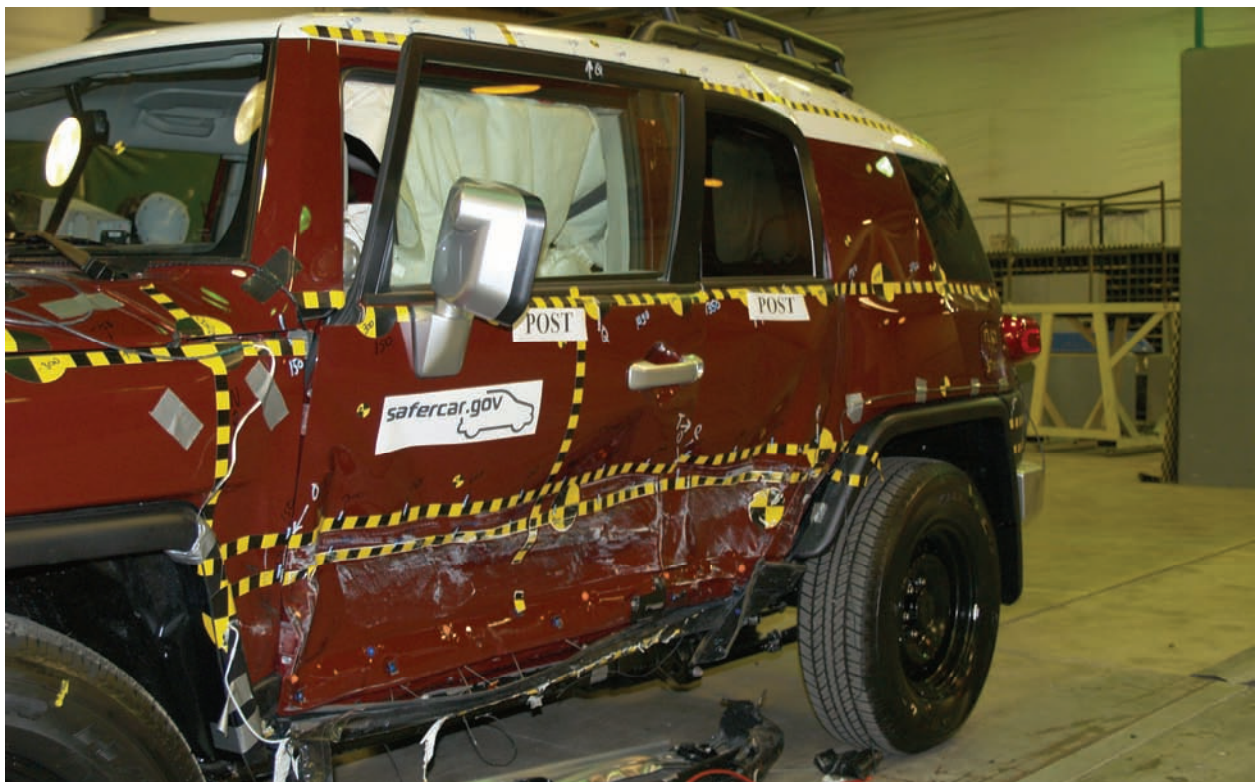
Figure A-28: Post test front 3/4 view of left side doors

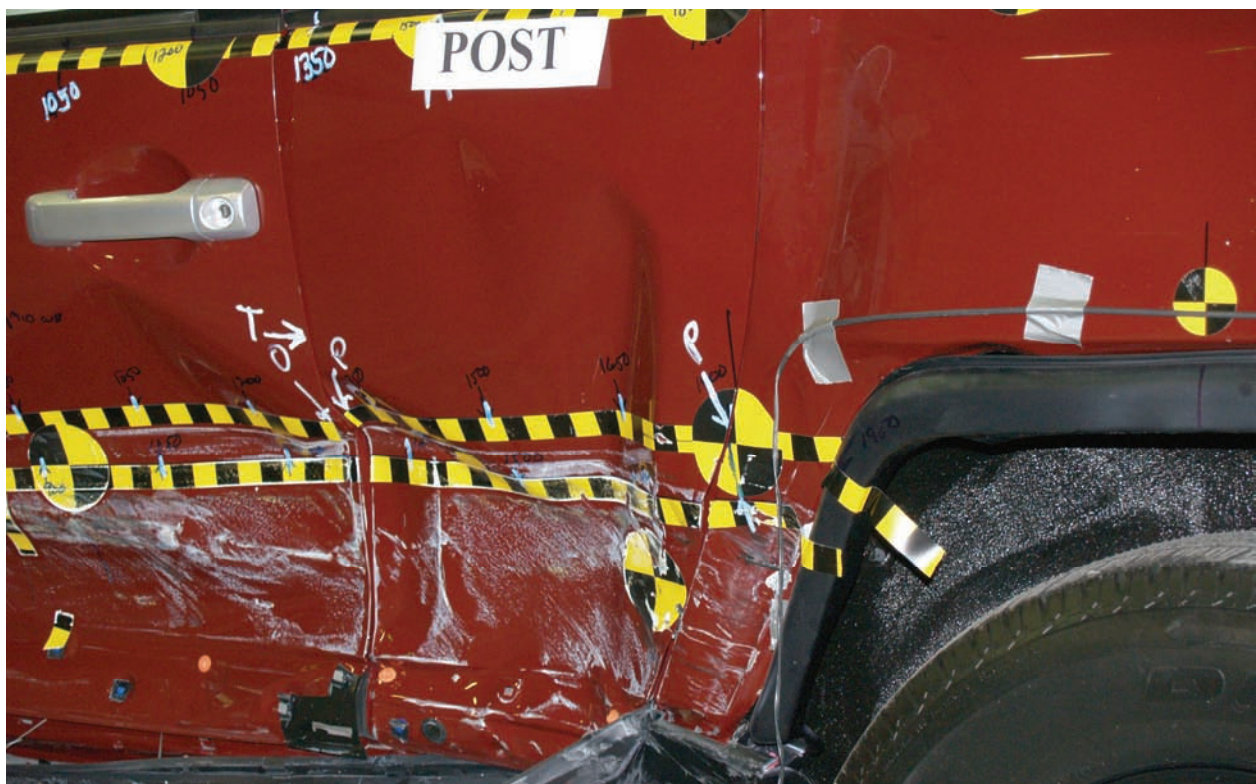
Figure A-34: Post test left rear door

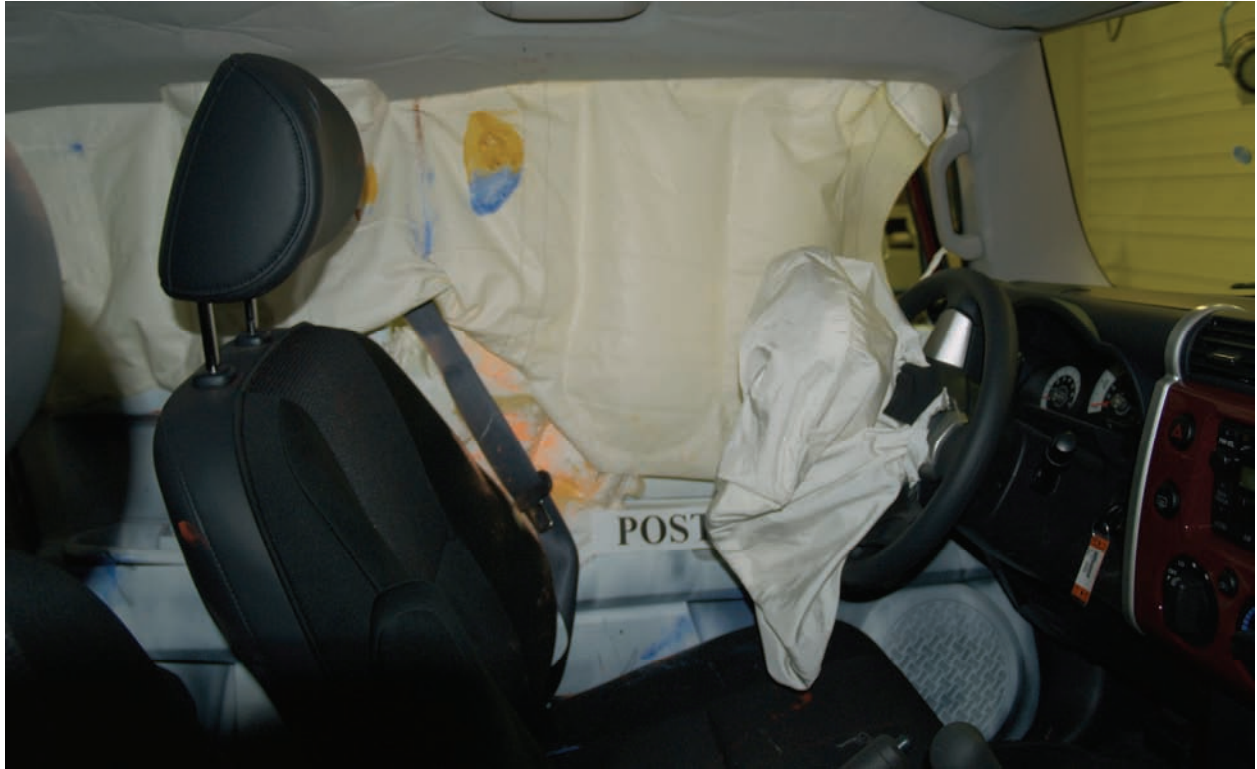
Figure A-41: Post test driver contact locations (1)

Figure A-42: Post test driver contact locations (2)

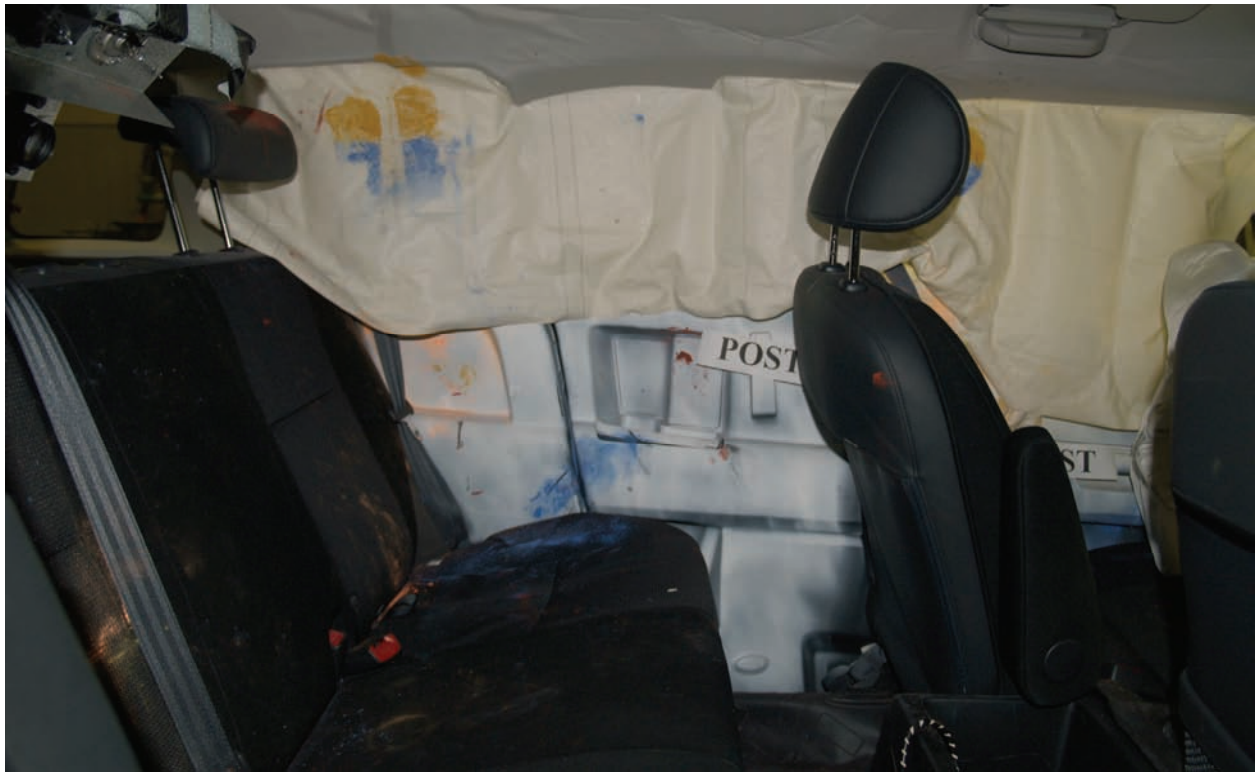
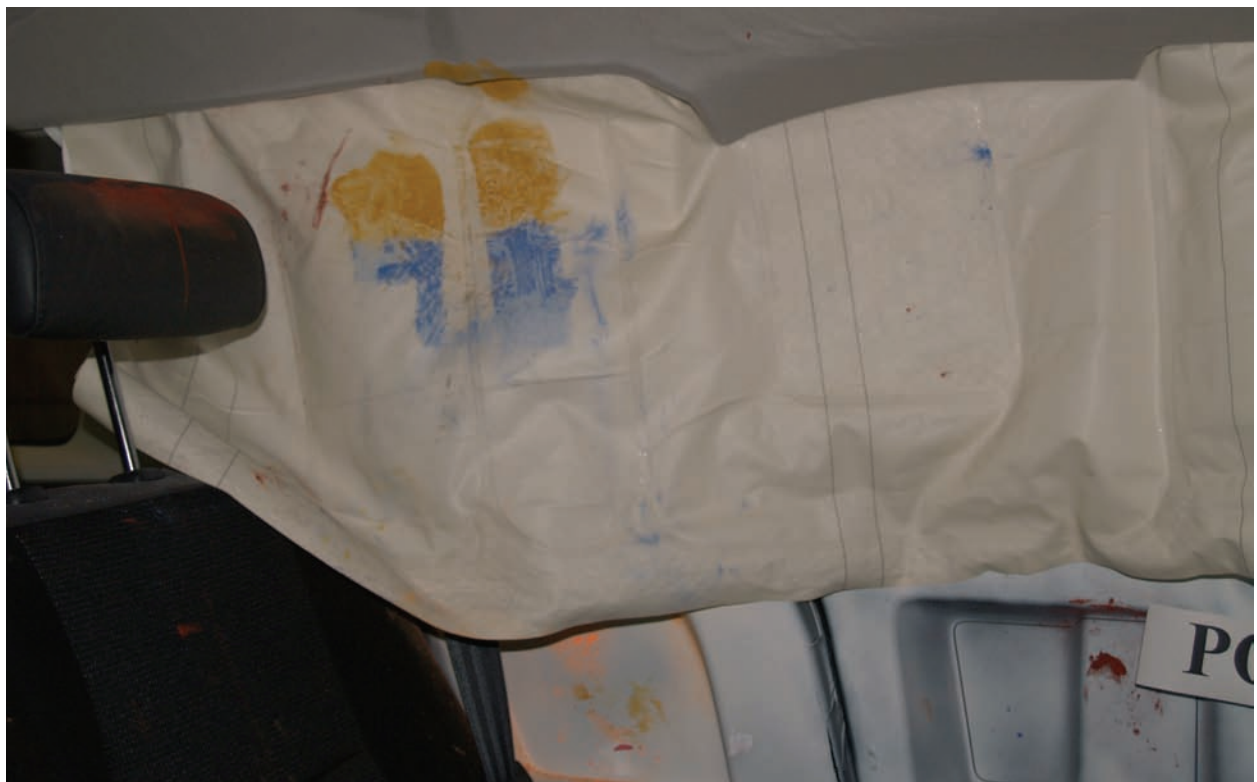
Figure A-49: Post test passenger contact locations (1)

Figure A-50: Post test passenger contact locations (2)
