**REPORT NUMBER: NCAPSIDE-MGA-2008-007**

**NEW CAR ASSESSMENT PROGRAM  
SIDE IMPACT TEST**

**DAIMLERCHRYSLER AG STUTTGART  
2008 MERCEDES-BENZ C300  
NHTSA NUMBER: M80509**

**PREPARED BY:  
MGA RESEARCH CORPORATION  
5000 WARREN ROAD  
BURLINGTON, WI 53105**

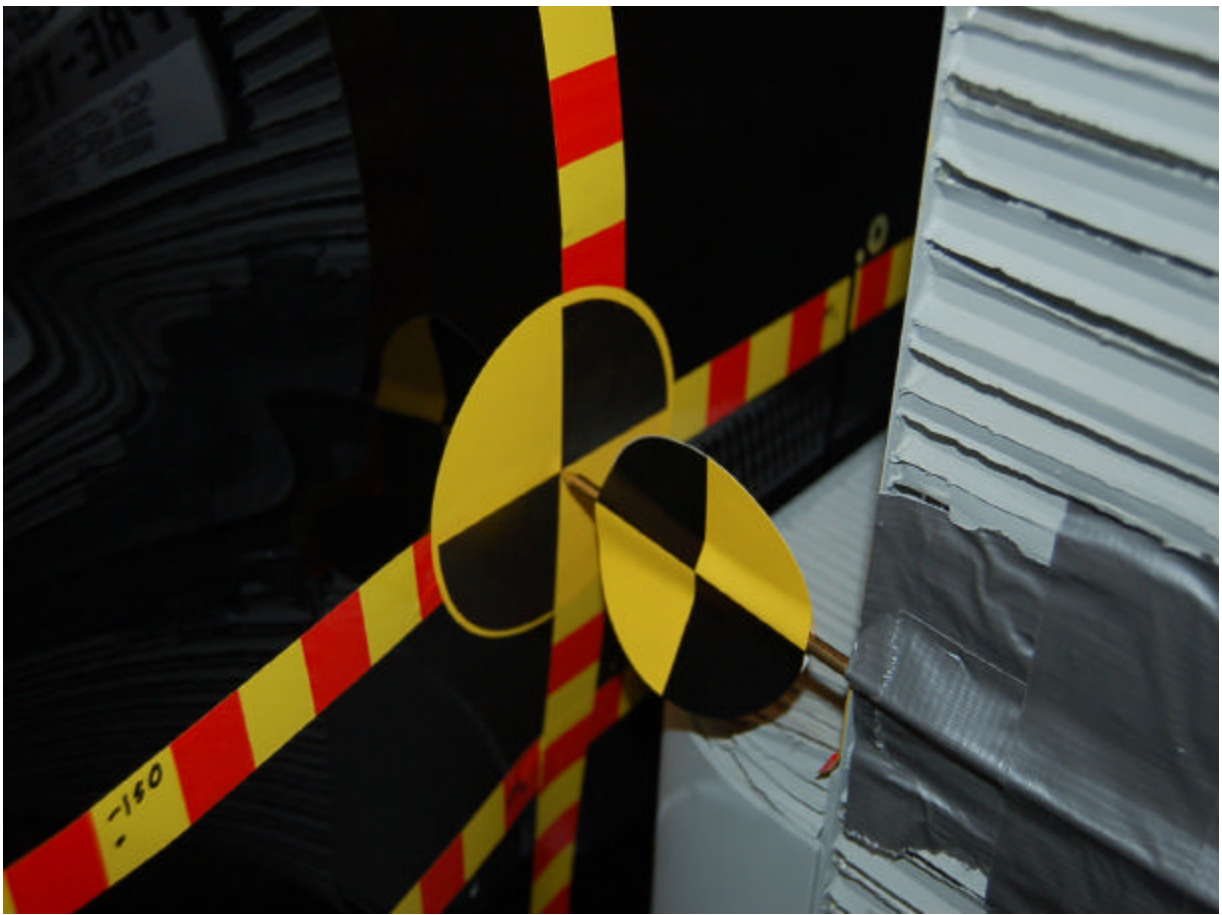
Pre-Test Left Impact Point

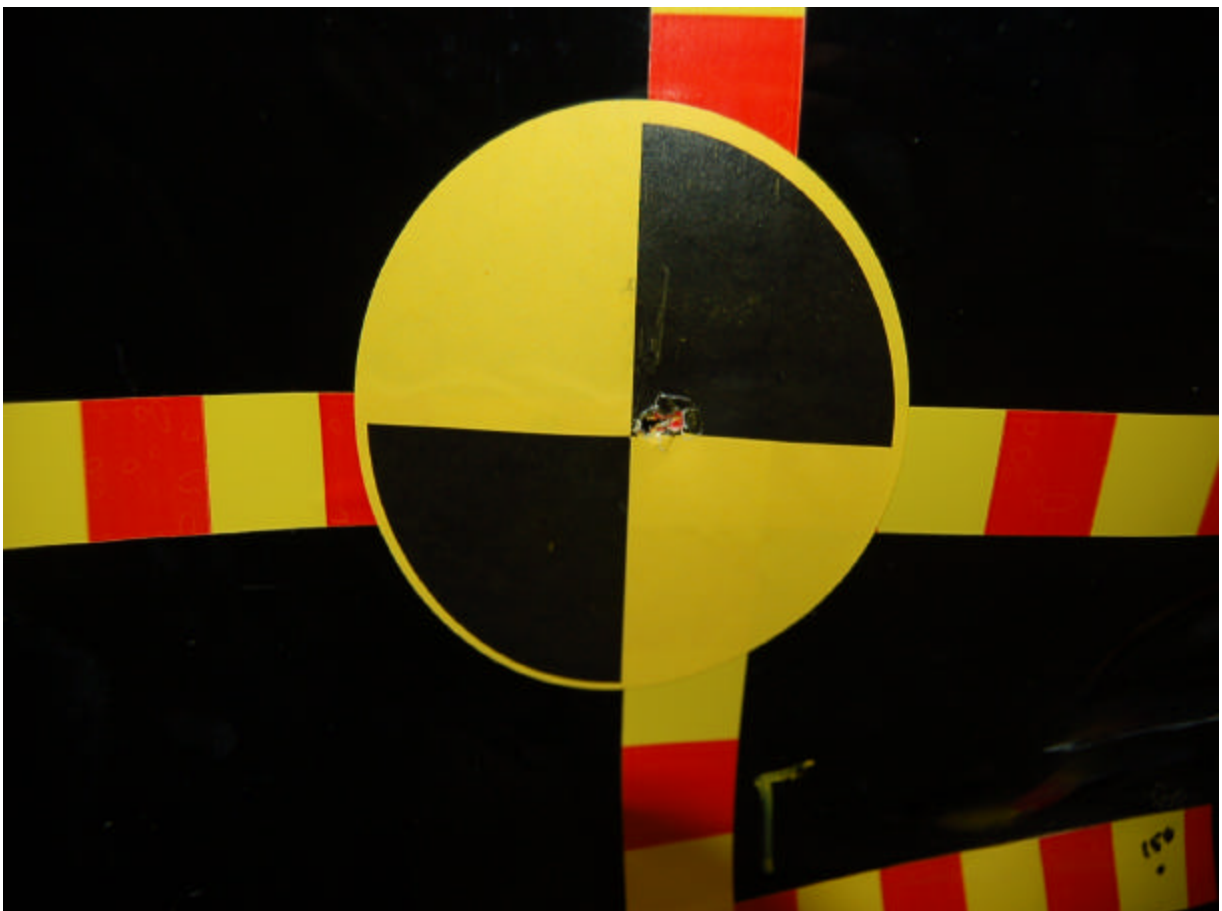
Post-Test Left Impact Point

The test vehicle sustained a maximum static crush of 191 mm at level 3, 1650 mm rearward of the vertical impact point. The driver and passenger SID/HIIIs, Serial Nos. 271 and 904 respectively, were calibrated just prior to this test.

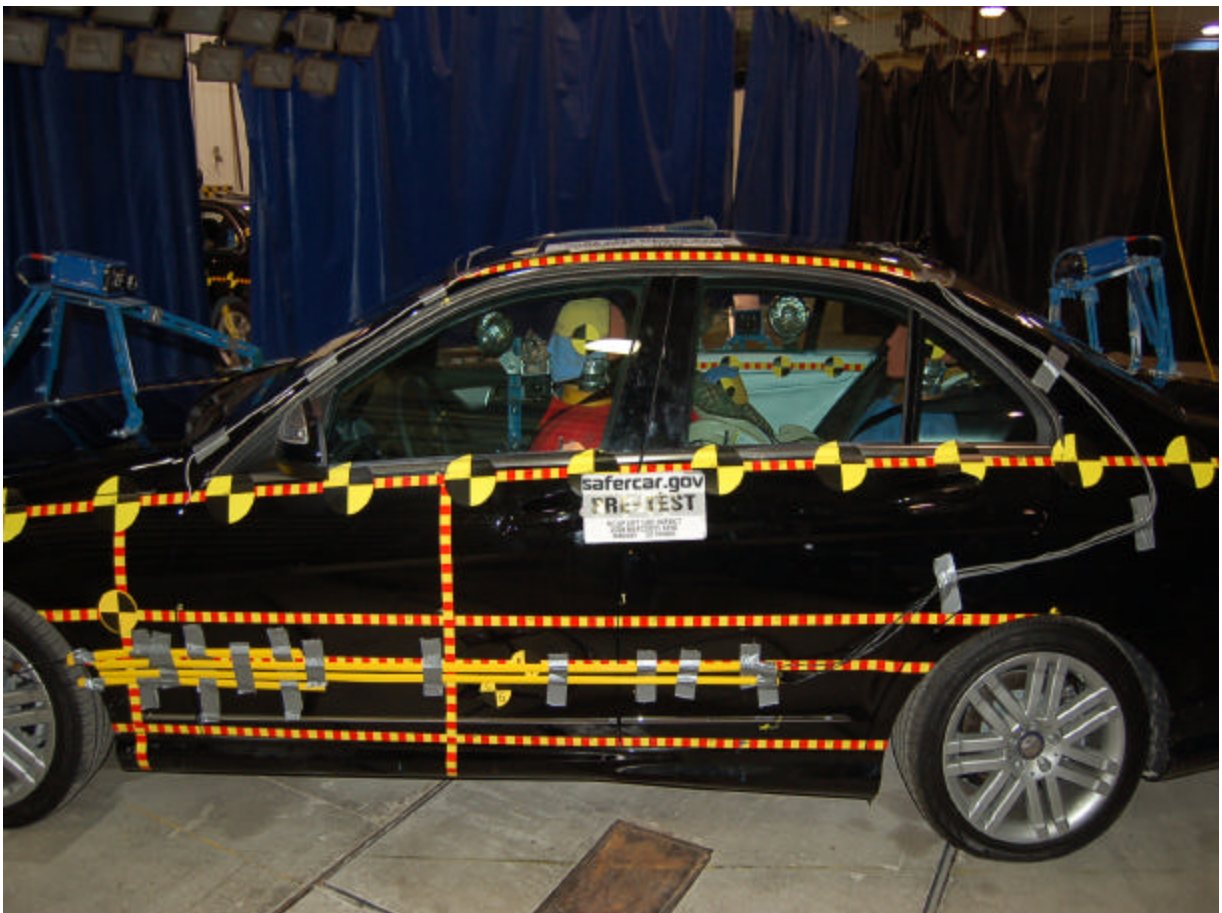
Pre-Test Left Side Impact Close-up

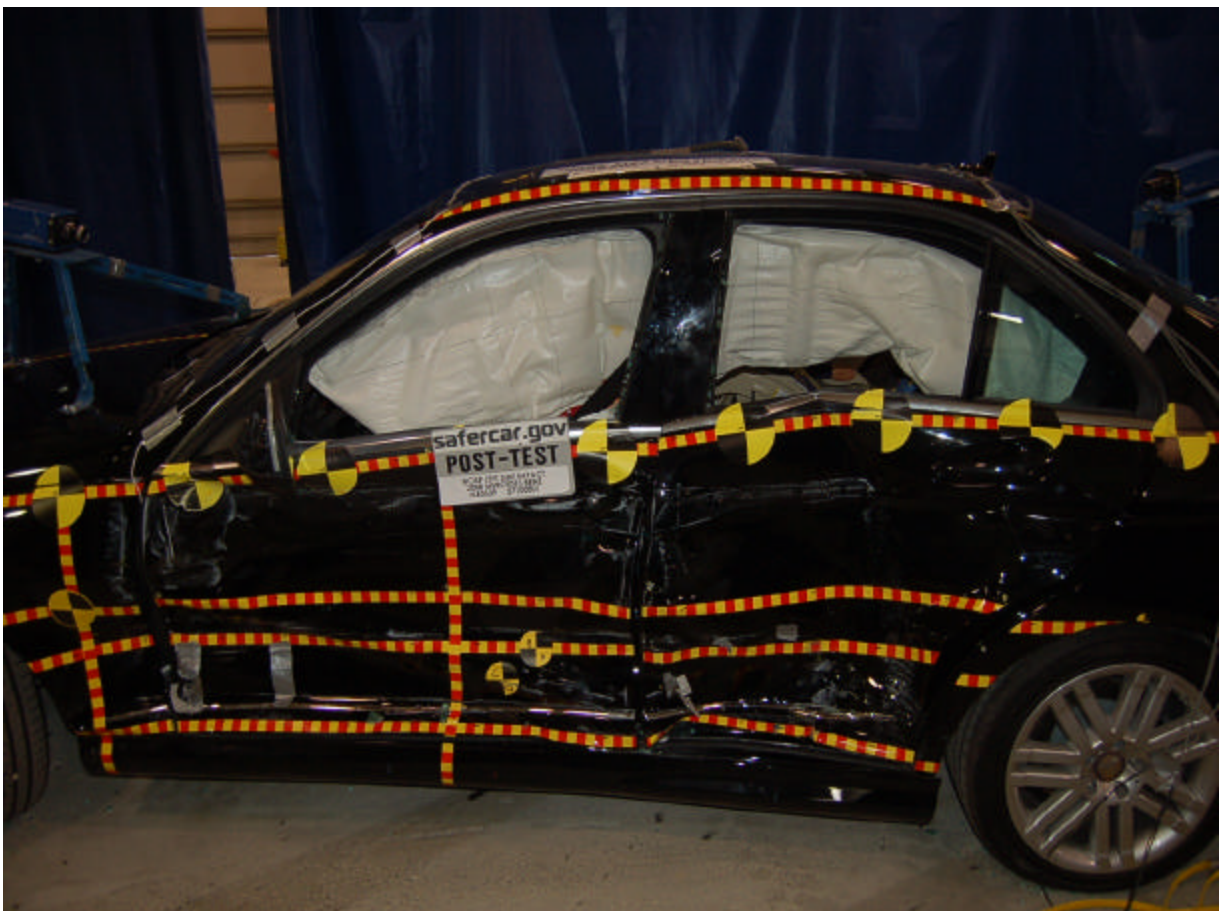
Post-Test Left Side Impact Close-up

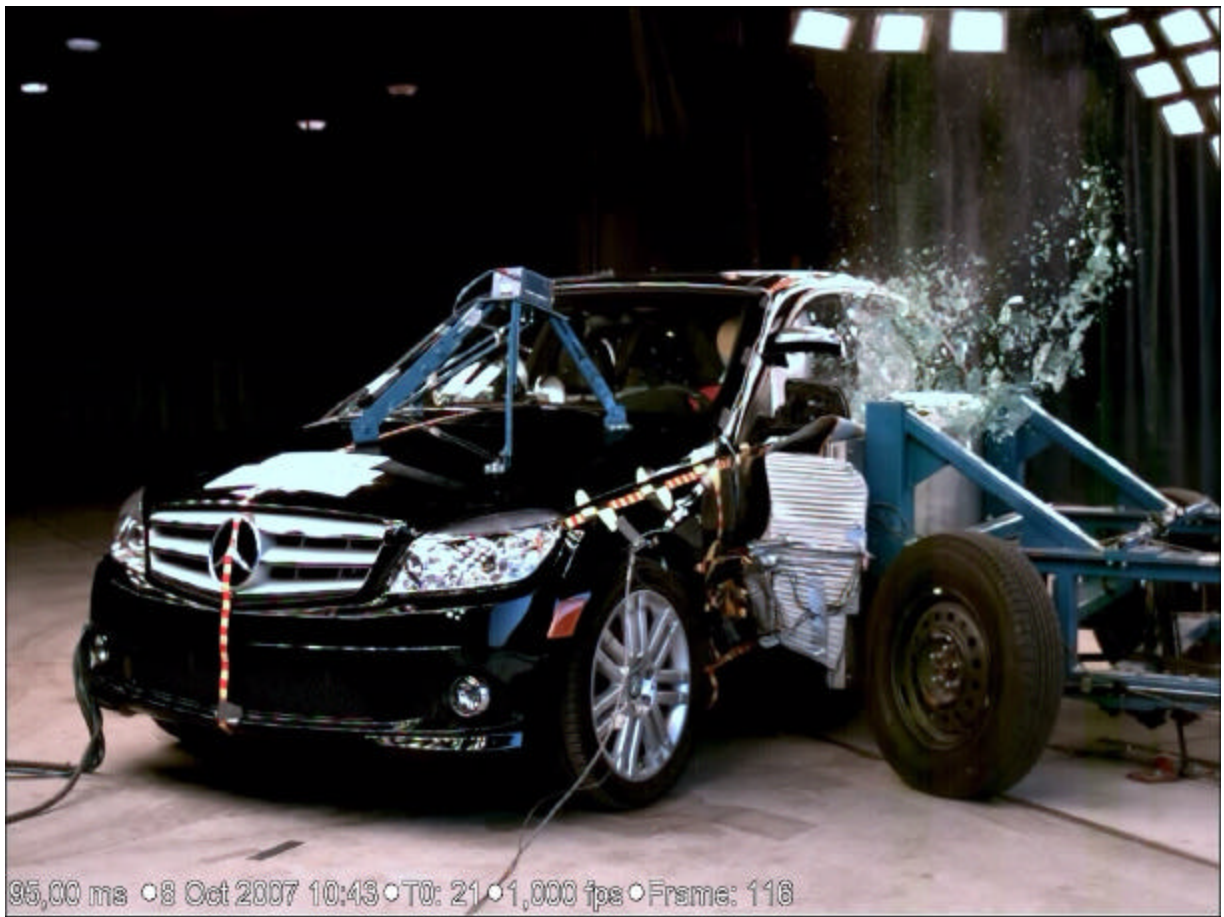
95,00 ms • 8 Oct 2007 10:43 • T0: 21 • 1,000 fps • Frame: 116

Vehicle Impact

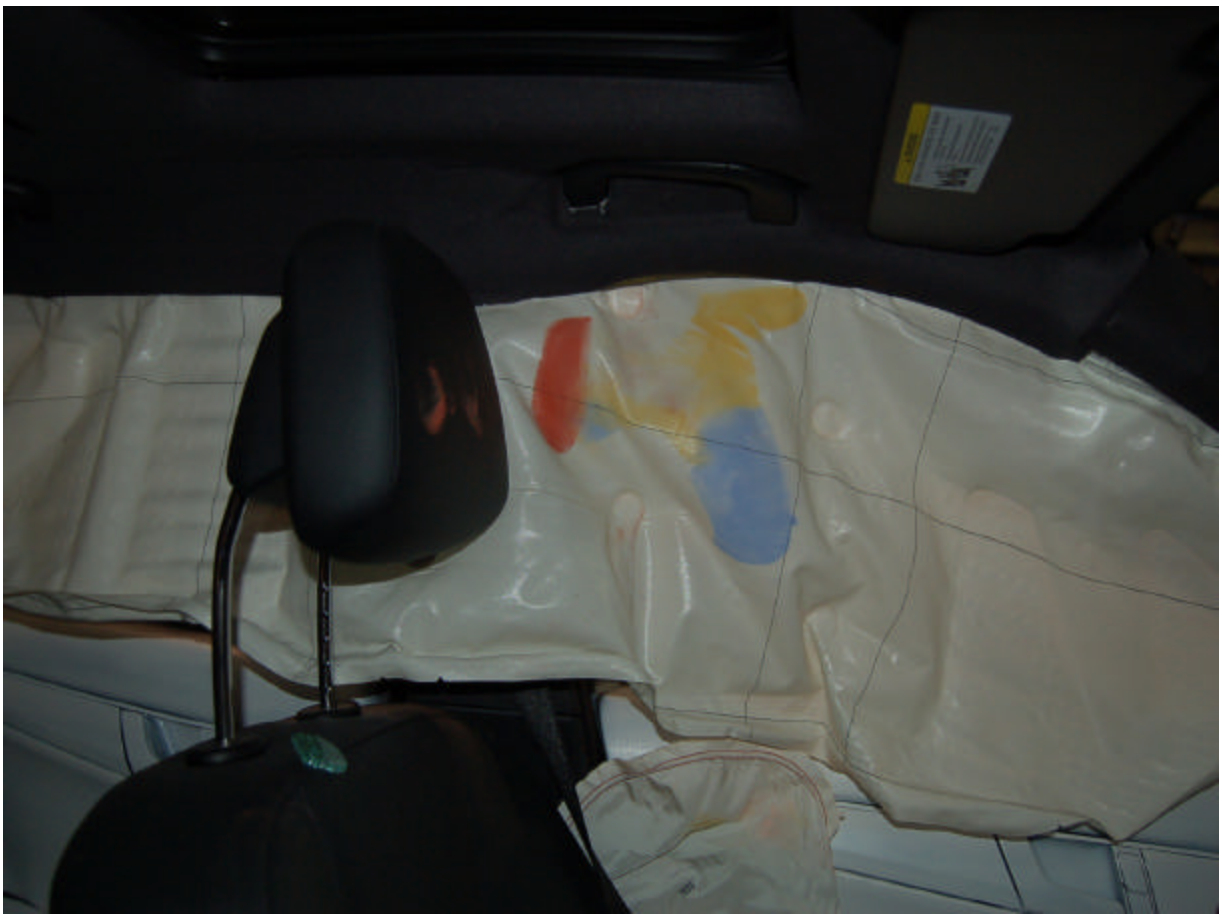
Post-Test Driver Dummy Head Contact

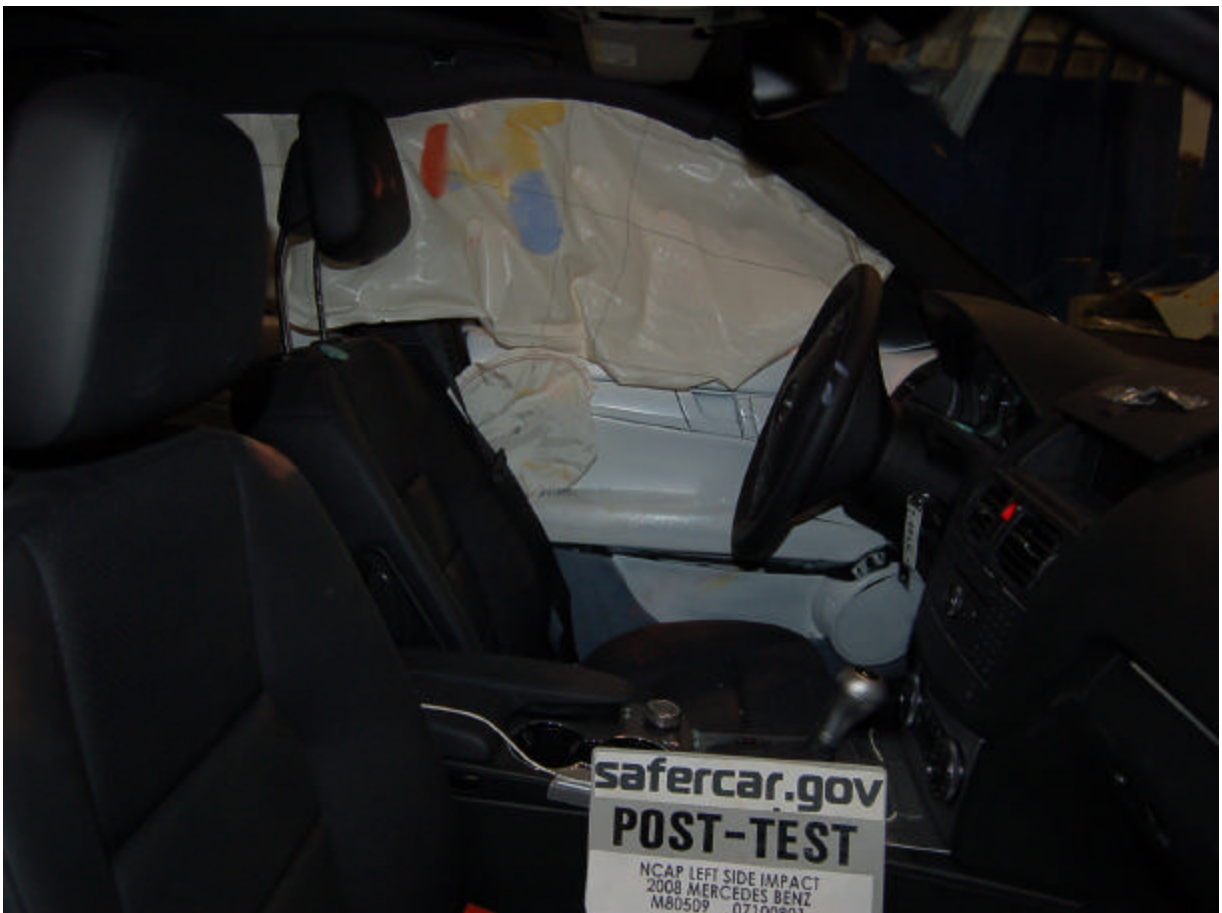
Post-Test Driver Dummy Contact

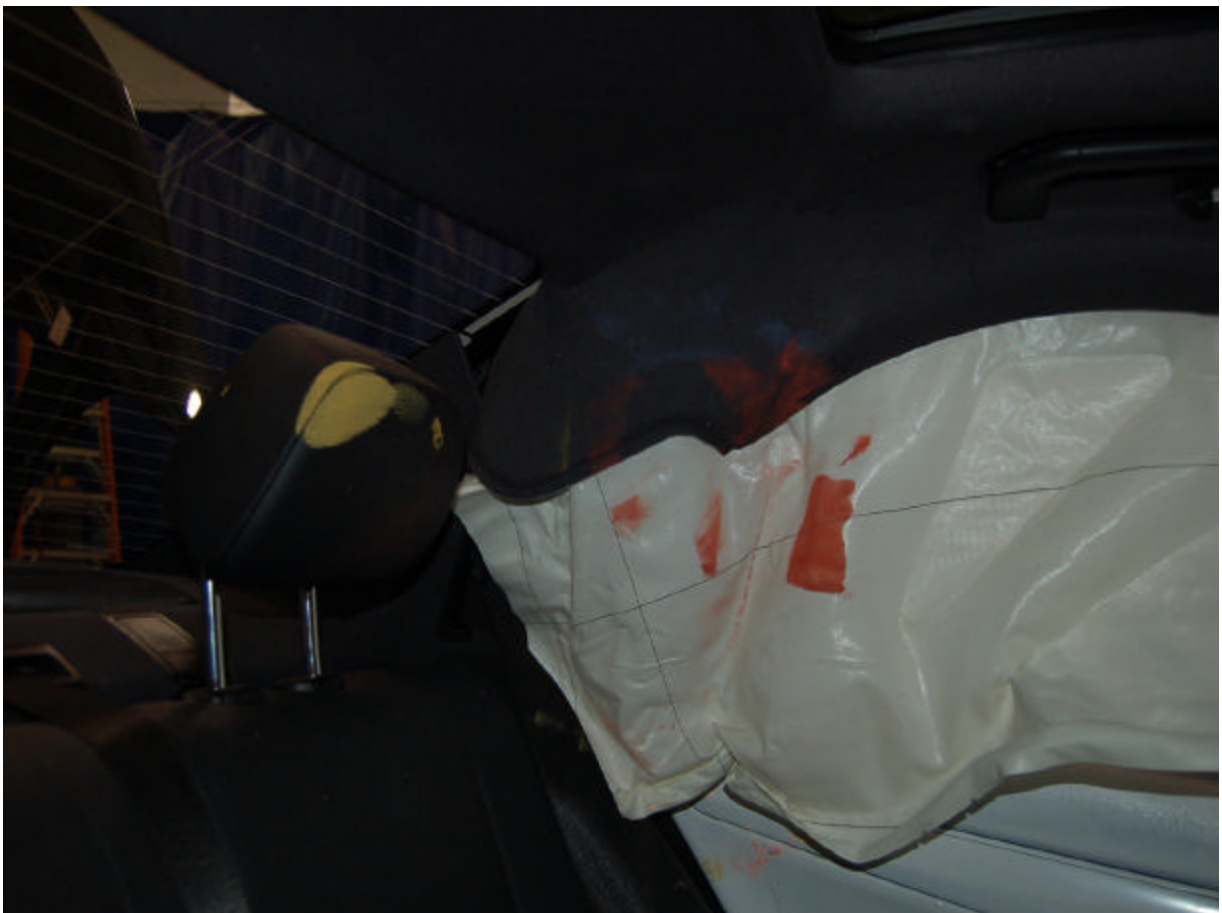
Post-Test Passenger Dummy Head Contact

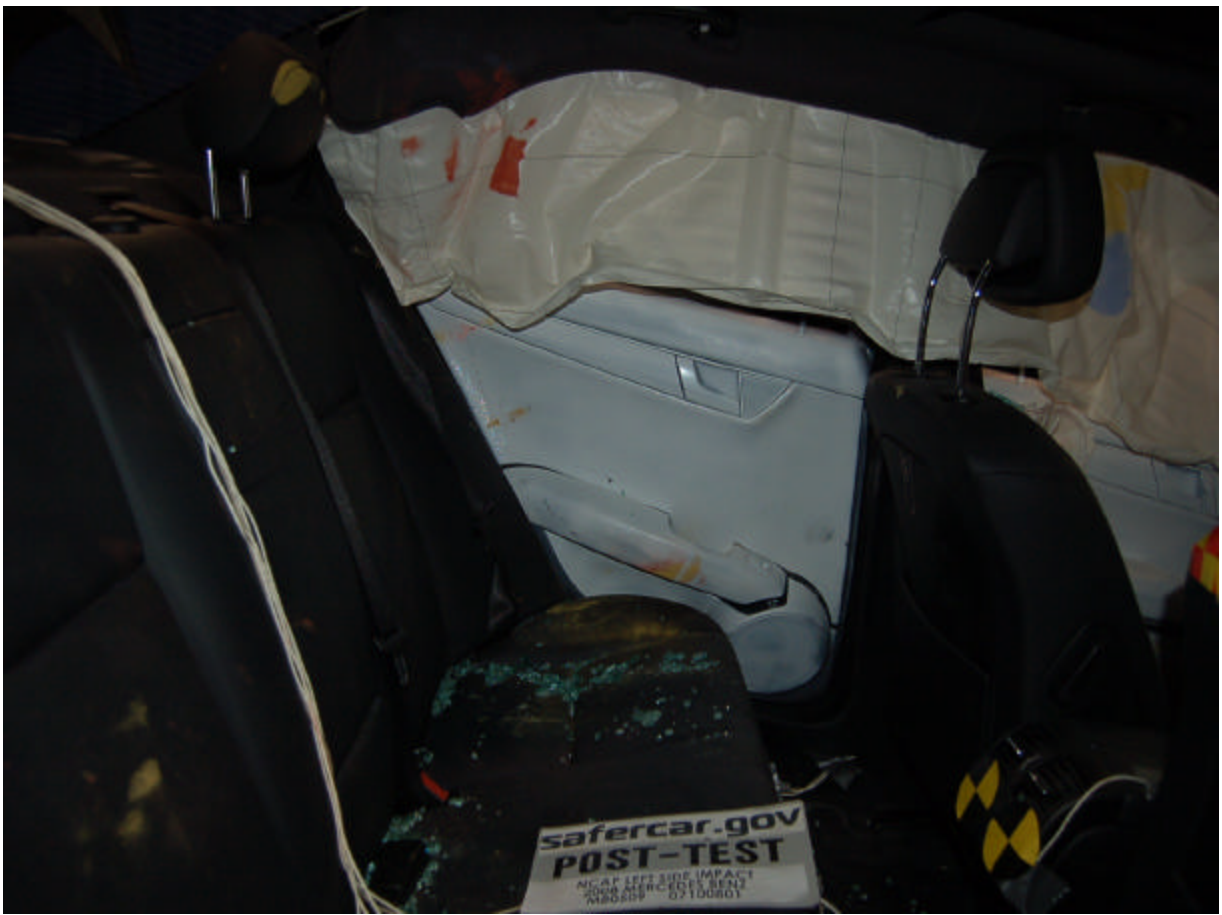
Post-Test Passenger Dummy Contact
