**REPORT NUMBER TR-P28003-04-NC**

**NEW CAR ASSESSMENT PROGRAM  
SIDE IMPACT TEST**

**TOYOTA MOTOR MANUFACTURING  
2008 TOYOTA CAMRY SOLARA SE  
2-DOOR COUPE**

**NHTSA NUMBER: M85108**

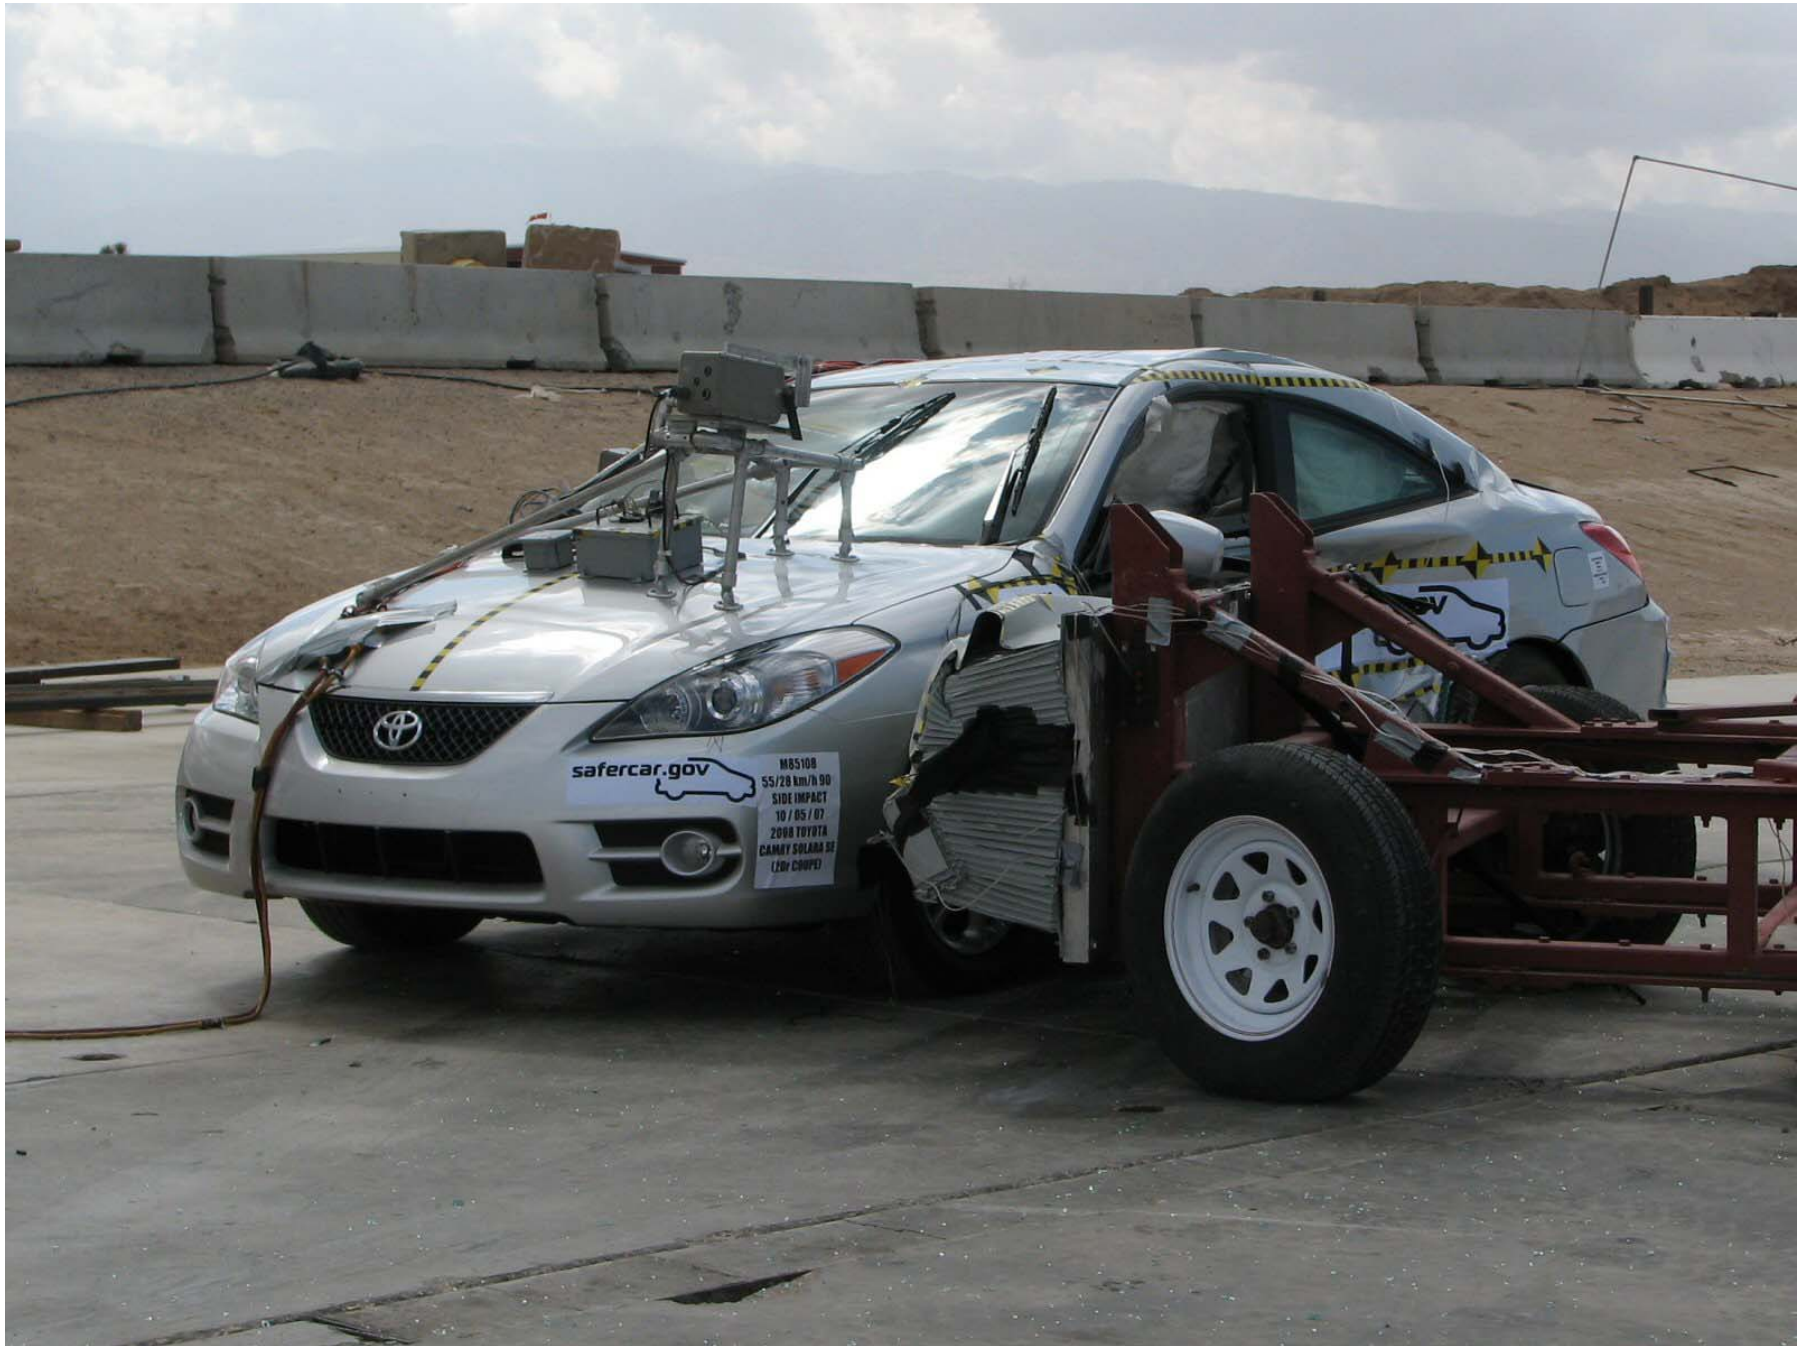
Figure A-8: Post-Test Left Front  $\frac{3}{4}$  View

Both the driver and passenger door remained closed during the impact. The test vehicle sustained a maximum static crush of 312 mm at level 2, 1500 mm rearward of the left vertical impact point. The driver SID/Hybrid III, Serial No. 274 and the passenger SID/Hybrid III, Serial No. 275 were calibrated prior to this test. The SID/Hybrid III injury criteria are summarized as follows:

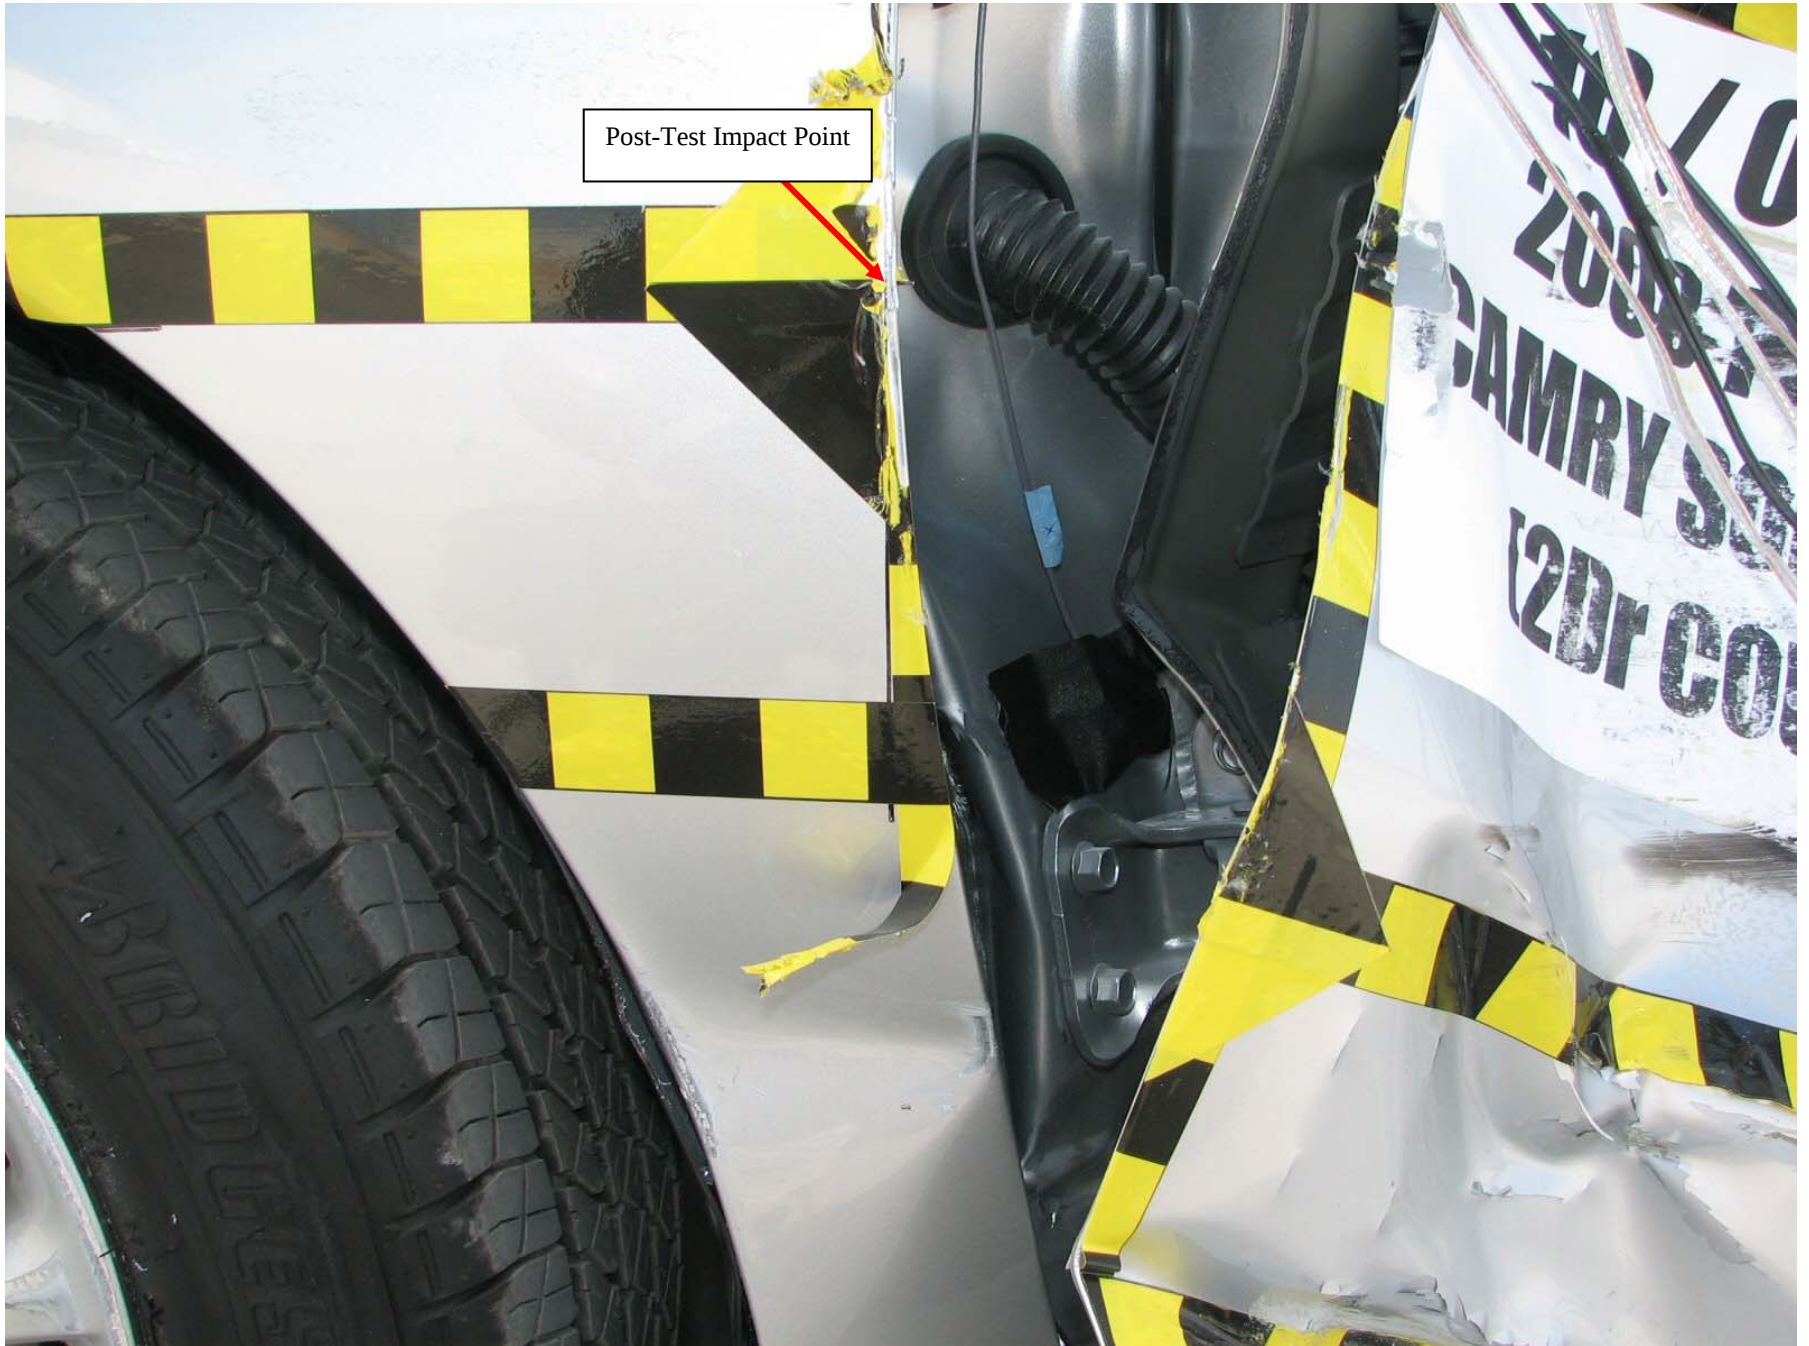
Figure A-26: Post-Test Left Impact Point

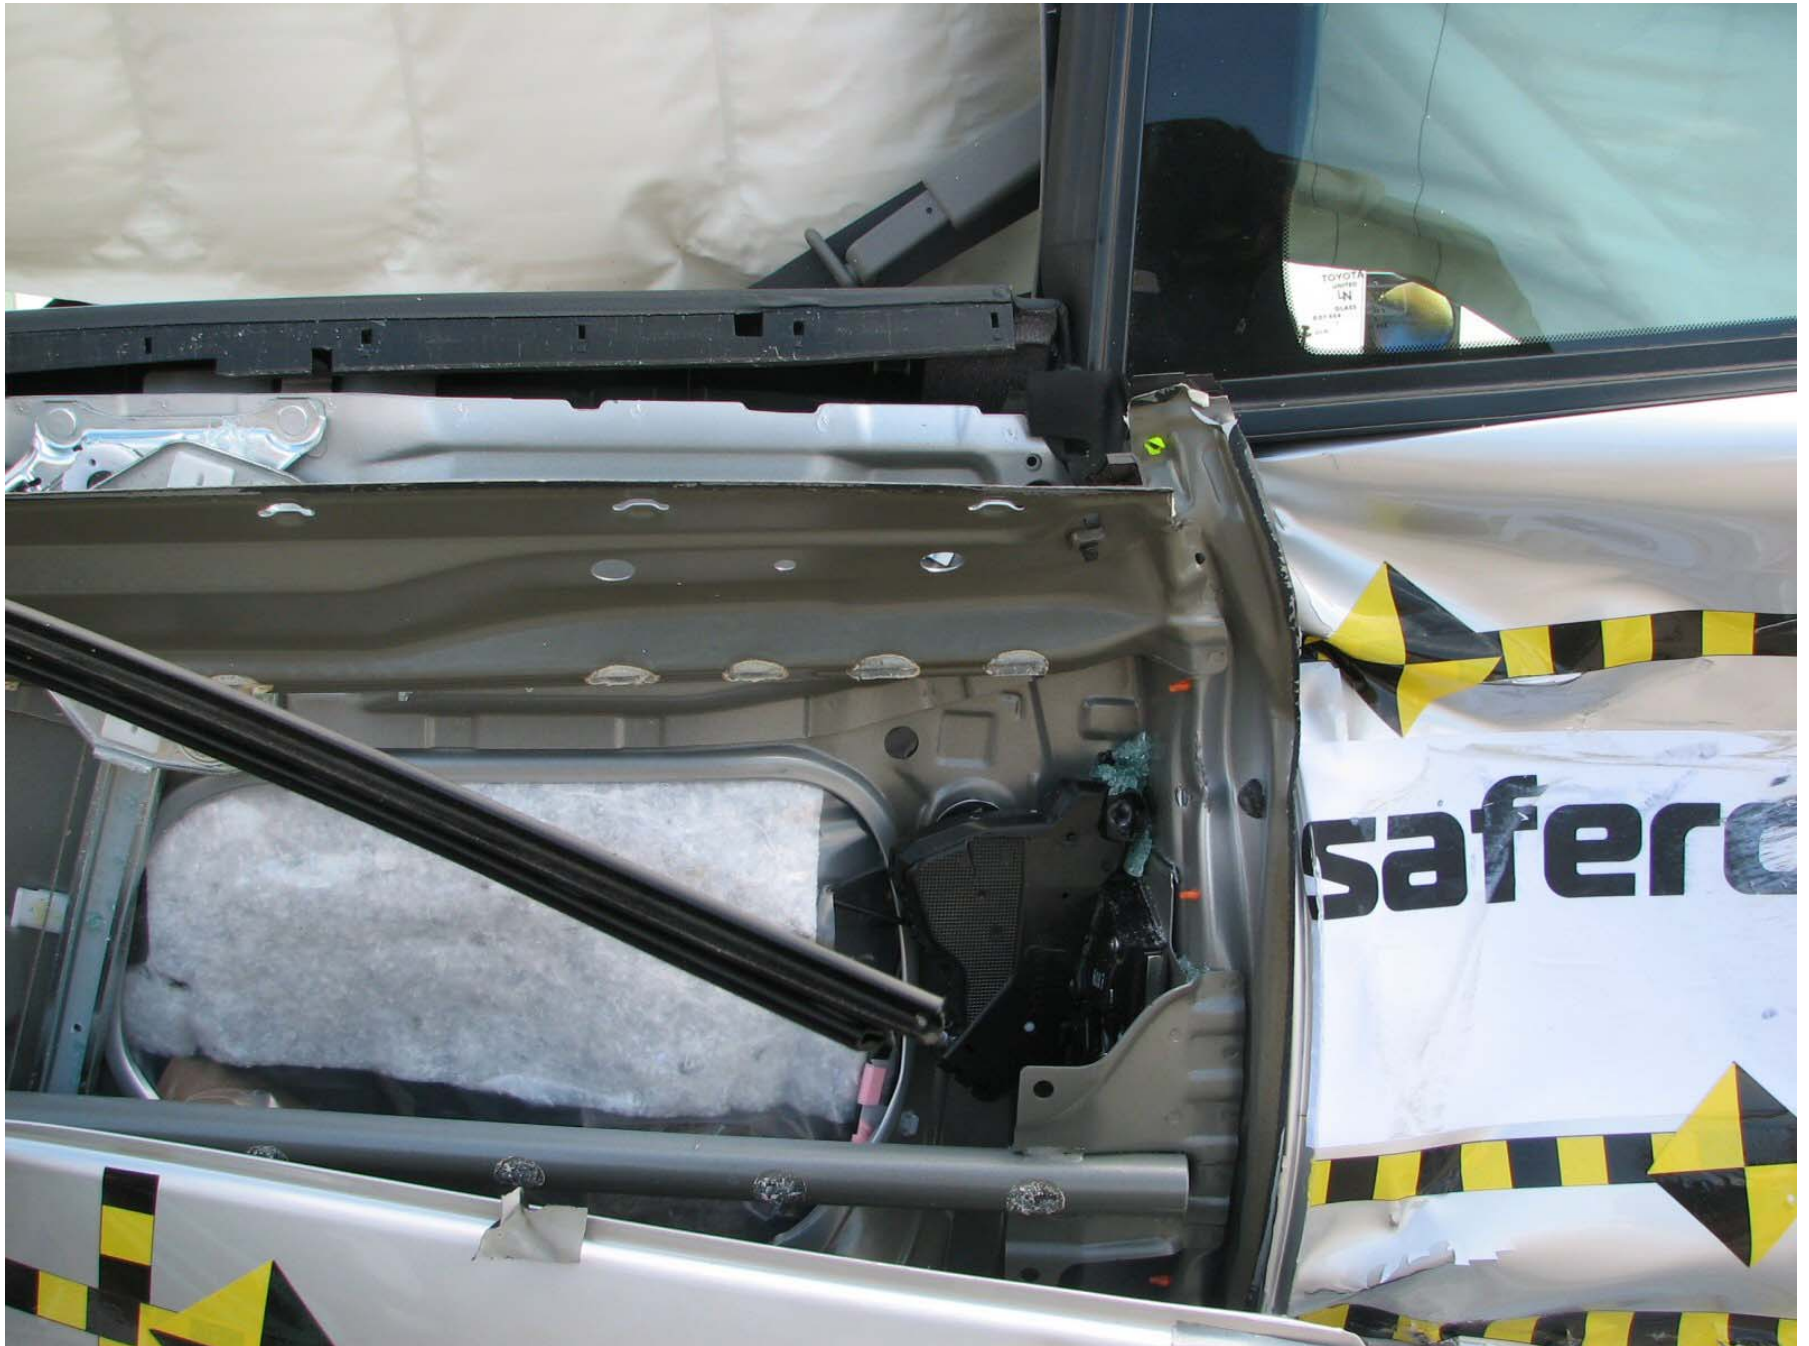
Figure A-32: Post-Test Left Front Door

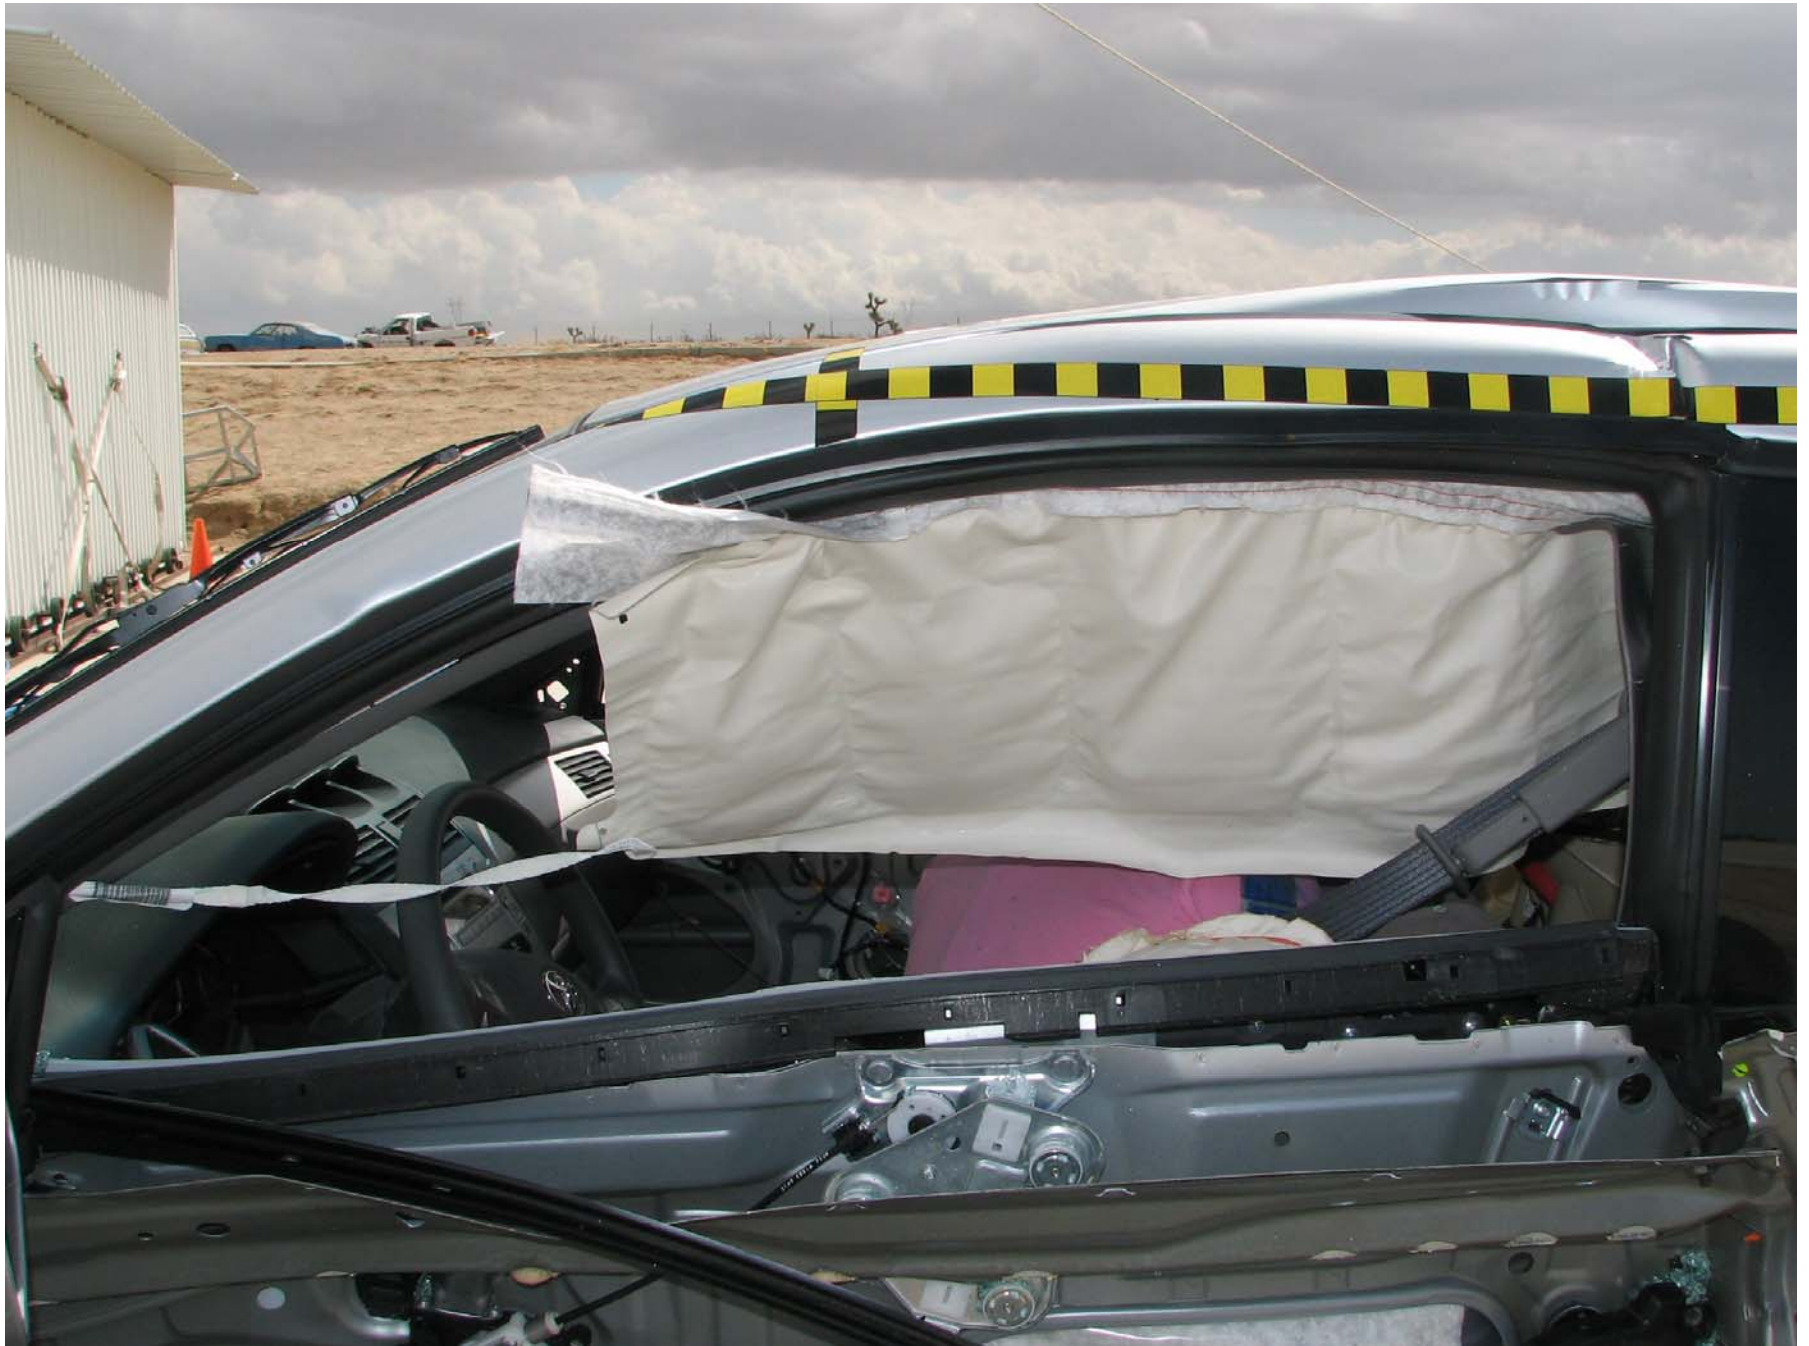
Figure A-37: Post-Test Driver Dummy (Through Window)

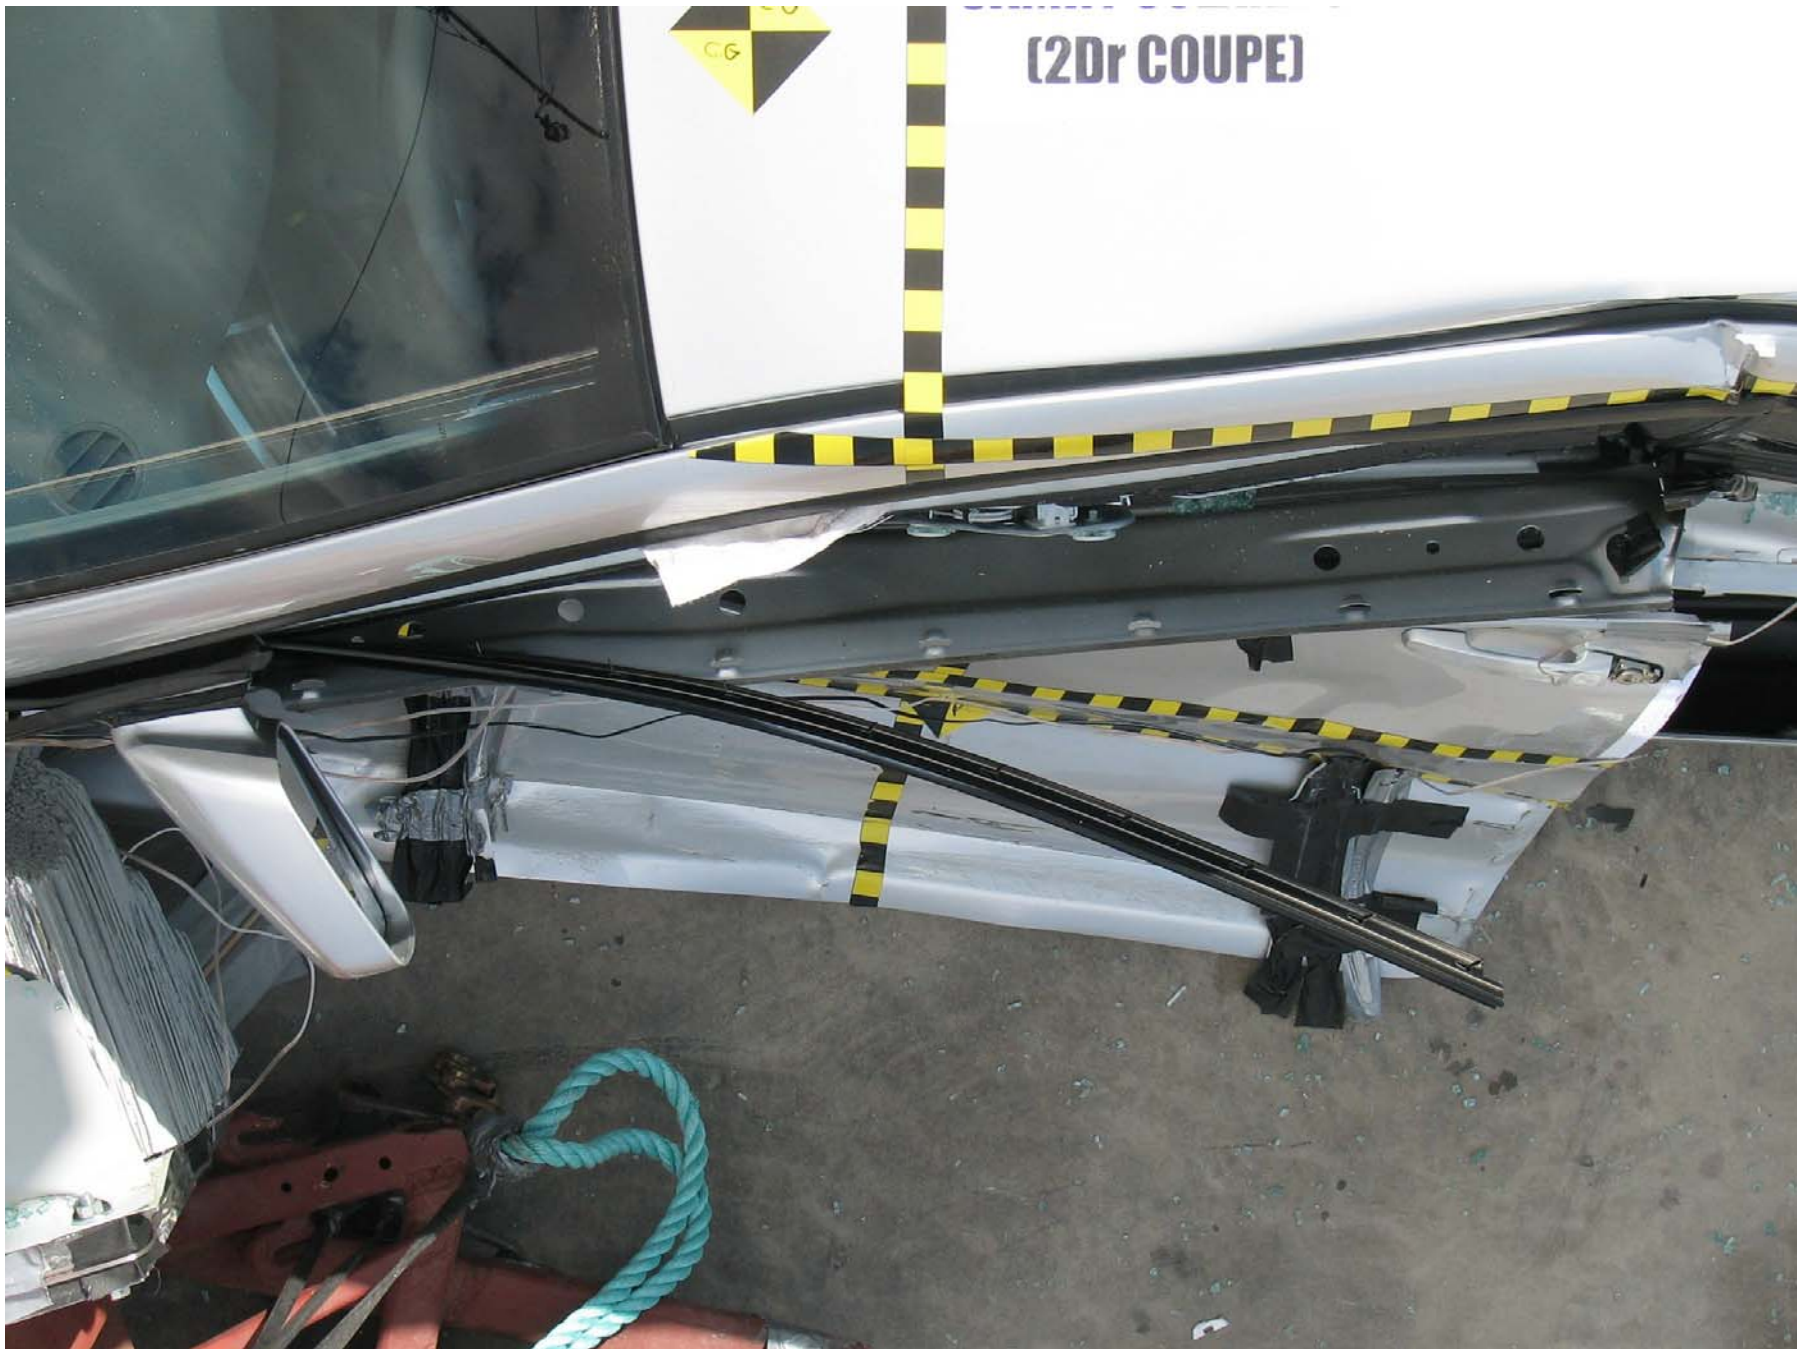
Figure A-39: Post-Test Driver Dummy Clearance From Door

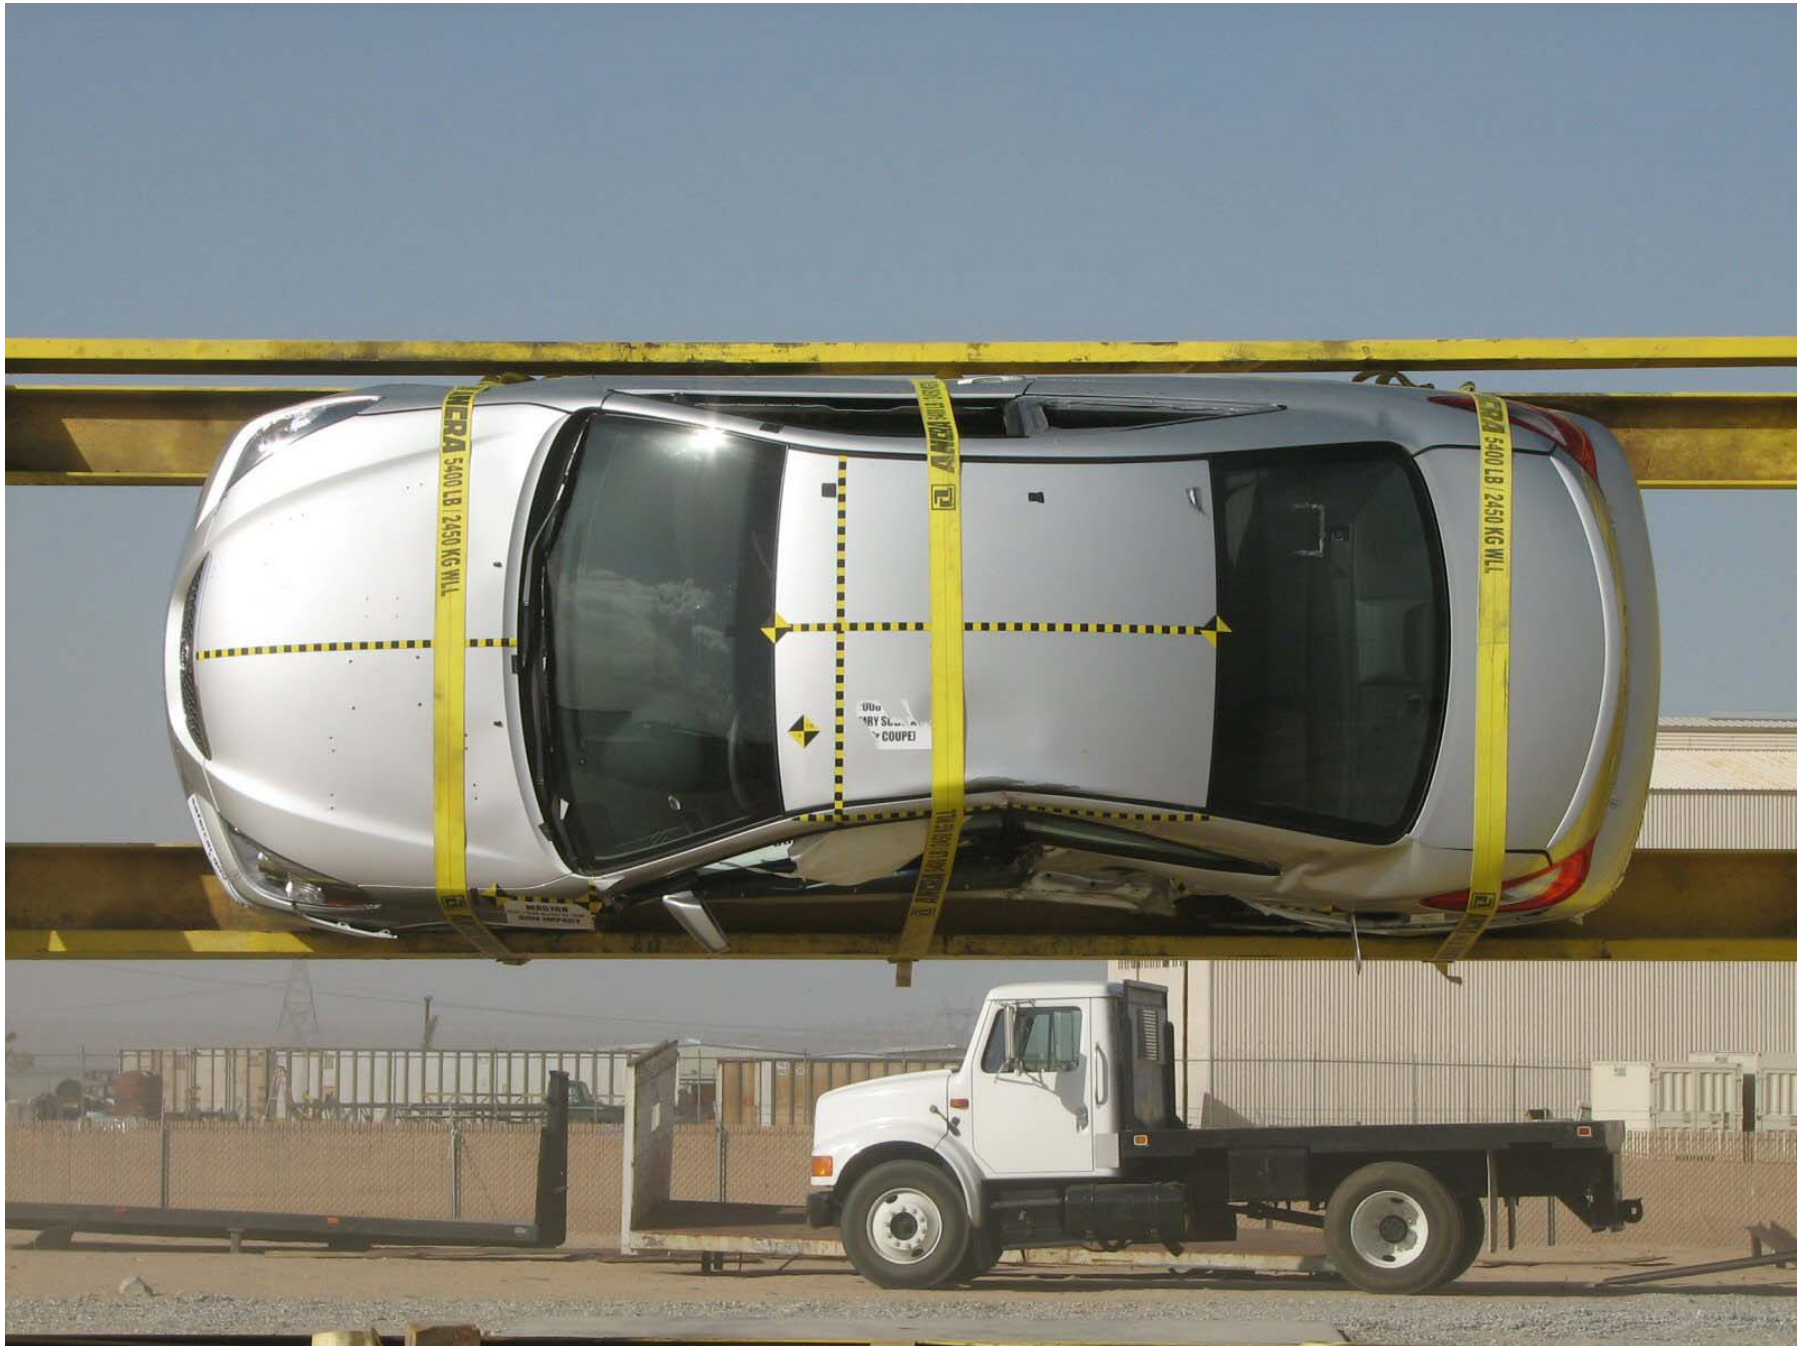
Figure A-62: Vehicle on Rollover Device (90°)

1. The specified fixture rollover rate for each 90° of rotation is 60 to 120 seconds.
2. The position hold time at each position is 300 seconds (minimum).
3. Details of Stoddard Solvent spillage locations.  
No solvent leakage occurred during static rollover testing.

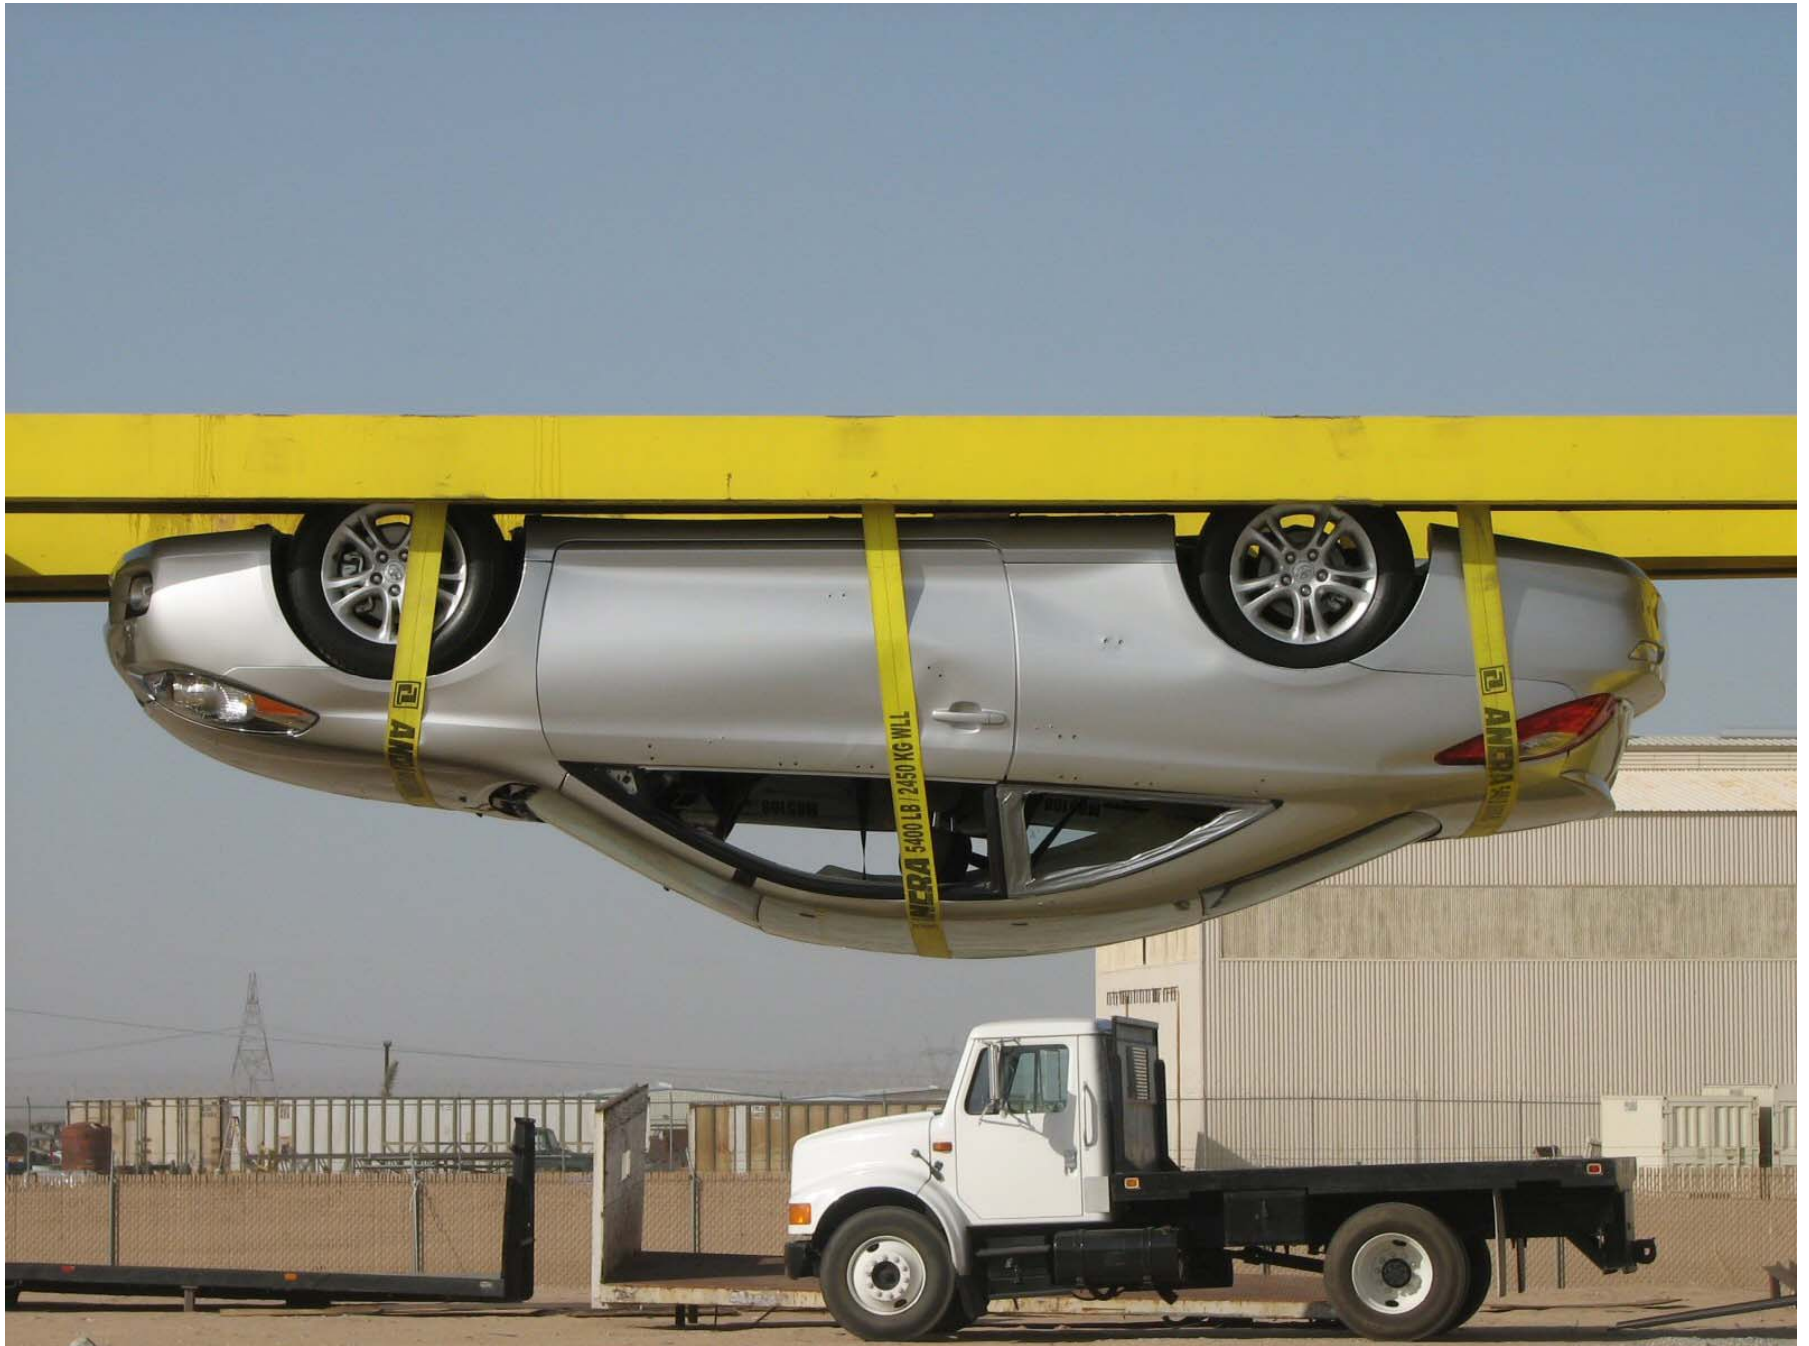
Figure A-63: Vehicle on Rollover Device (180°)

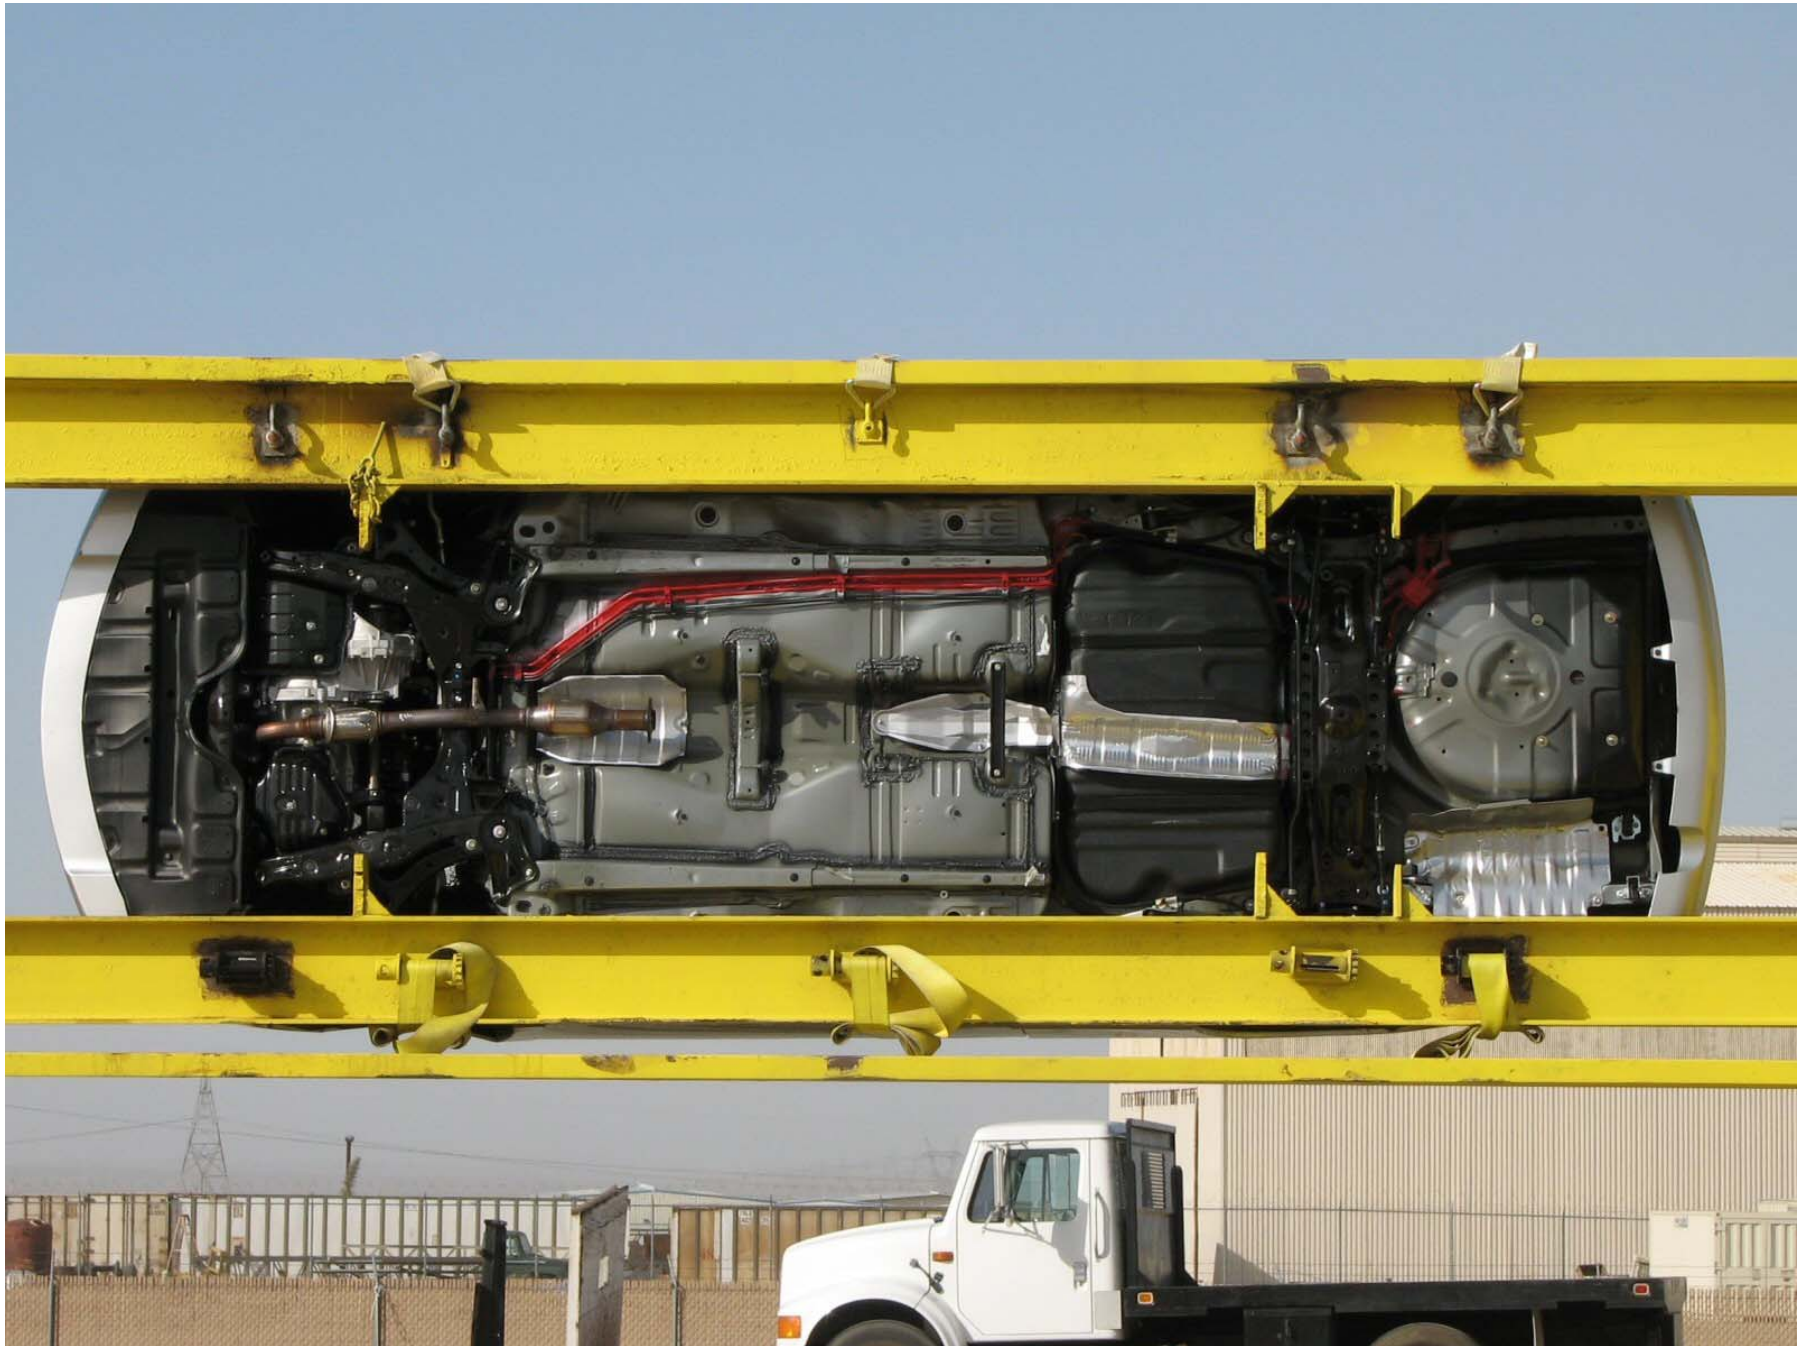
Figure A-64: Vehicle on Rollover Device (270°)
