**REPORT NUMBER: NCAP-MGA-2008-006**

**NEW CAR ASSESSMENT PROGRAM  
FRONTAL BARRIER IMPACT TEST**

**DAIMLERCHRYSLER AG STUTTGART  
2008 MERCEDES-BENZ C300  
NHTSA NUMBER: M80508**

**PREPARED BY:  
MGA RESEARCH CORPORATION  
5000 WARREN ROAD  
BURLINGTON, WI 53105**

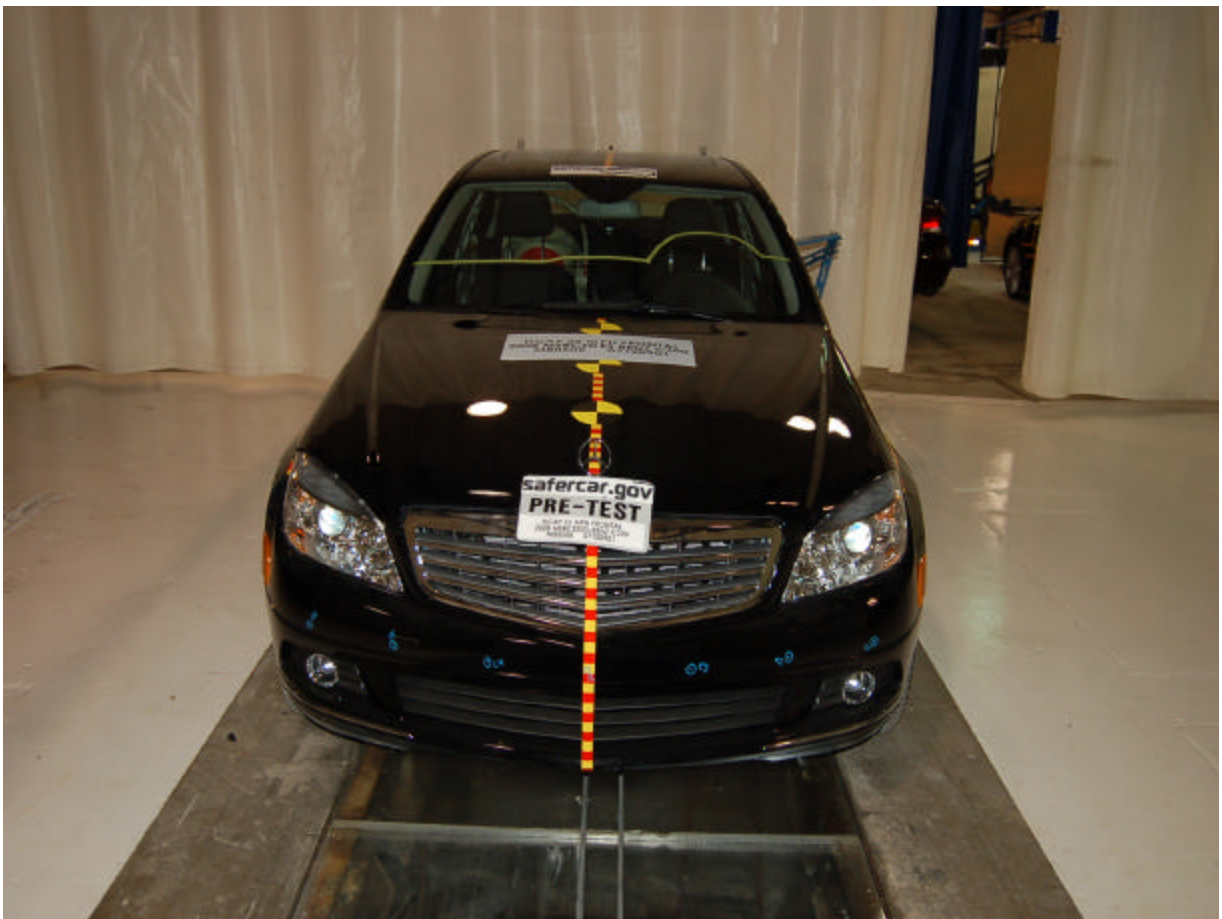
Pre-Test Front View

Post-Test Front View

The maximum static crush of the vehicle was 460 mm and both the driver and passenger side doors remained closed and latched during the impact event and were operable after the impact.

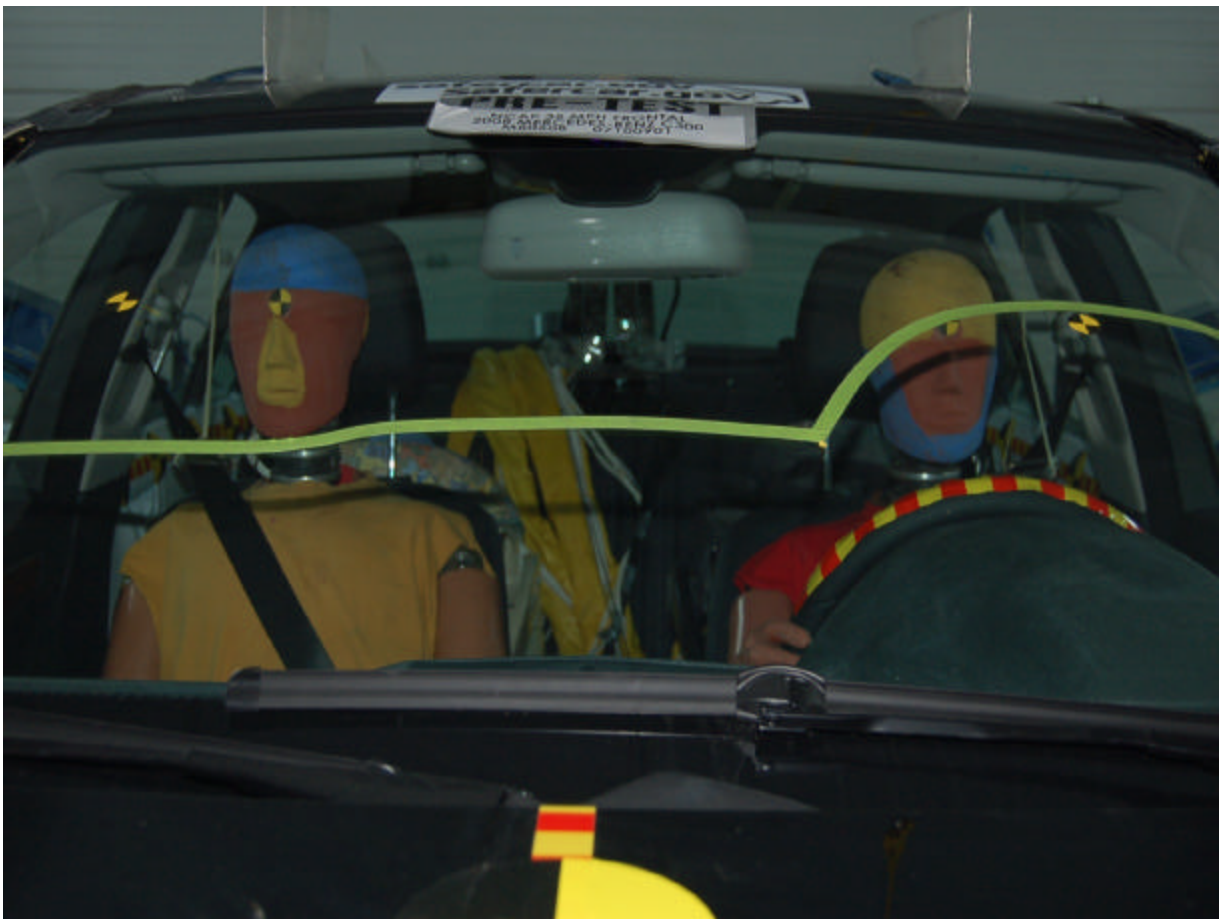
Pre-Test Windshield View

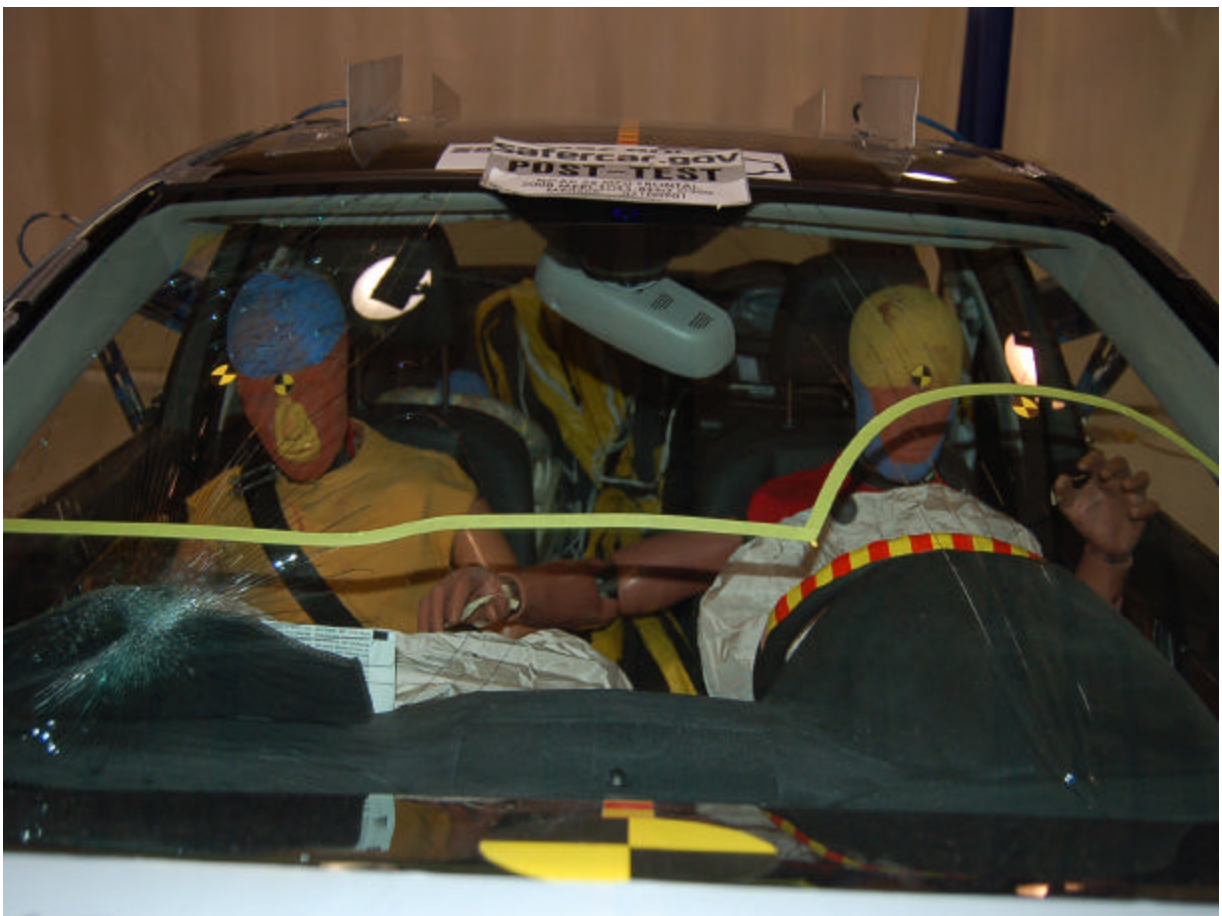
Post-Test Windshield View

There was 100 percent windshield retention and no intrusion into the protected zone of the windshield during the event. There was no Stoddard Solvent leakage after the event or during any phase of the static rollover.

| Description | Driver | Passenger |
|---|---|---|
| Glazing Damage | The windshield cracked. | |

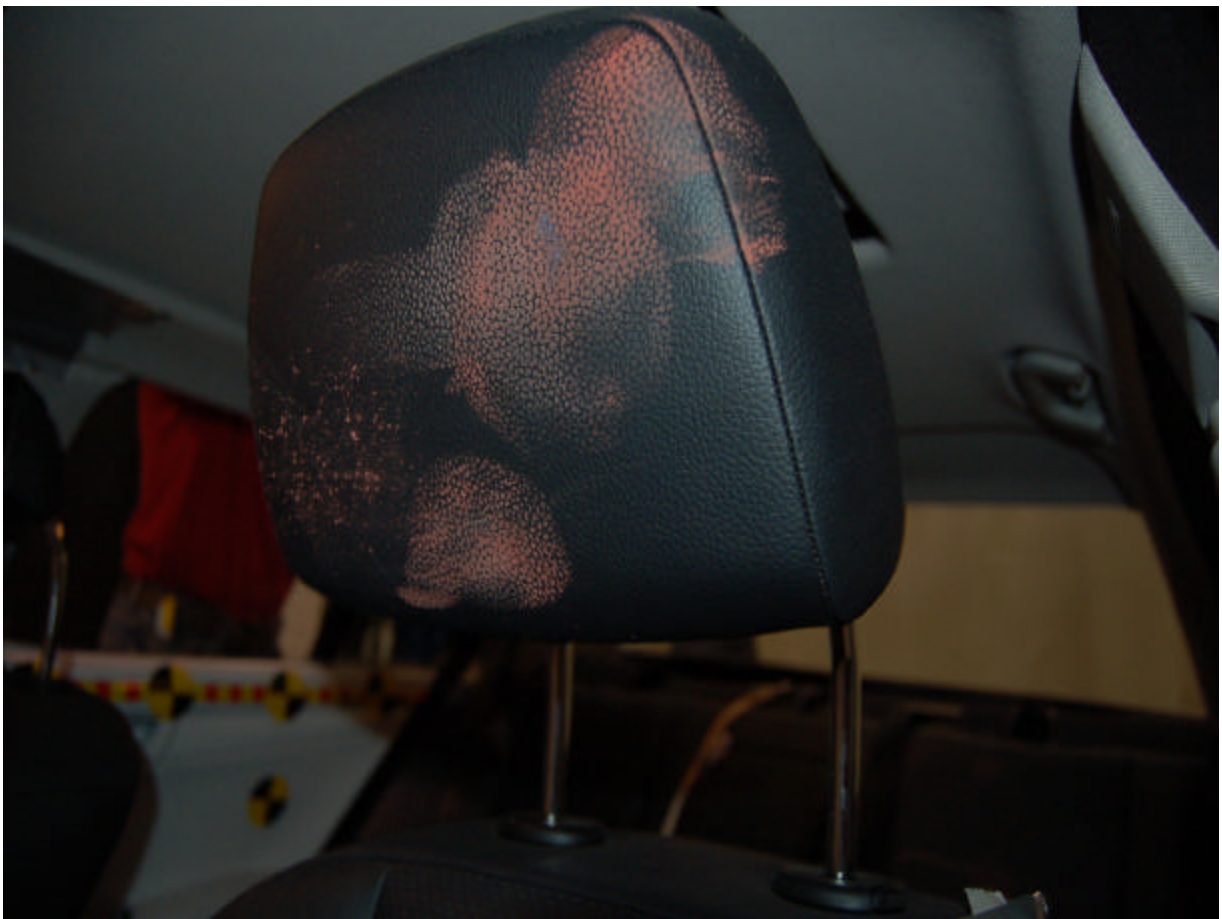
Post-Test Driver Dummy Head Contact (headrest)

Post-Test Driver Dummy Head Contact (side header)

The driver's head and chest contacted the airbag. The driver's head also contacted the headrest and side header. The driver's knees contacted the knee bolster. The passenger's head and chest contacted the airbag. The passenger's head also contacted the headrest, visor, and side header. The passenger's knees contacted the glove box.

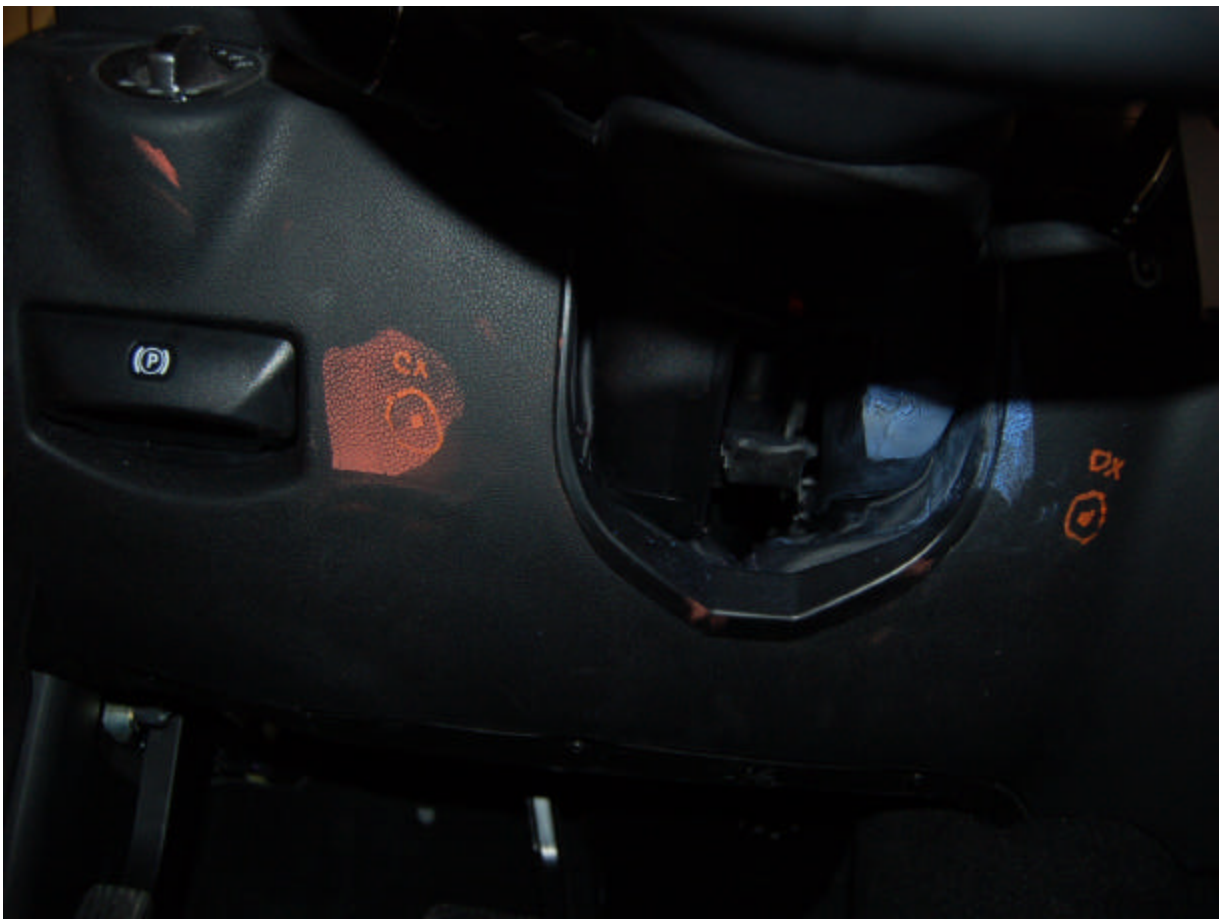
Post-Test Driver Dummy Knee Contact

Post-Test Driver Dummy Airbag Contact

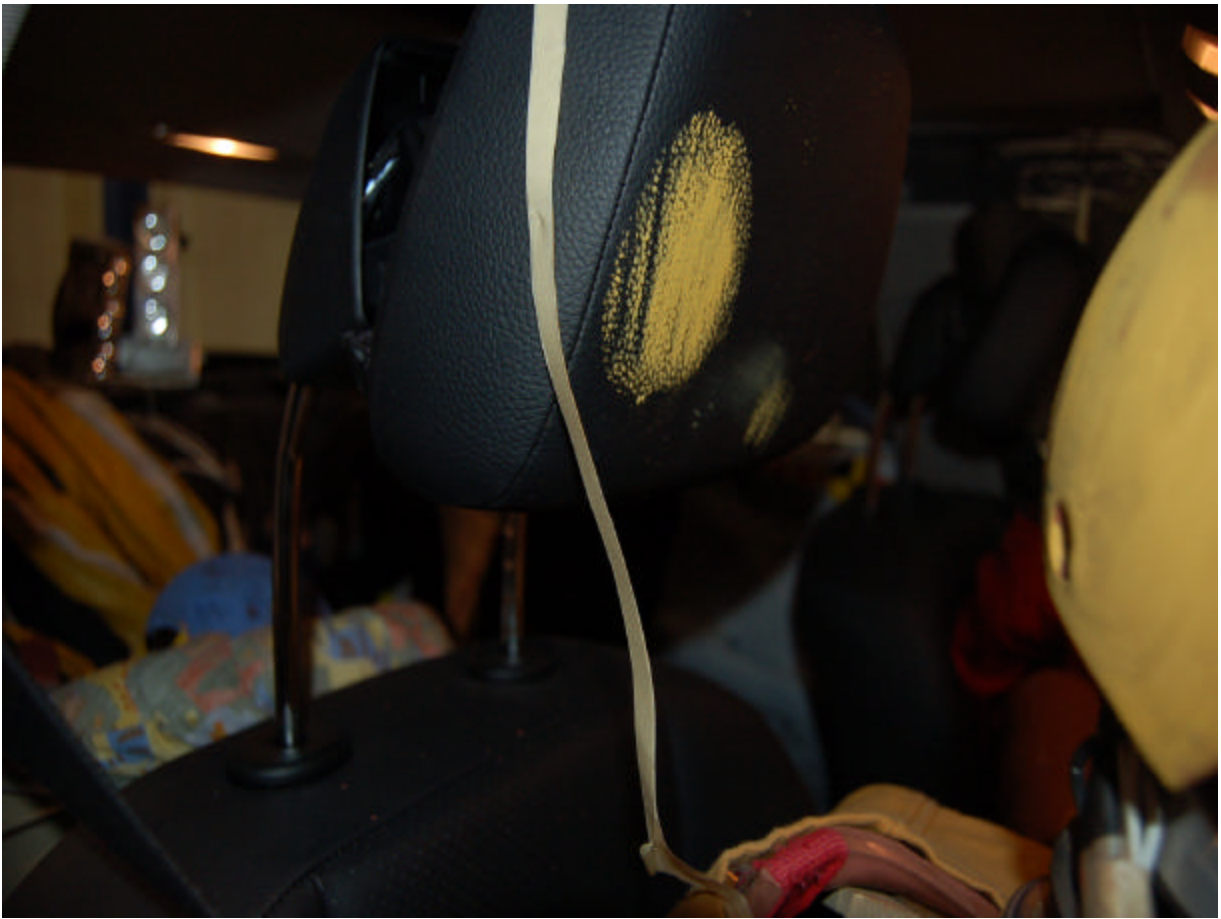
Post-Test Passenger Dummy Head Contact (headrest)

Post-Test Passenger Dummy Head Contact (visor & side header)

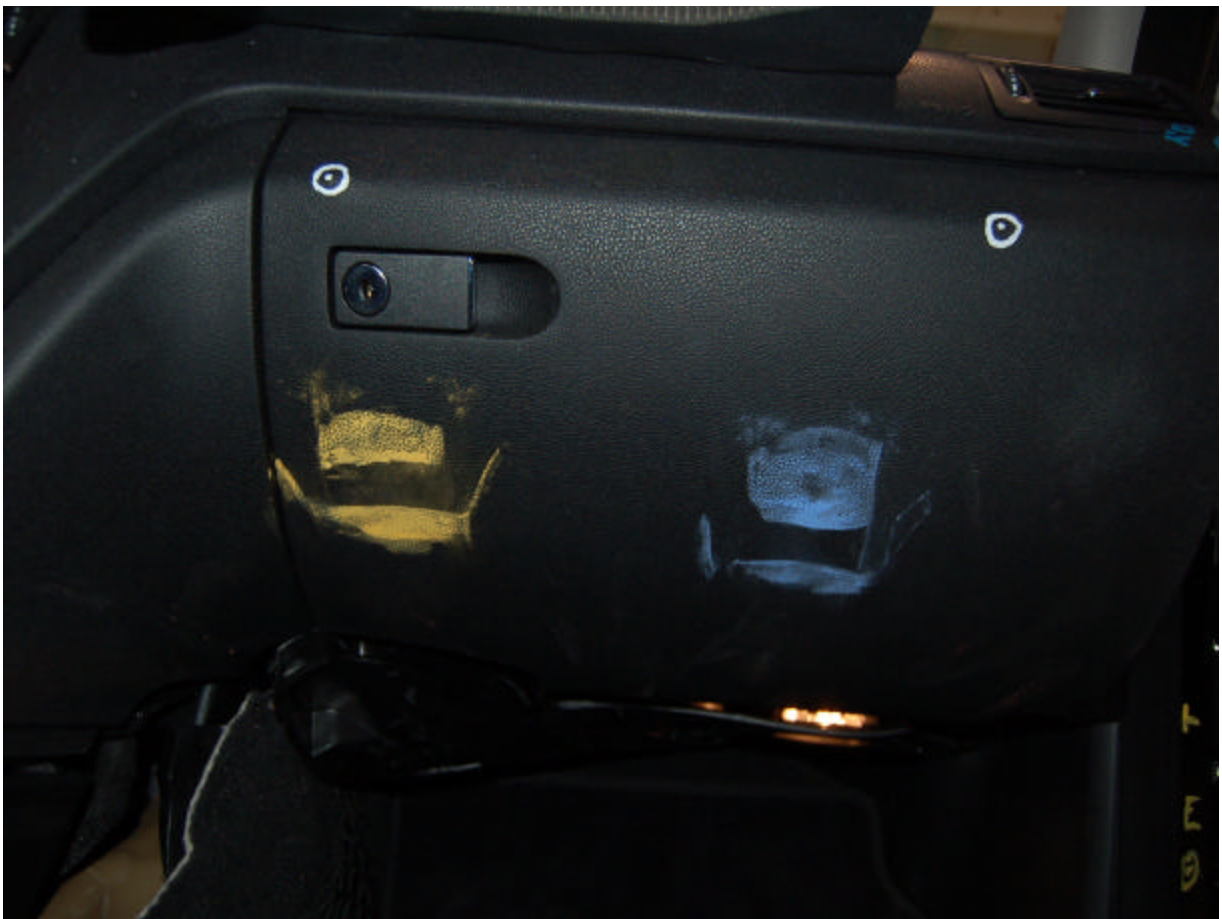
Post-Test Passenger Dummy Knee Contact

Post-Test Passenger Dummy Airbag Contact
