**REPORT NUMBER: NCAPSIDE-MGA-2008-008**

**NEW CAR ASSESSMENT PROGRAM  
SIDE IMPACT TEST**

**TOYOTA MOTOR CORPORATION  
2008 TOYOTA YARIS 3-DOOR LIFTBACK  
NHTSA NUMBER: M85117**

**PREPARED BY:  
MGA RESEARCH CORPORATION  
5000 WARREN ROAD  
BURLINGTON, WI 53105**

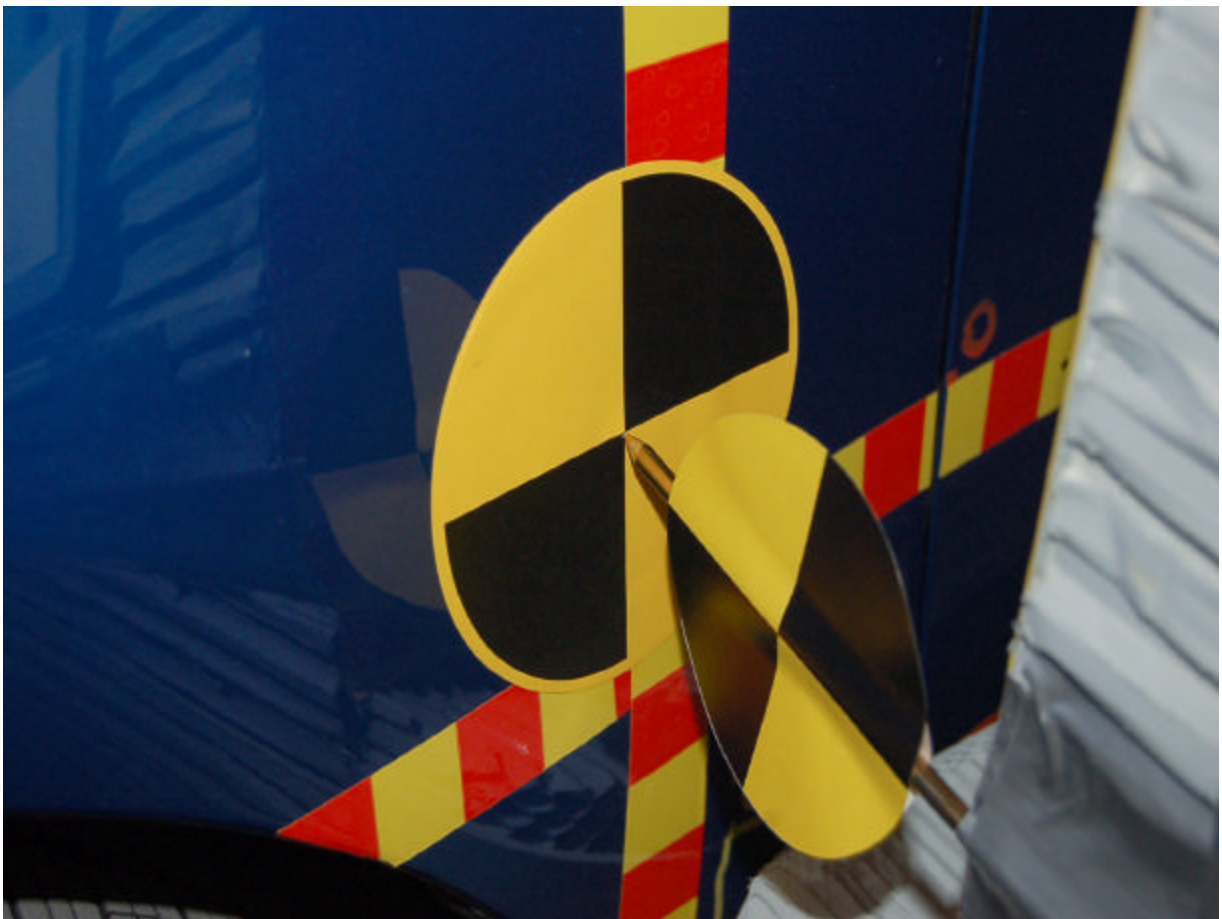
Pre-Test Left Impact Point

Post-Test Left Impact Point

The test vehicle sustained a maximum static crush of 248 mm at level 2, 1200 mm rearward of the vertical impact point. The driver and passenger SID/HIIIs, Serial Nos. 904 and 271 respectively, were calibrated just prior to this test.

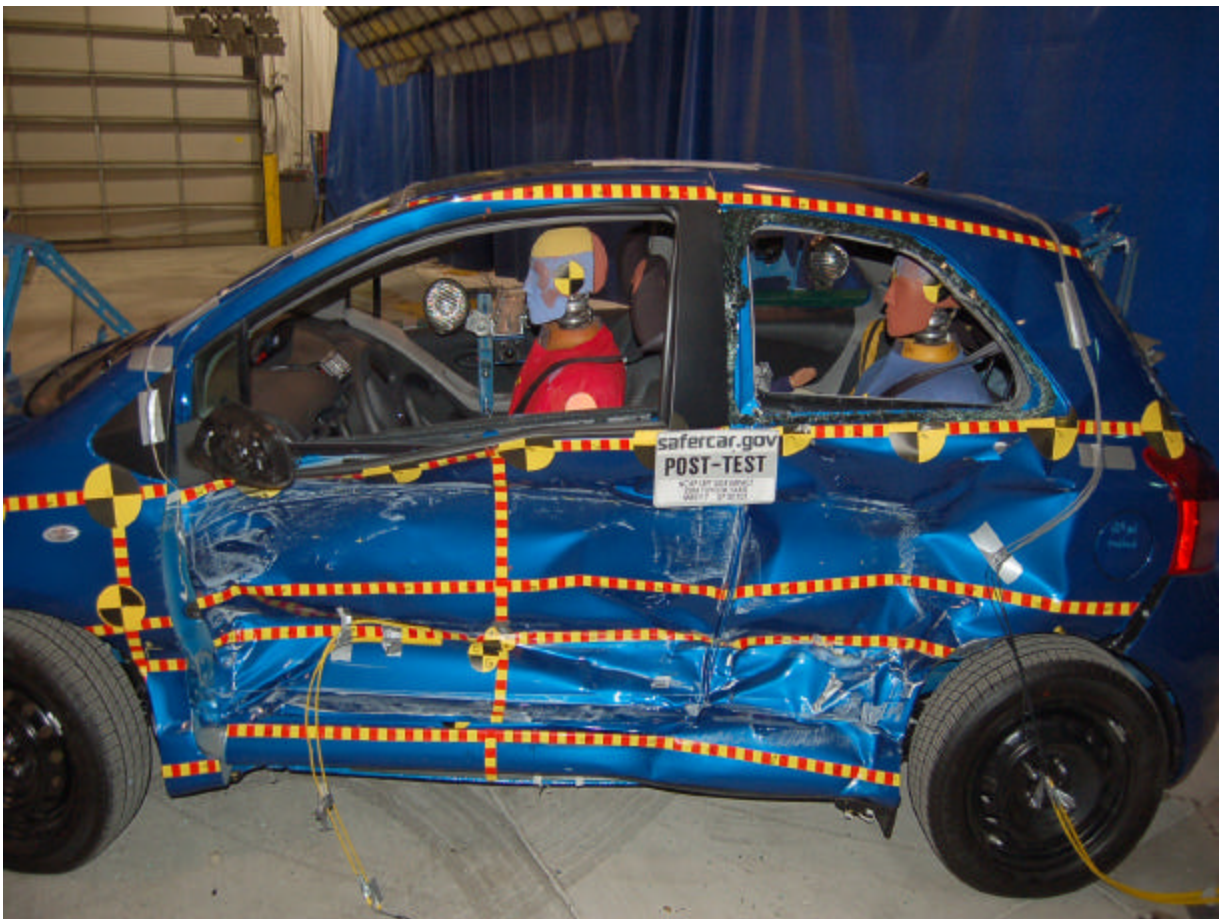
Post-Test Left Side Impact Close-up

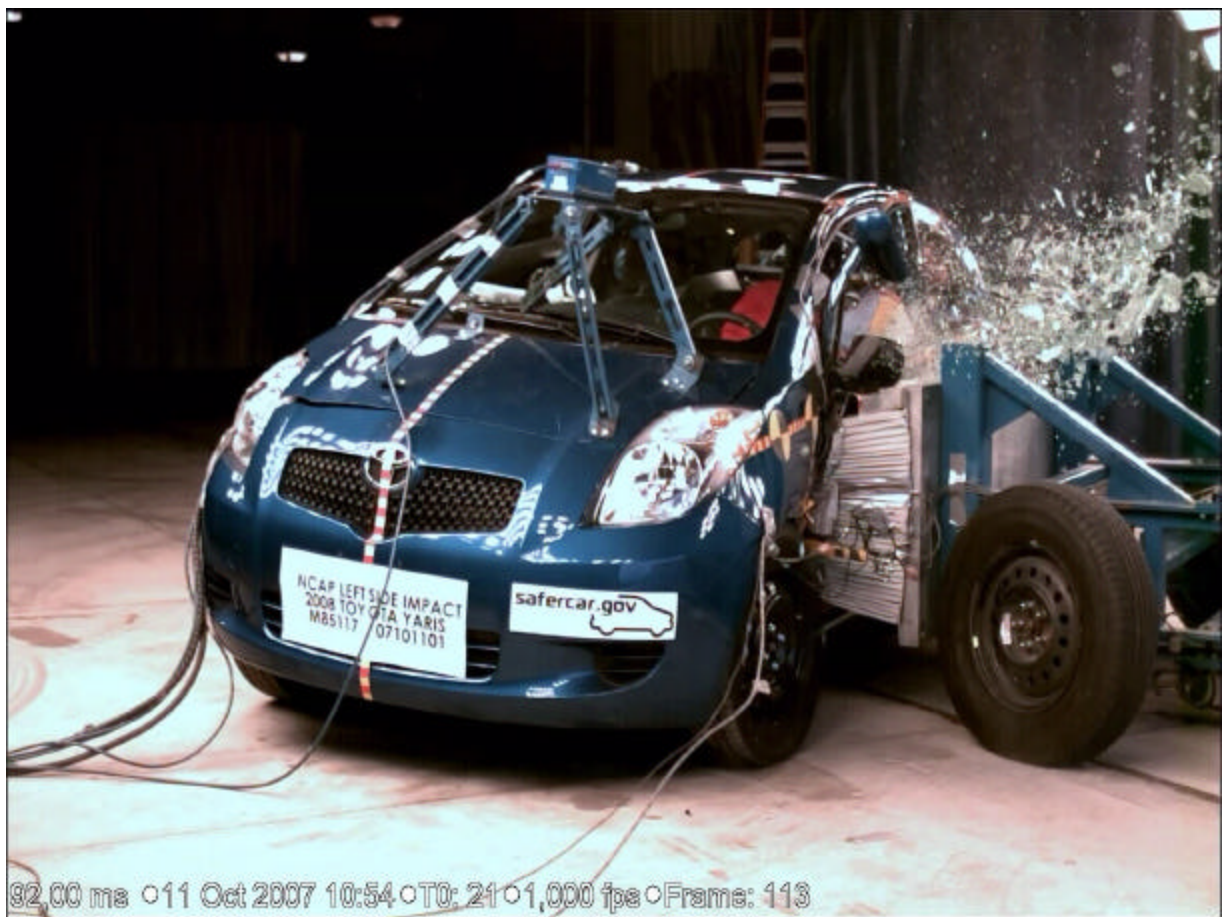
82.00 ms 011 Oct 2007 10:54 0T0: 21 01,000 fpe 0Frame: 113

Vehicle Impact

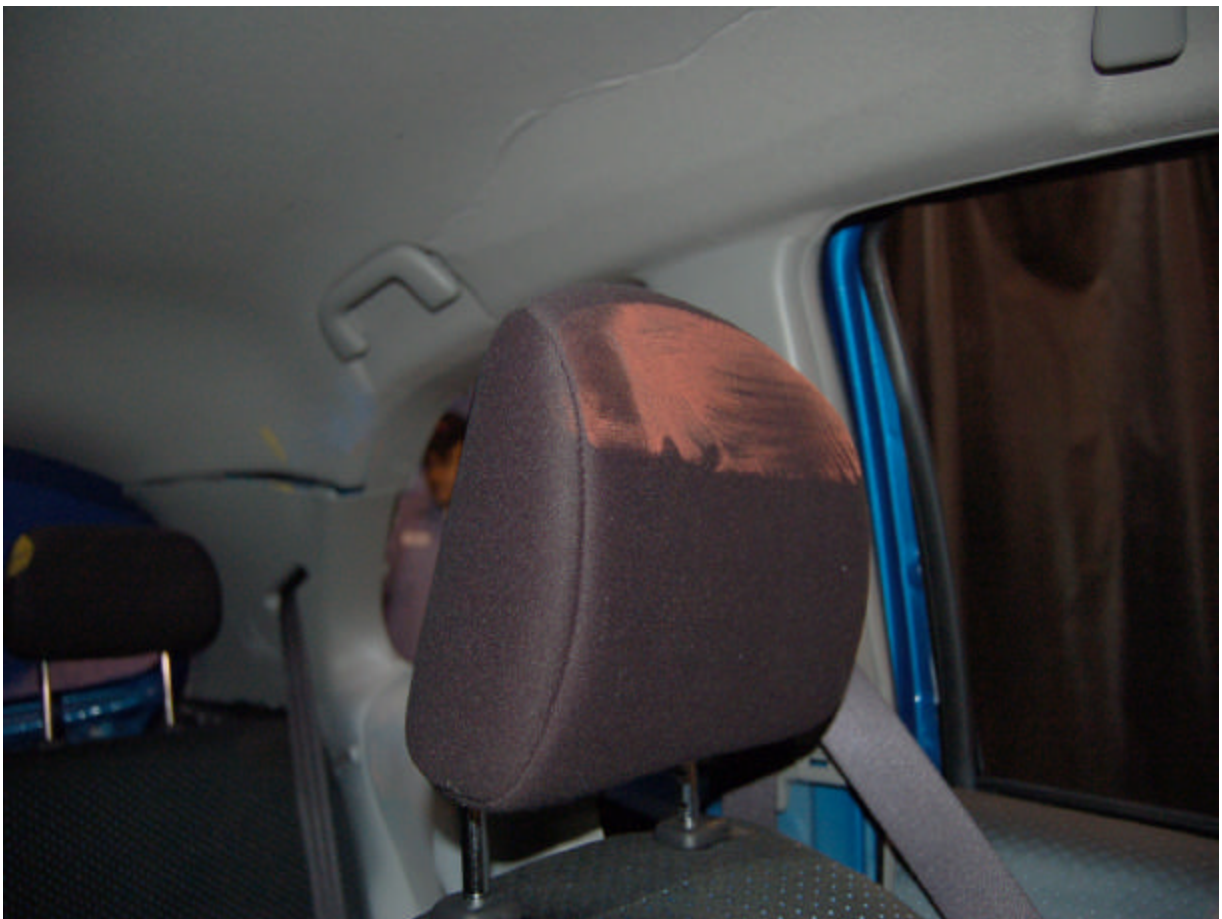
Post-Test Driver Dummy Head Contact

Post-Test Driver Dummy Torso Contact
