**Report Number: 214-TRC-06-011**

**Safety Compliance Testing For FMVSS 214**

**Side Impact Protection**

**2008 Saturn Vue XE MPV**

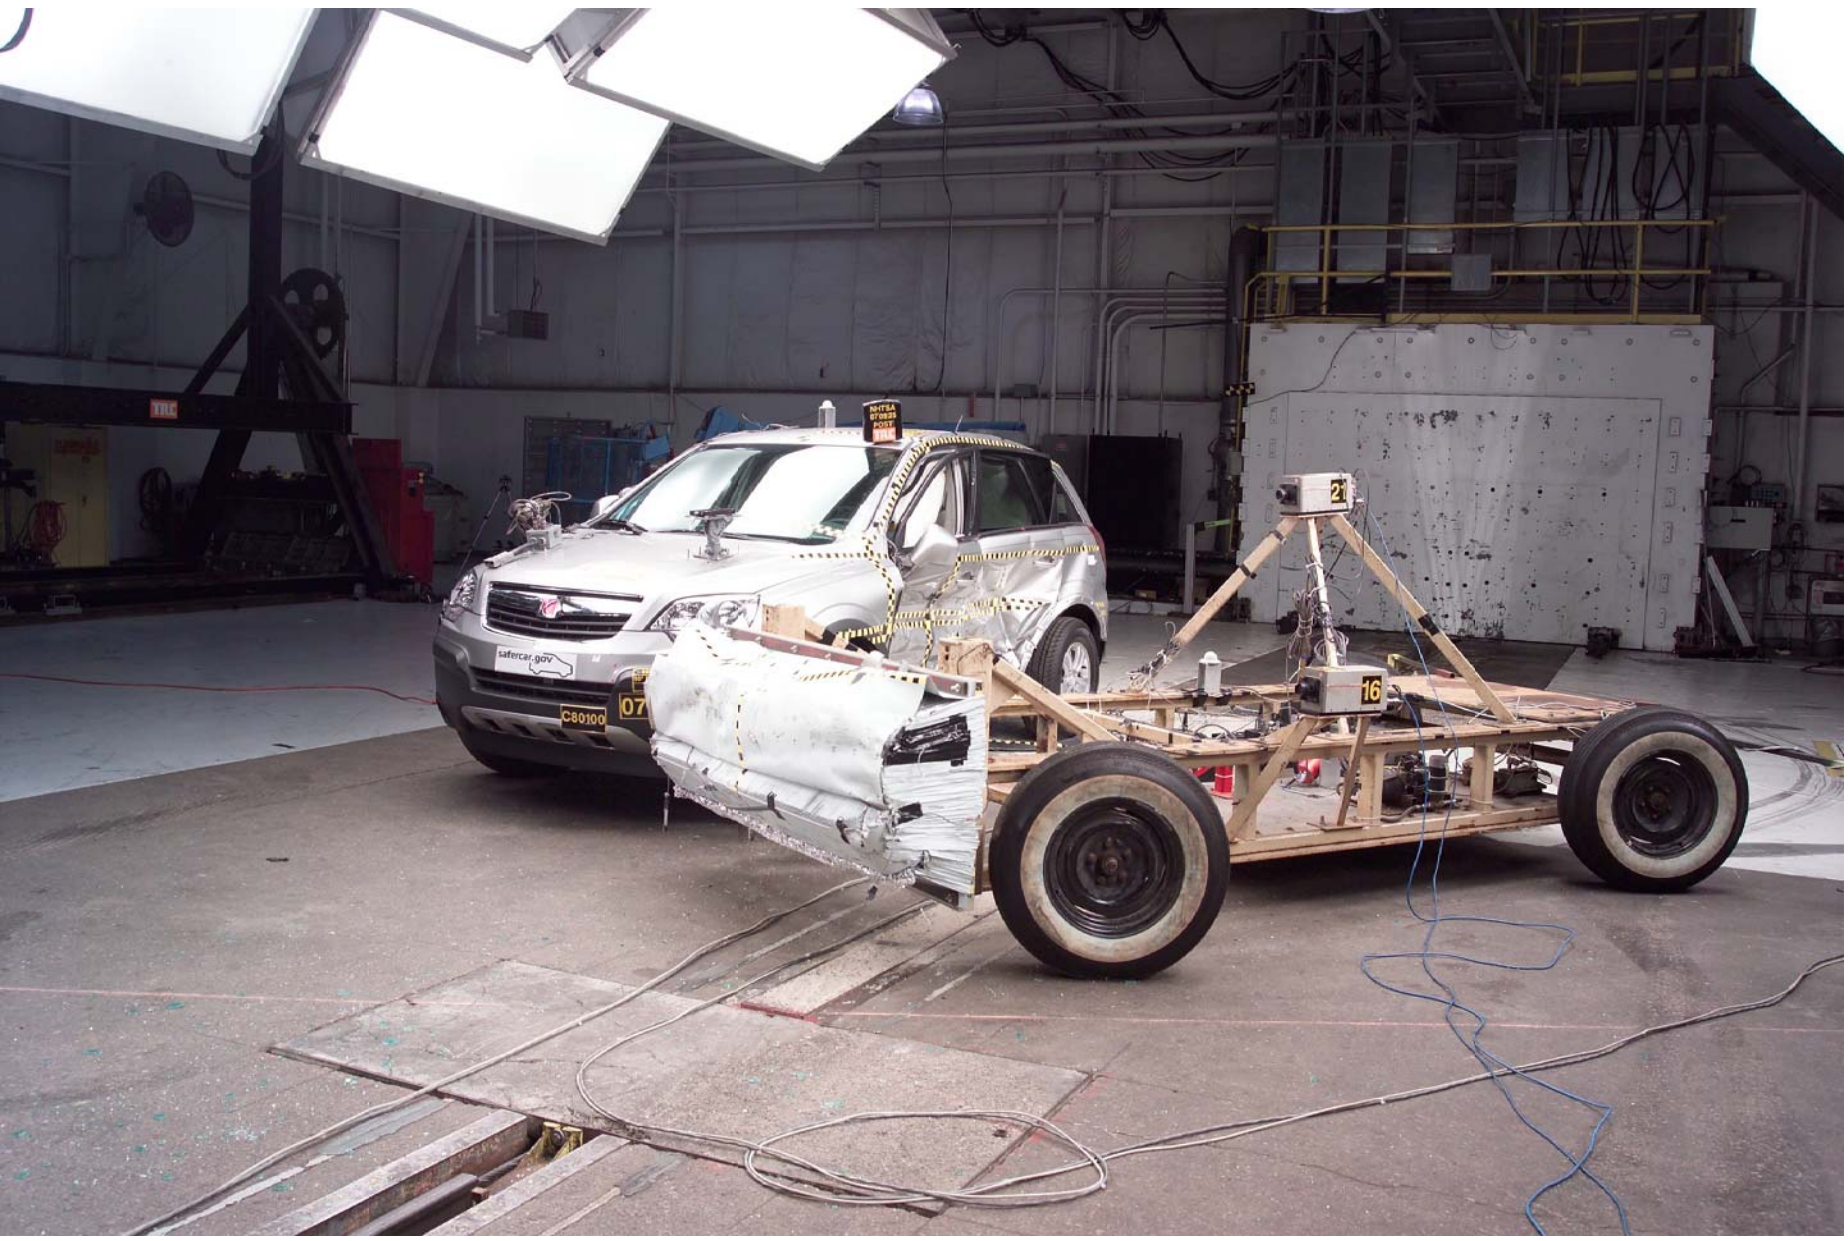
Figure A-4 Post-Test Left Front View of Test Vehicle

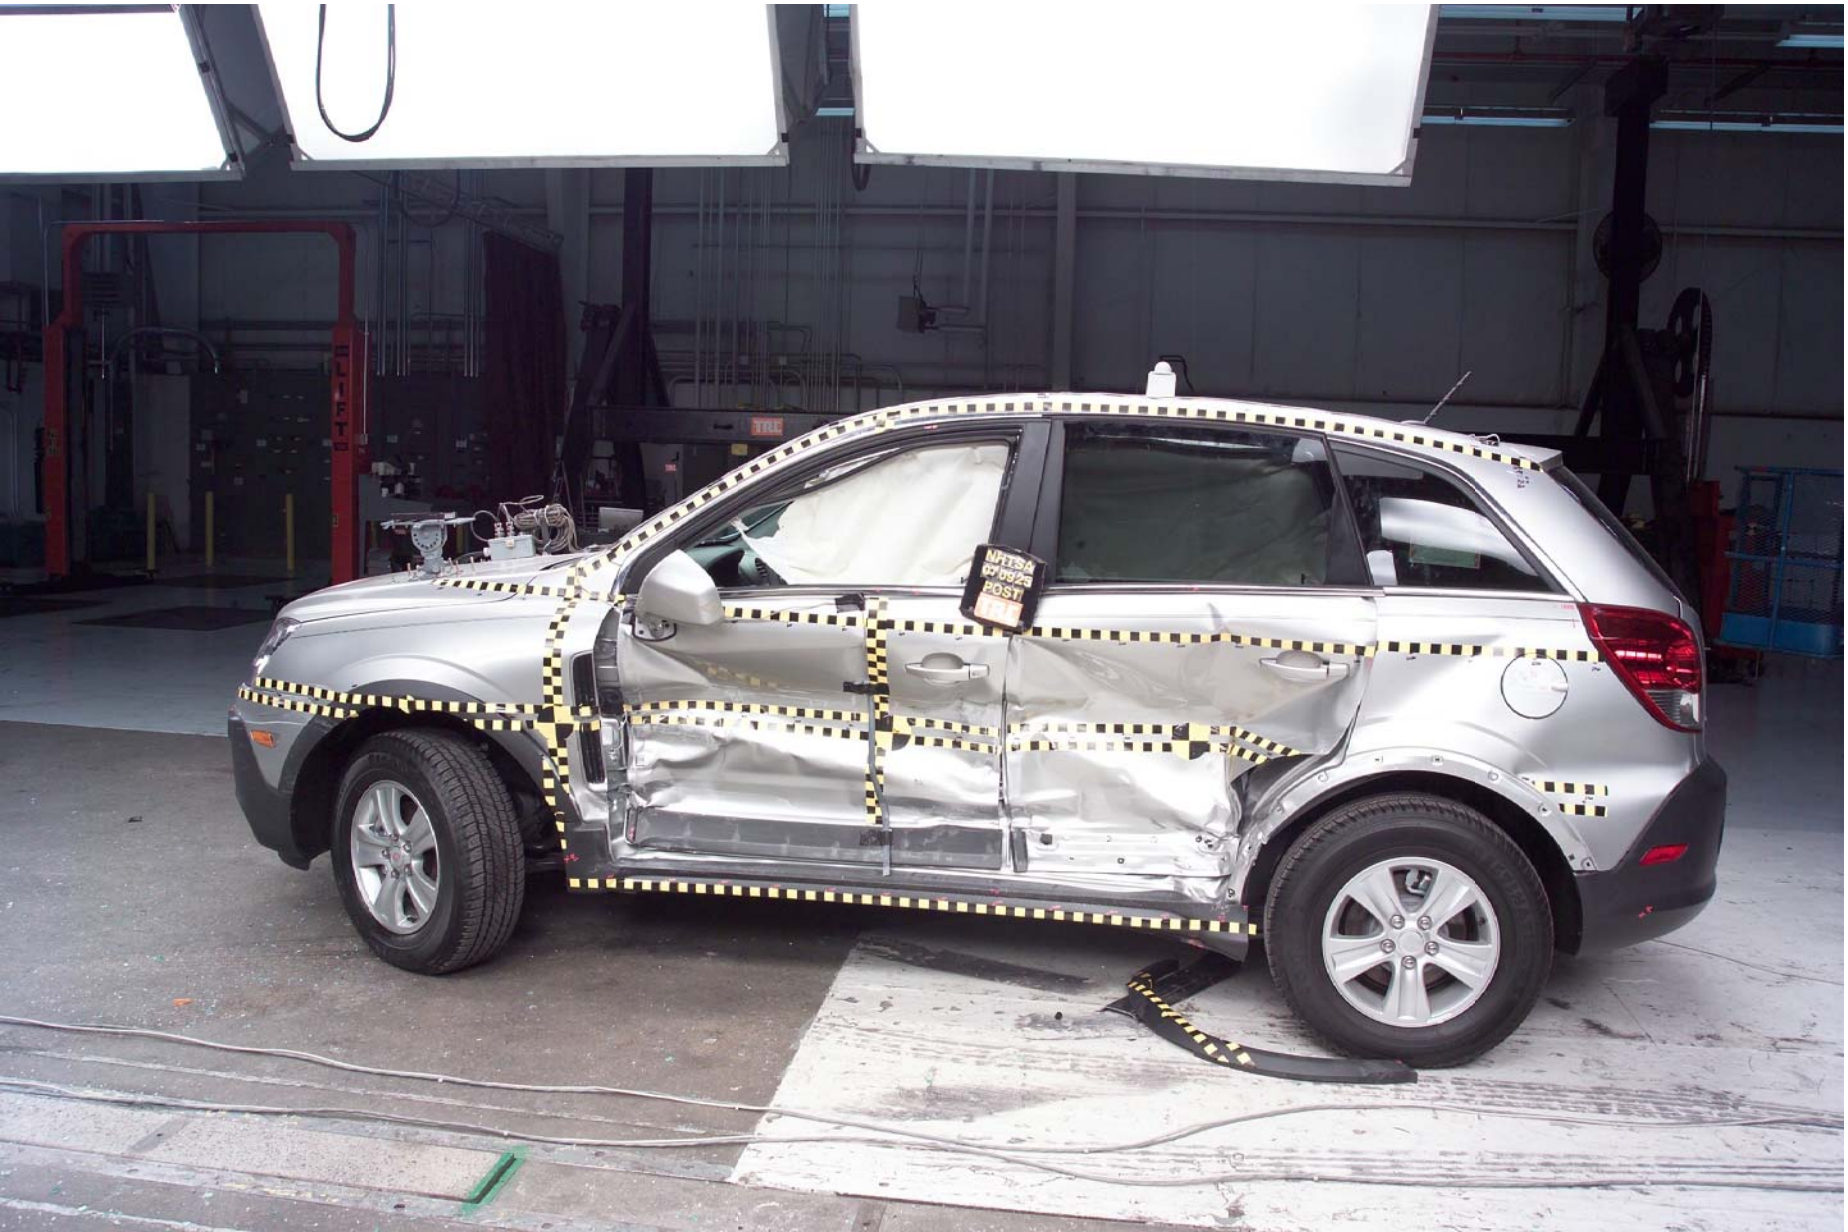
Figure A-6 Post-Test Impacted Side View of Test Vehicle

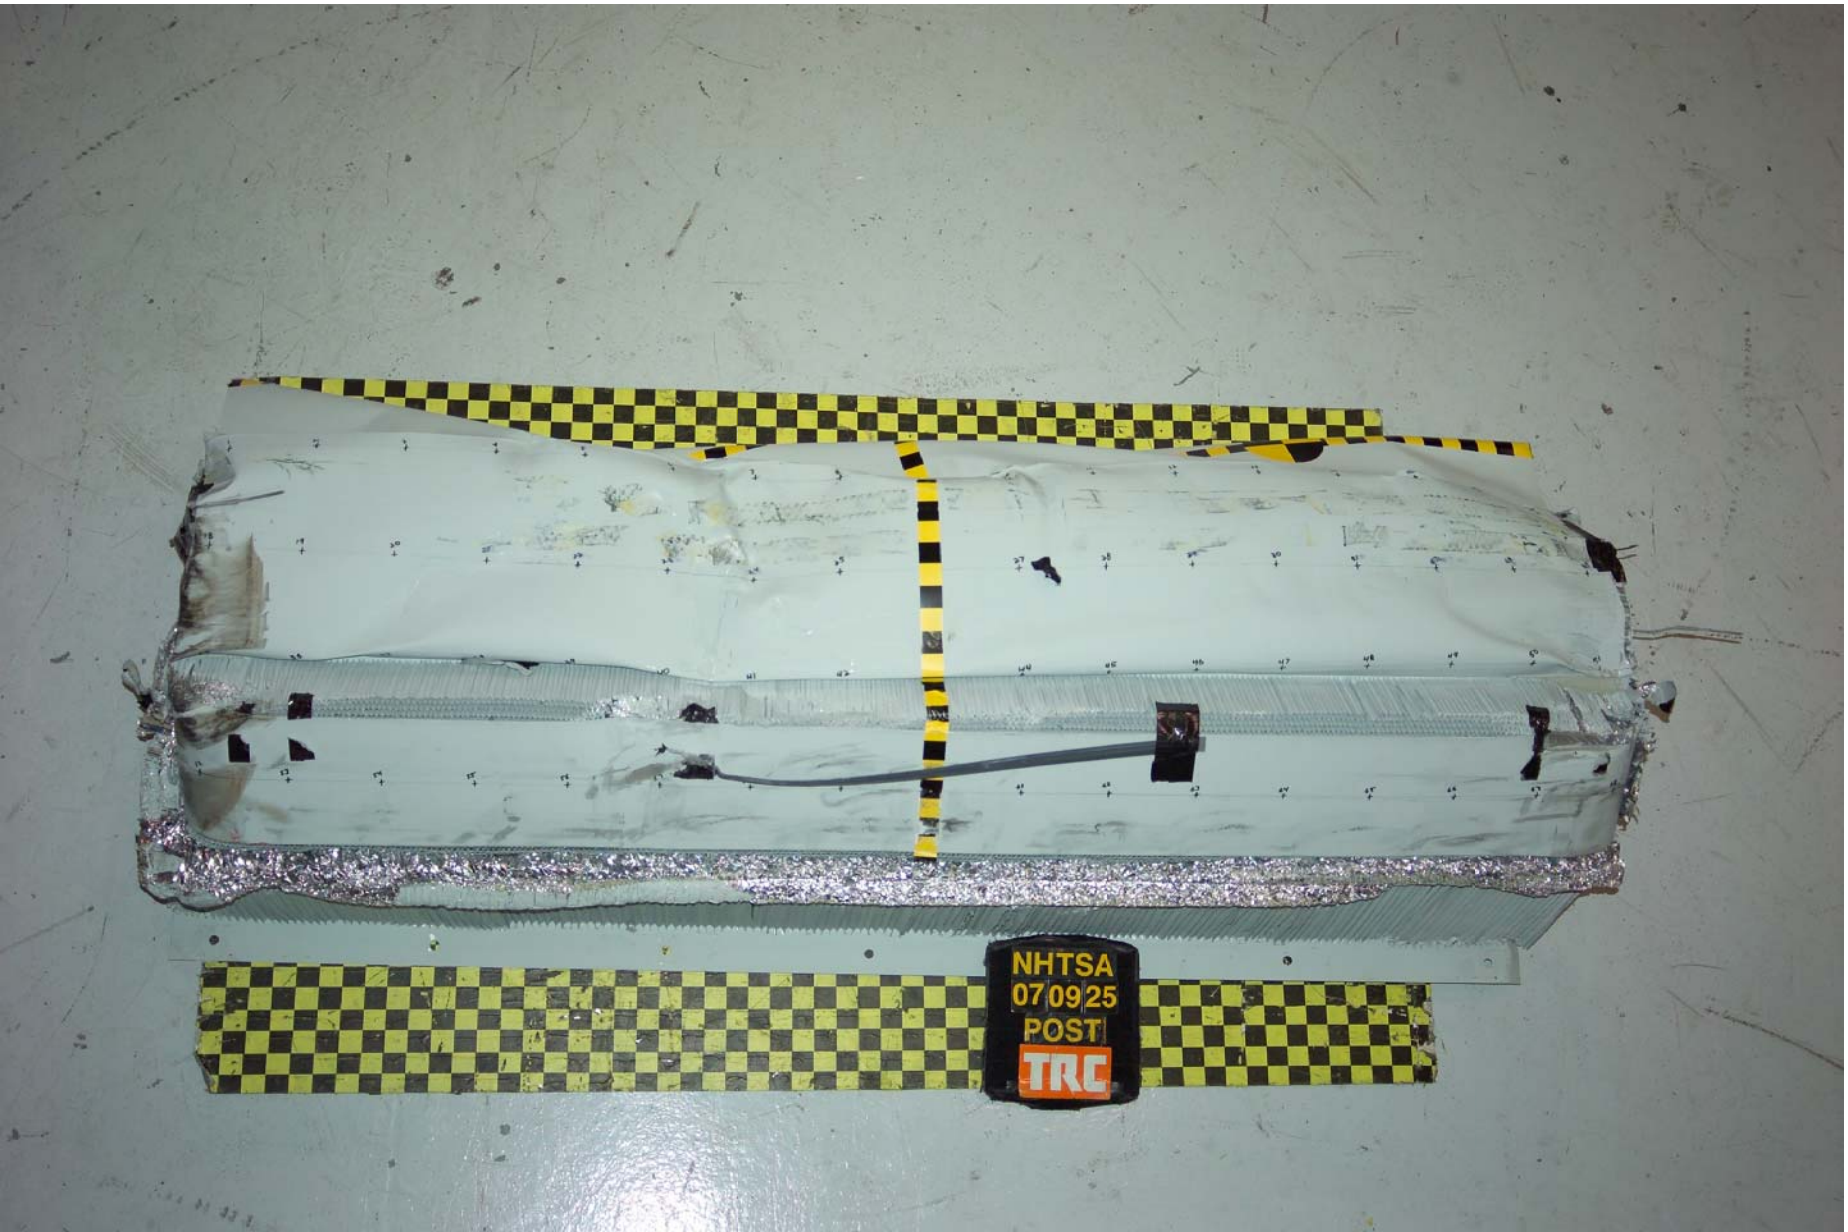
Figure A-18 Post-Test Frontal View of Impactor Face

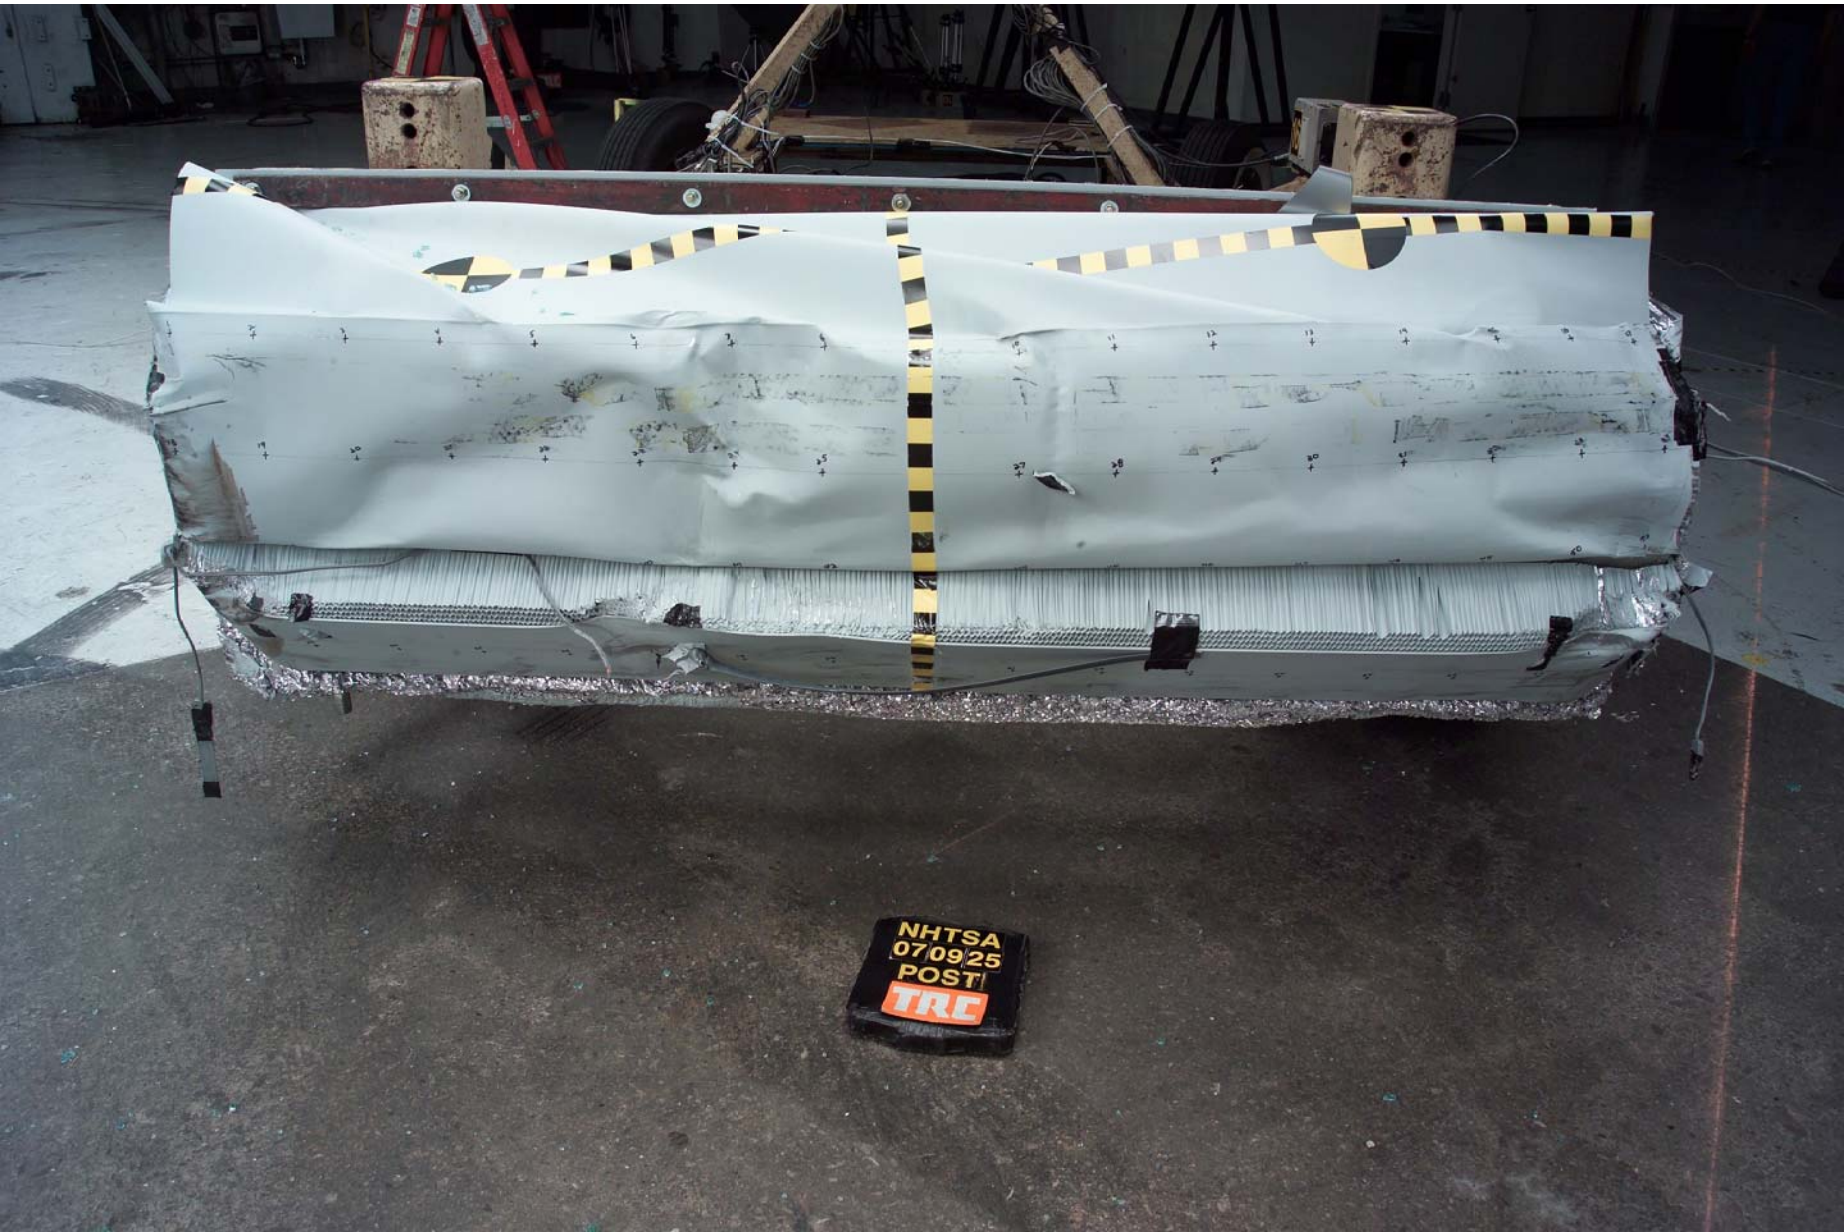
Figure A-38 Post-Test View of MDB Showing Contact Switches in Place

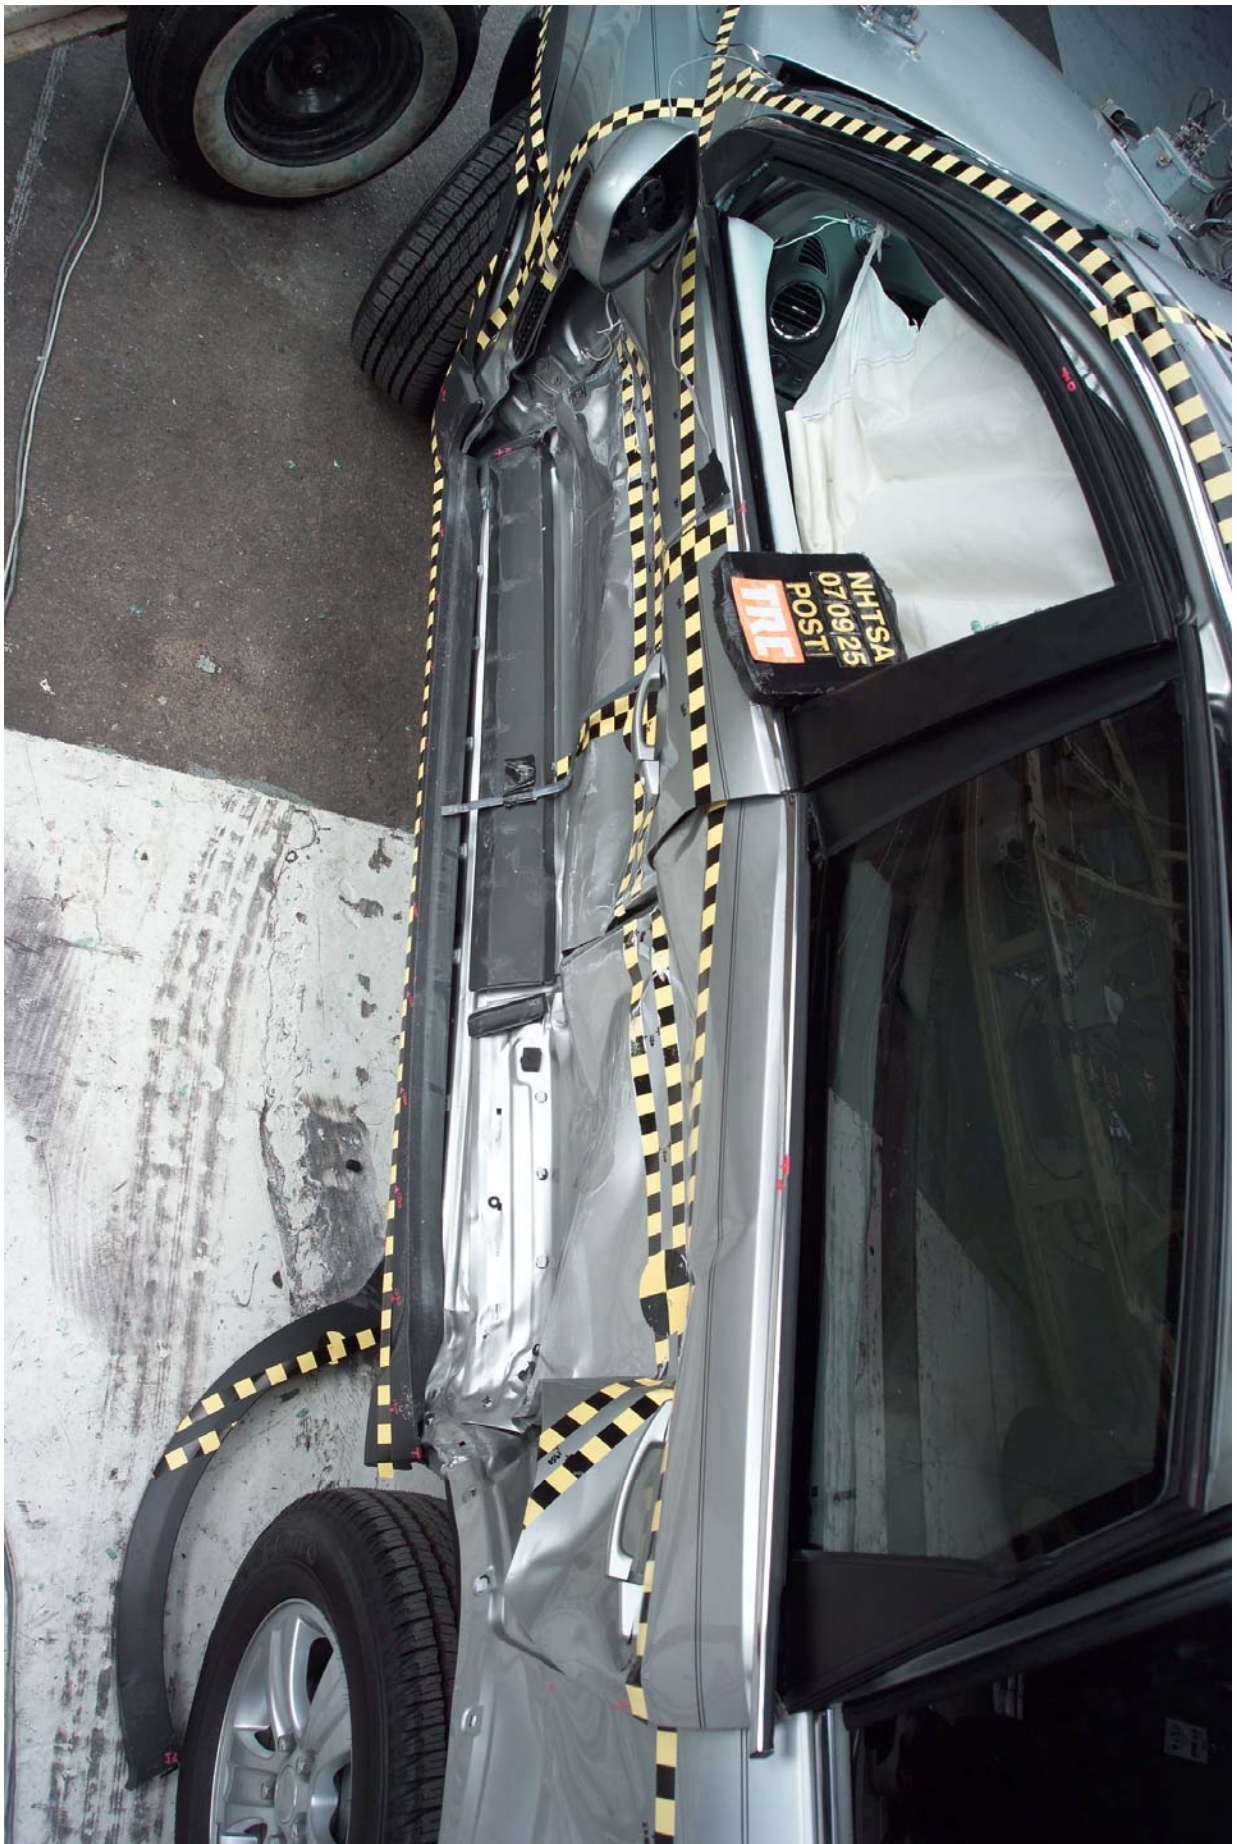
**Figure A-40 Post-Test Overhead View of MDB and Vehicle**

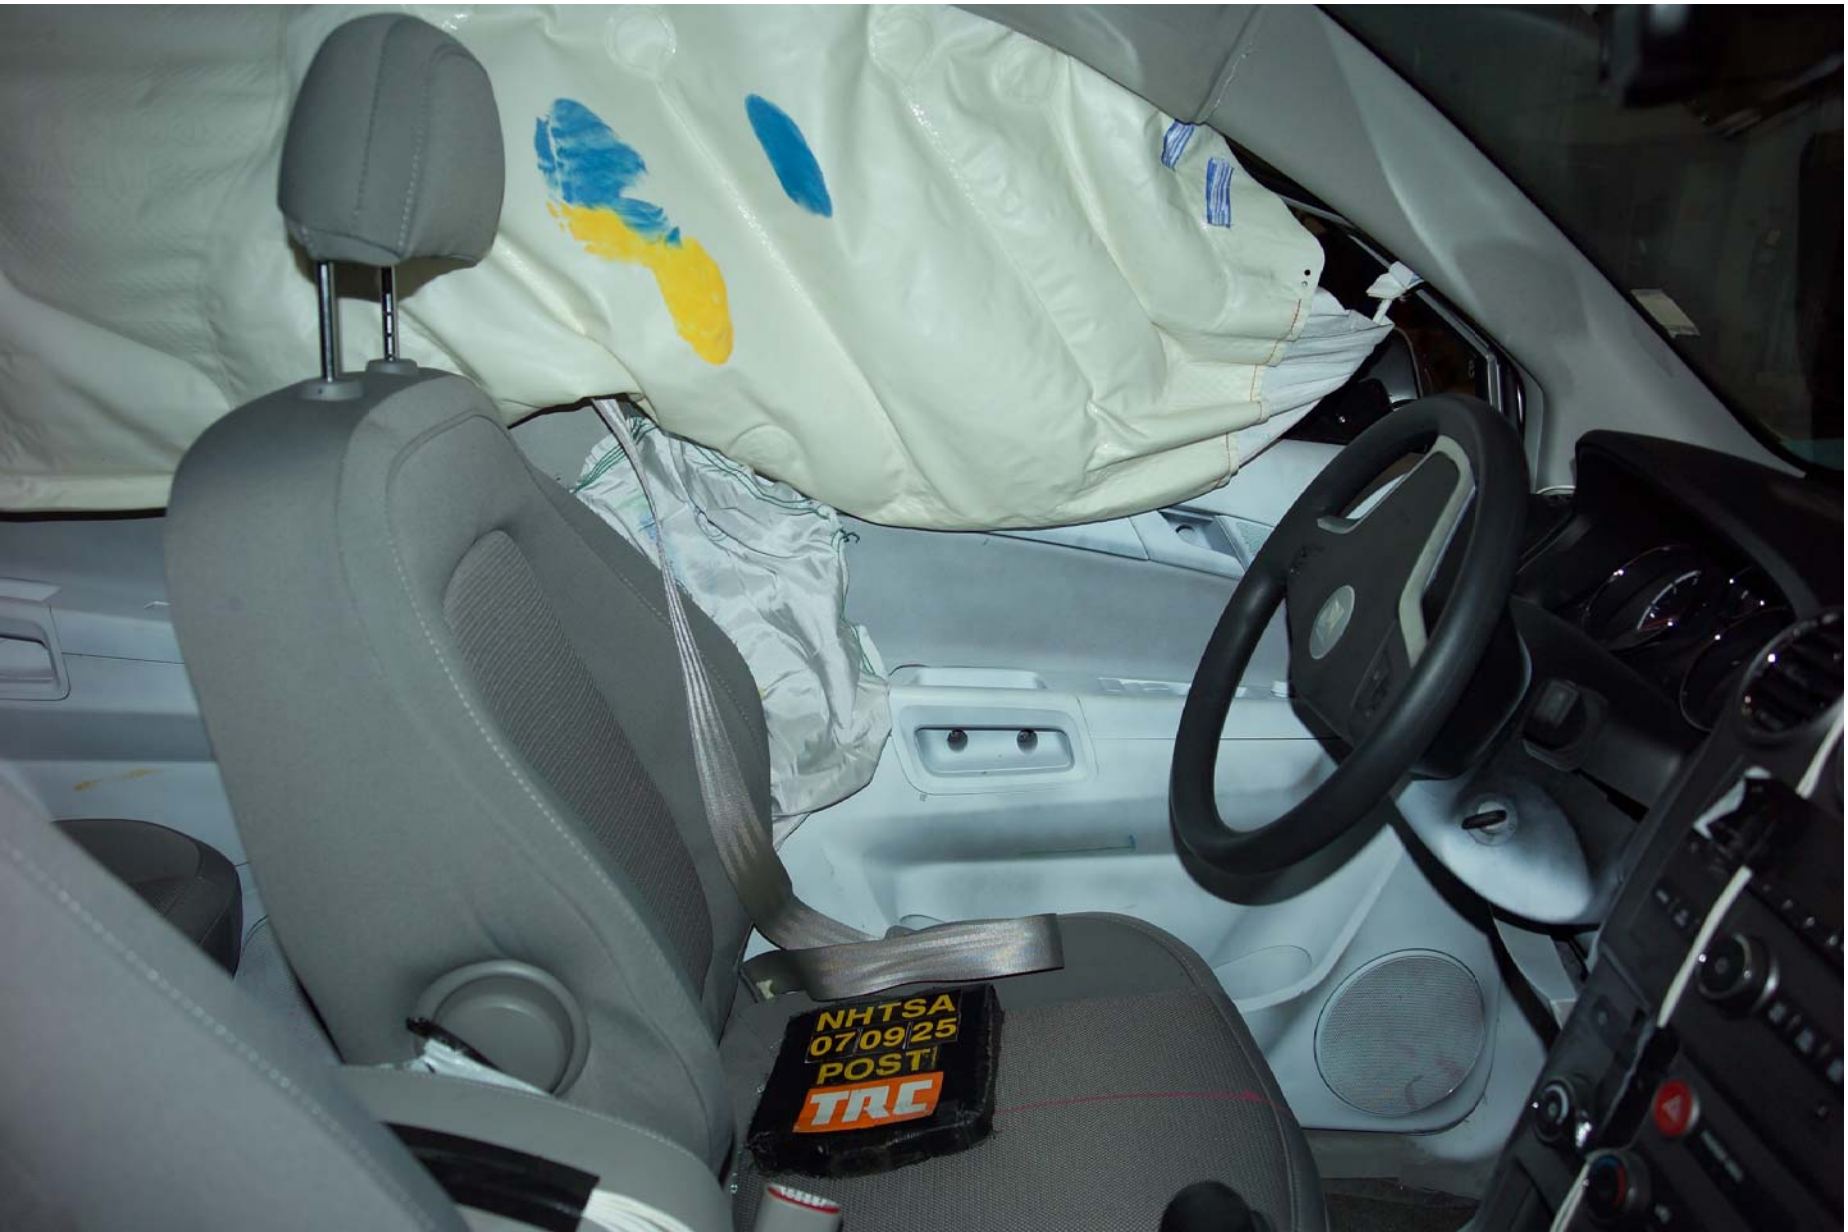
**Figure A-56 Post-Test Interior of Front Door Showing SID Impact Locations**

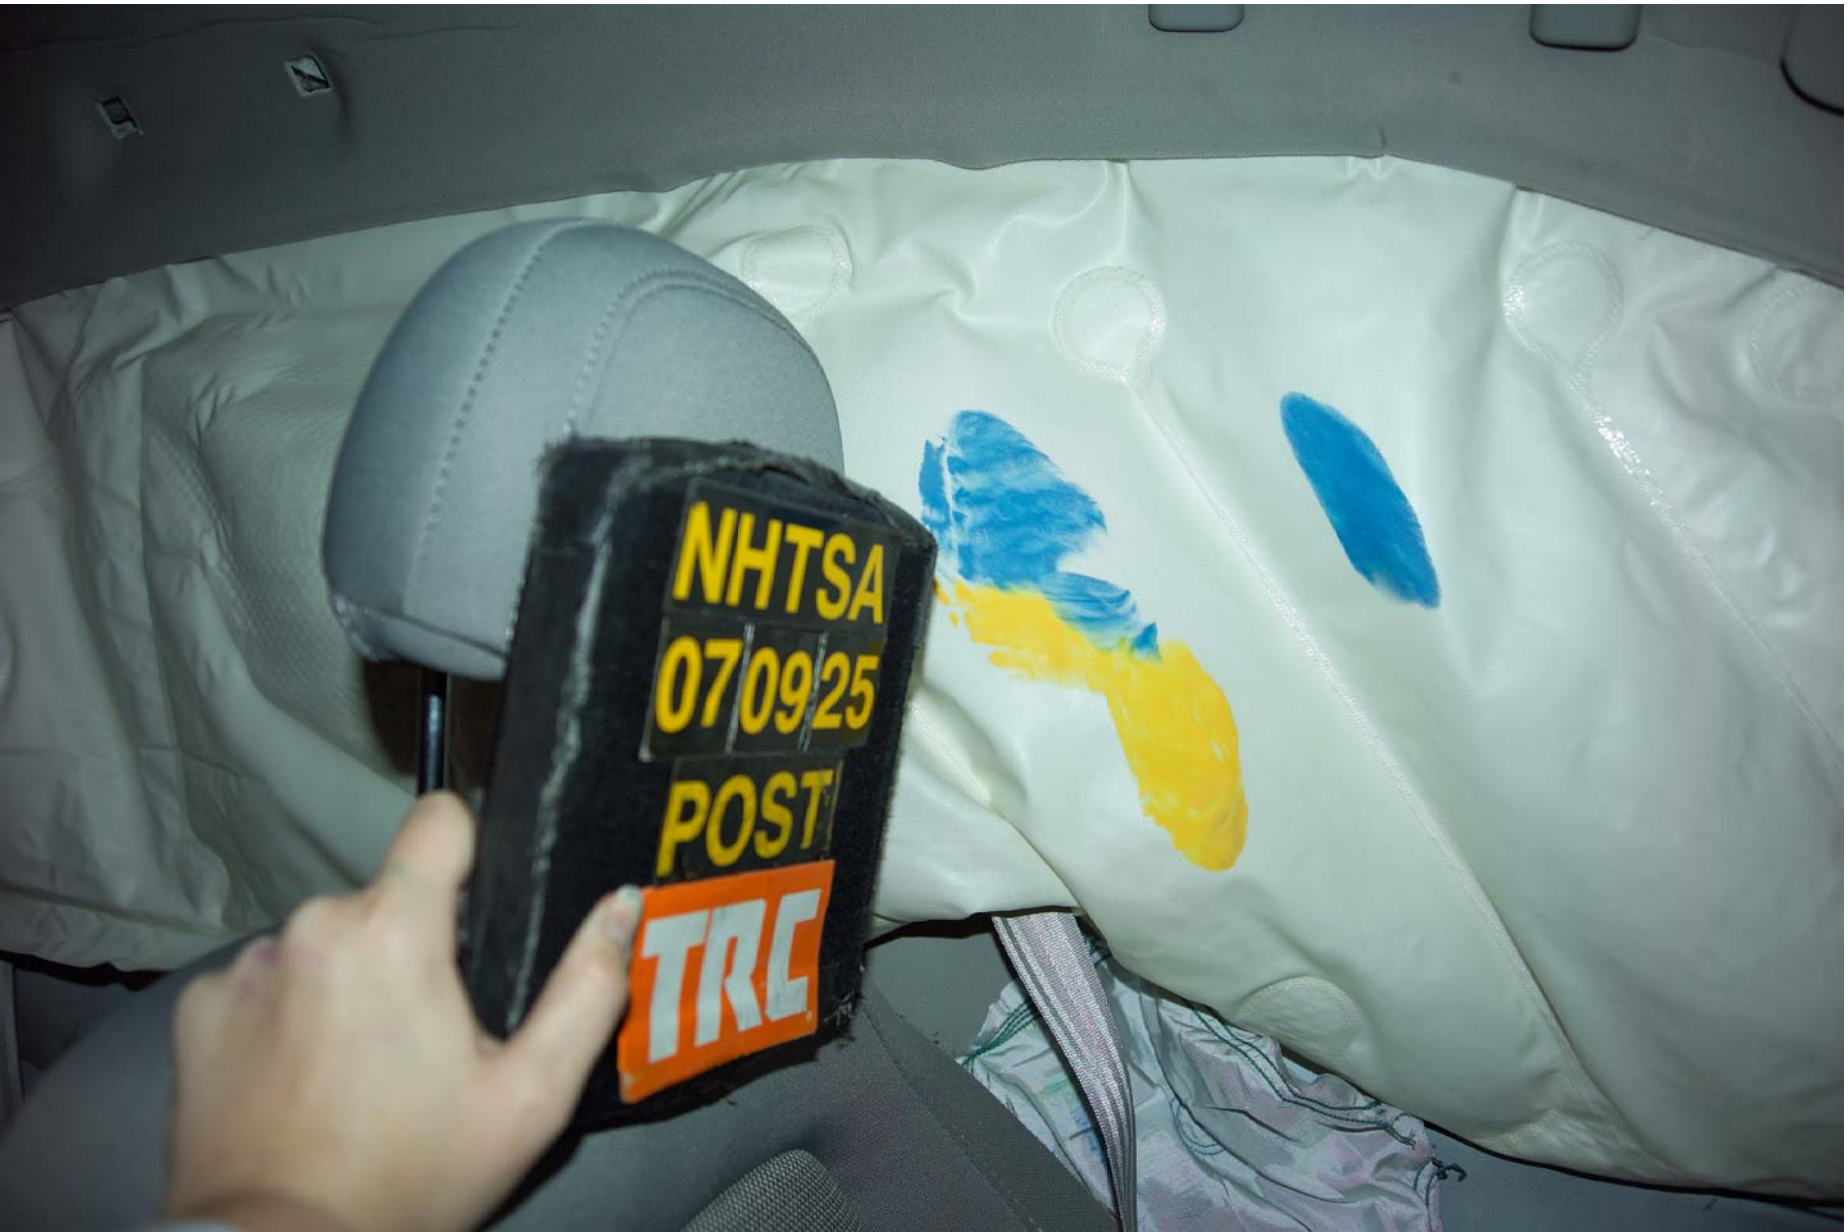
Figure A-57 Post-Test Front SID Contact – View 1

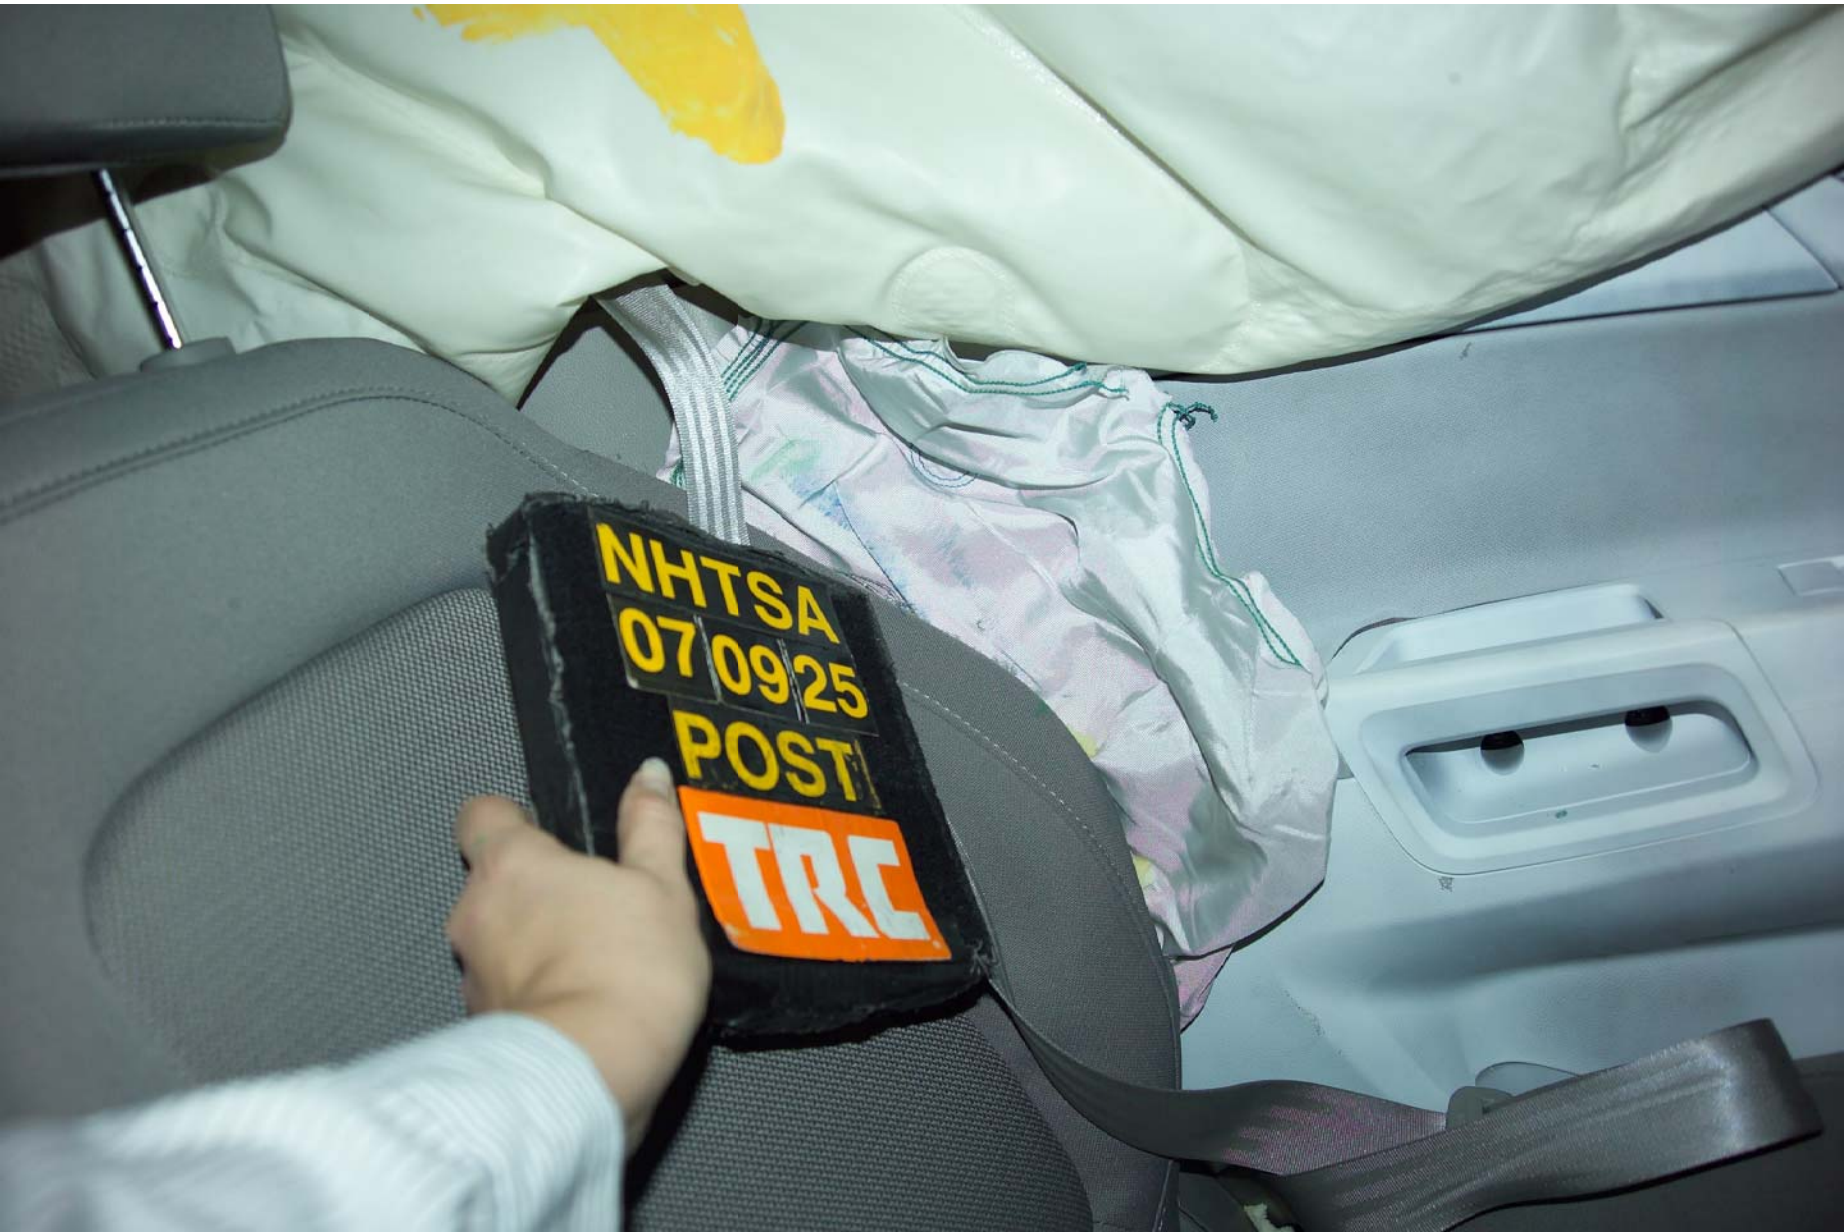
Figure A-58 Post-Test Front SID Contact – View 2

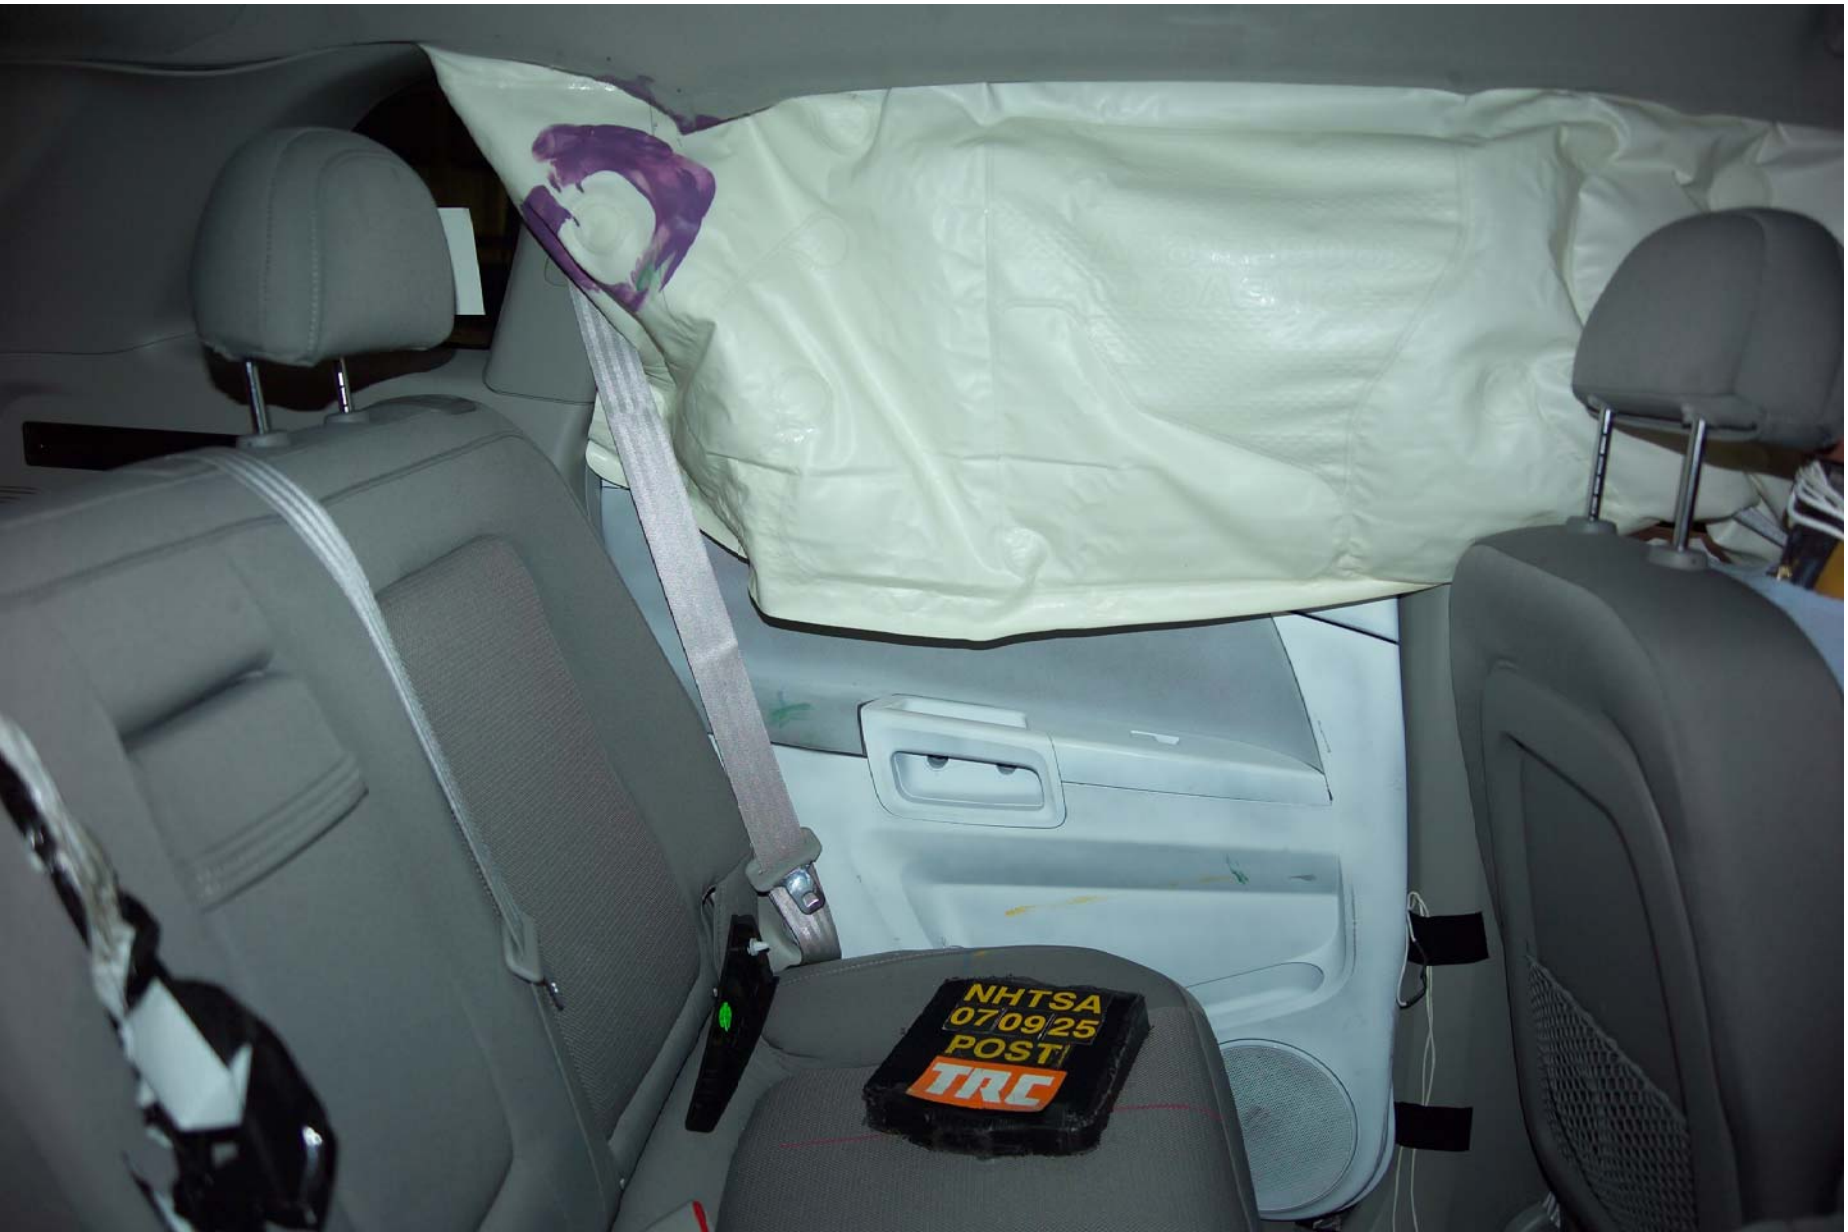
**Figure A-60 Post-Test Interior of Rear Door Showing SID Impact Locations**

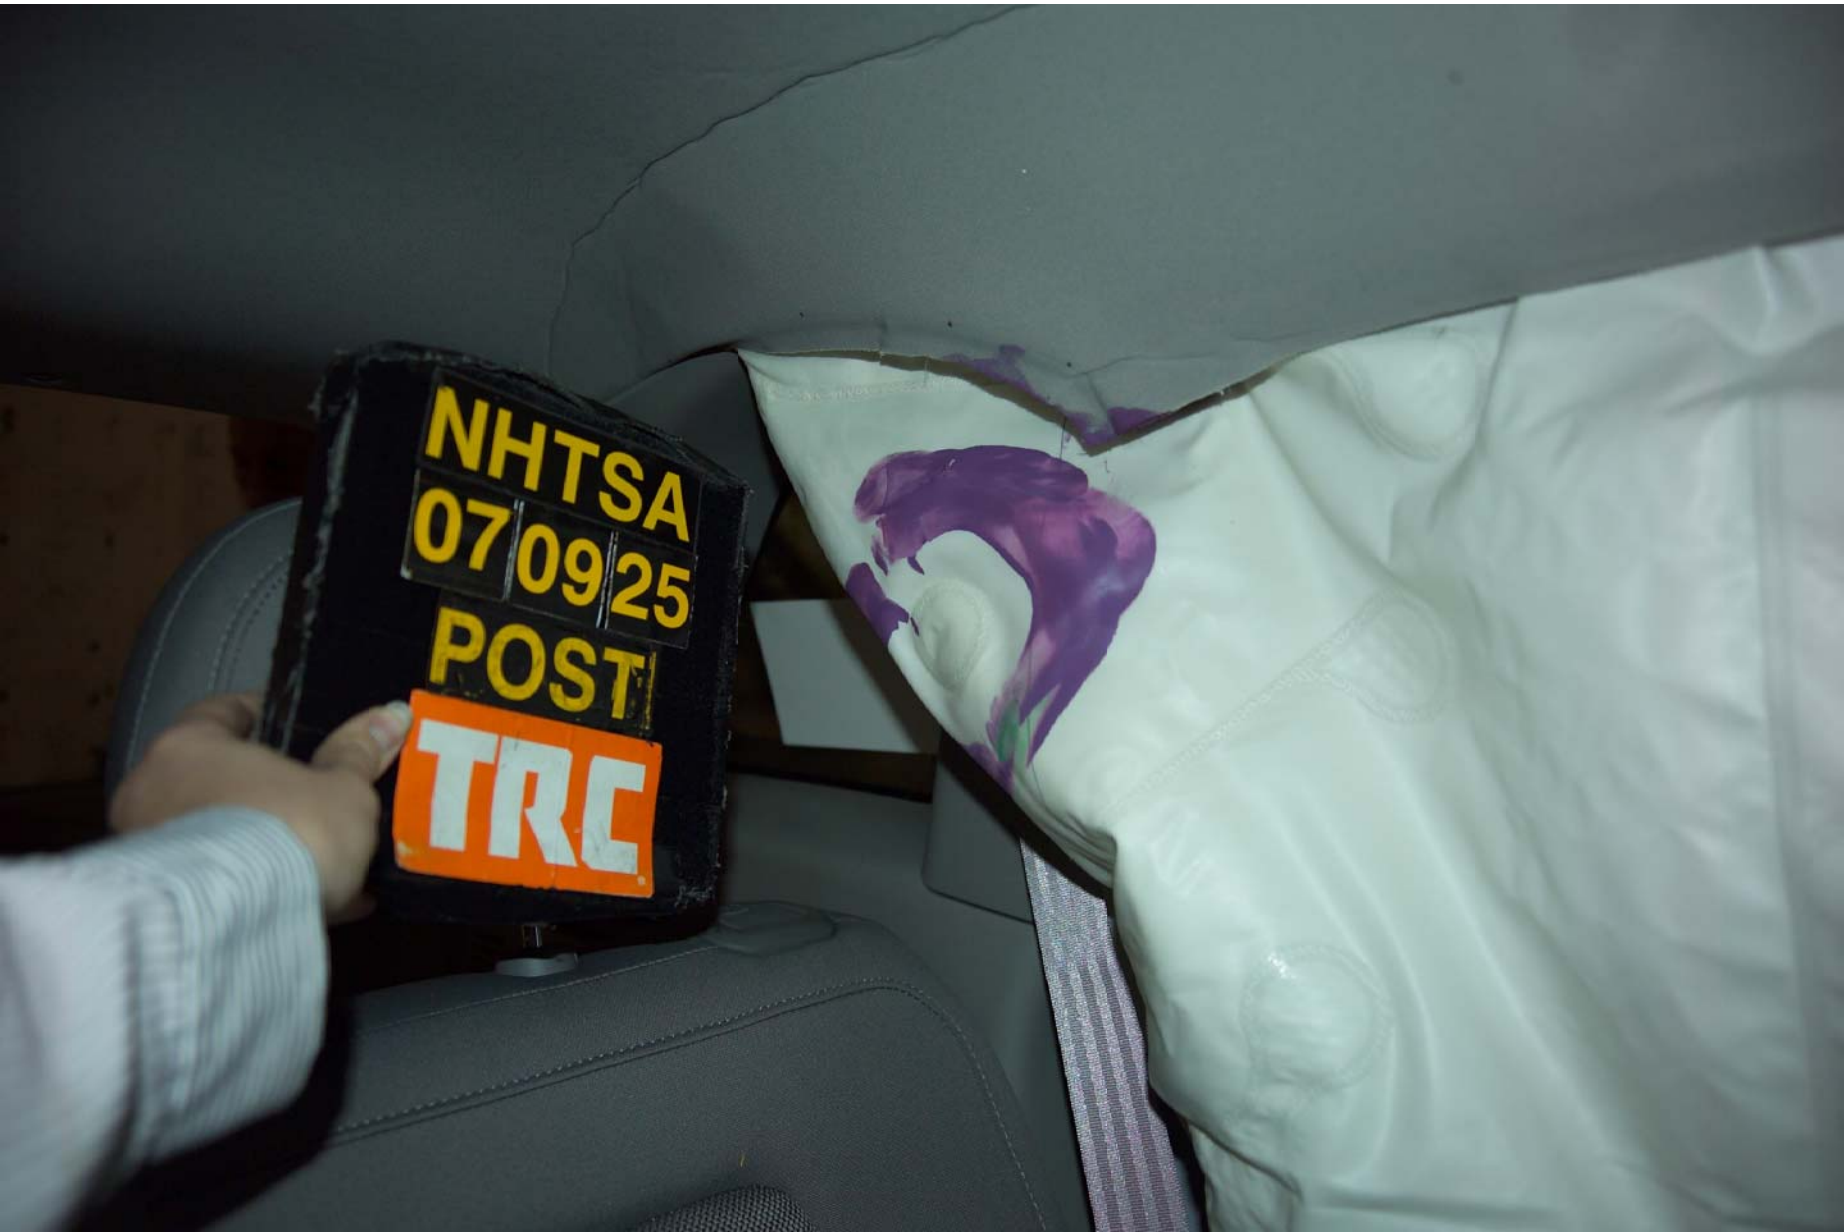
Figure A-61 Post-Test Rear SID Contact – View 1
