**Report Number: 214-TRC-06-011**

**Safety Compliance Testing For FMVSS 214**

**Side Impact Protection**

**2008 Saturn Vue XE MPV**

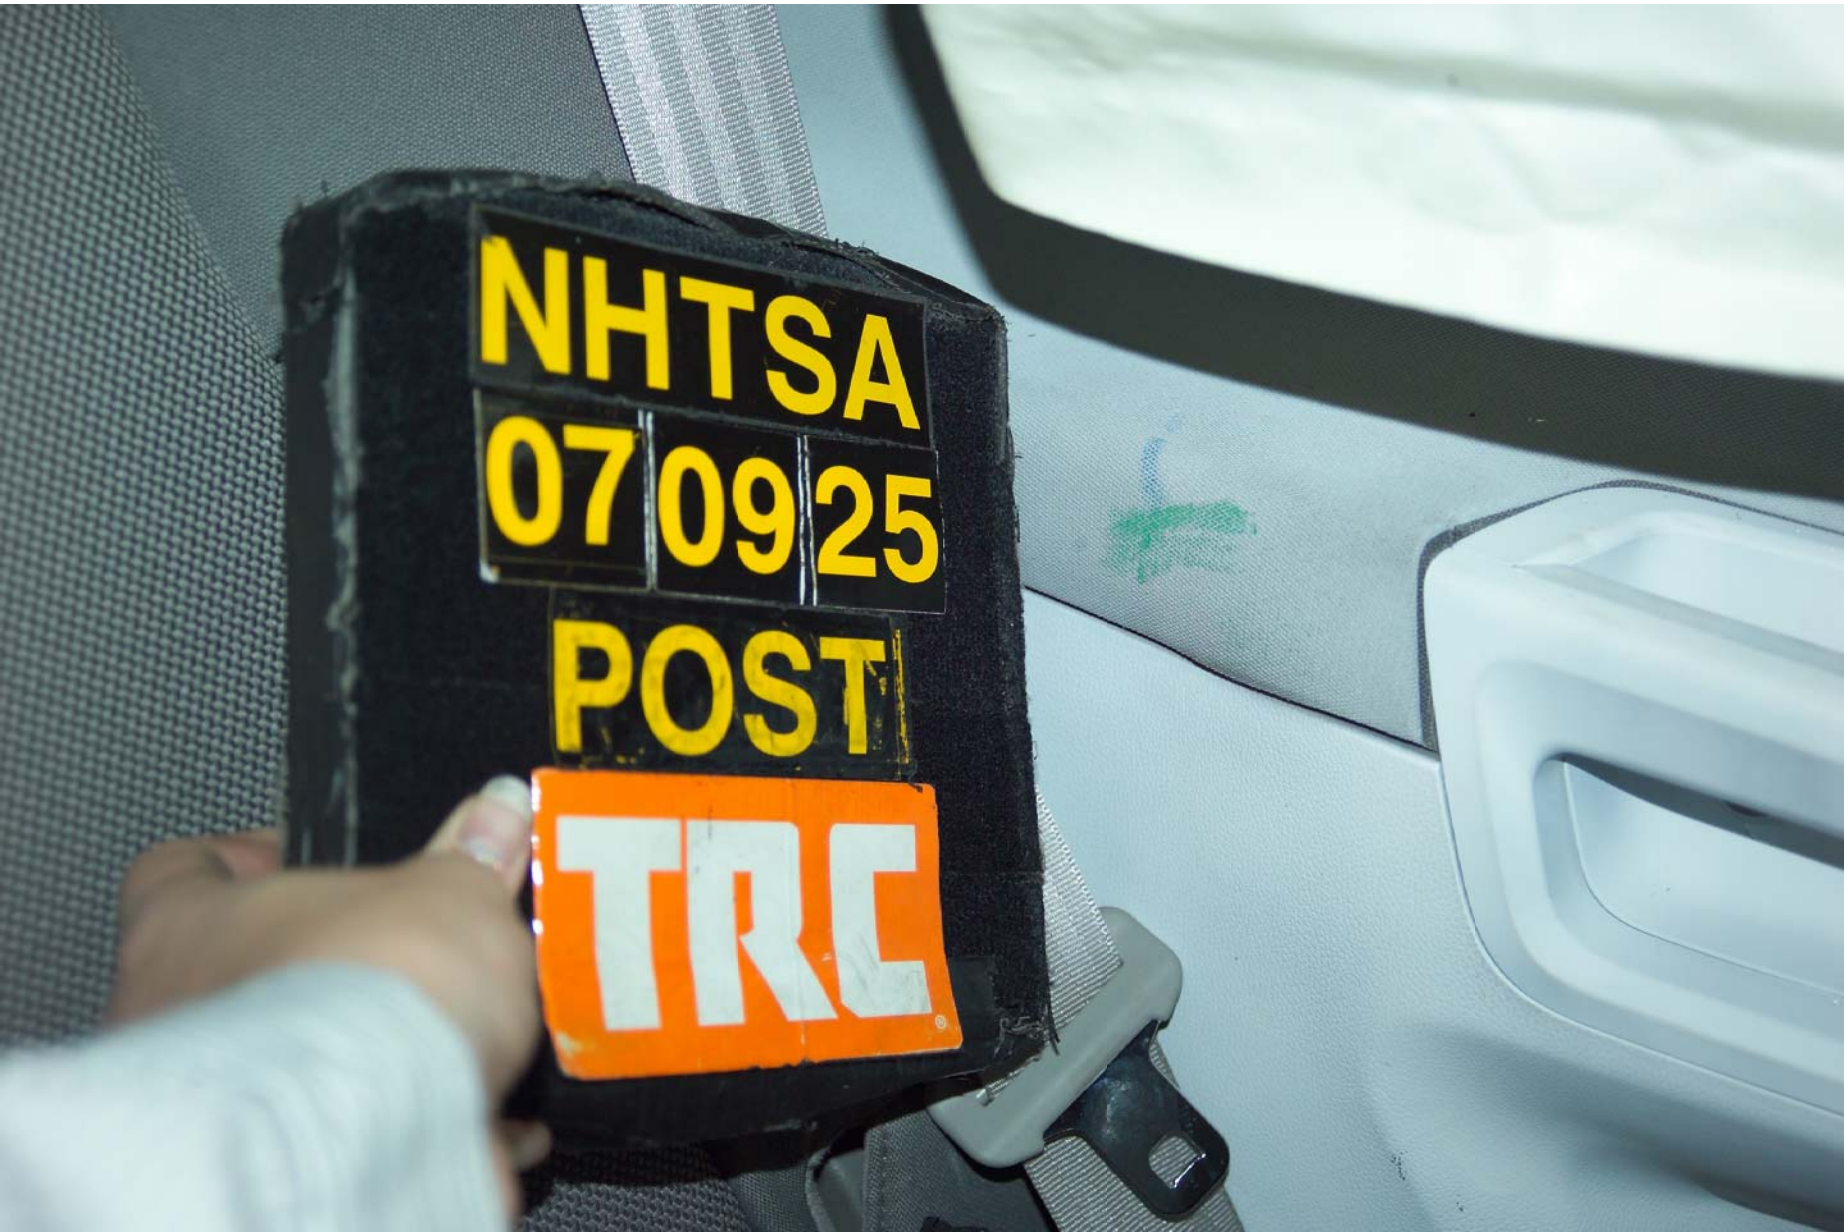
Figure A-62 Post-Test Rear SID Contact – View 2

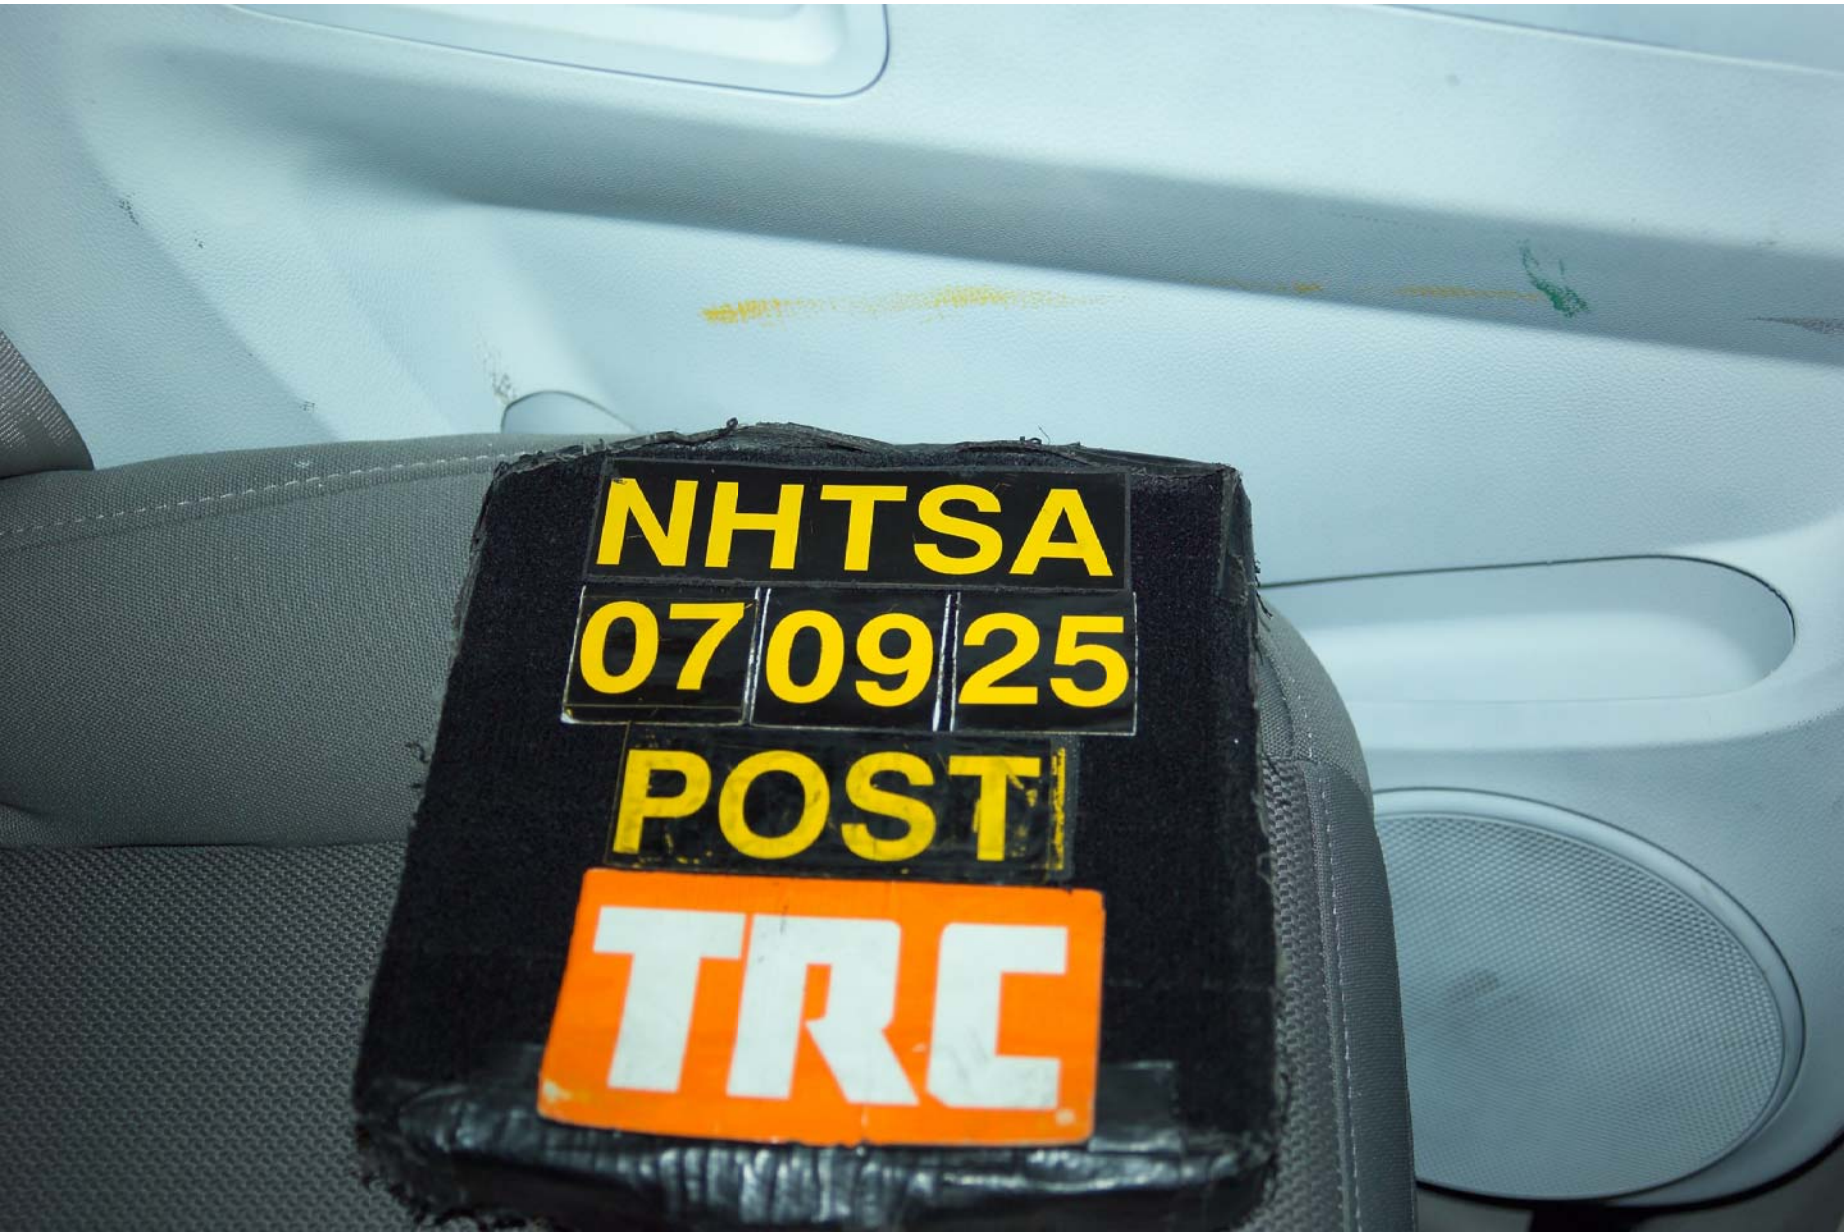
Figure A-63 Post-Test Rear SID Contact – View 3

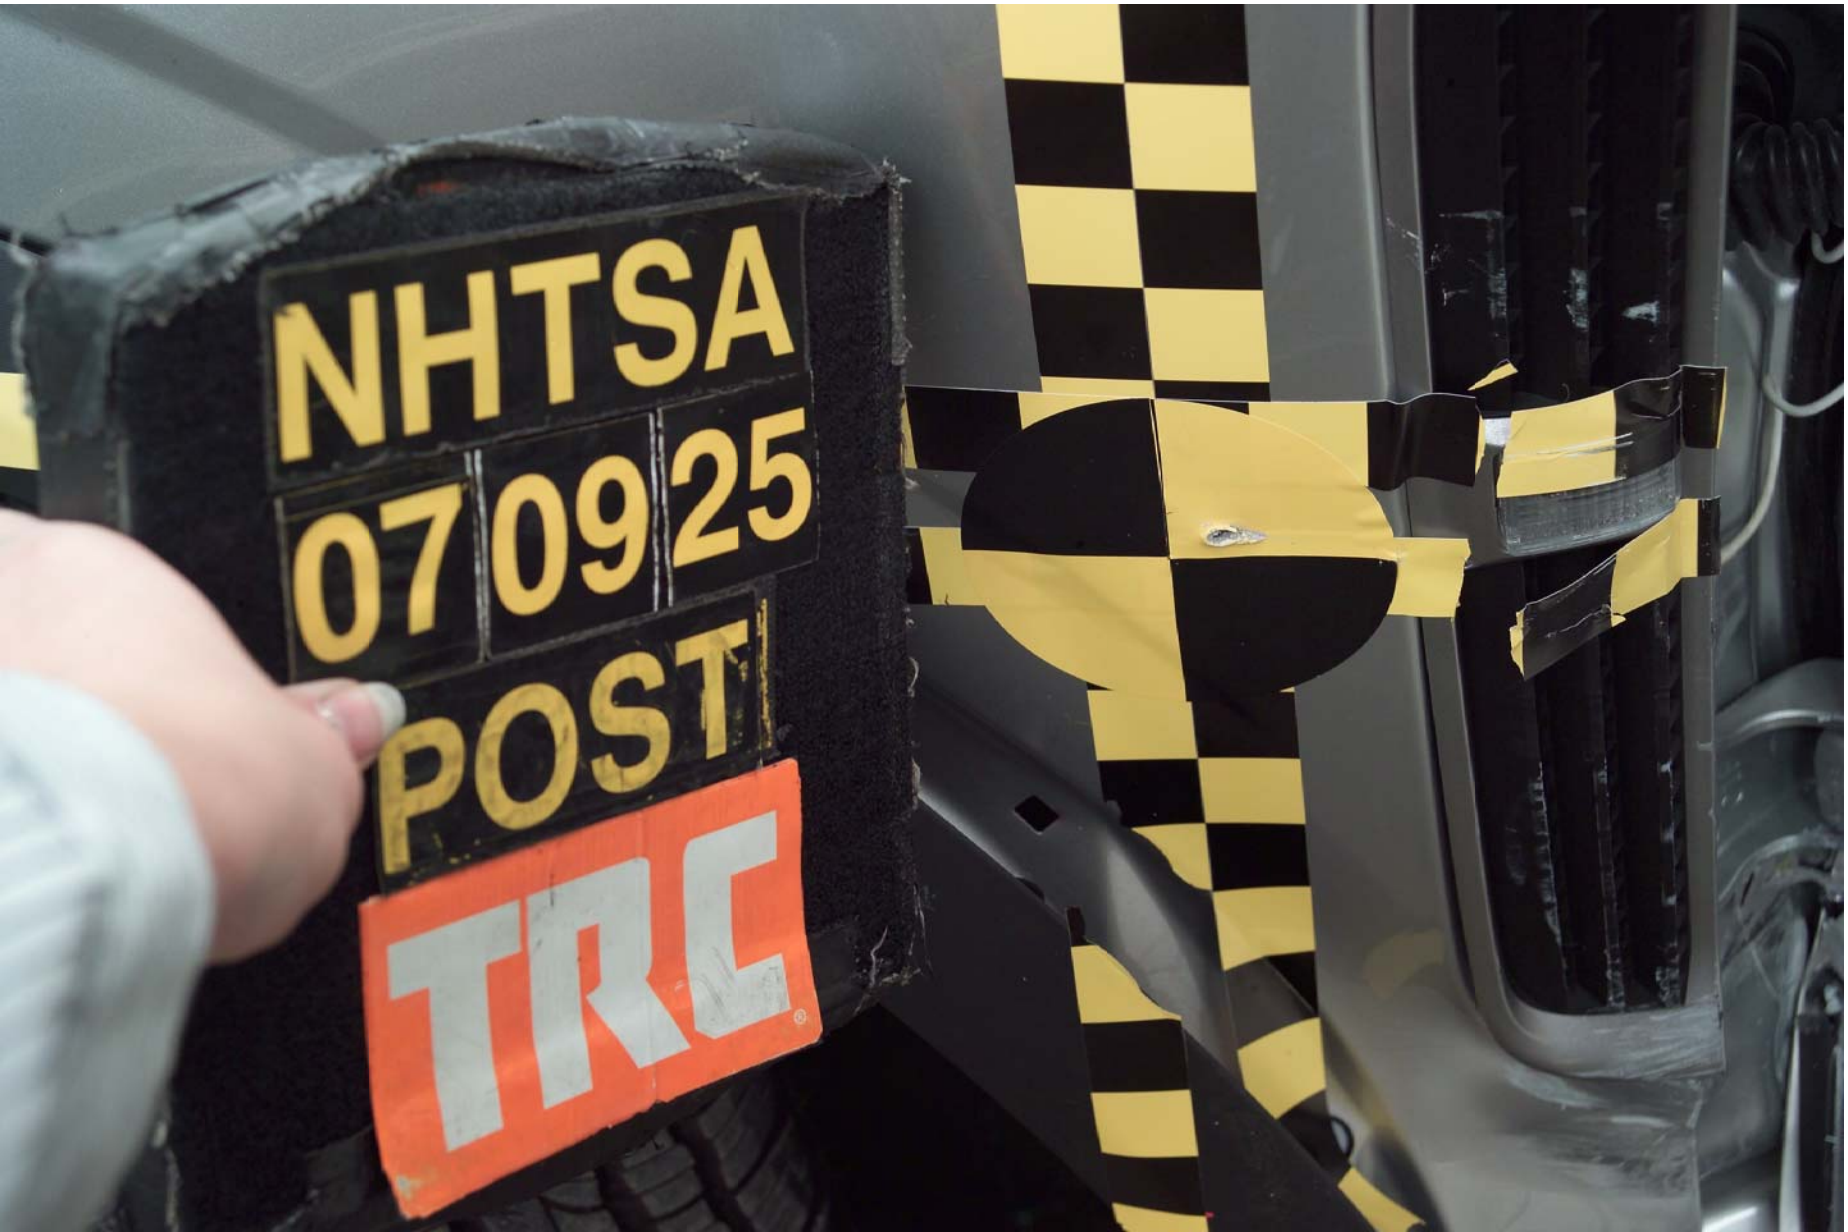
Figure A-67 Post-Test Primary Impact Point View

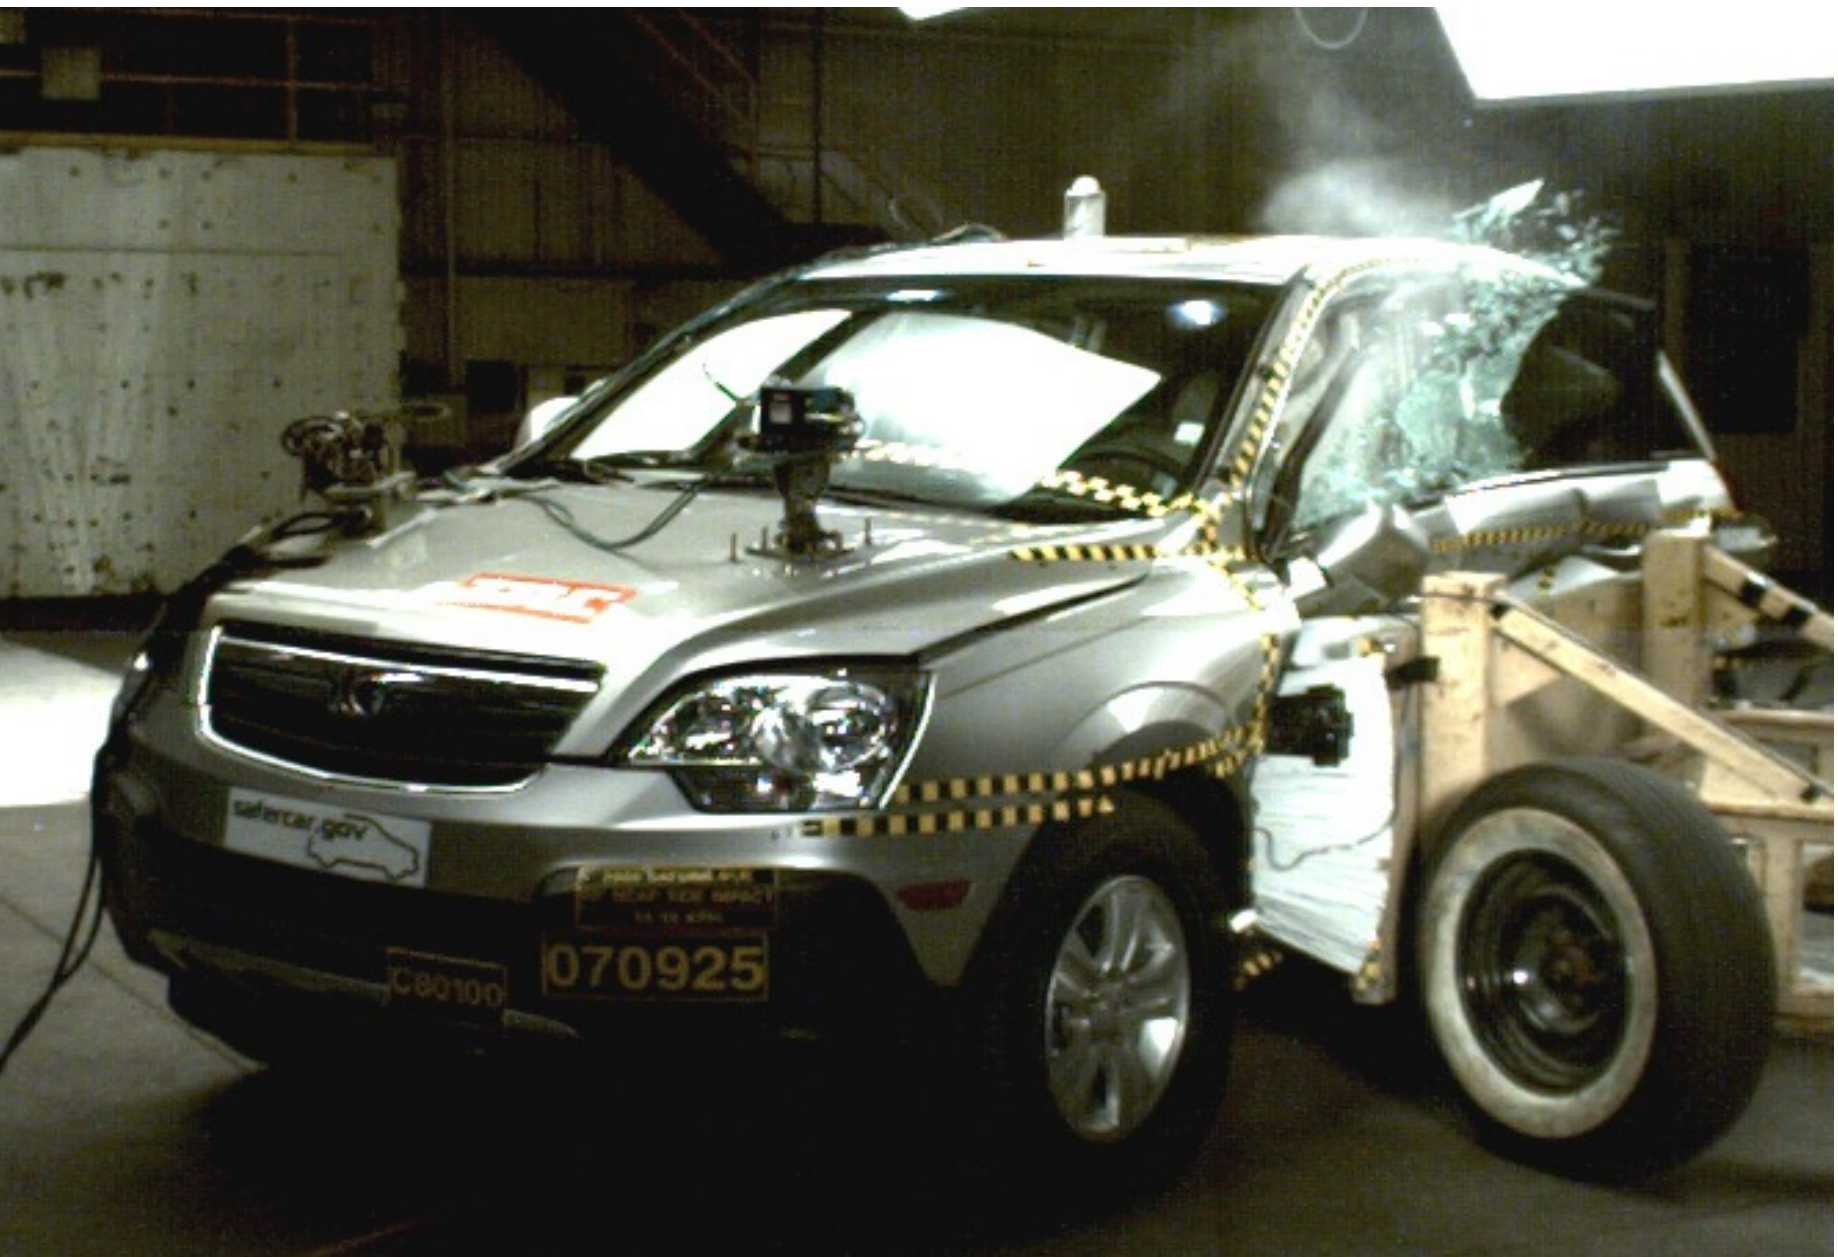
Figure A-79 Impact Event
