**REPORT NUMBER: NCAP-MGA-2008-005**

**NEW CAR ASSESSMENT PROGRAM  
FRONTAL BARRIER IMPACT TEST**

**FORD MOTOR COMPANY  
2008 FORD FUSION SE  
NHTSA NUMBER: F80202**

**PREPARED BY:  
MGA RESEARCH CORPORATION  
5000 WARREN ROAD  
BURLINGTON, WI 53105**

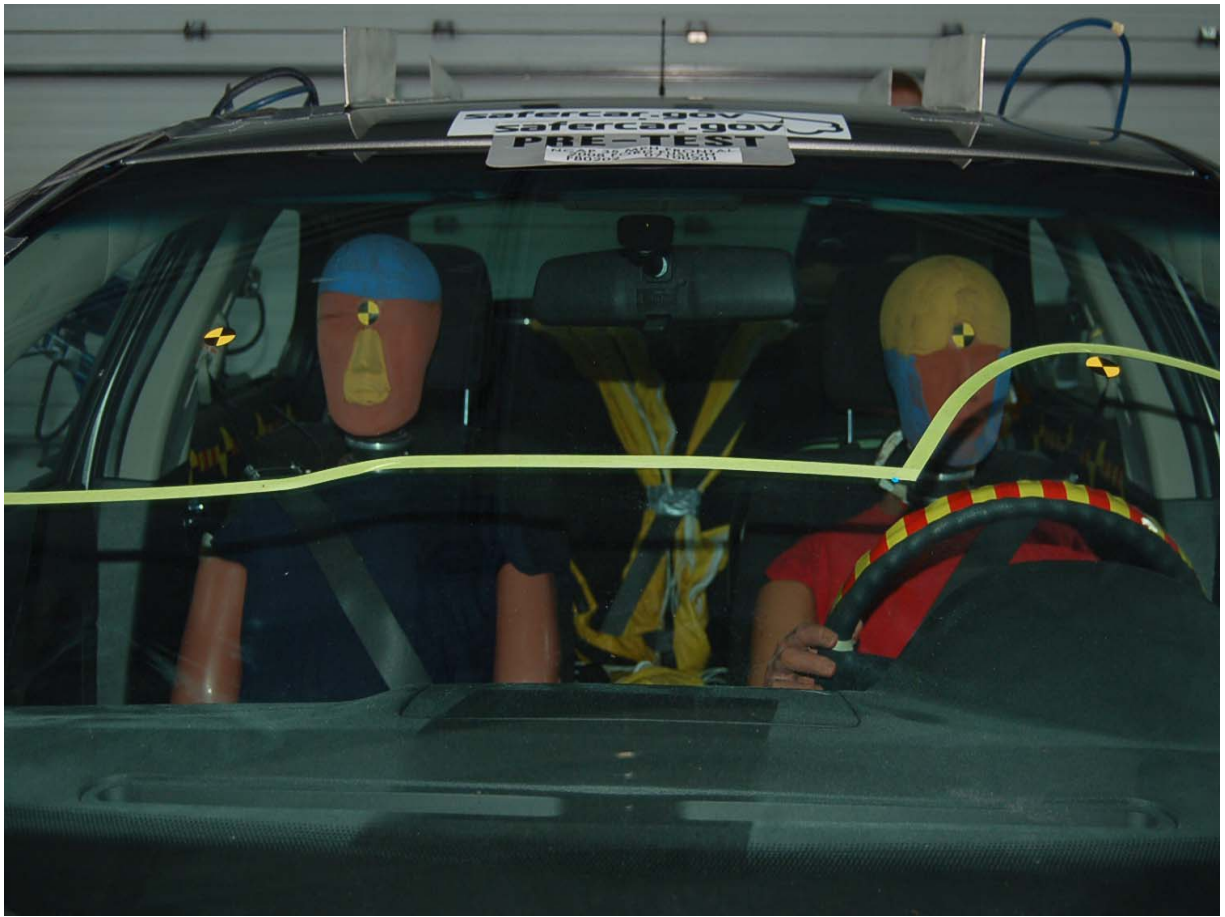
Pre-Test Windshield View

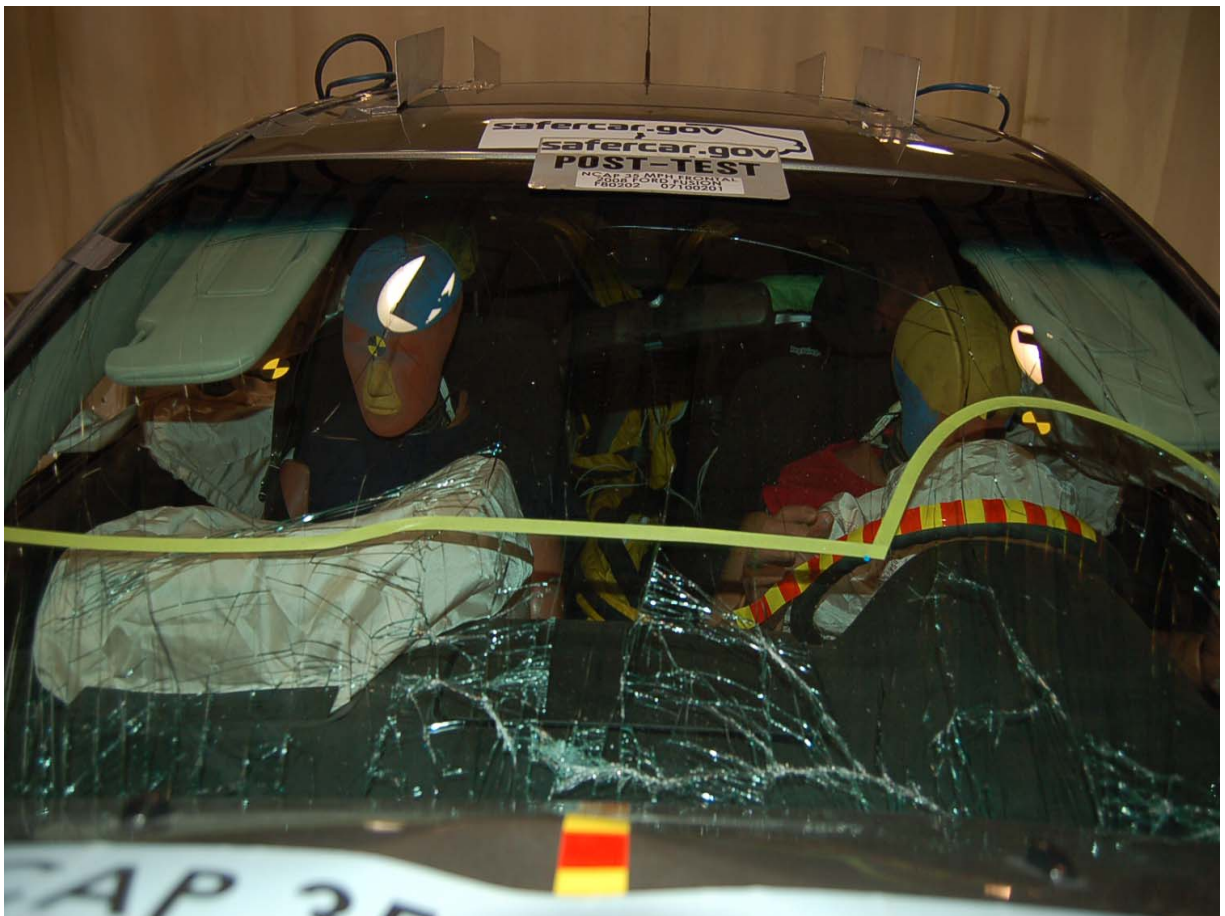
Post-Test Windshield View

There was 90.6 percent windshield retention and no intrusion into the protected zone of the windshield during the event (see figure on page 2). There was no Stoddard Solvent leakage after the event or during any phase of the static rollover.

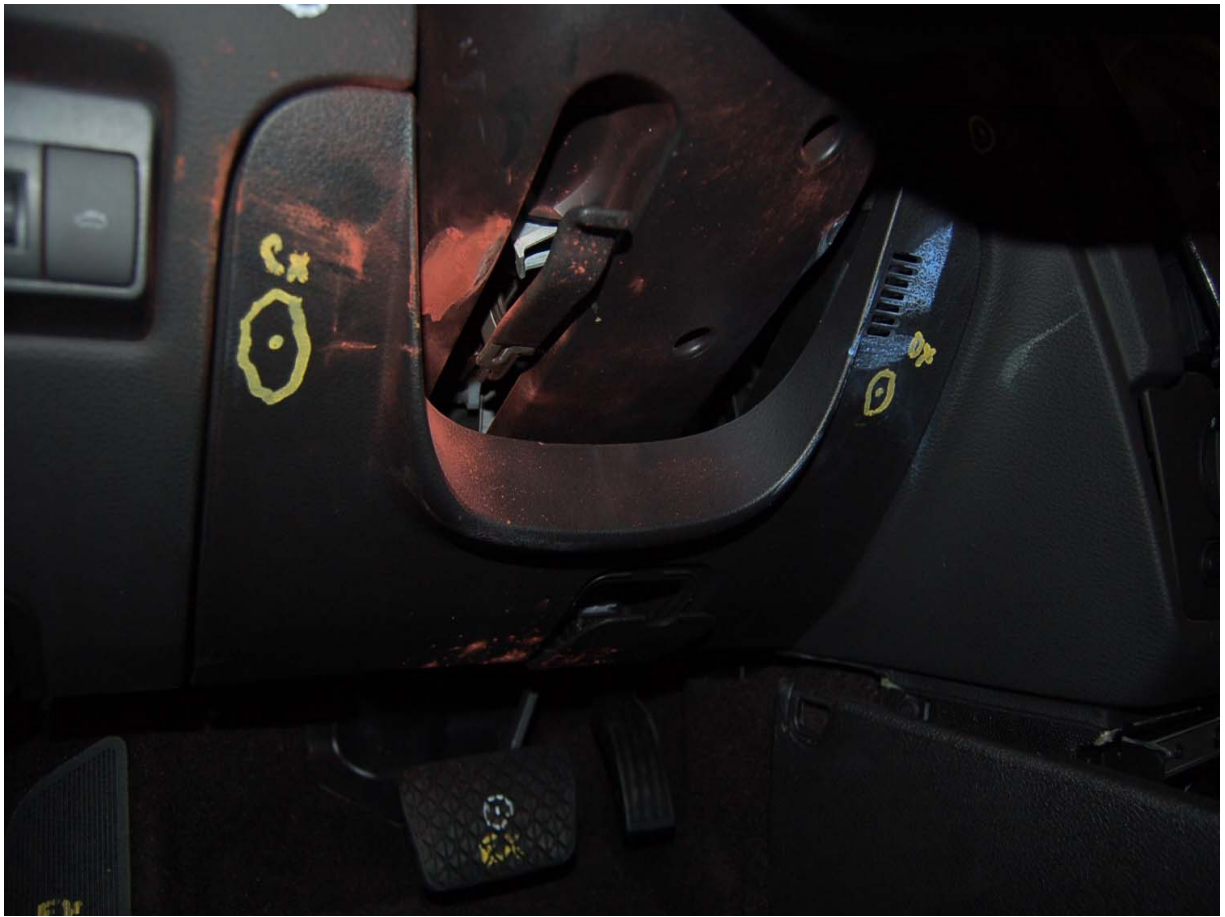
Post-Test Driver Dummy Knee Contact

The driver's head and chest contacted the airbag. The driver's head also contacted the headrest. The driver's knees contacted the knee bolster. The passenger's head and chest contacted the airbag. The passenger's head also contacted the headrest. The passenger's knees contacted the glove box.

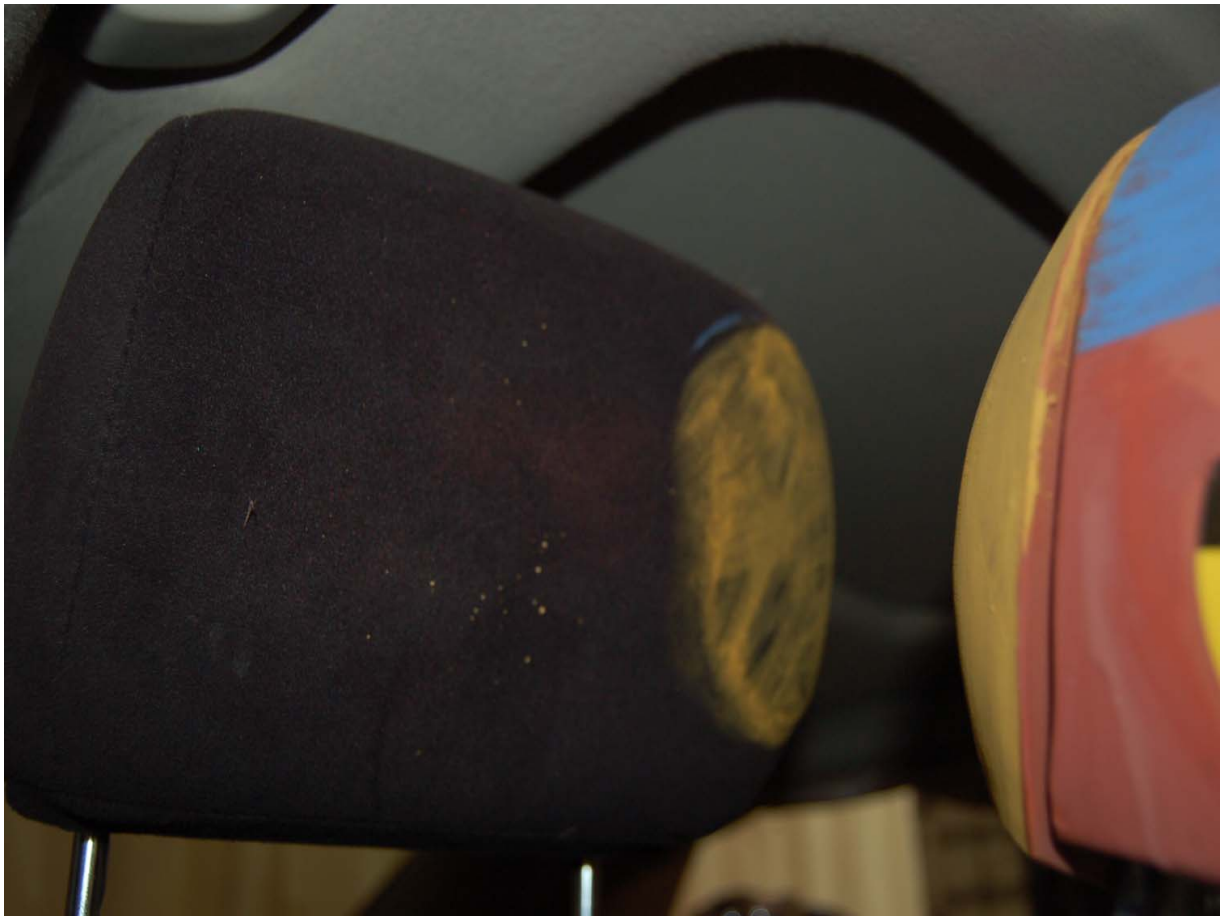
Post-Test Passenger Dummy Head Contact (headrest)

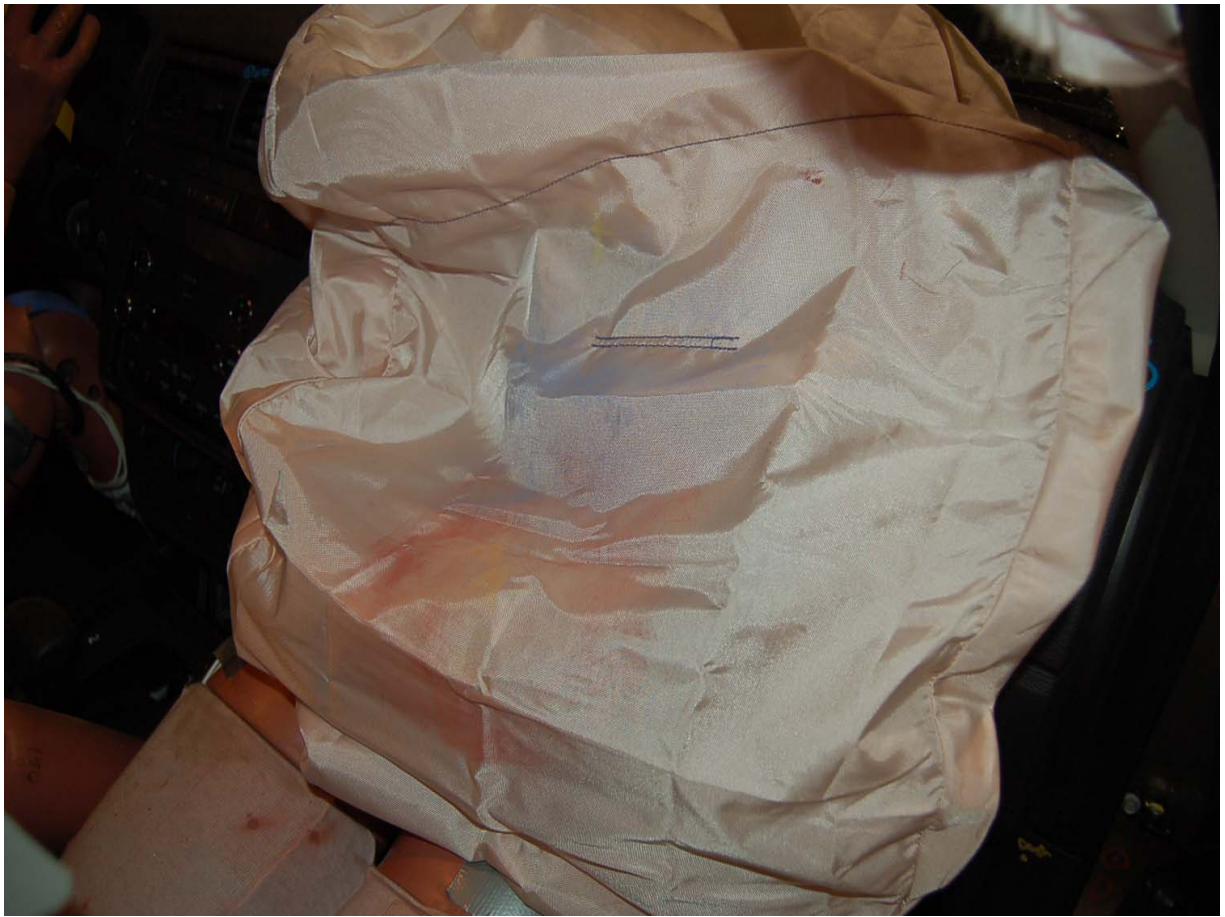
Post-Test Passenger Dummy Airbag Contact

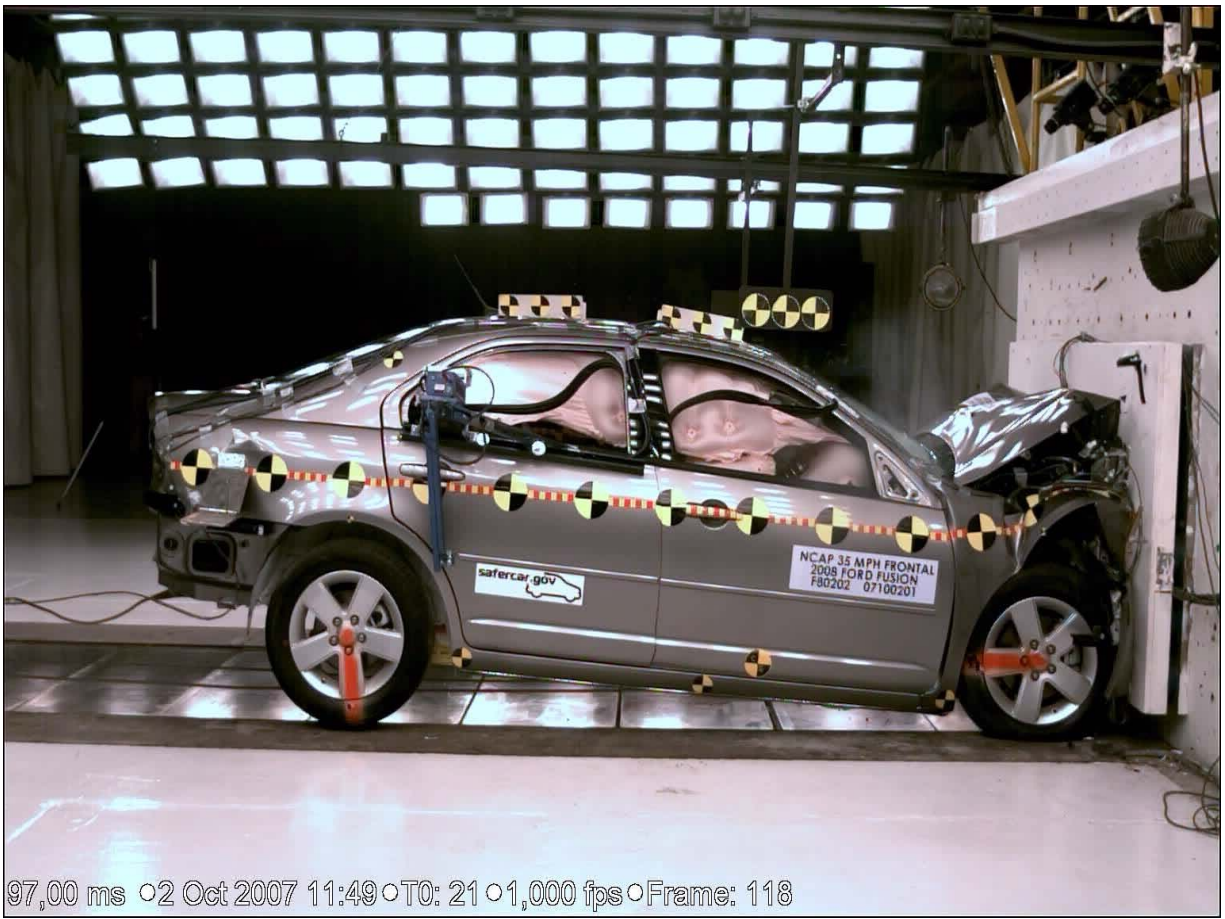
97,00 ms ◦ 2 Oct 2007 11:49 ◦ T0: 21 ◦ 1,000 fps ◦ Frame: 118

Vehicle Impact

A load cell barrier was impacted by a 2008 Ford Fusion SE at a velocity of 56.3 kph. The test was performed at MGA Research Corporation on October 2, 2007. Pre- and post-test photographs of the vehicle and dummies can be found in Appendix A.
