**REPORT NUMBER: NCAP-MGA-2008-008**

**NEW CAR ASSESSMENT PROGRAM  
FRONTAL BARRIER IMPACT TEST**

**HONDA OF AMERICA MFG., INC.  
2008 HONDA ACCORD 4-DOOR LX  
NHTSA NUMBER: M85302**

**PREPARED BY:  
MGA RESEARCH CORPORATION  
5000 WARREN ROAD  
BURLINGTON, WI 53105**

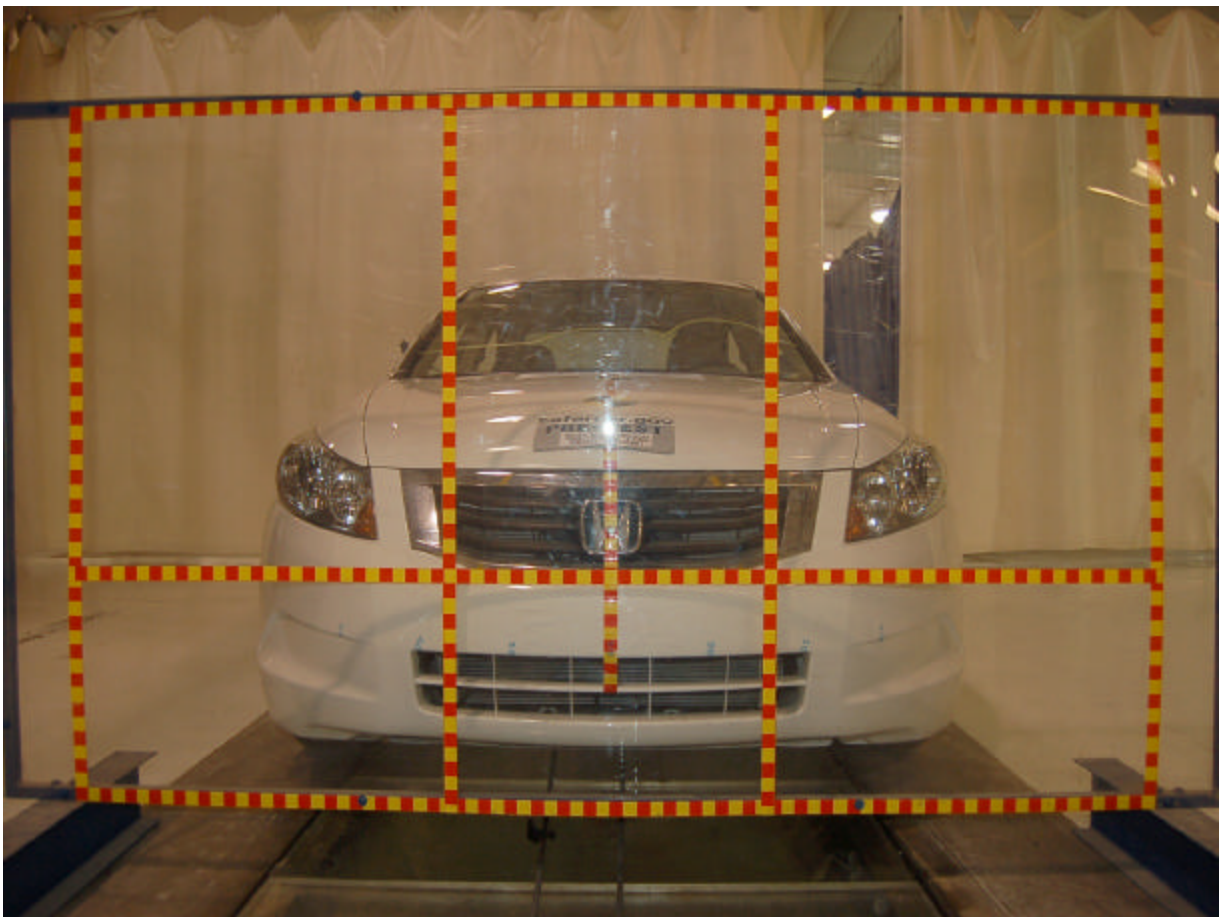
Load Cell Location

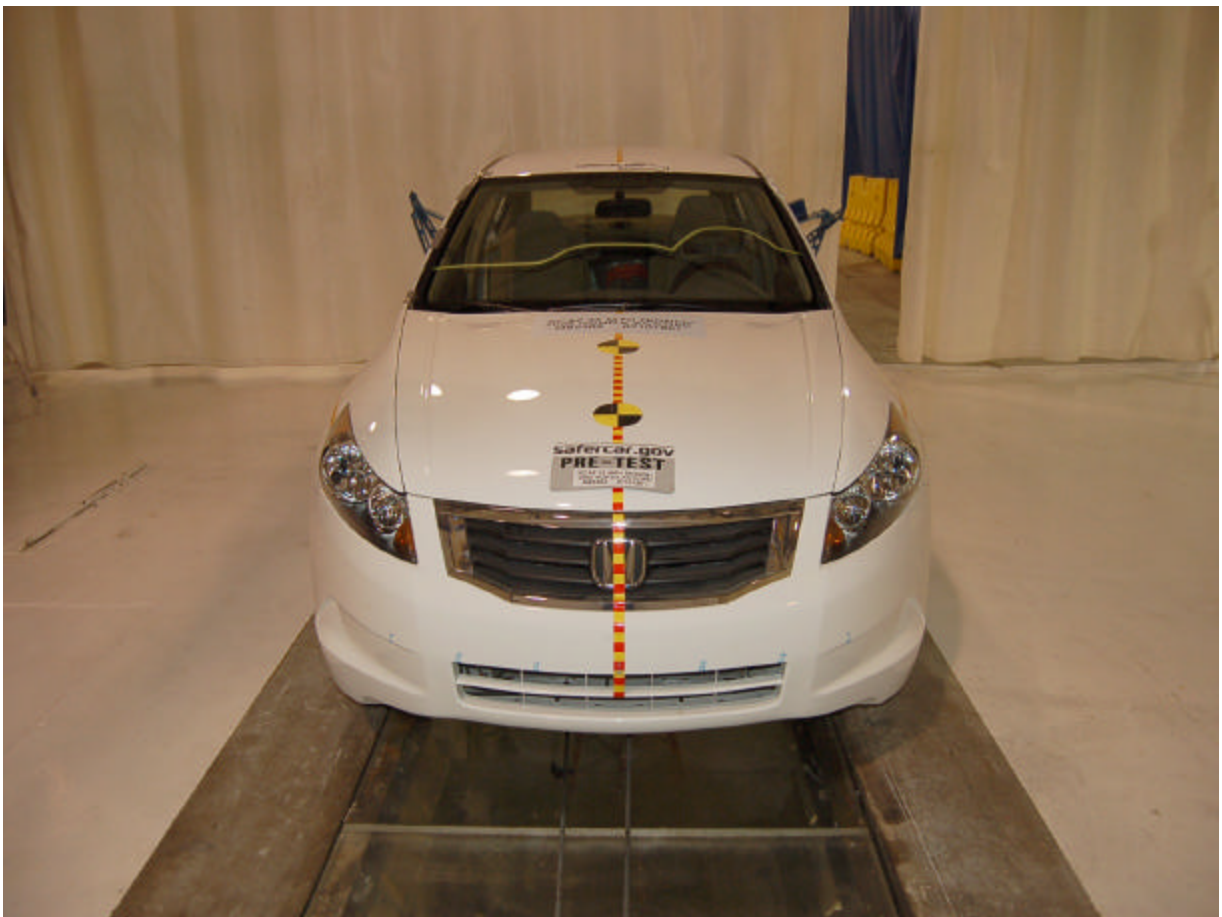
Pre-Test Front View

Post-Test Front View

The maximum static crush of the vehicle was 621 mm and both the driver and passenger side doors remained closed and latched during the impact event and were operable after the impact.

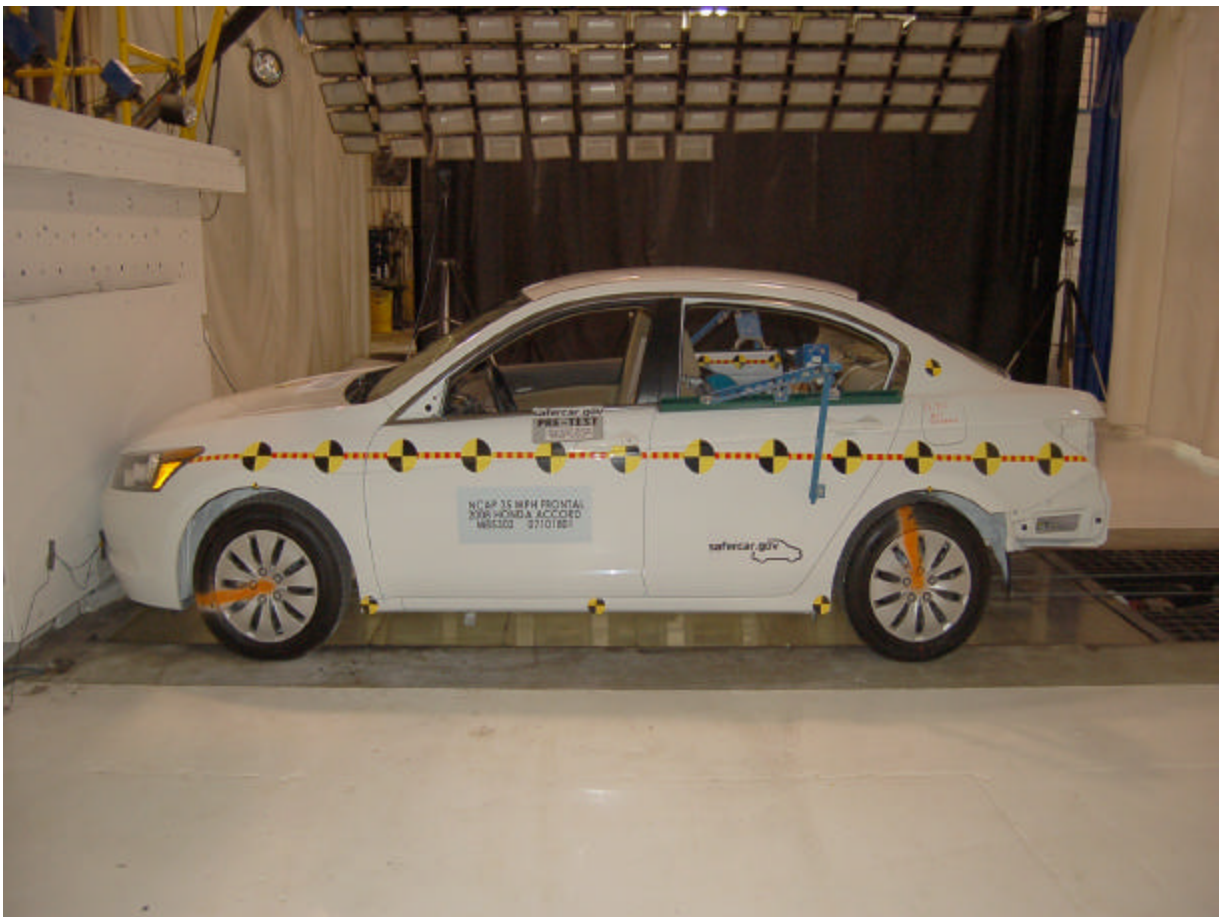
Pre-Test Left Side View

Post-Test Left Side View

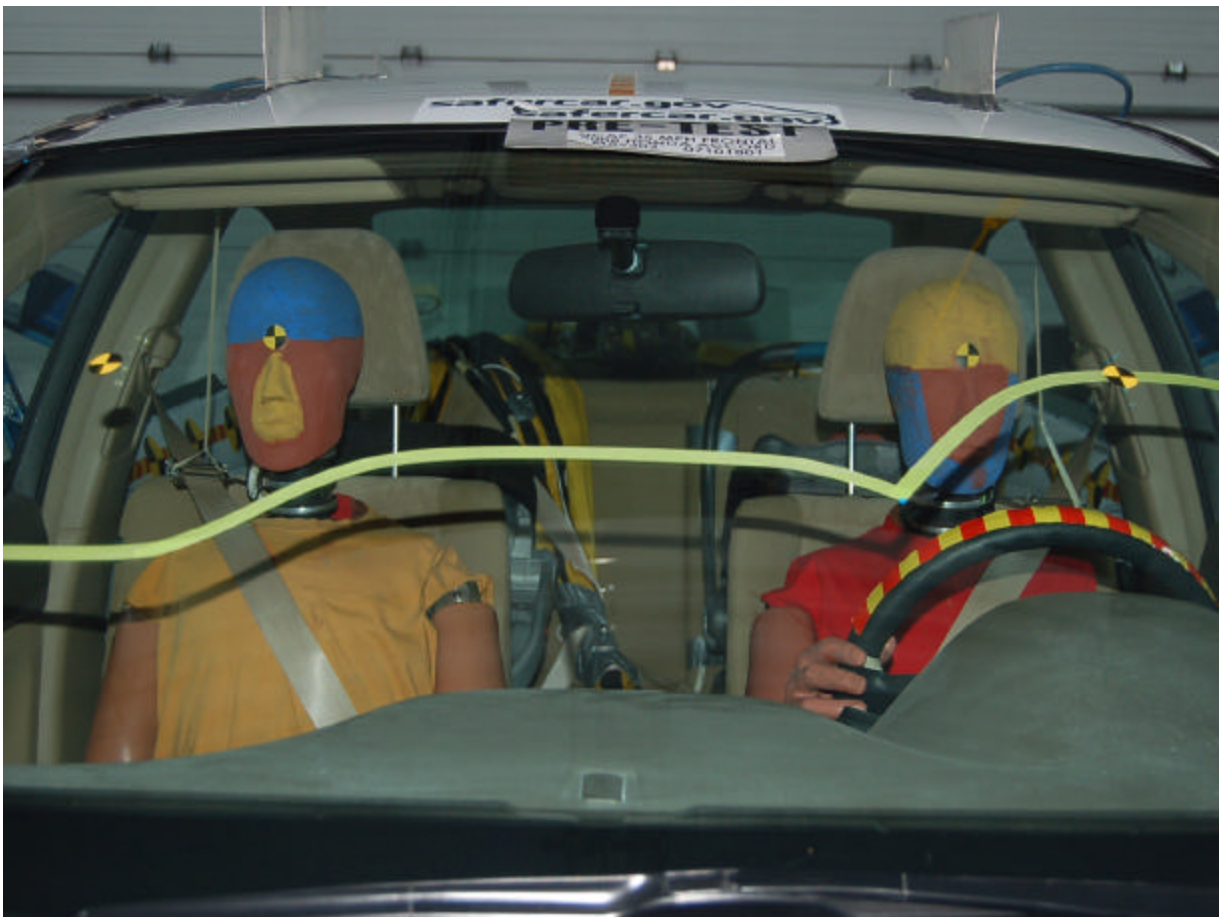
Pre-Test Windshield View

Post-Test Windshield View

There was 100 percent windshield retention and no intrusion into the protected zone of the windshield during the event. There was no Stoddard Solvent leakage after the event or during any phase of the static rollover.

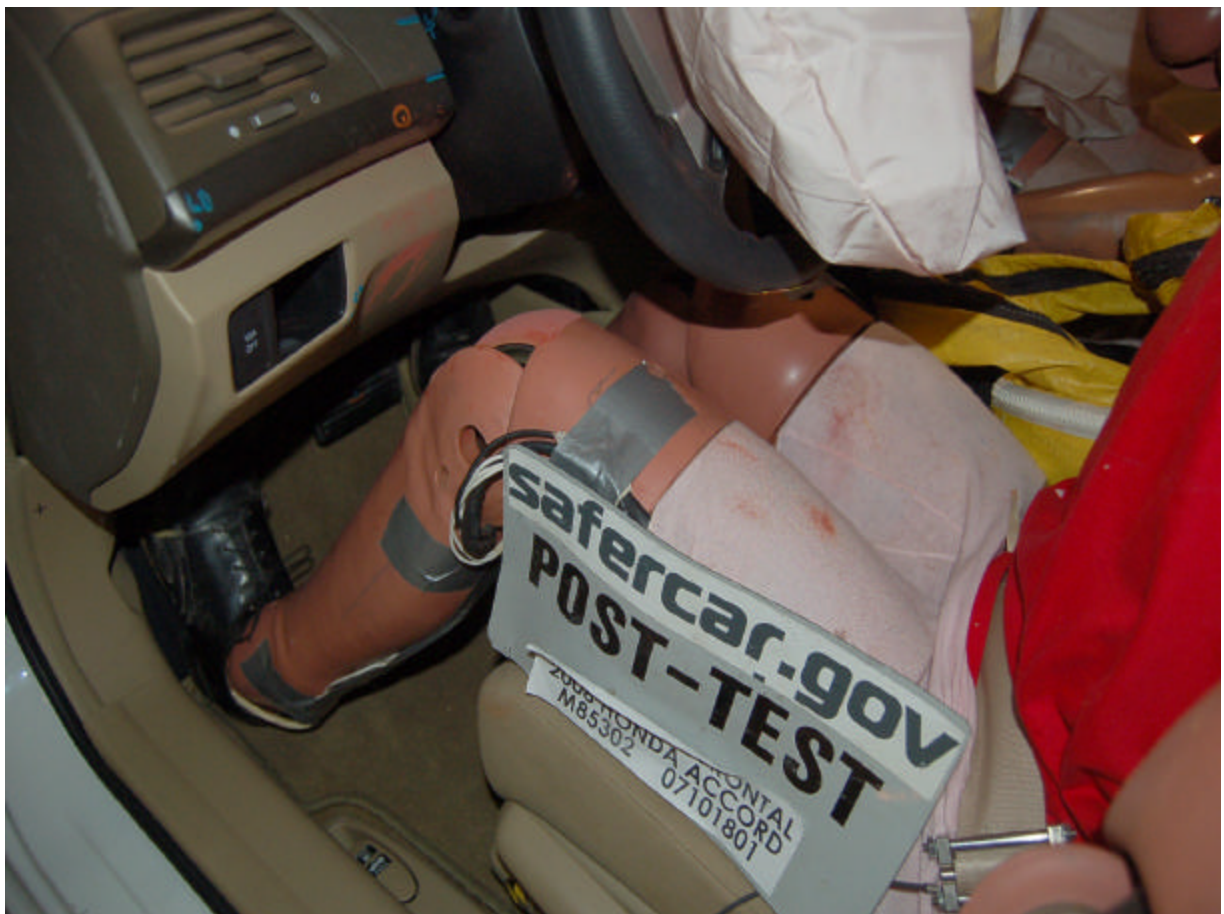
Post-Test Driver Side Knee Bolster

The driver's head and chest contacted the airbag. The driver's head also contacted the headrest. The driver's knees contacted the knee bolster. The passenger's head and chest contacted the airbag. The passenger's head also contacted the headrest. The passenger's knees contacted the glove box.

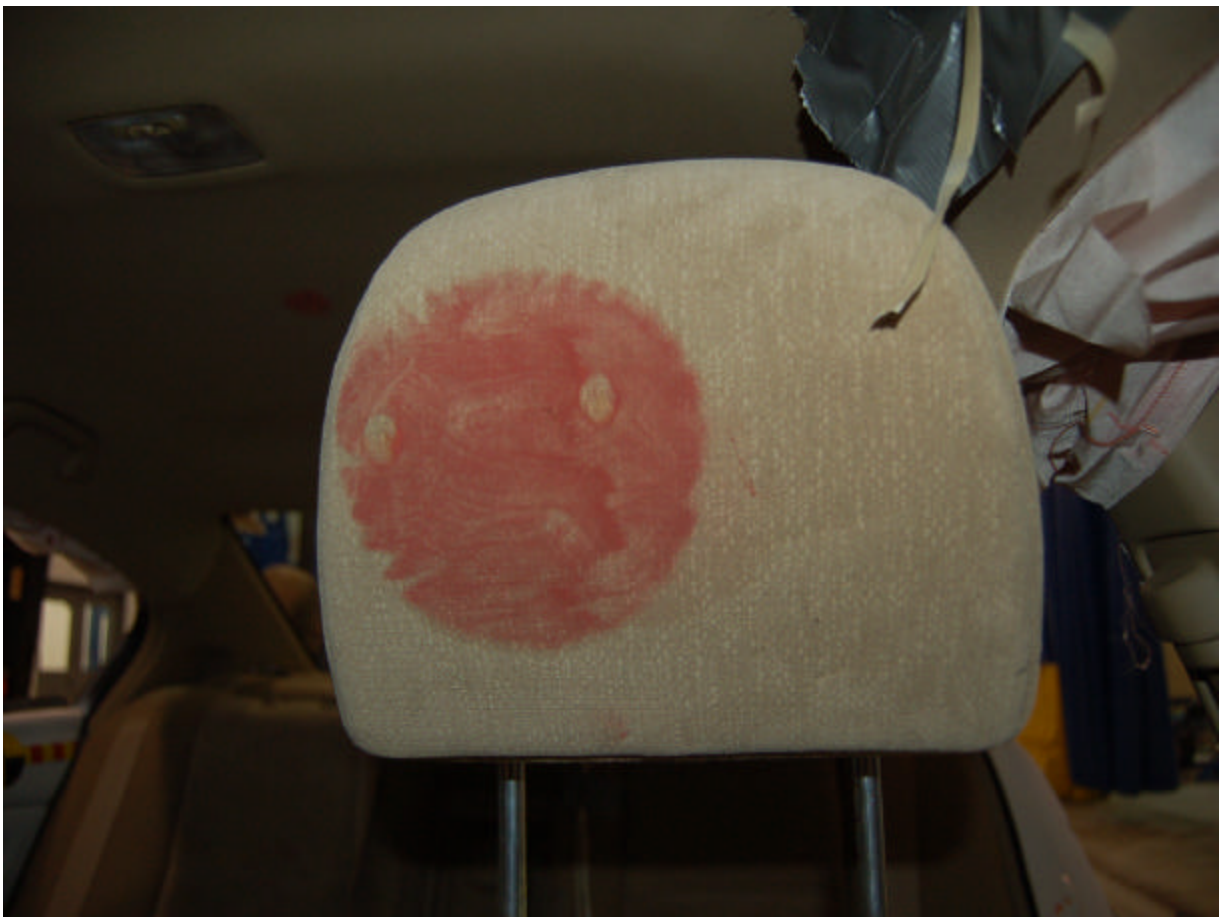
Post-Test Driver Dummy Head Contact (headrest)

Post-Test Driver Dummy Left Knee Contact

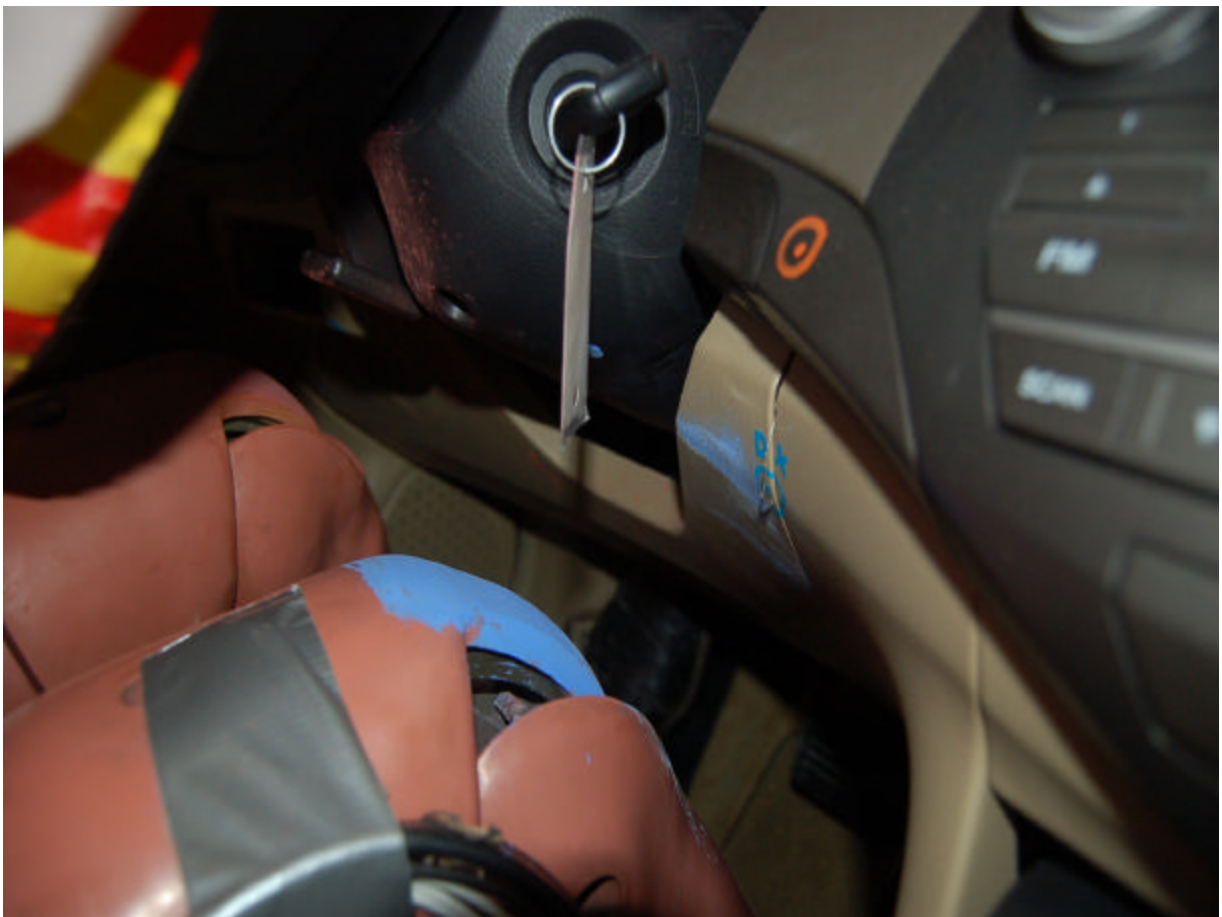
Post-Test Driver Dummy Right Knee Contact

Post-Test Driver Dummy Airbag Contact

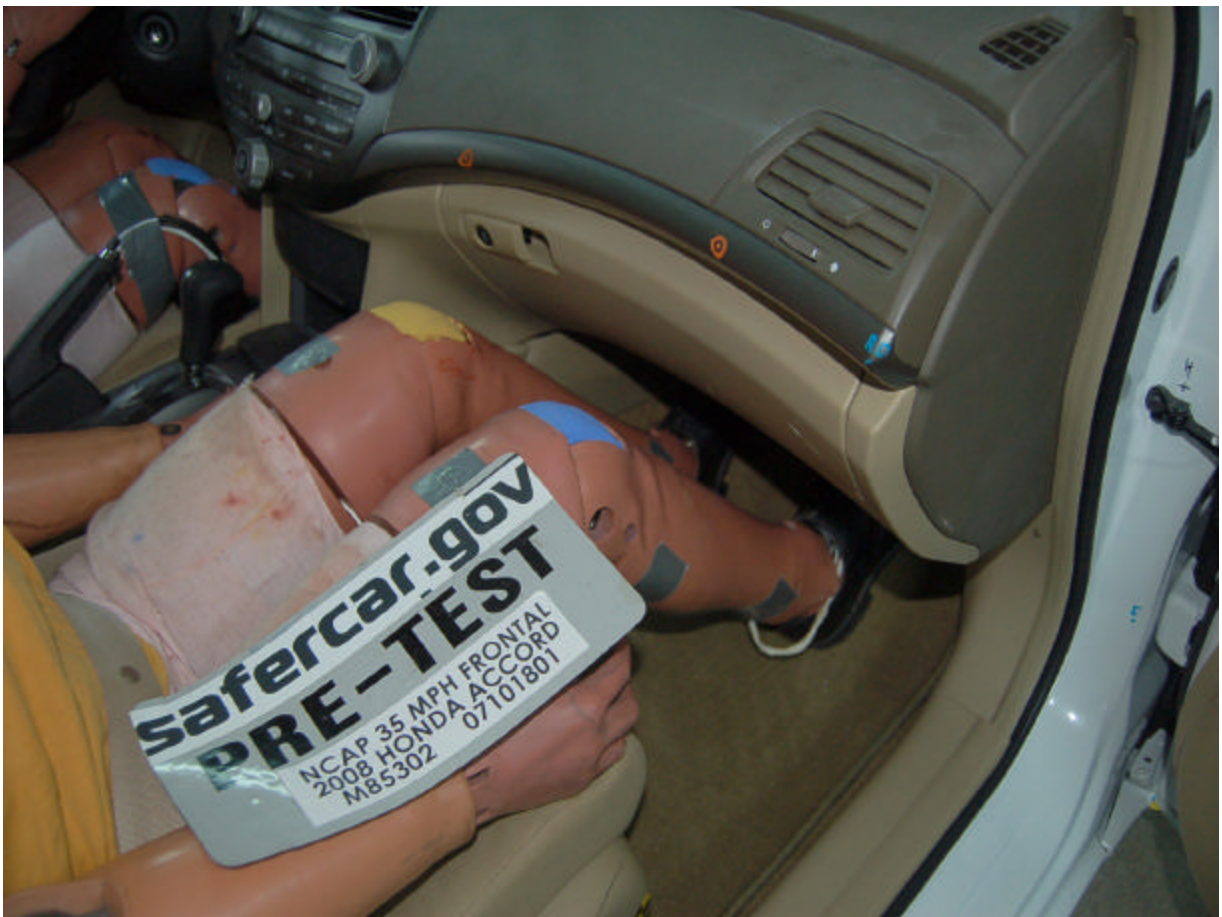
Pre-Test Passenger Side Glove Box

Post-Test Passenger Side Glove Box

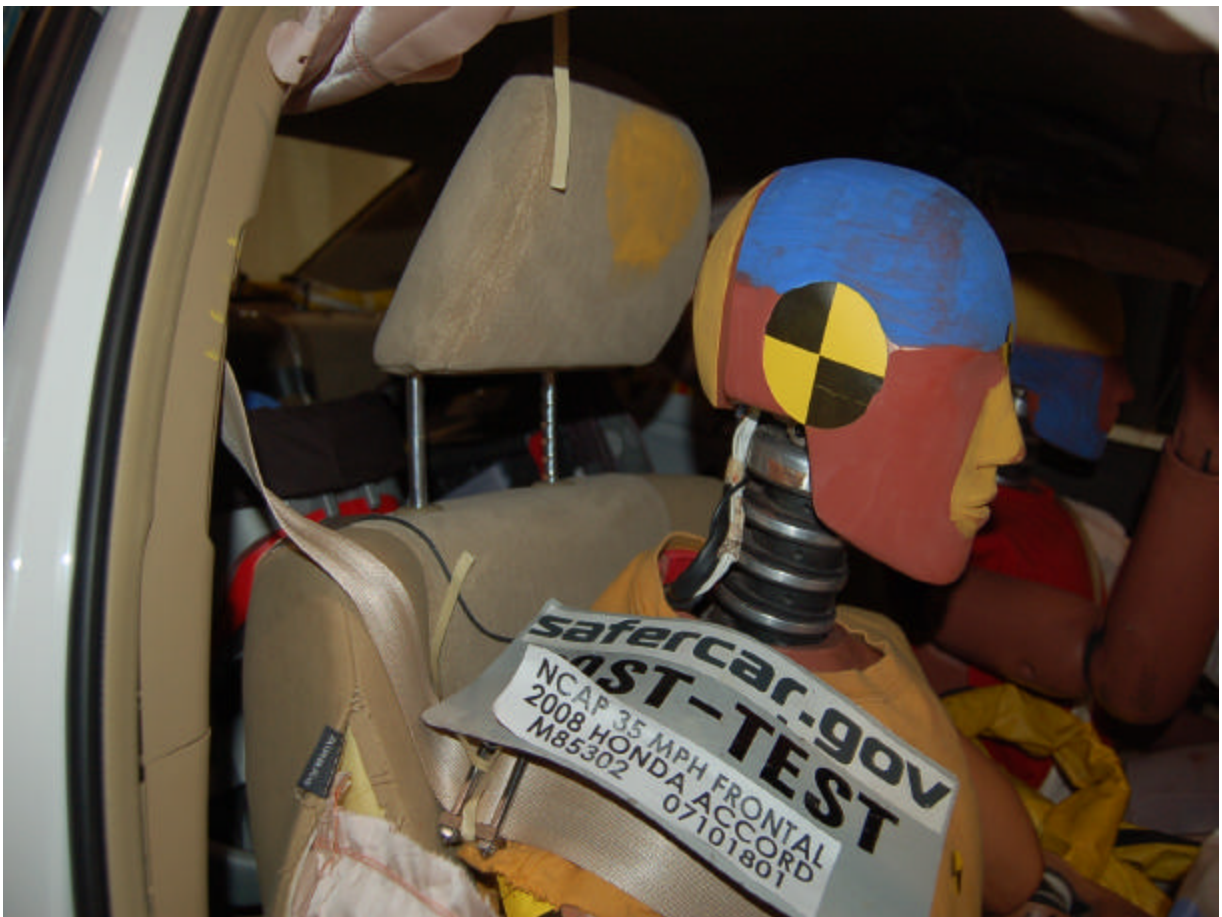
Post-Test Passenger Dummy Head Contact (headrest)

Post-Test Passenger Dummy Knee Contact

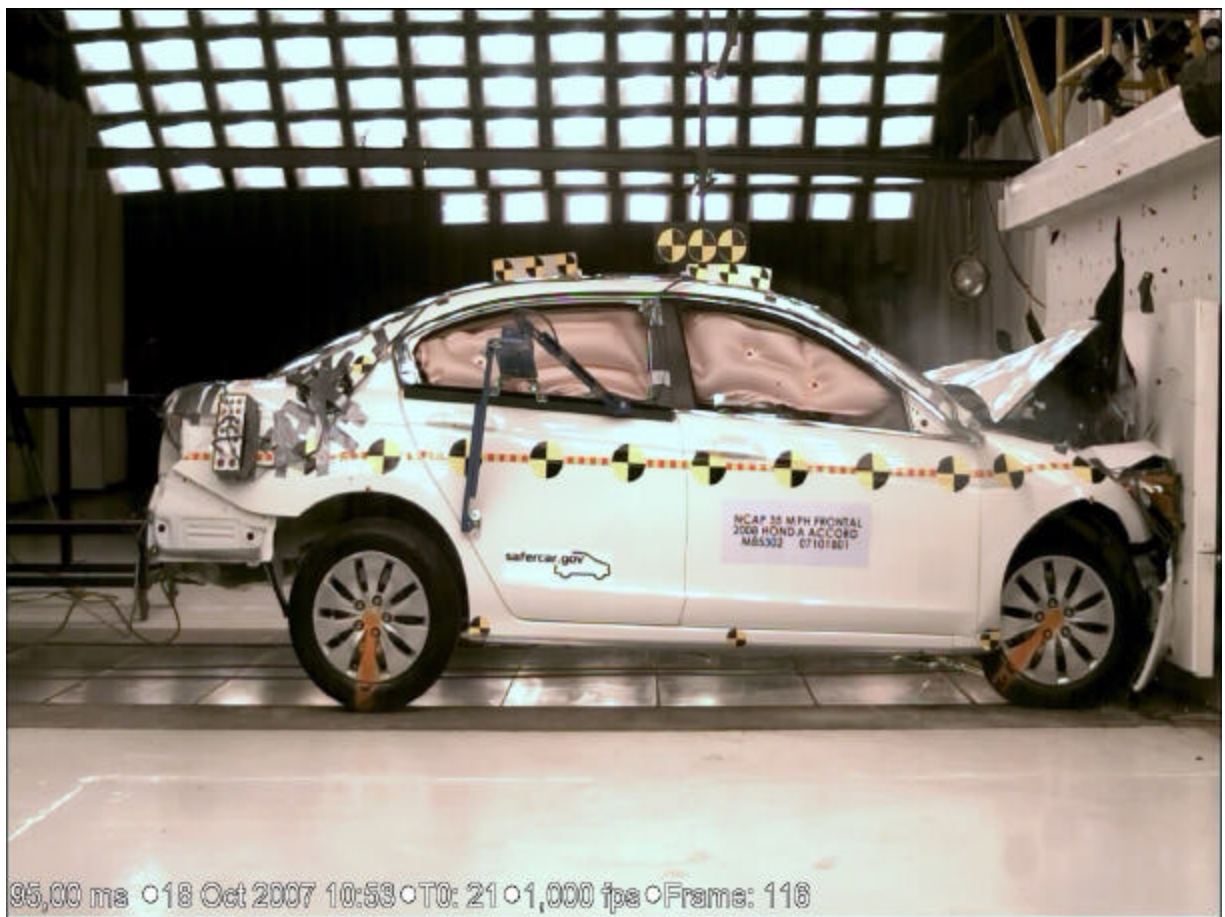
Vehicle Impact

A load cell barrier was impacted by a 2008 Honda Accord 4-Door LX at a velocity of 56.3 kph. The test was performed at MGA Research Corporation on October 18, 2007. Pre-and post-test photographs of the vehicle and dummies can be found in Appendix A.

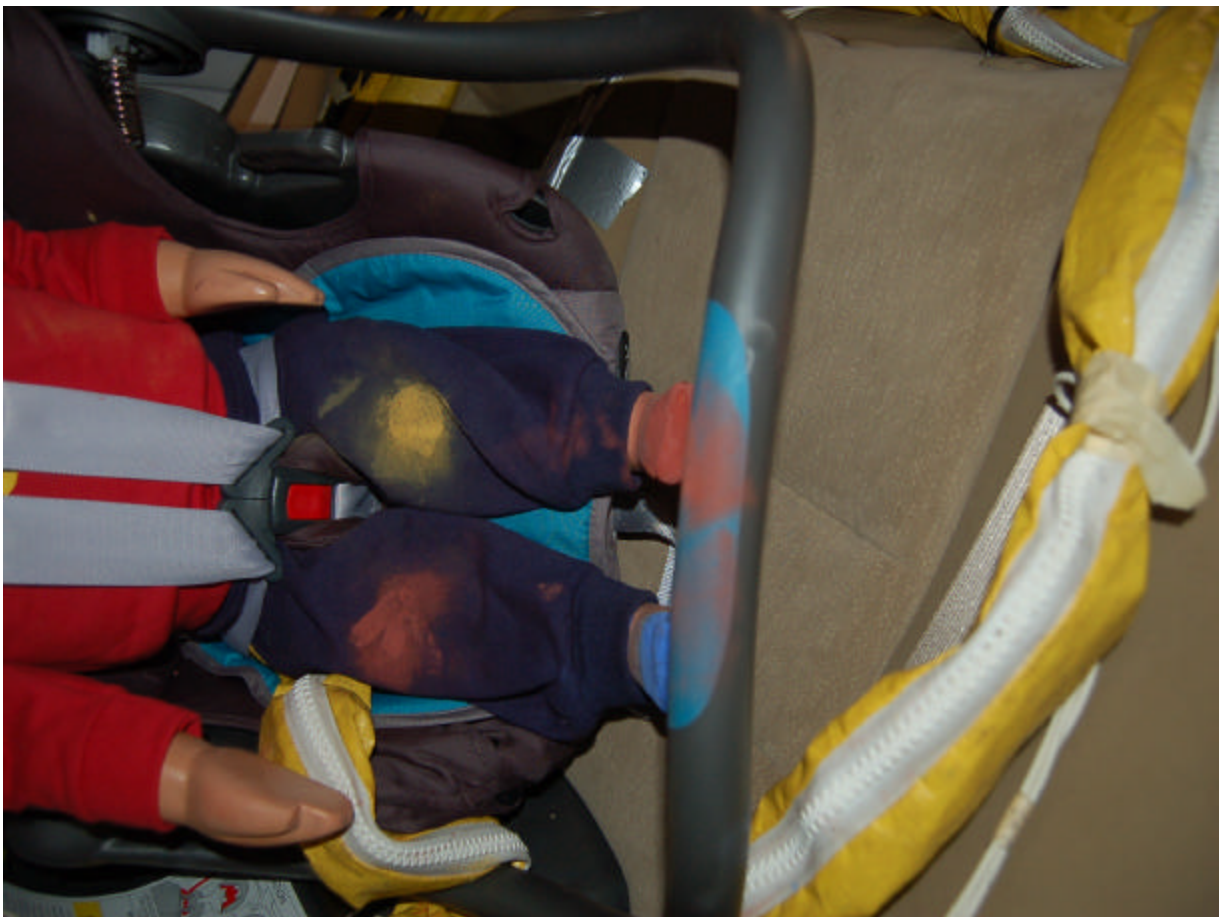
Post-Test Position 4 Head Contact (Handle of CRS)

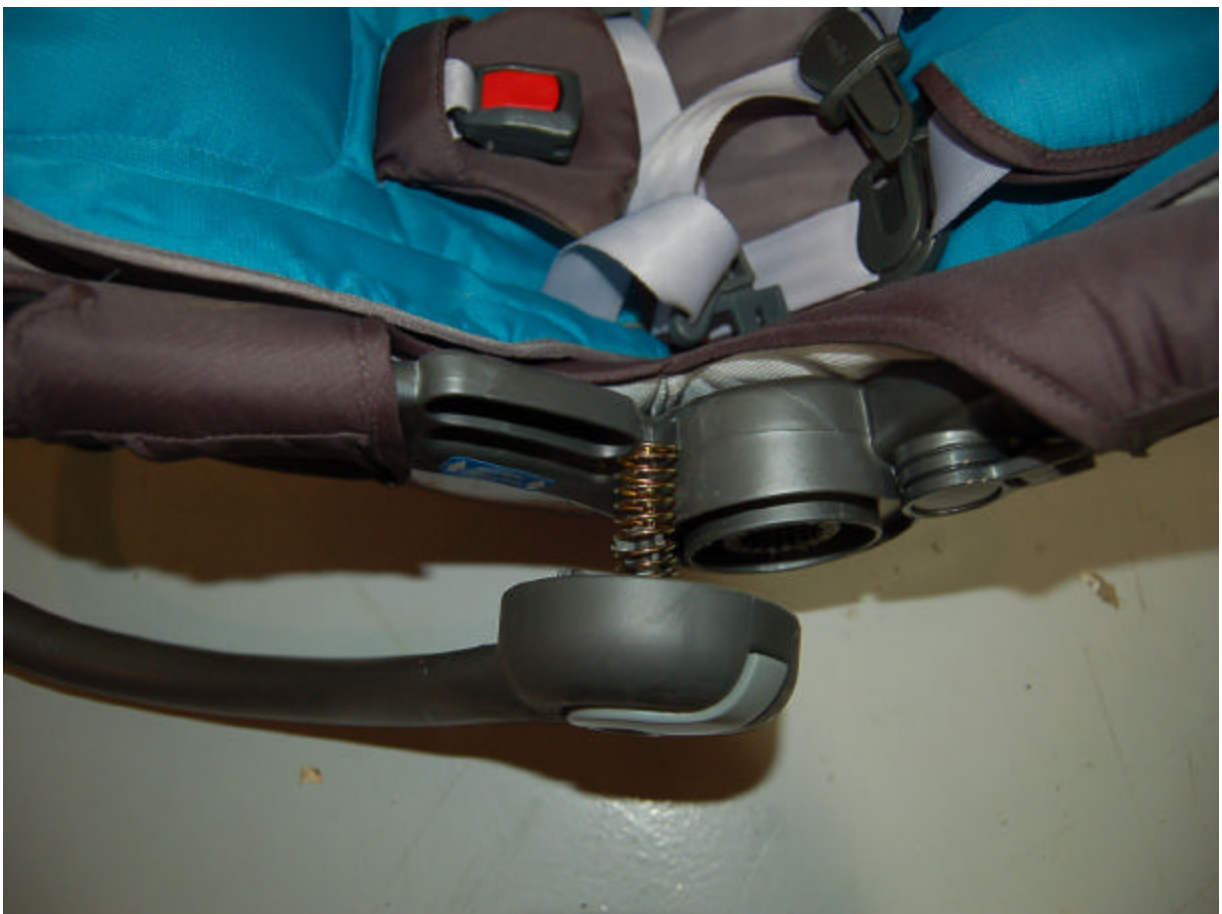
Post-Test Position 4 CRS Damage

| Location | Damage | Remarks |
|---|---|---|
| Cracks on CRS | Yes | Broken Carrying Handle |
