**REPORT NUMBER TR-P28003-06-NC**

**NEW CAR ASSESMENT PROGRAM  
SIDE IMPACT TEST**

**SUZUKI MOTOR CORPORATION JAPAN  
2008 SUZUKI SX4  
4-DOOR**

**NHTSA NUMBER: M80513**

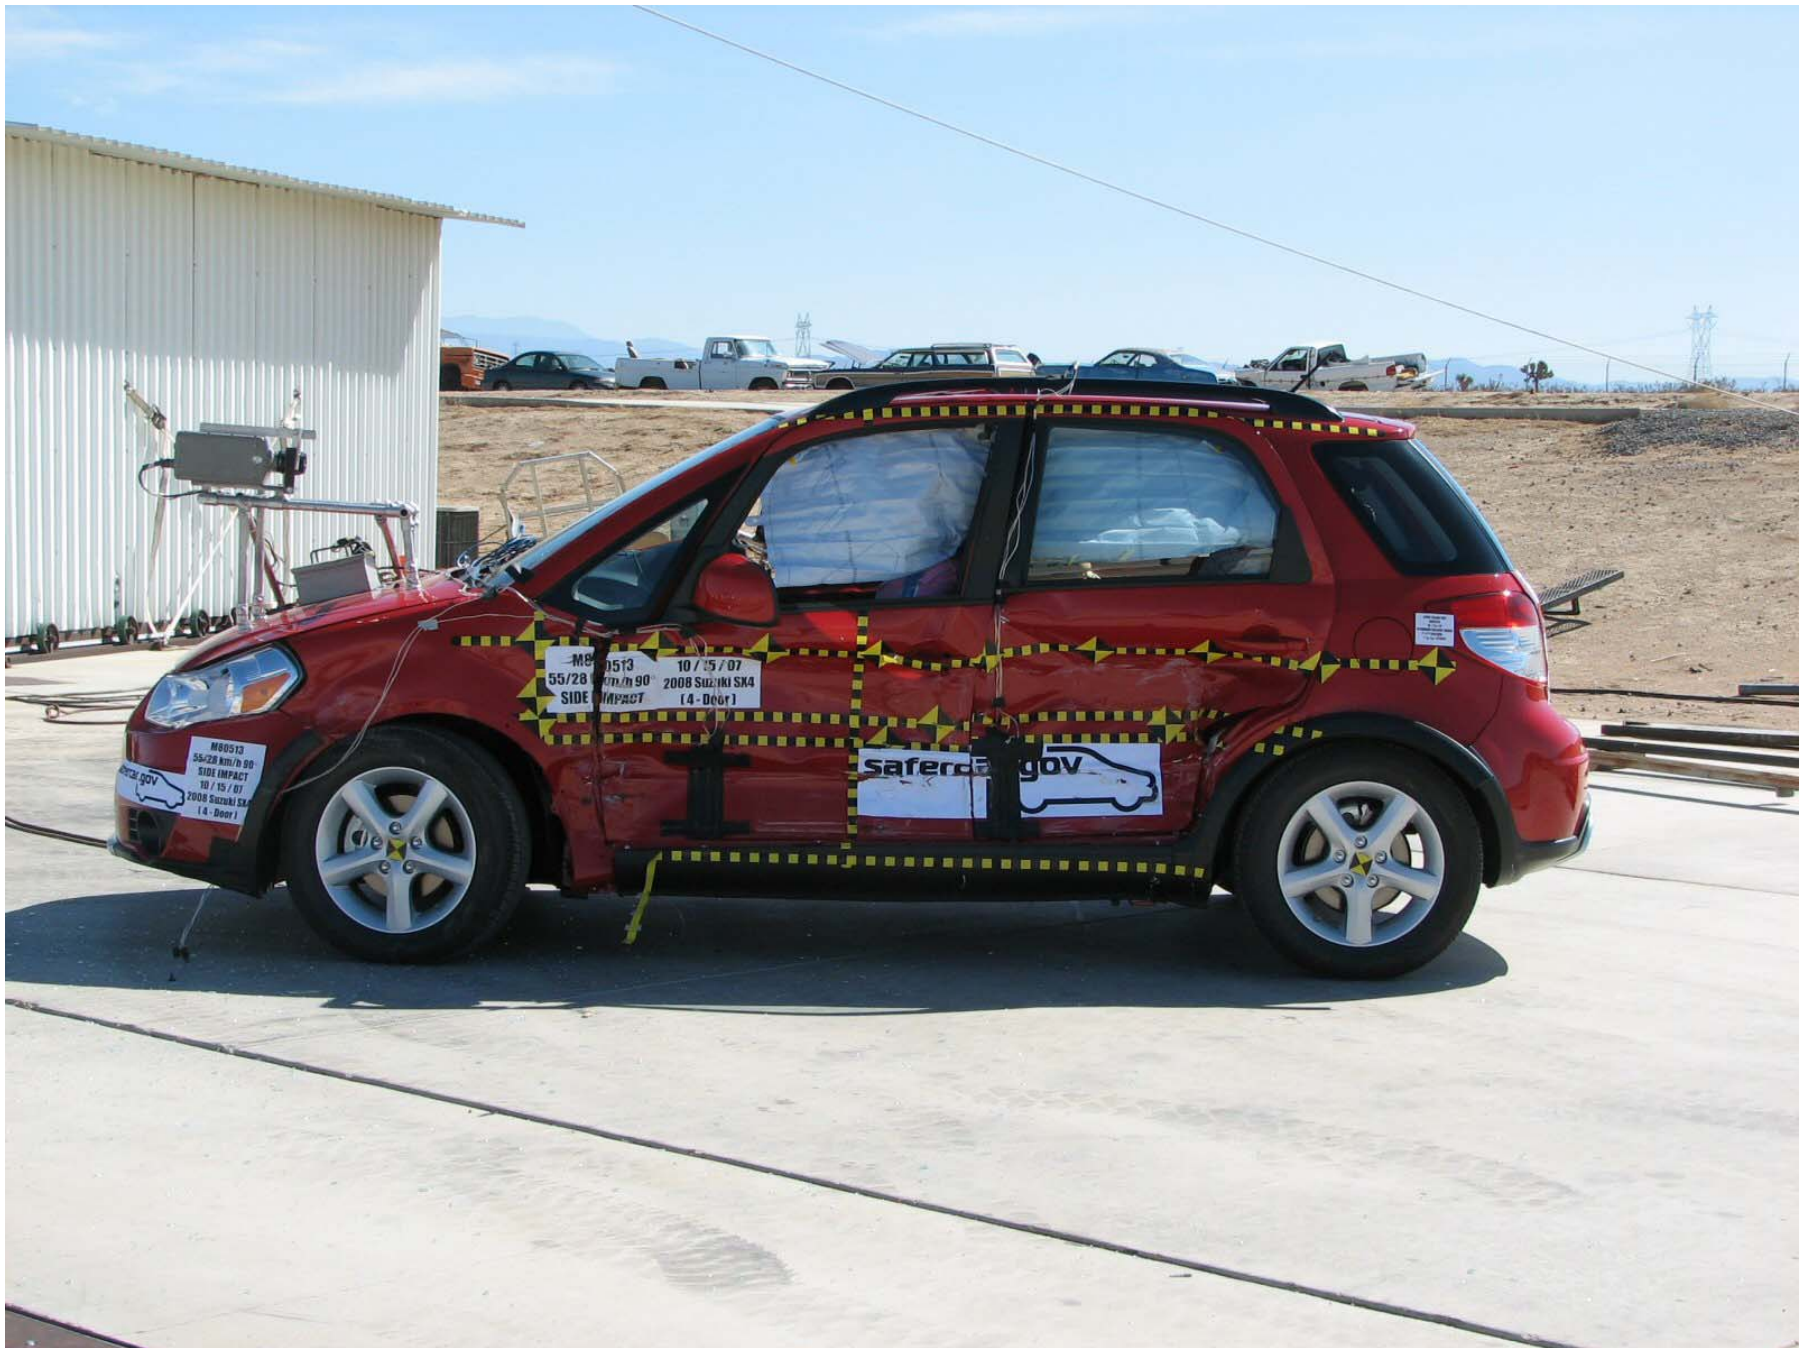
Figure A-10: Post-Test Left Side View

The driver and passenger doors remained closed during impact. The test vehicle sustained a maximum static crush of 214 mm at level 3, 1500 mm rearward of the left vertical impact point. The driver SID/Hybrid III, Serial No. 274, and the passenger SID/Hybrid III, Serial No. 275, were calibrated prior to this test. The SID/Hybrid III injury criteria are summarized as follows:

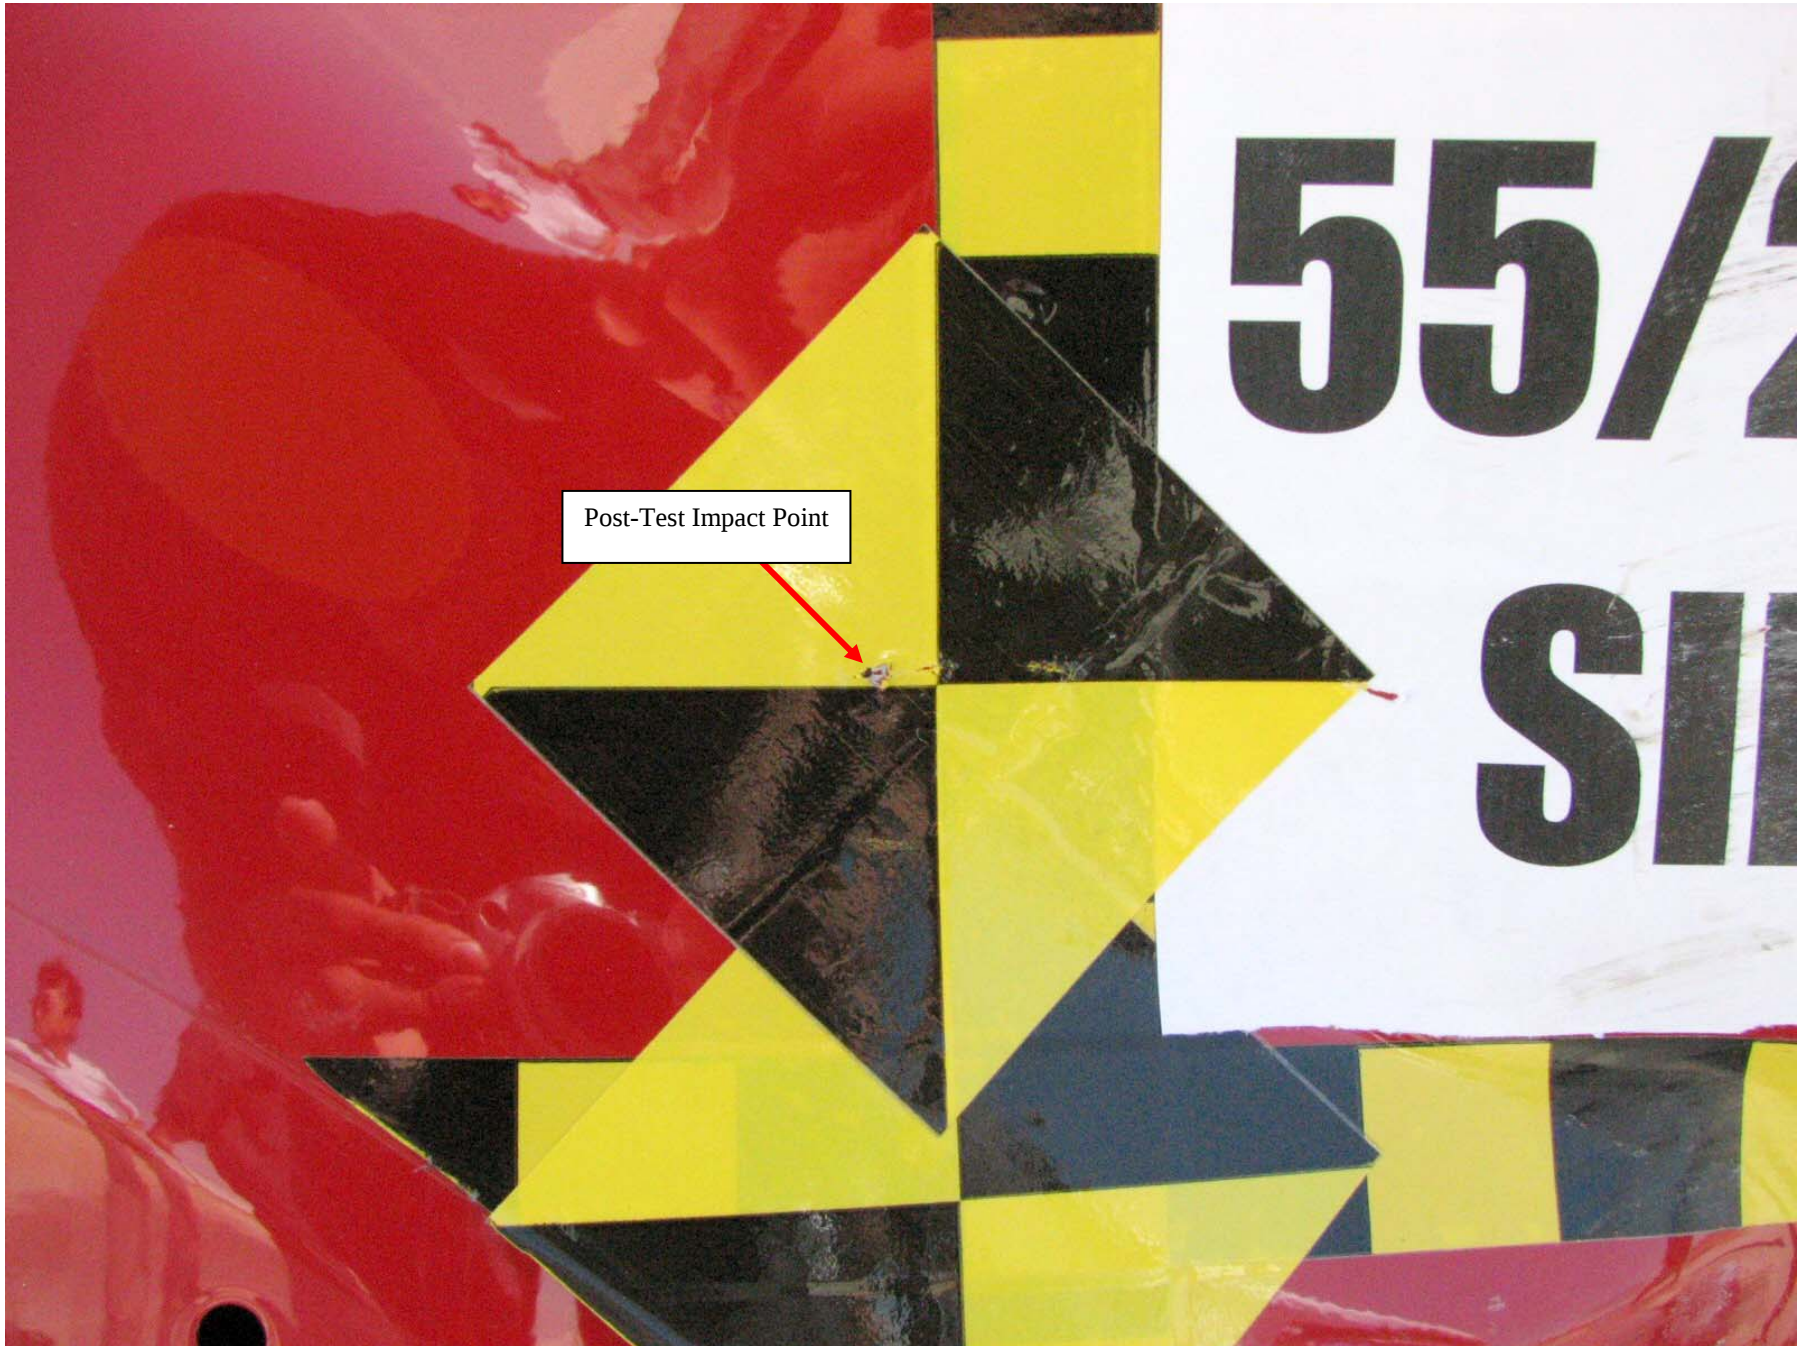
Figure A-26: Post-Test Left Impact Point

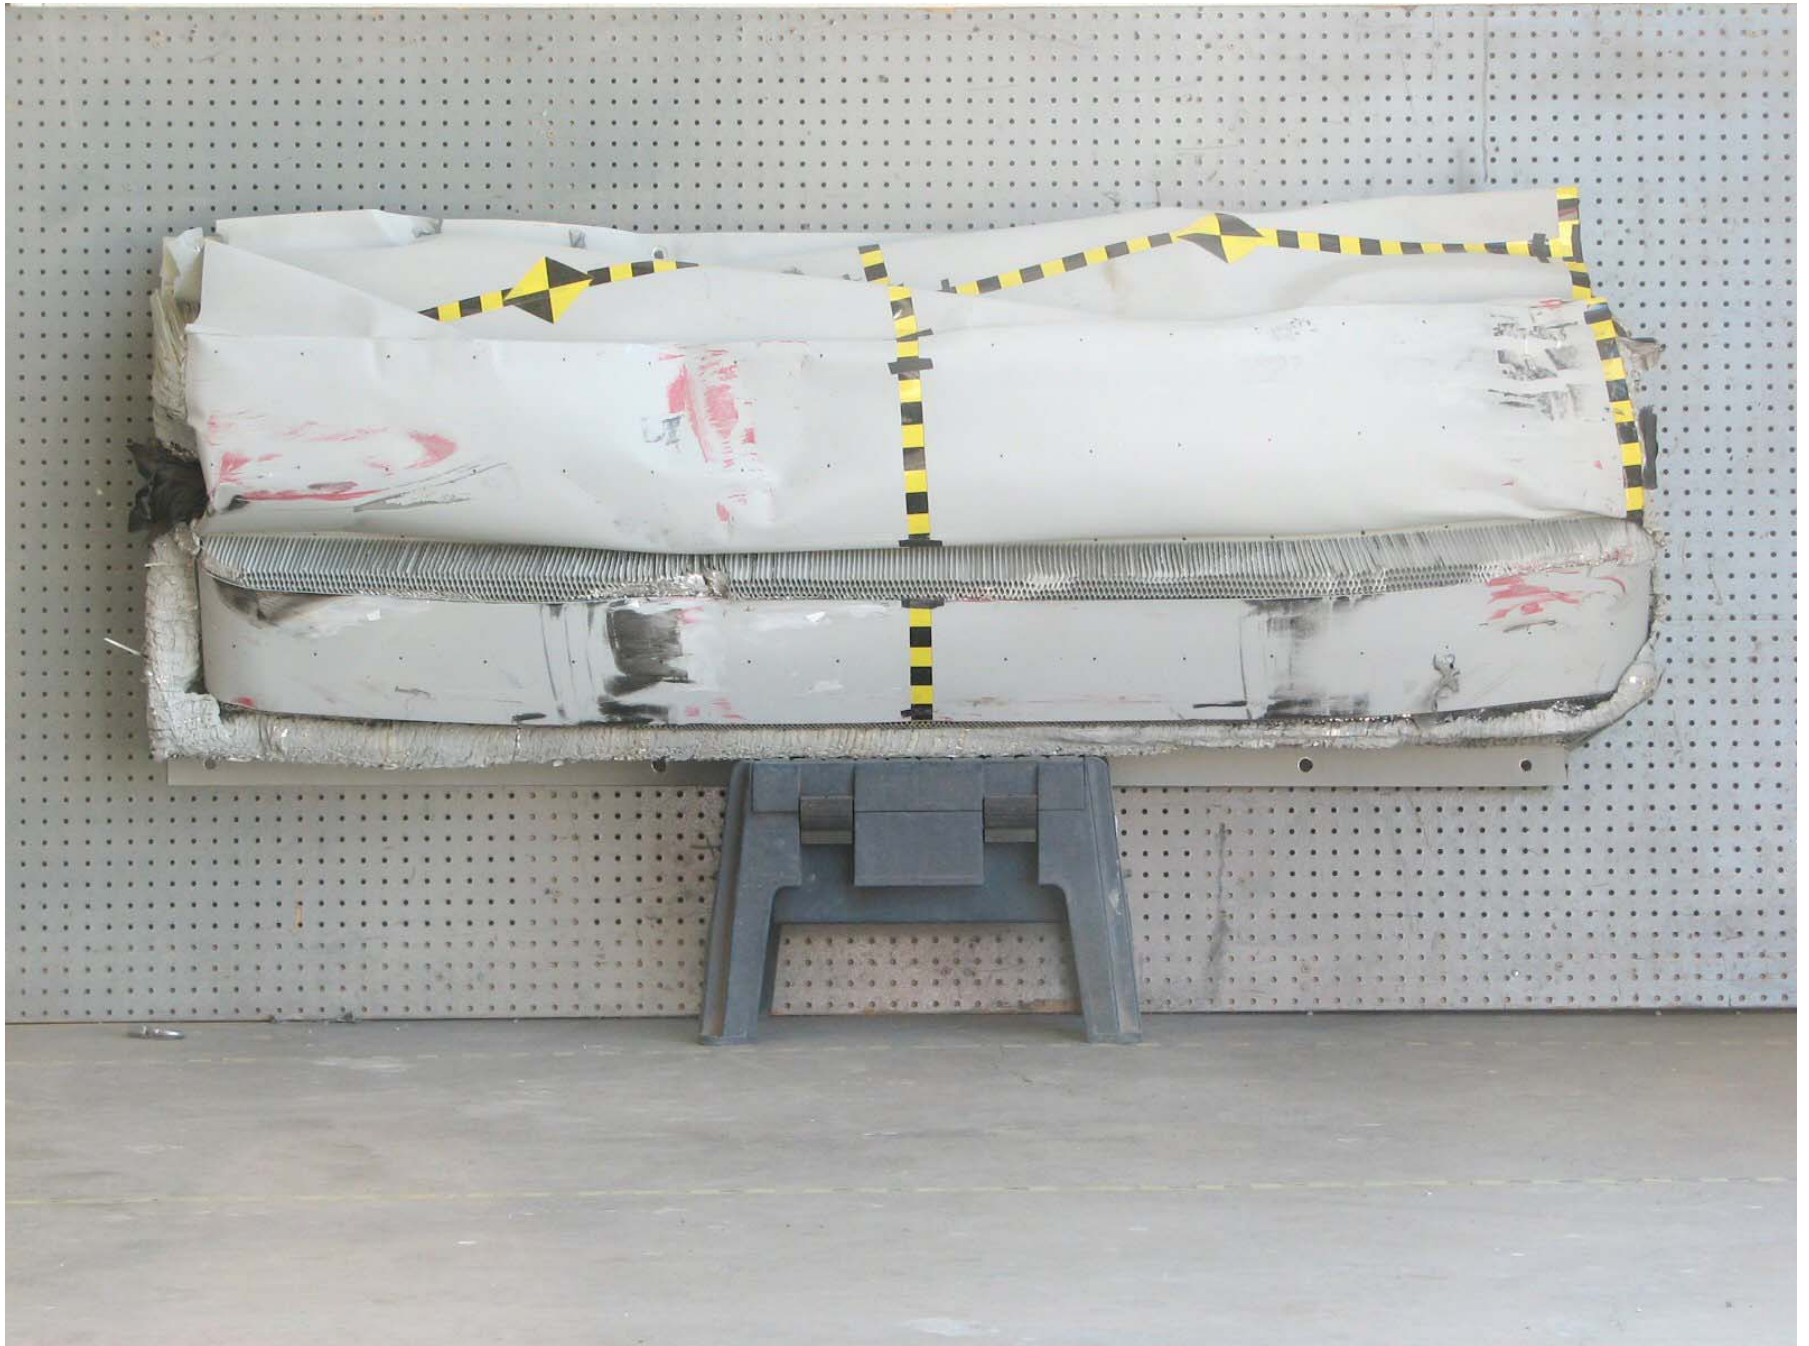
Figure A-54: Post-Test Front View of Deformable Barrier

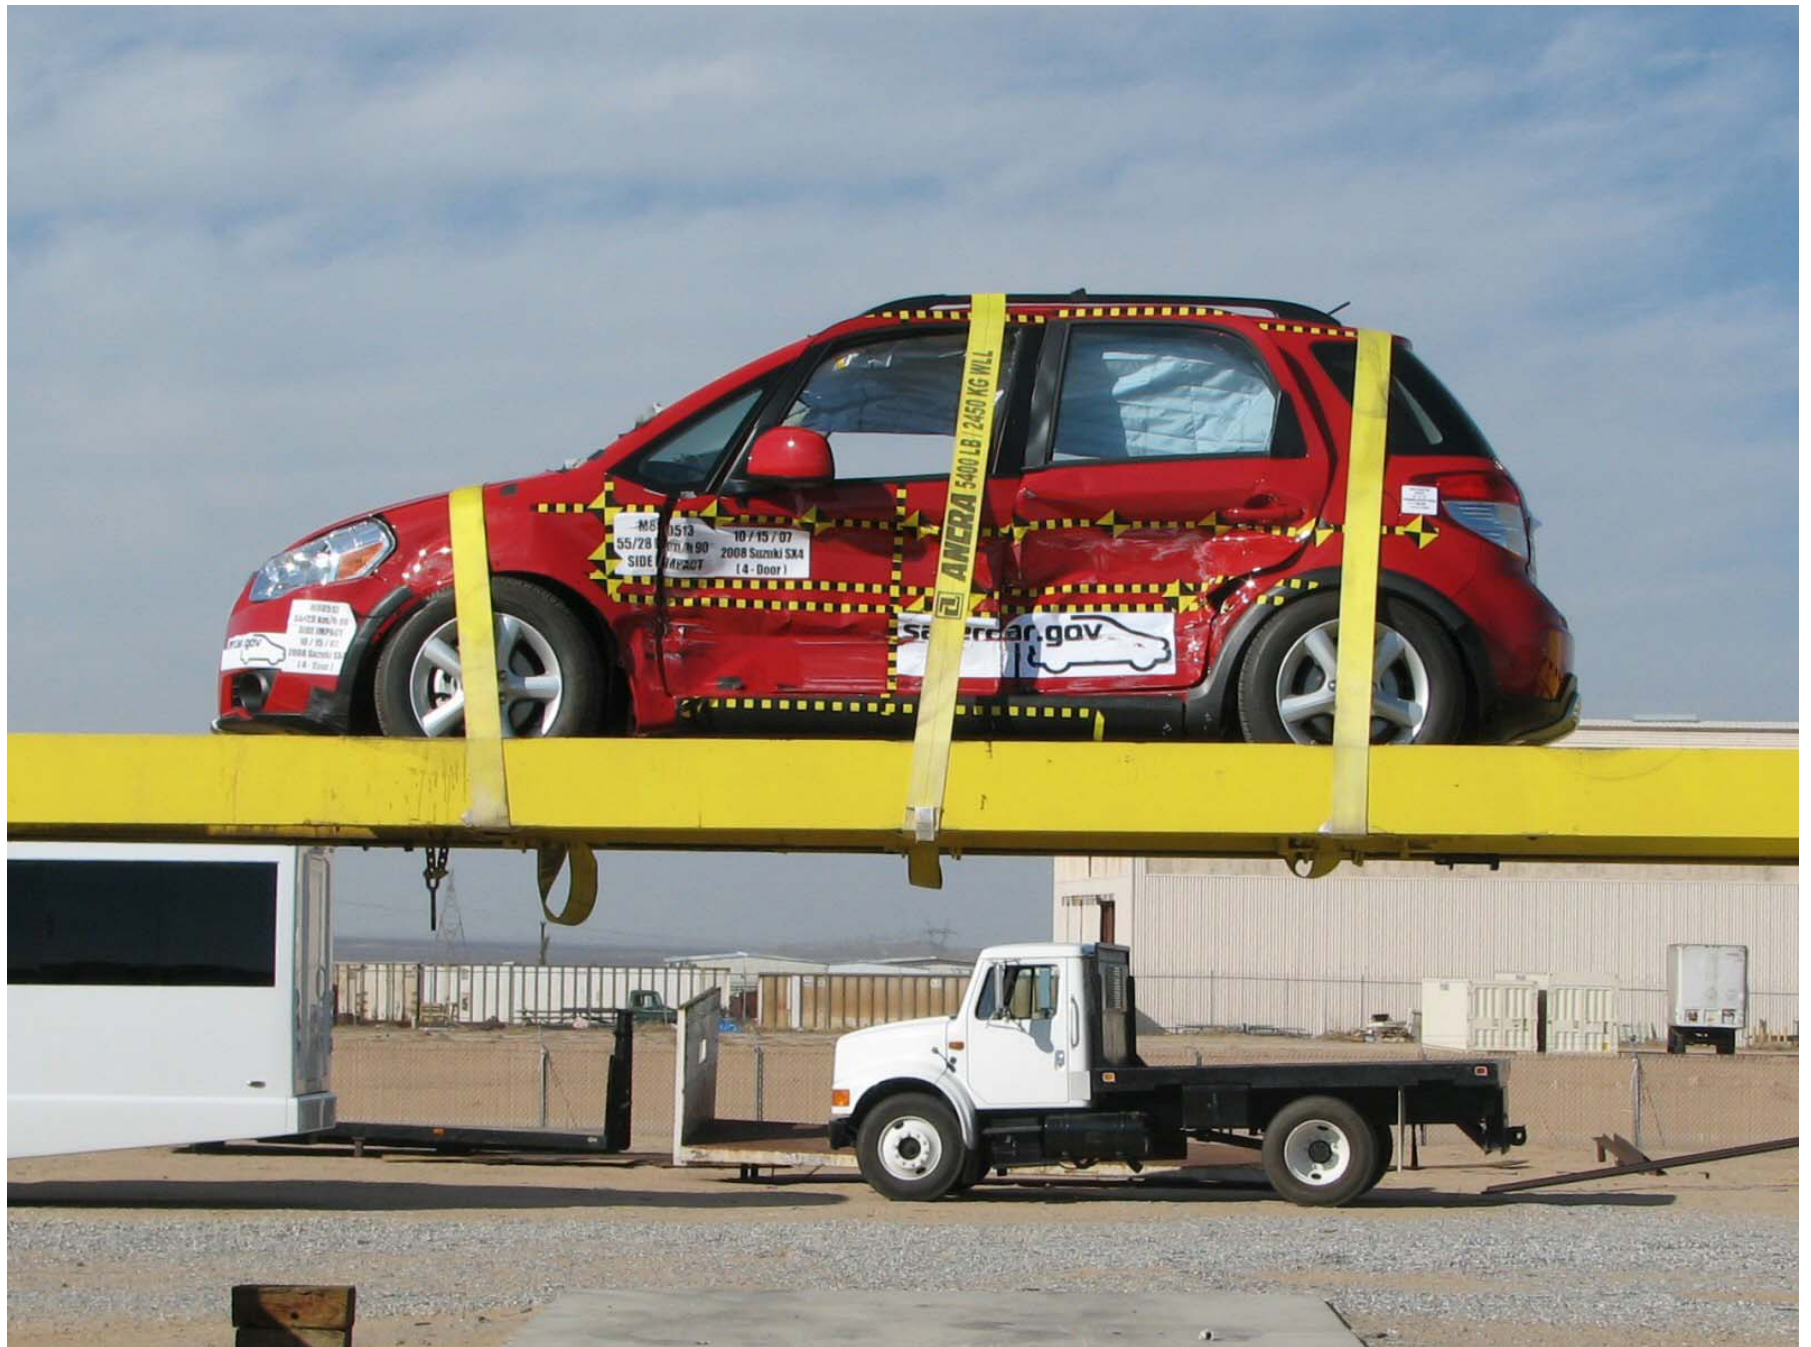
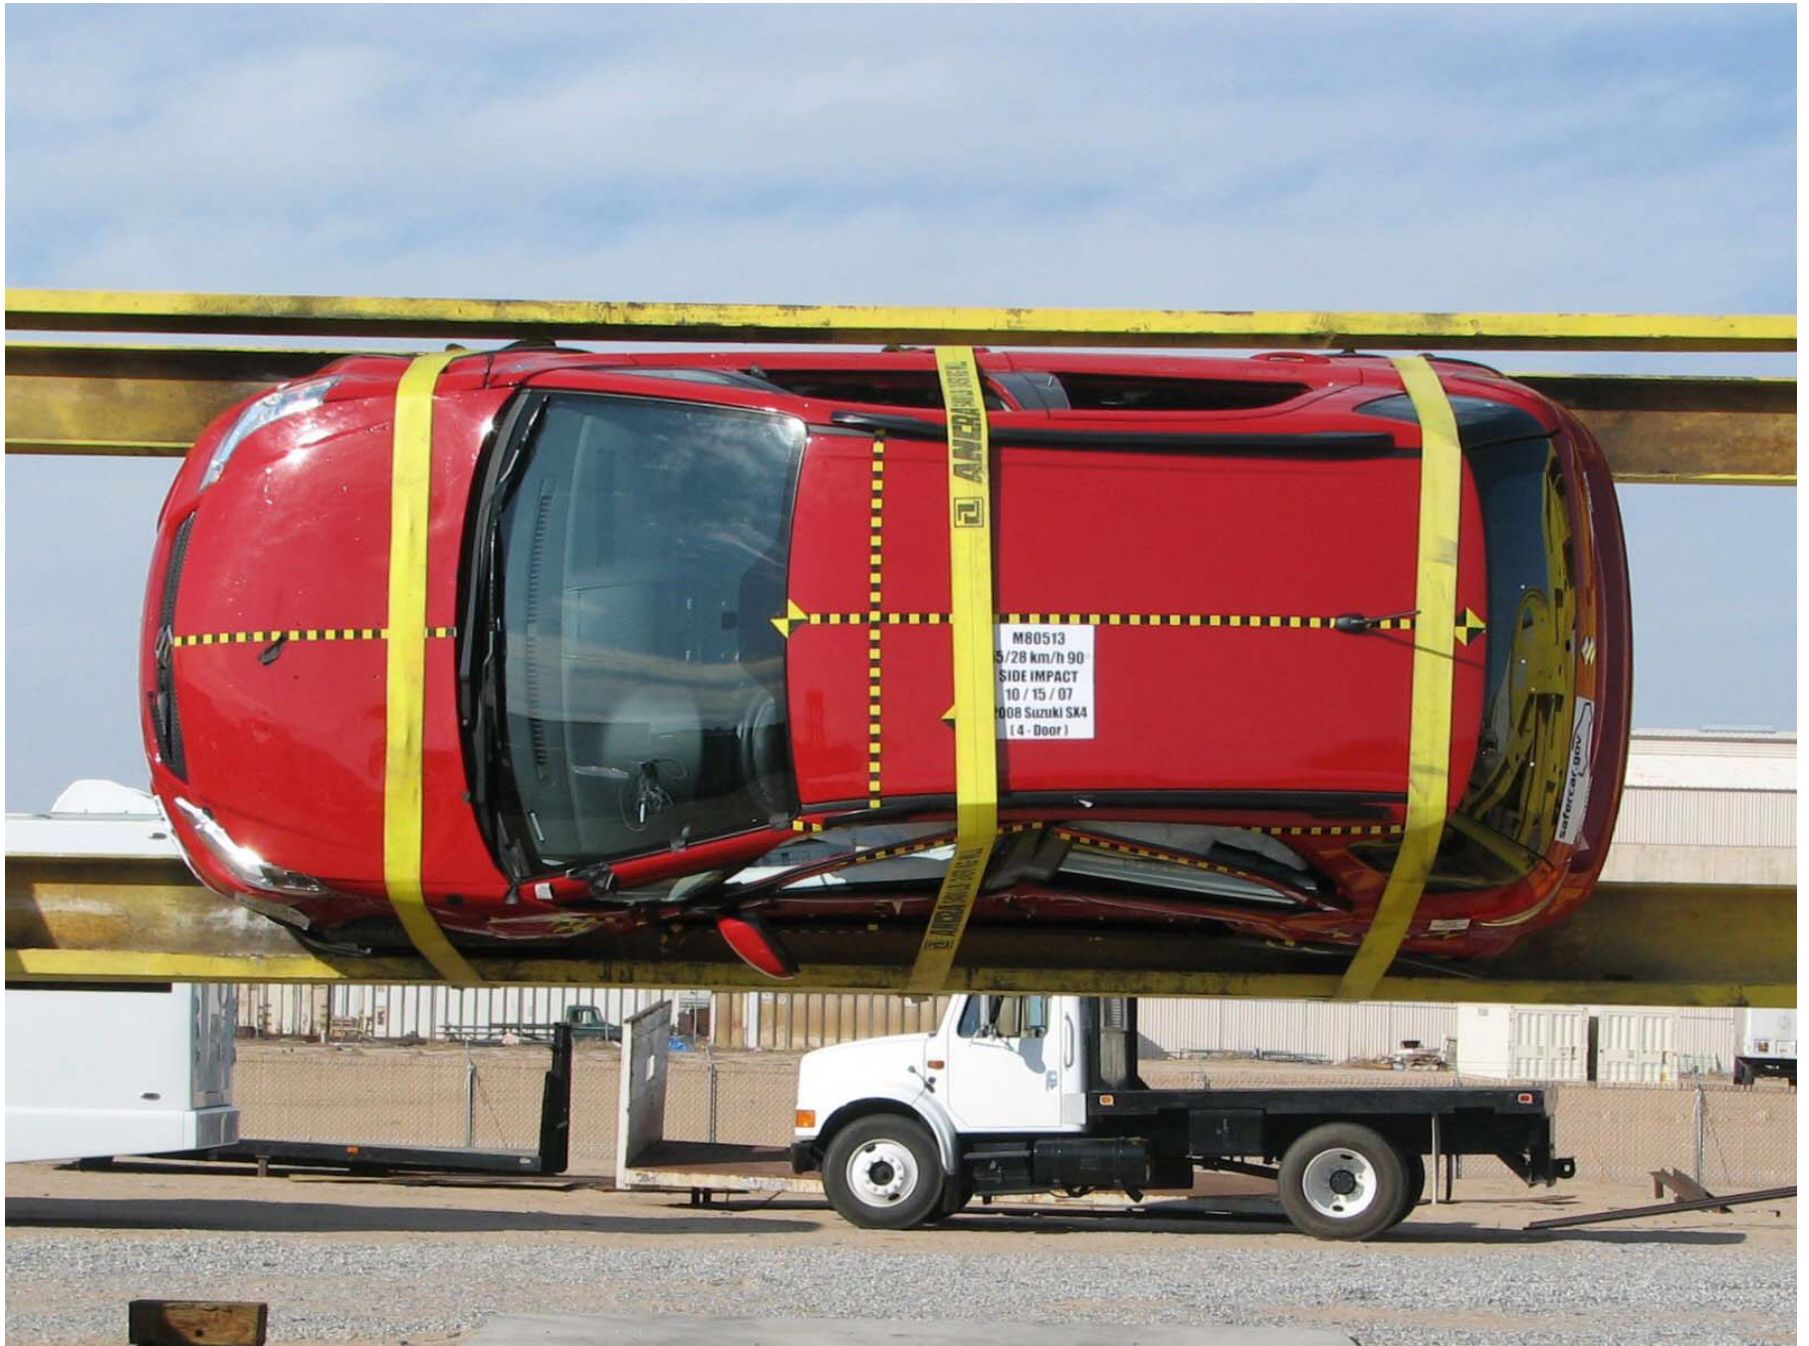
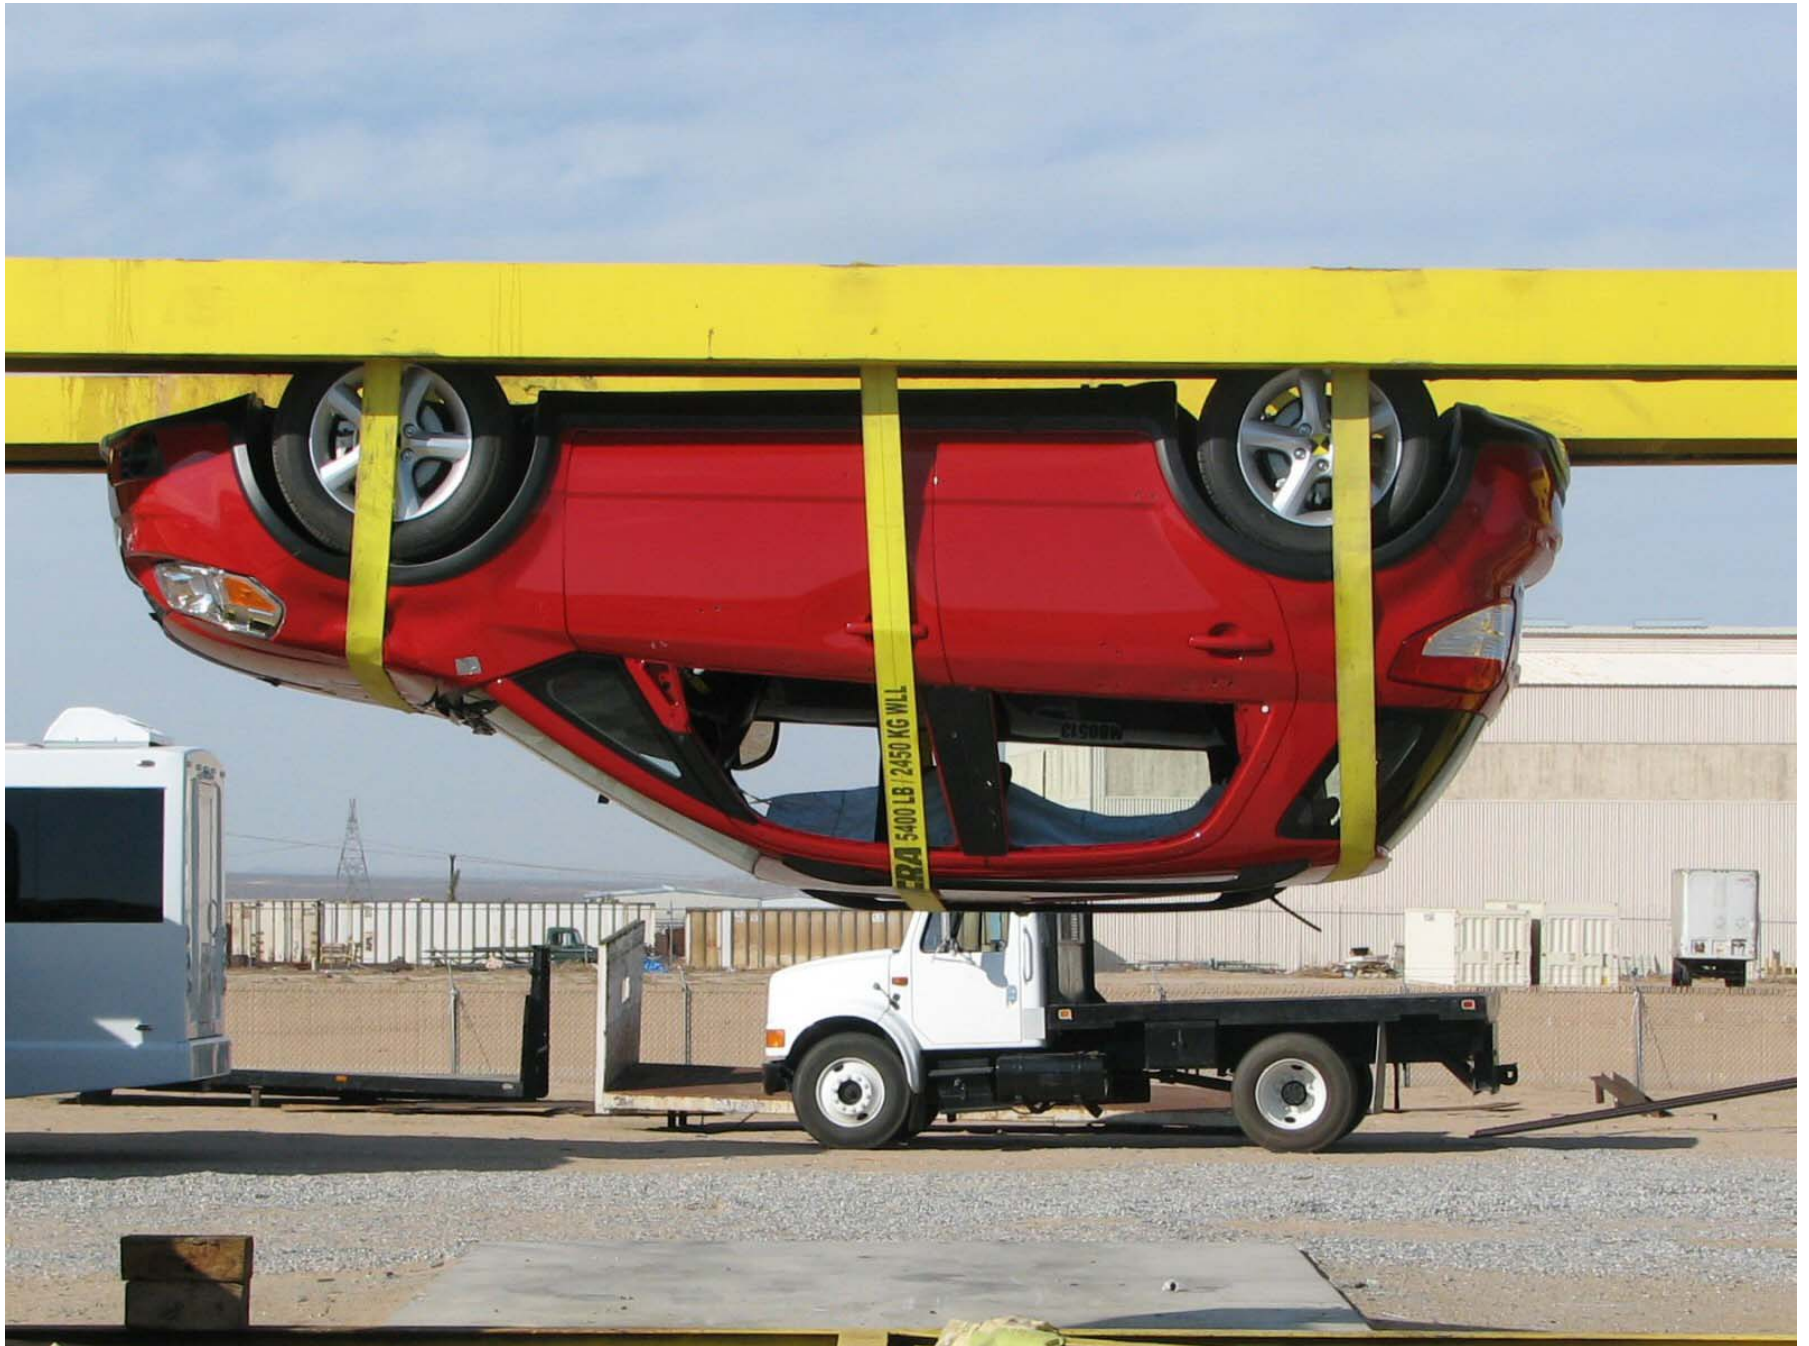
Figure A-61: Vehicle on Rollover Device (0°)

Figure A-62: Vehicle on Rollover Device (90°)

Figure A-63: Vehicle on Rollover Device (180°)

Figure A-64: Vehicle on Rollover Device (270°)

1. The specified fixture rollover rate for each 90° of rotation is 60 to 120 seconds.
  2. The position hold time at each position is 300 seconds (minimum).
  3. Details of Stoddard Solvent spillage locations.
- No solvent leakage occurred during static rollover testing.
