REPORT NUMBER TR-P28003-07-NC

**NEW CAR ASSESMENT PROGRAM
SIDE IMPACT TEST**

**NISSAN MOTOR CO., LTD.
2008 INFINITI G35
4-DOOR SEDAN**

FINAL REPORT

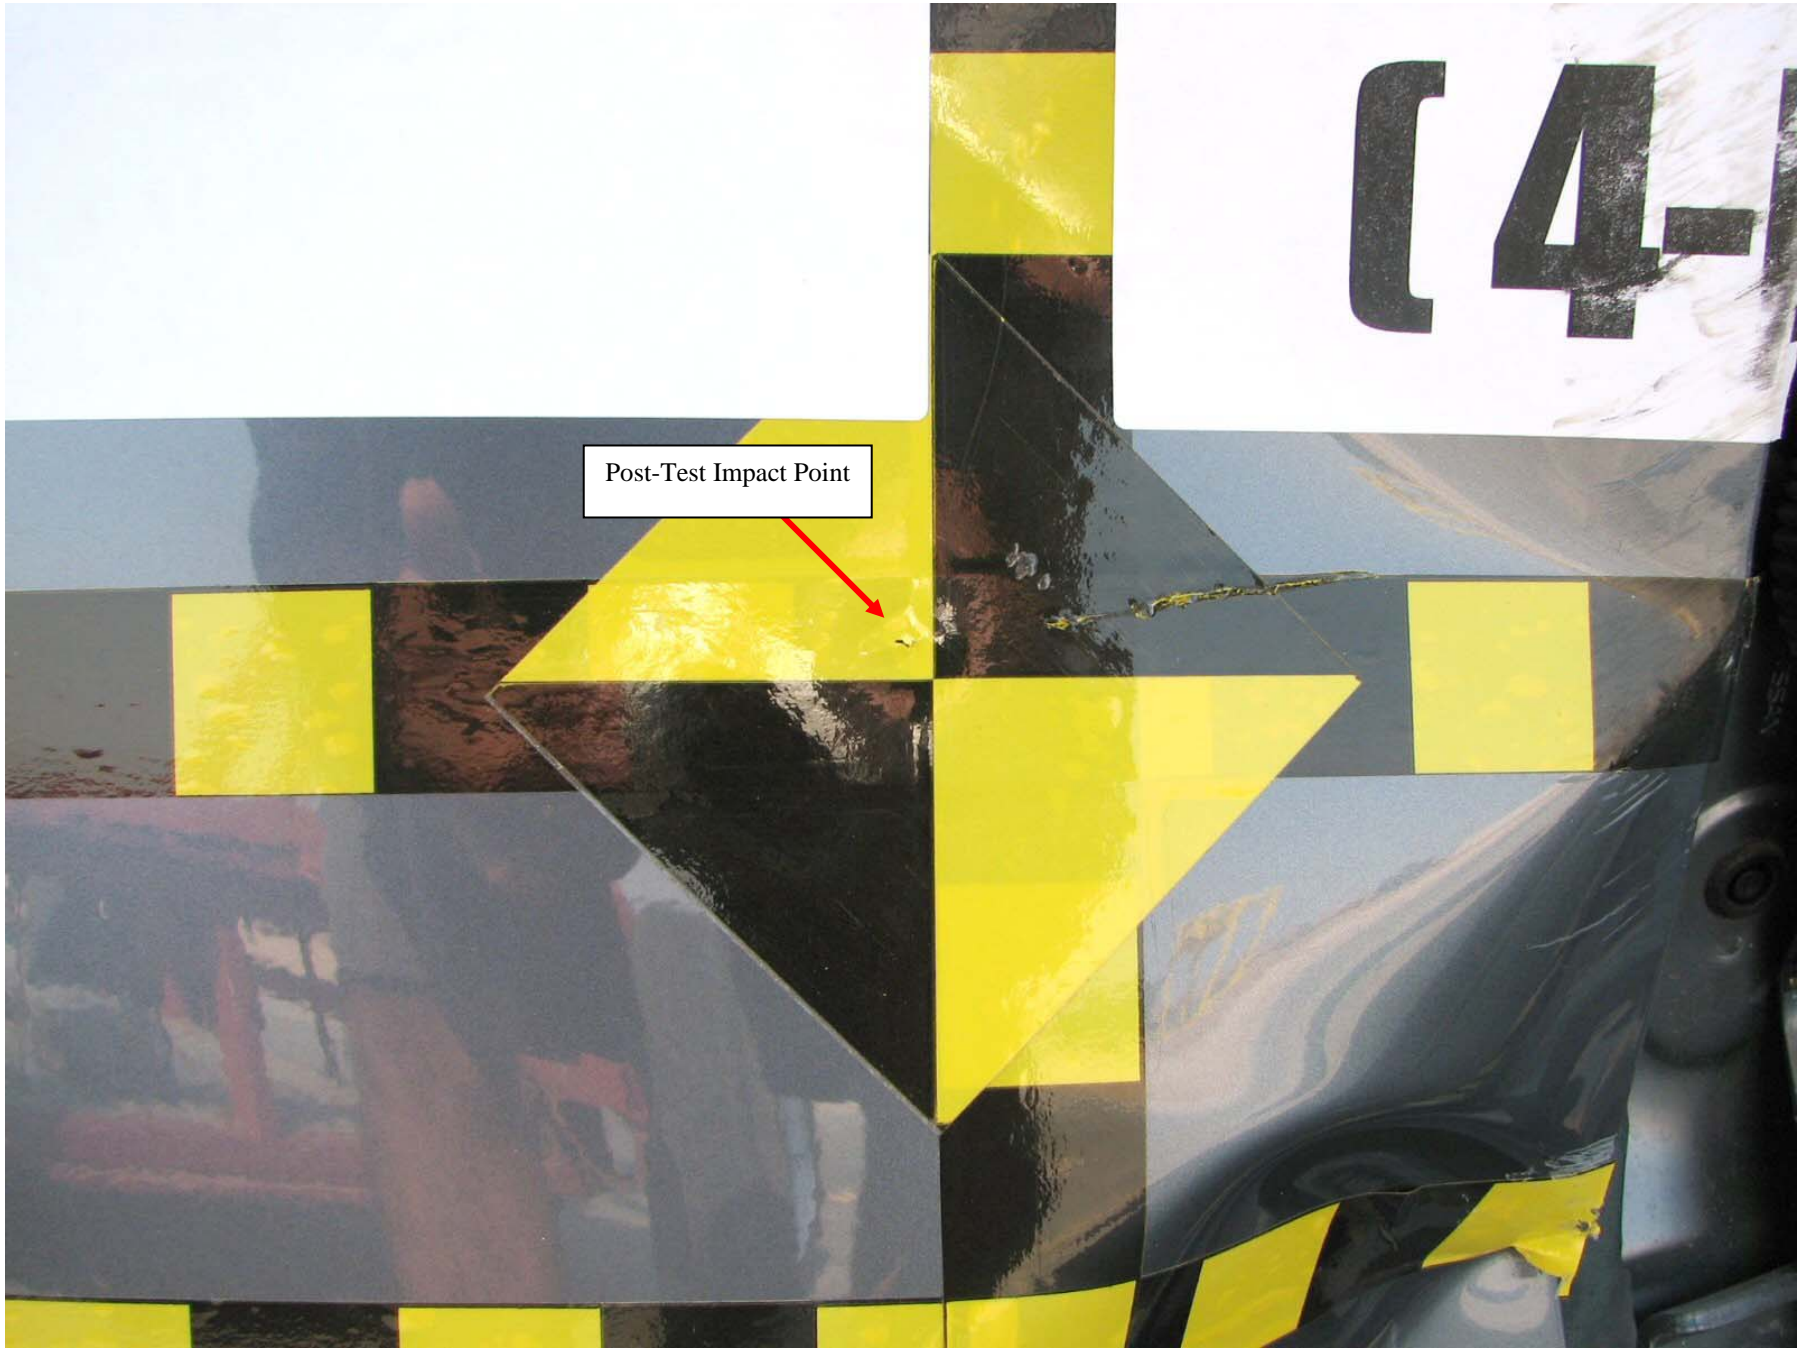
Post-Test Impact Point

Figure A-26: Post-Test Left Impact Point

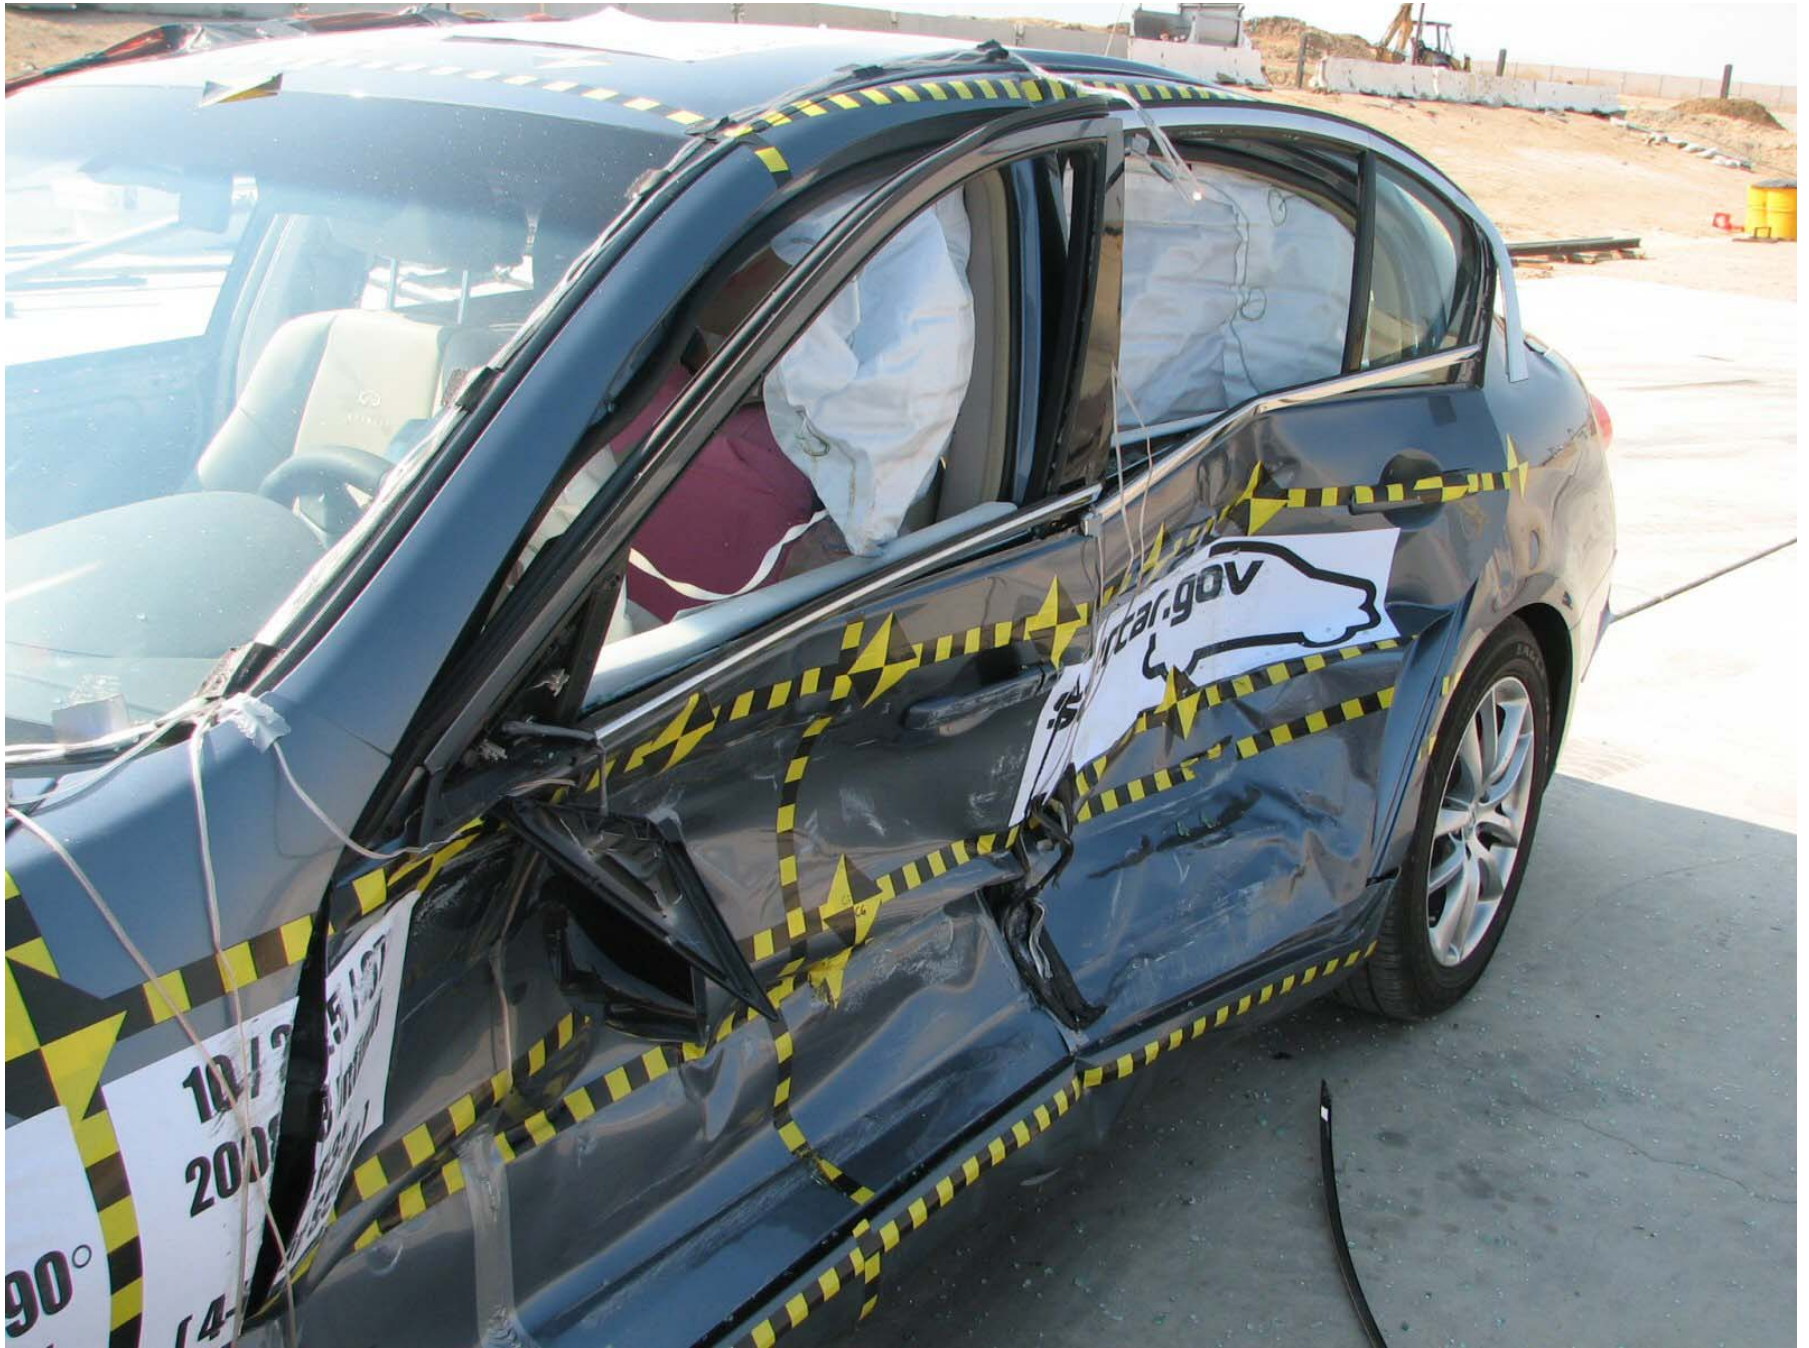
Figure A-28: Post-Test Front $\frac{3}{4}$ View of Left Side Door

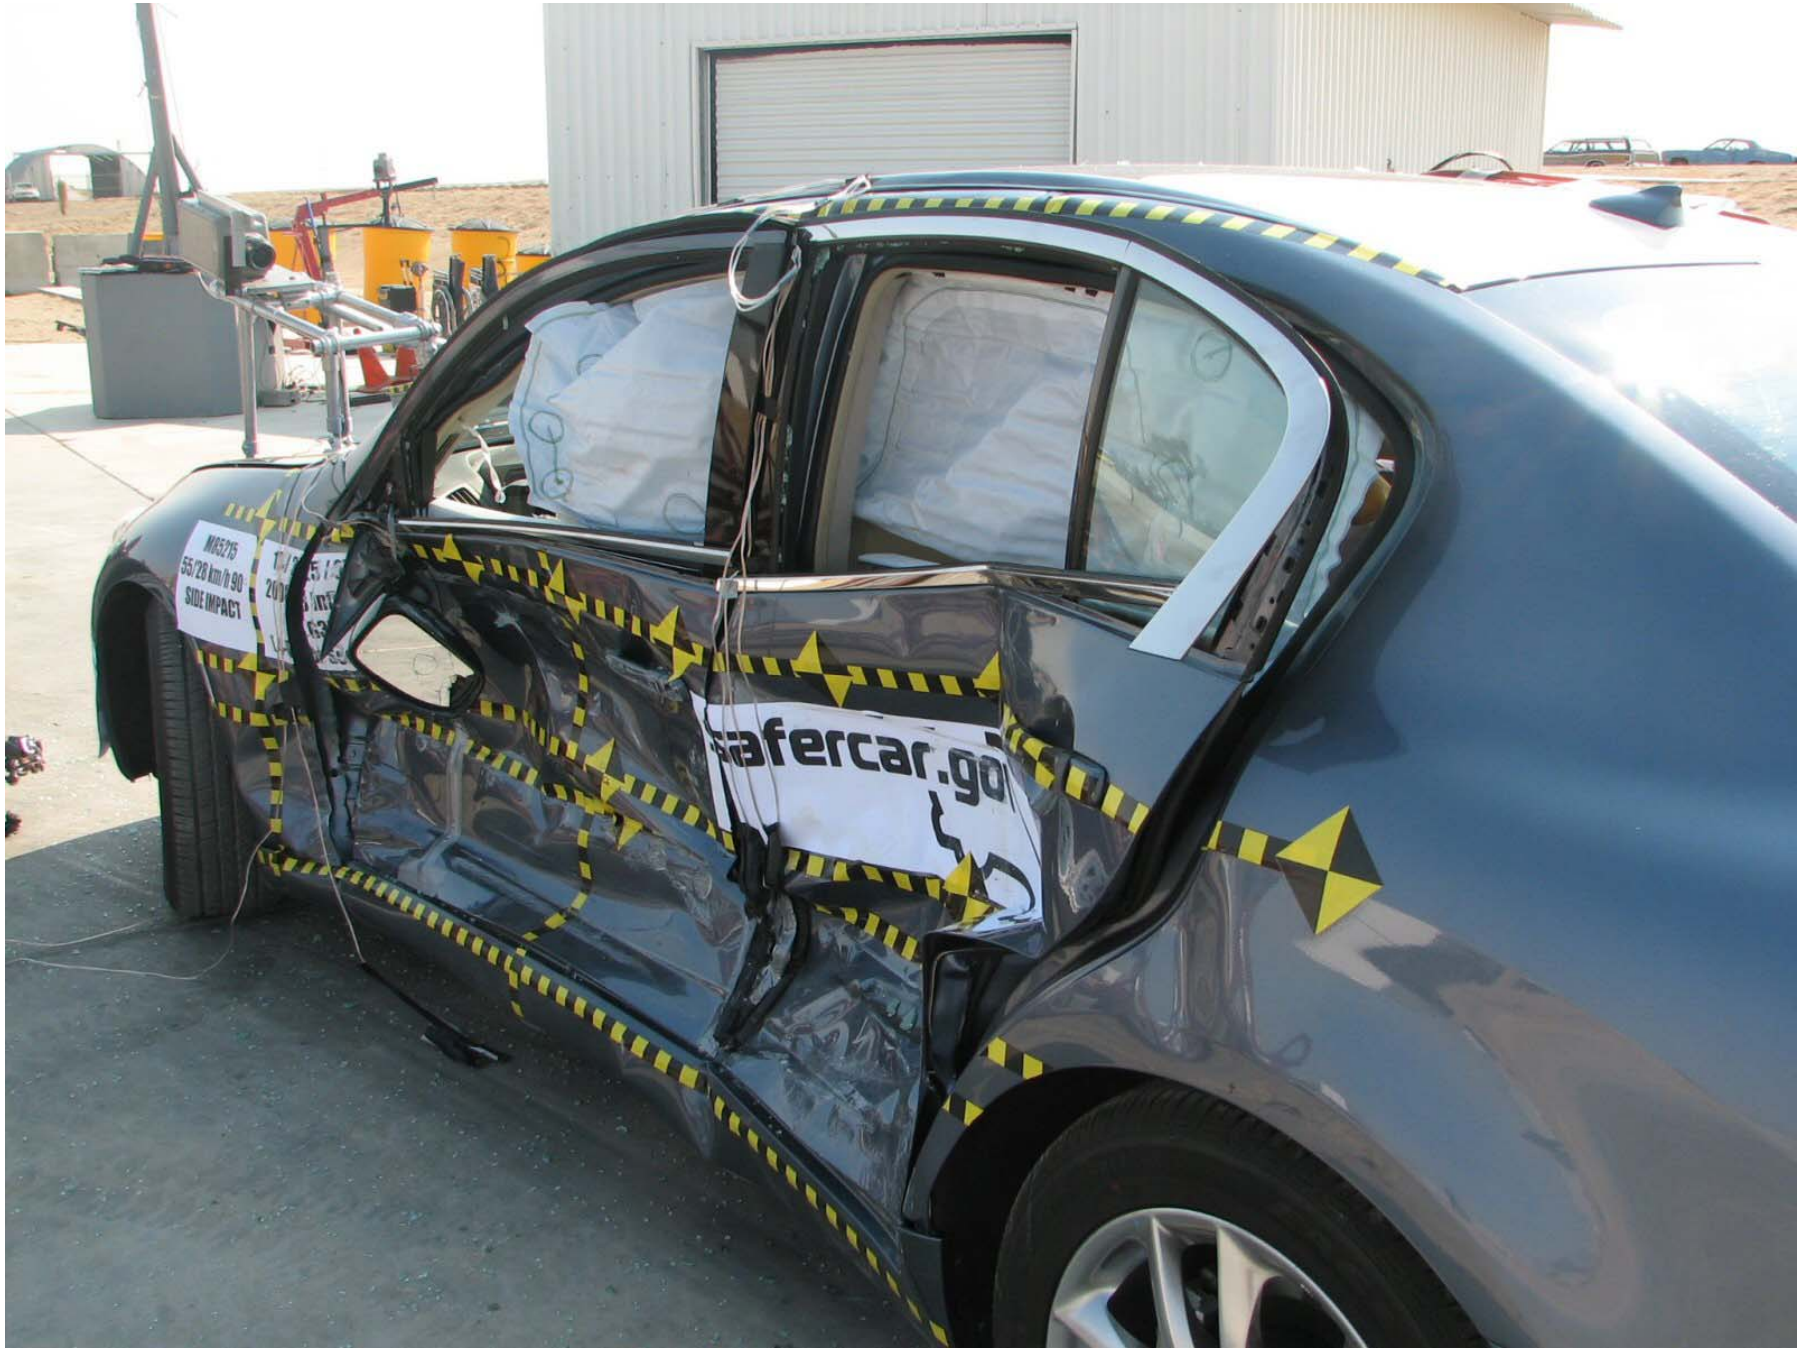
Figure A-30: Post-Test Rear 3/4 View of Left Side Door

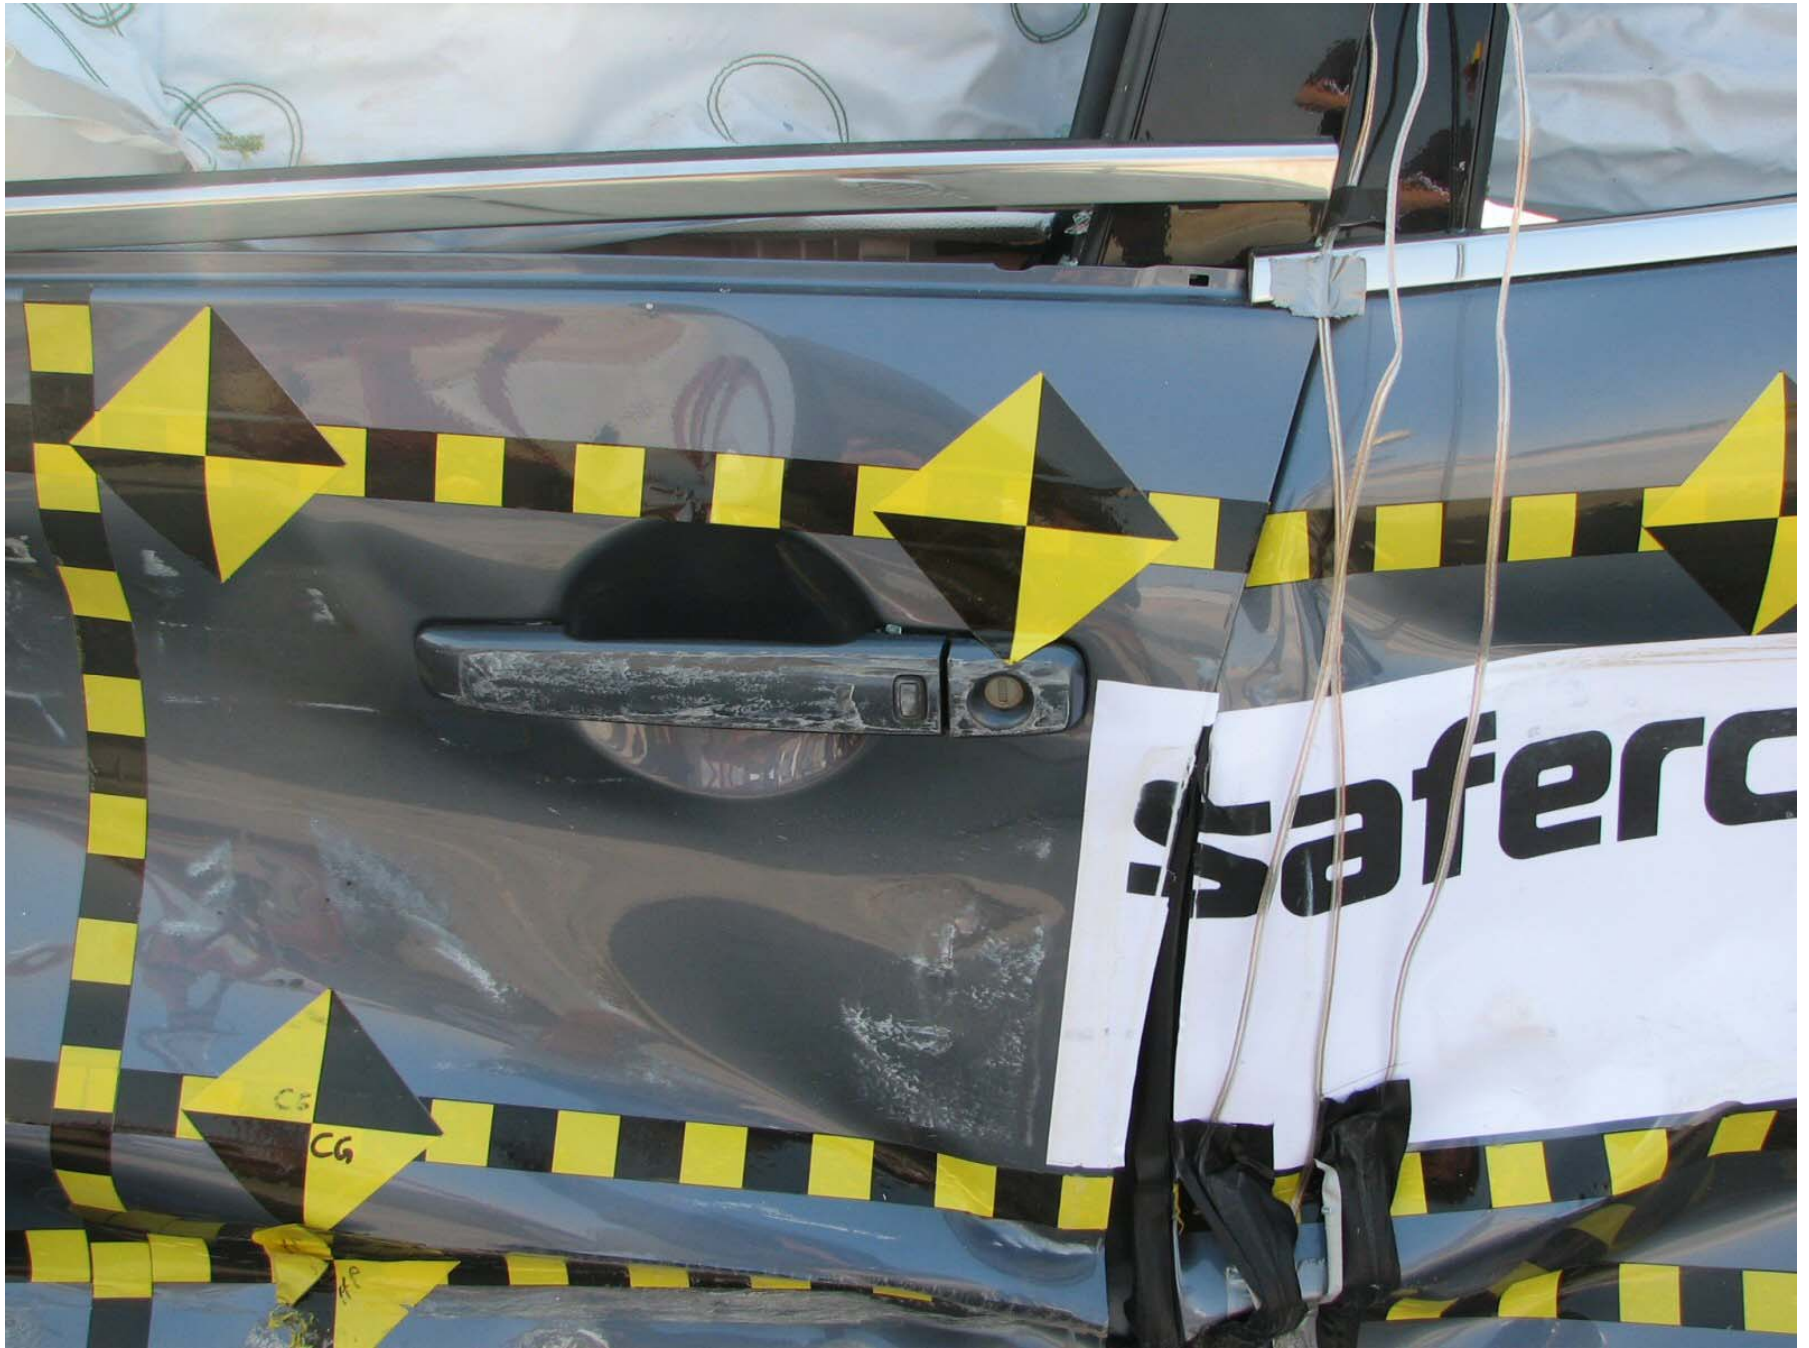
Figure A-32: Post-Test Left Front Door

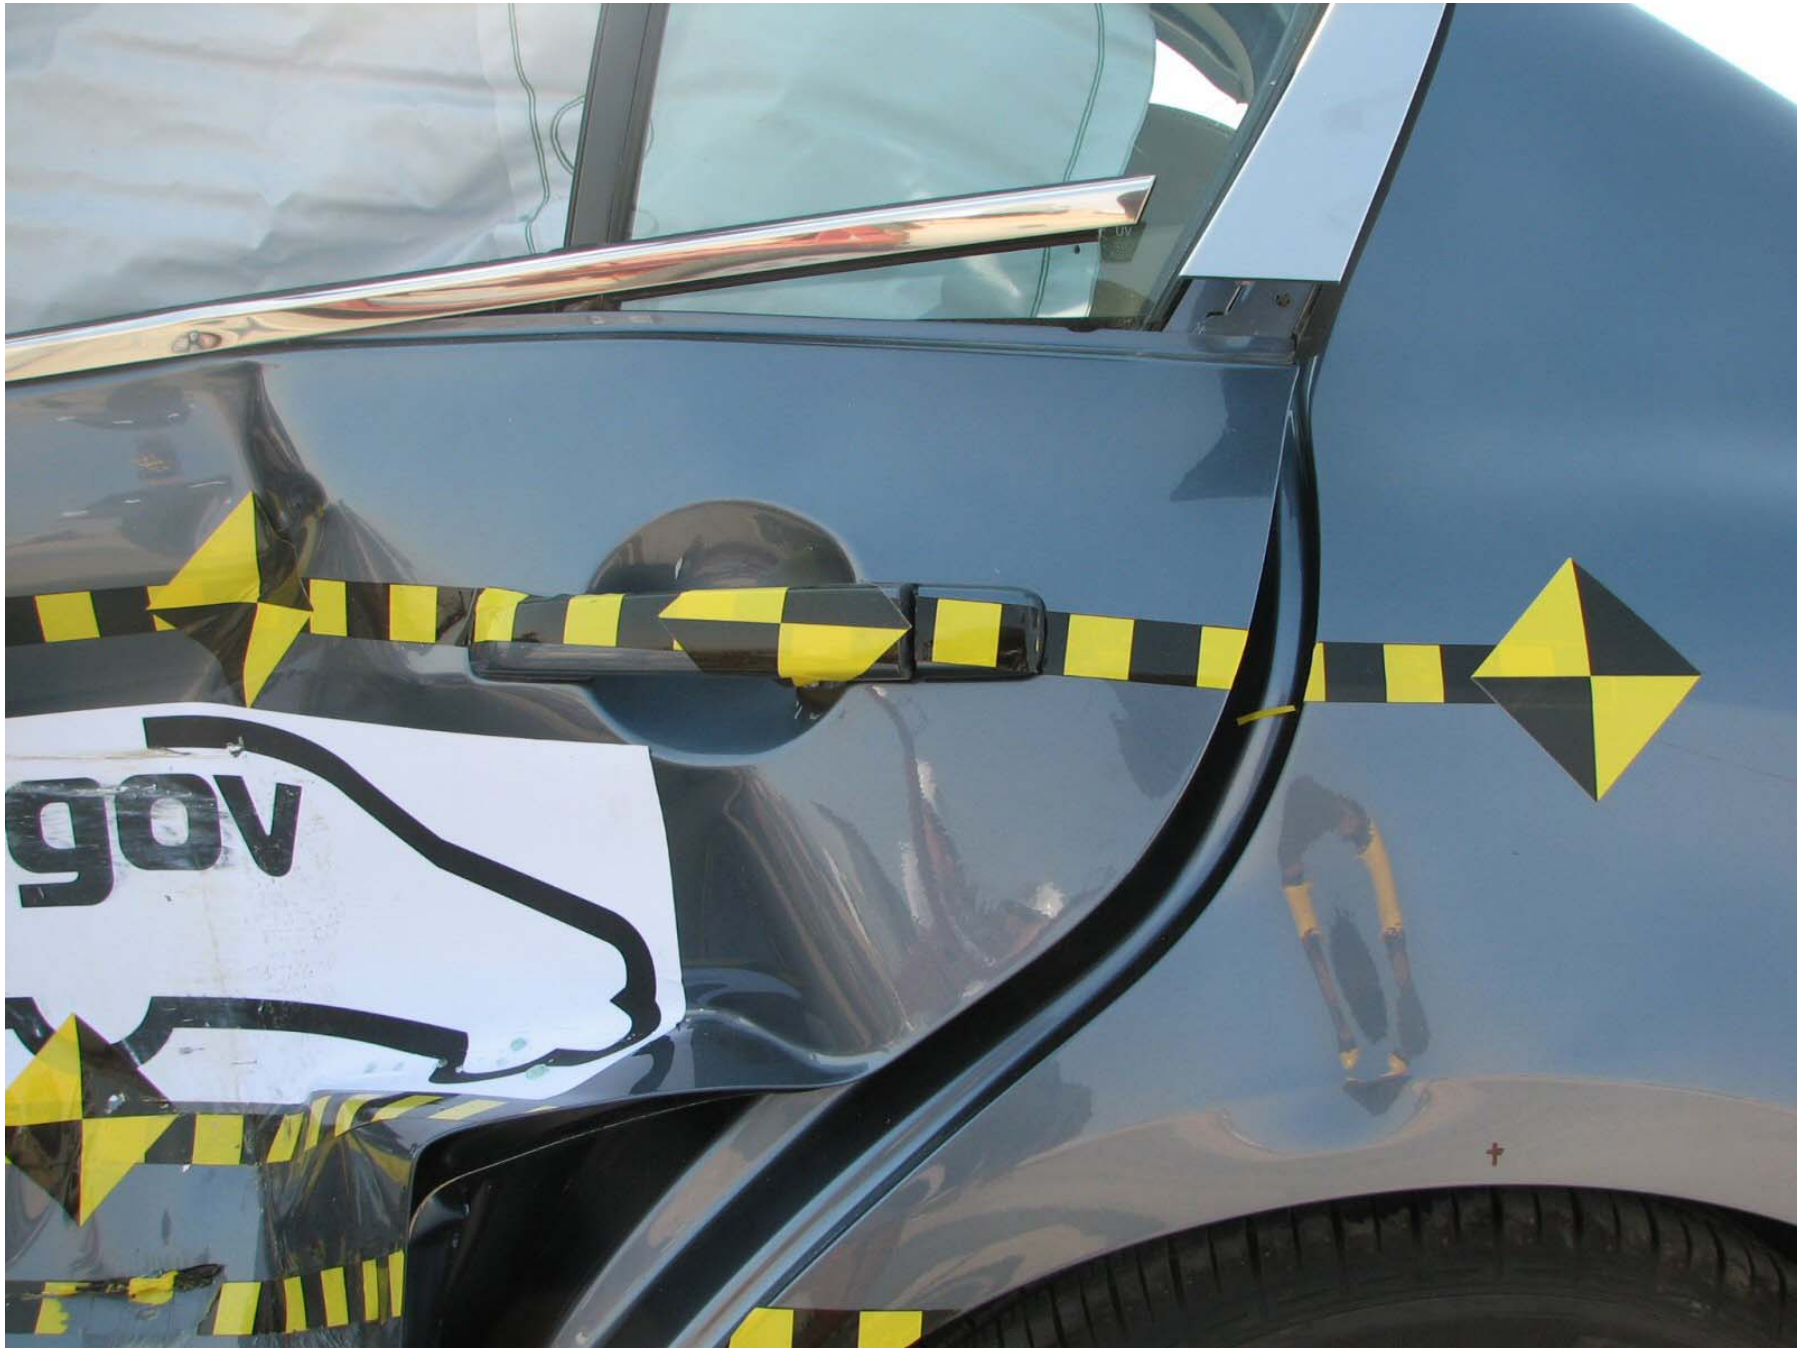
Figure A-34: Post-Test Left Rear Door

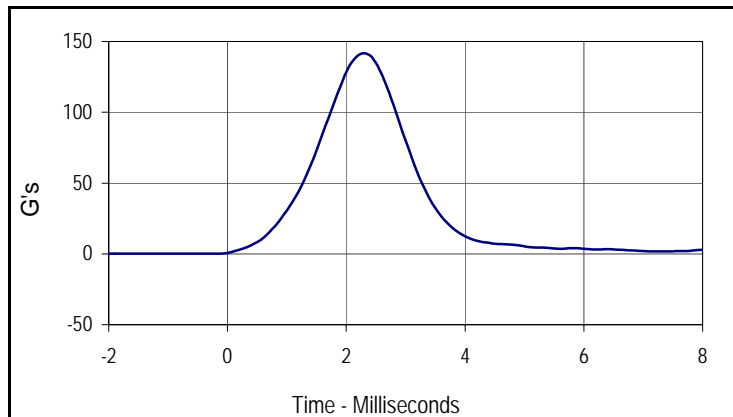
Tested Parameter	Units	Specification	Result	Pass/Fail
Laboratory Temperature	°C	18.9 to 25.6	21.7	Pass
Laboratory Relative Humidity	%	10 to 70	30	Pass
Peak Resultant Acceleration	G's	120.0 to 150.0	141.6	Pass
Peak Longitudinal Acceleration	G's	≤15.0	7.4	Pass
Is Acceleration Unimodal?	Yes/No	Yes	Yes	Pass
Oscillations After Main Pulse	%	<15	3.7	Pass
Overall Test Results				Pass

Curve Description			
Head Resultant			
CURNO	Type	SAE Class	Units
001	RES	1000	G's
Max	Time	Min	Time
141.6	2.3	0.1	-0.2
