**REPORT NUMBER: NCAP-MGA-2008-010**

**NEW CAR ASSESSMENT PROGRAM  
FRONTAL BARRIER IMPACT TEST**

**FORD MOTOR COMPANY  
2008 FORD FOCUS 2-DOOR COUPE  
NHTSA NUMBER: M80202**

**PREPARED BY:  
MGA RESEARCH CORPORATION  
5000 WARREN ROAD  
BURLINGTON, WI 53105**

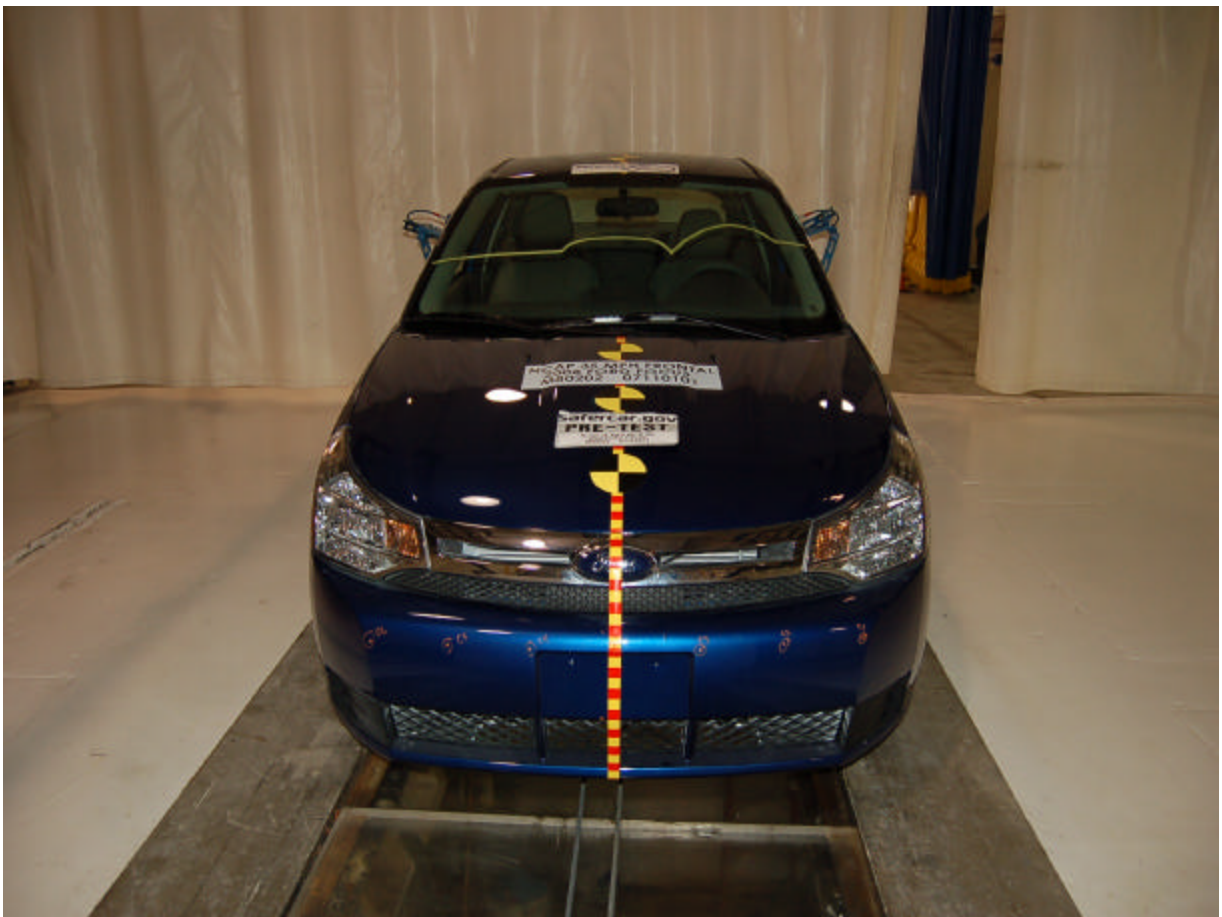
Pre-Test Front View

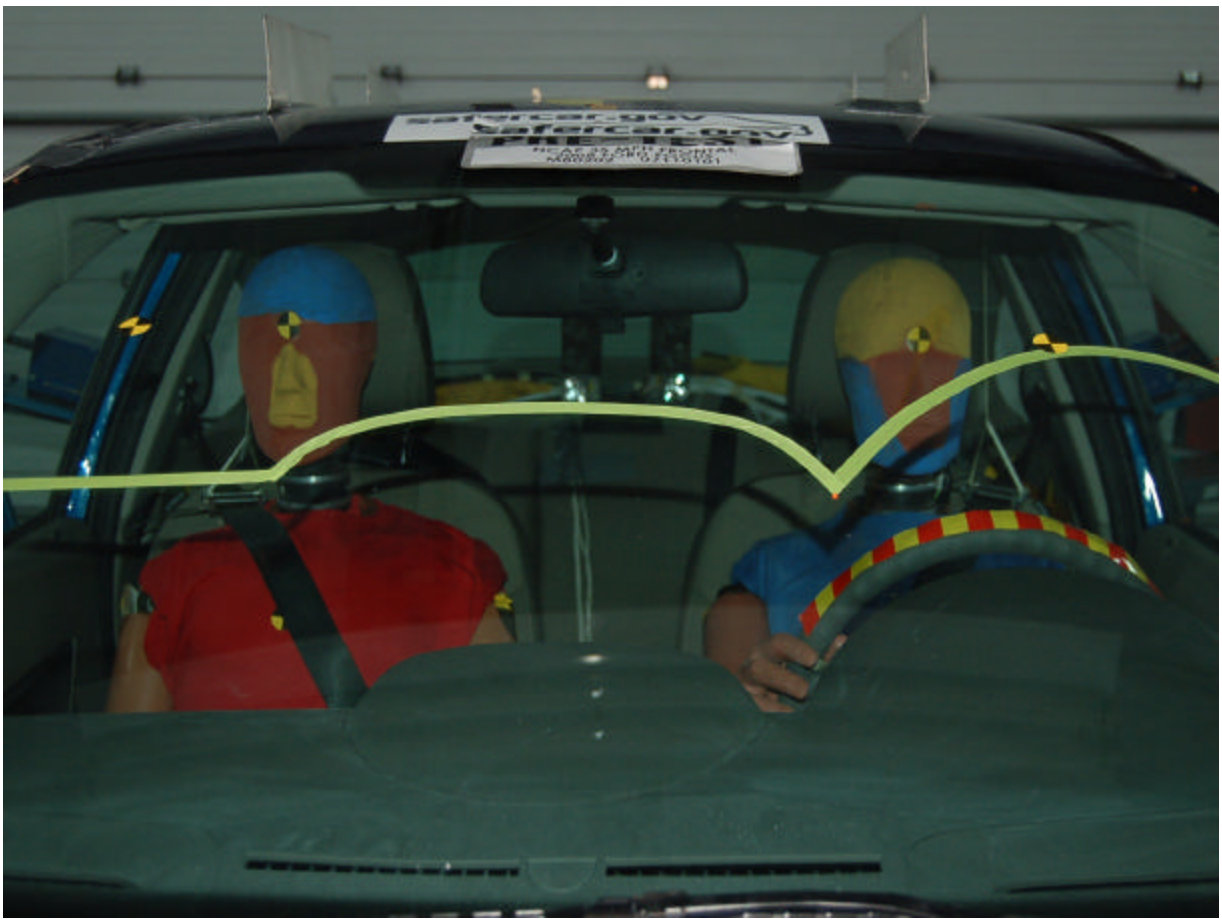
Pre-Test Windshield View

There was 97 percent windshield retention and no intrusion into the protected zone of the windshield during the event. There was no Stoddard Solvent leakage after the event or during any phase of the static rollover.

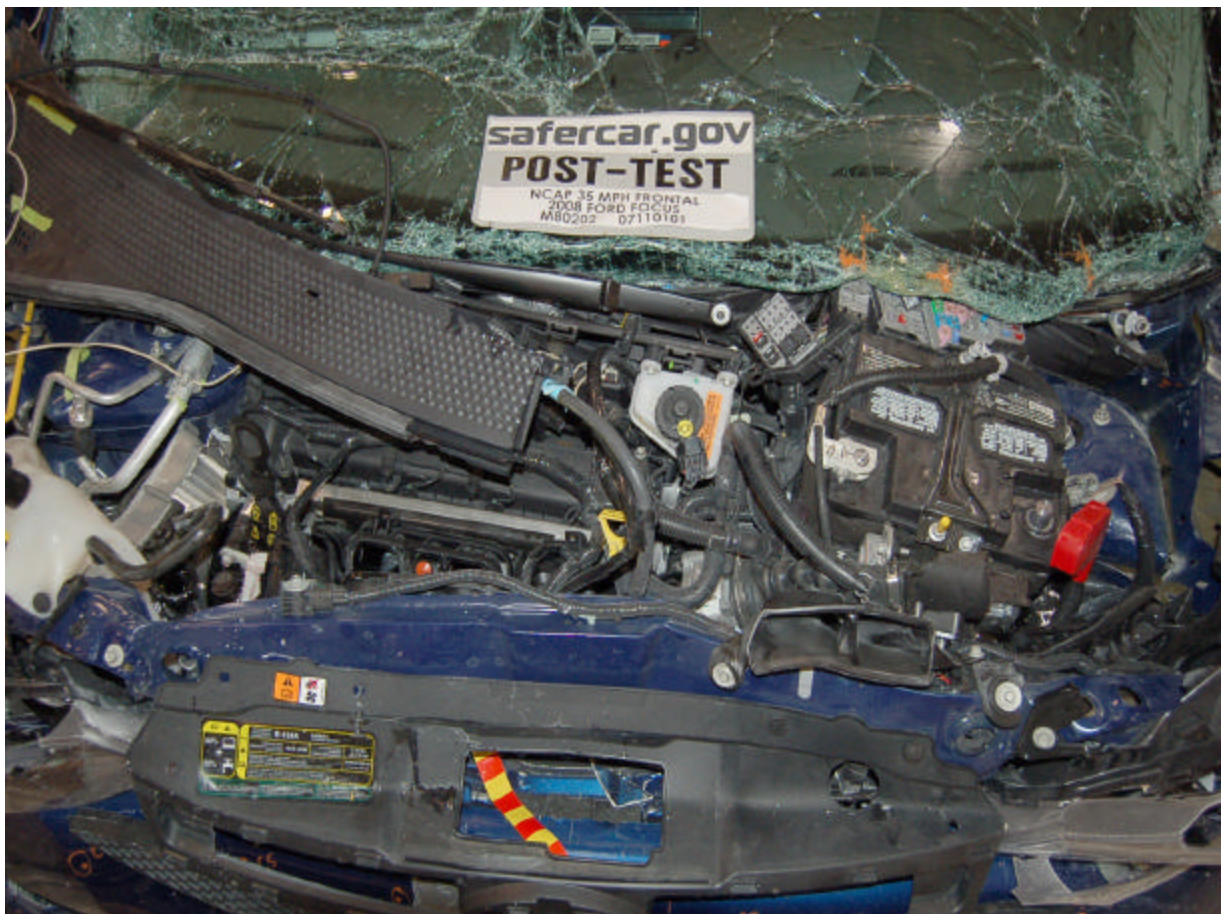
Post-Test Engine Compartment View

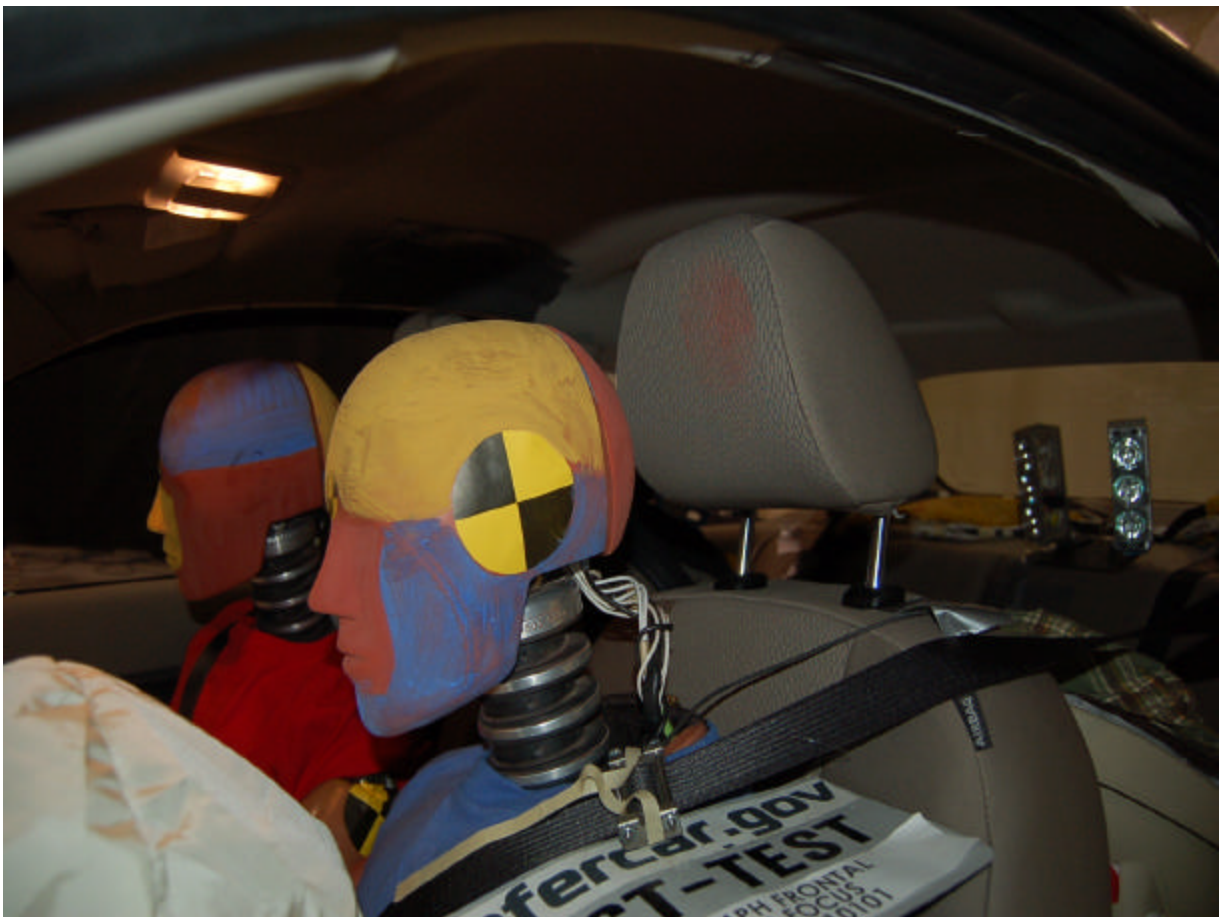
Post-Test Driver Dummy Head Contact (headrest)

The driver's head and chest contacted the airbag. The driver's head also contacted the headrest. The driver's knees contacted the knee bolster. The passenger's head and chest contacted the airbag. The passenger's head also contacted the headrest. The passenger's knees contacted the glove box.

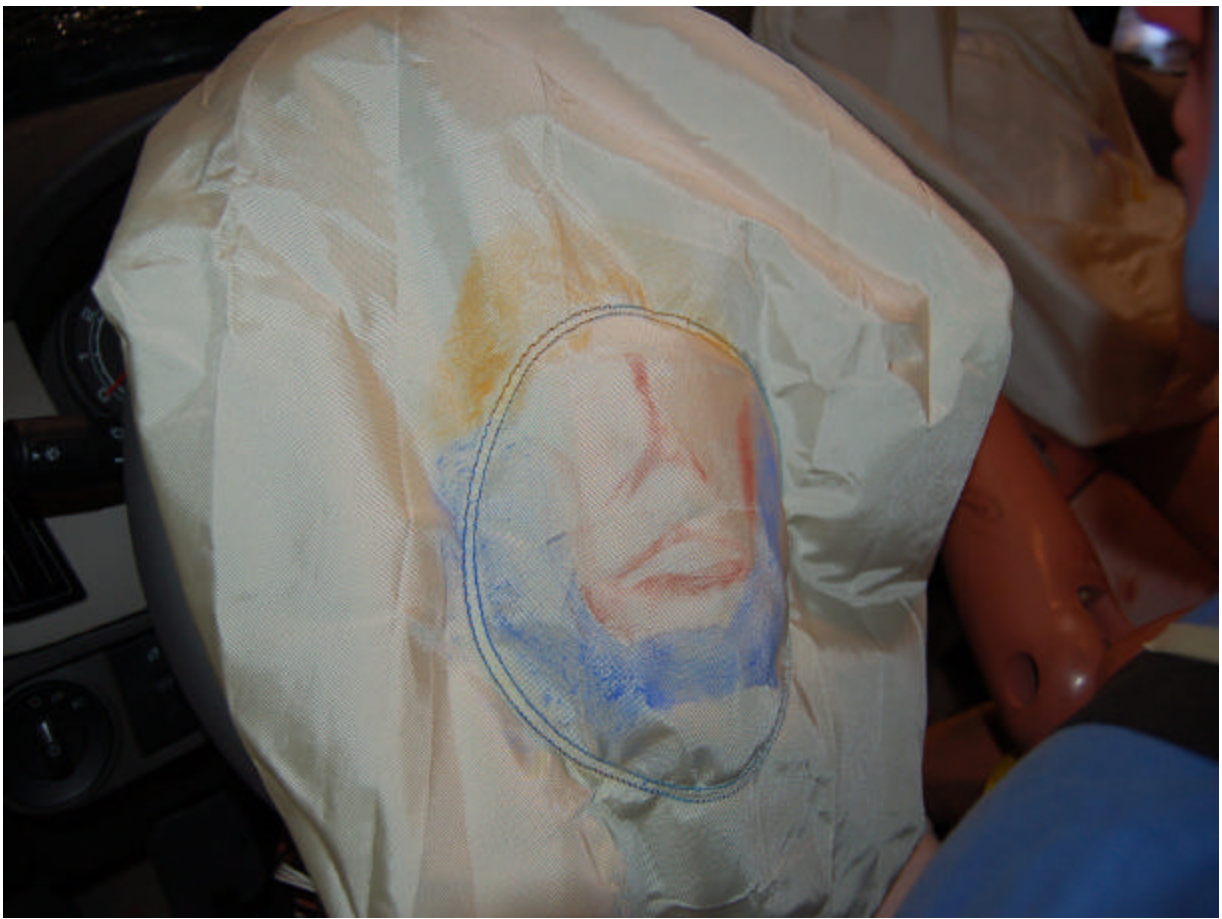
Post-Test Driver Dummy Airbag Contact

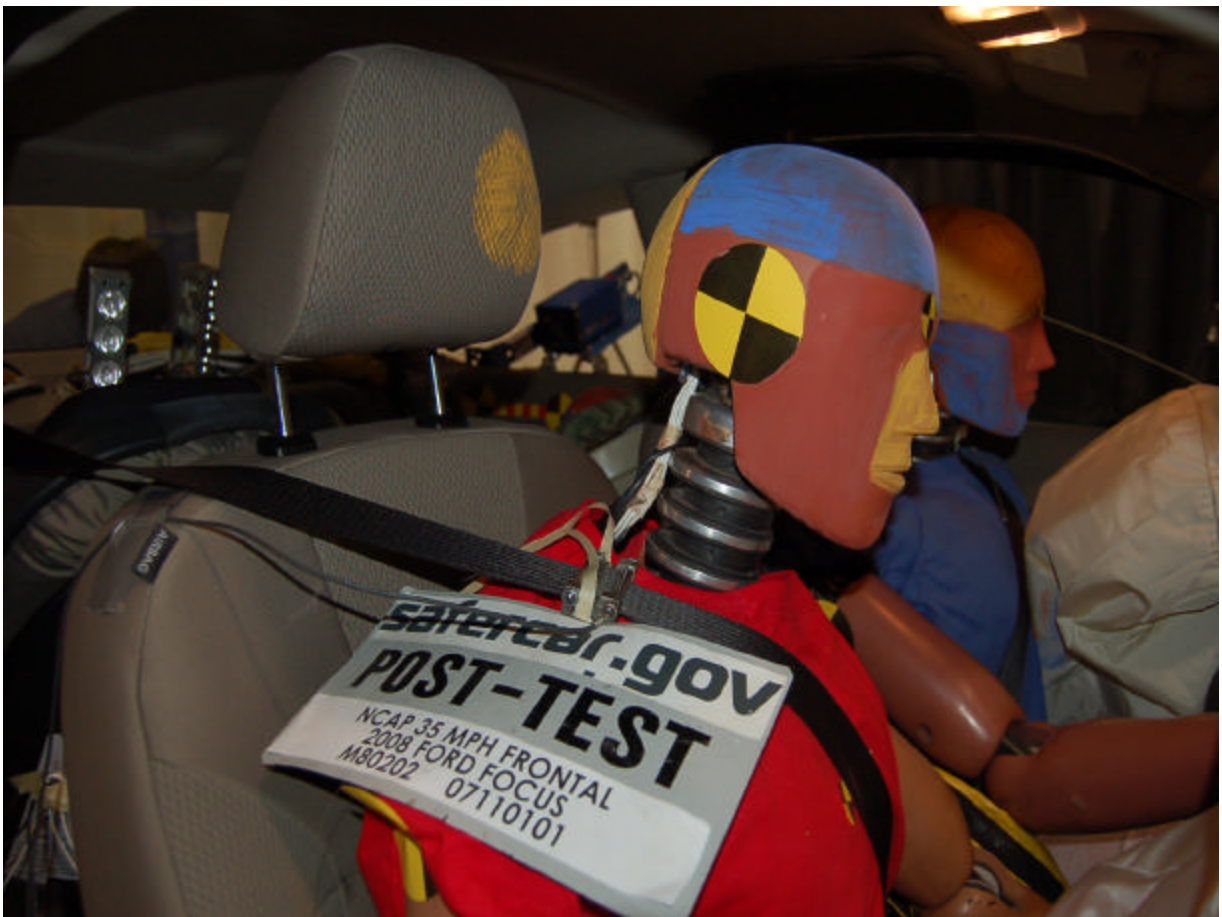
Post-Test Passenger Dummy Head Contact (headrest)

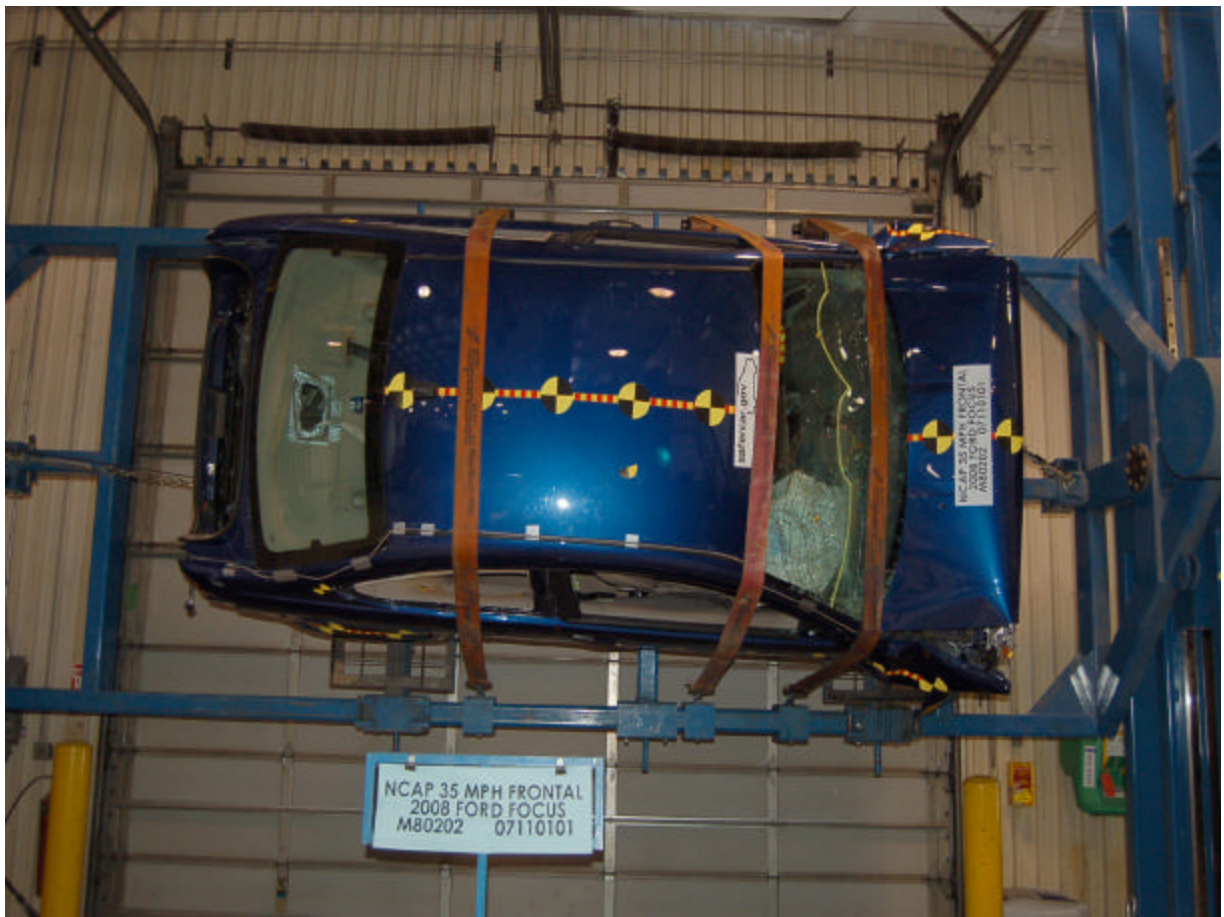
Rollover 90 Degrees

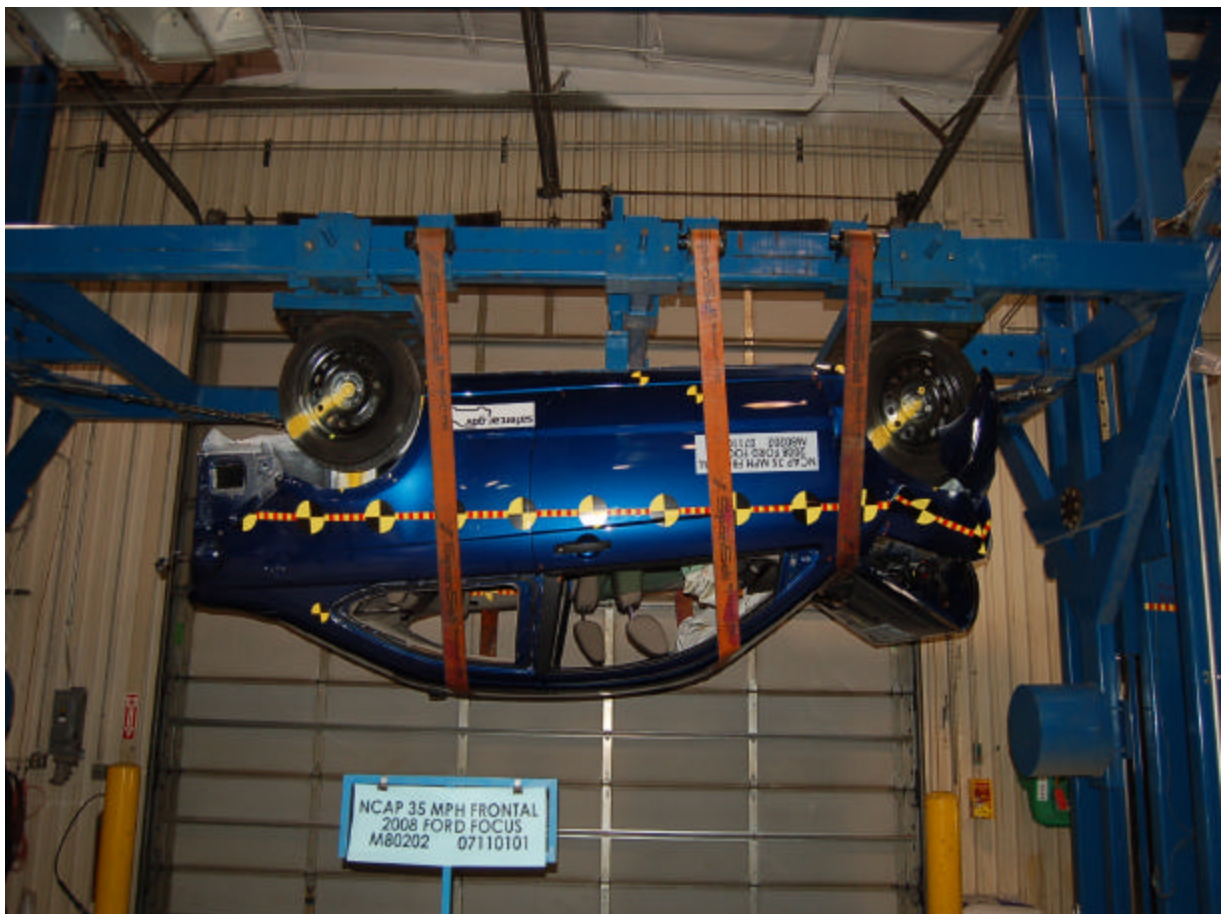
Rollover 180 Degrees
