REPORT NUMBER: SNCAP-CAL-07-11

**NEW CAR ASSESSMENT PROGRAM
SIDE IMPACT TEST**

**FORD MOTOR COMPANY
2008 FORD FOCUS
FOUR-DOOR SEDAN**

FINAL REPORT

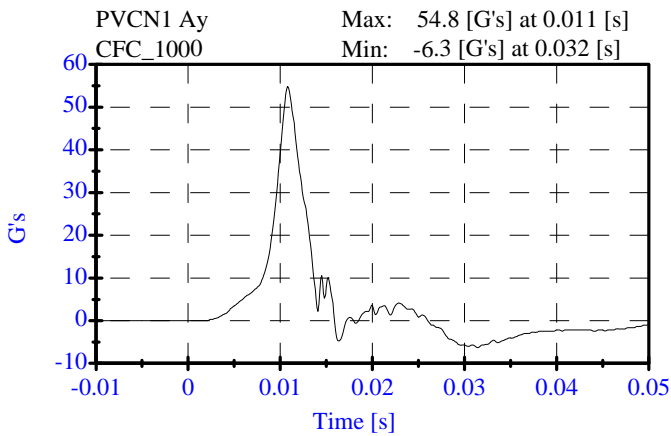
<u>TEST PARAMETER</u>	<u>SPECIFICATION</u>	<u>TEST RESULTS</u>	<u>STATUS</u>
Lab Temperature:	18.9-25.5 C	21.1 C	Passed
Lab Humidity:	10-70 %	38.00 %	Passed
Probe Velocity:	4.27- 4.33 m/s	4.30 m/s	Passed
Pelvis Y Acceleration:	40.00-60.00 G's	40.34 G's	Passed
Time Above 20 Gs	3.0-7.0 ms	5.1 ms	Passed
