**REPORT NUMBER: NCAPSIDE-TRC-2007-003**

**NEW CAR ASSESSMENT PROGRAM  
SIDE IMPACT TEST**

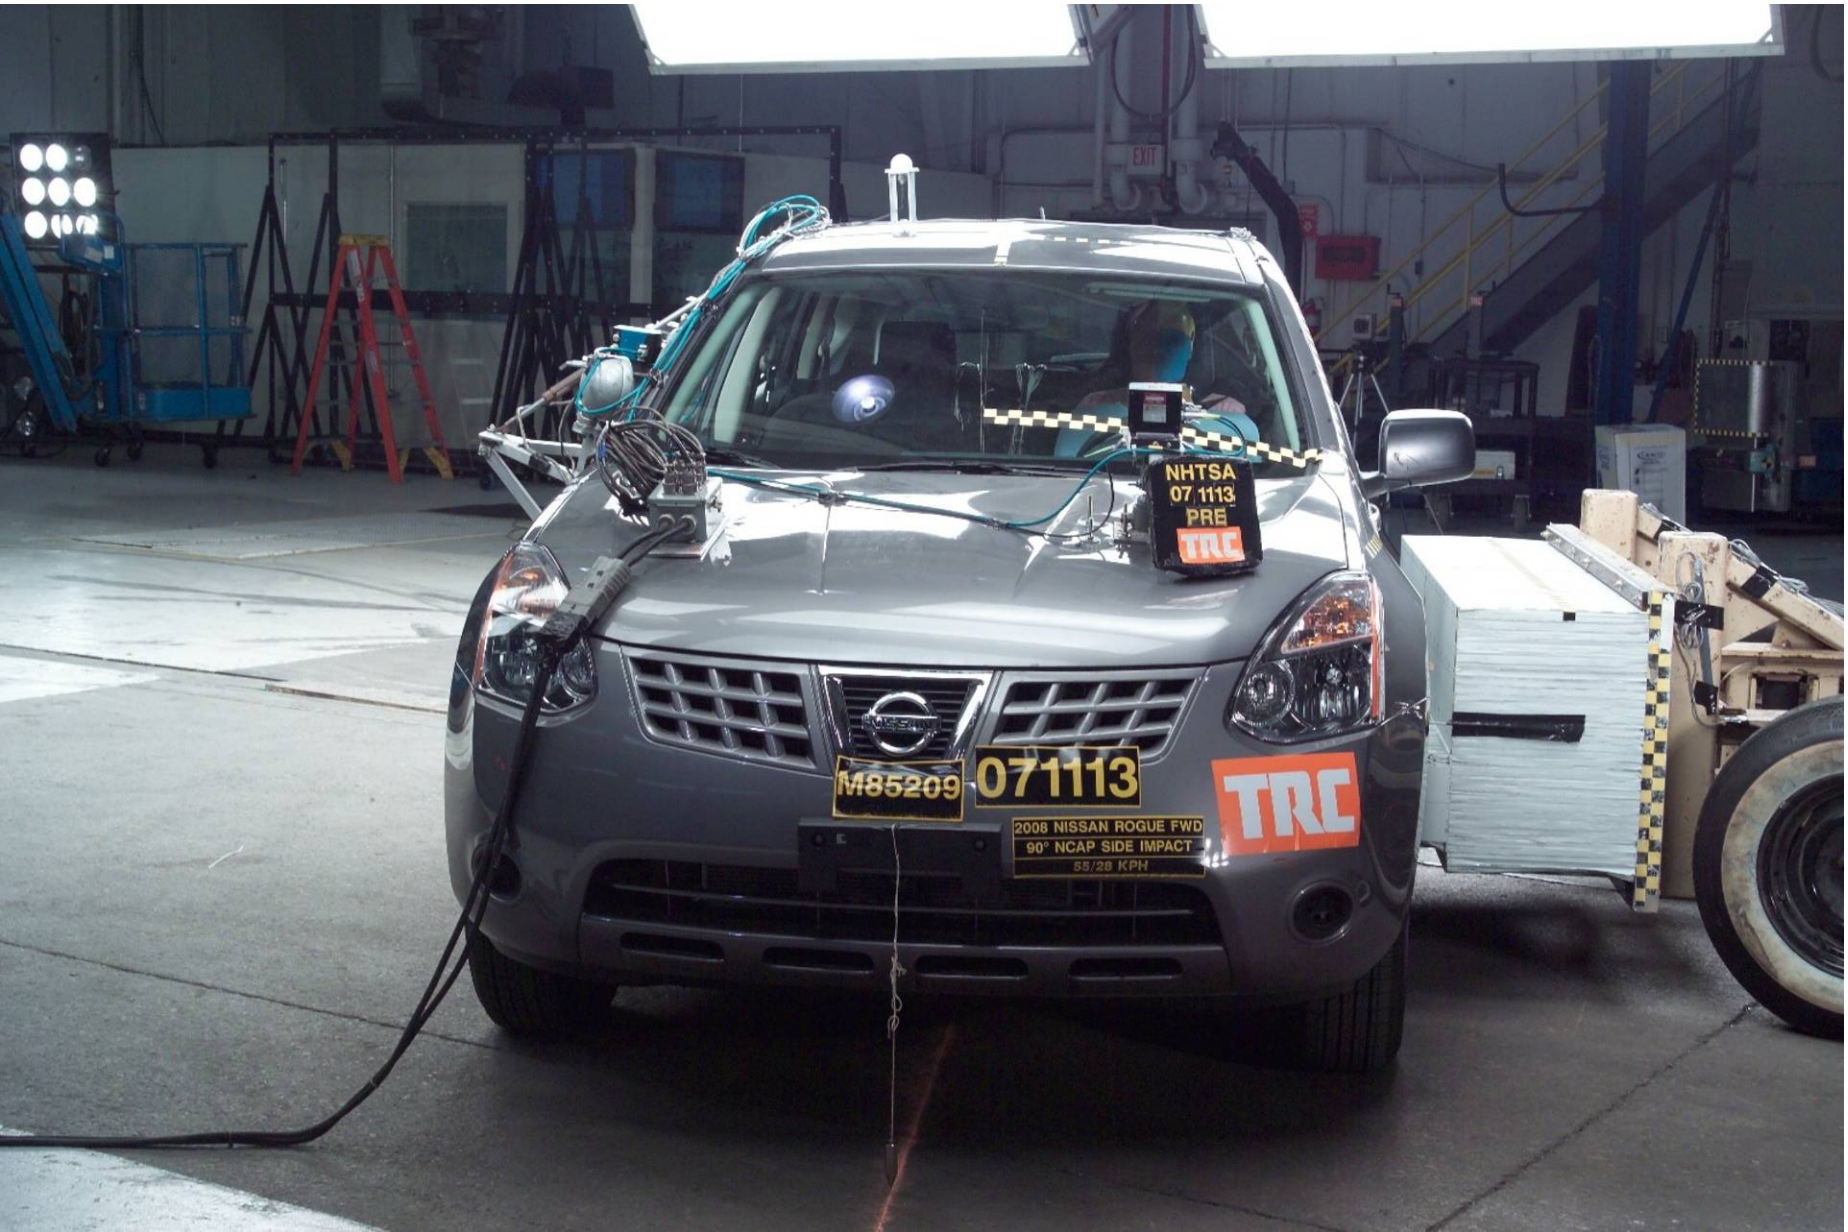
Figure A-1 Pre-Test Front View of Test Vehicle

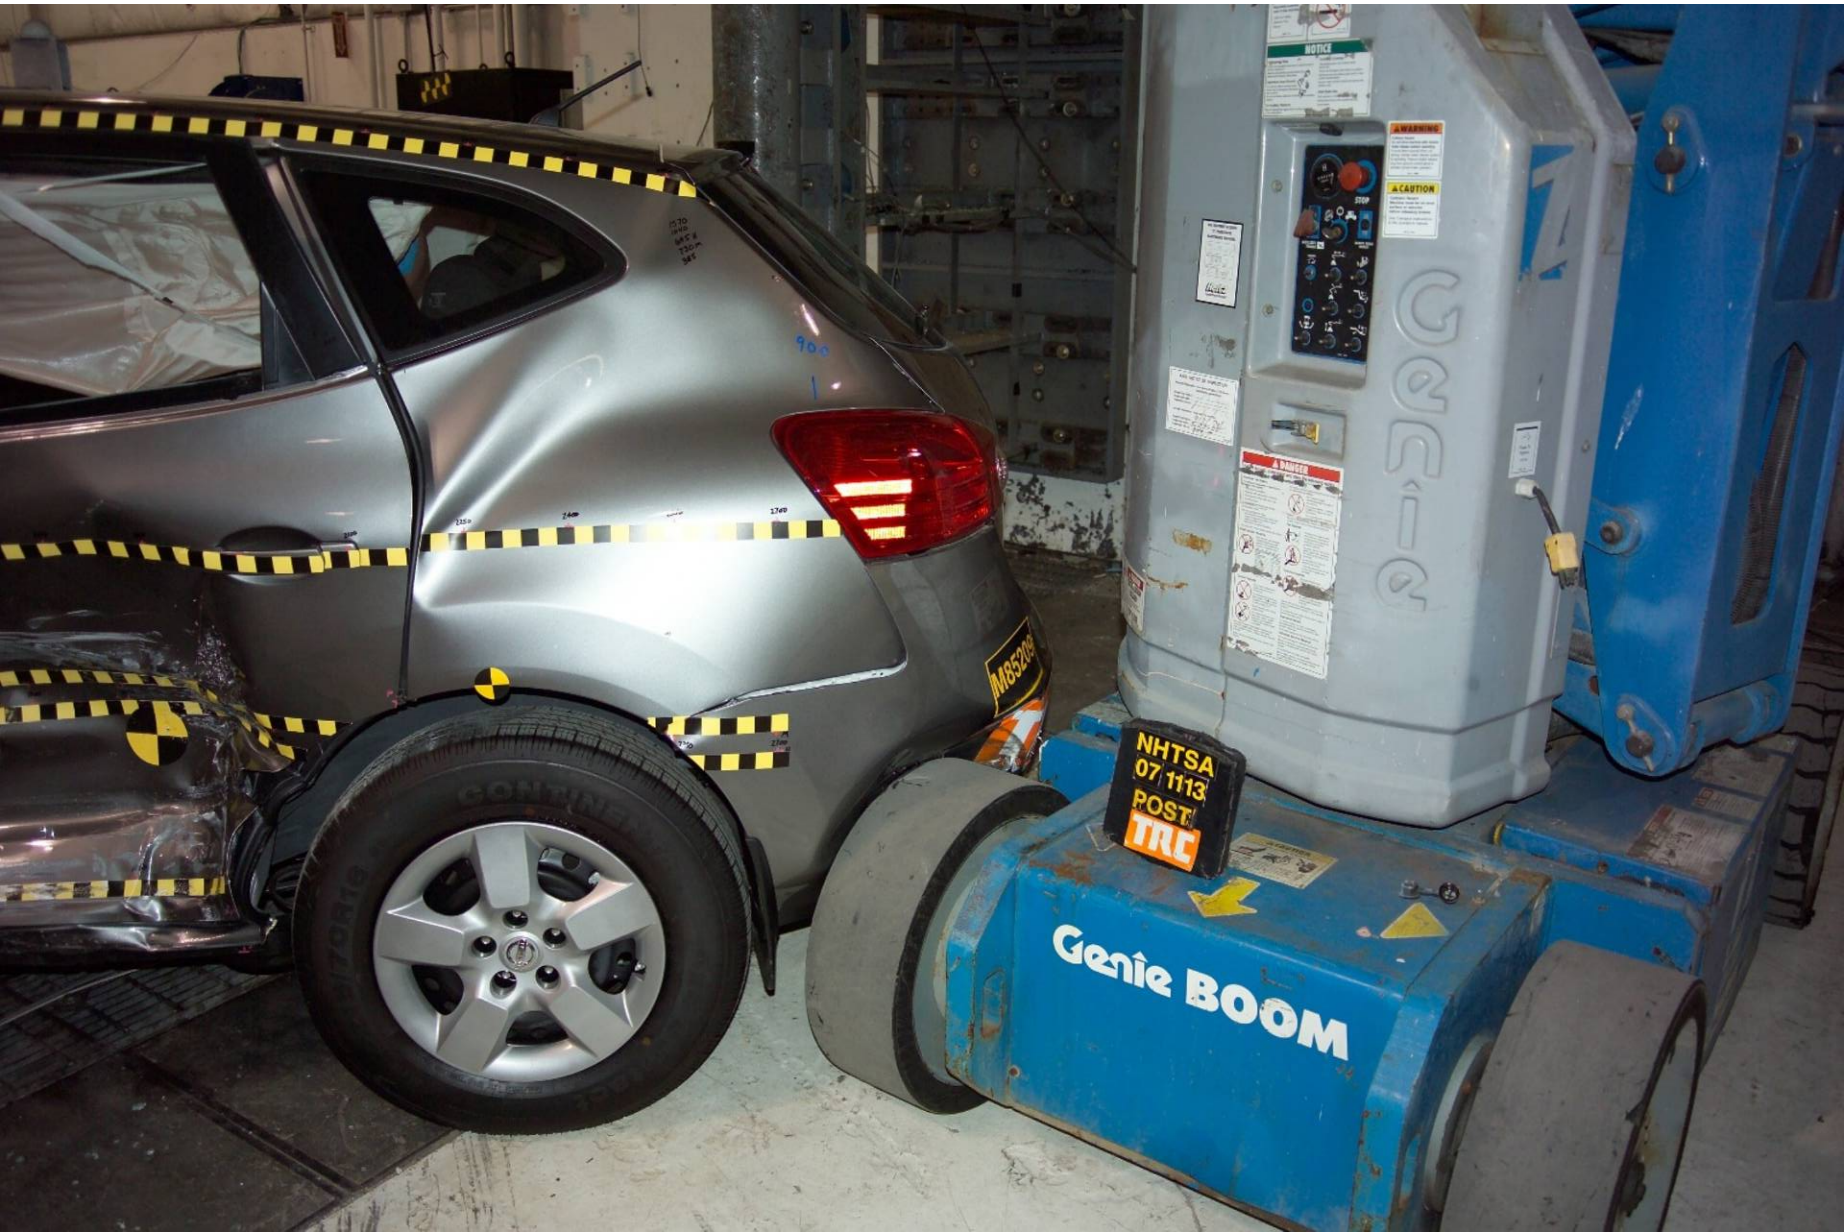
Figure A-83 Post-Test Vehicle Damage - View 1

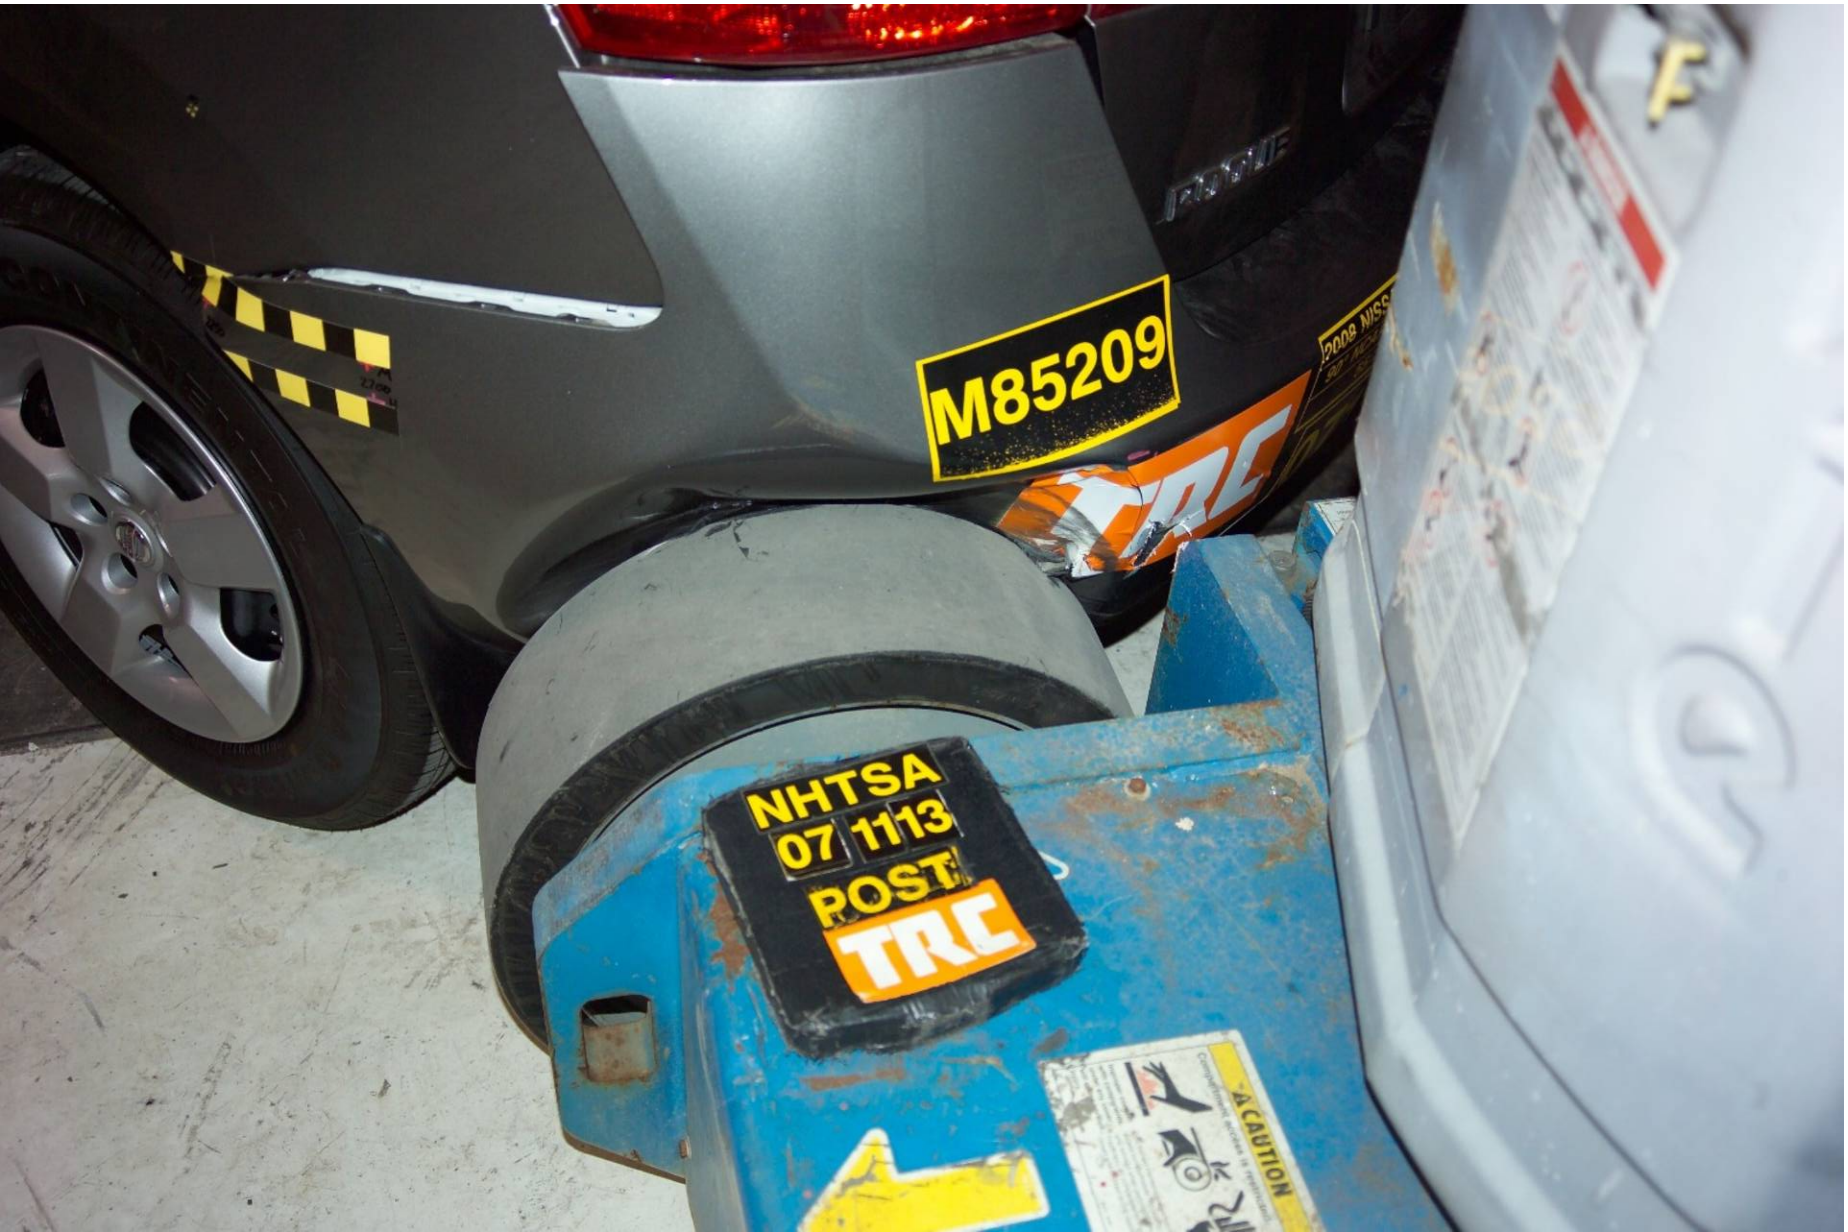
Figure A-84 Post-Test Vehicle Damage - View 2

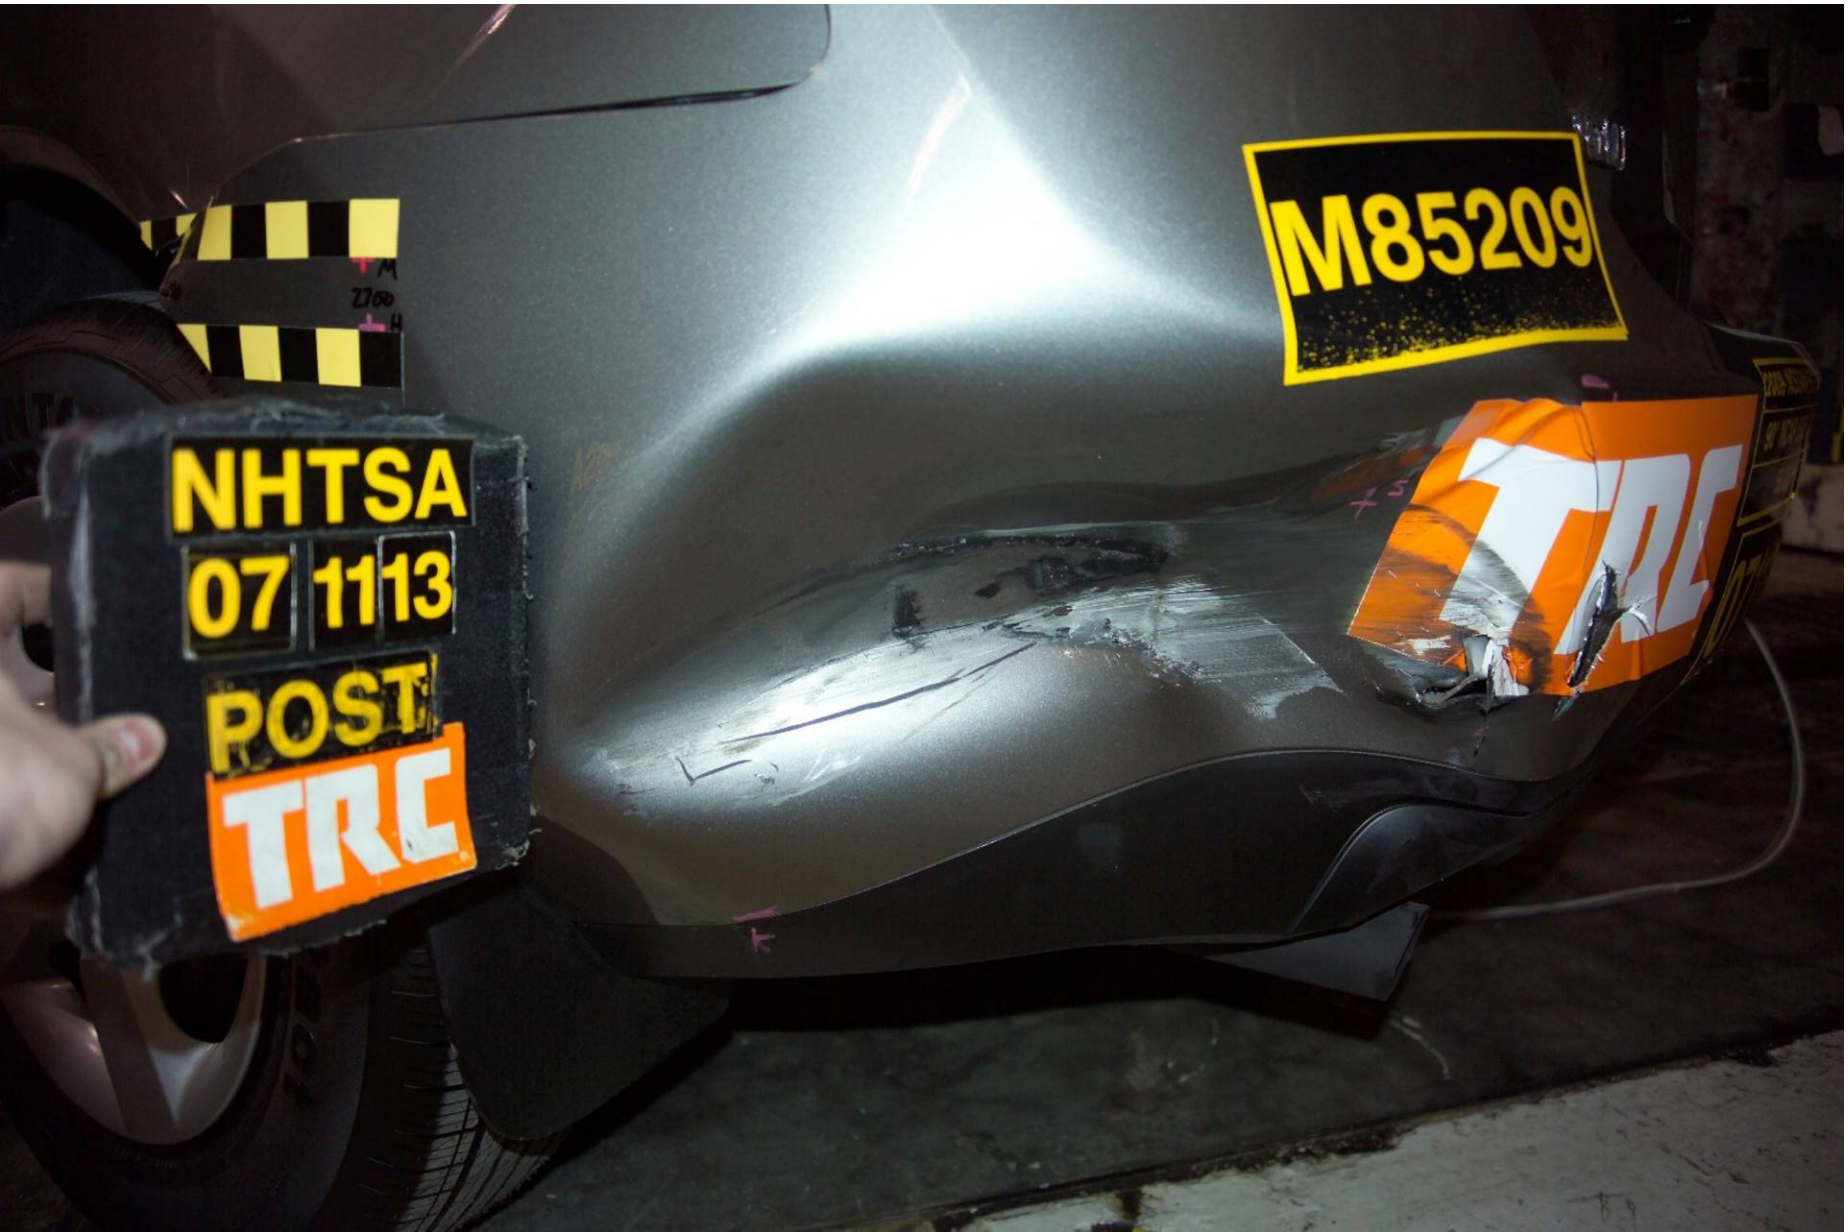
Figure A-85 Post-Test Vehicle Damage - View 3

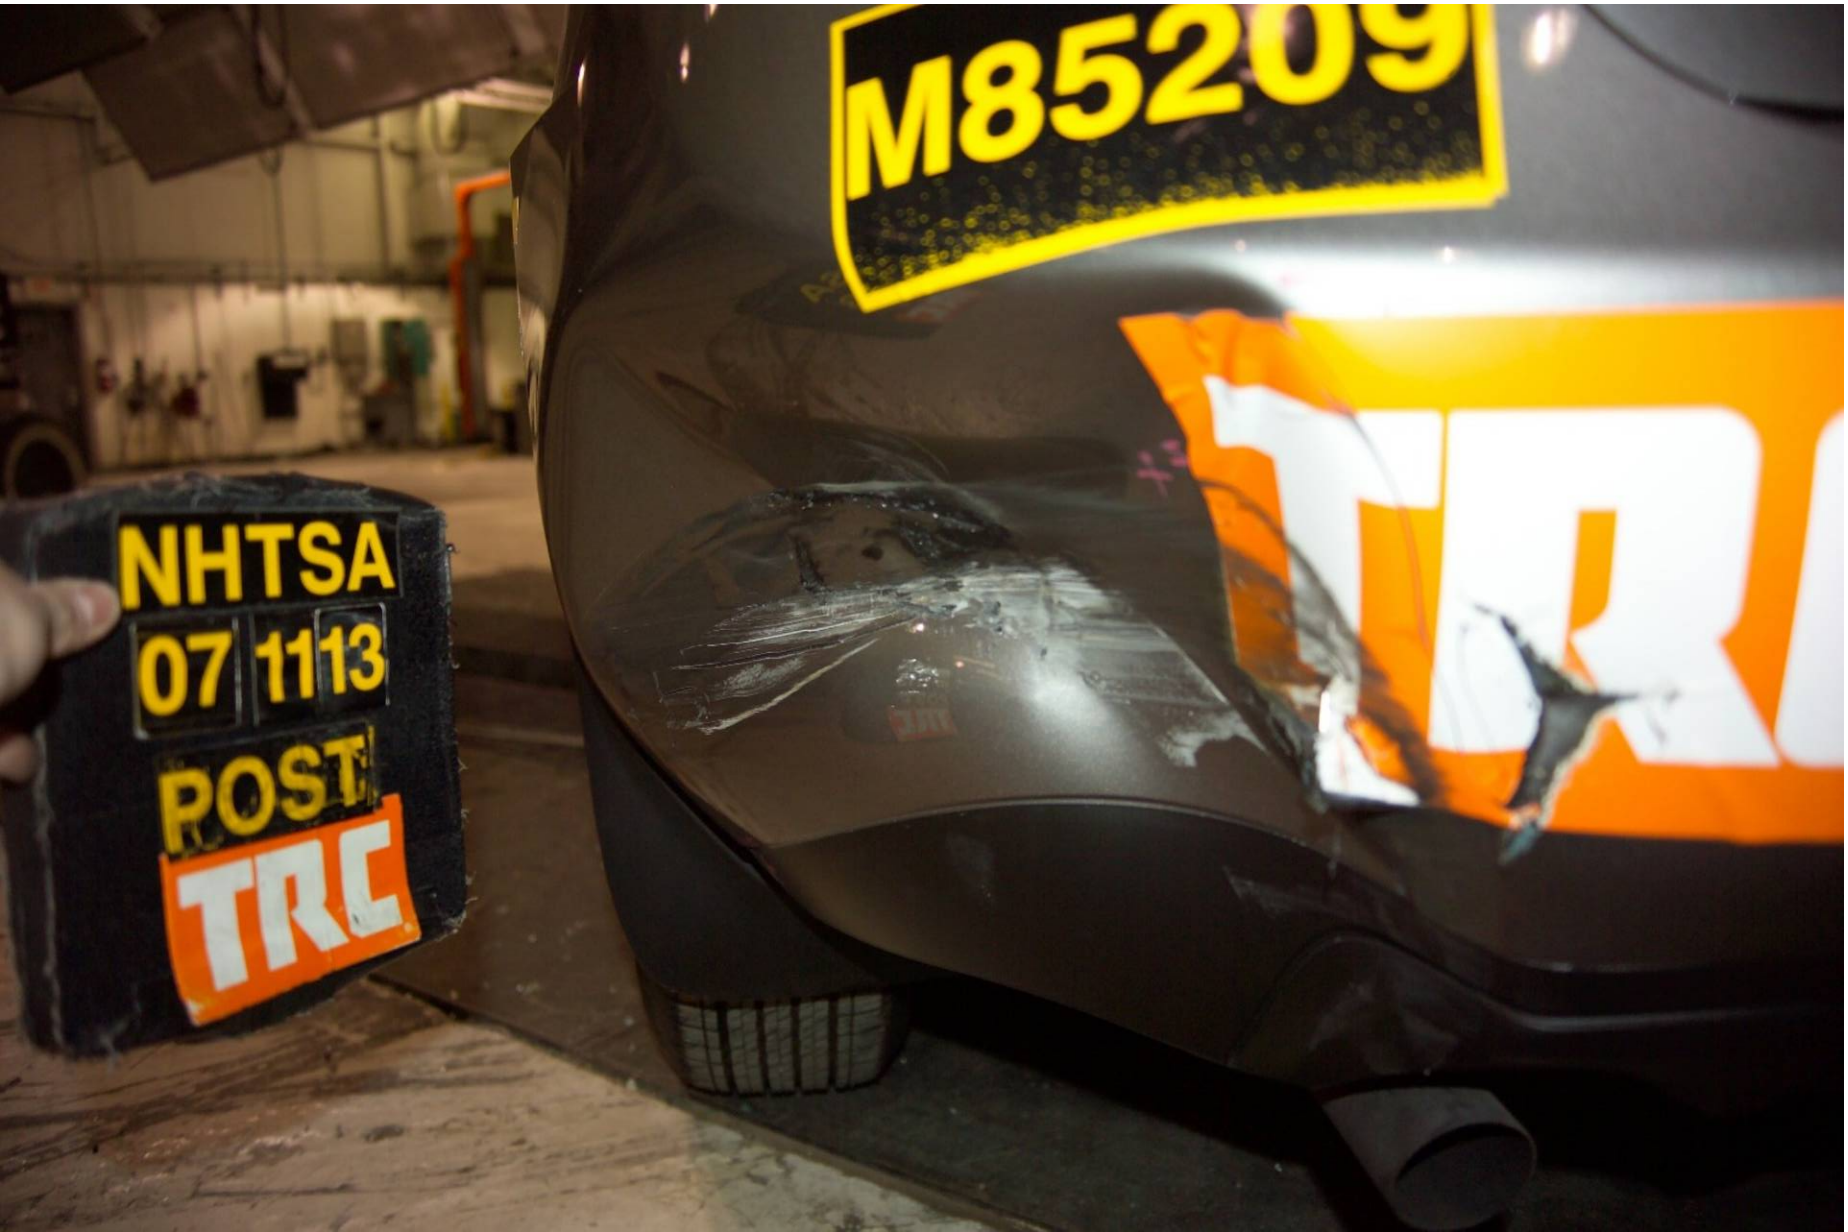
Figure A-86 Post-Test Vehicle Damage - View 4
