REPORT NUMBER: CAL-07-16

**NEW CAR ASSESSMENT PROGRAM (NCAP)  
FRONTAL BARRIER IMPACT TEST**

FORD MOTOR COMPANY  
2008 FORD FOCUS  
FOUR-DOOR SEDAN

FINAL REPORT

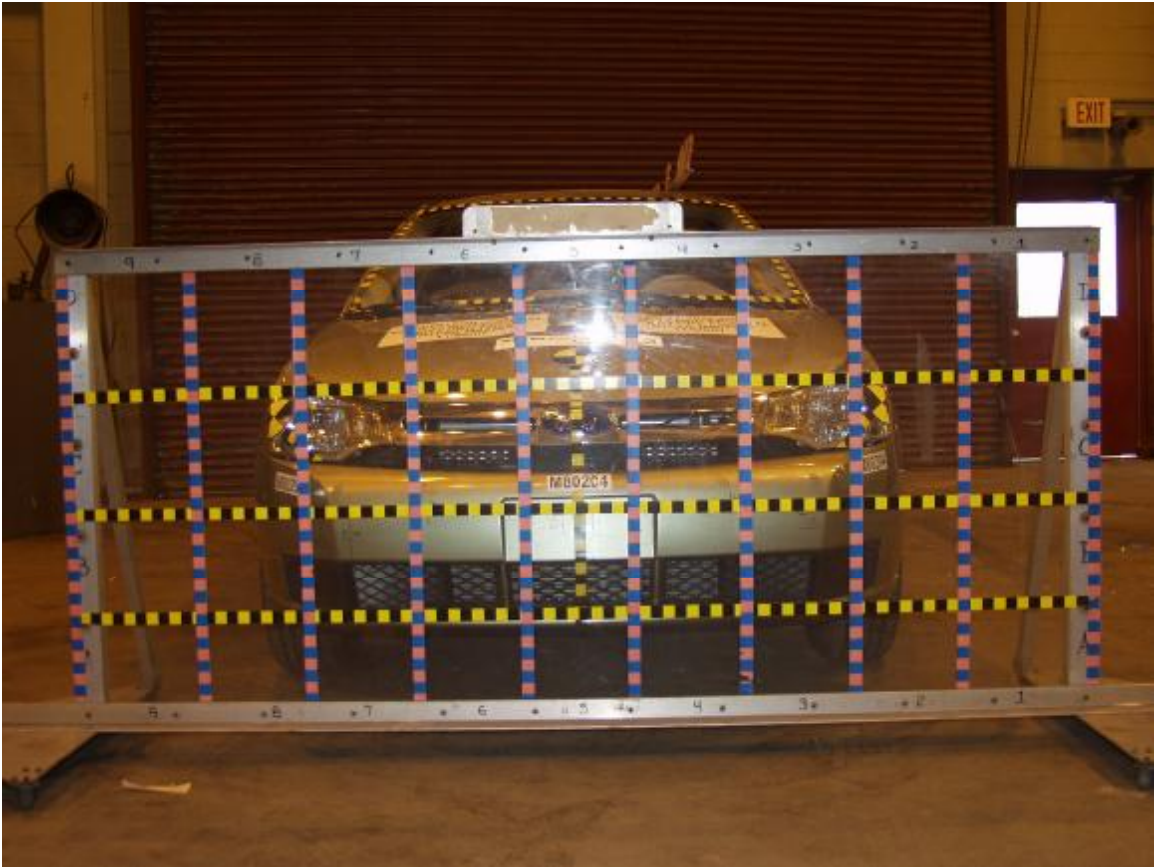
**Figure A-1: Load Cell Locations**

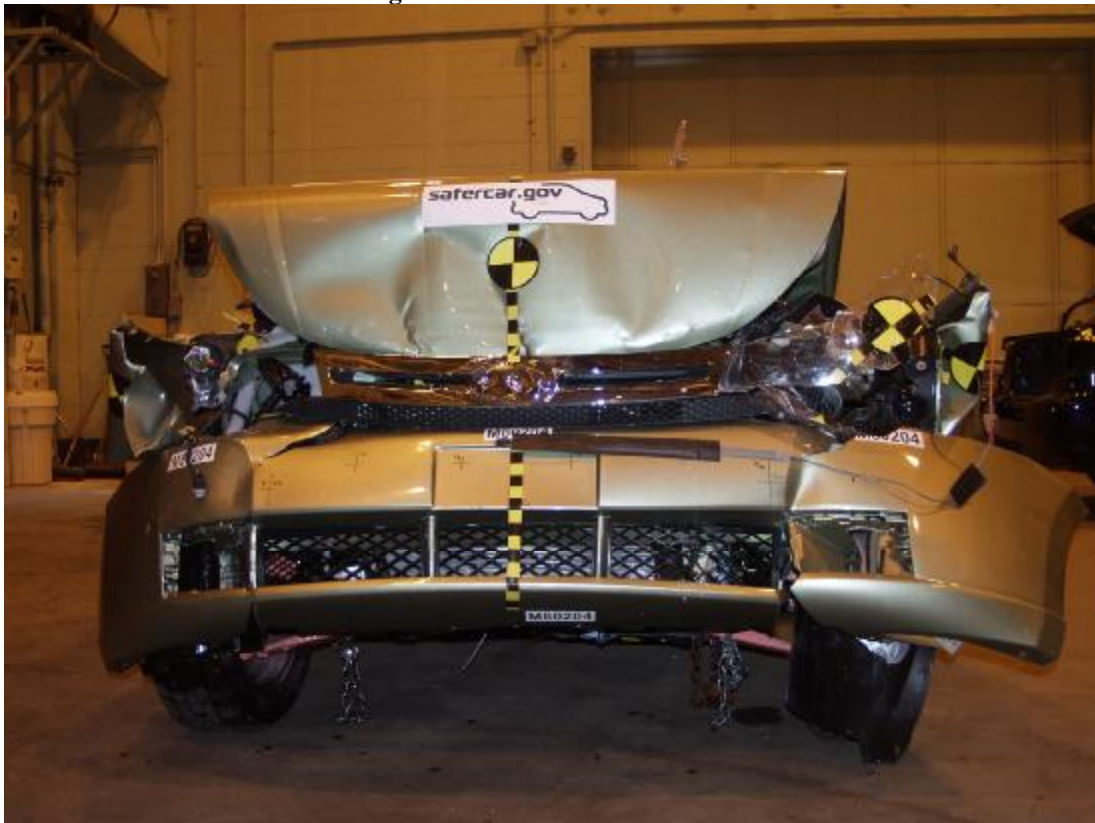
**Figure A-7: Post-Test Front View**

Vehicle NHTSA No.:           M80204           Test Mode:           56.3 kph Frontal Barrier            
 Test Date:           November 20, 2007           Time:           11:50           Temperature:           21           °C  
 Vehicle Make/Model/Body Style:           2008 Ford Focus Four-Door Sedan            
 Vehicle Test Weight:           1398.0           kg Impact Velocity:           55.68           kph (55.5 – 57.1 kph)  
 Vehicle/Barrier Impact Angle:           0           ° Max Static Crush:           531           mm

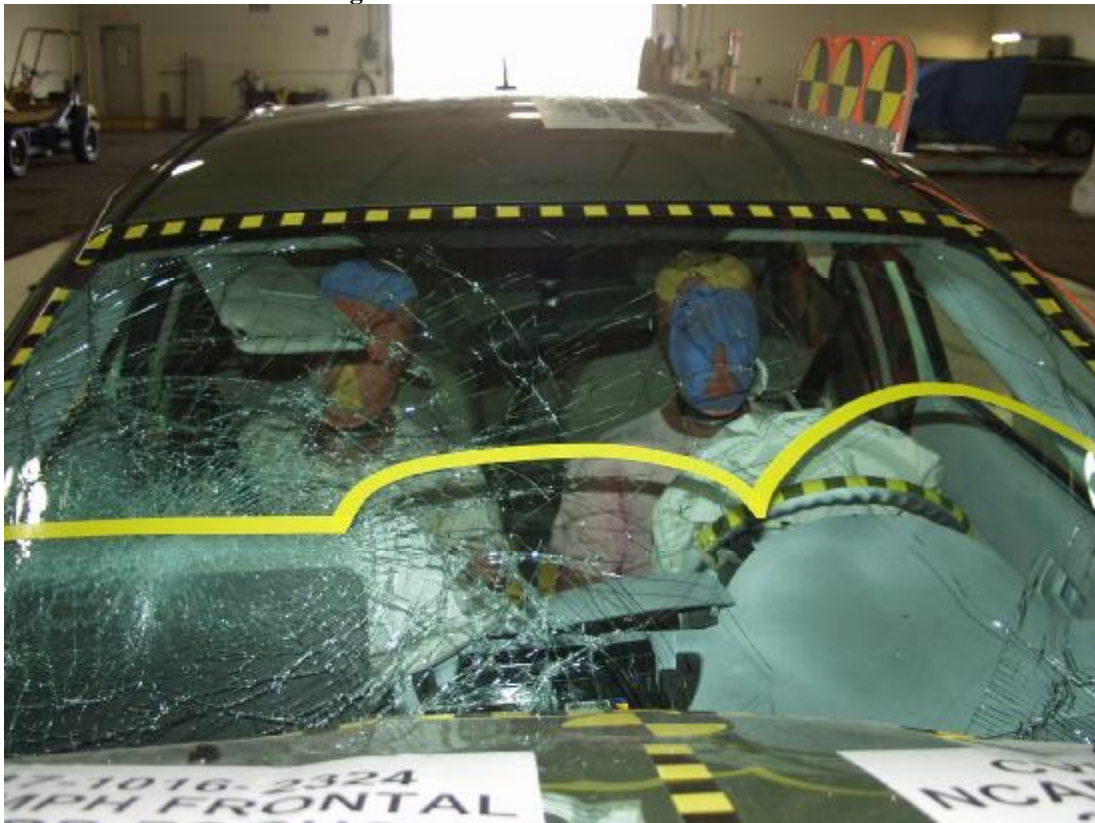
**Figure A-19: Post-Test Windshield View**

Description	Driver Side	Passenger Side
Door Lock Status	Unlocked	Unlocked
Front Door Opening	Closed, latched and operable without tools	Closed, latched and operable without tools
Rear Door Opening	Closed, latched and operable without tools	Closed, latched and operable without tools
Hatch/Other Door Opening	N/A	N/A
Front Seat Track Shift (mm)	0	0
Front Seat Back Failure	None	None
Glazing Damage	The windshield was cracked due to the passenger airbag deployment

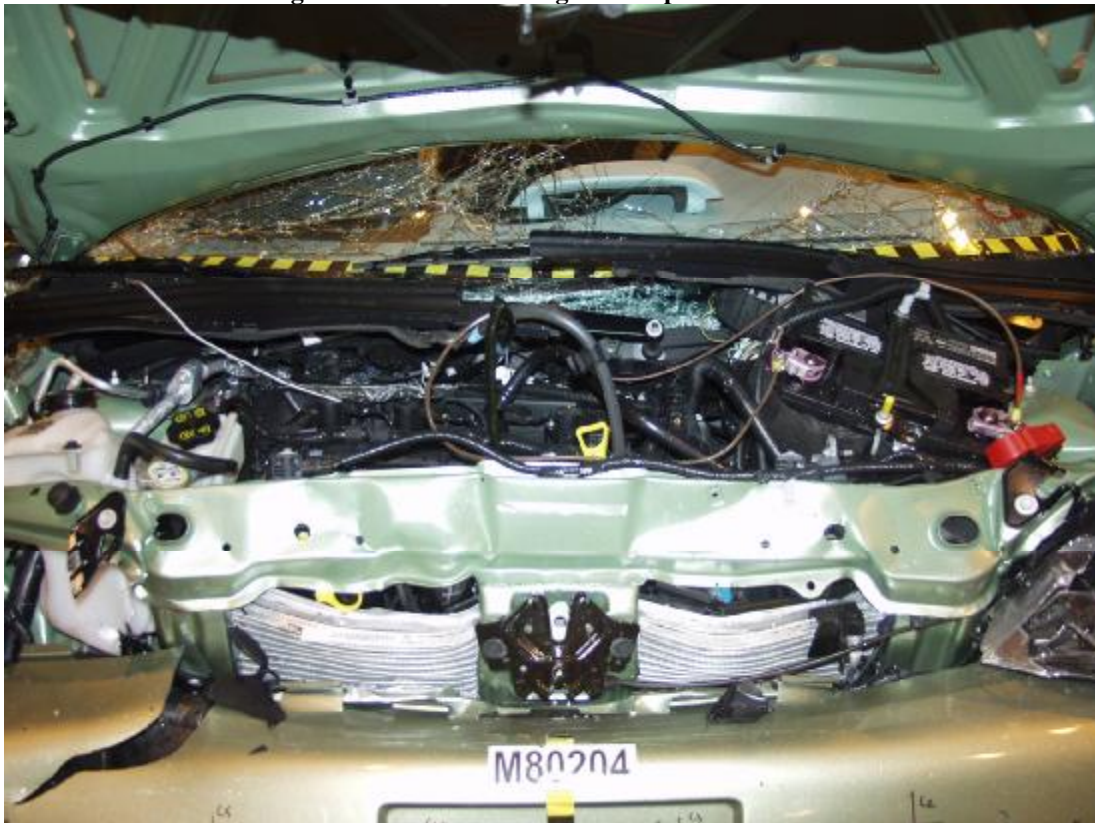
**Figure A-21: Post-Test Engine Compartment View**

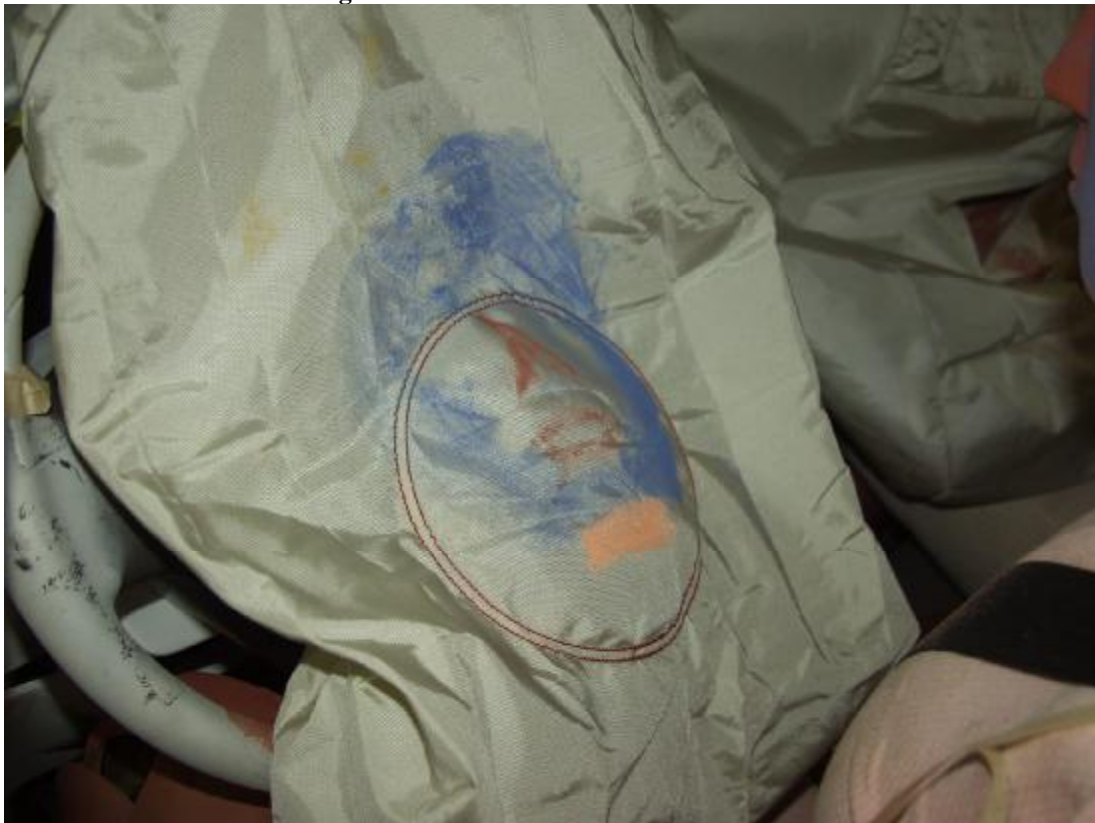
**Figure A-43: Post-Test Driver Contact to Airbag**

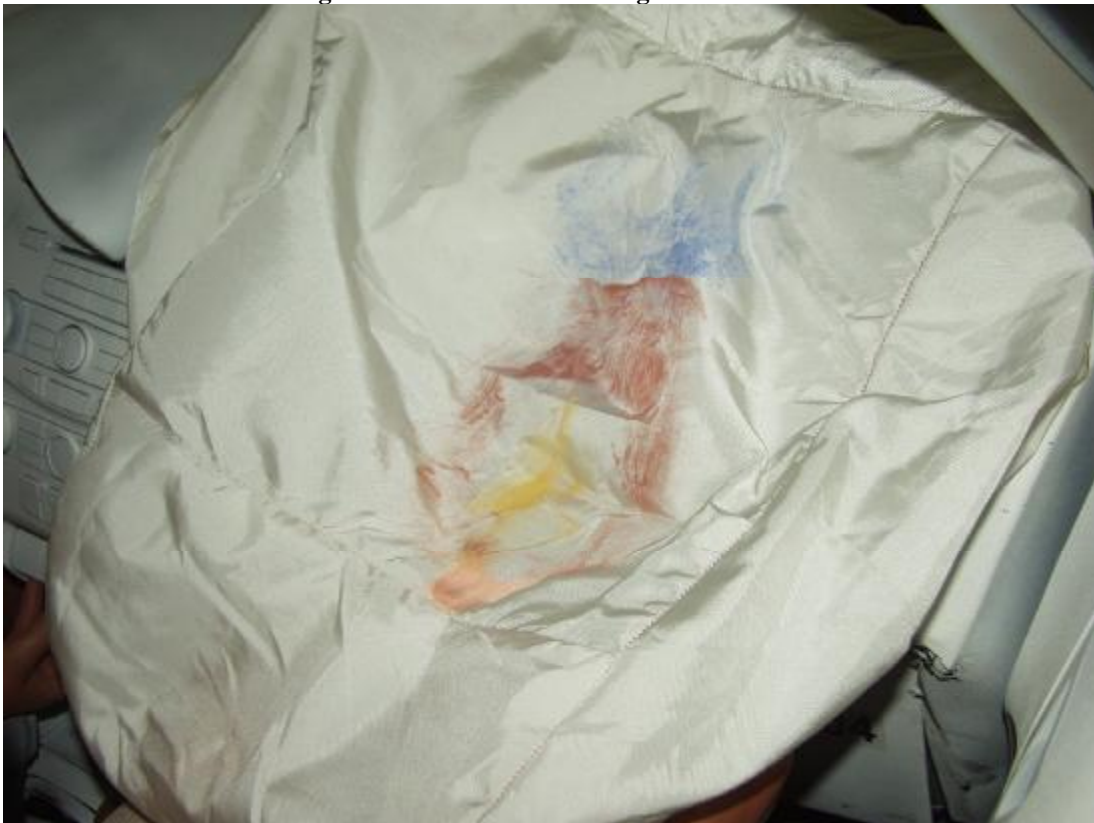
**Figure A-57: Post-Test Passenger Contact to Airbag**
