**REPORT NUMBER: NCAP-TRC-2007-005**

**NEW CAR ASSESSMENT PROGRAM  
FRONTAL BARRIER IMPACT TEST**

**MITSUBISHI MOTORS CORPORATION  
2008 MITSUBISHI OUTLANDER MPV  
NHTSA NUMBER: M85602**

**FINAL REPORT**

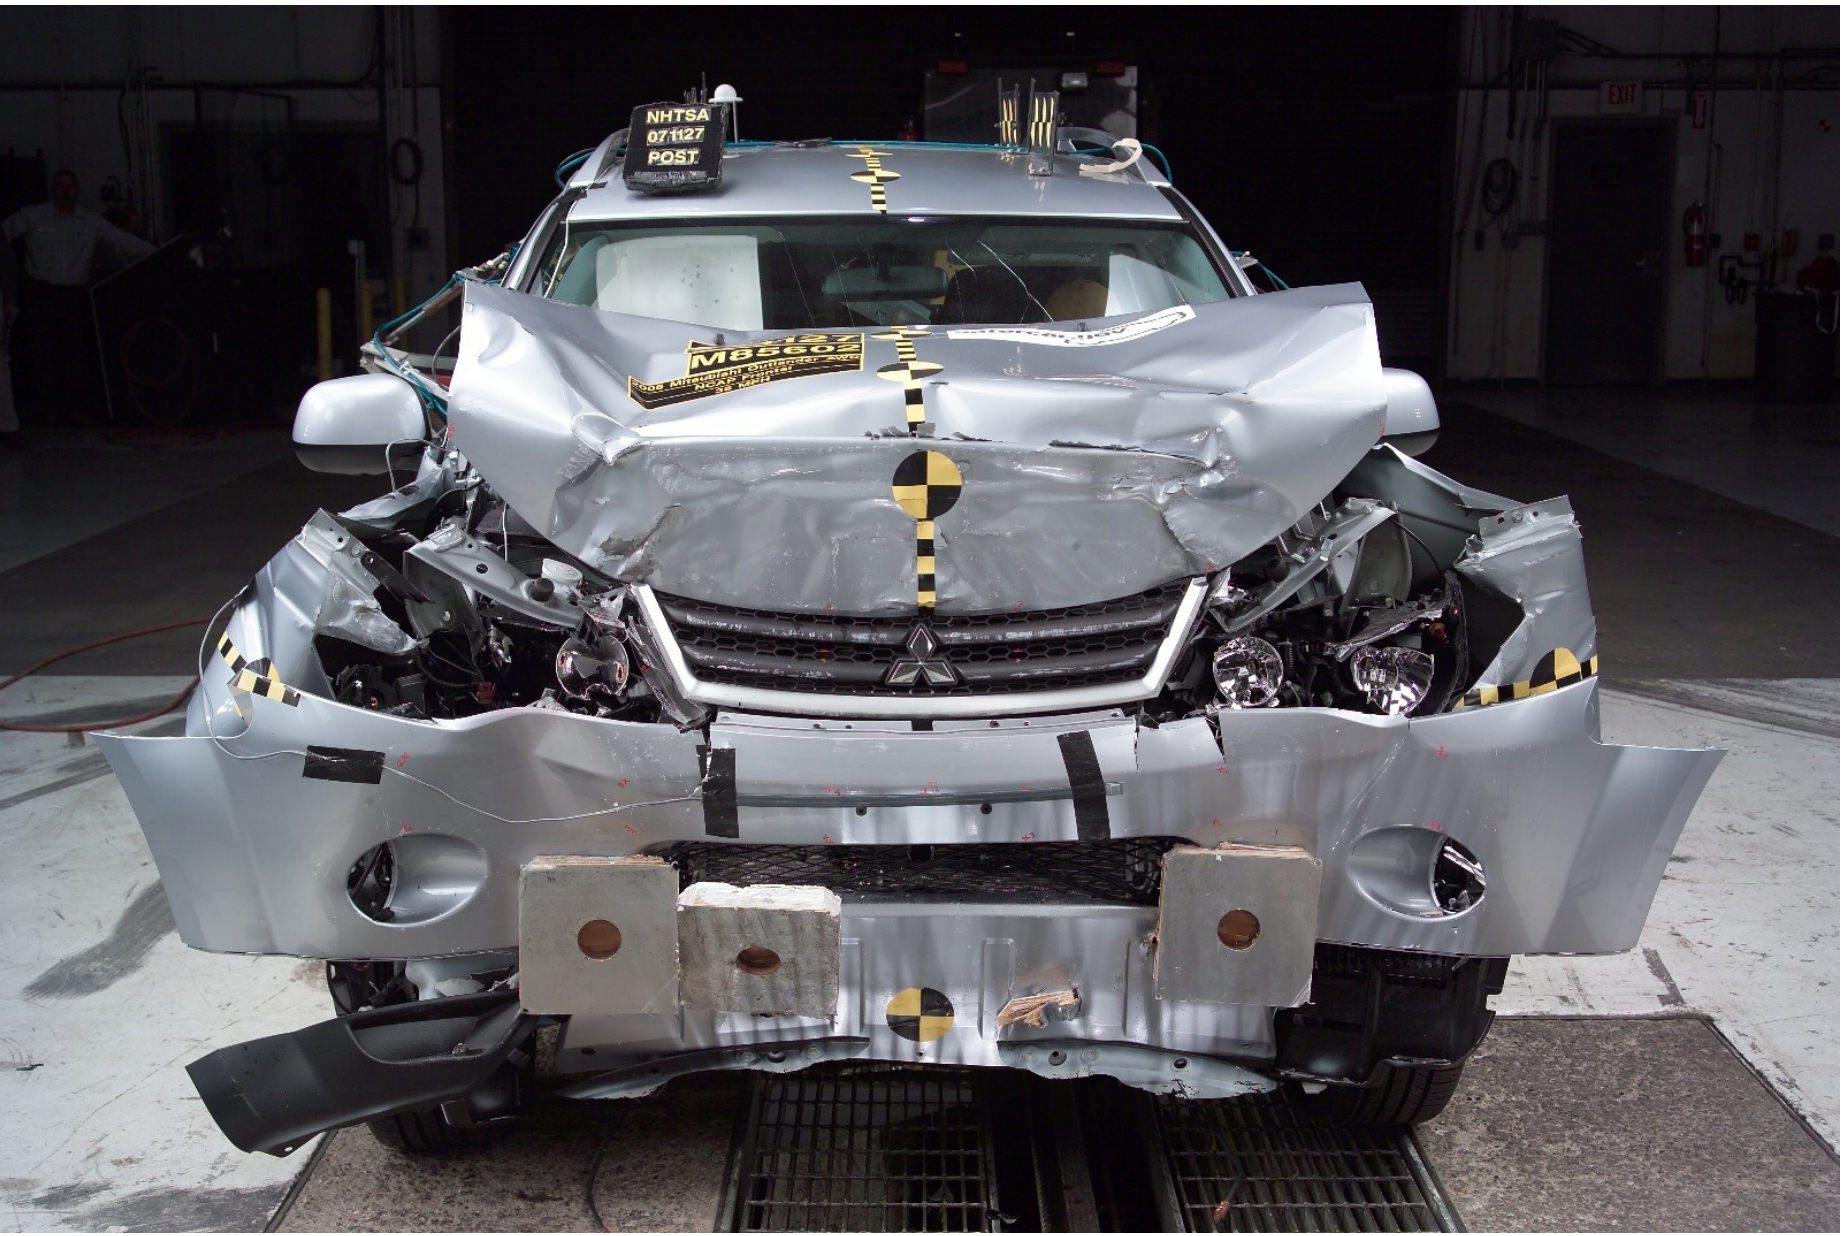
Figure A-2 Post-Test Front View

The maximum static crush of the vehicle was 549 mm and both the driver and passenger side doors remained closed during the impact event and were operable after the impact.

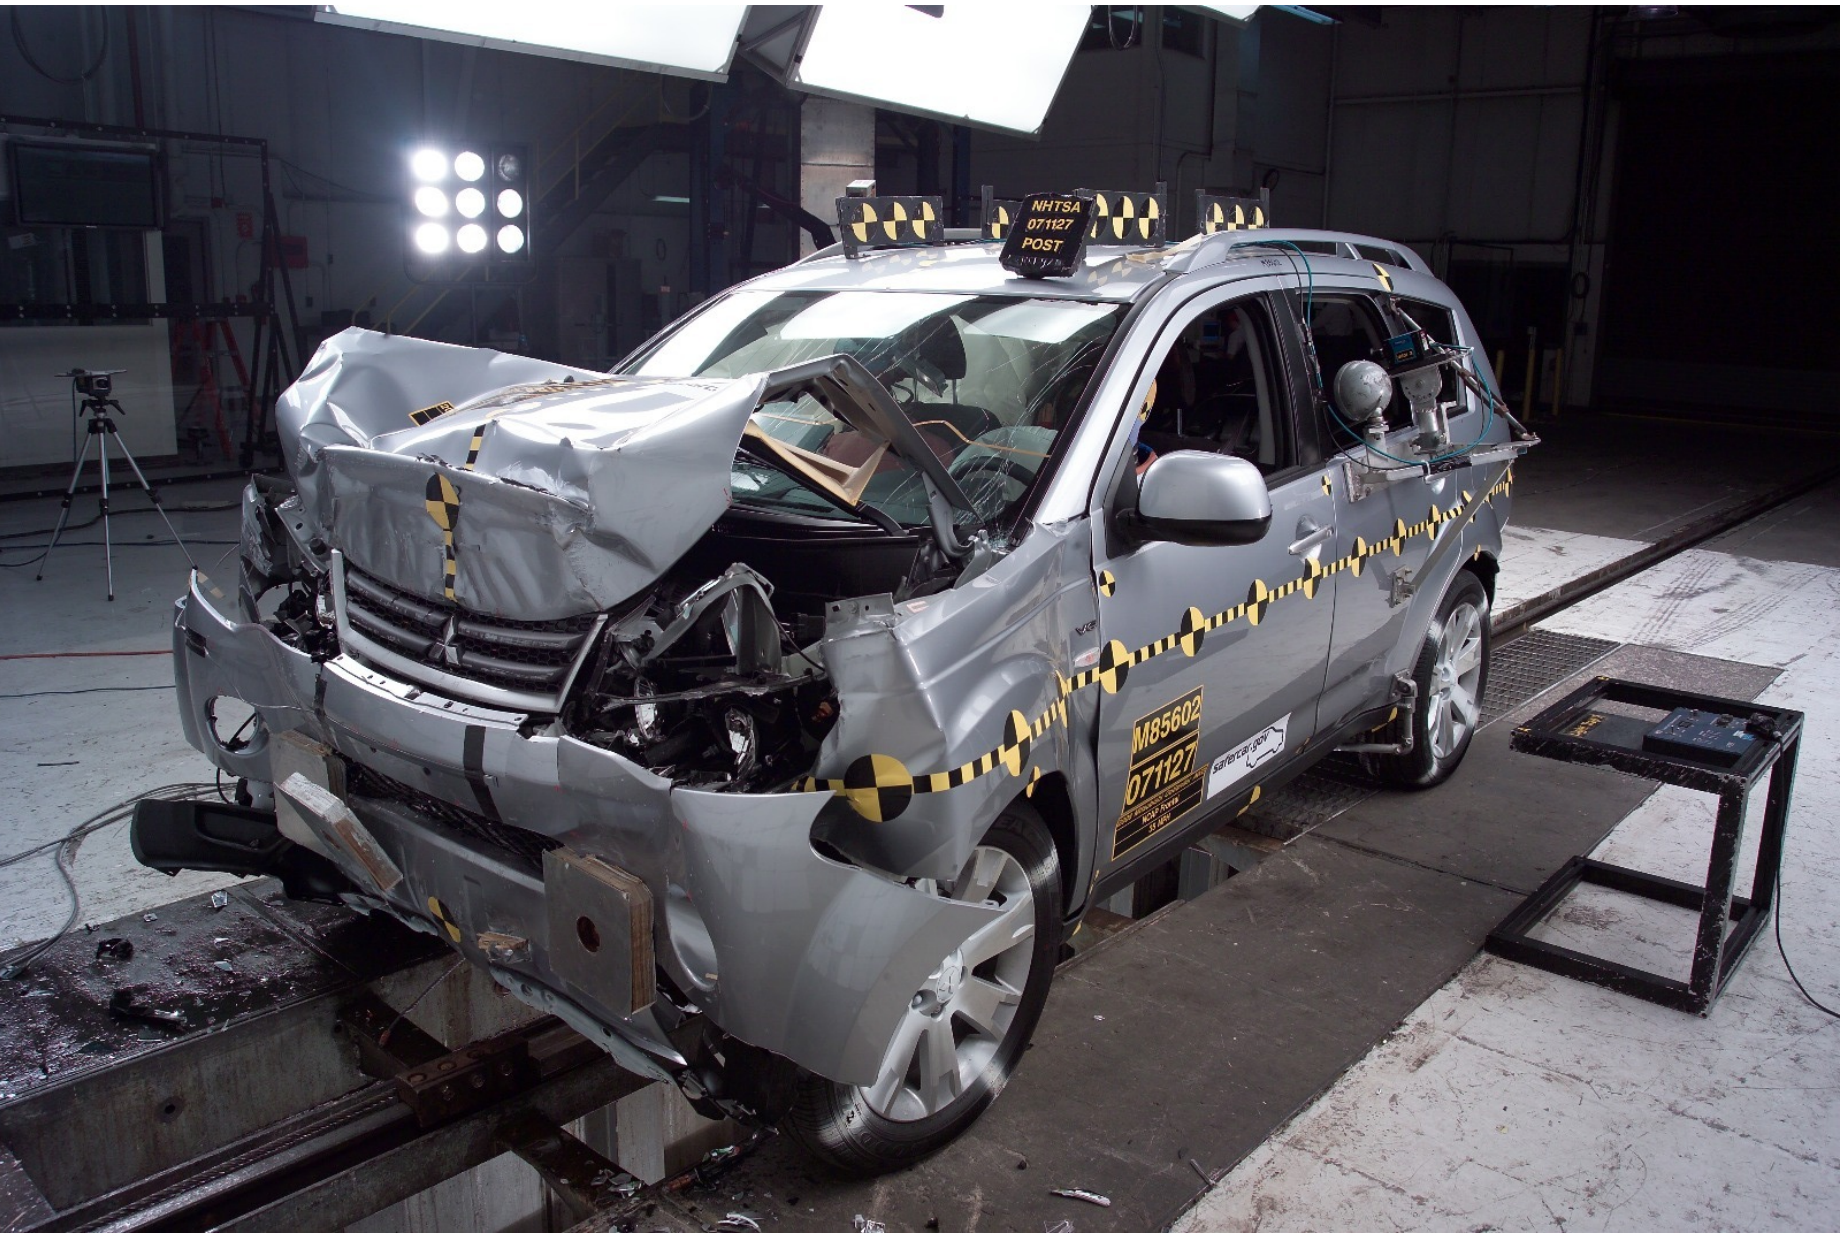
Figure A-4 Post-Test Left Front View

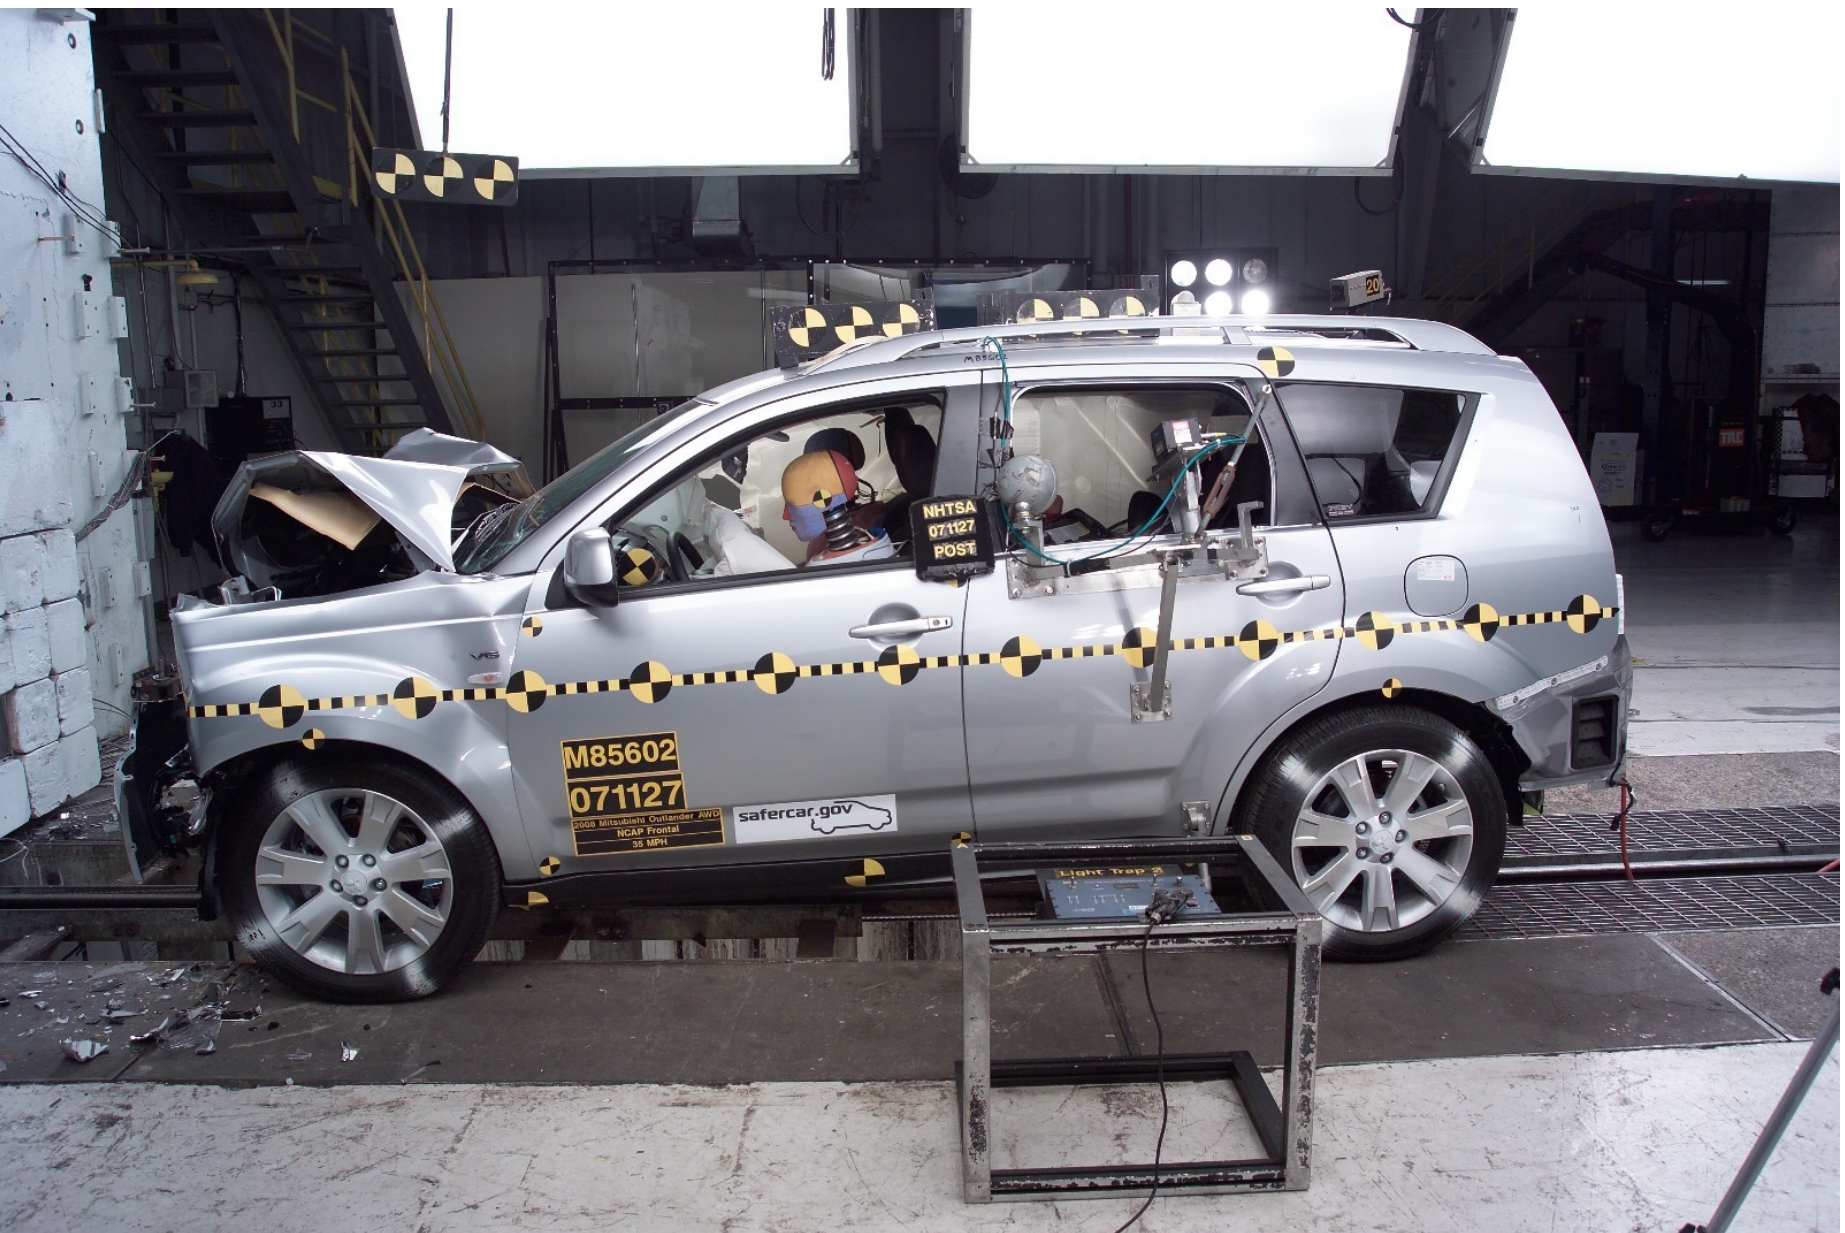
Figure A-6 Post-Test Left Side View

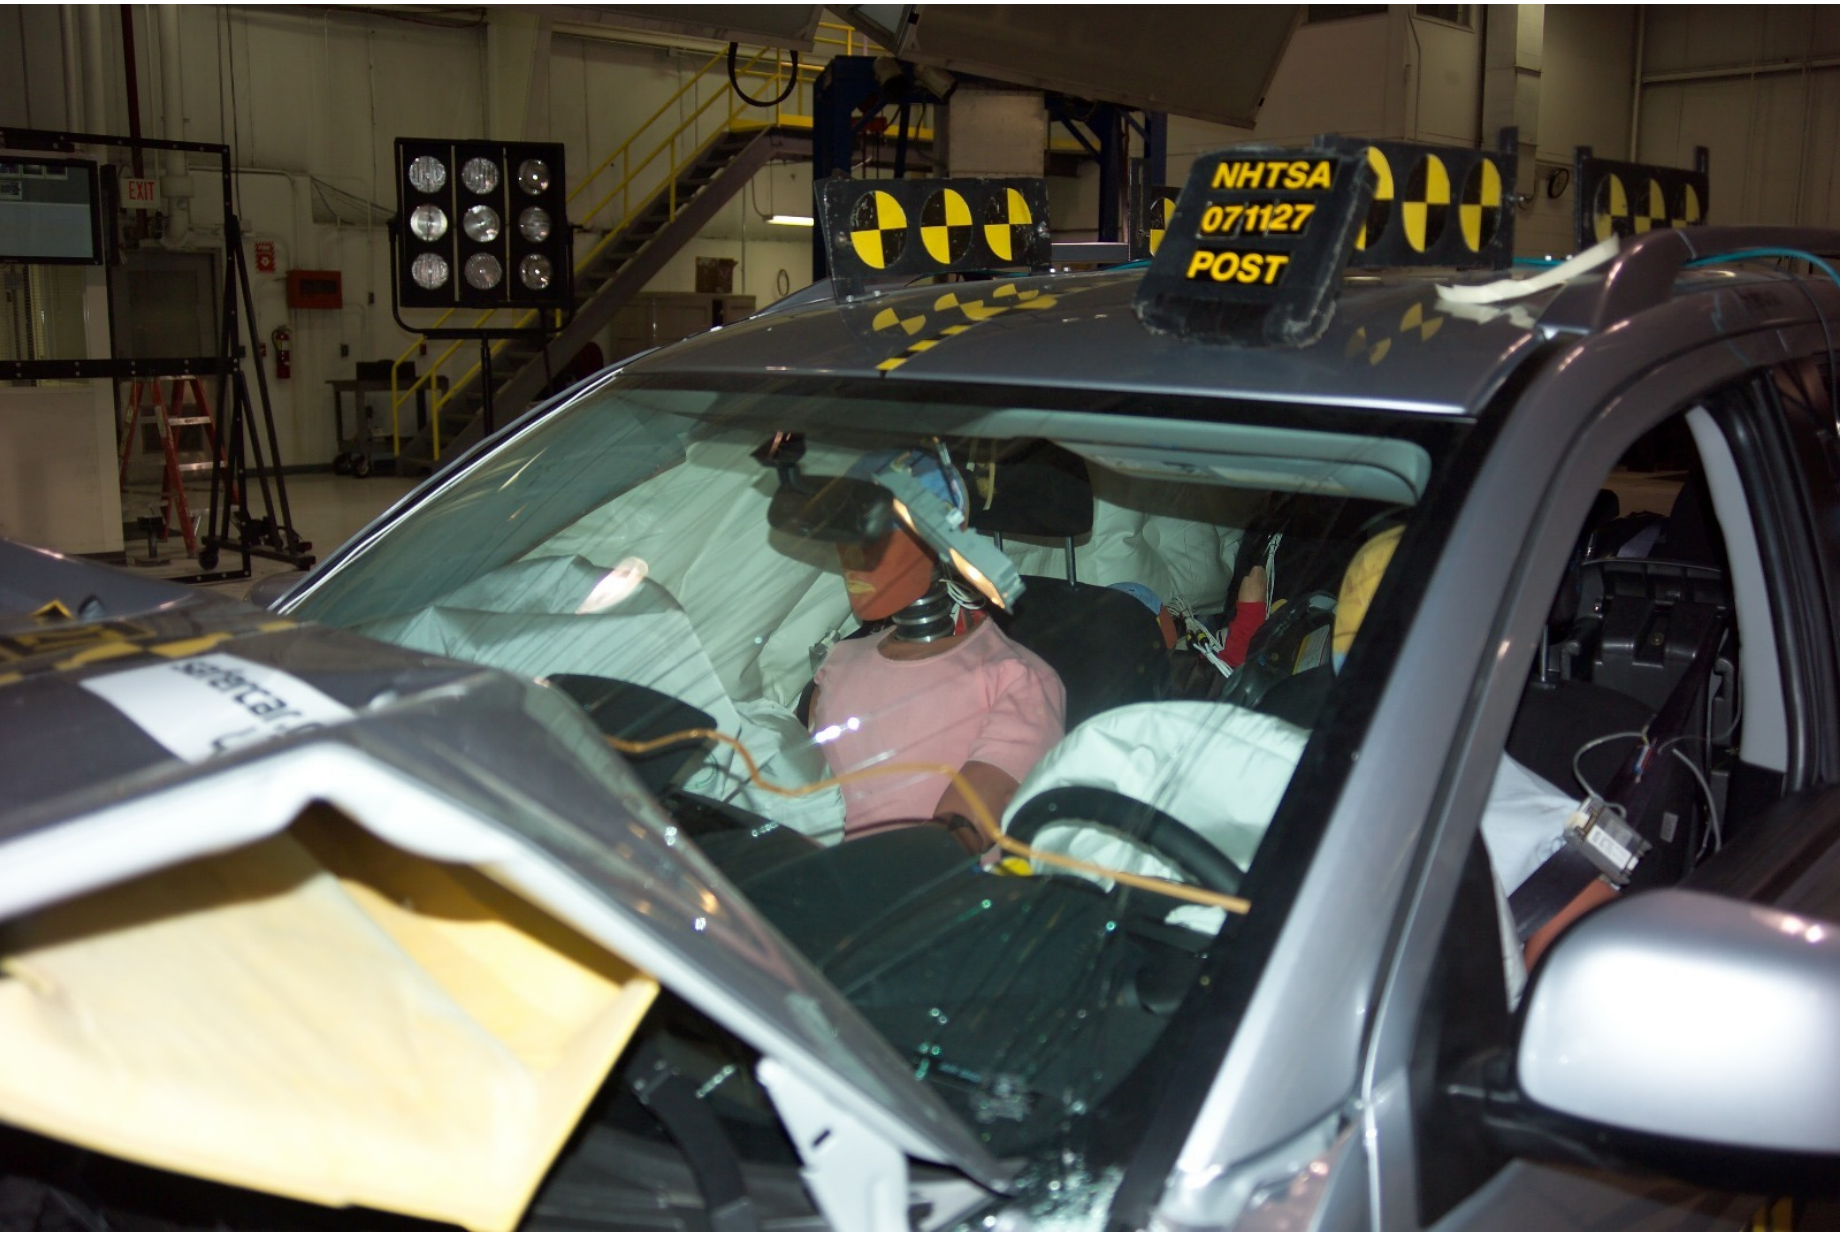
Figure A-41 Post-Test Windshield View - Left Side

There was 66 mm intrusion into the protected zone of the windshield during the event. There was no Stoddard solvent leakage after the event or during any phase of the static rollover.

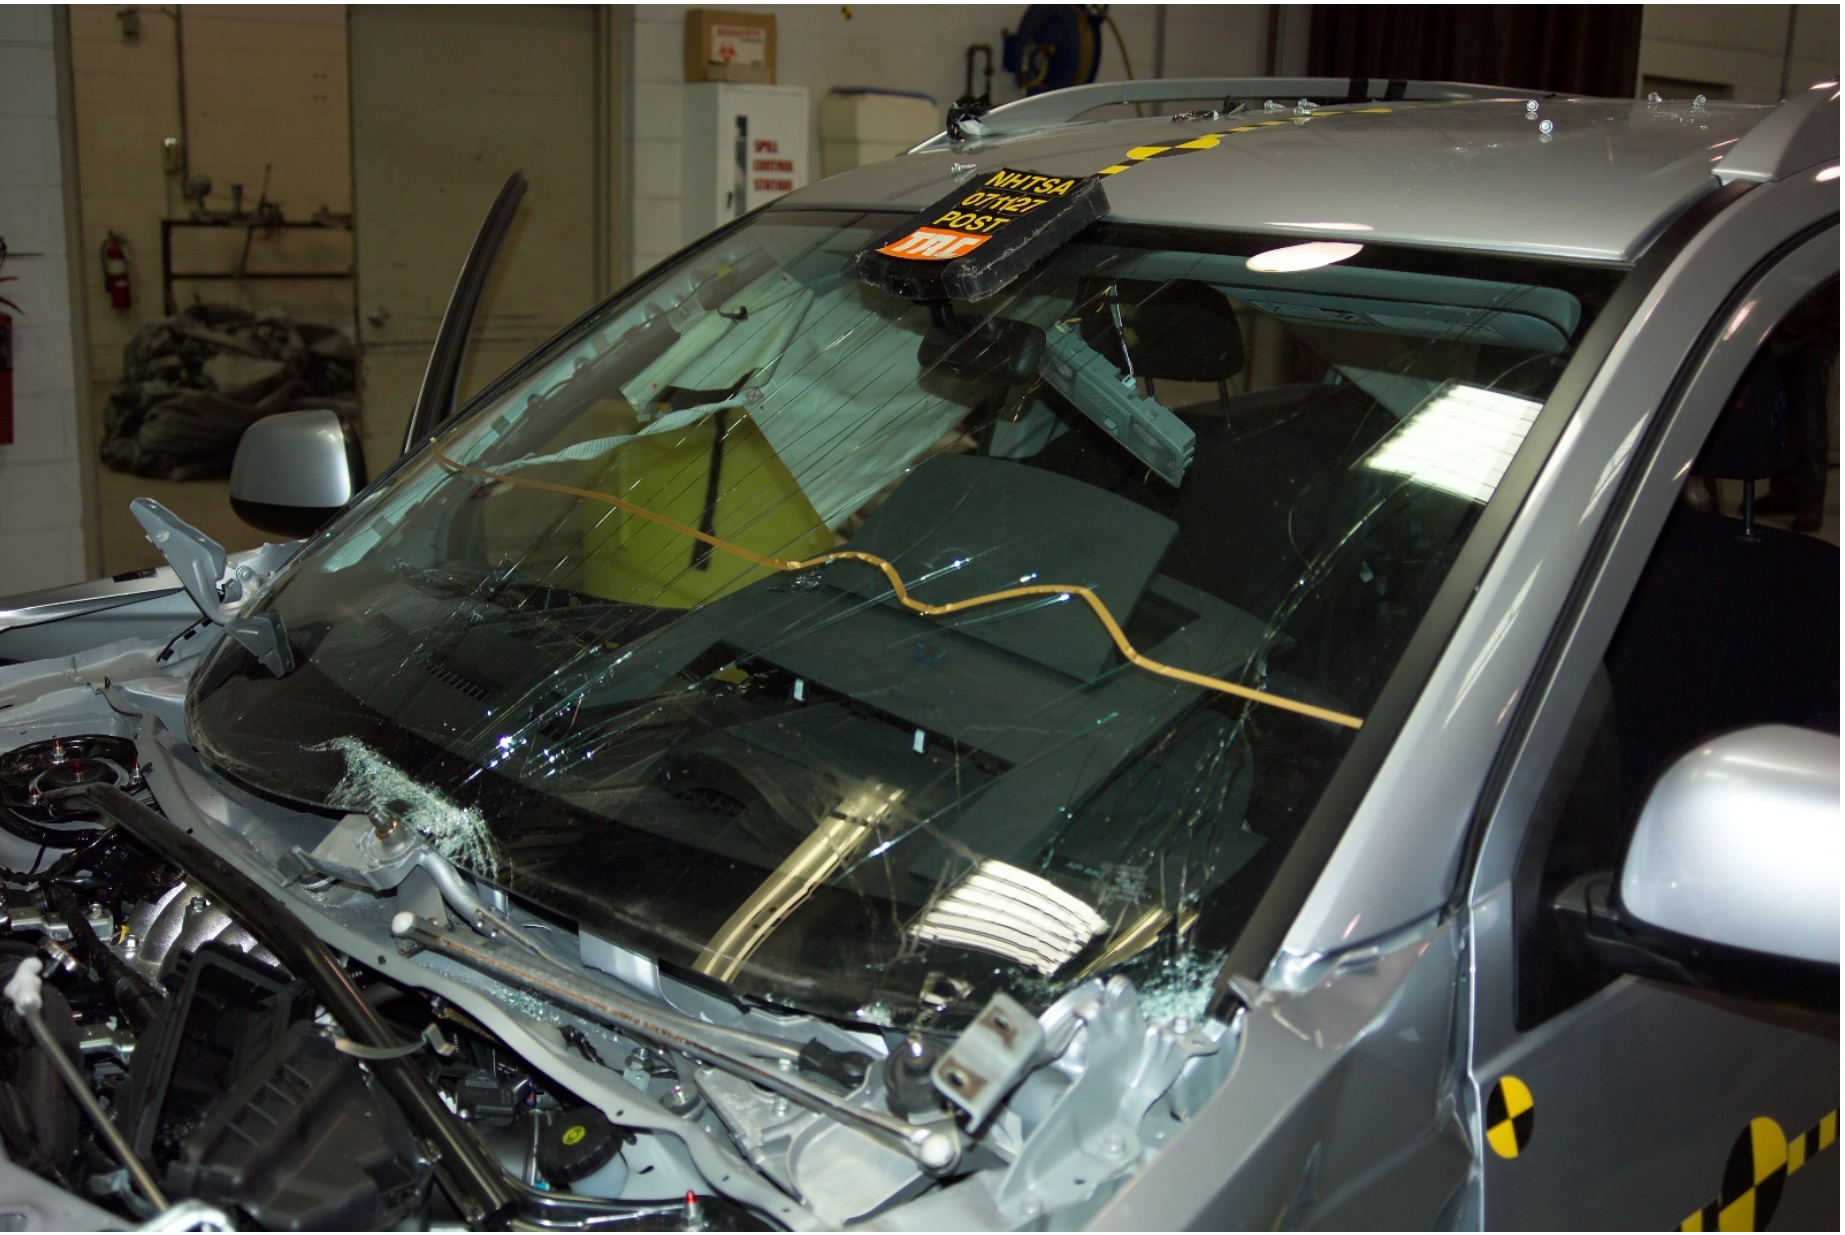
**Figure A-42 Post-Test Windshield View - Left Side without Cowl**

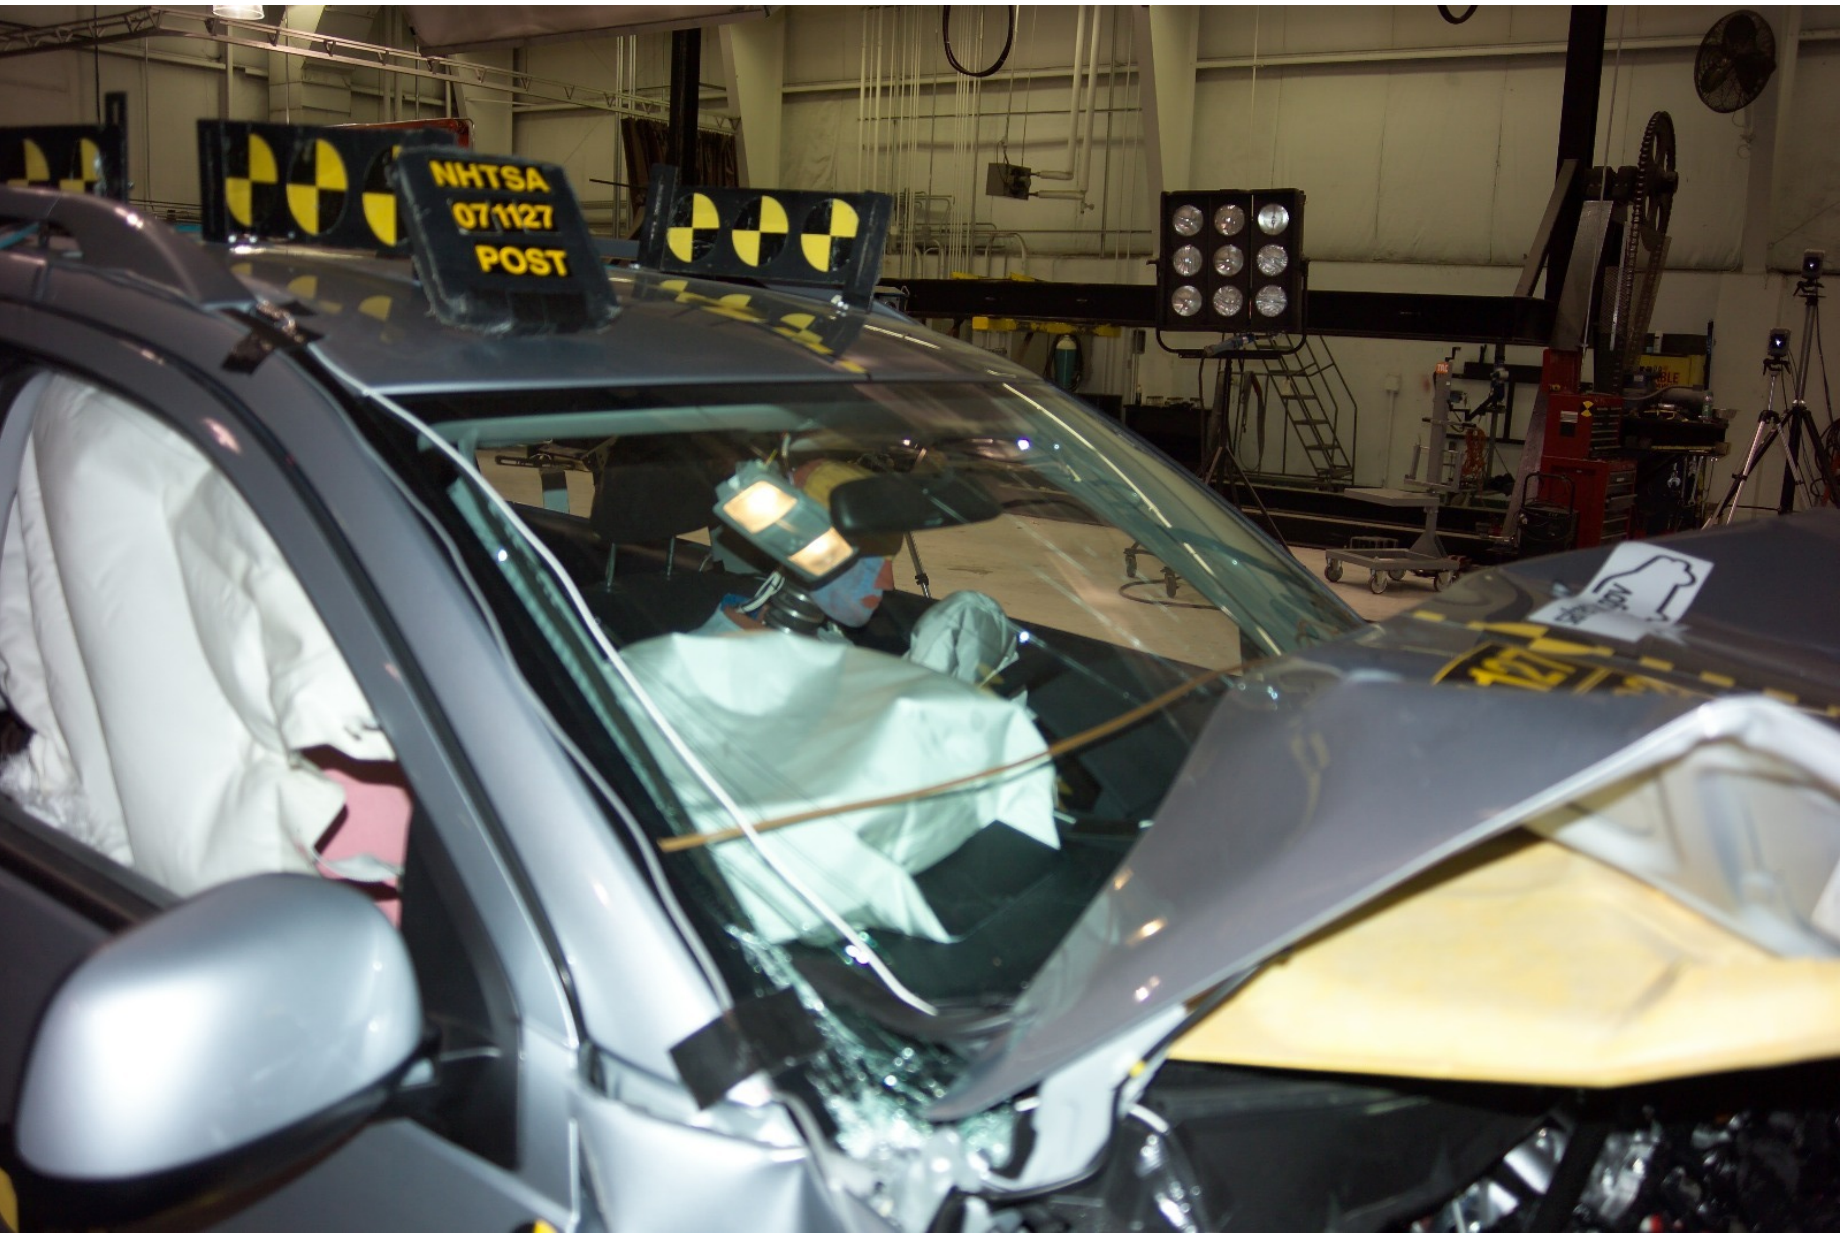
Figure A-44 Post-Test Windshield View - Right Side

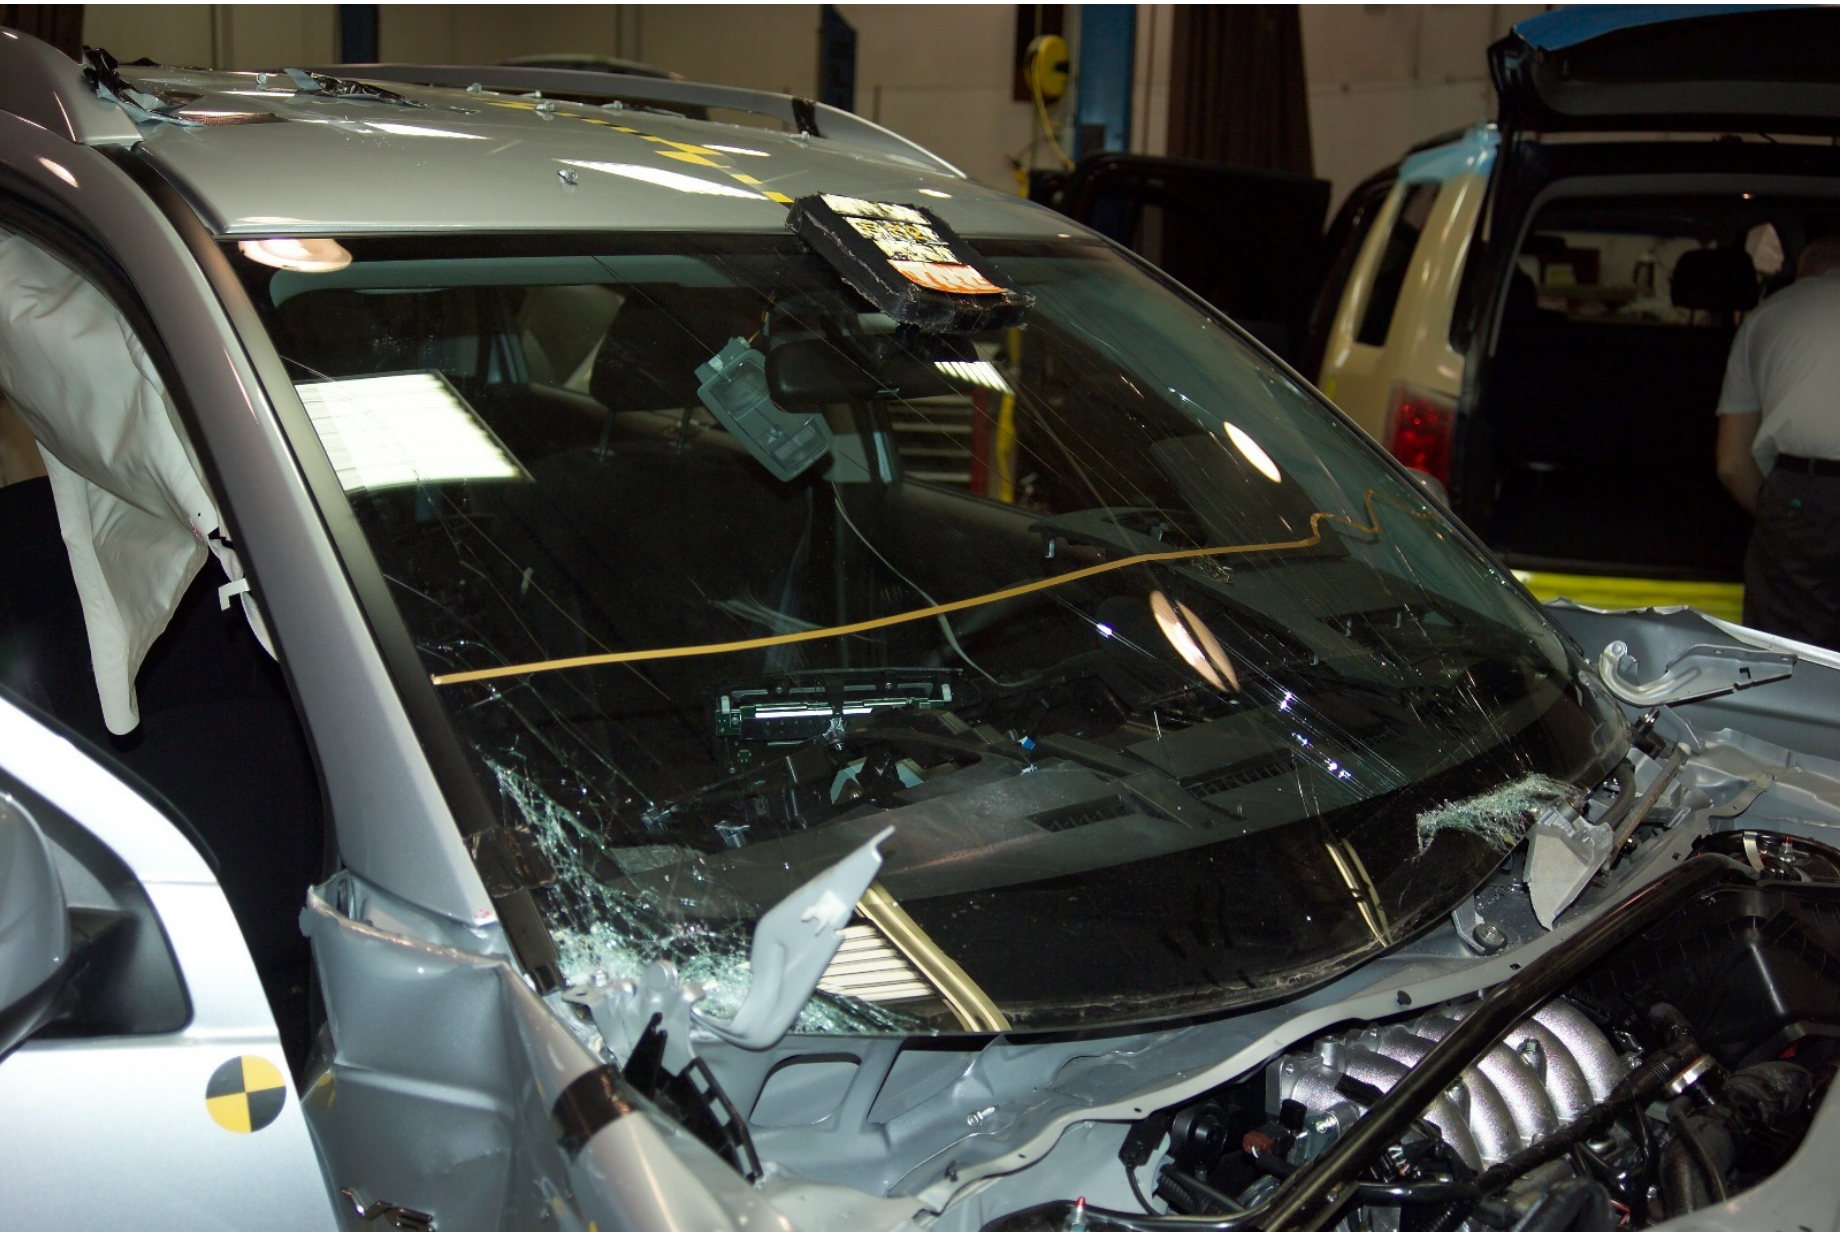
Figure A-45 Post-Test Windshield View - Right Side without Cowl

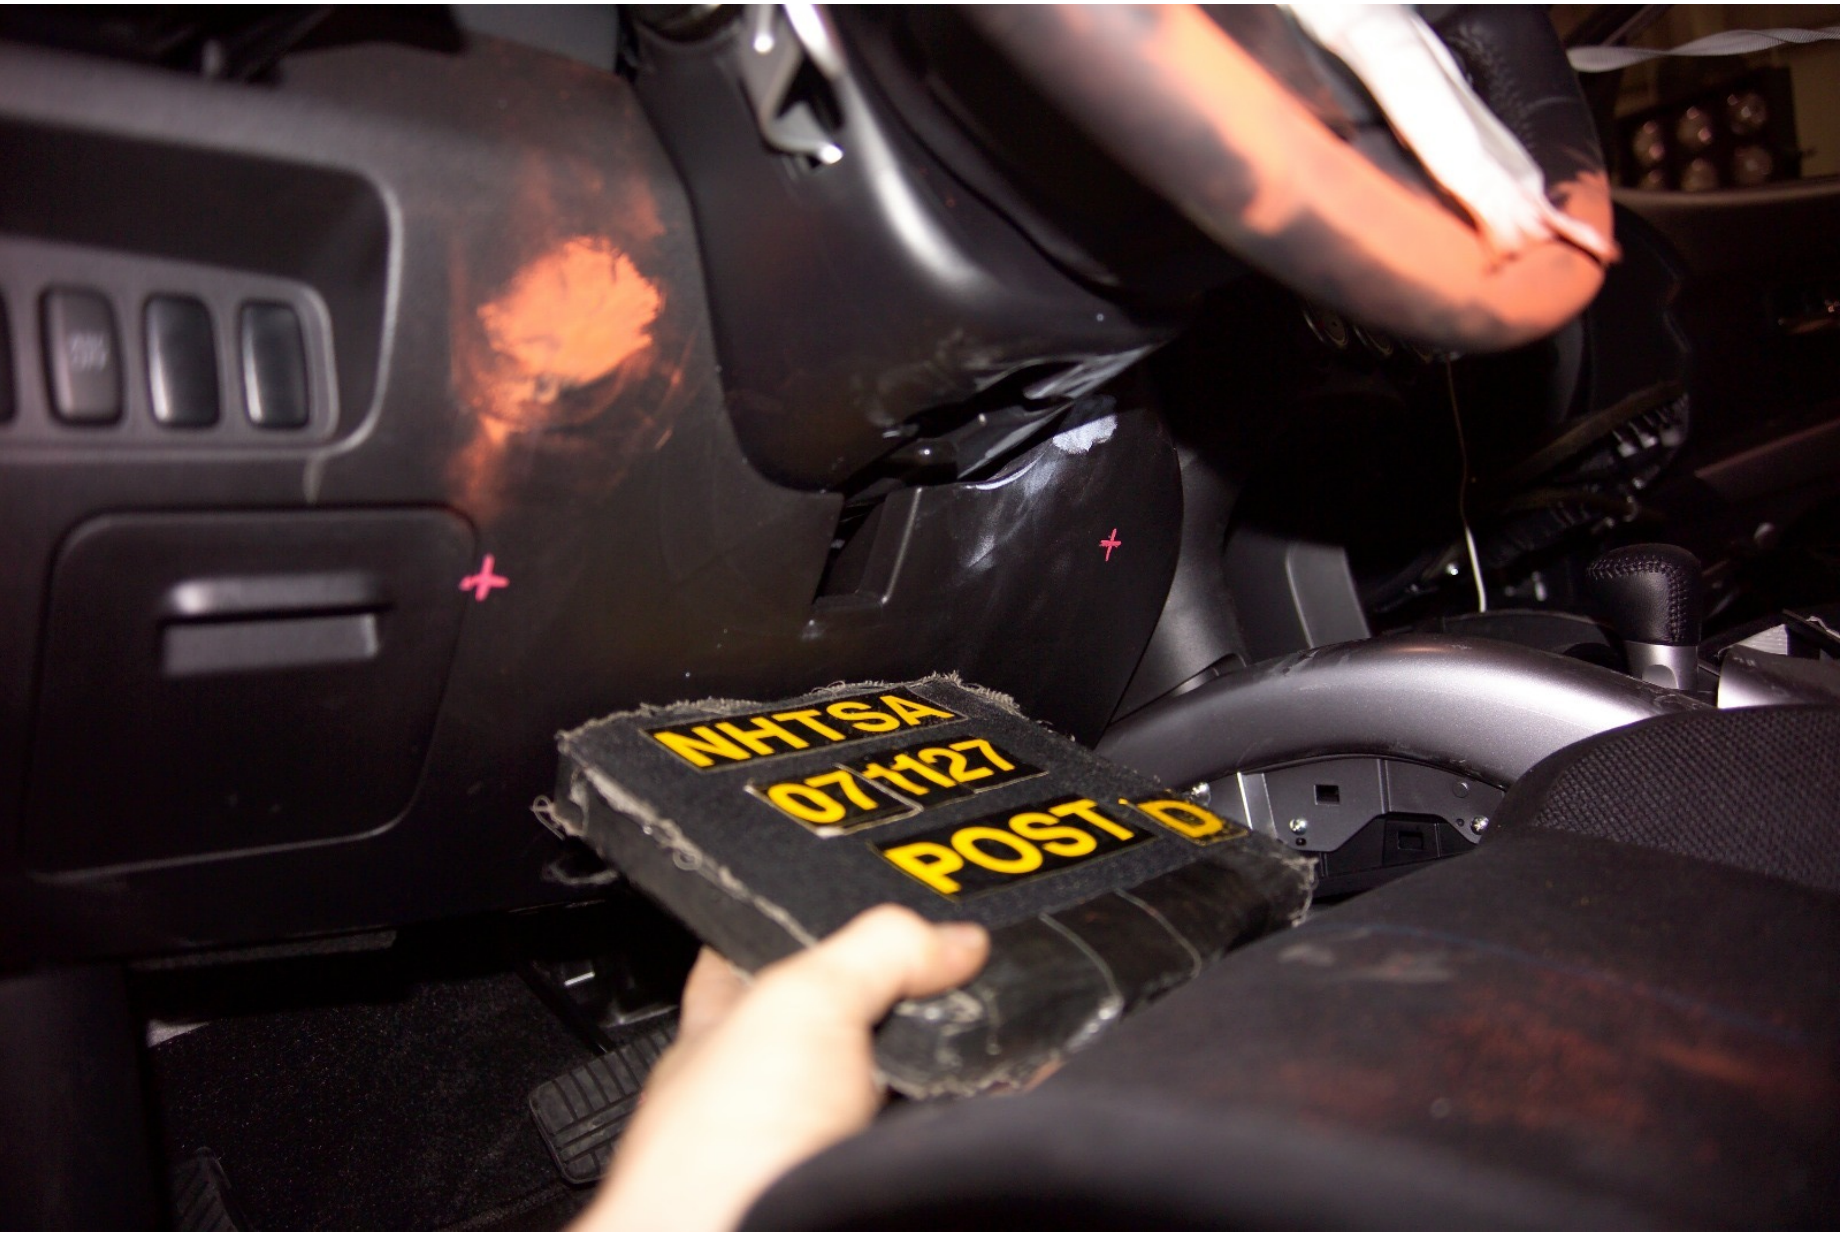
Figure A-62 Post-Test Driver Dummy Knee Contact View

The driver's visible contact points were as follows: airbag, head restraint, and knee bolster. The passenger's visible contact points were as follows: airbag, head restraint, and glove box.

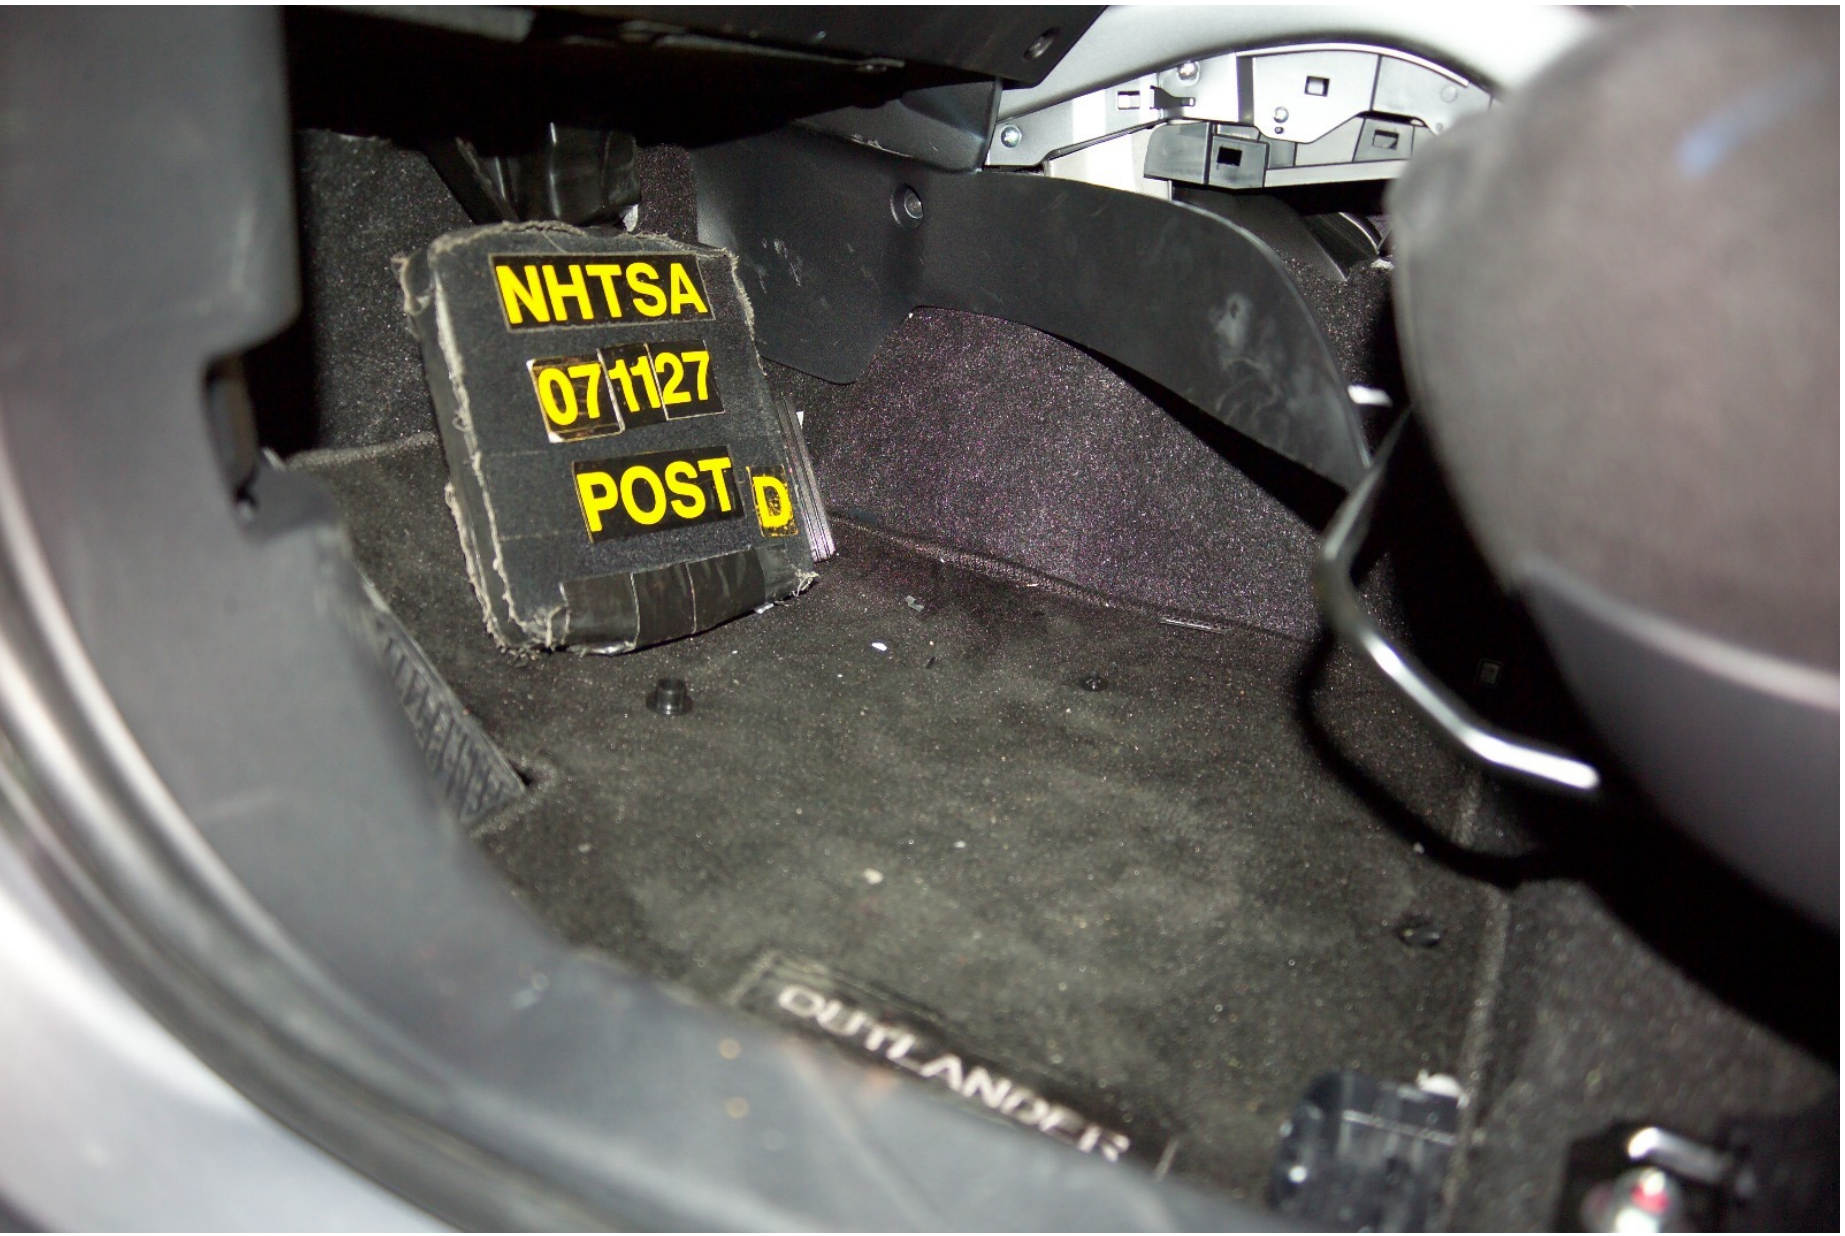
Figure A-63 Post-Test Driver Floorboard Deformation View

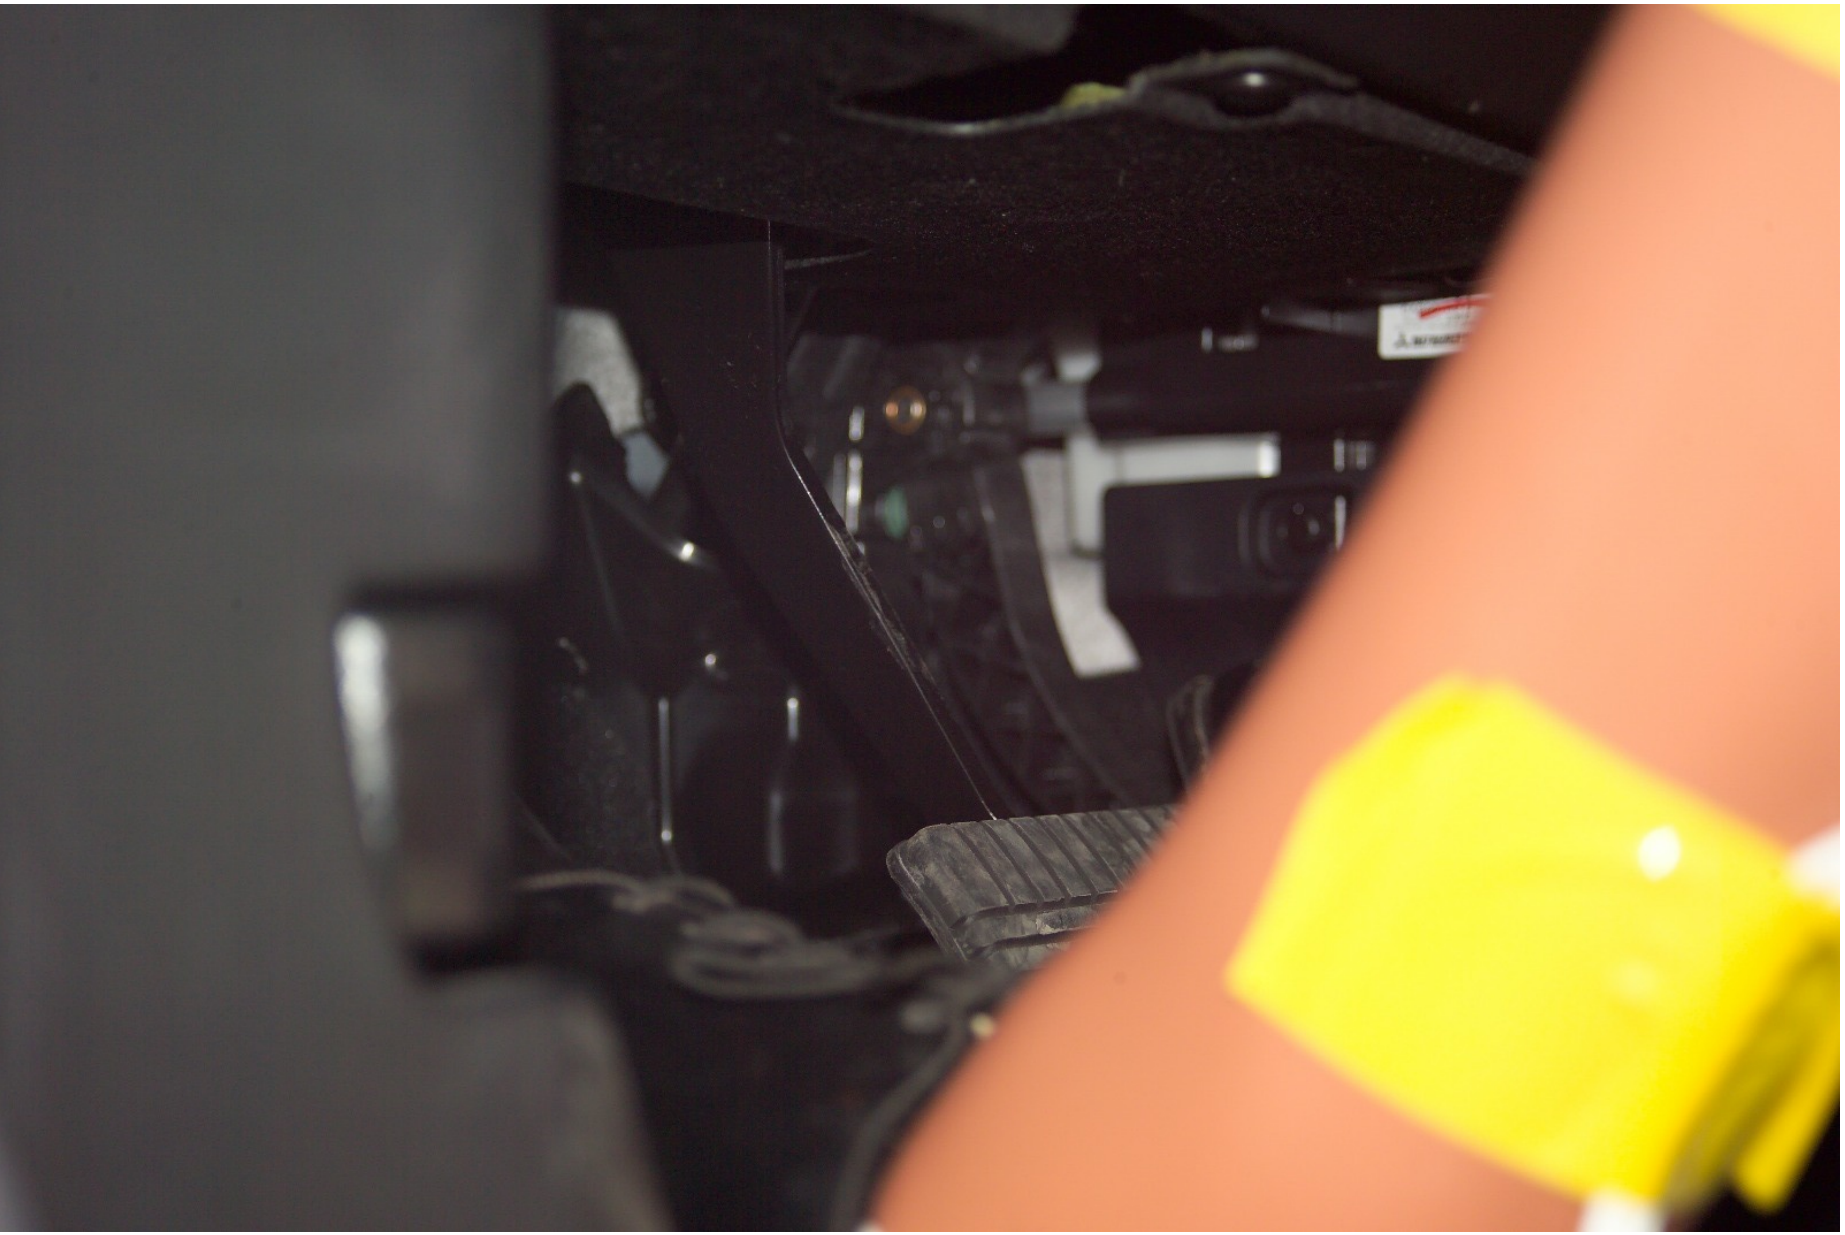
Figure A-65 Post-Test Driver Toeboard Deformation - View 2
