**REPORT NUMBER: NCAP-TRC-2007-005**

**NEW CAR ASSESSMENT PROGRAM  
FRONTAL BARRIER IMPACT TEST**

**MITSUBISHI MOTORS CORPORATION  
2008 MITSUBISHI OUTLANDER MPV  
NHTSA NUMBER: M85602**

**FINAL REPORT**

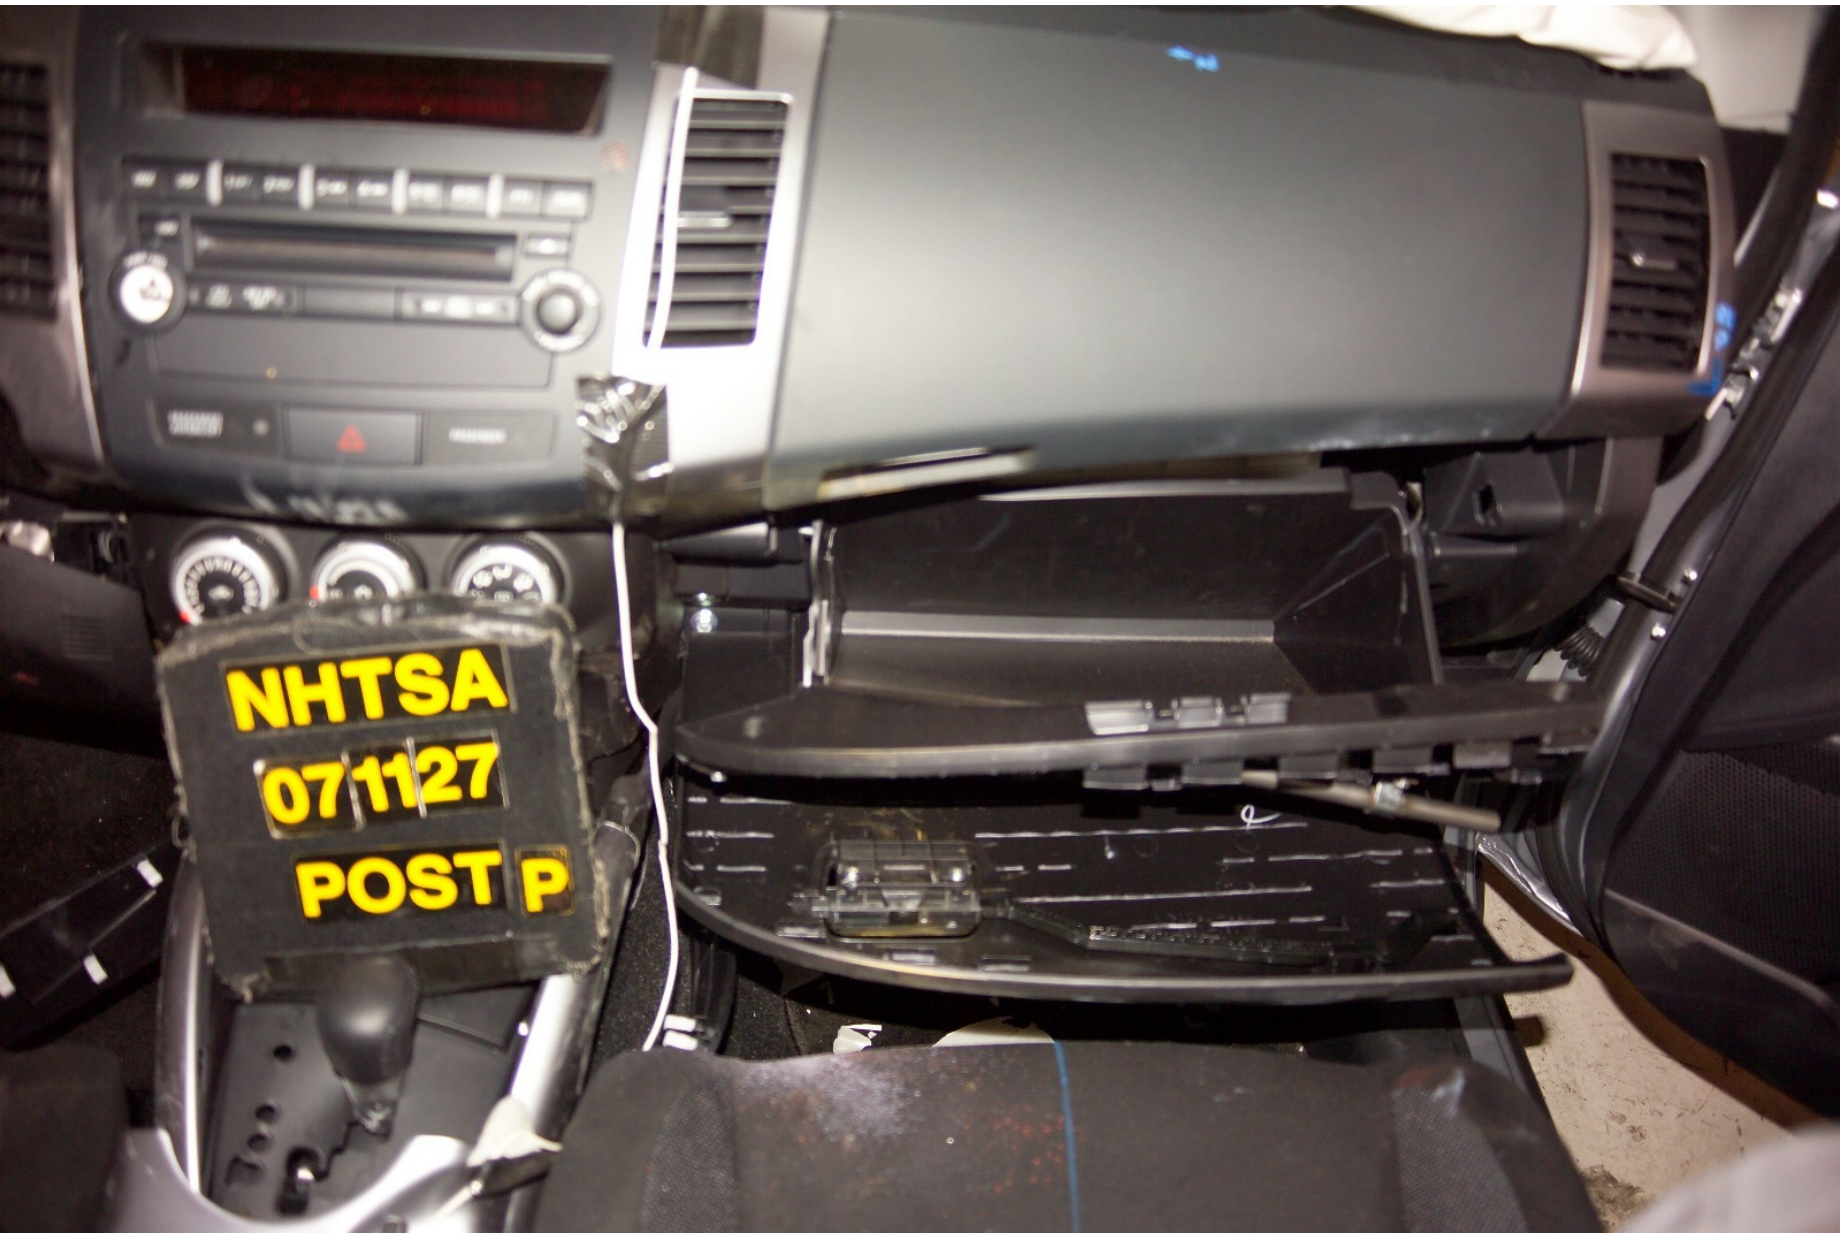
Figure A-78 Post-Test Glove Box Damage View

The driver's visible contact points were as follows: airbag, head restraint, and knee bolster. The passenger's visible contact points were as follows: airbag, head restraint, and glove box.

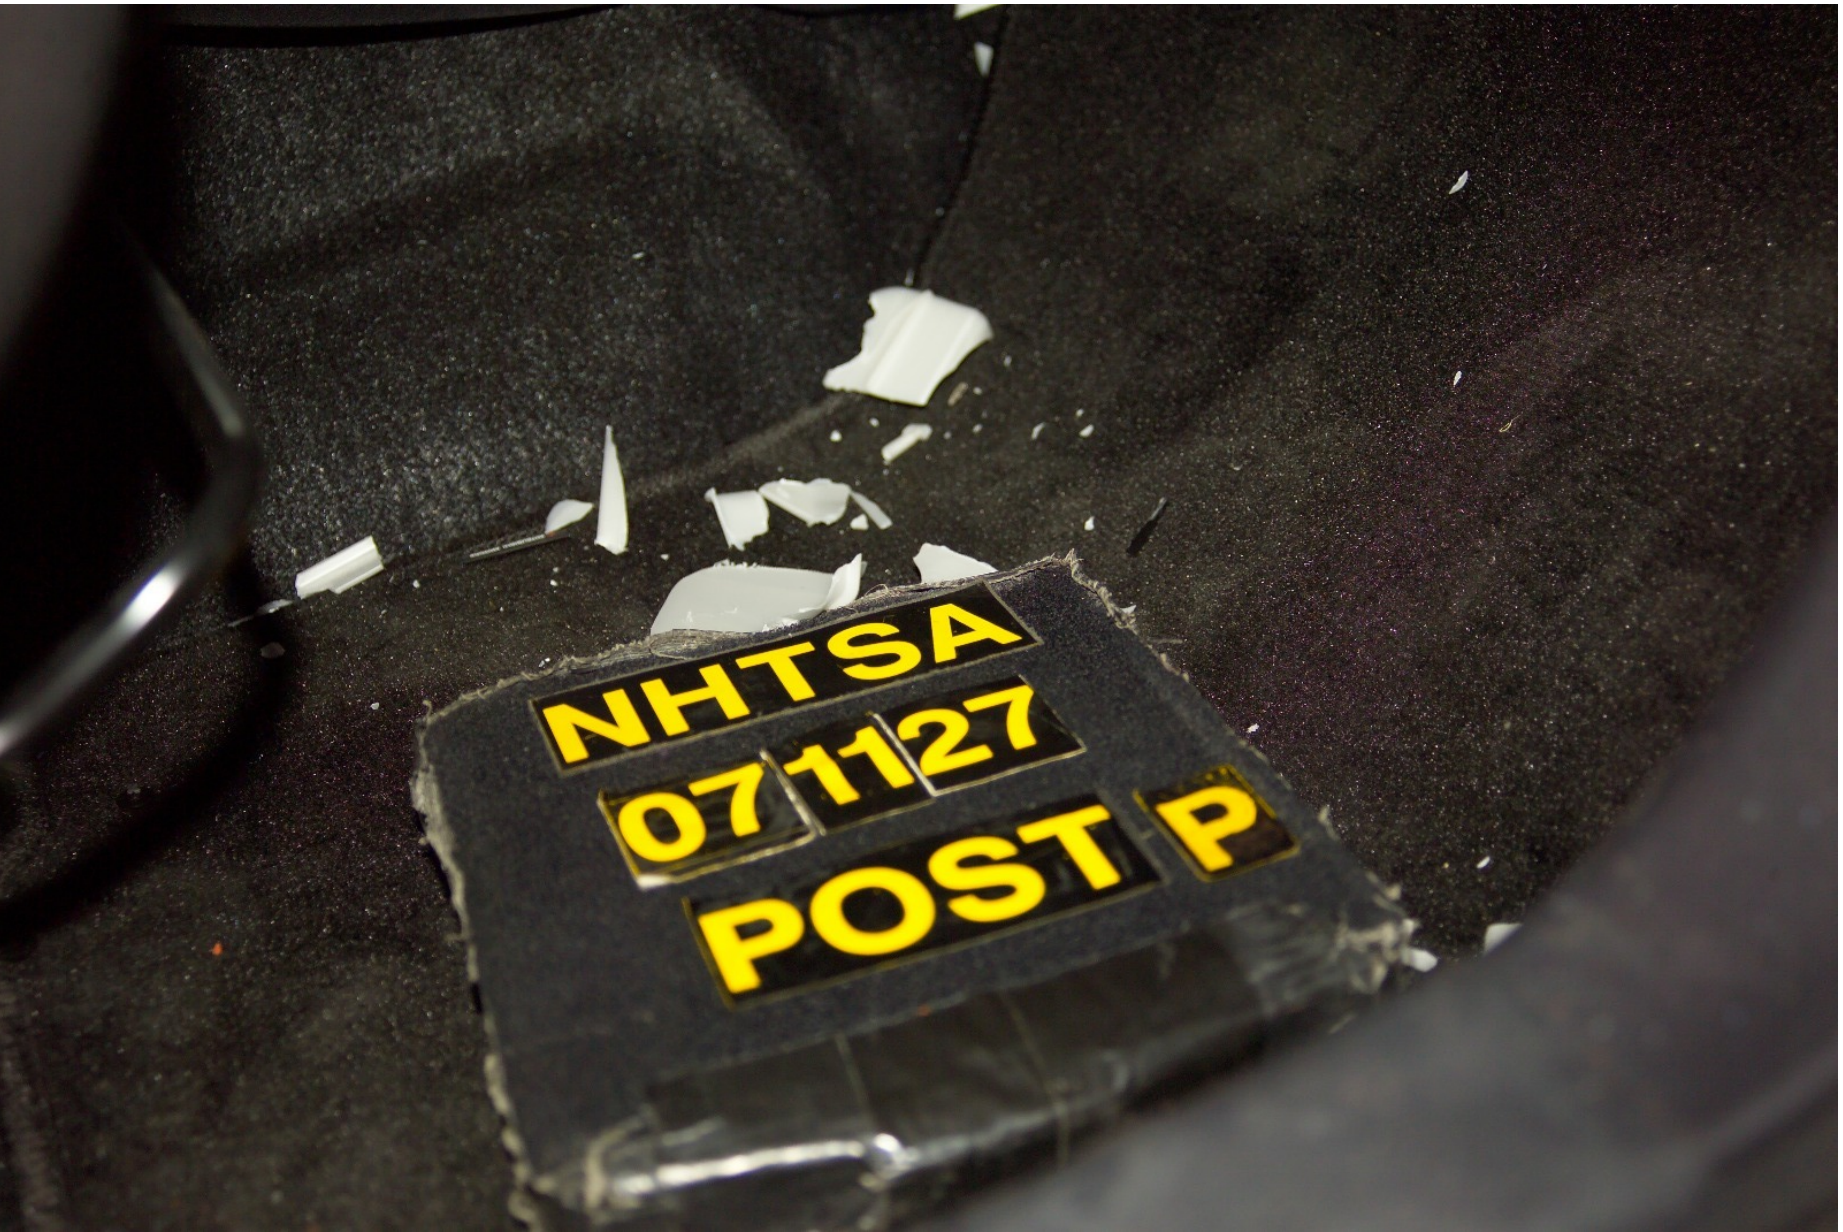
Figure A-79 Post-Test Right Front Passenger Floorboard Deformation View

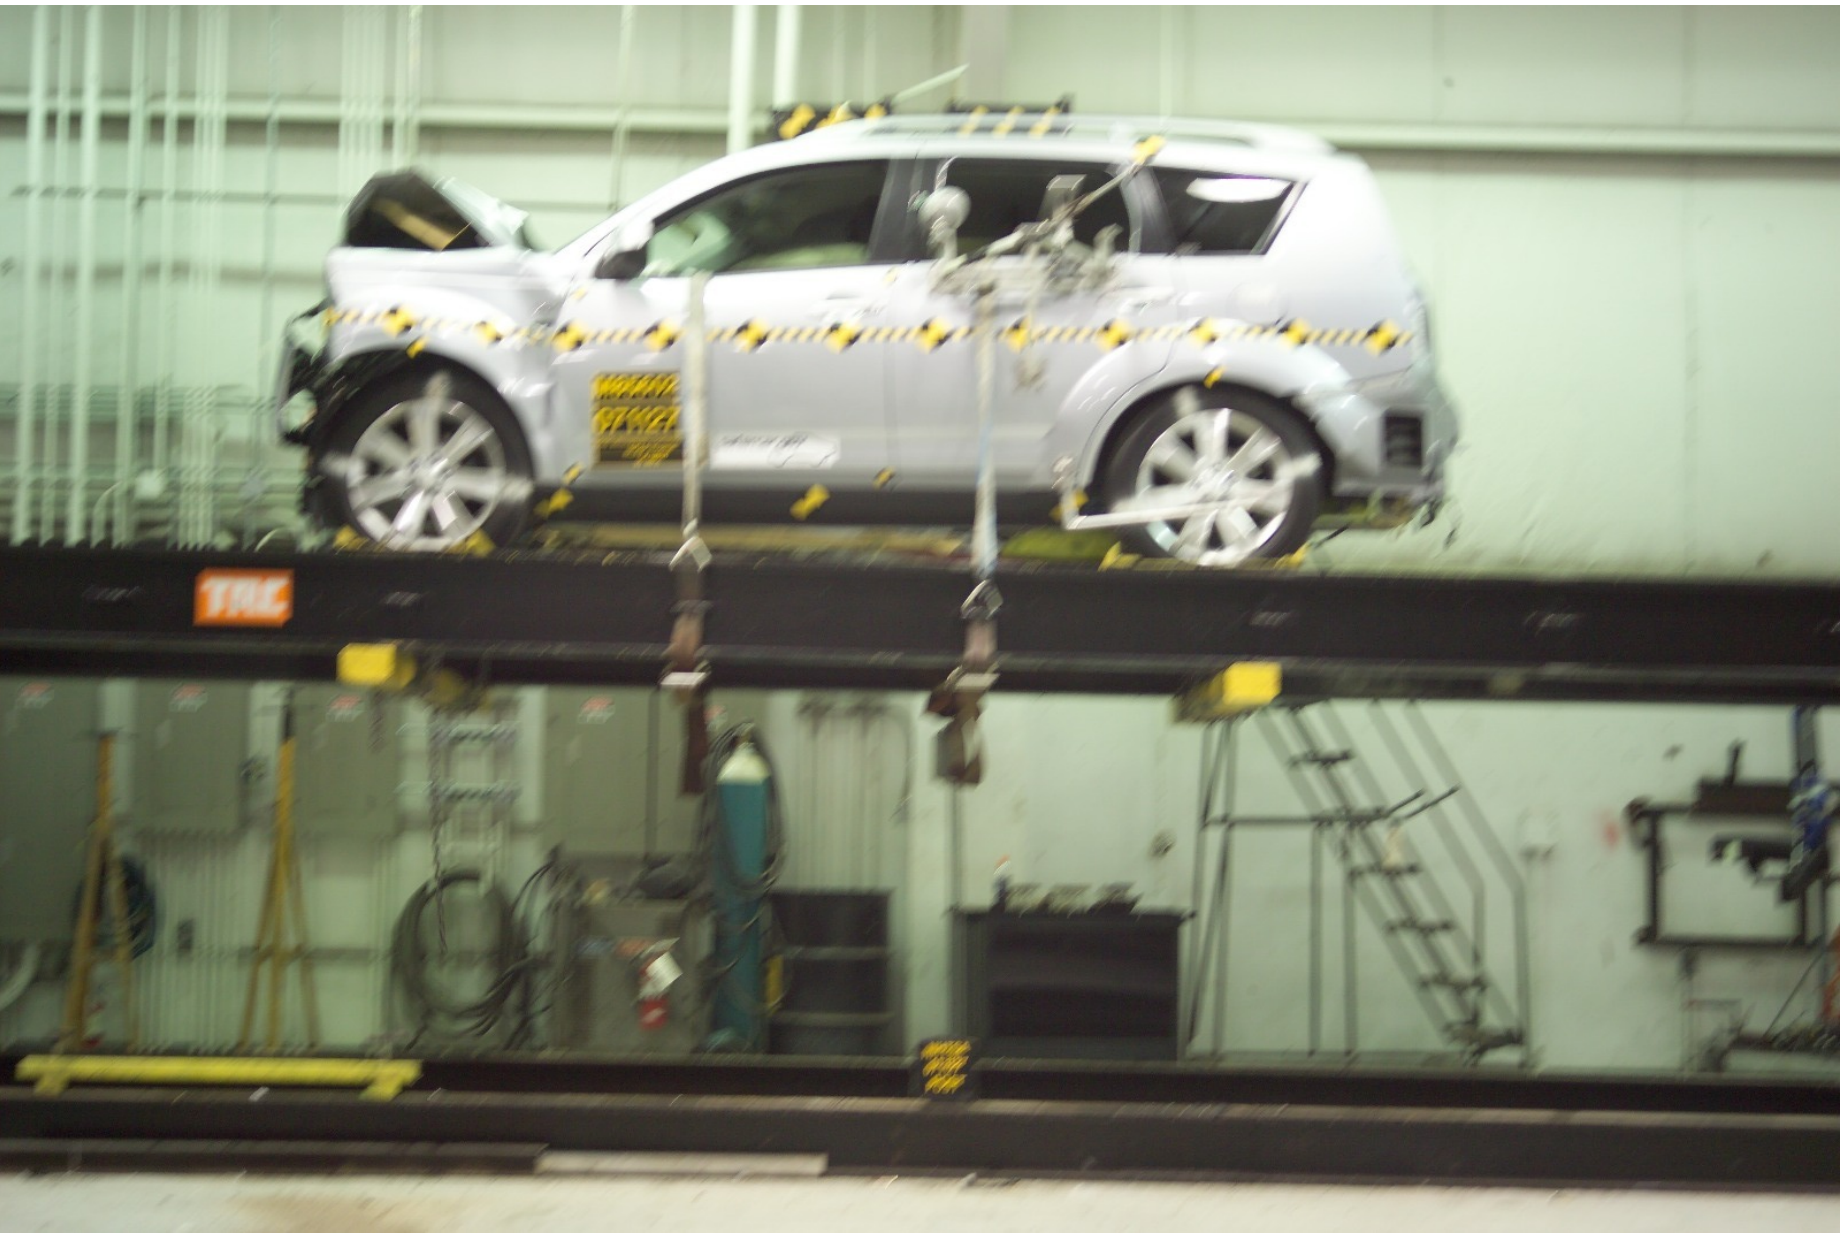
Figure A-88 FMVSS 301 Rollover View at 360°

1. The specified fixture rollover rate for each 90° of rotation is 60 to 120 seconds.
2. The position hold time at each position is 300 seconds (minimum).
3. No solvent leakage occurred during rollover.

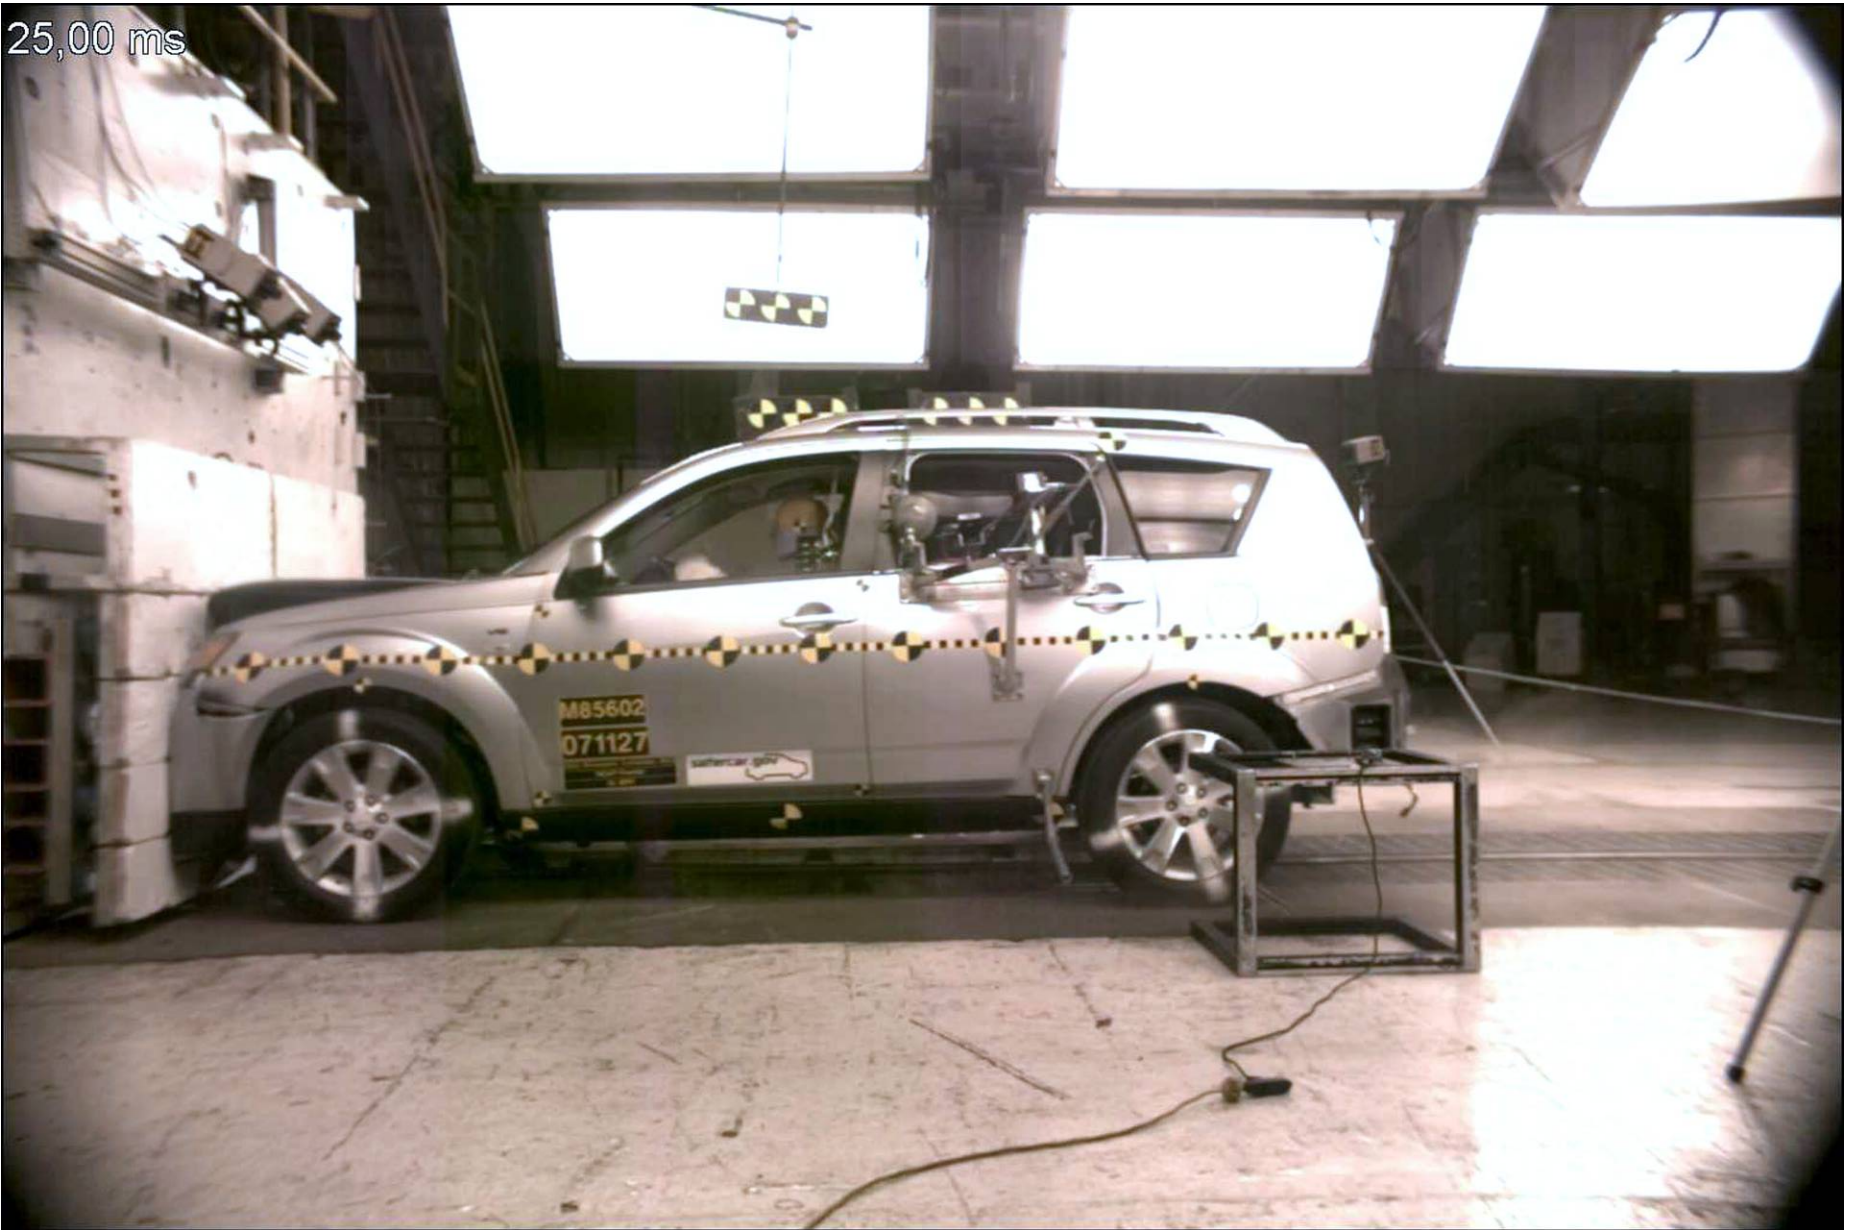
Figure A-91 Impact Event
