**NEW CAR ASSESSMENT PROGRAM  
FRONTAL BARRIER IMPACT TEST**

**NISSAN MOTOR CO., LTD  
2008 NISSAN 350Z  
2-DOOR CONVERTIBLE**

**NHTSA NUMBER: M85216**

**FINAL REPORT**

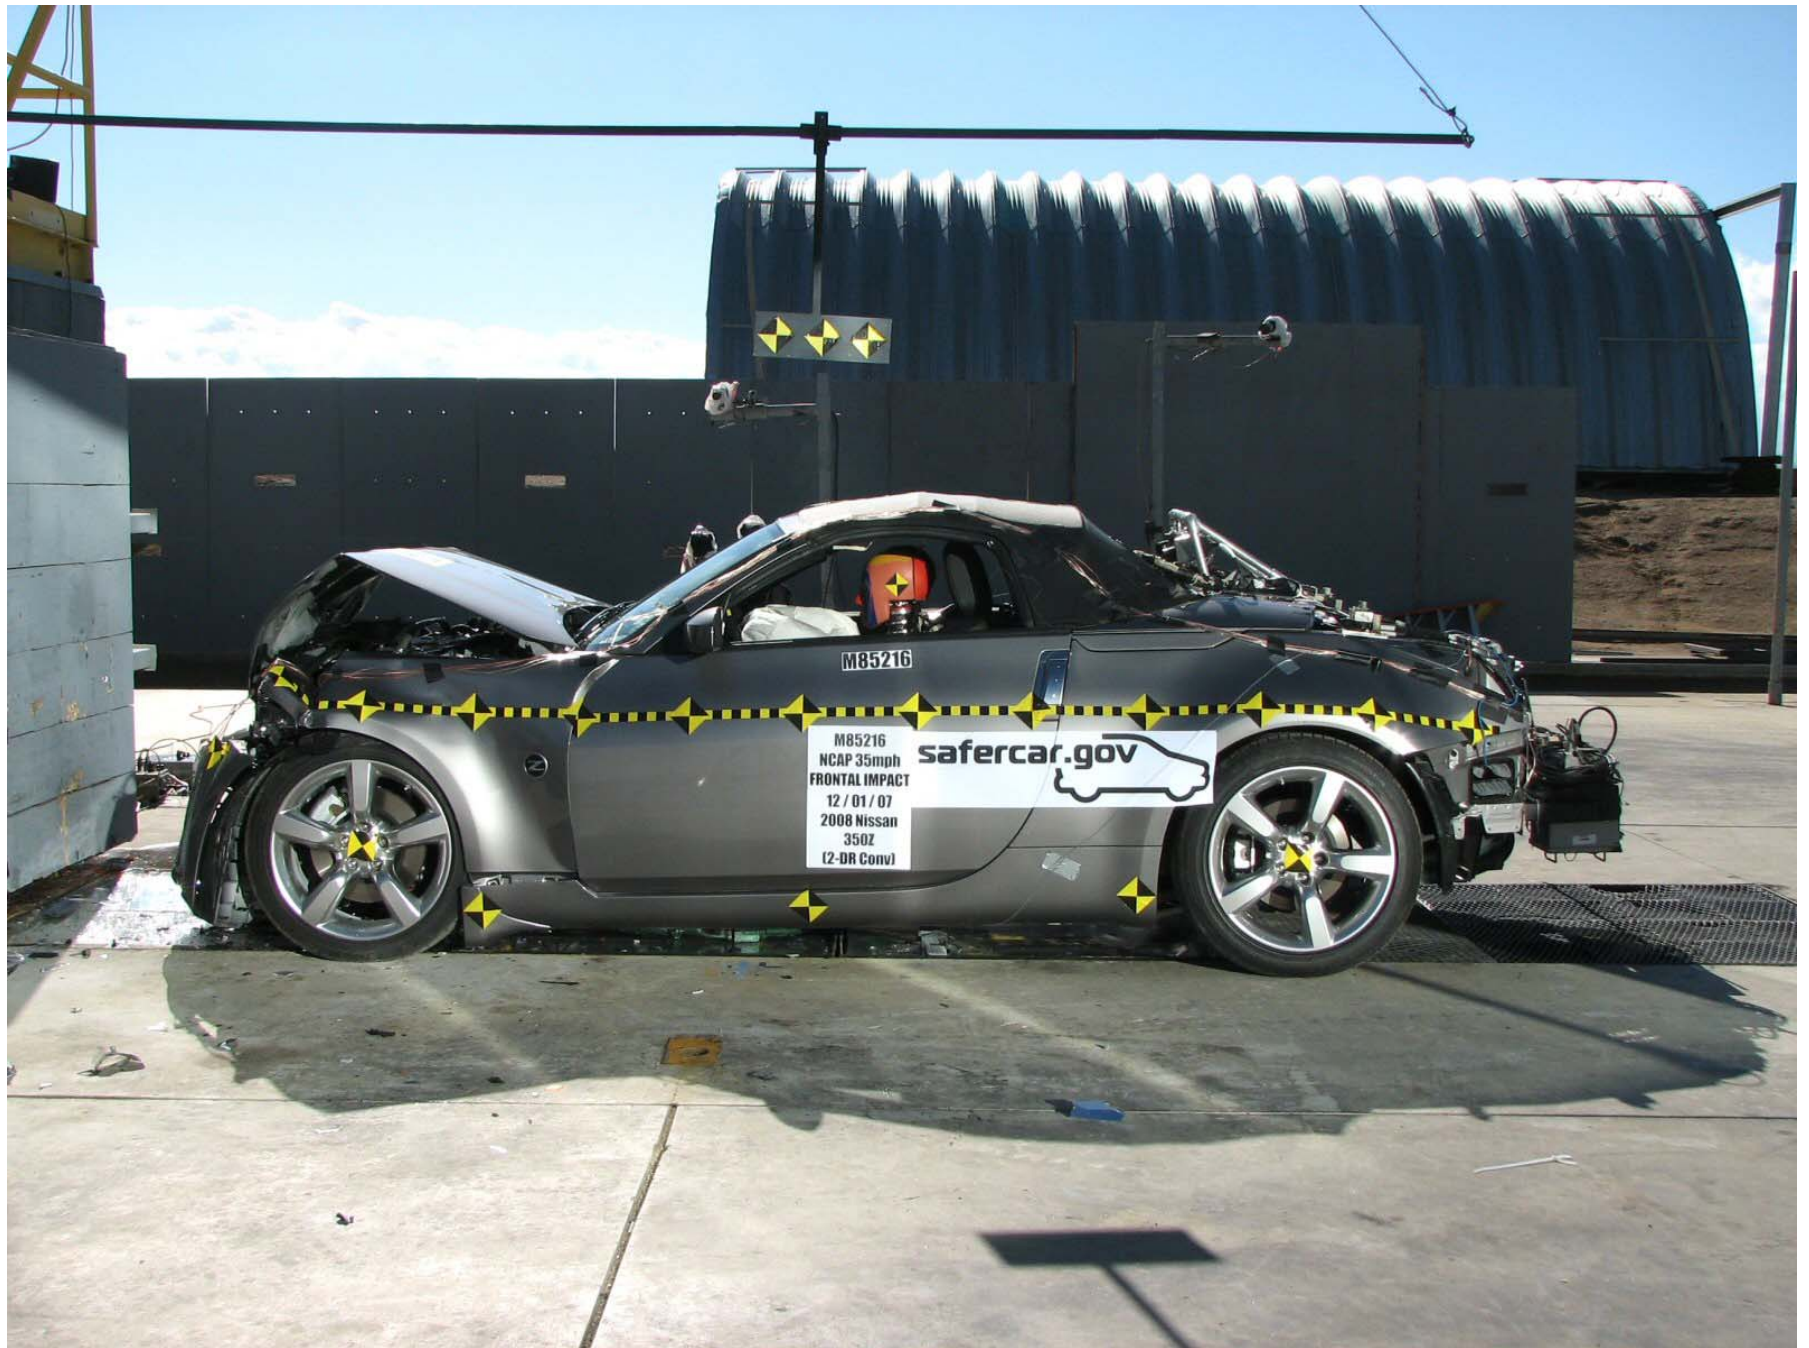
Figure A-9: Post-Test Left Side View

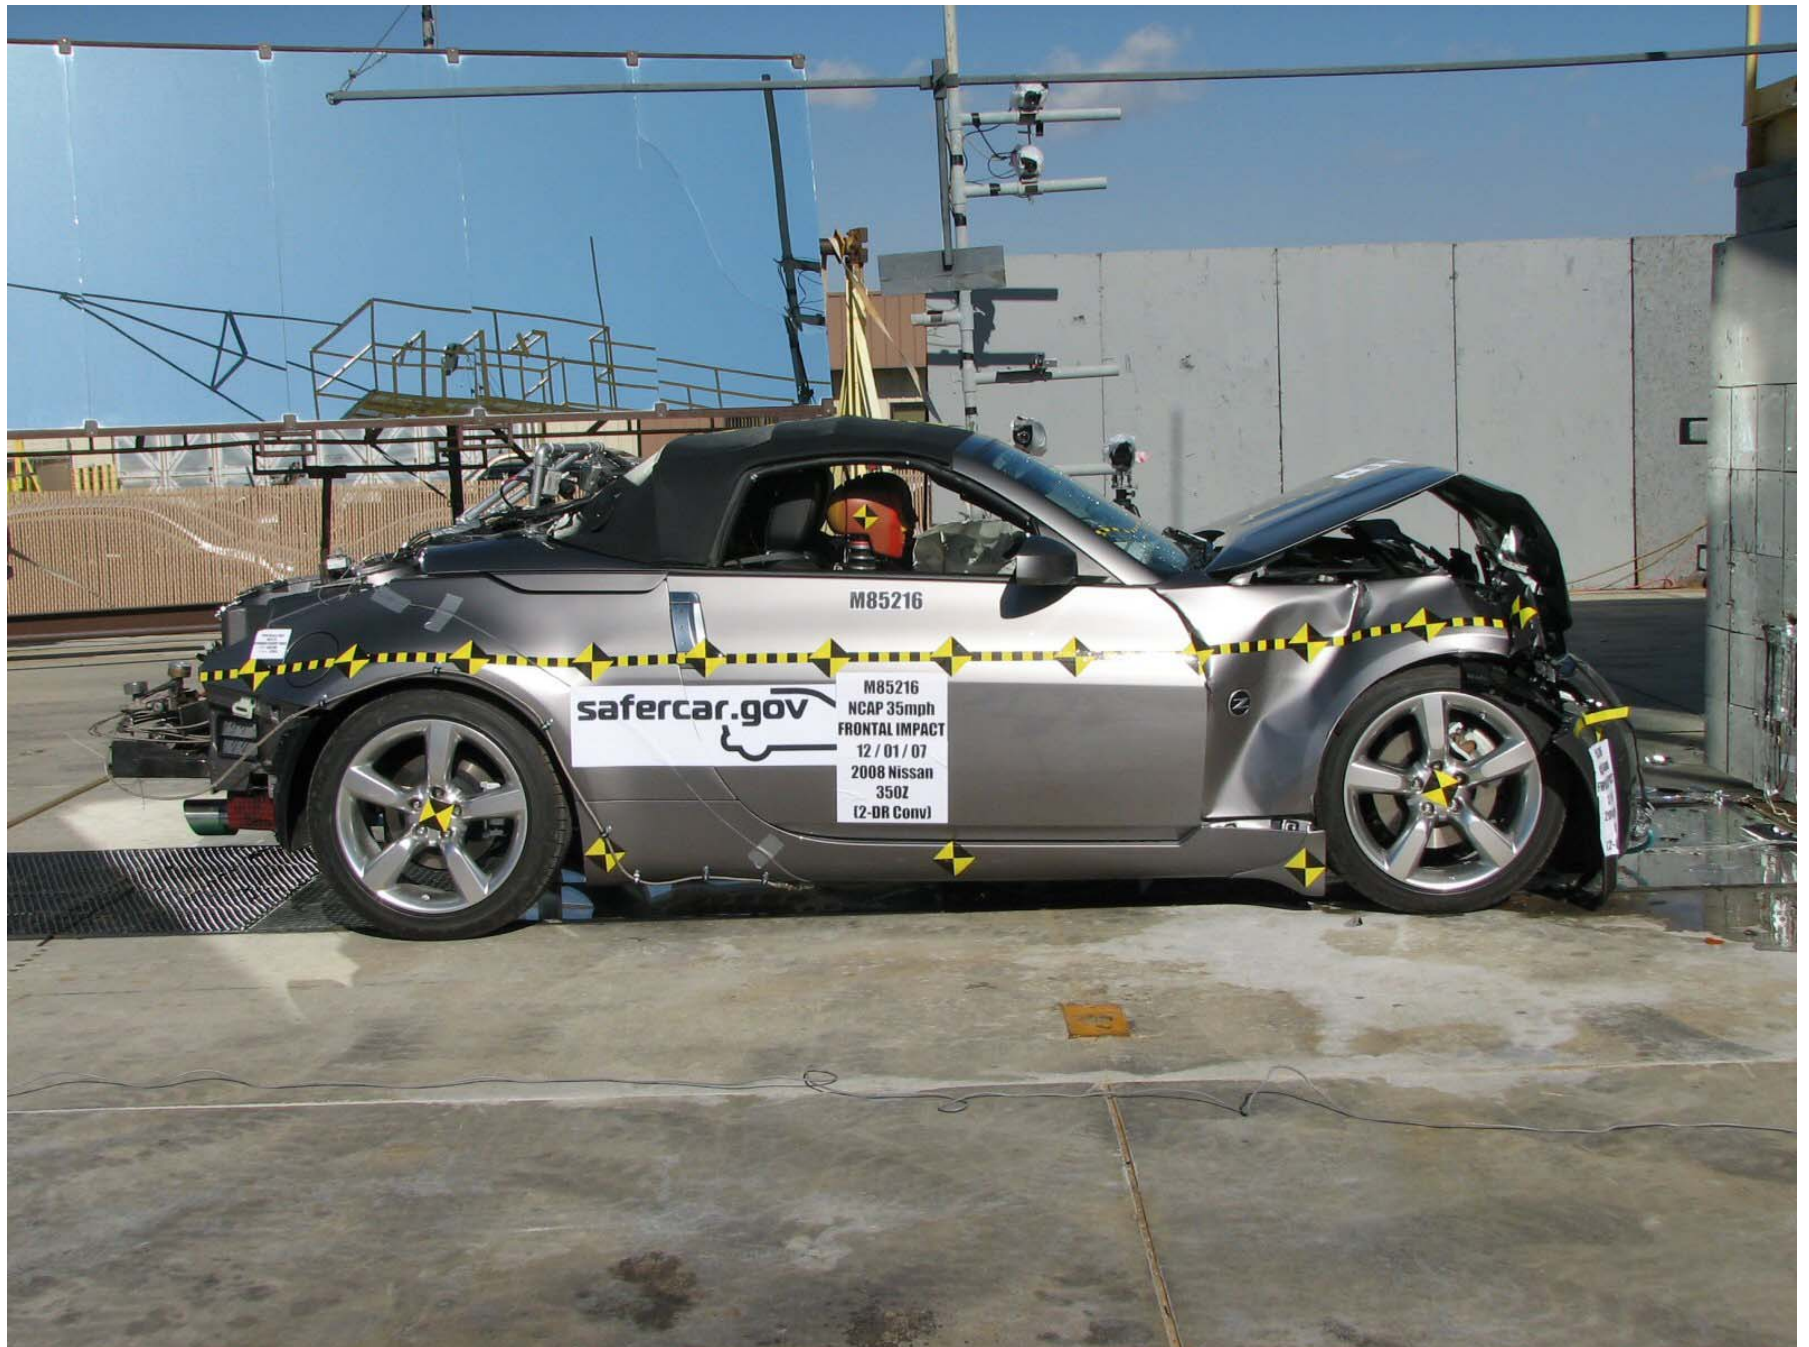
Figure A-11: Post-Test Right Side View

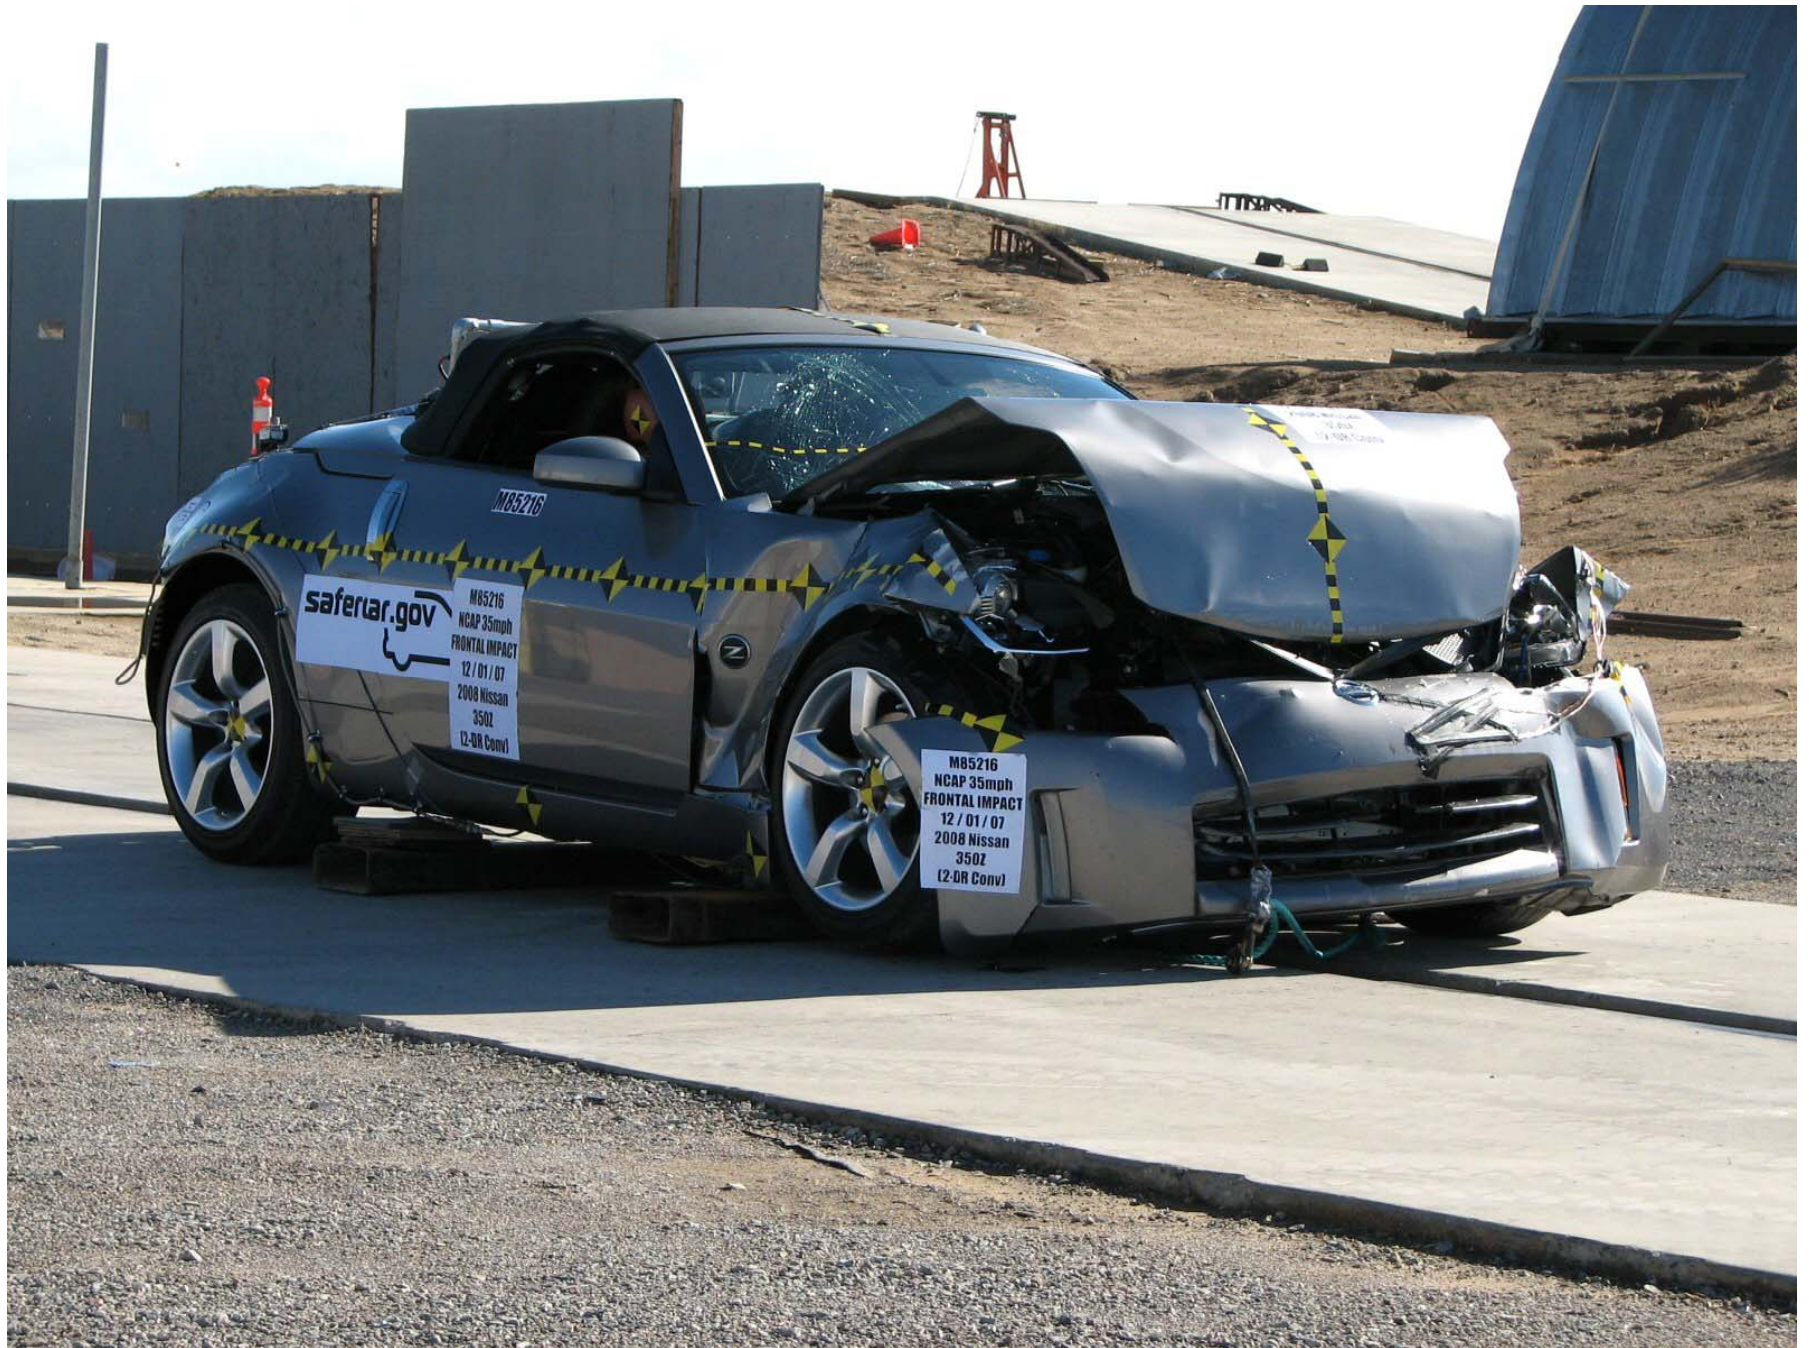
Figure A-13: Post-Test Right Front ¾ View (Vehicle Moved)

The maximum static crush of the vehicle was 275 mm at DPD 5 to the right of the vehicle's centerline and both the driver and the passenger side doors remained closed and latched during the impact event, and were operable after the impact.

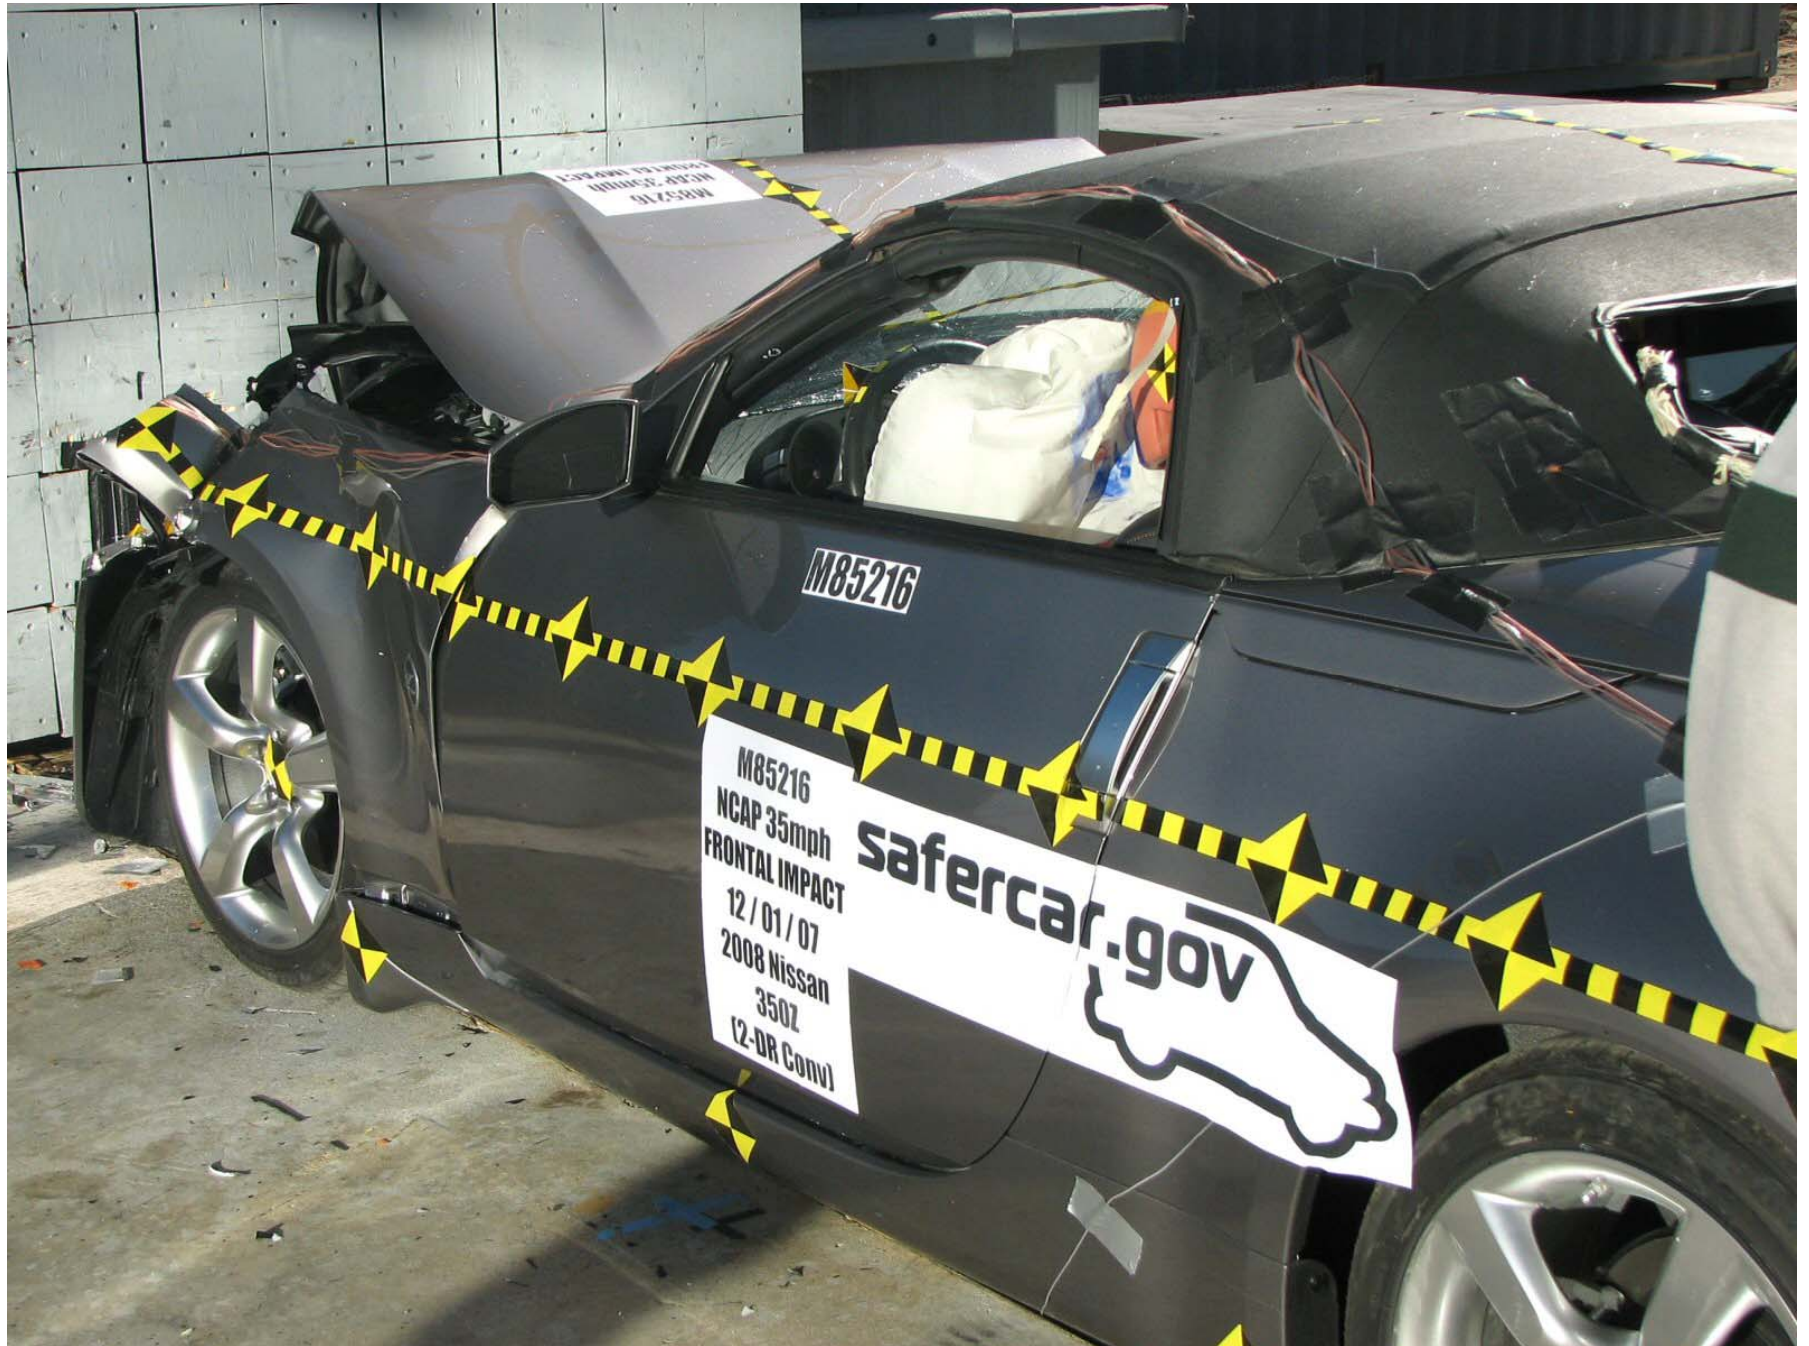
Figure A-16: Post-Test Left Side  $\frac{3}{4}$  View of Doors After Impact

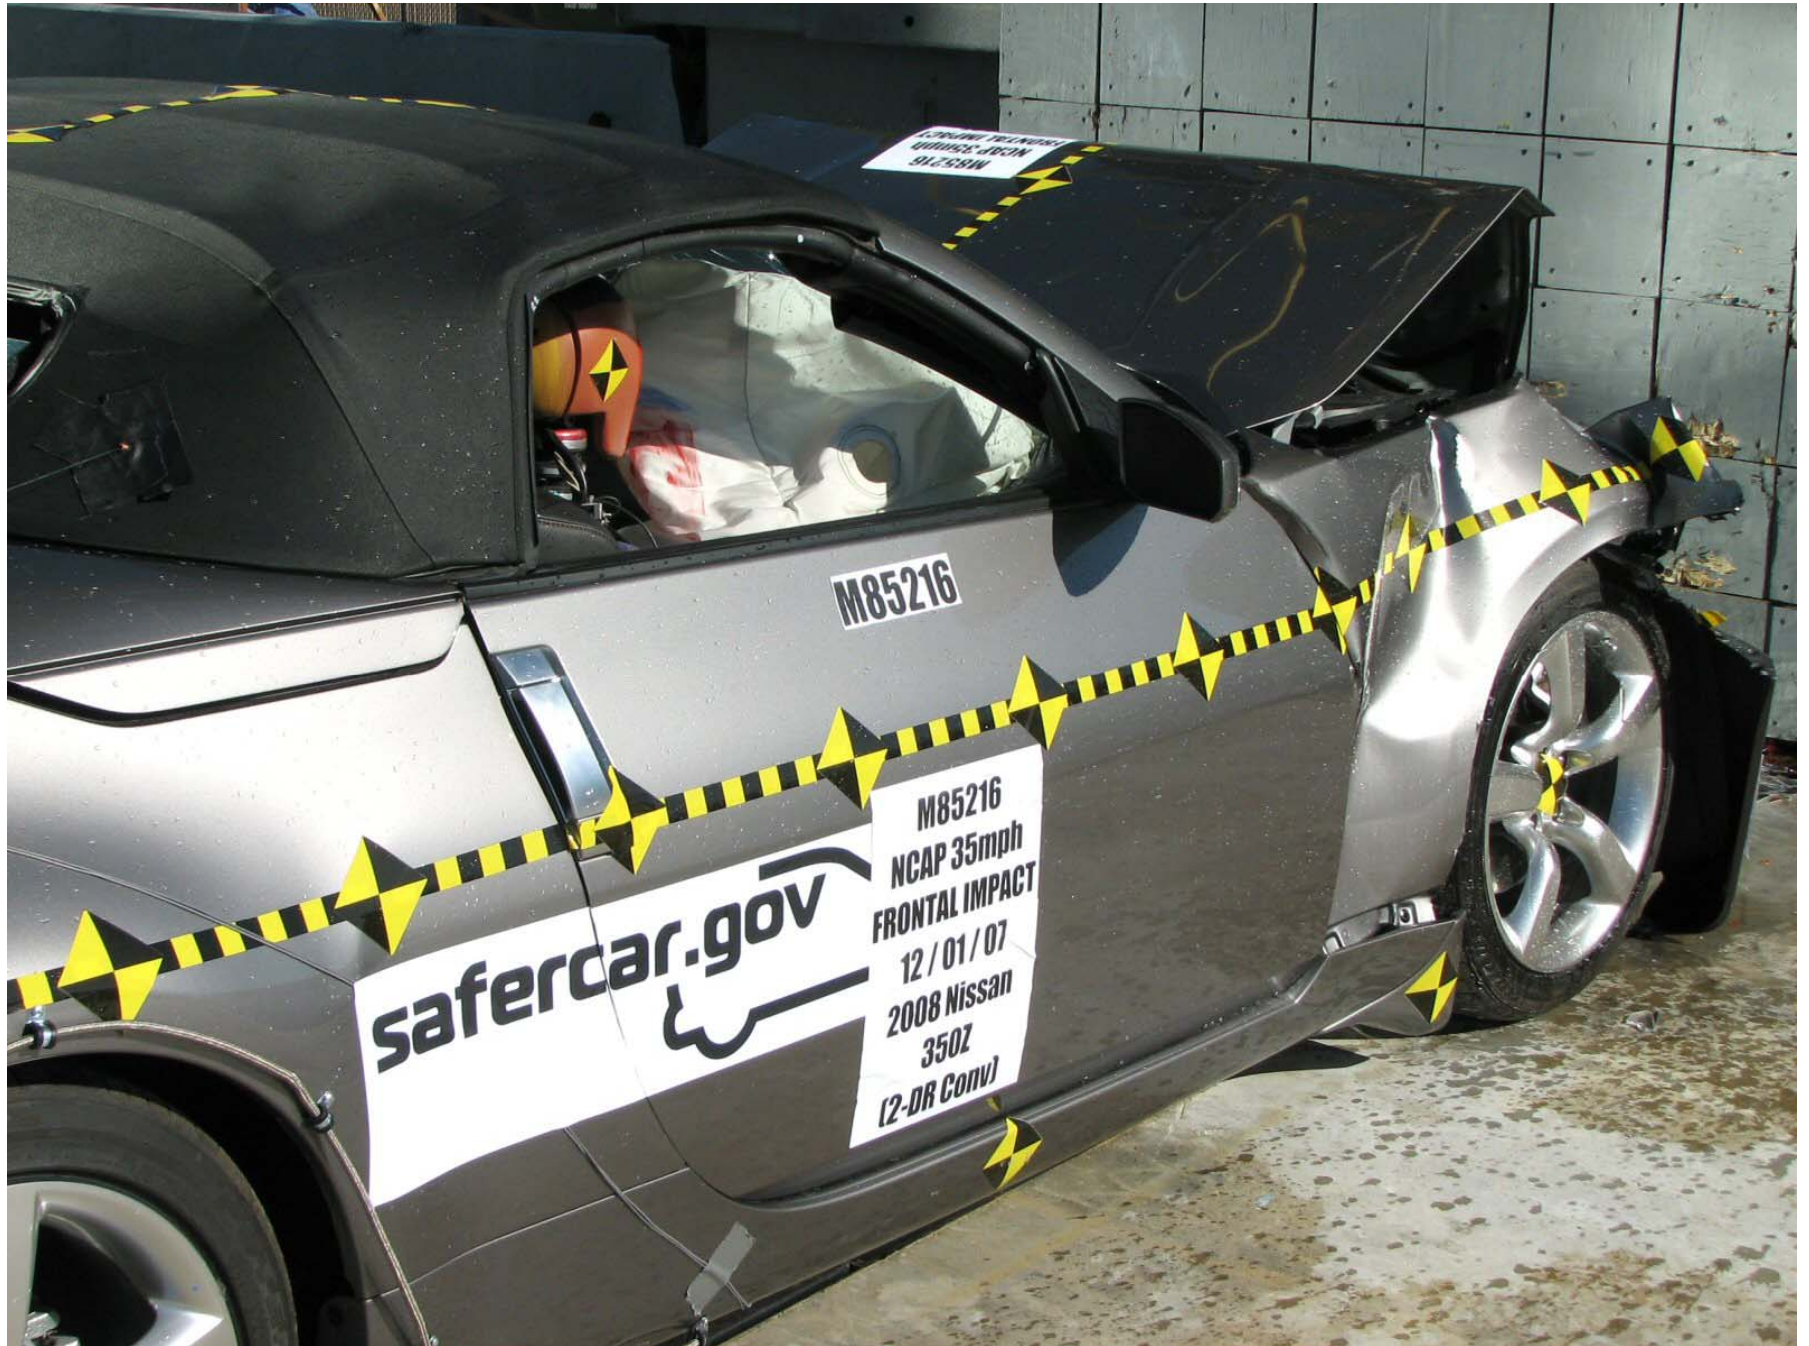
Figure A-17: Post-Test Right Side  $\frac{3}{4}$  View of Doors After Impact

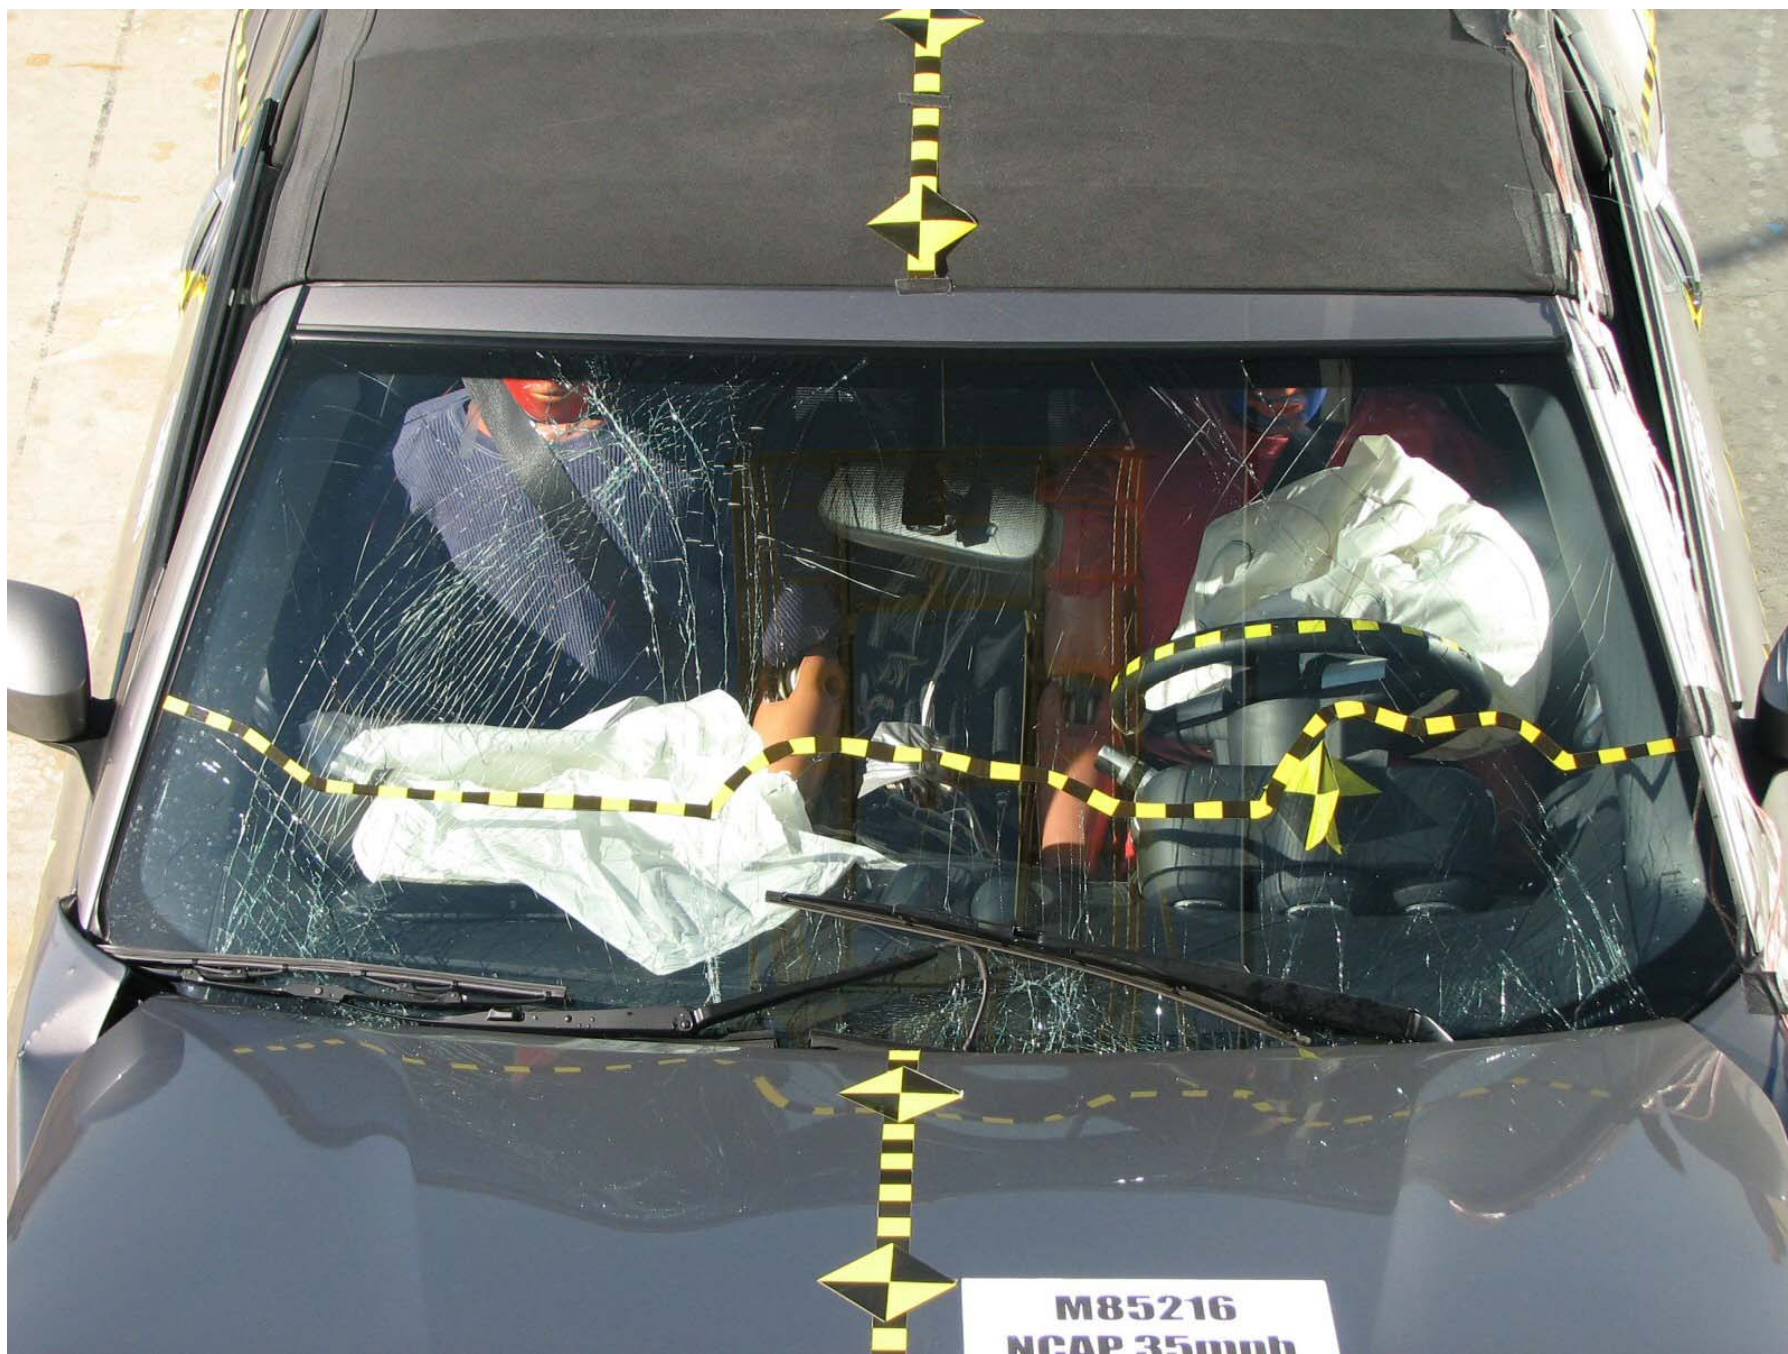
Figure A-19: Post-Test Windshield

There was 100 percent windshield retention and there was no intrusion into the protected zone of the windshield during the impact event. There was no stoddard solvent leakage after the event or during any phase of the static rollover.

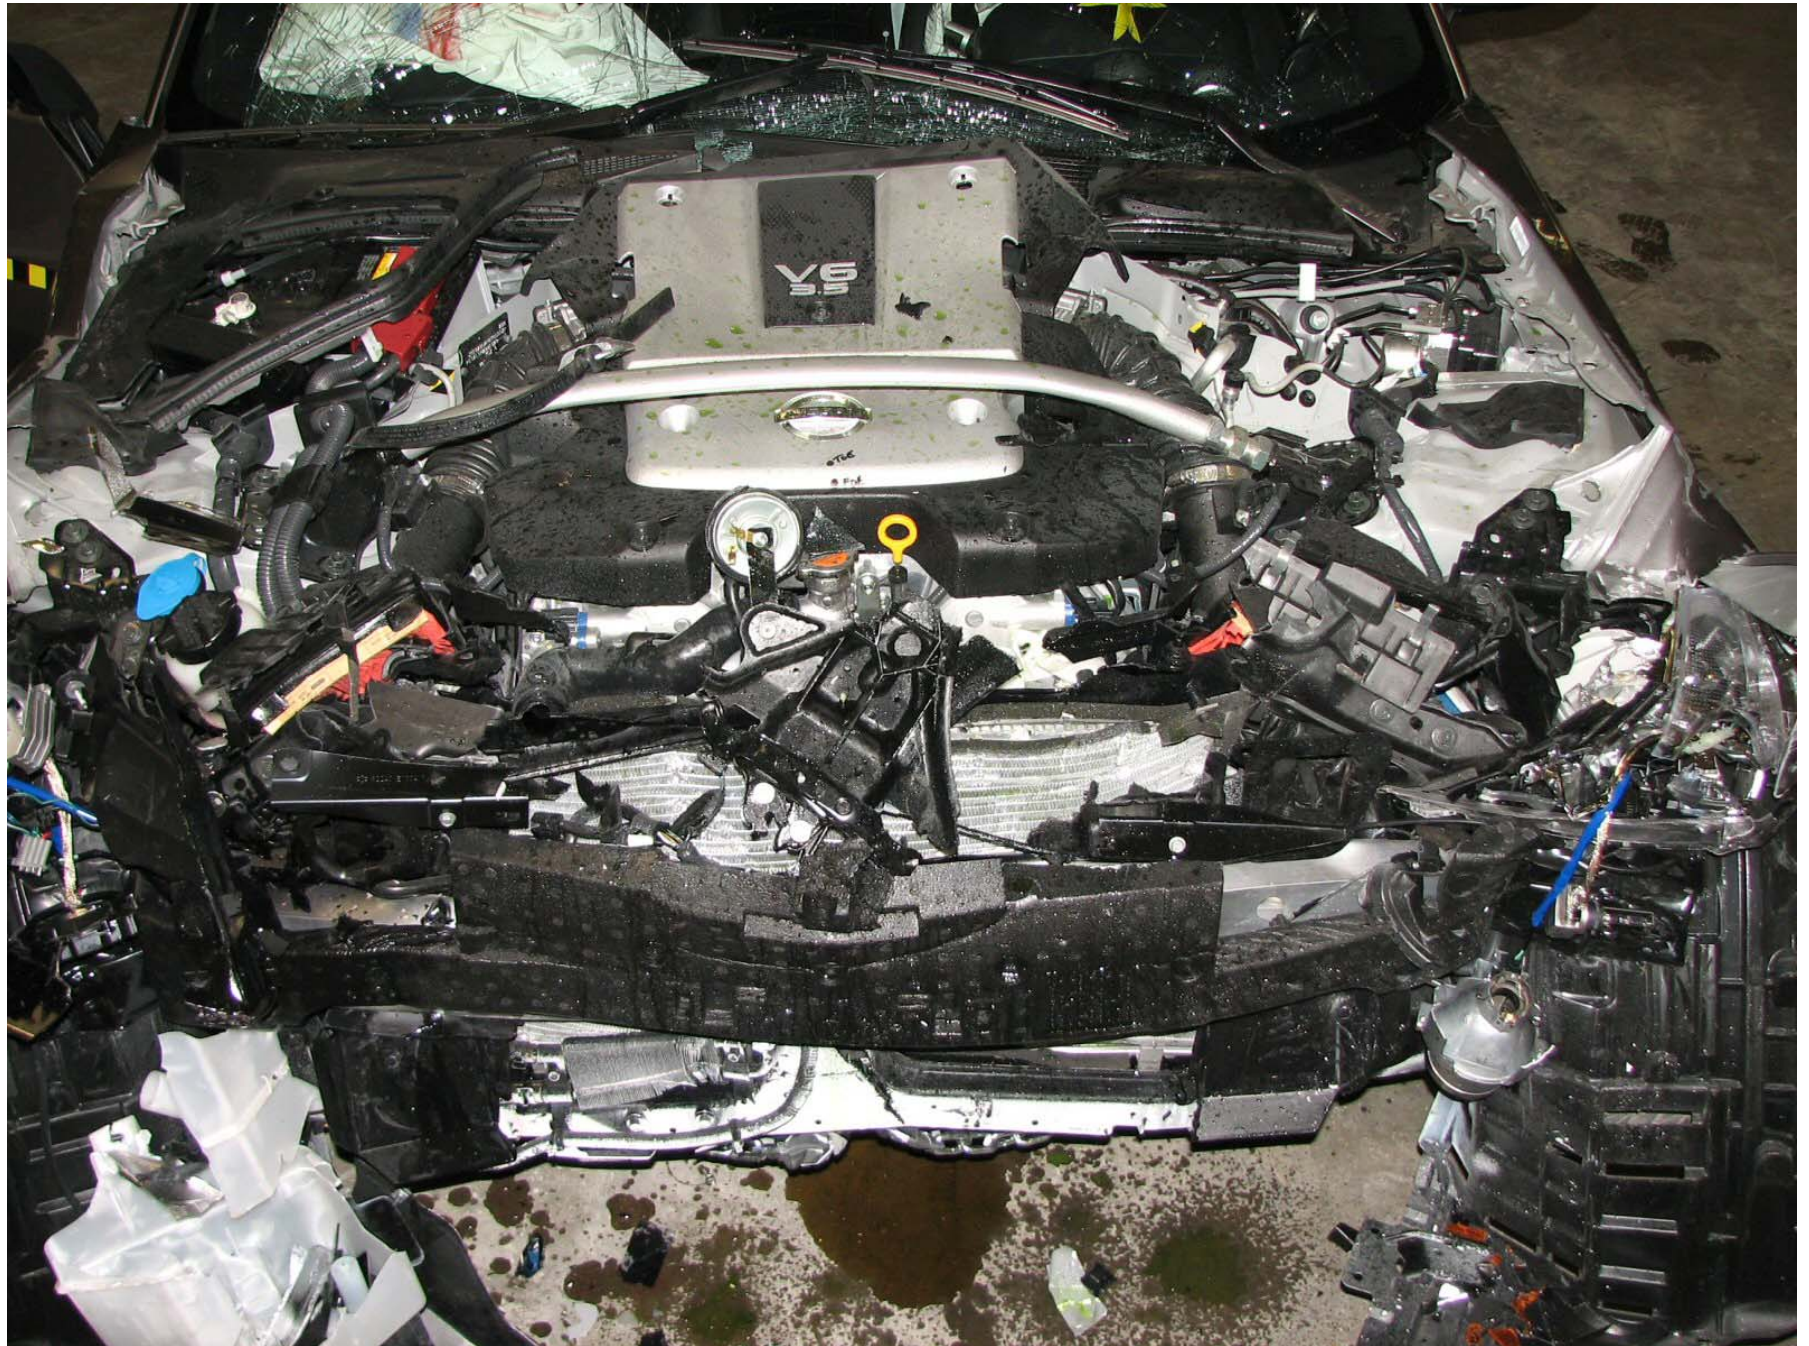
Figure A-21: Post-Test Engine Compartment (Vehicle Moved)

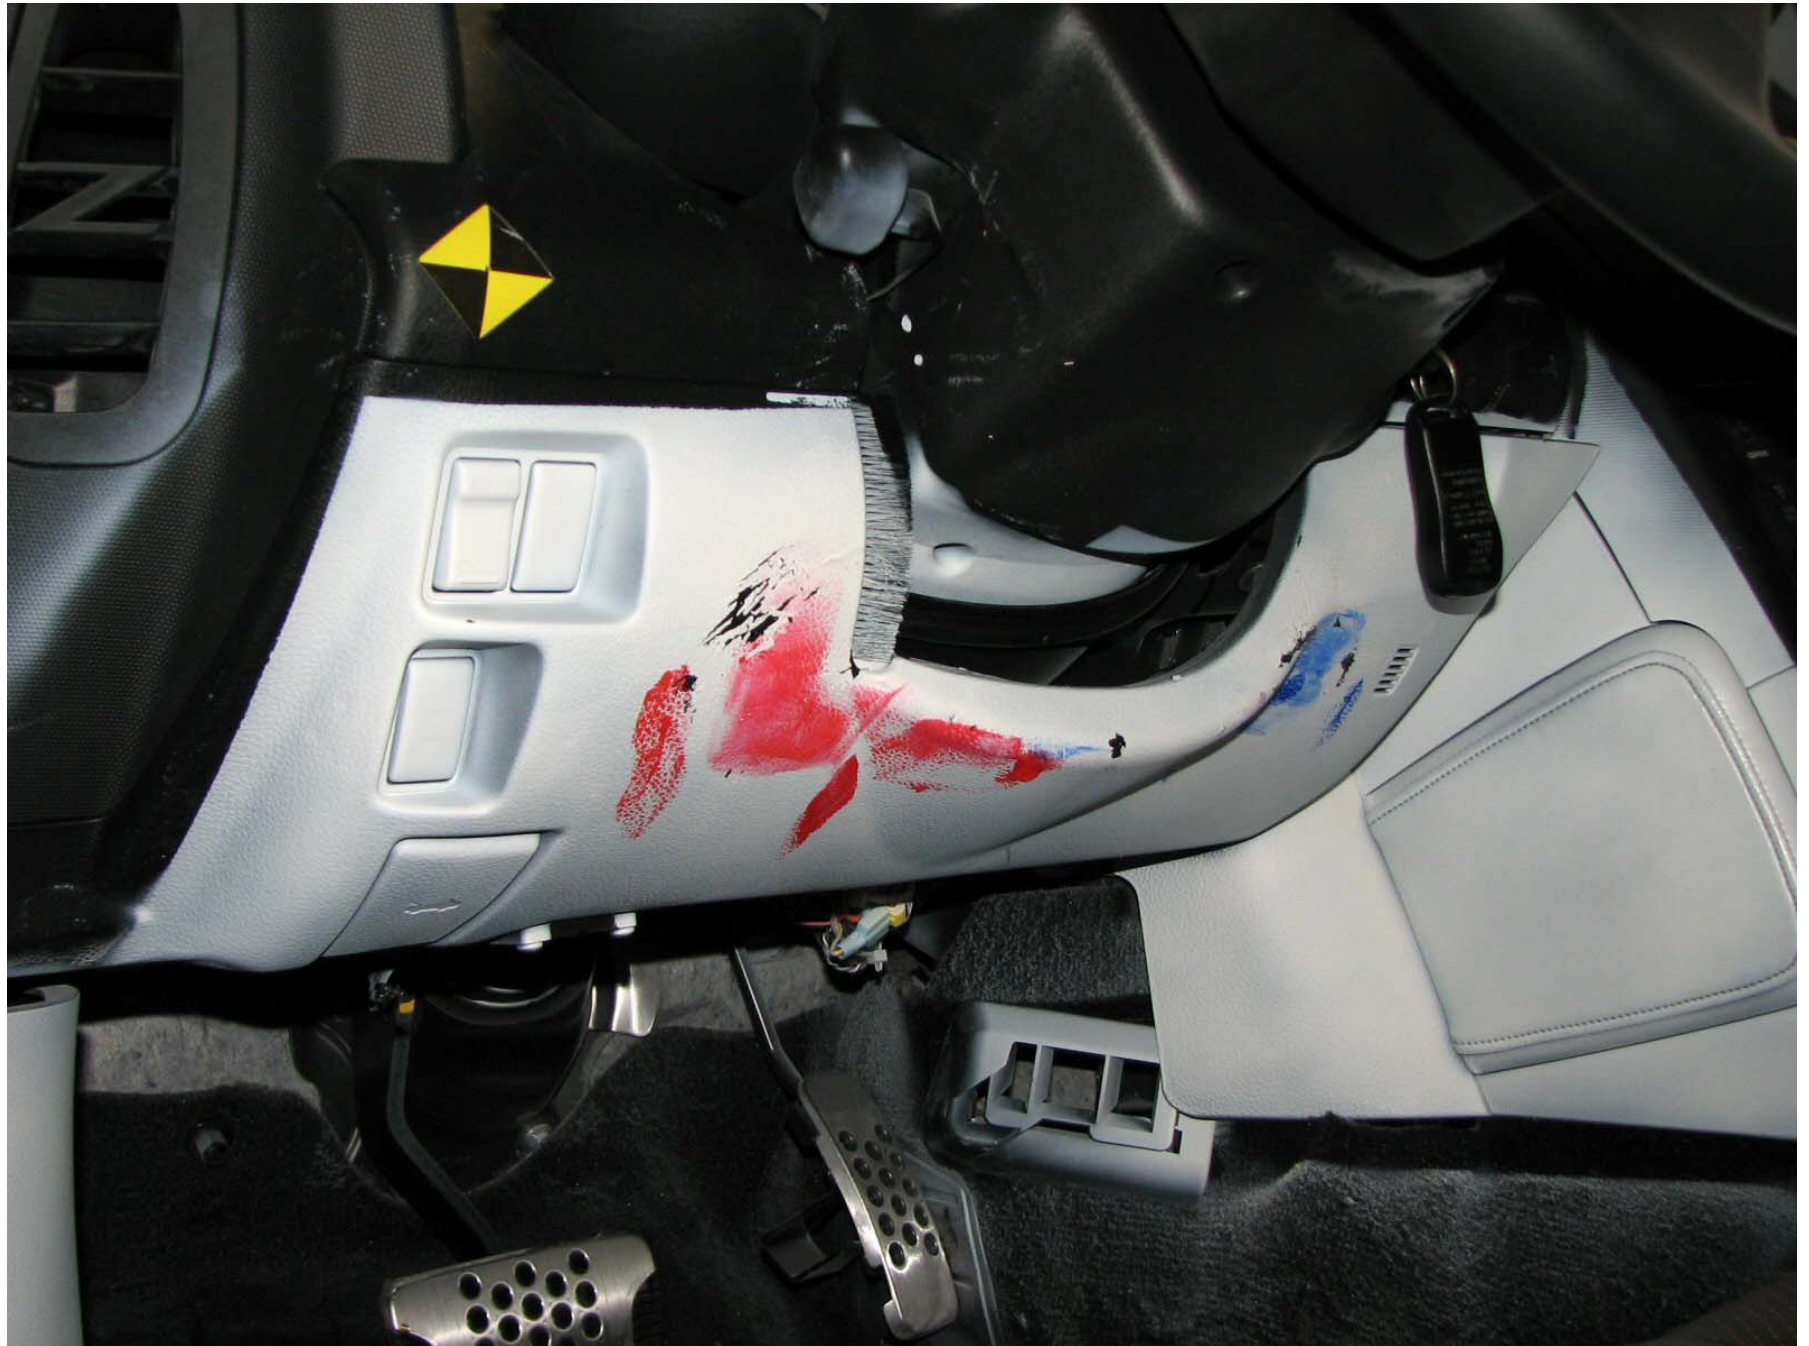
Figure A-39: Post-Test Driver Side Knee Bolster

The driver's visible contact points were as follows: The driver ATD's head and chest contacted the airbag. The head also contacted the headrest. Both the left and right knees contacted the knee bolster.

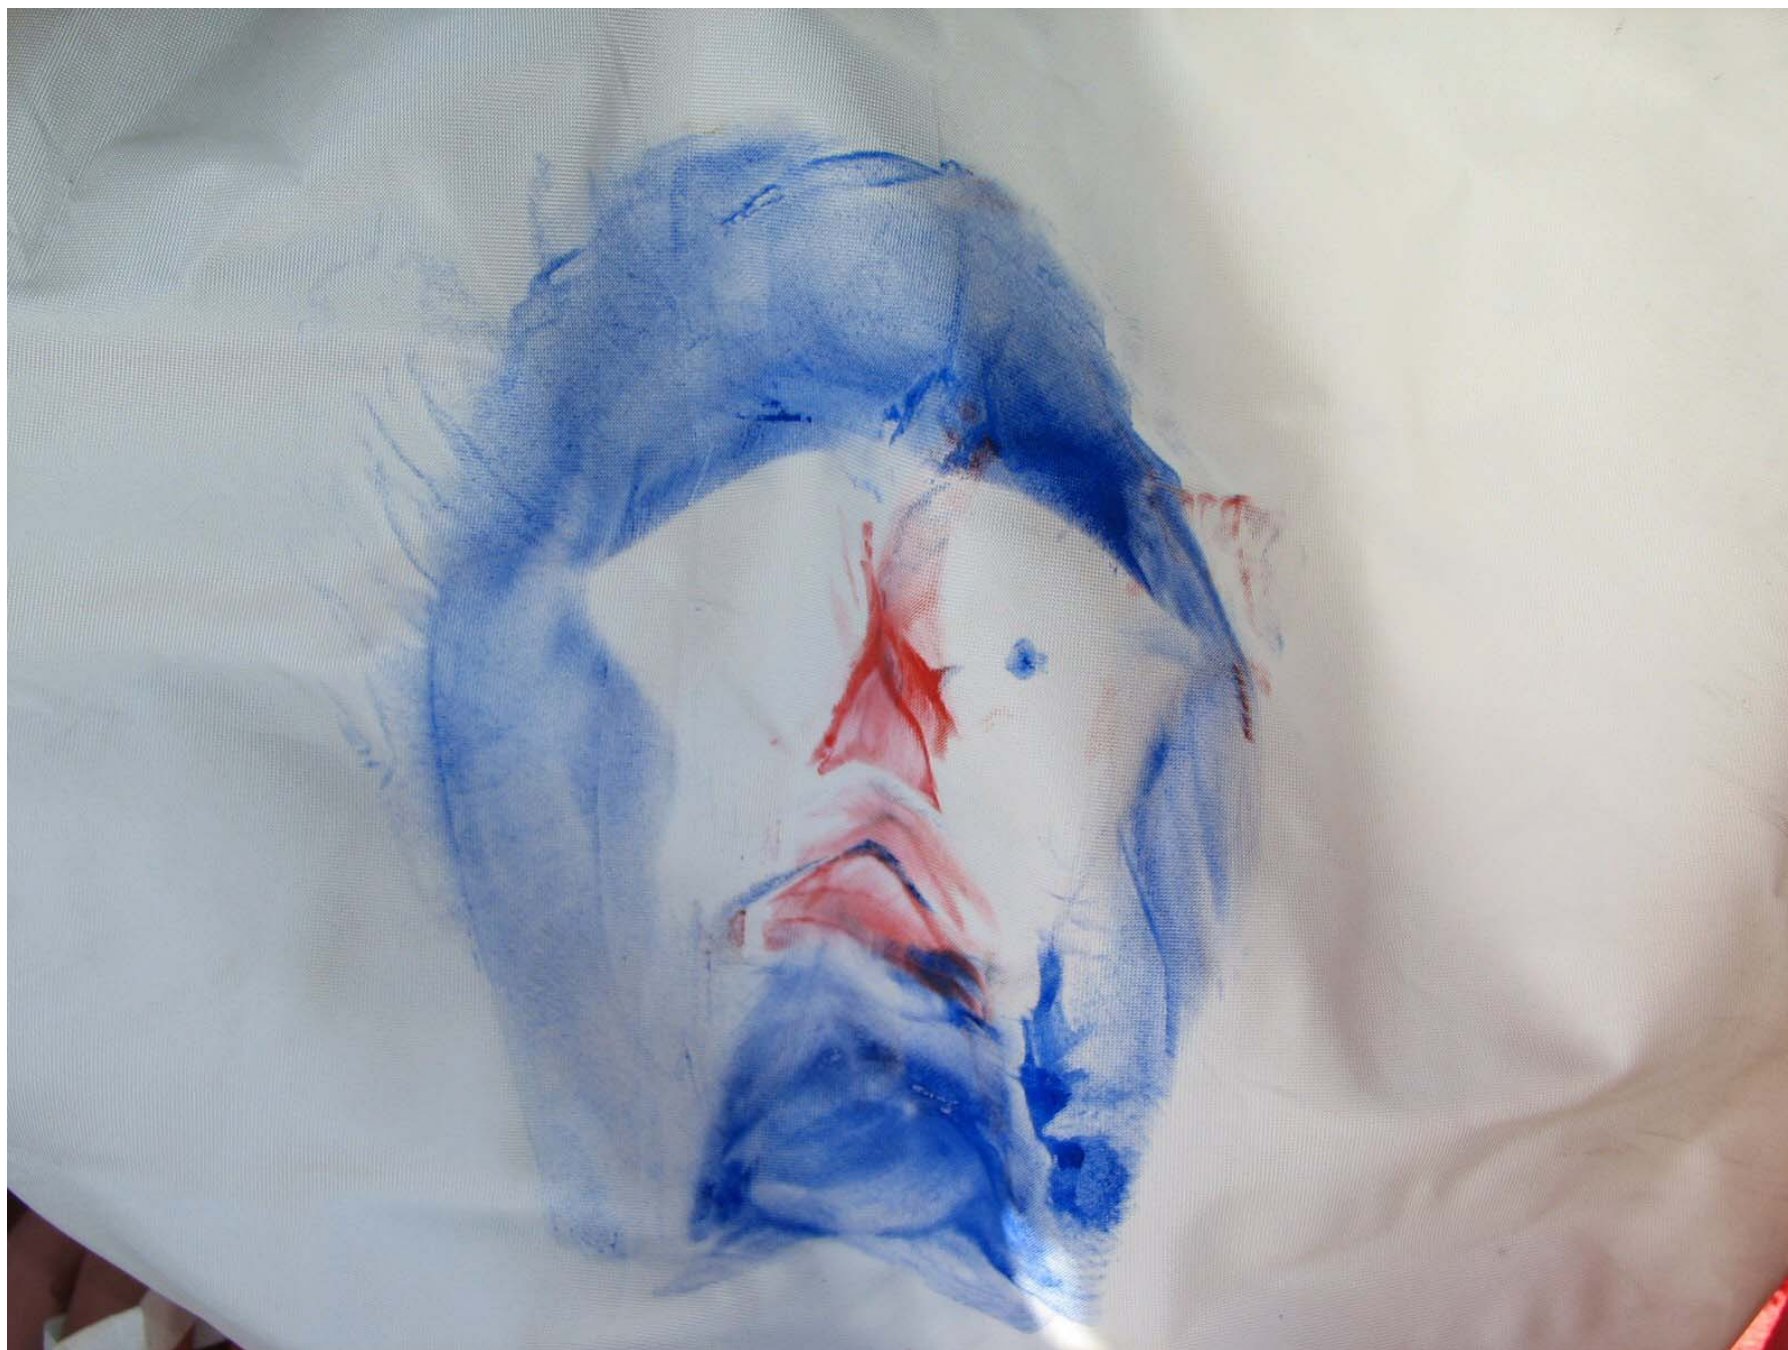
Figure A-43: Post-Test Driver Dummy Airbag Contact
