**NEW CAR ASSESSMENT PROGRAM  
FRONTAL BARRIER IMPACT TEST**

**NISSAN MOTOR CO., LTD  
2008 NISSAN 350Z  
2-DOOR CONVERTIBLE**

**NHTSA NUMBER: M85216**

**FINAL REPORT**

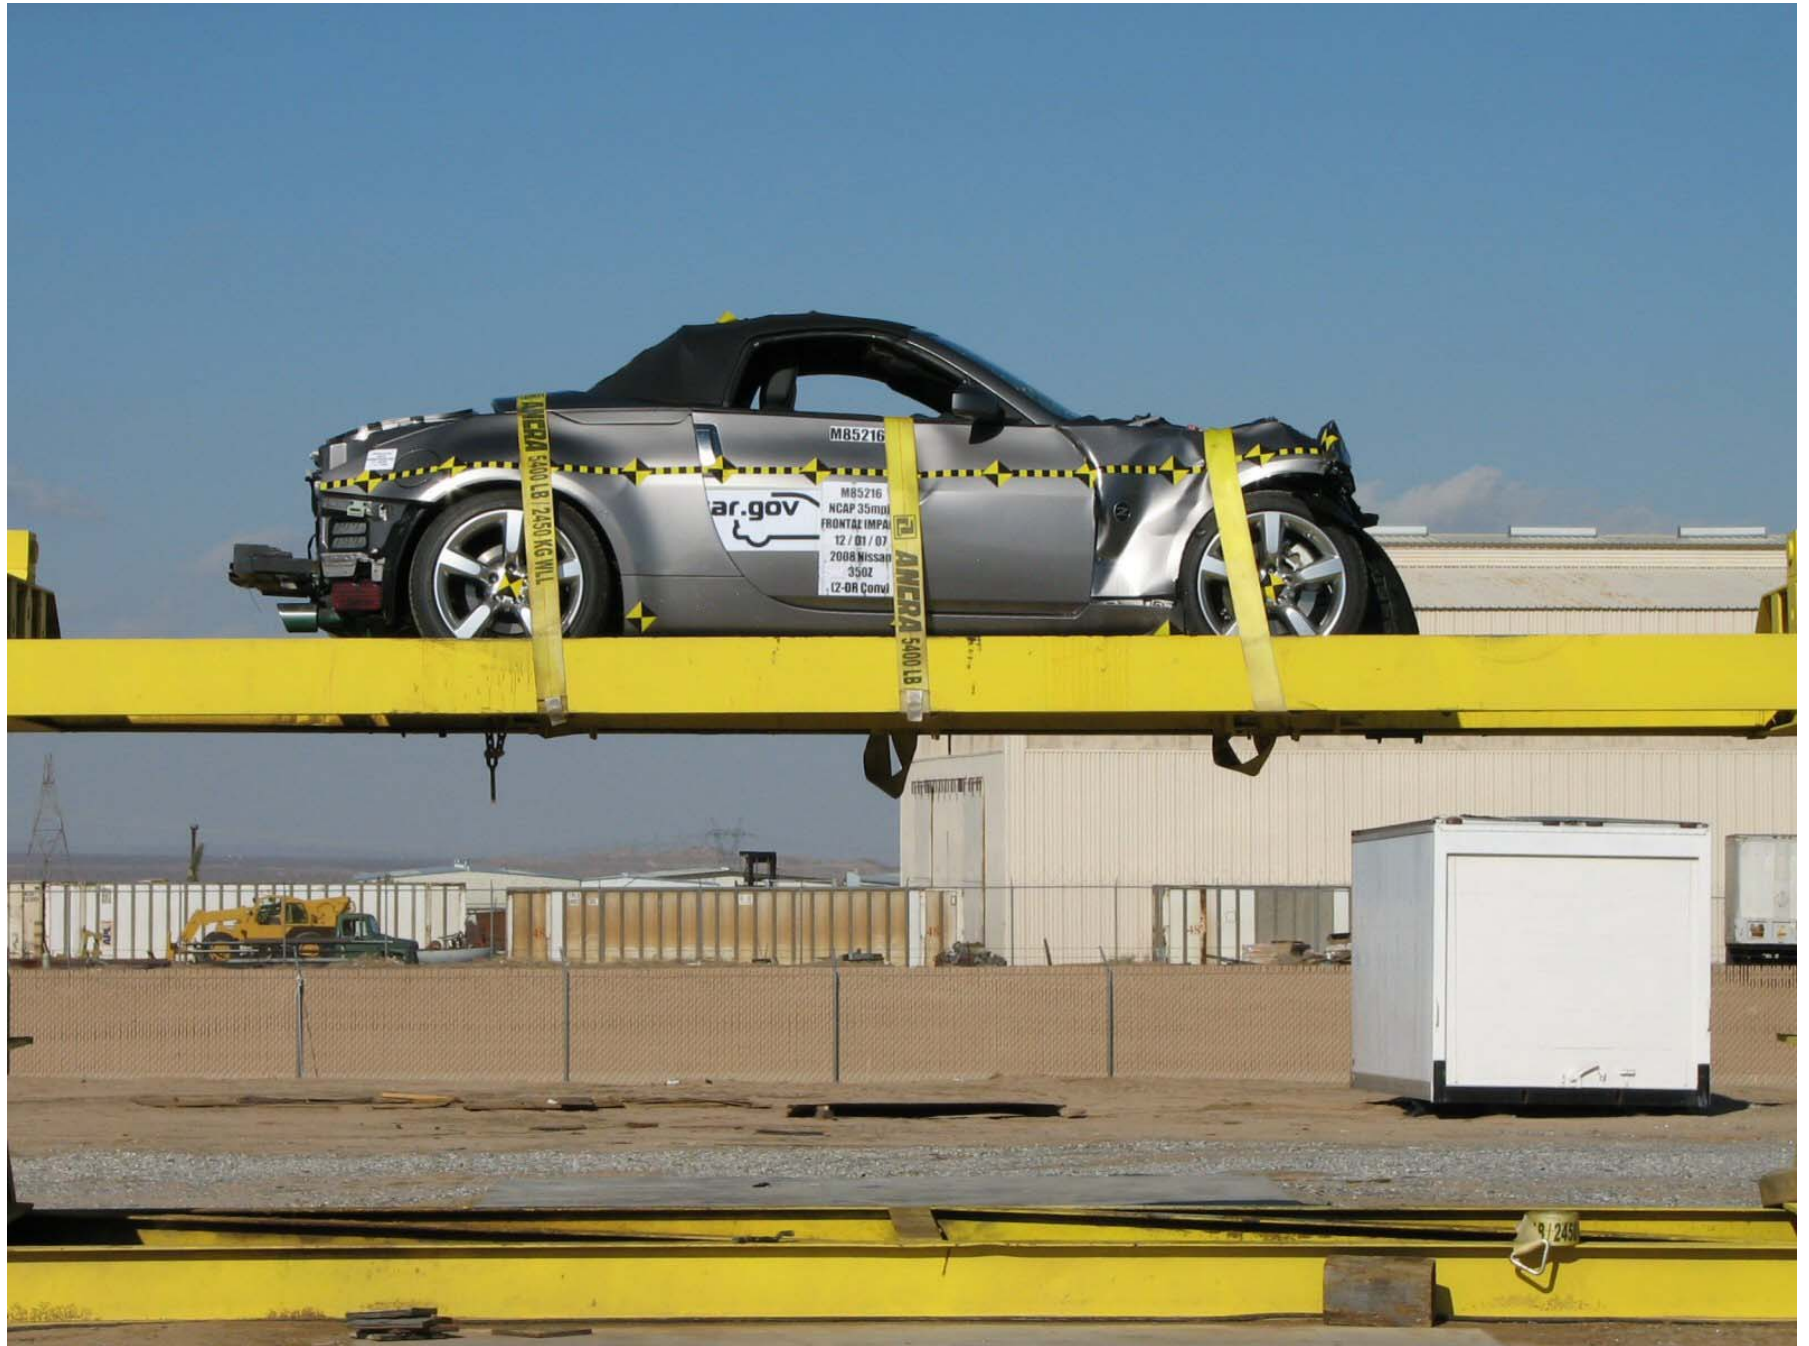
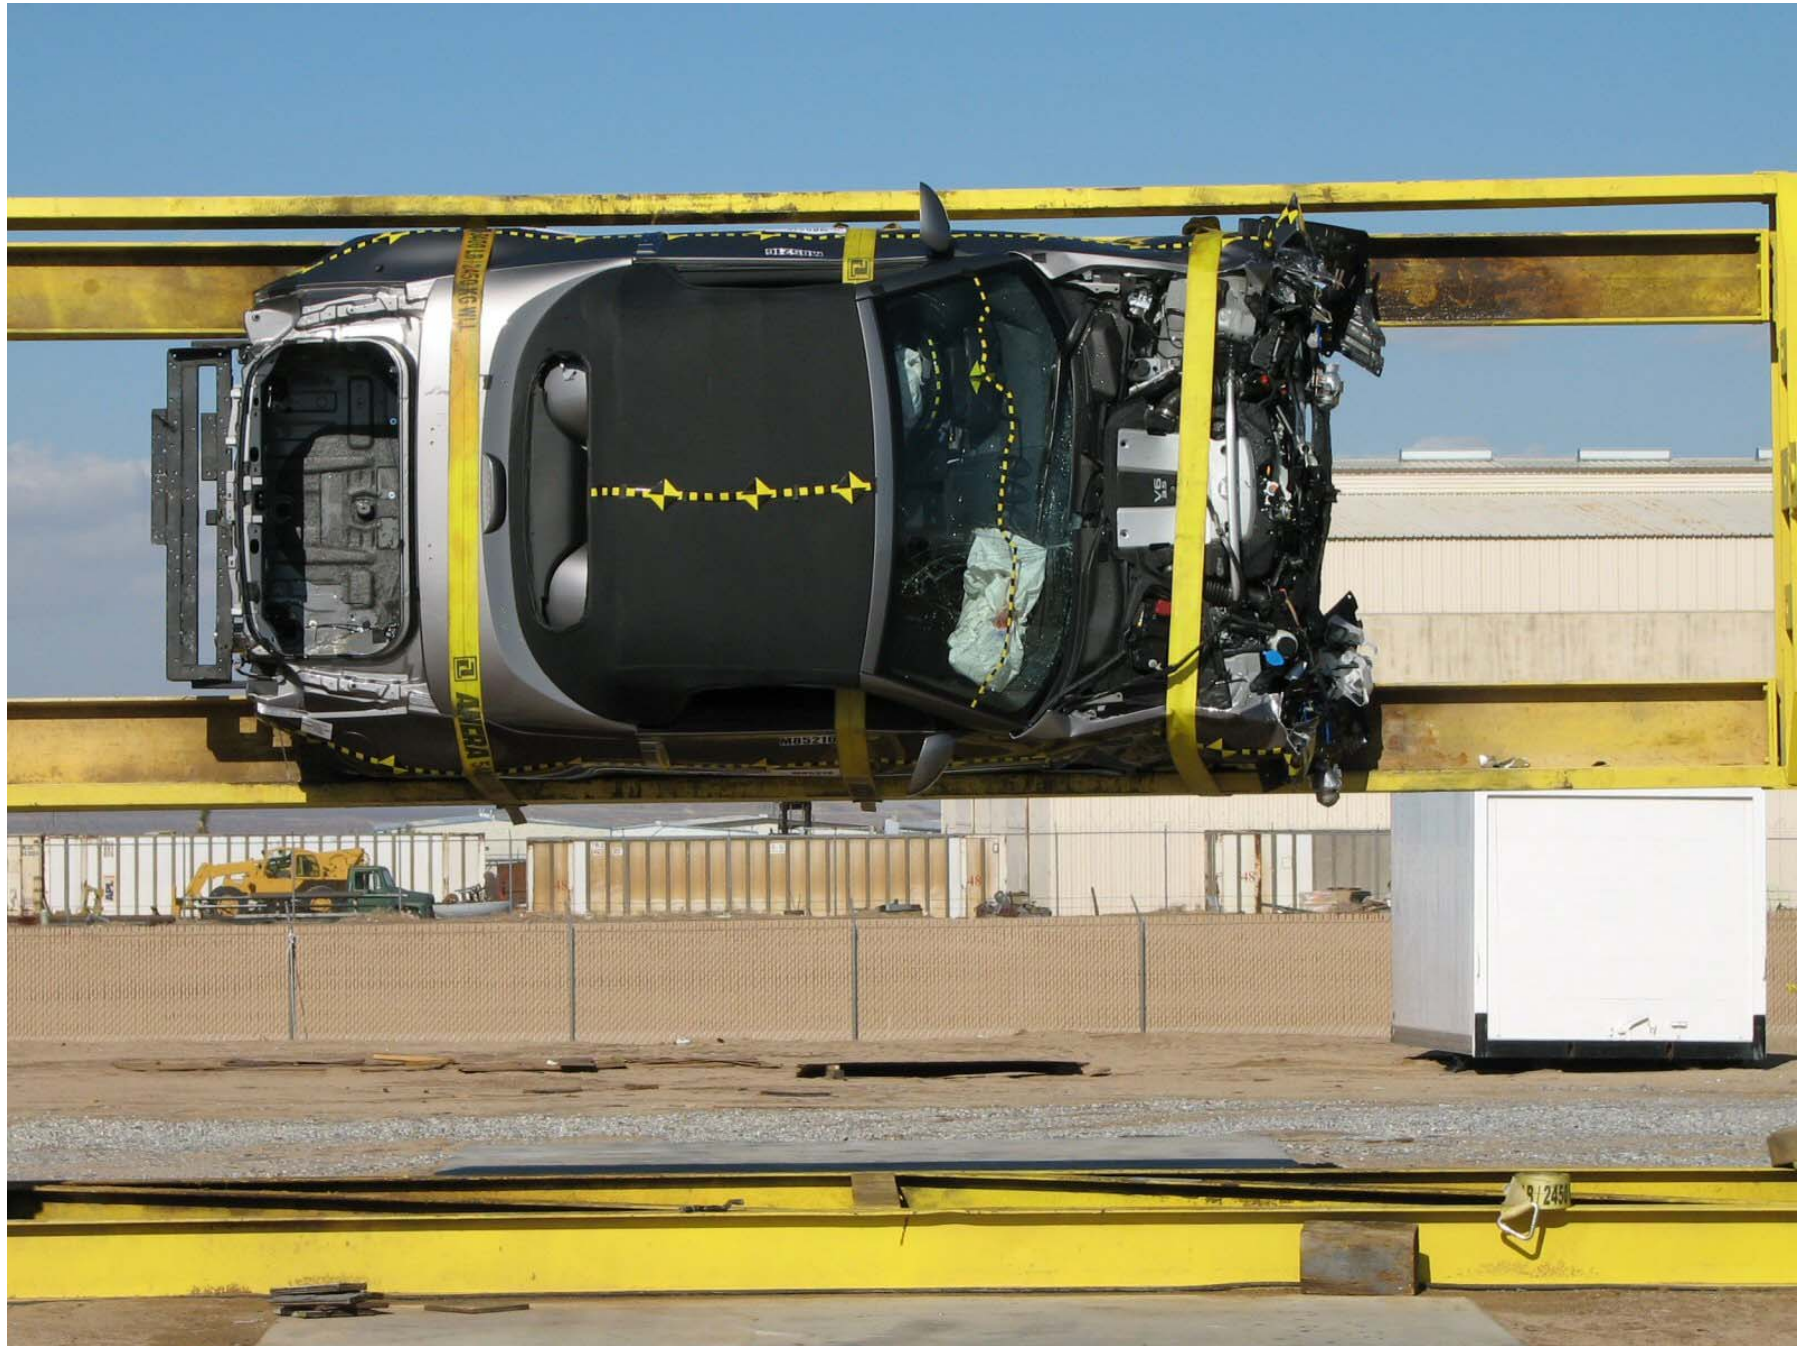
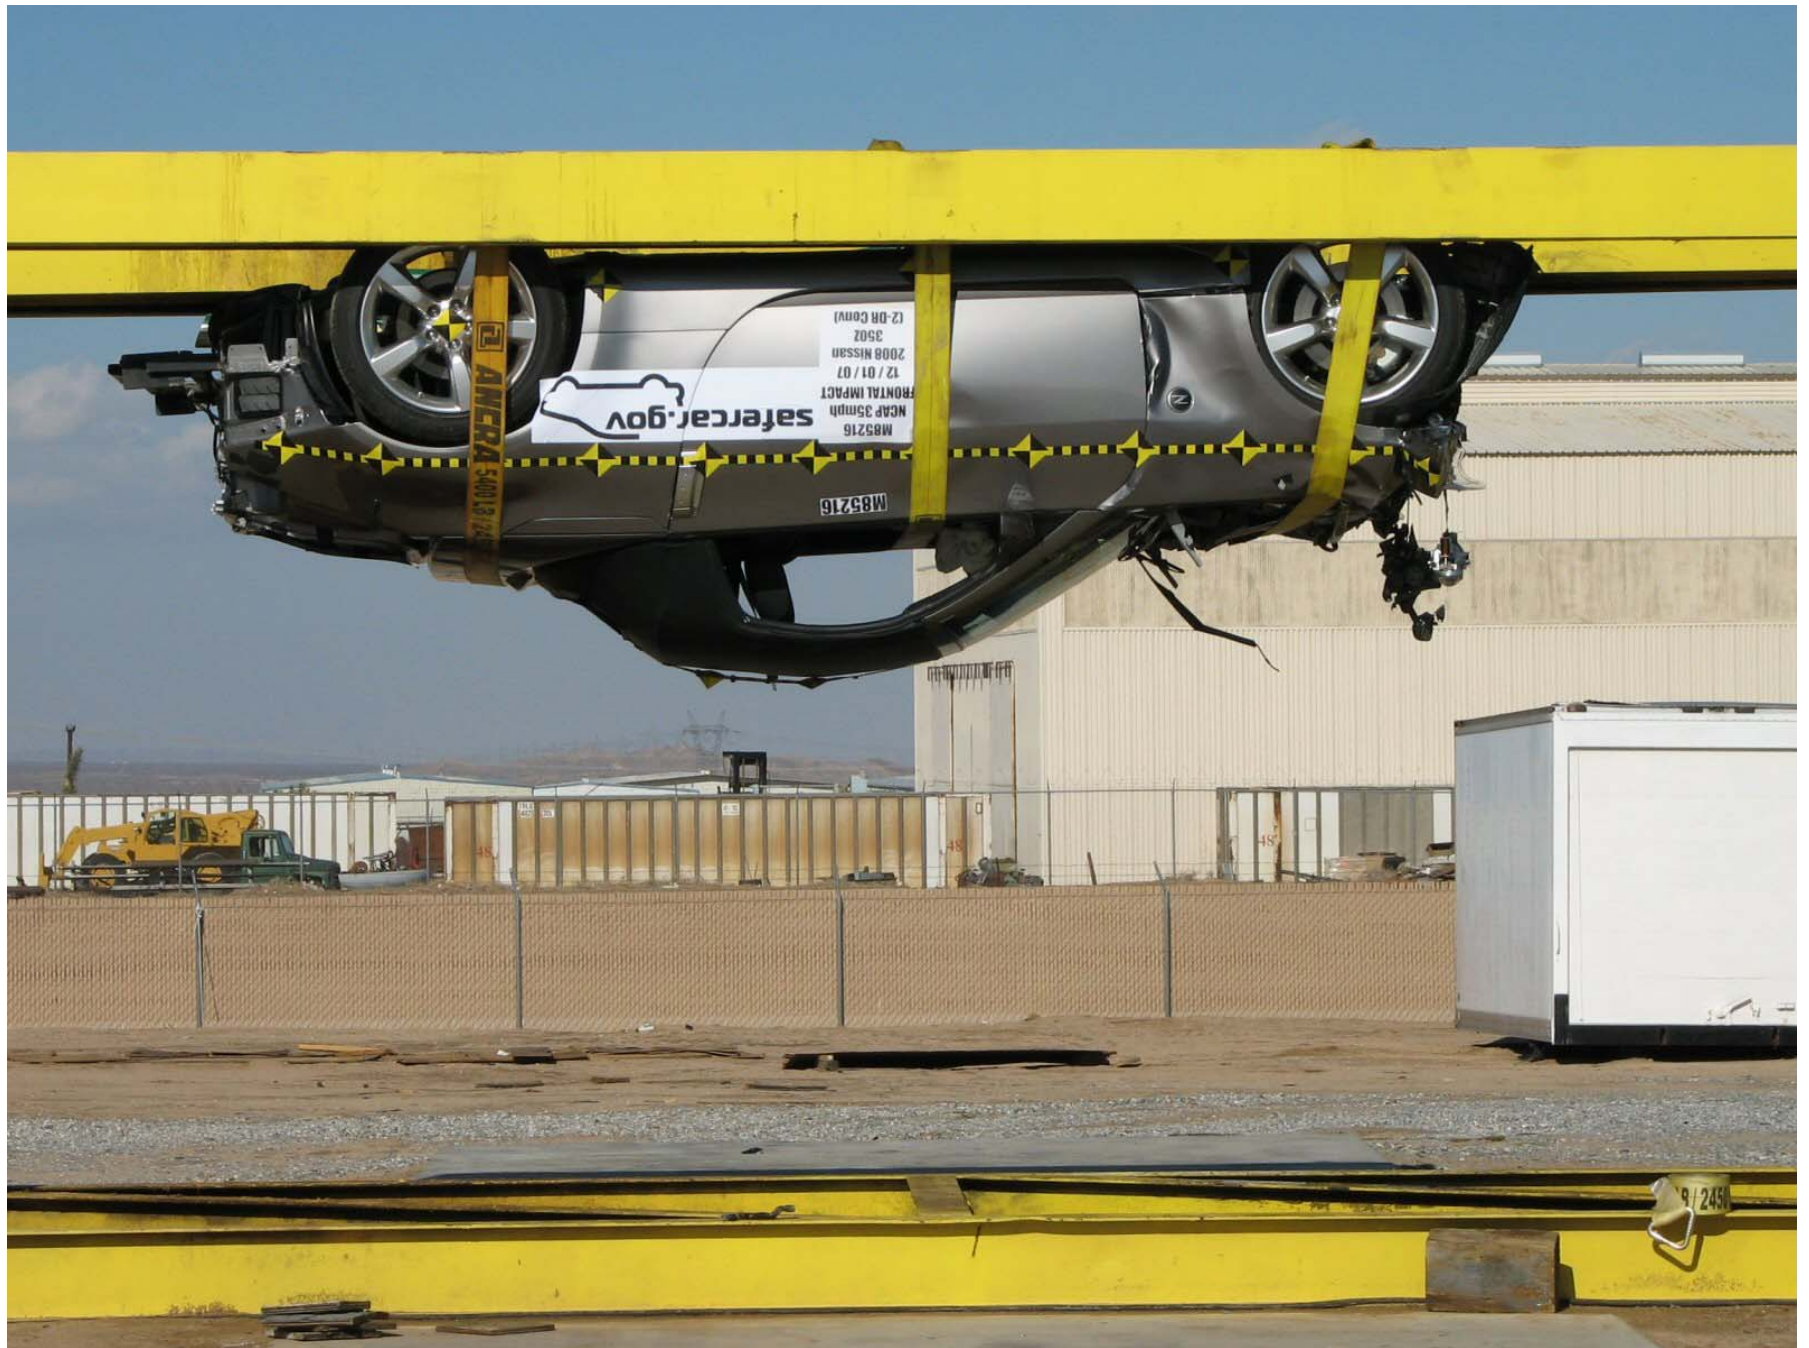
Figure A-58: Vehicle on Rollover Device (0°)

Figure A-59: Vehicle on Rollover Device (90°)

Figure A-60: Vehicle on Rollover Device (180°)

Figure A-61: Vehicle on Rollover Device (270°)

1. The specified fixture rollover rate for each 90° of rotation is 60 to 120 seconds.
2. The position hold time at each position is 300 seconds (minimum).
3. No solvent leakage occurred during rollover.

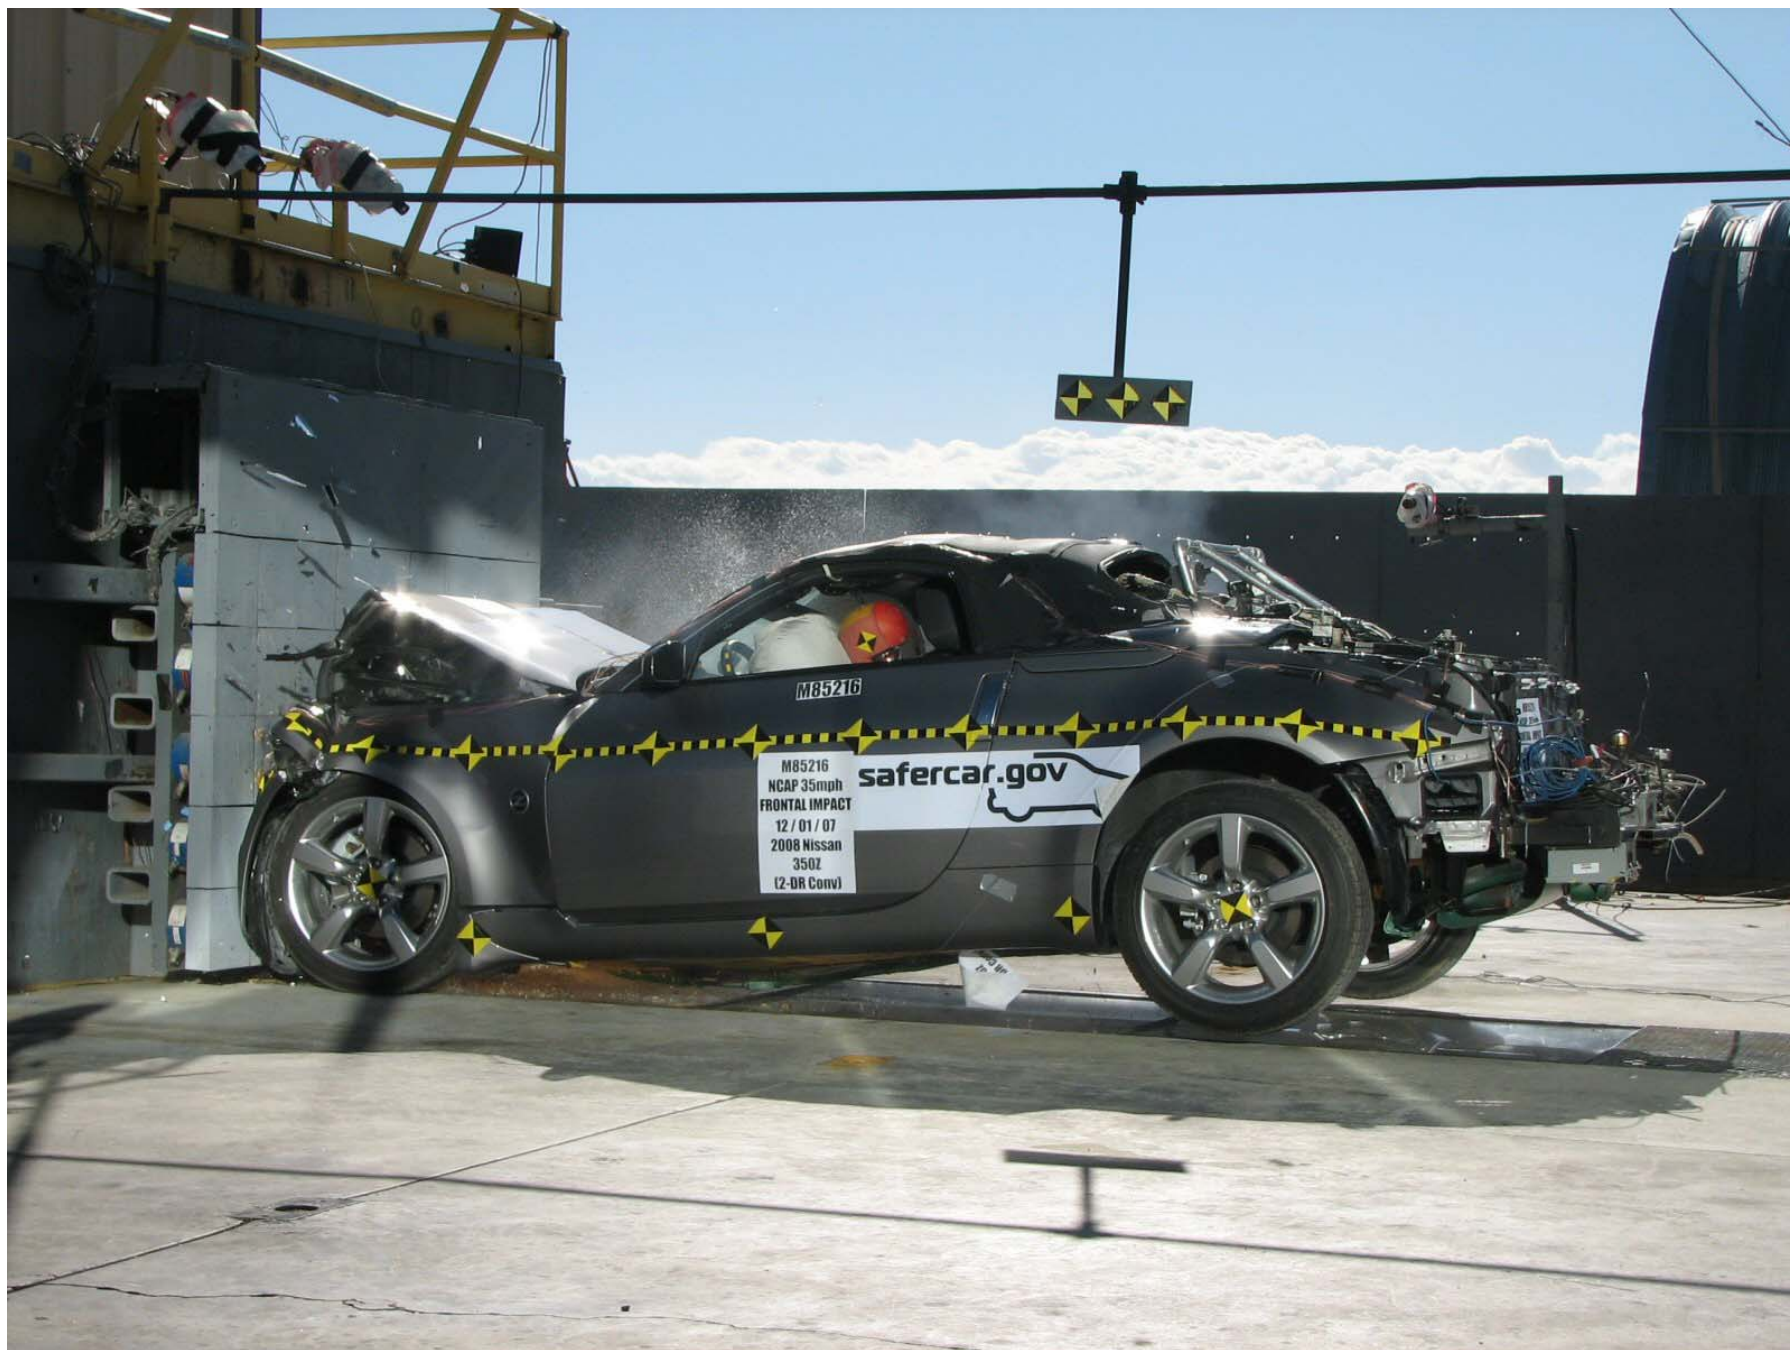
Figure A-62: Vehicle Impact

A load cell barrier consisting of 36 load cells was impacted by a 2008 Nissan 350Z 2-Door Convertible at a velocity of 55.75 km/h. The test was performed at Karco Engineering, LLC on December 1, 2007.
